REPORT NUMBER: SideNCAPMDB-MGA-25-015

**NEW CAR ASSESSMENT PROGRAM (NCAP)
Moving Deformable Barrier Side Impact Test**

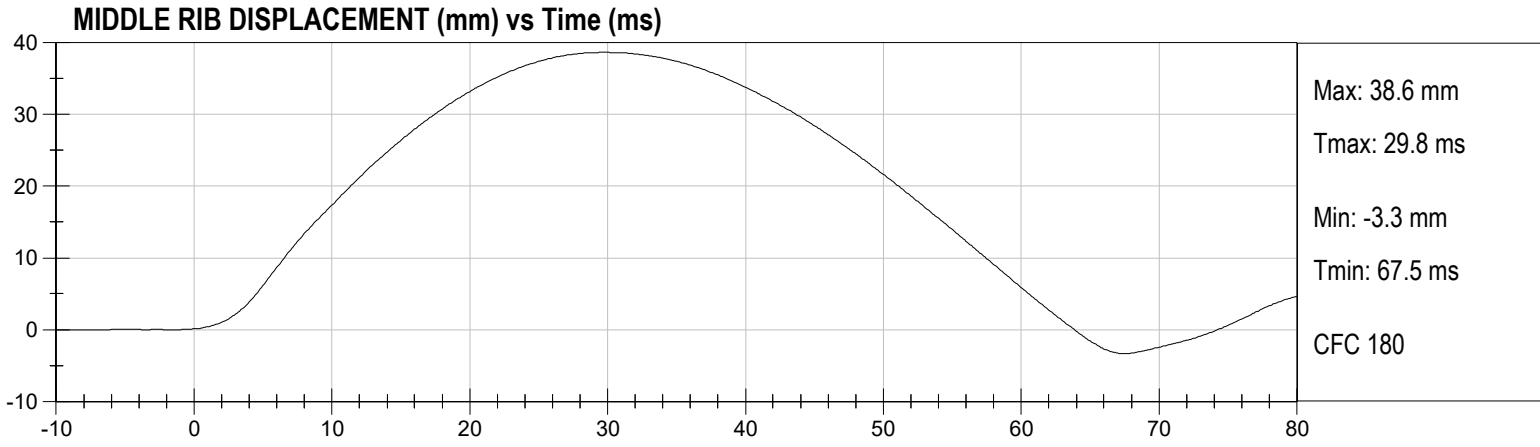
Channel	Manufacturer	Serial Number	Calibration Date	Calibration Due Date
MIDDLE RIB DISPLACEMENT	Honeywell	G368	11/21/2024	5/23/2025

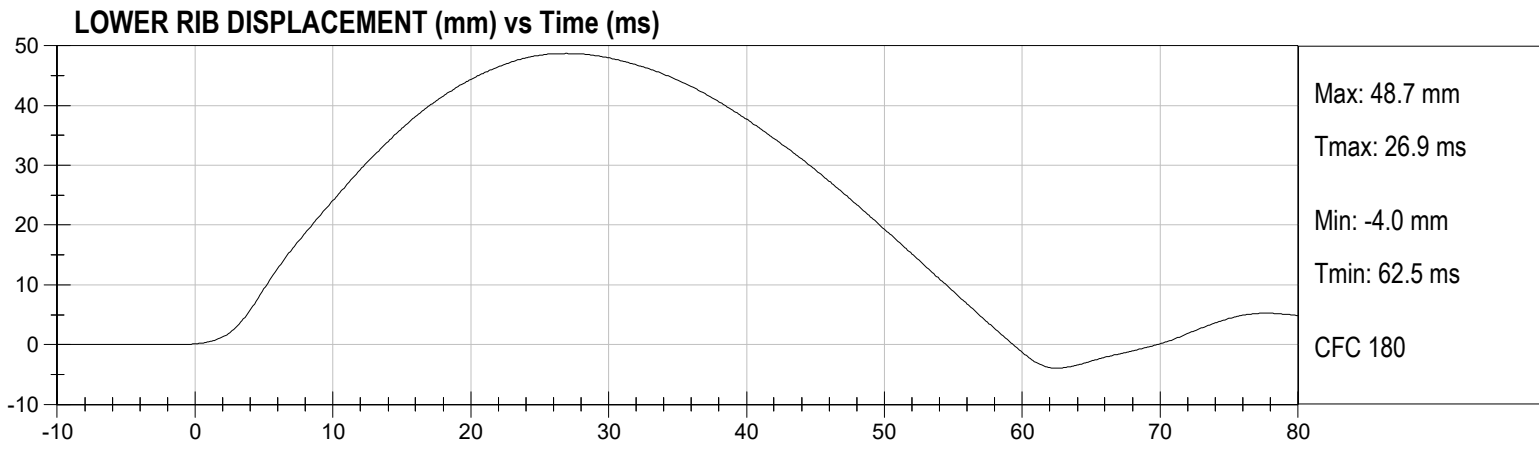
Channel	Manufacturer	Serial Number	Calibration Date	Calibration Due Date
LOWER RIB DISPLACEMENT	Honeywell	G164	11/21/2024	5/23/2025

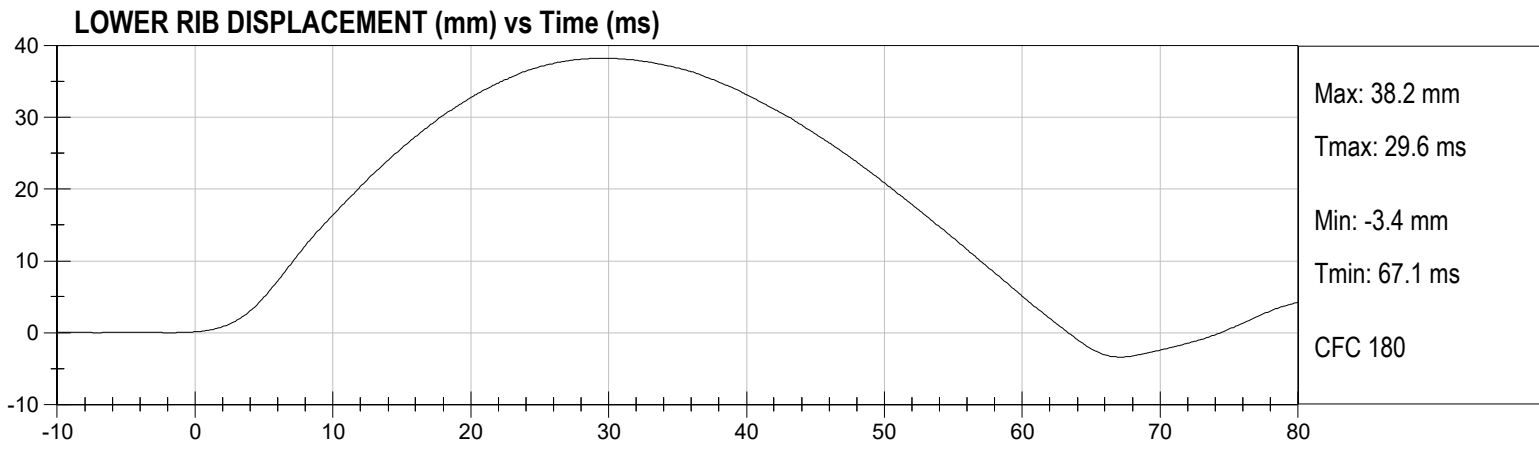
Channel	Manufacturer	Serial Number	Calibration Date	Calibration Due Date
LOWER RIB DISPLACEMENT	Honeywell	G164	11/21/2024	5/23/2025

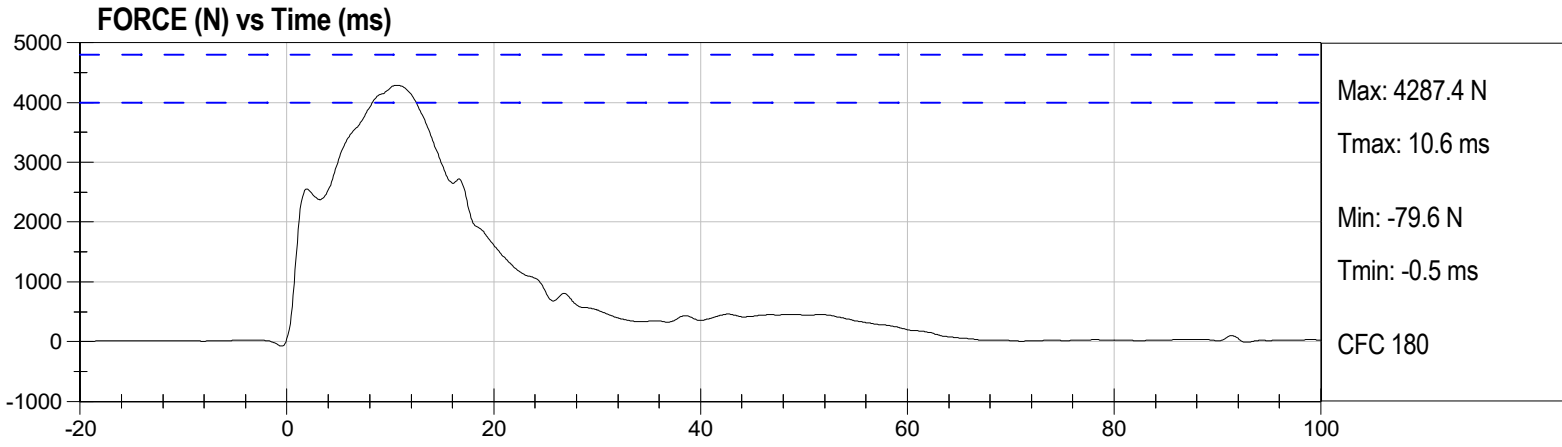
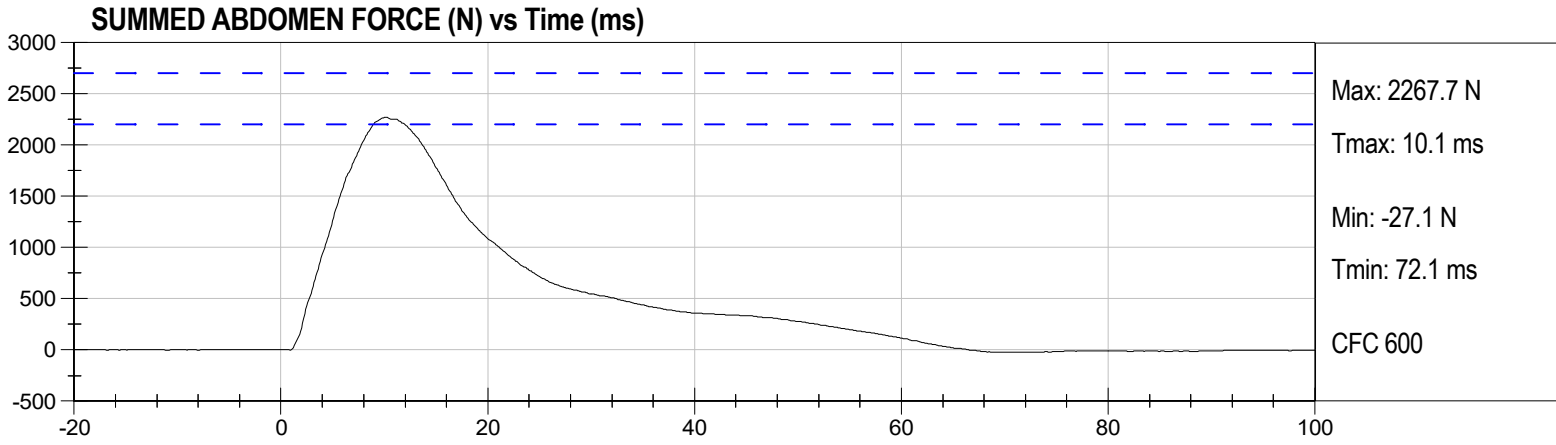
FRONT ABDOMEN FY (N) vs Time (ms)

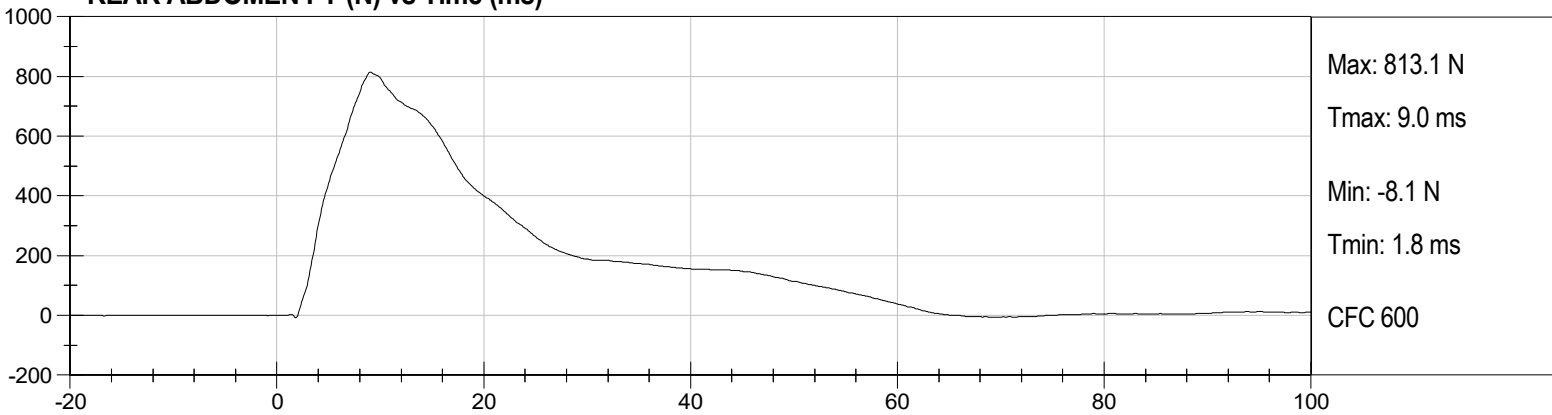
REAR ABDOMEN FY (N) vs Time (ms)

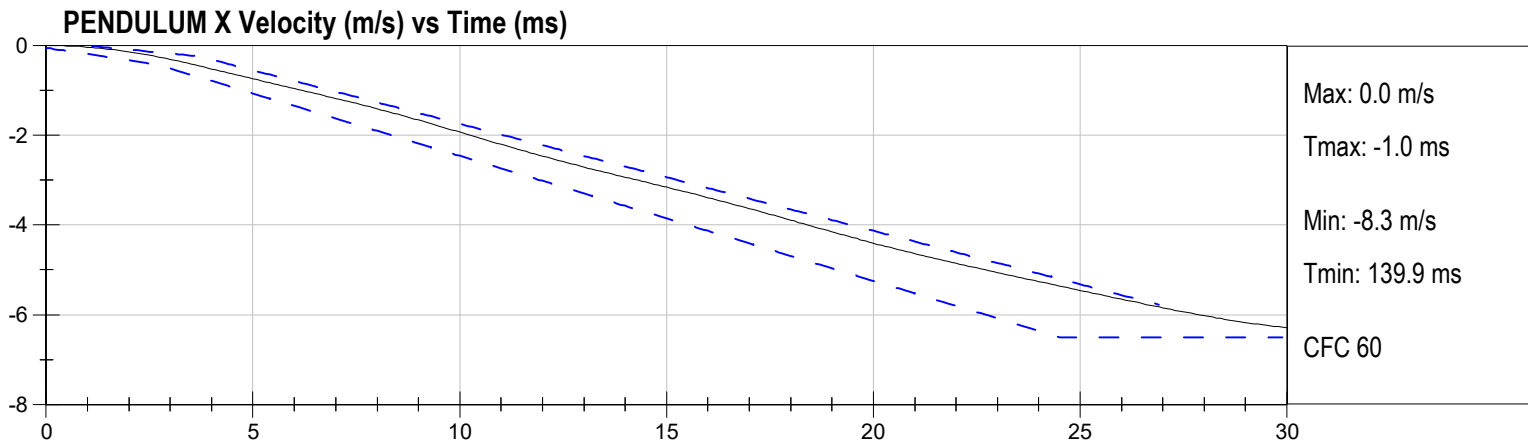
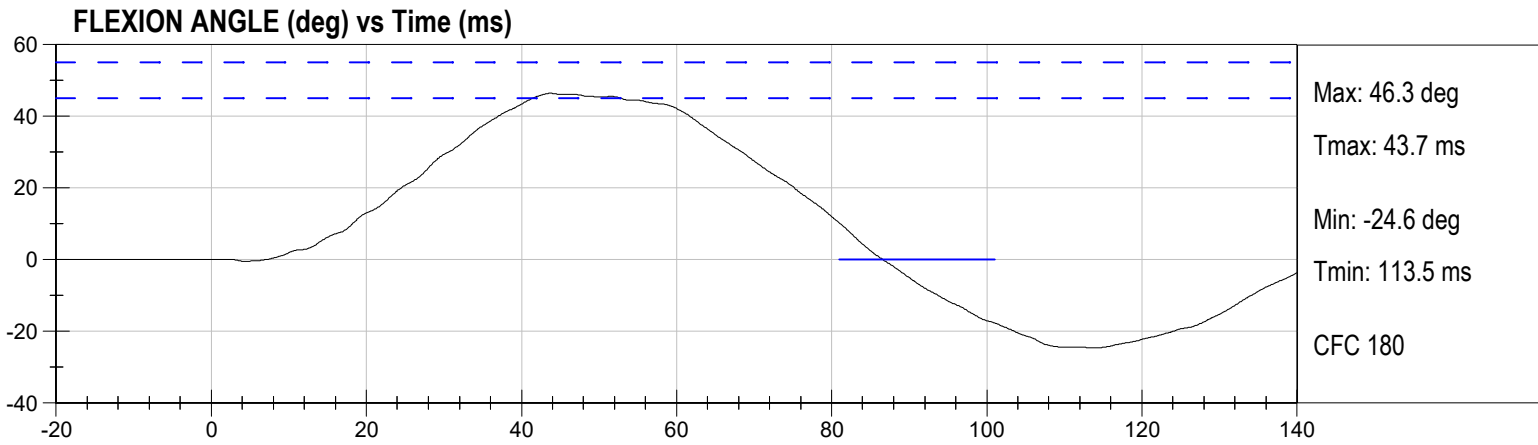
Channel	Manufacturer	Serial Number	Calibration Date	Calibration Due Date
PEND. ACCEL.	Endevco	AH5P1	01/13/2025	7/15/2025
POT. B - REAR	Spectrol	025_es2	01/13/2025	7/15/2025
POT. A - FRONT	Spectrol	027_es2	01/13/2025	7/15/2025
POT. C - HEADFORM	Spectrol	028_es2	01/13/2025	7/15/2025

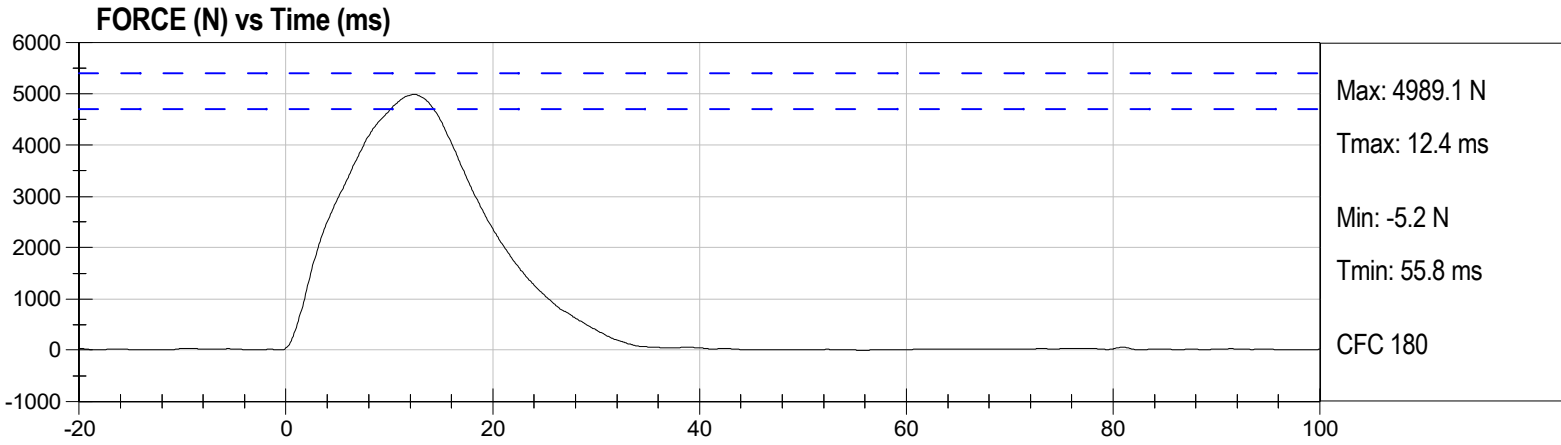
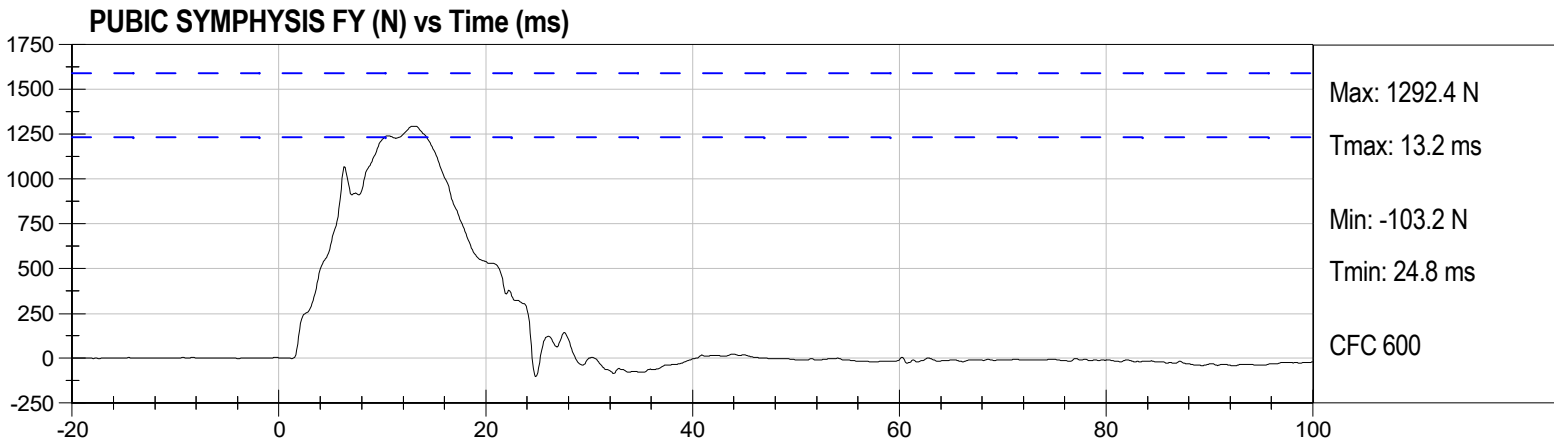
Channel	Manufacturer	Serial Number	Calibration Date	Calibration Due Date
PROBE	Endevco	P79577	09/18/2024	3/20/2025
PUBIC SYMPHYSIS FY	Denton	PG461FY	01/20/2025	1/20/2026

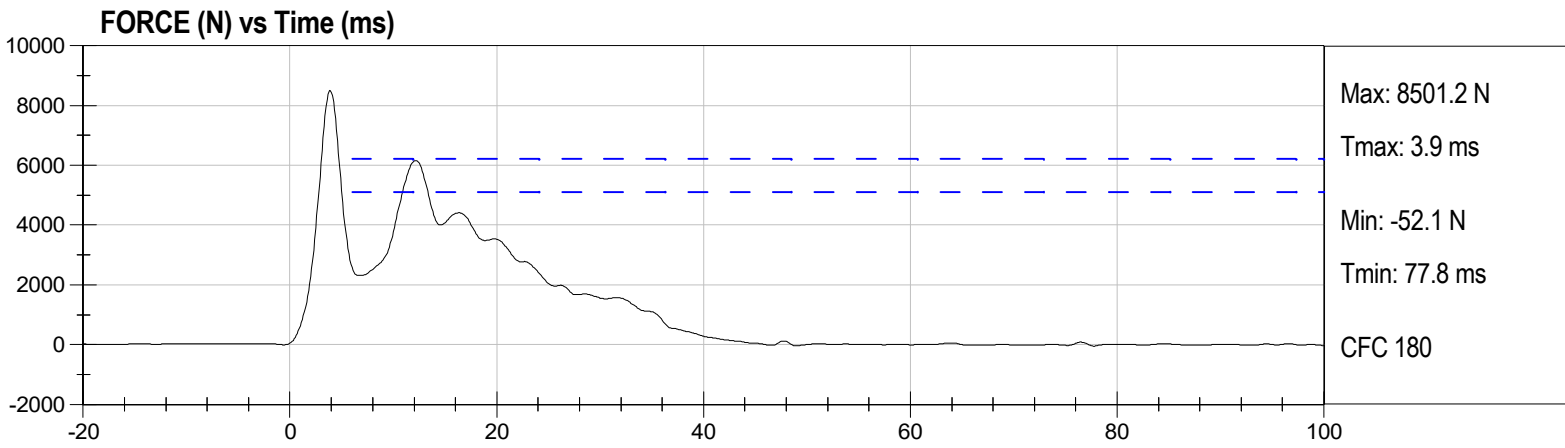
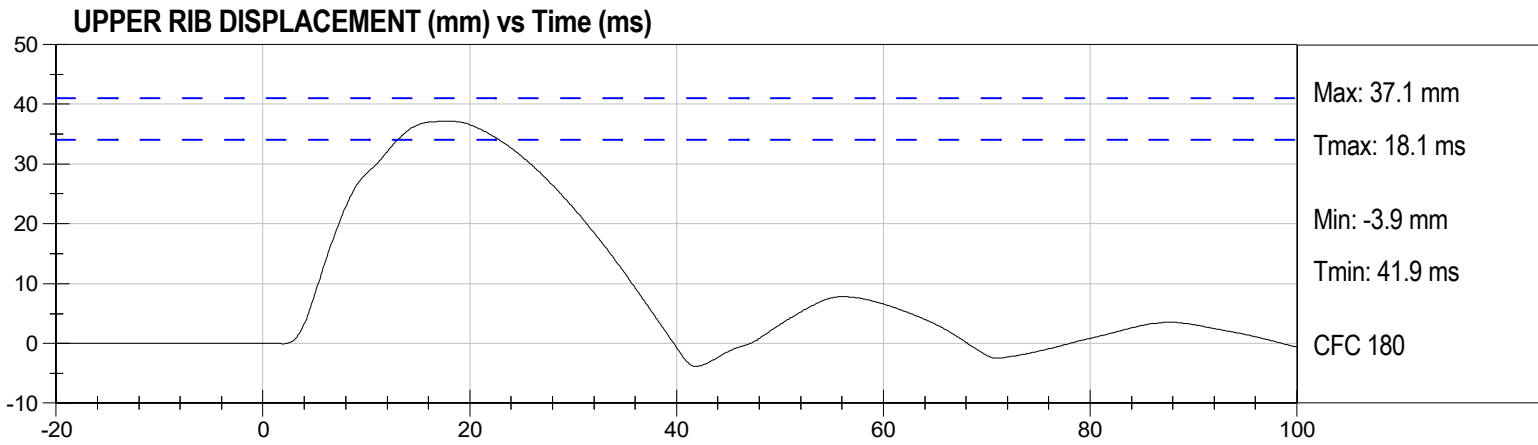
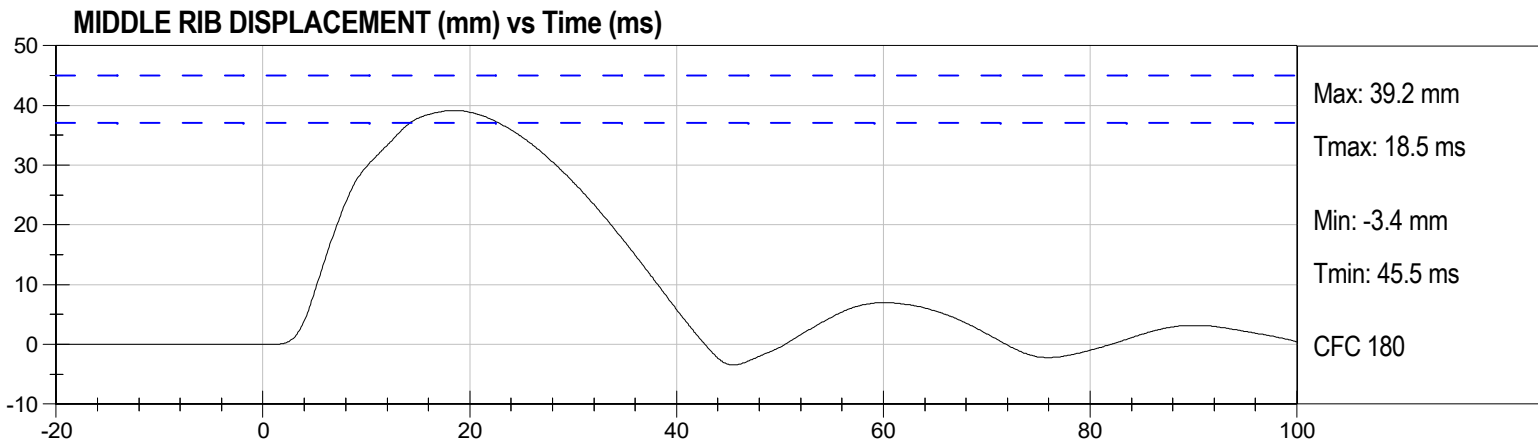
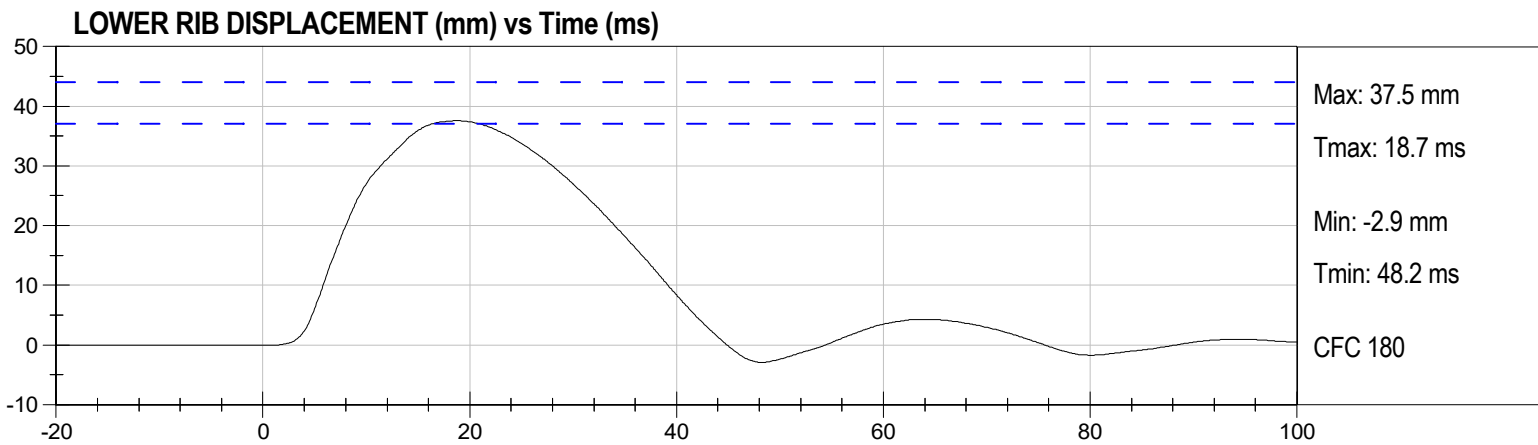
QUALIFICATION TEST RESULTS

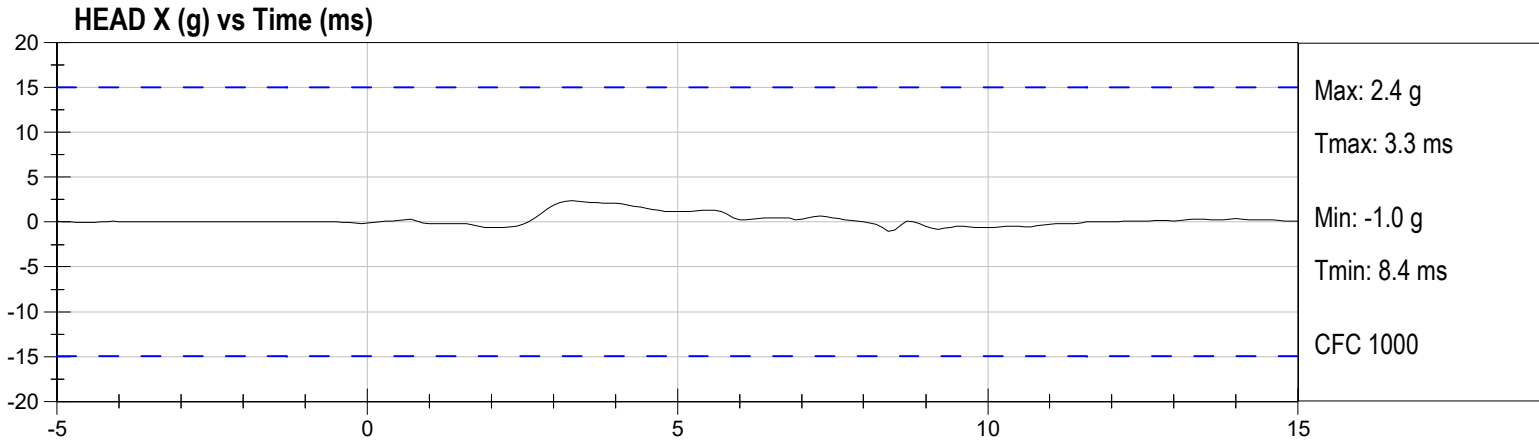
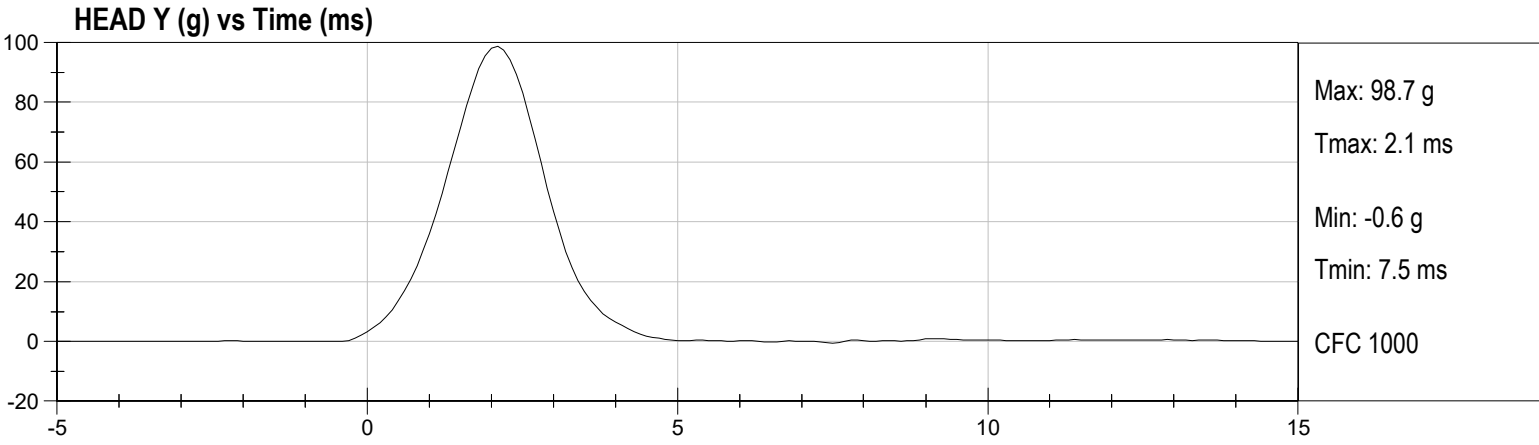
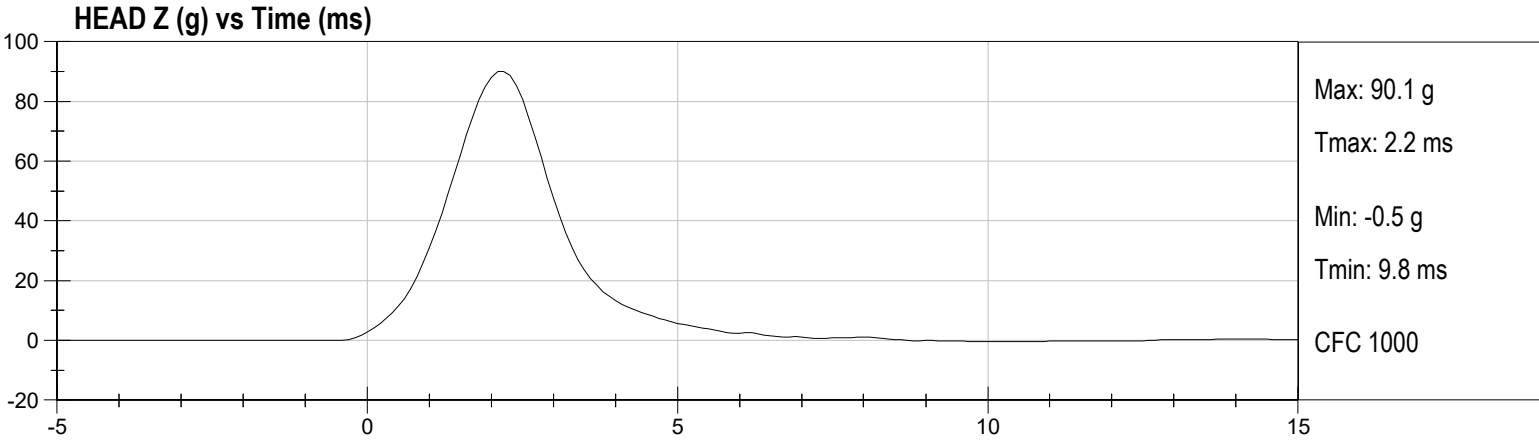
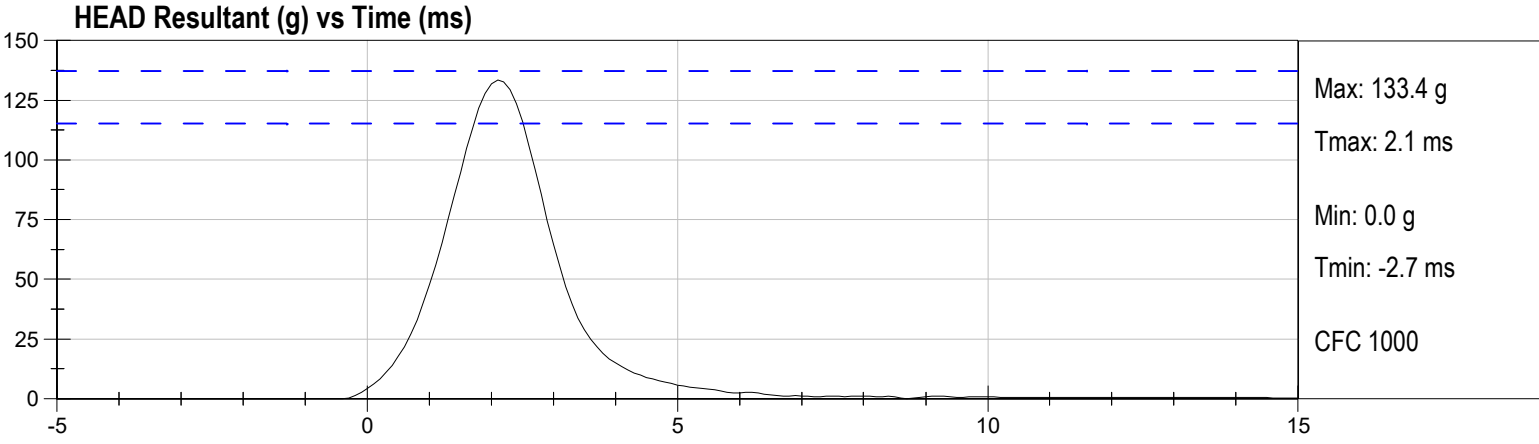
Channel	Manufacturer	Serial Number	Calibration Date	Calibration Due Date
HEAD Y	Endevco	T30974	11/25/2024	5/27/2025
HEAD X	Endevco	T30975	11/25/2024	5/27/2025
HEAD Z	Endevco	T30976	11/25/2024	5/27/2025

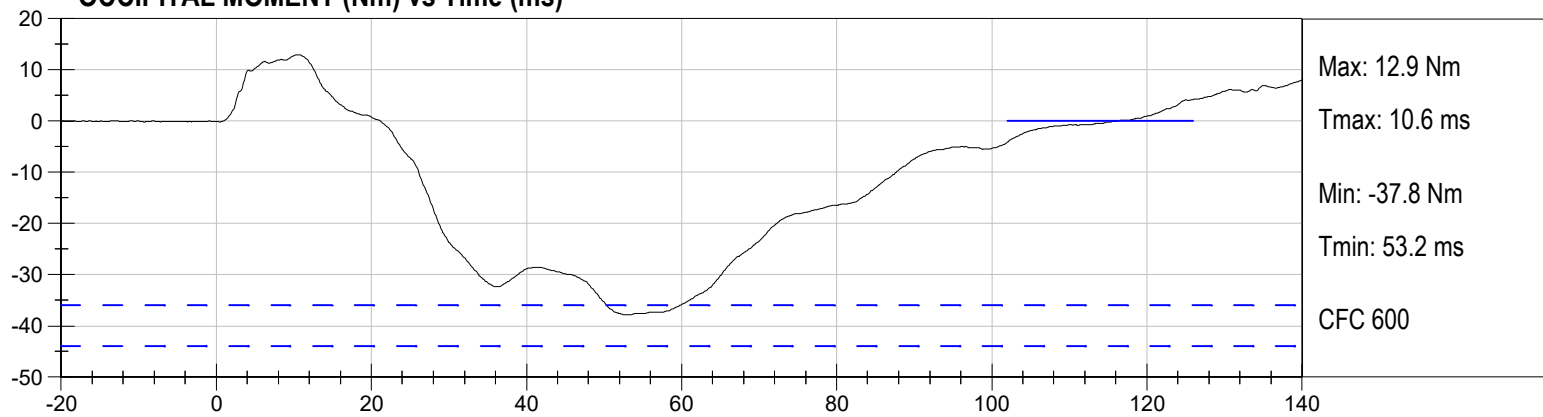
OCCIPITAL MOMENT (Nm) vs Time (ms)

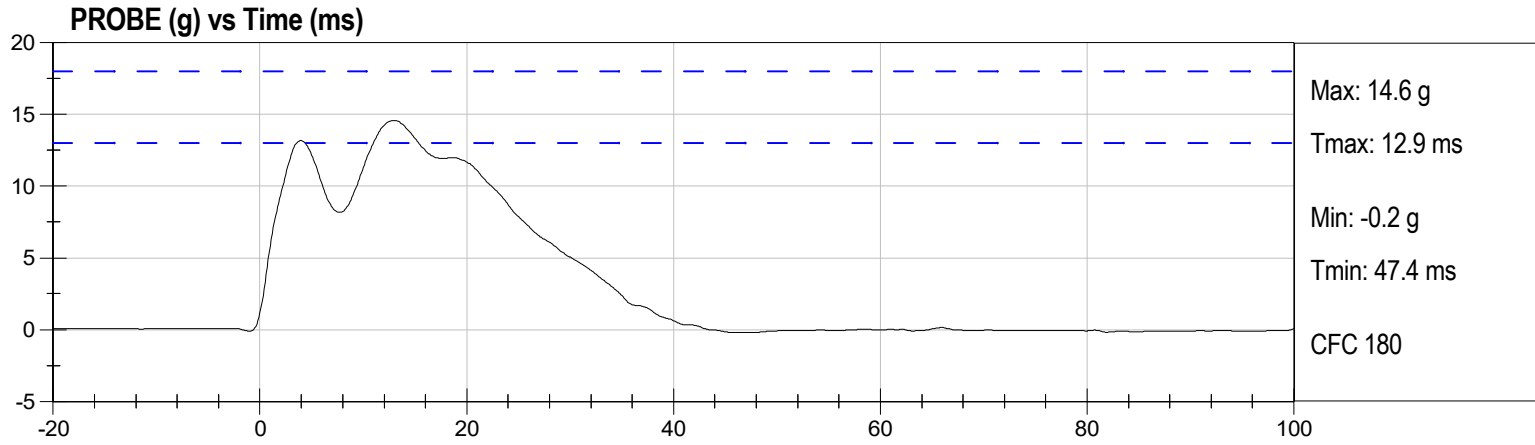
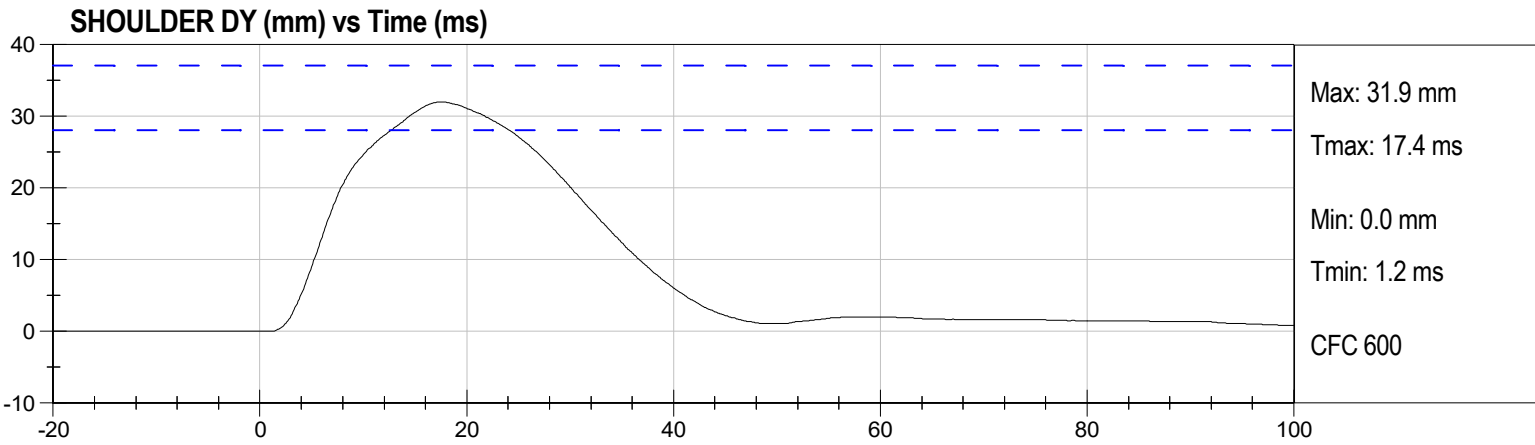
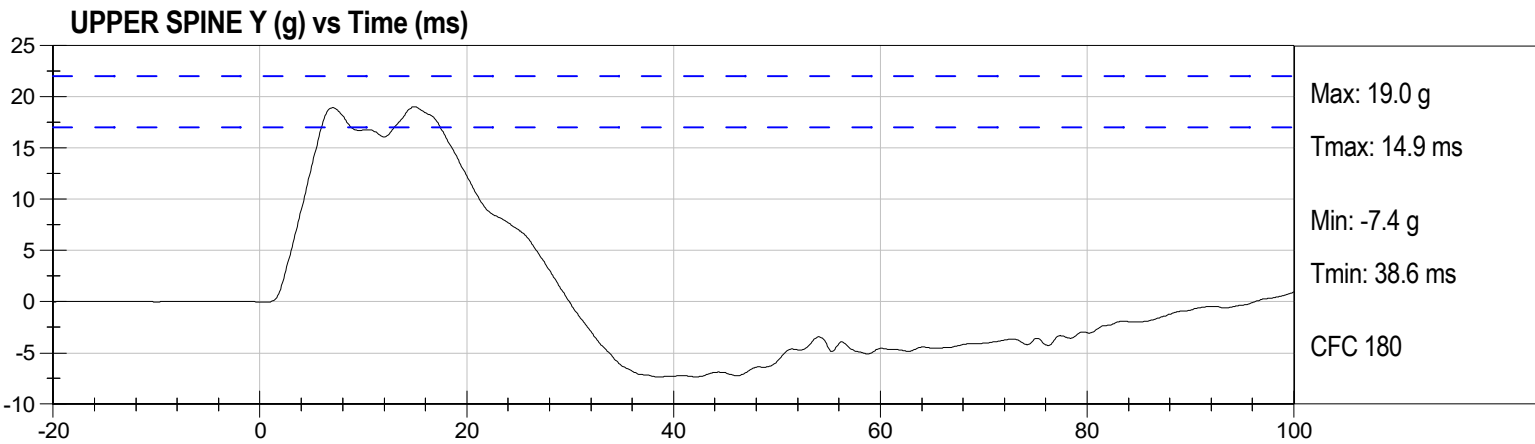
Channel	Manufacturer	Serial Number	Calibration Date	Calibration Due Date
PROBE	Endevco	P79577	09/18/2024	3/20/2025
UPPER SPINE Y	Endevco	P82319	12/10/2024	6/11/2025
SHOULDER DY	FTSS	G050	12/11/2024	6/12/2025

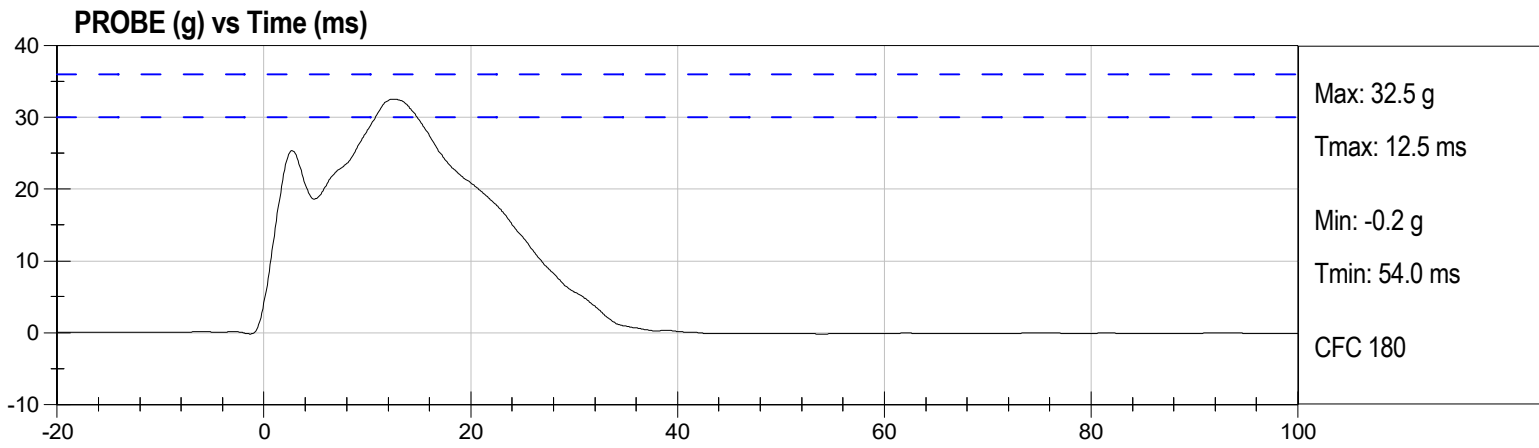
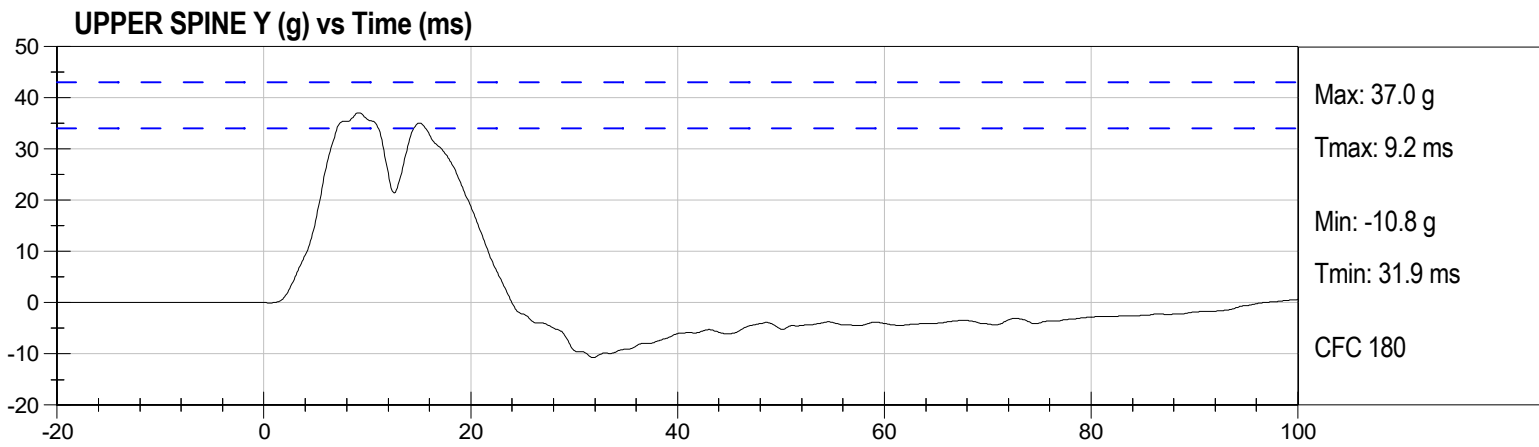
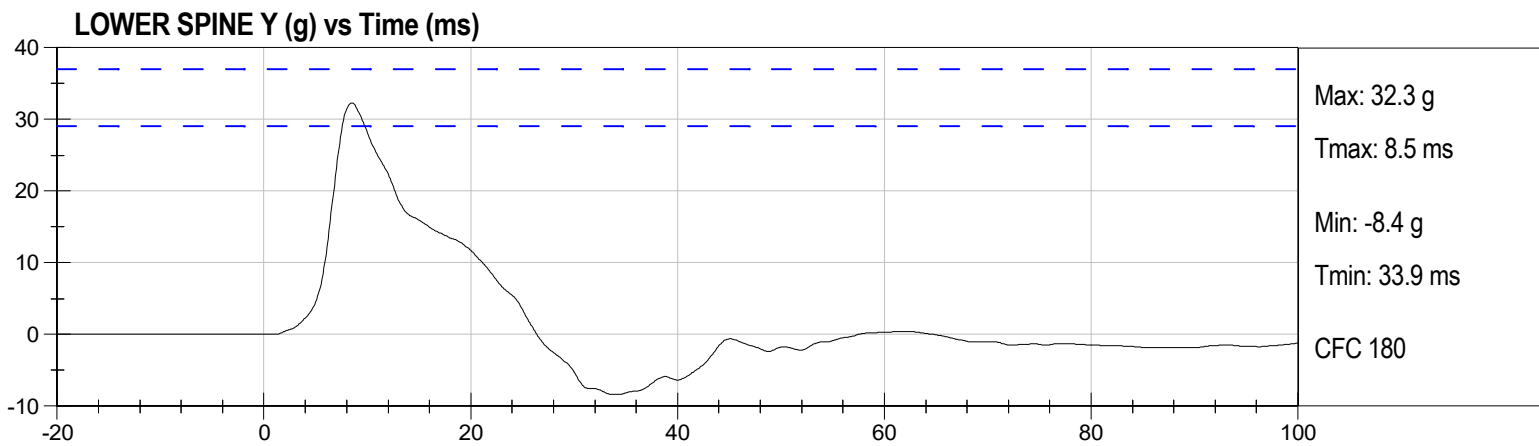
Channel	Manufacturer	Serial Number	Calibration Date	Calibration Due Date
PROBE	Endevco	P79577	09/18/2024	3/20/2025
UPPER SPINE Y	Endevco	P82319	12/10/2024	6/11/2025
LOWER SPINE Y	Endevco	P96335	12/10/2024	6/11/2025
SHOULDER DY	FTSS	G050	12/11/2024	6/12/2025
UPPER THORAX RIB DY	FTSS	G033	12/11/2024	6/12/2025
MID THORAX RIB DY	Servo	G2403	12/11/2024	6/12/2025
LOWER THORAX RIB DY	FTSS	G1270	12/11/2024	6/12/2025

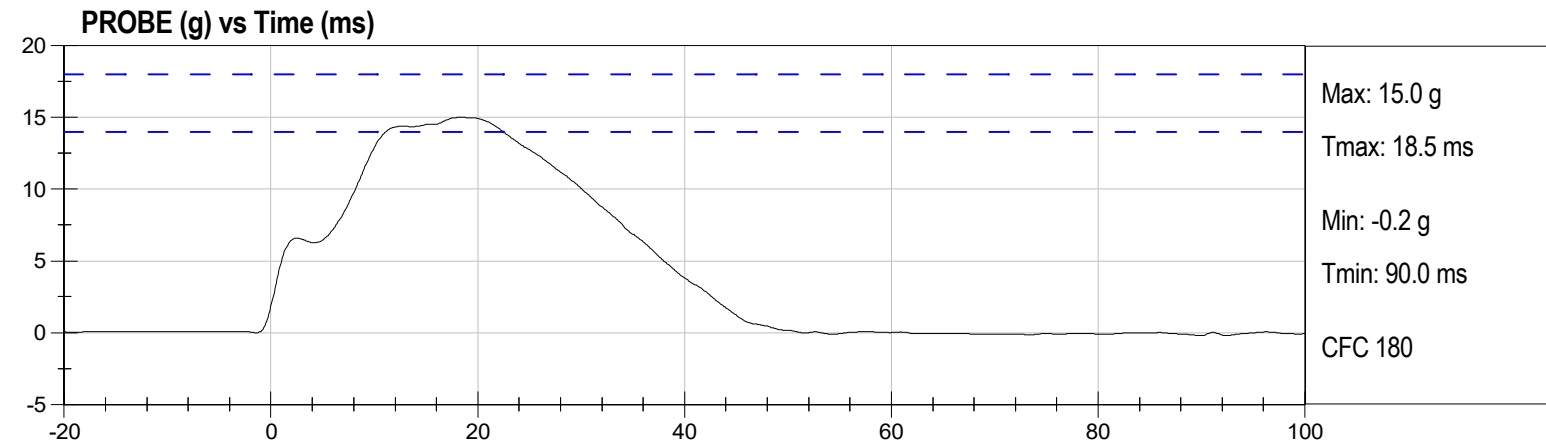
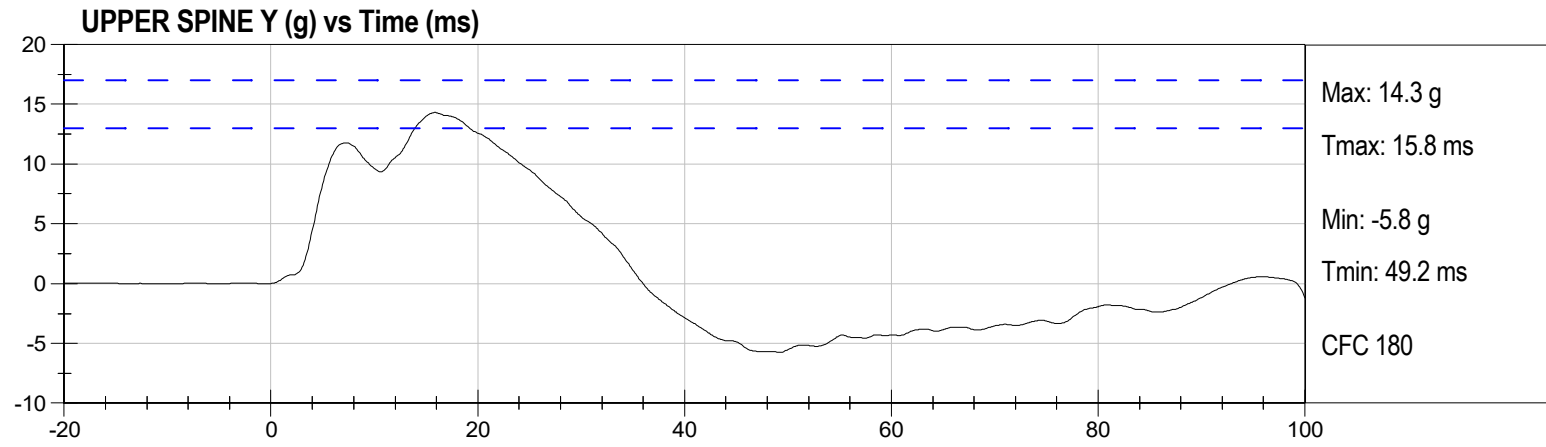
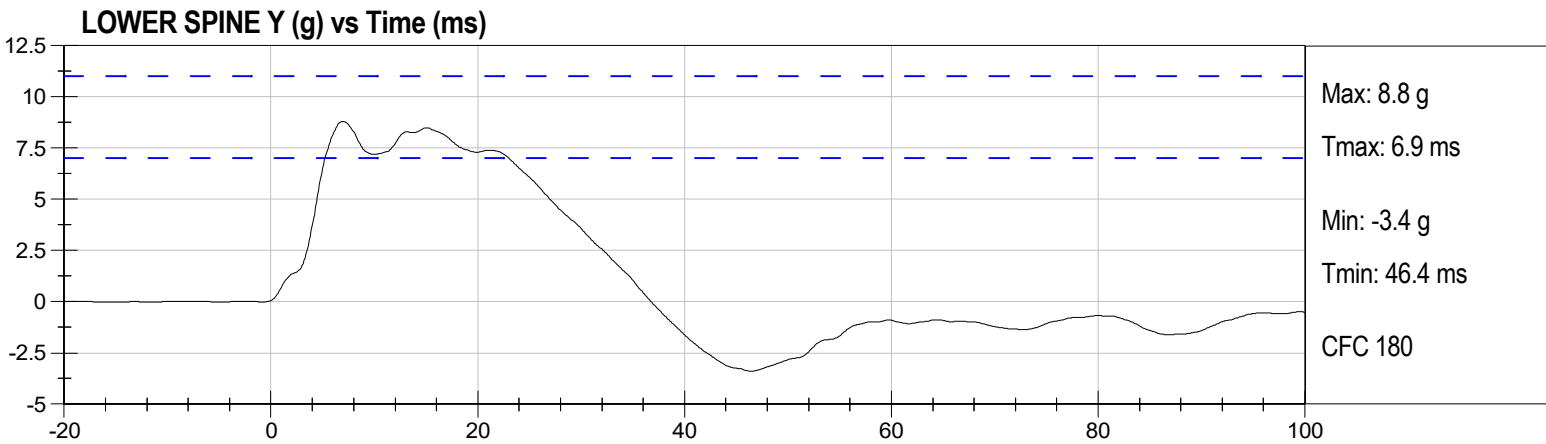
UPPER THORAX RIB DY (mm) vs Time (ms)

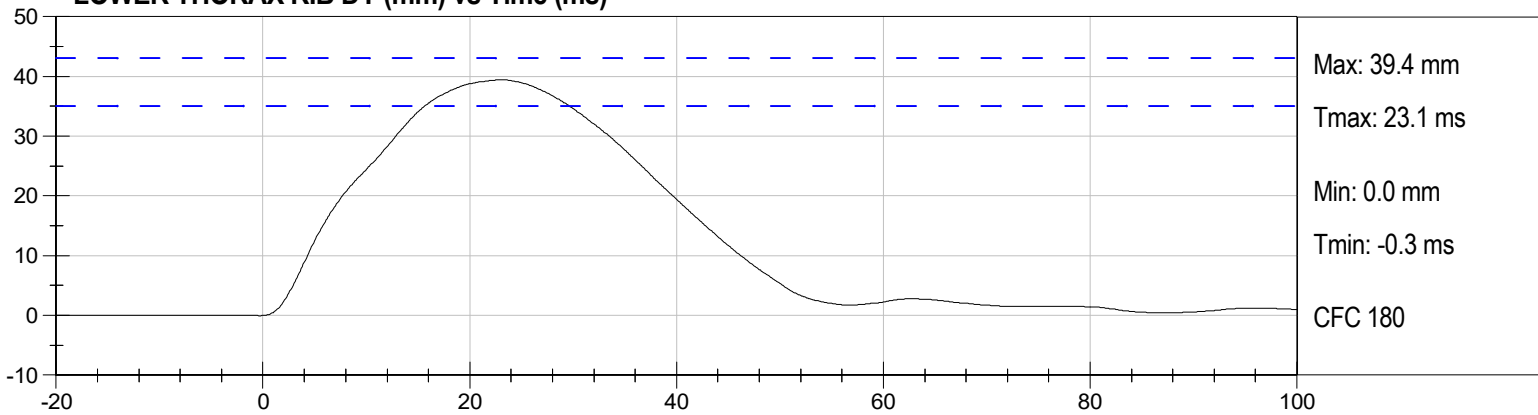
LOWER THORAX RIB DY (mm) vs Time (ms)

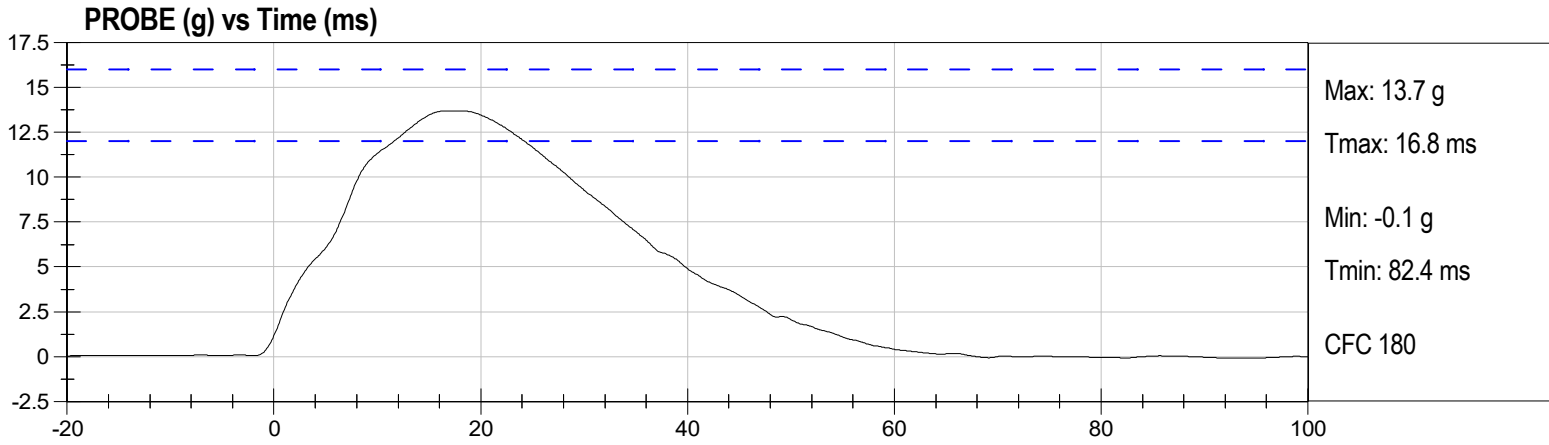
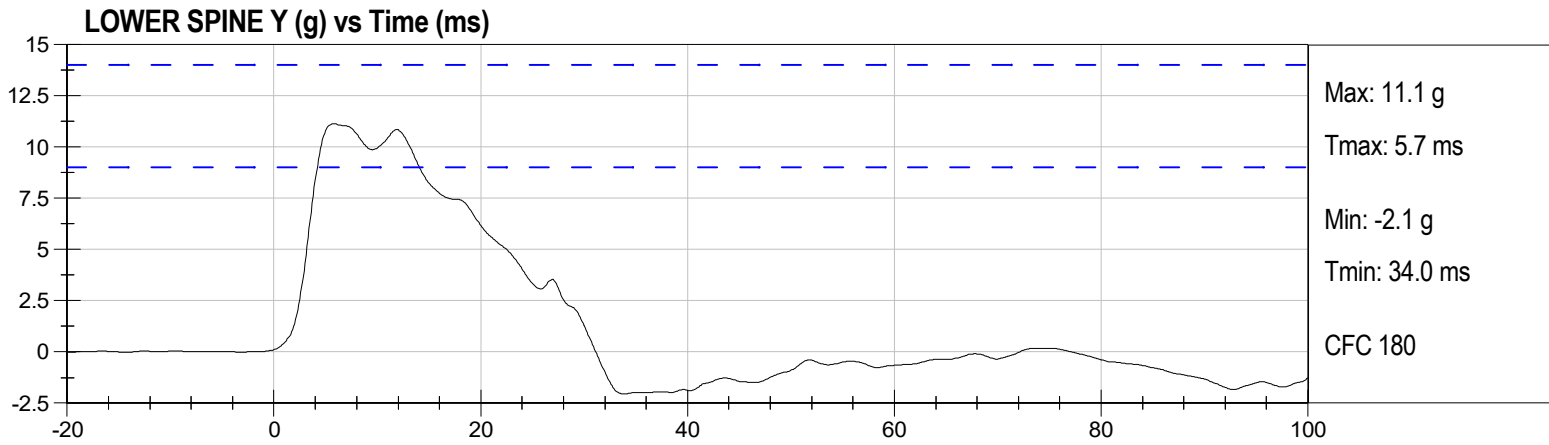
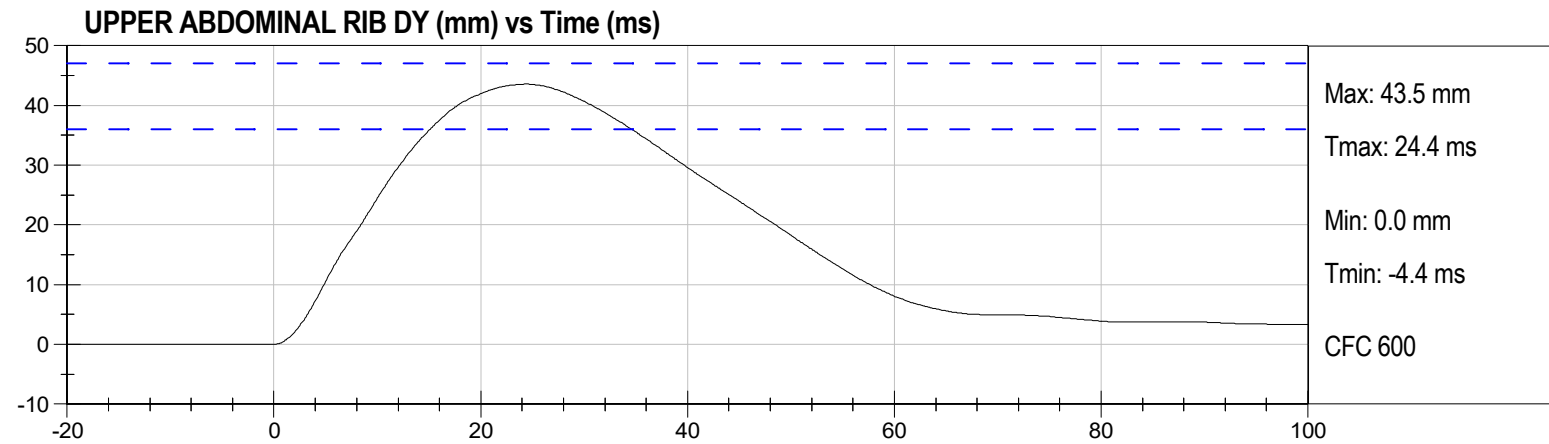
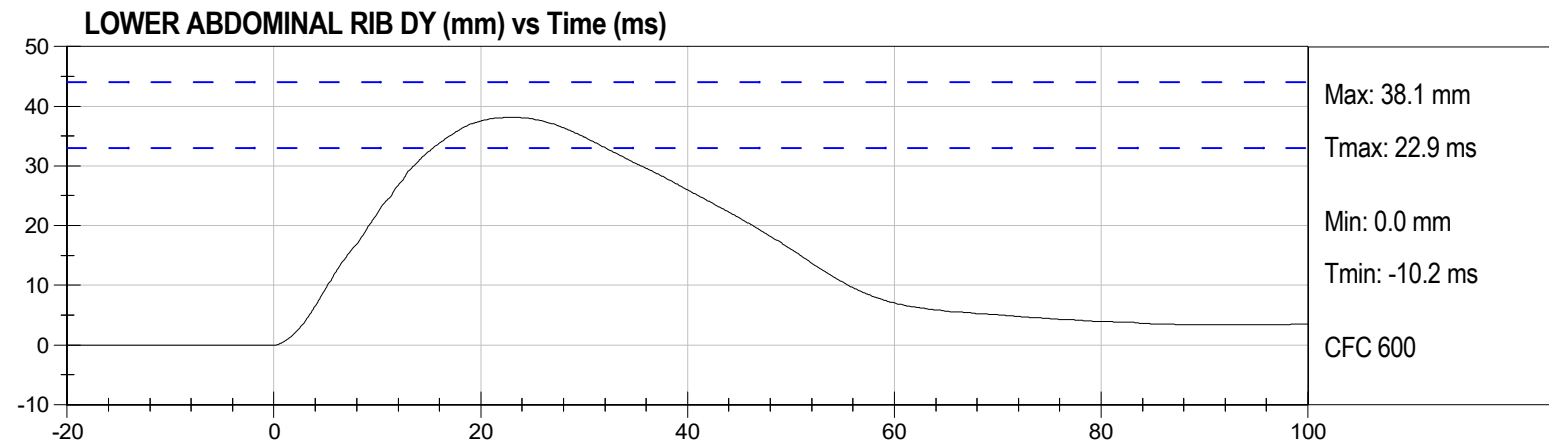
Channel	Manufacturer	Serial Number	Calibration Date	Calibration Due Date
PROBE	Endevco	P79577	09/18/2024	3/20/2025
LOWER SPINE Y	Endevco	P96335	12/10/2024	6/11/2025
UPPER ABDOMINAL RIB DY	FTSS	G032	12/11/2024	6/12/2025
LOWER ABDOMINAL RIB DY	Medius	MJ5171	12/11/2024	6/12/2025
