REPORT NUMBER: SideNCAPMDB-MGA-25-015

**NEW CAR ASSESSMENT PROGRAM (NCAP)
Moving Deformable Barrier Side Impact Test**

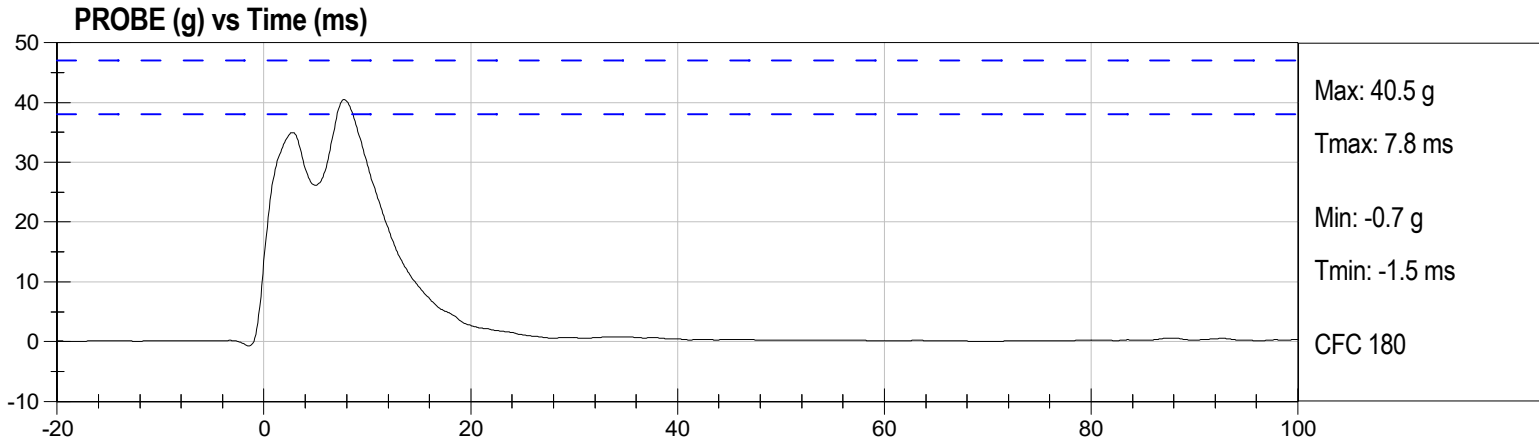
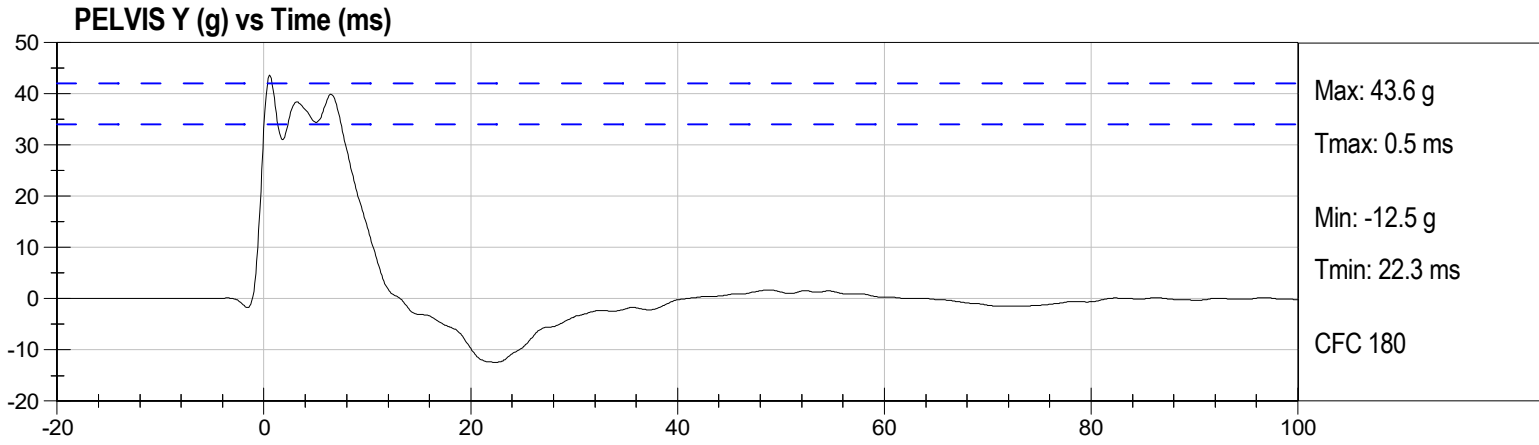
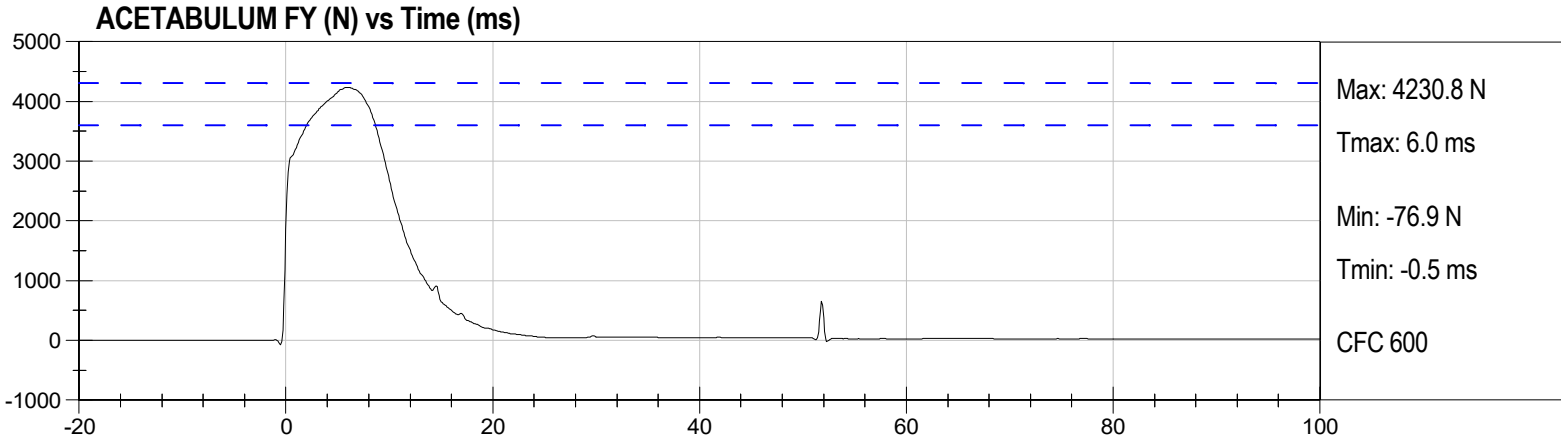
Channel	Manufacturer	Serial Number	Calibration Date	Calibration Due Date
PROBE	Endevco	P79577	09/18/2024	3/20/2025
PELVIS Y	Endevco	P82673	12/10/2024	6/11/2025
ACETABULUM FY	FTSS	ACG4285FY	05/24/2024	5/24/2025

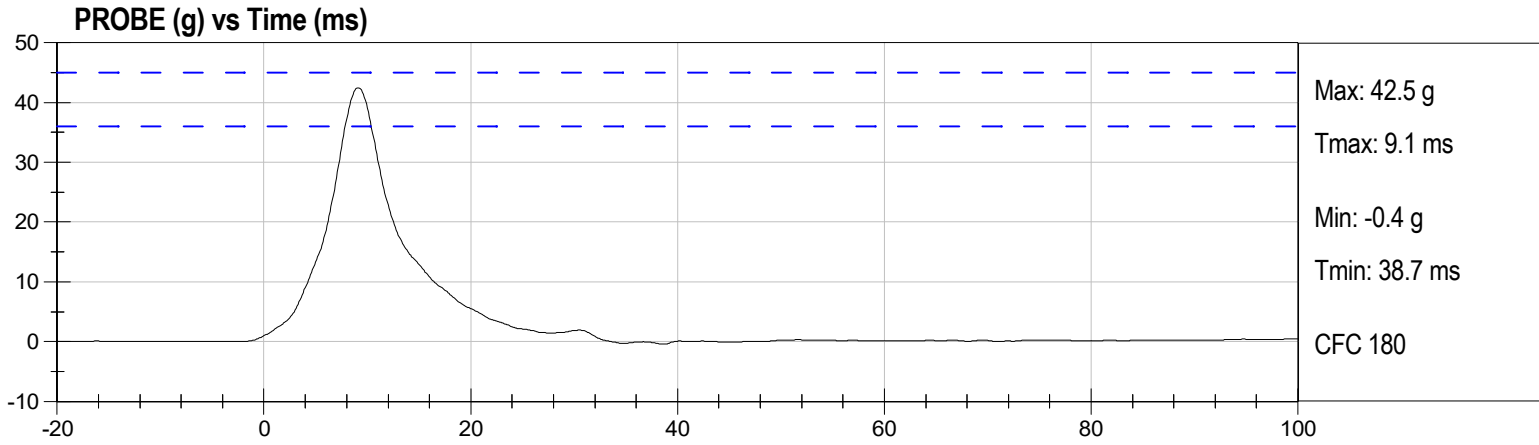
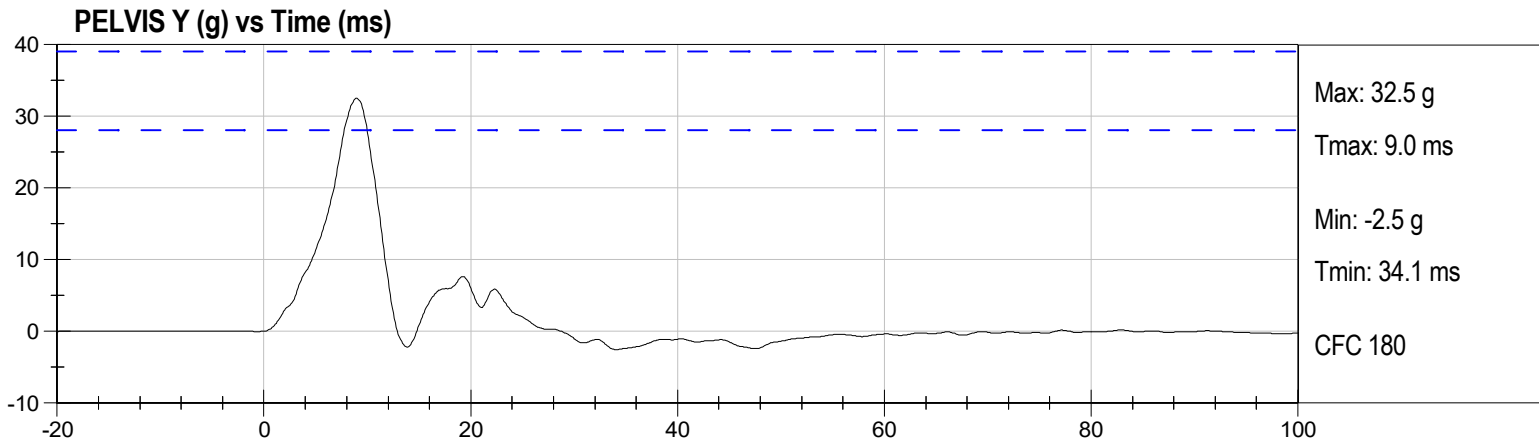
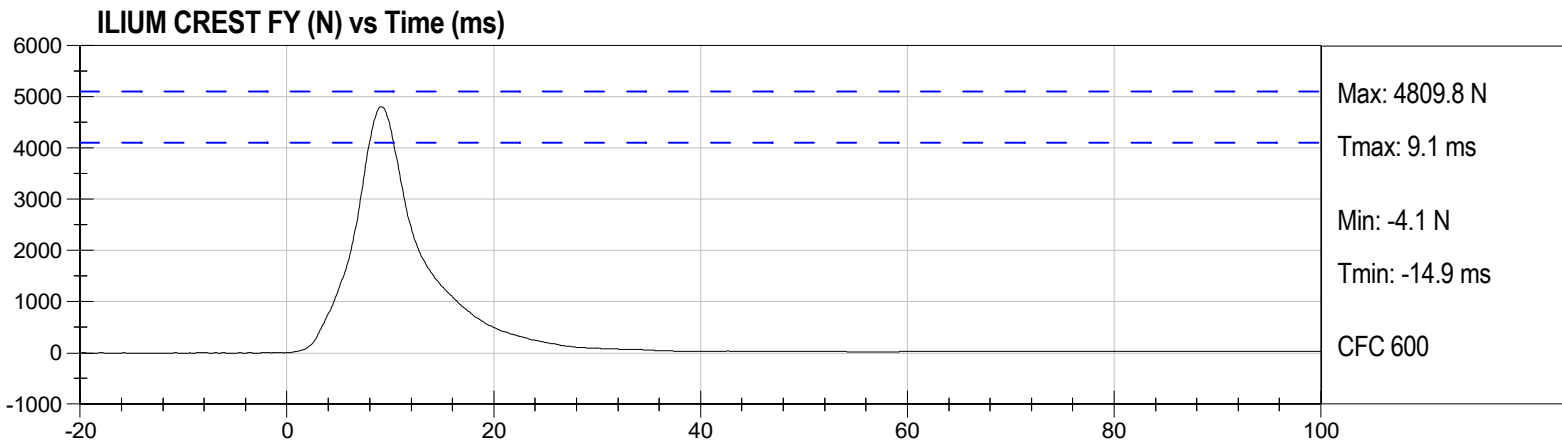
QUALIFICATION TEST RESULTS

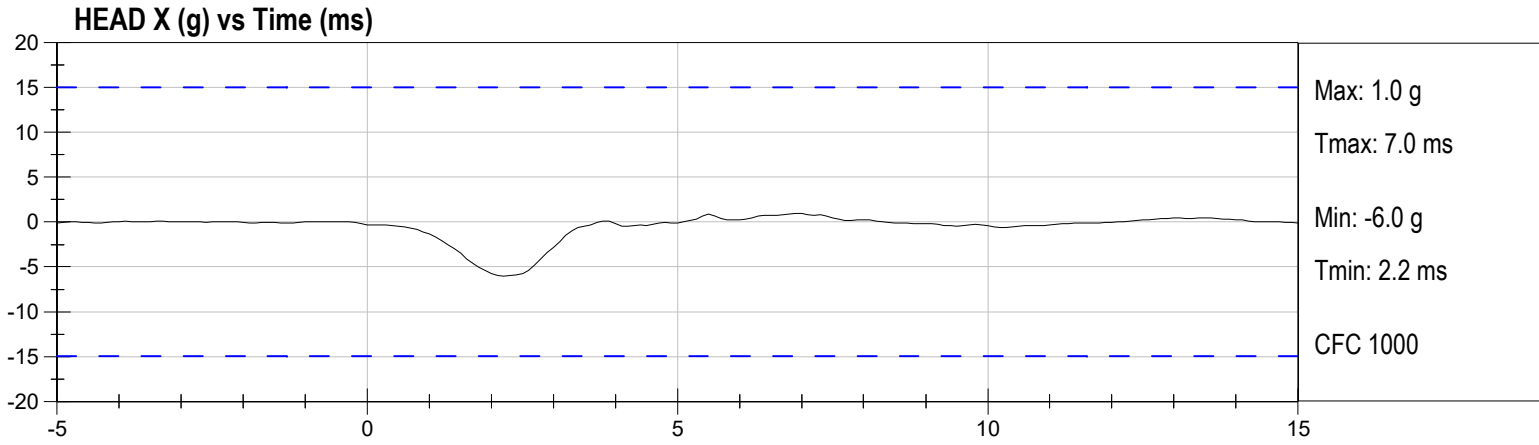
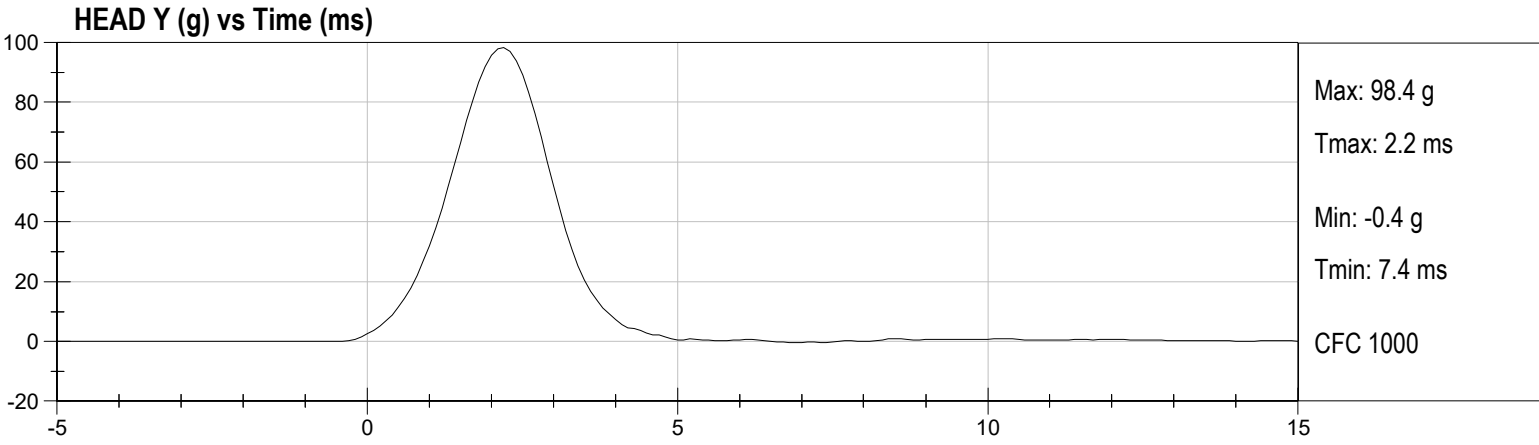
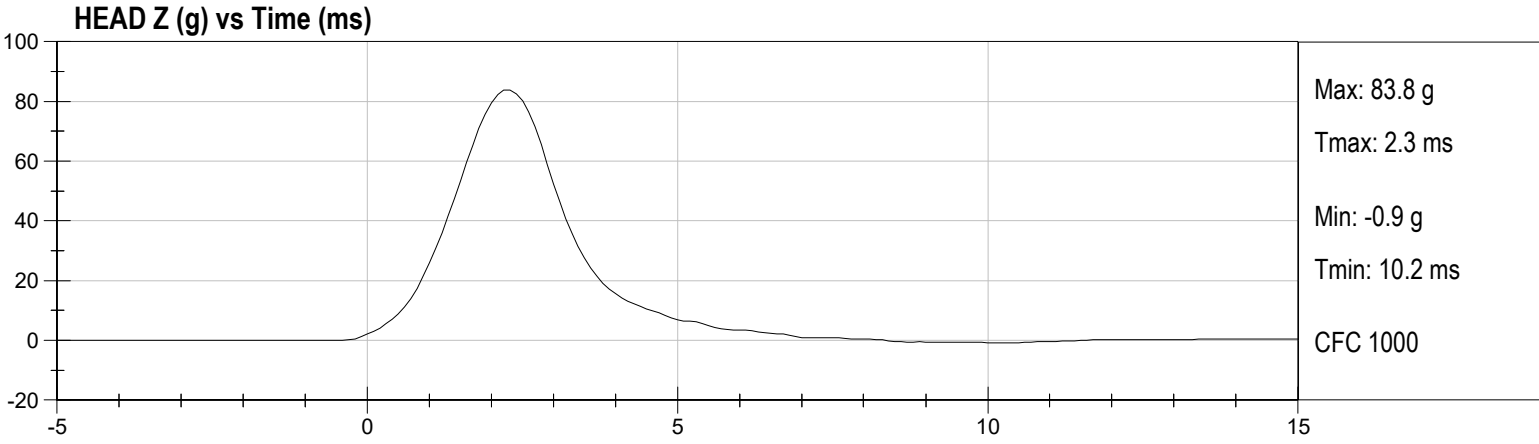
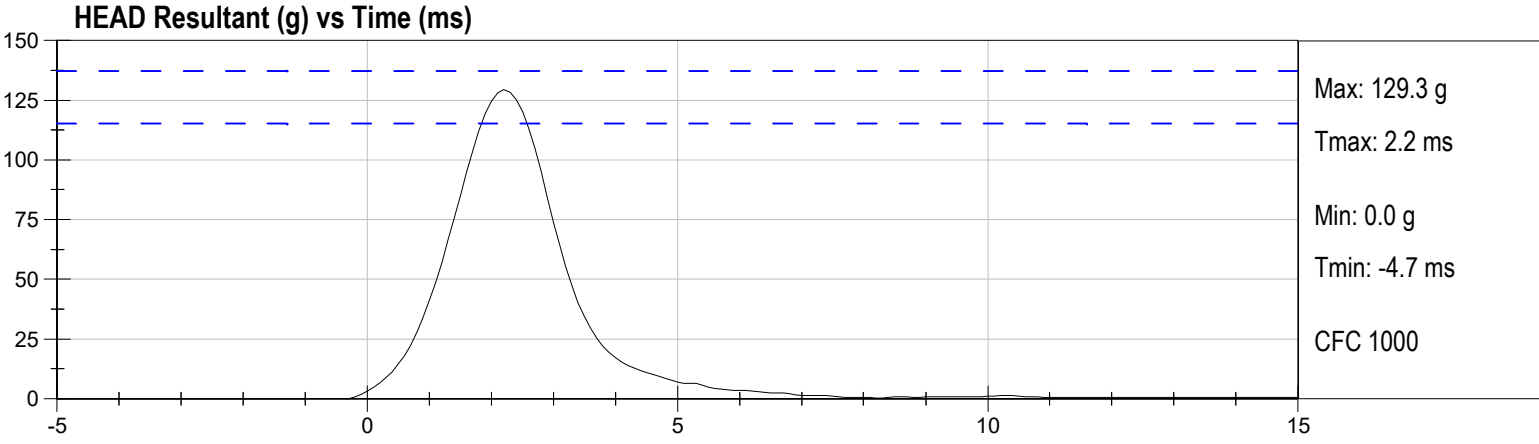
Channel	Manufacturer	Serial Number	Calibration Date	Calibration Due Date
HEAD Y	Endevco	T30974	11/25/2024	5/27/2025
HEAD X	Endevco	T30975	11/25/2024	5/27/2025
HEAD Z	Endevco	T30976	11/25/2024	5/27/2025

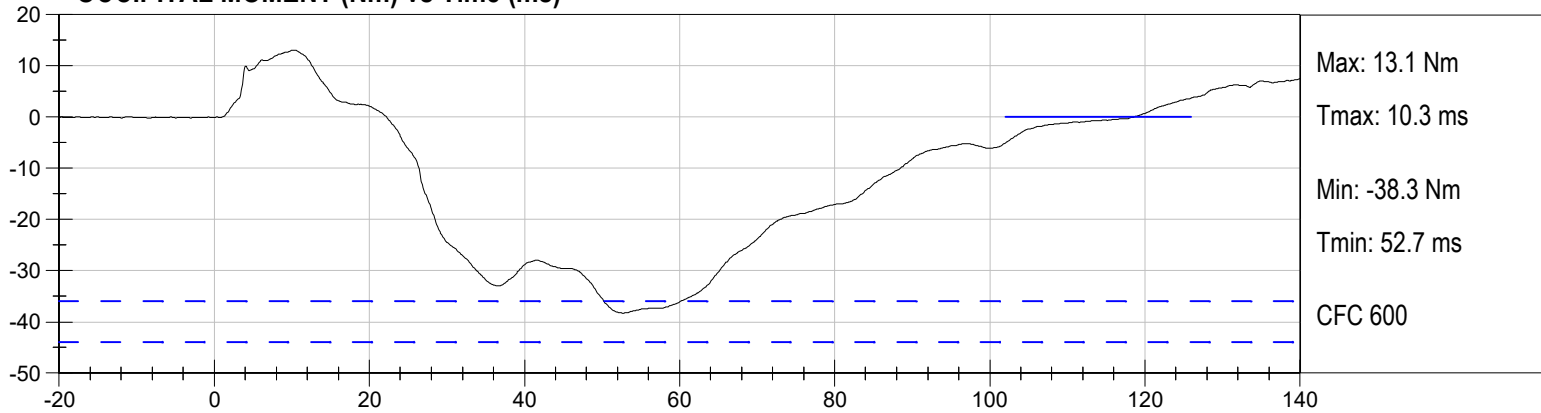
OCCIPITAL MOMENT (Nm) vs Time (ms)

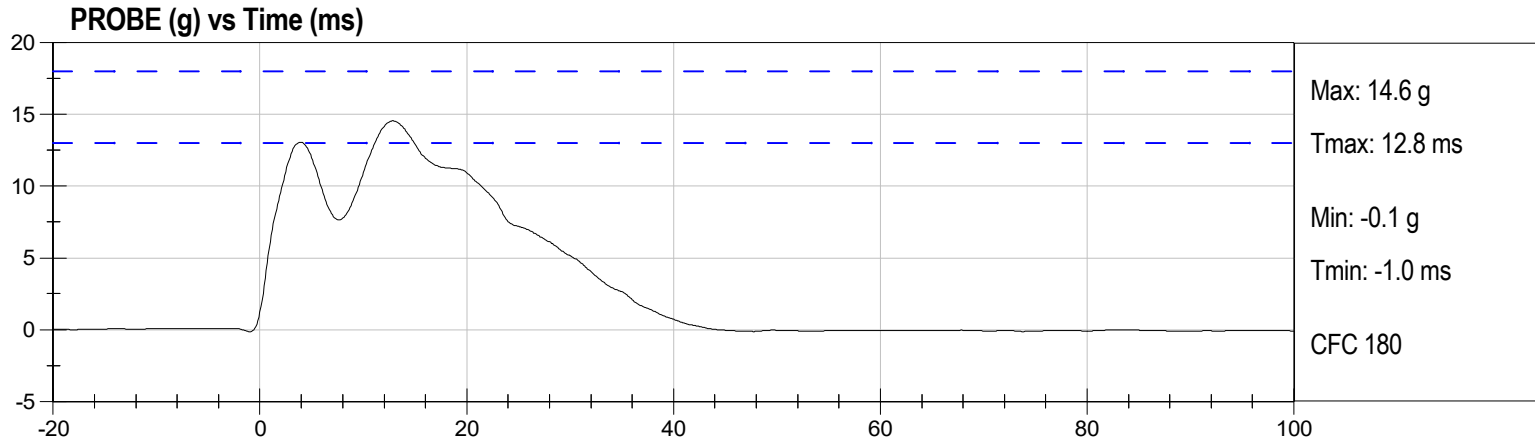
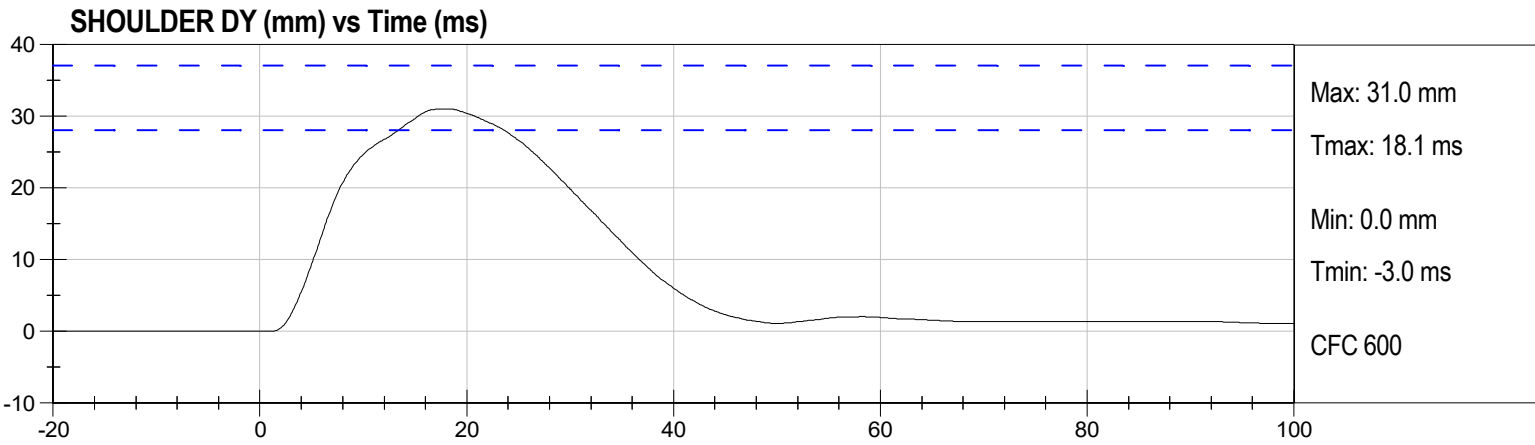
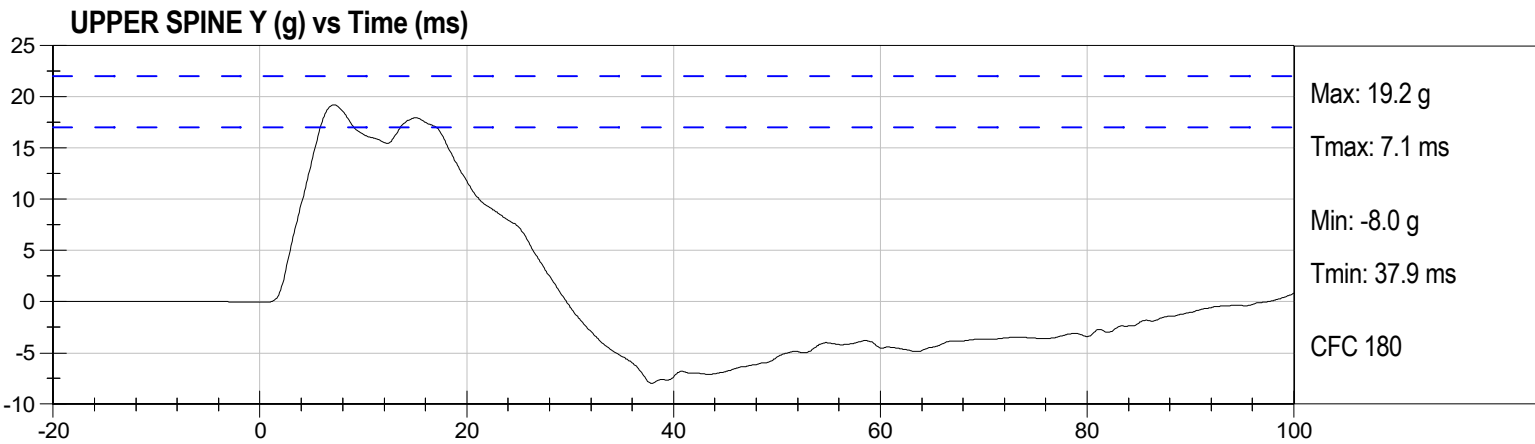
Channel	Manufacturer	Serial Number	Calibration Date	Calibration Due Date
PROBE	Endevco	P79577	09/18/2024	3/20/2025
UPPER SPINE Y	Endevco	P82319	12/10/2024	6/11/2025
SHOULDER DY	FTSS	G050	12/11/2024	6/12/2025

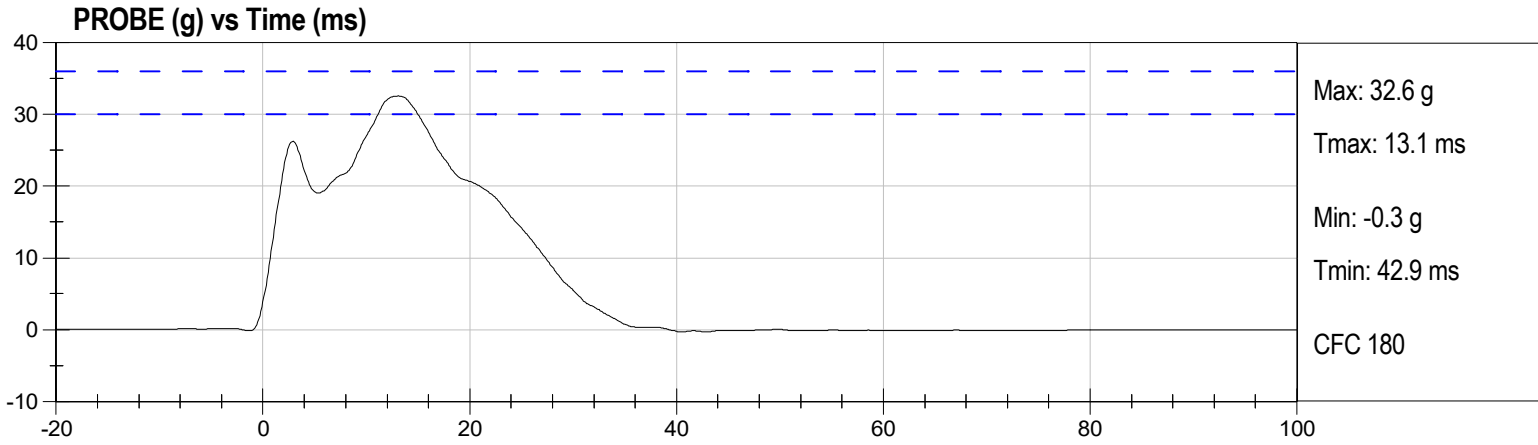
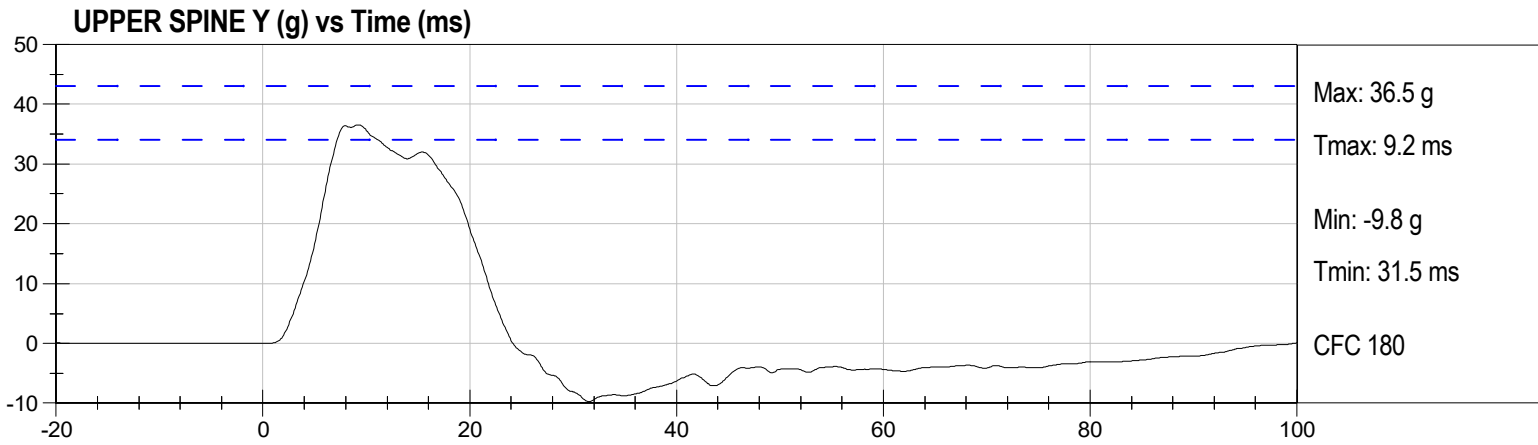
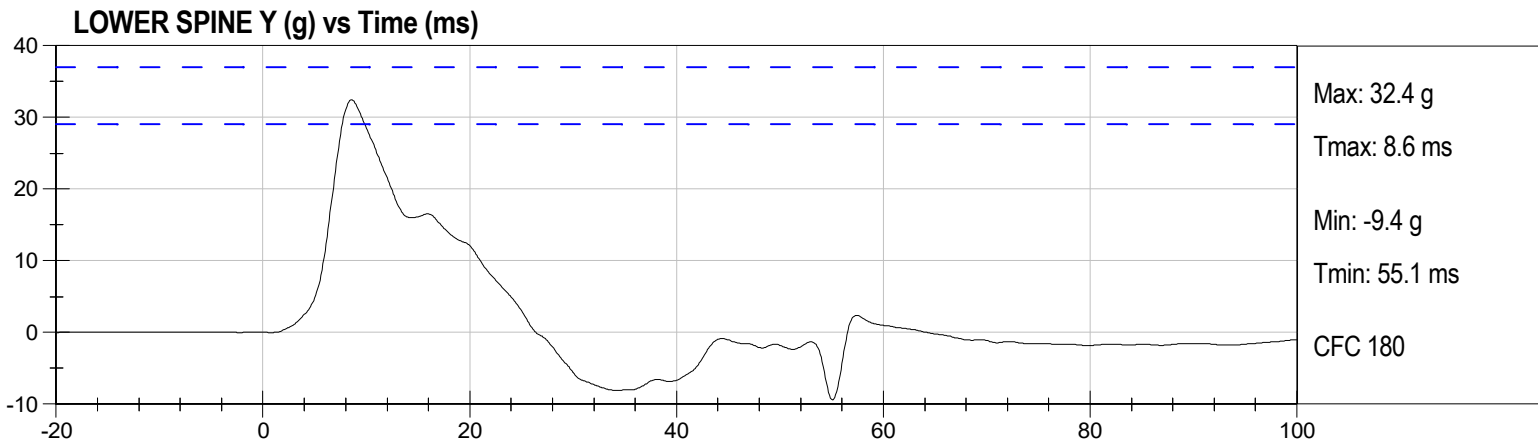
SHOULDER DY (mm) vs Time (ms)

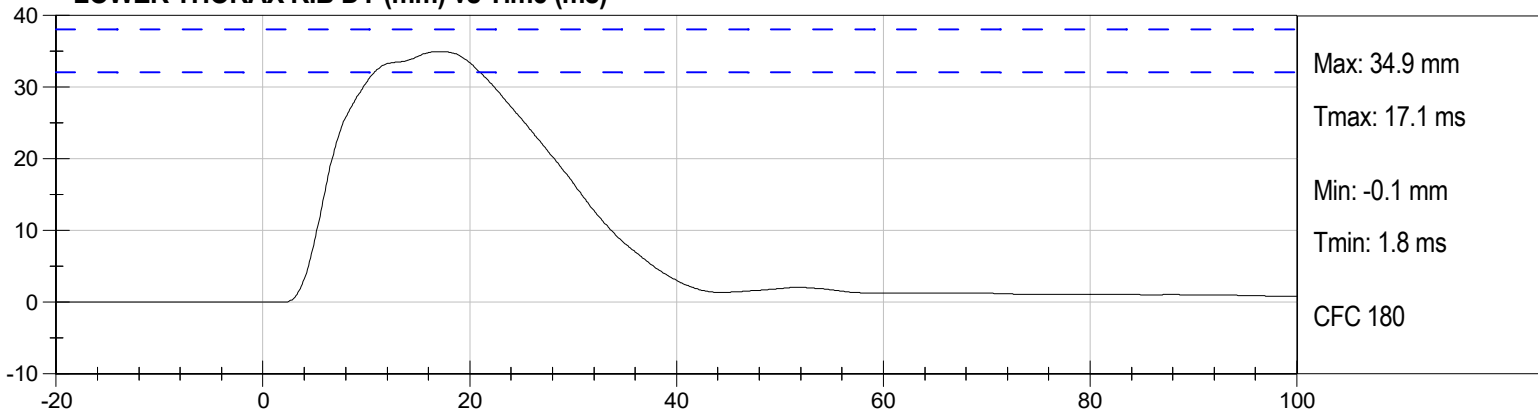
LOWER THORAX RIB DY (mm) vs Time (ms)

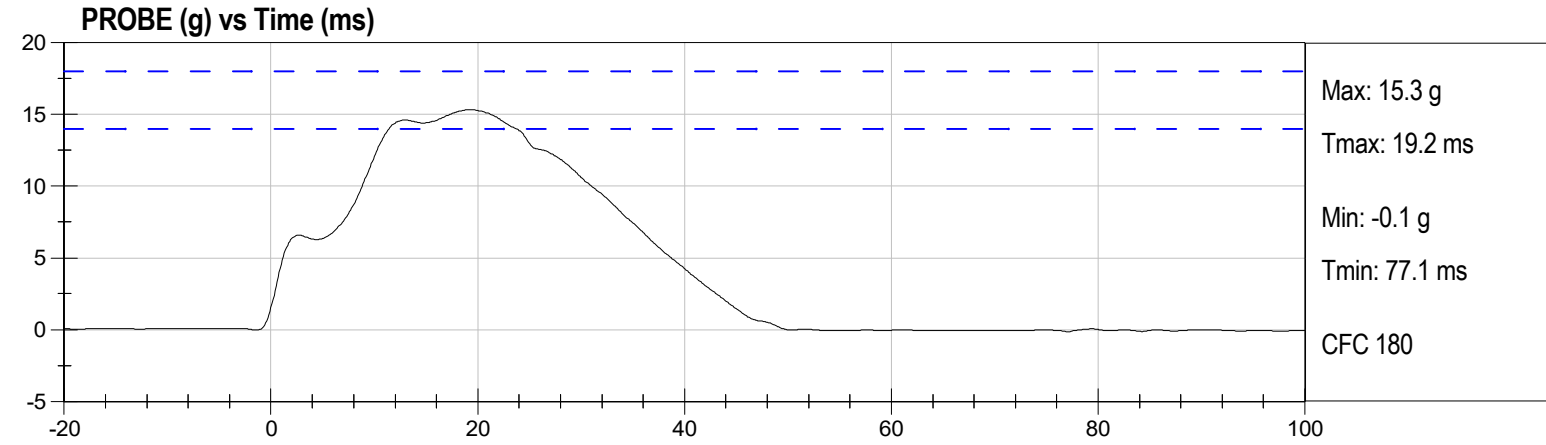
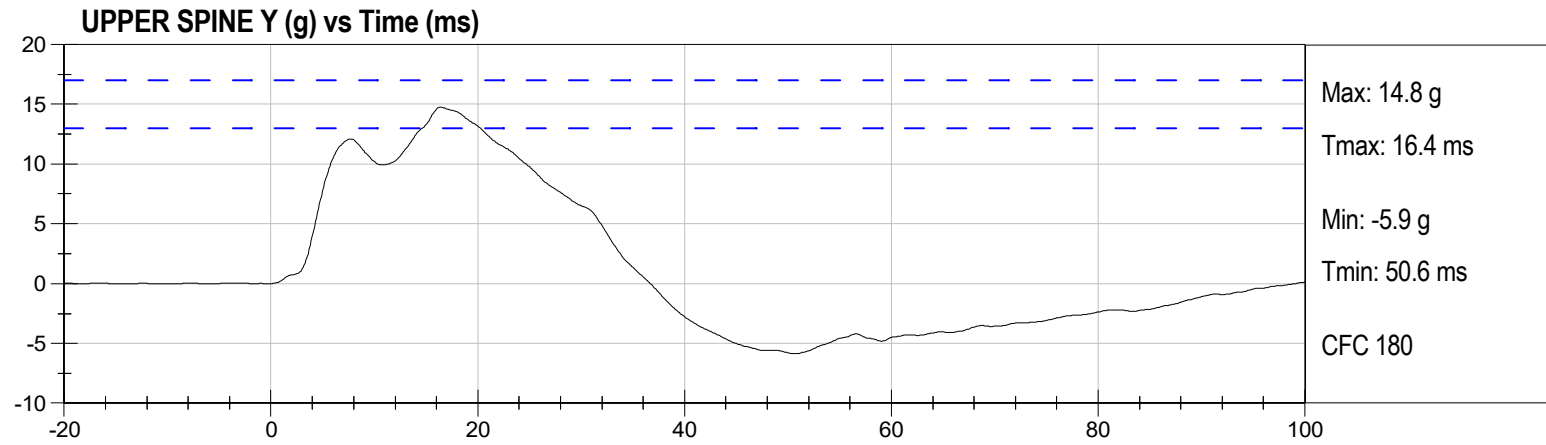
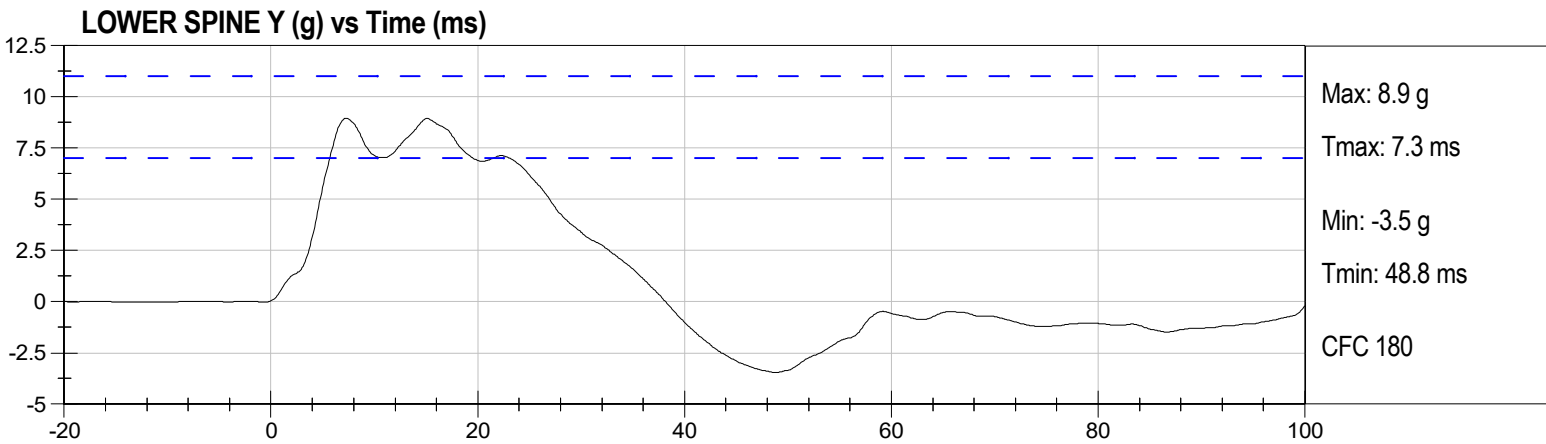
UPPER THORAX RIB DY (mm) vs Time (ms)

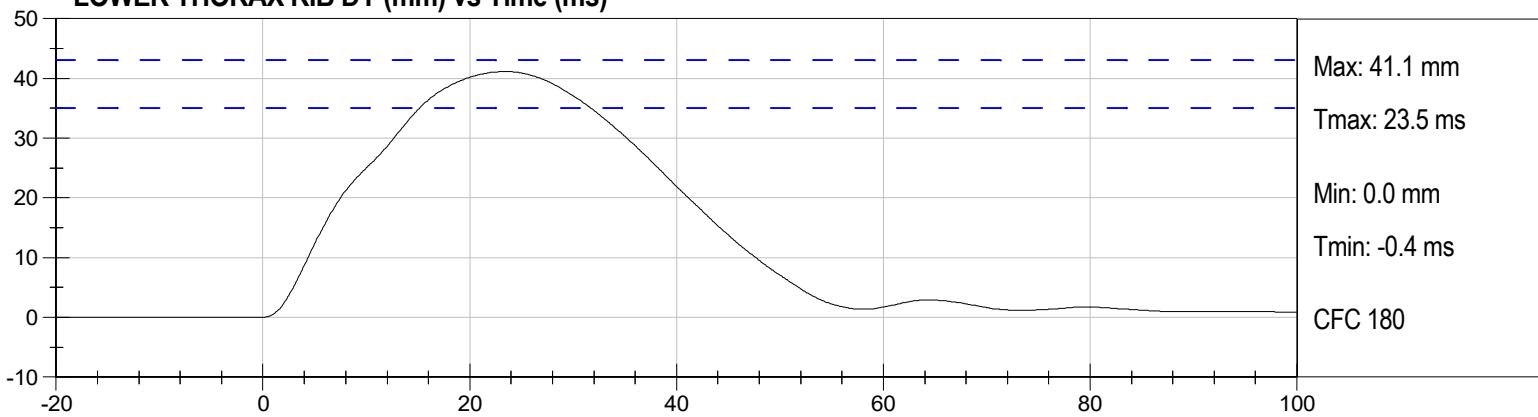
LOWER THORAX RIB DY (mm) vs Time (ms)

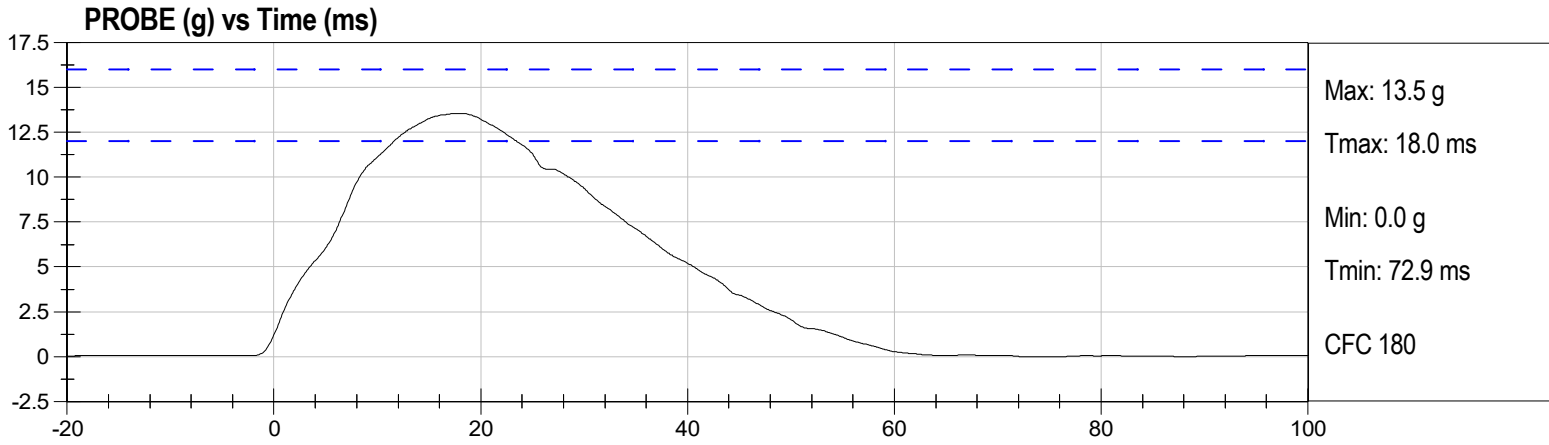
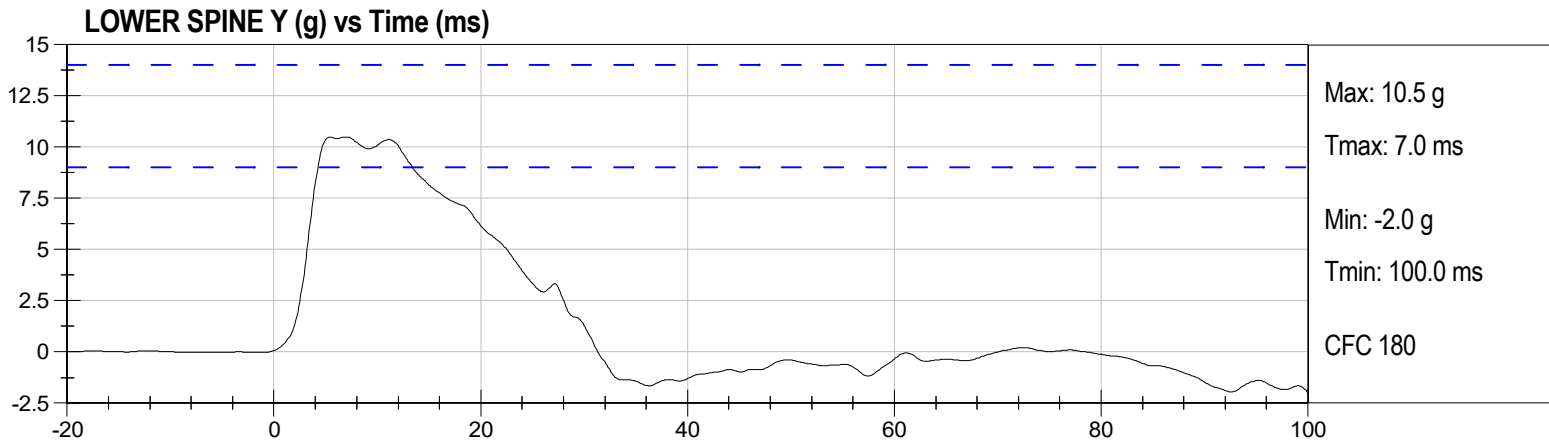
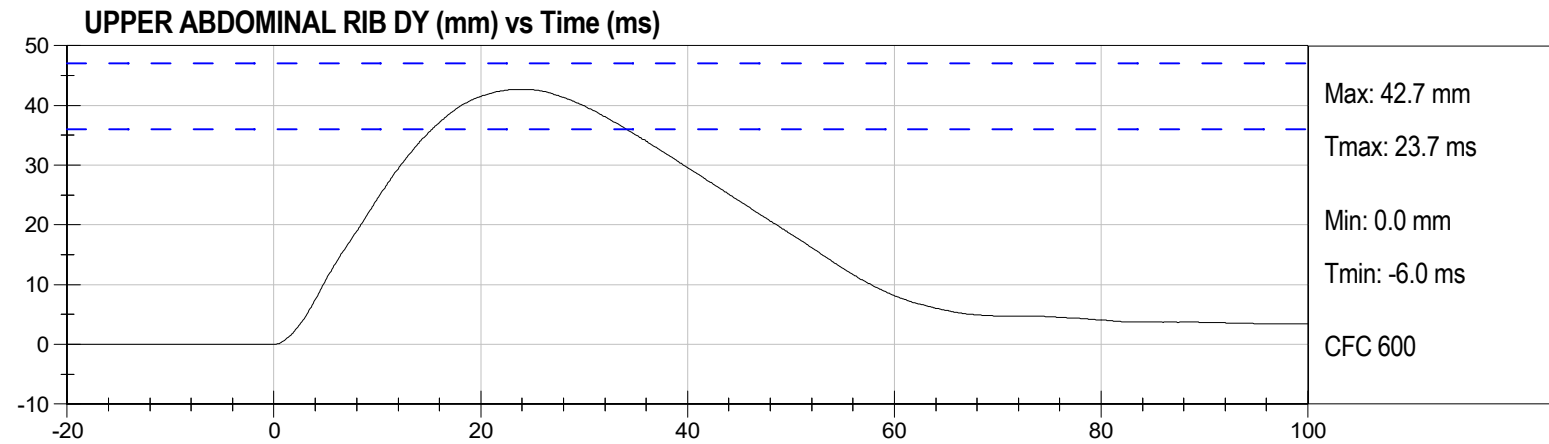
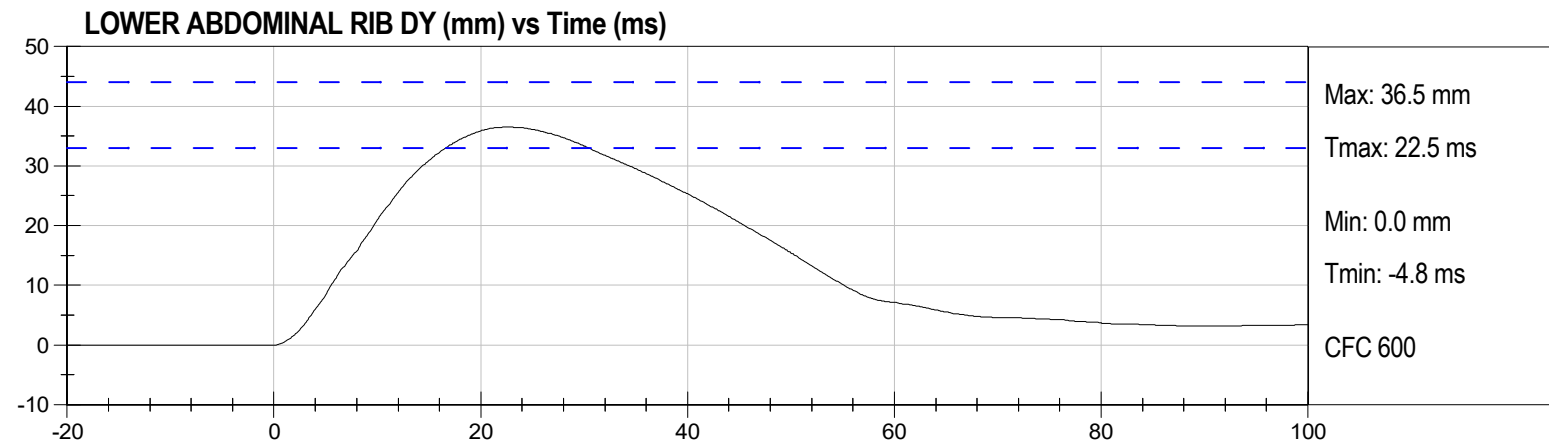
Channel	Manufacturer	Serial Number	Calibration Date	Calibration Due Date
PROBE	Endevco	P79577	09/18/2024	3/20/2025
LOWER SPINE Y	Endevco	P96335	12/10/2024	6/11/2025
UPPER ABDOMINAL RIB DY	FTSS	G032	12/11/2024	6/12/2025
LOWER ABDOMINAL RIB DY	Medius	MJ5171	12/11/2024	6/12/2025

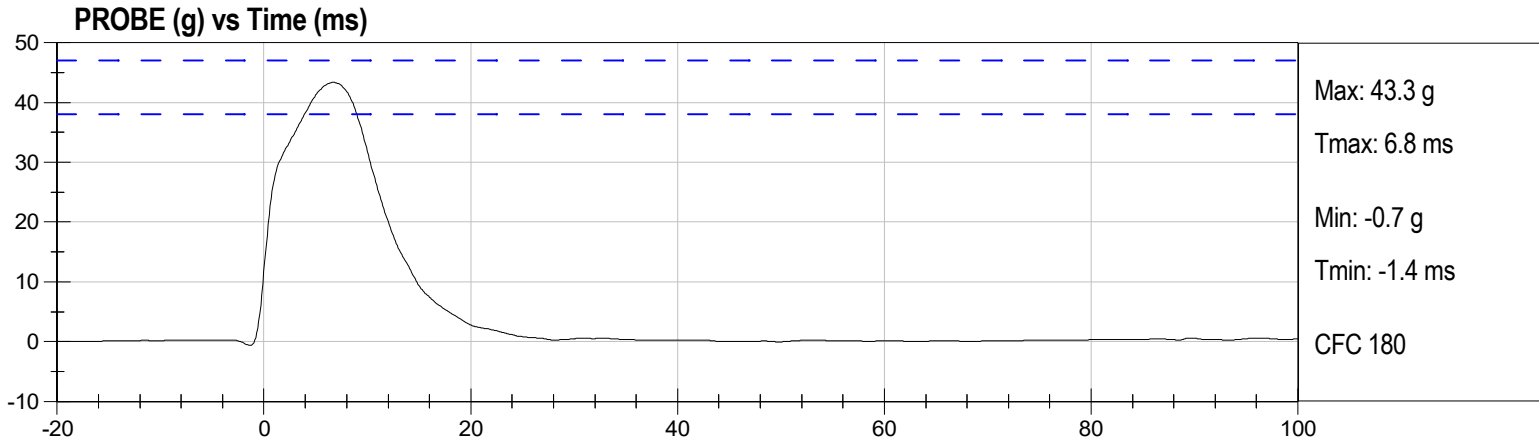
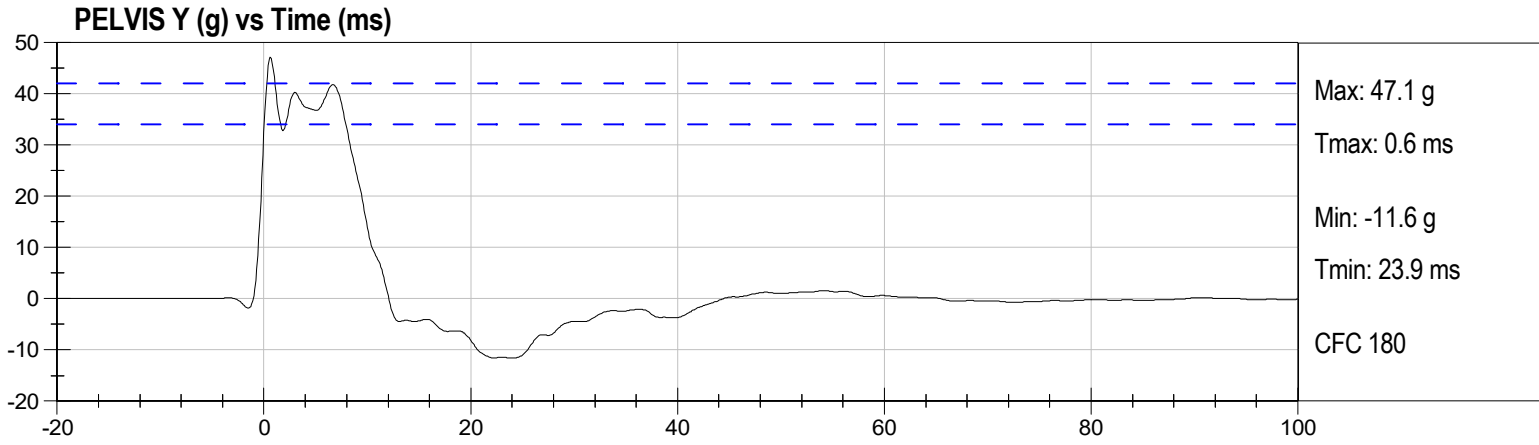
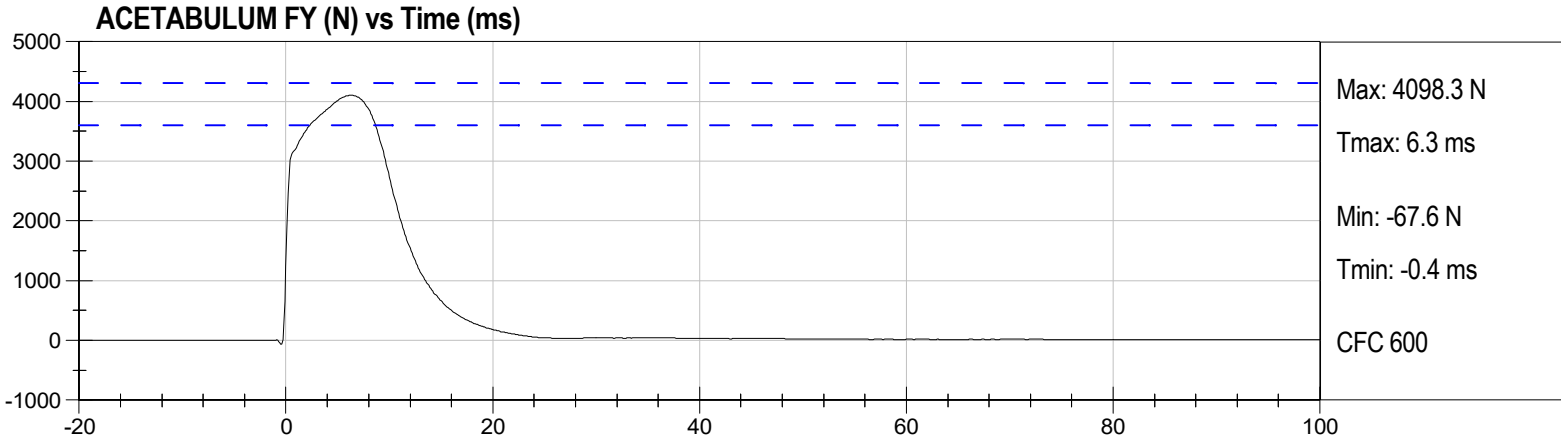
Channel	Manufacturer	Serial Number	Calibration Date	Calibration Due Date
PROBE	Endevco	P79577	09/18/2024	3/20/2025
PELVIS Y	Endevco	P82673	12/10/2024	6/11/2025
ACETABULUM FY	FTSS	ACG4285FY	05/24/2024	5/24/2025

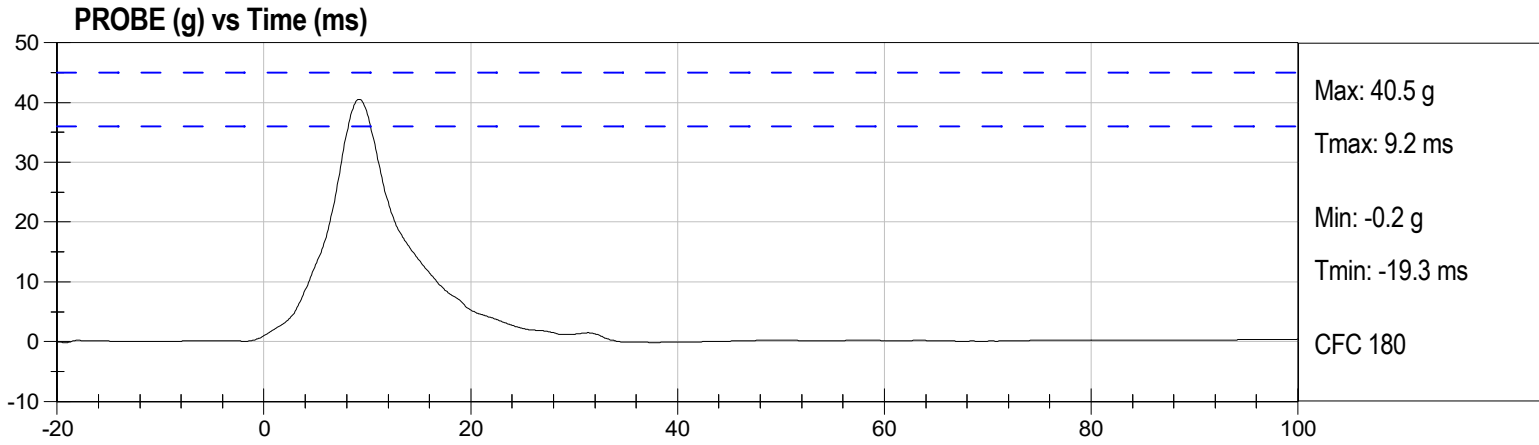
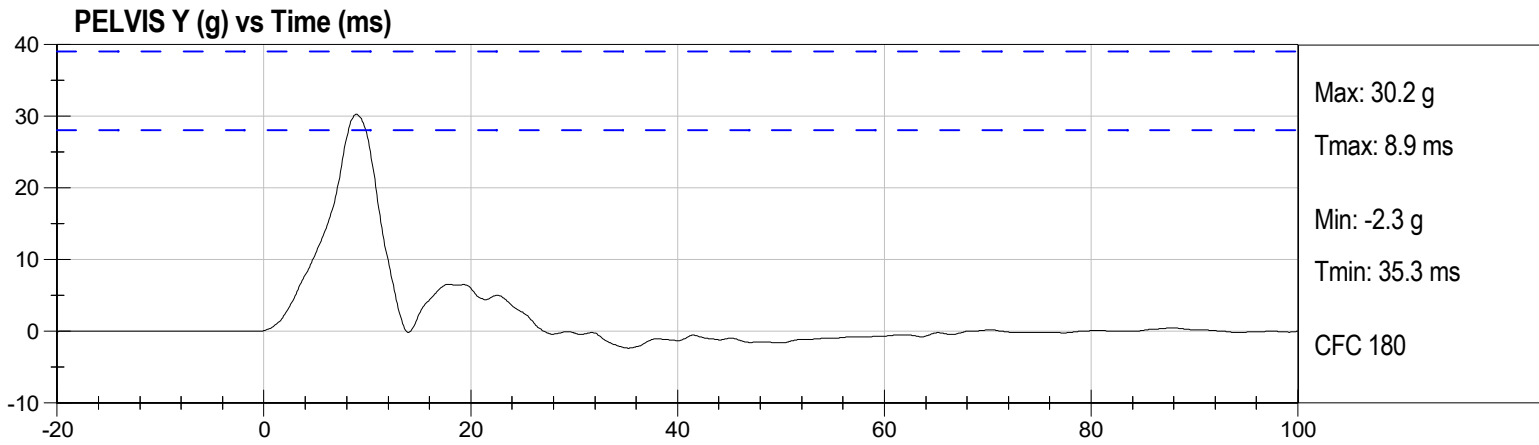
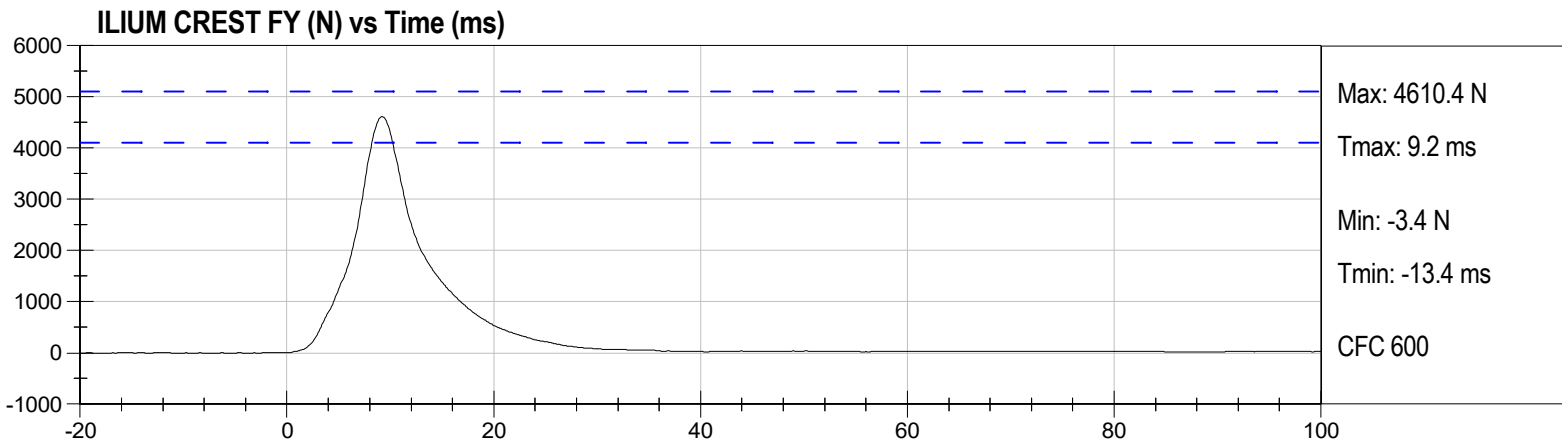
Channel	Manufacturer	Serial Number	Calibration Date	Calibration Due Date
PROBE	Endevco	P79577	09/18/2024	3/20/2025
PELVIS Y	Endevco	P82673	12/10/2024	6/11/2025
ILIUM CREST FY	FTSS	IWG3023FY	05/24/2024	5/24/2025
