**REPORT NUMBER: NCAP-MGA-25-017**

**NEW CAR ASSESSMENT PROGRAM (NCAP)  
Frontal Barrier Impact Test**

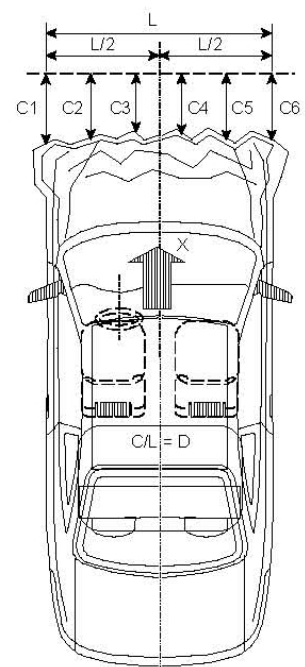
| No. | Measurement Description | Units | Pre-Test | Post-Test | Exterior Crush |

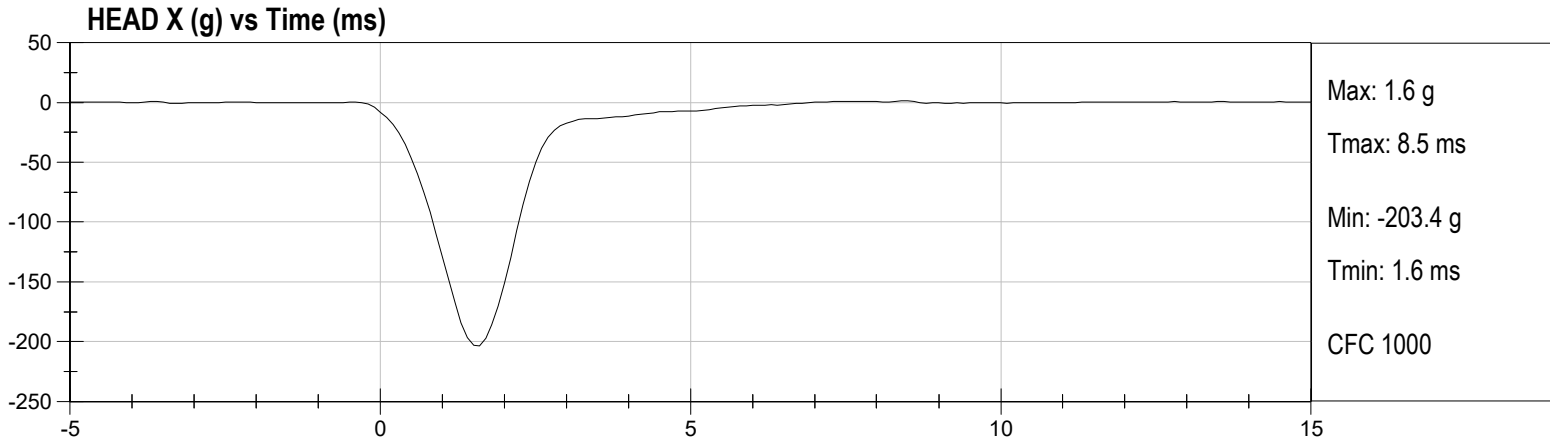
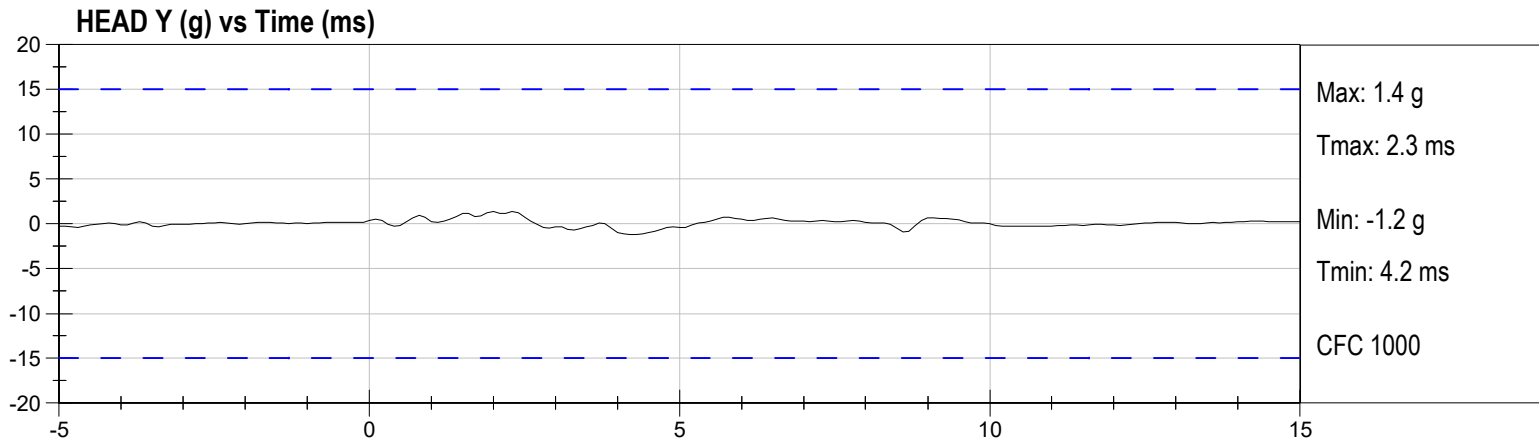
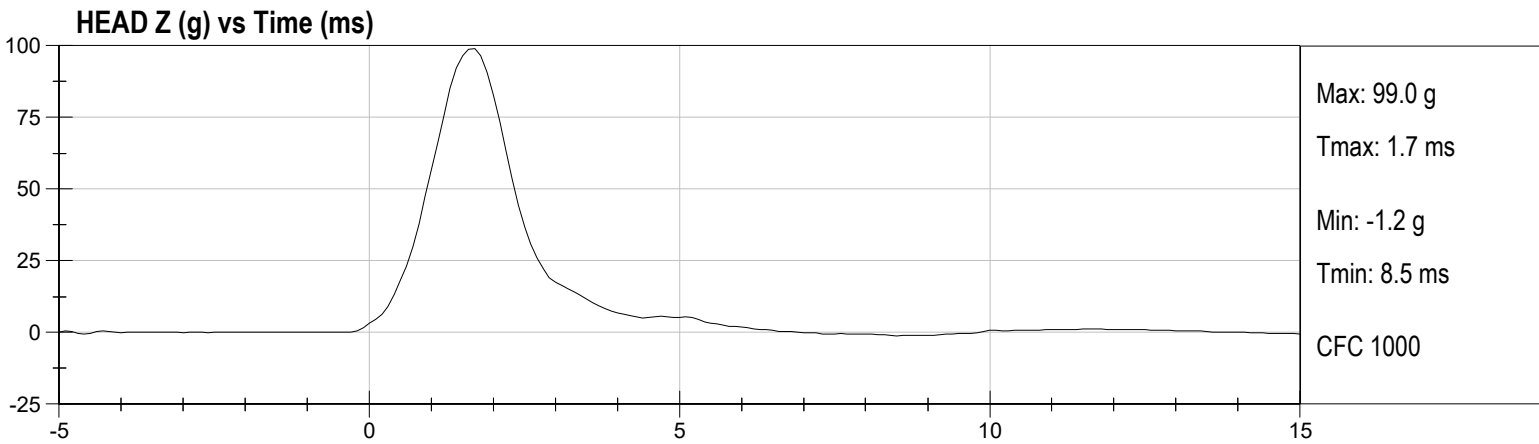
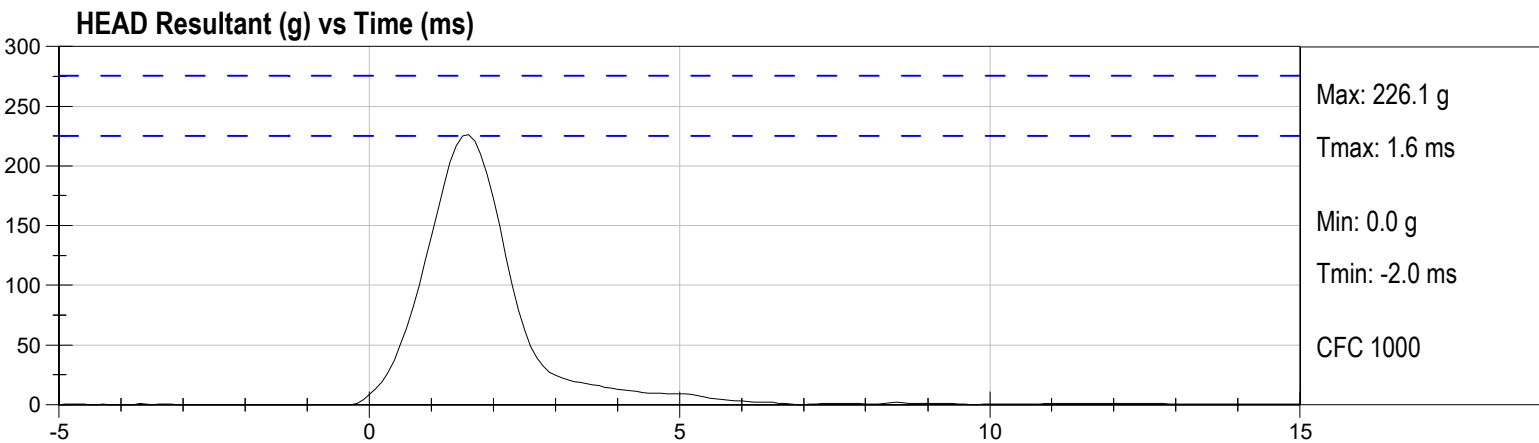
| Tested Parameter | Units | Specification | Result | Pass/Fail |

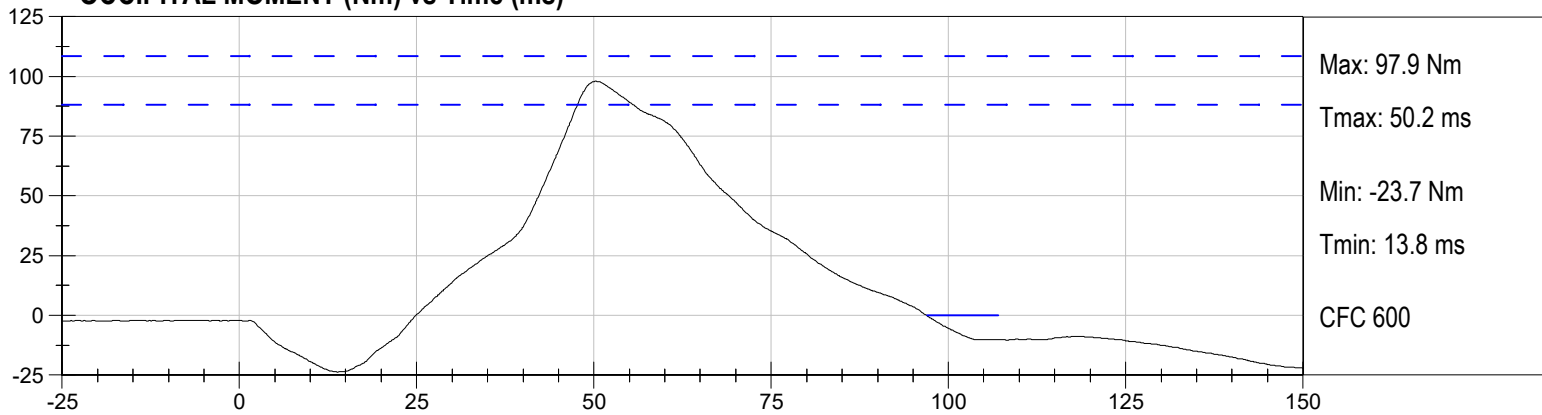
| Tested Parameter | Units | Specification | Result | Pass/Fail |

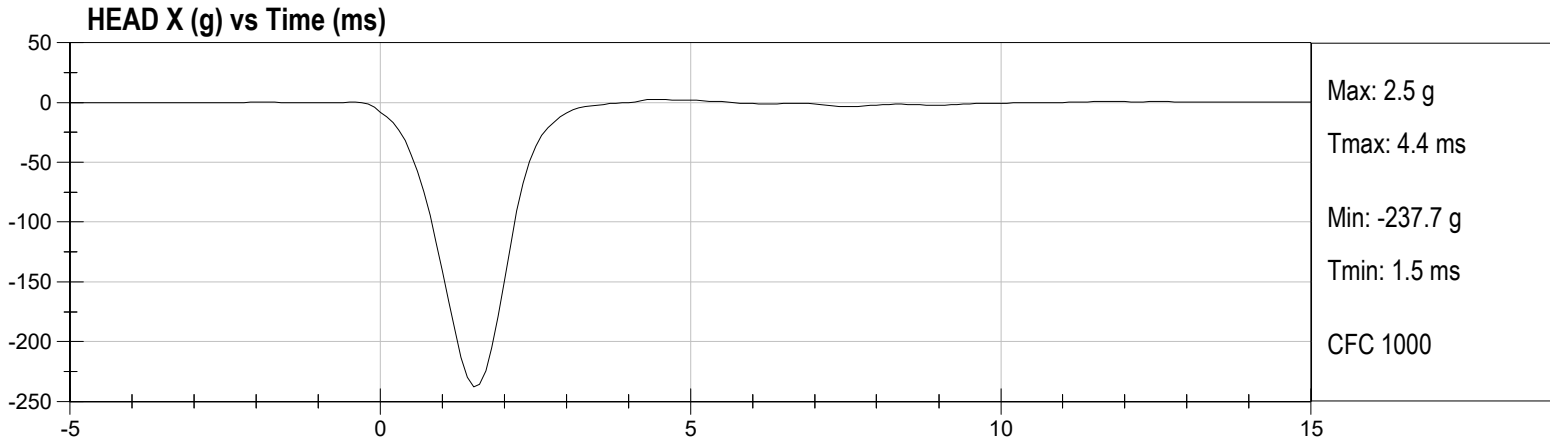
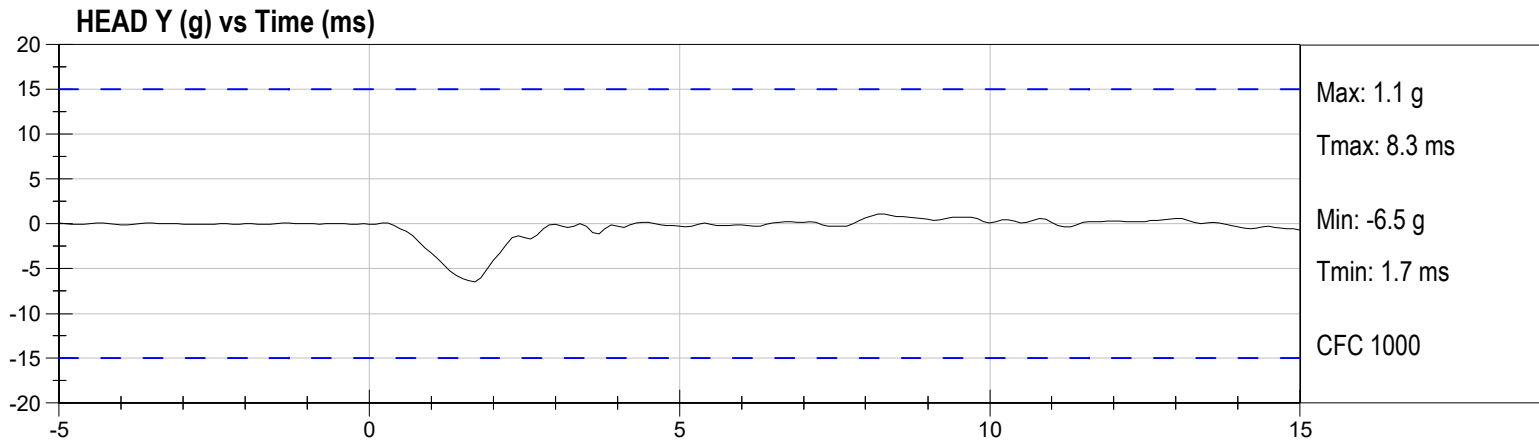
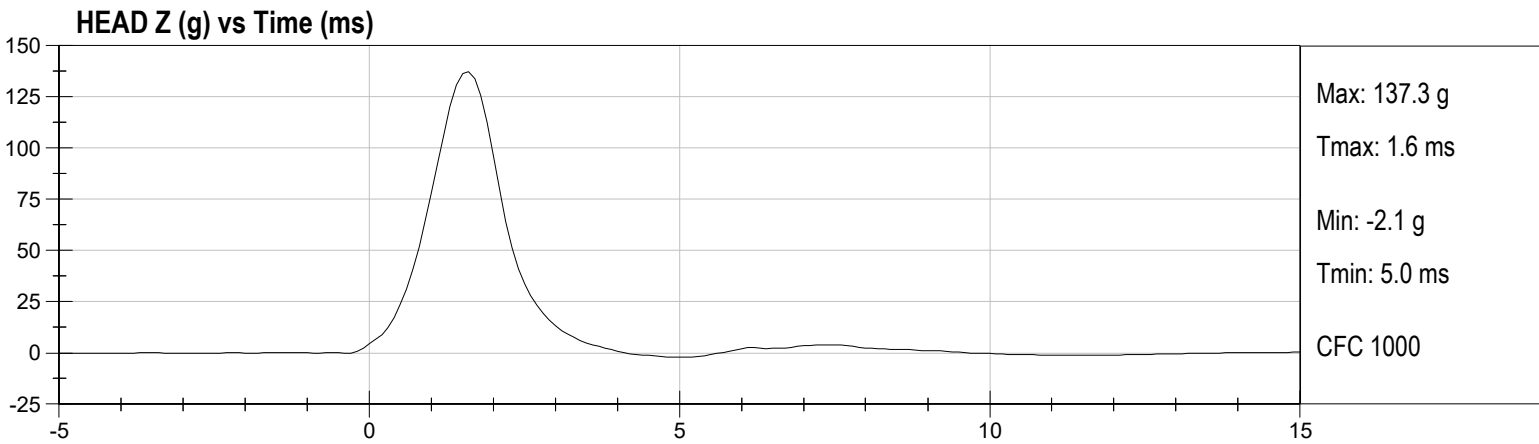
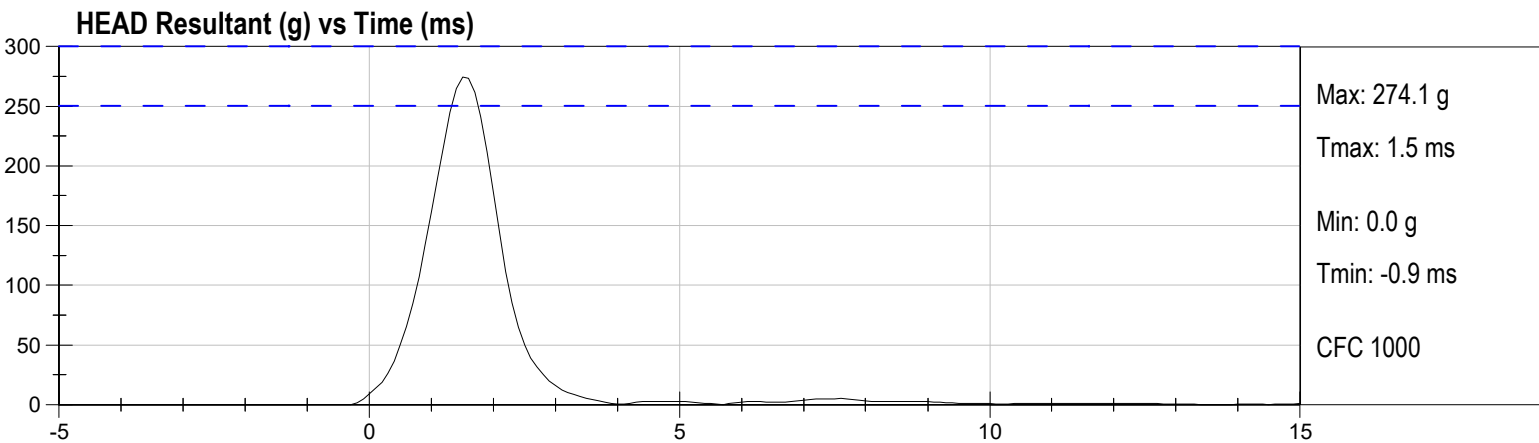
| Tested Parameter | Units | Specification | Result | Pass/Fail |

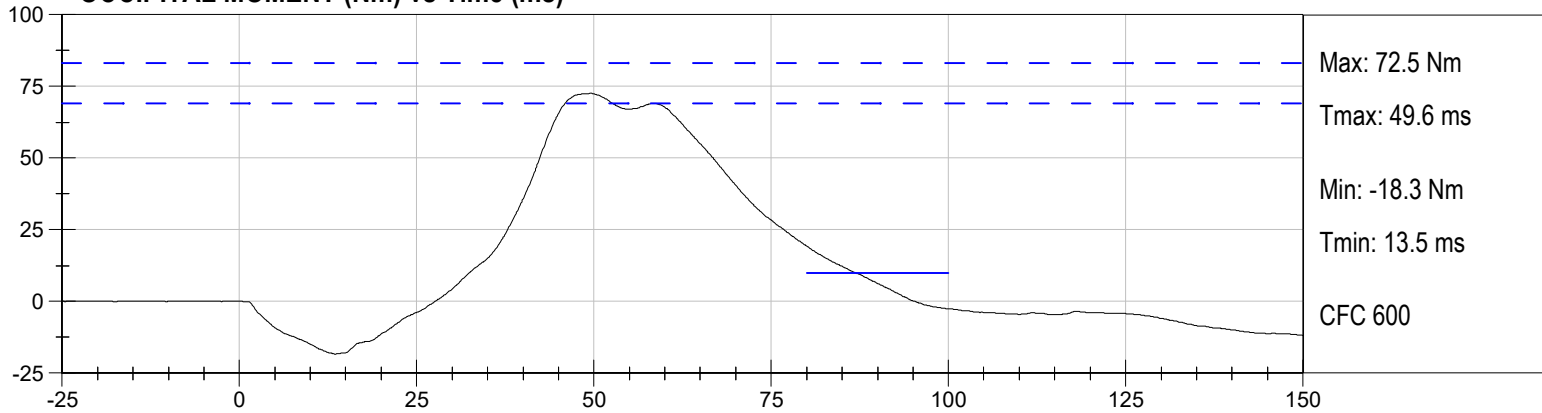
| Tested Parameter | Units | Specification | Result | Pass/Fail |

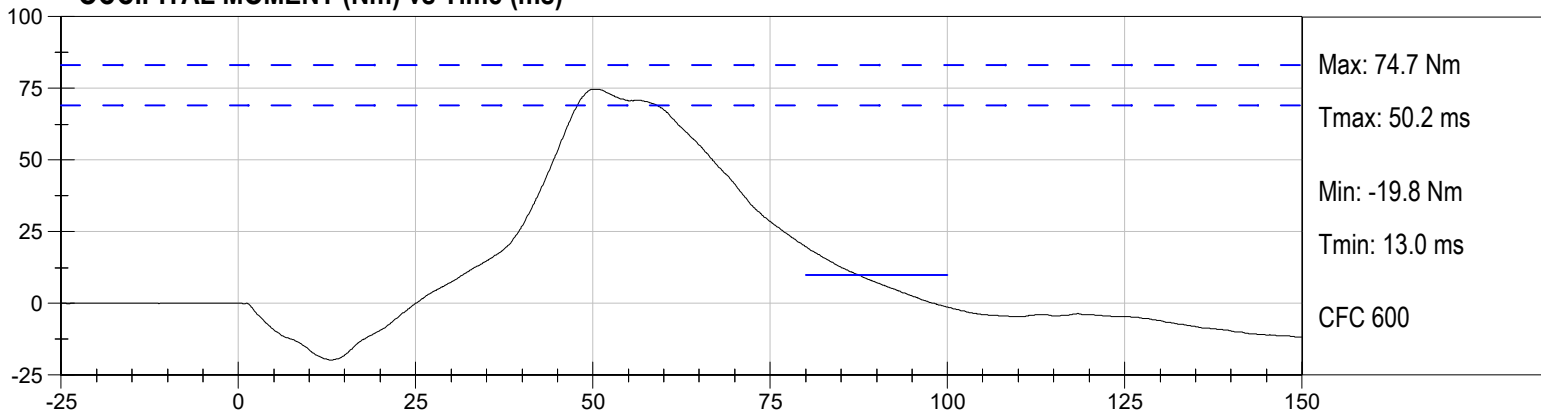
| Tested Parameter | Units | Specification | Result | Pass/Fail |
