REPORT NUMBER: 214P-CAL-23-006

**SAFETY COMPLIANCE TESTING FOR FMVSS 214
DYNAMIC SIDE IMPACT PROTECTION
RIGID POLE TEST**

**Bayerische Motoren Werke AG
2023 BMW X1 xDrive28i
5 Door SUV**

NHTSA No: C20234101

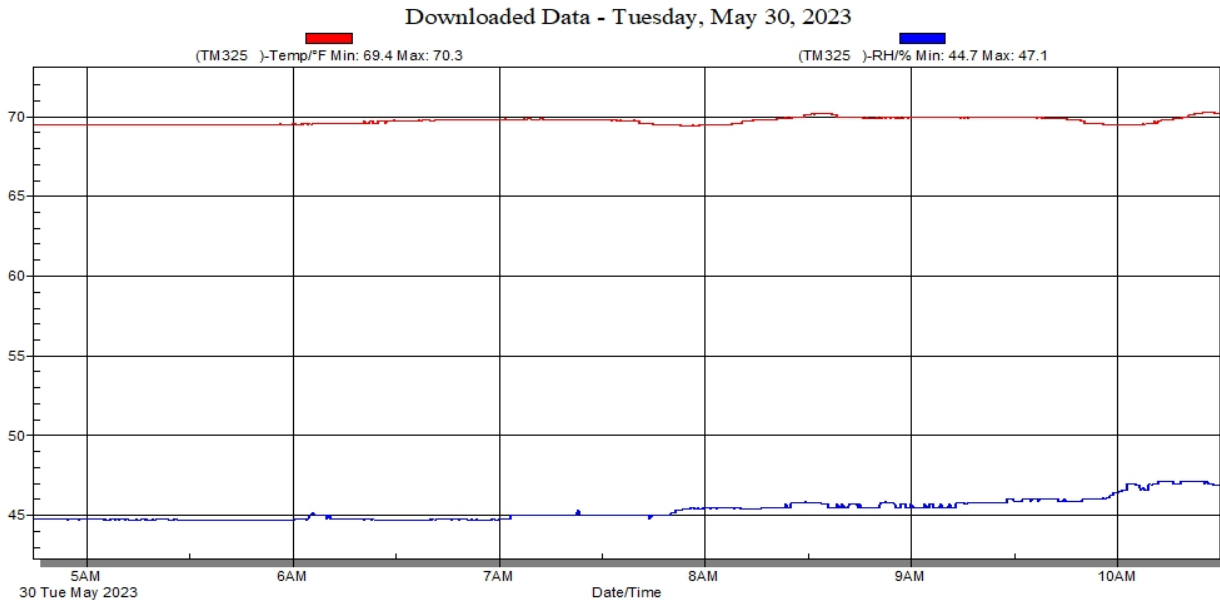
DATA SHEET NO. 16
DUMMY / VEHICLE TEMPERATURE AND HUMIDITY STABILIZATION DATA

Temperature and Humidity Stabilization Chart/Data for Dummies and Test Vehicle

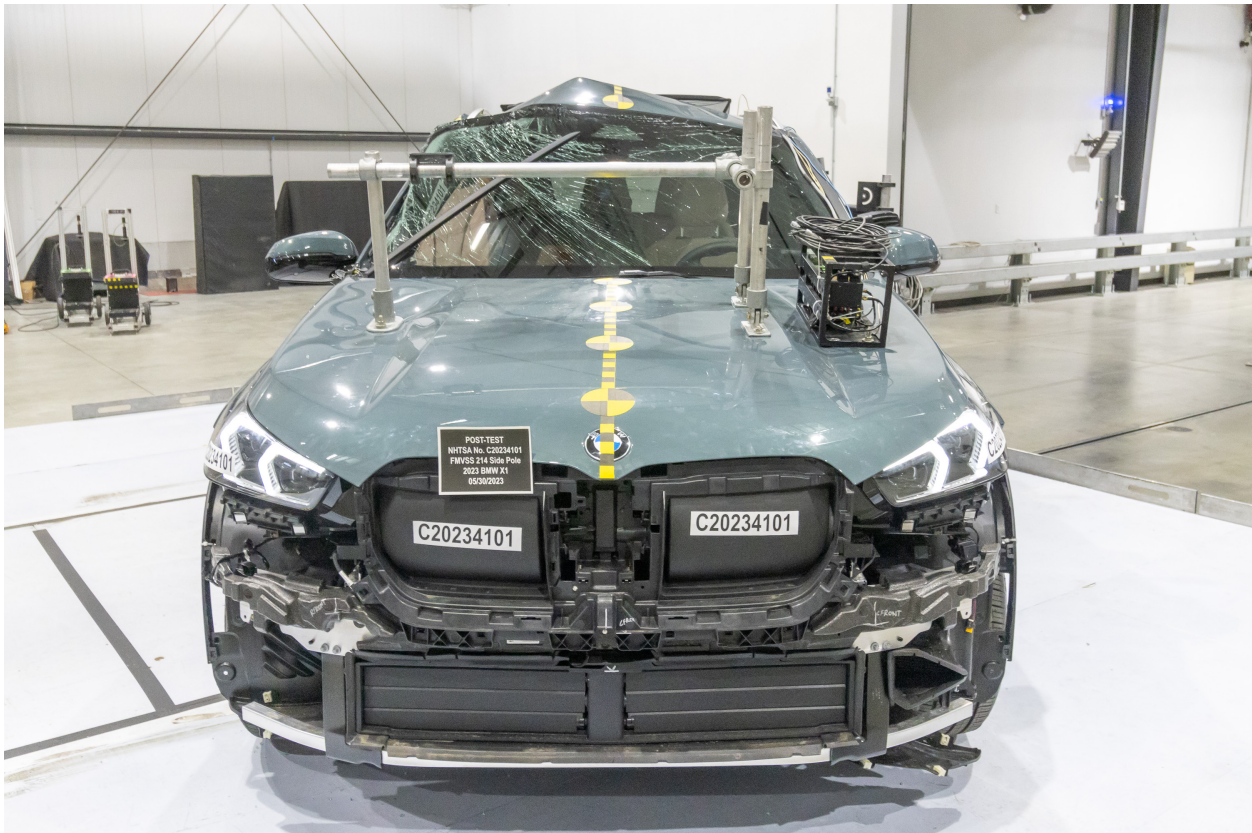
Figure A-2: Post Test Frontal View of Test Vehicle

Critical Areas of Performance	Observations and Conclusions
Pillar Performance	B-Pillar and C-Pillar Buckled
Sill Separation	None
Windshield Damage	Separation along struck side A-Pillar and cracked throughout
Side Window Damage	Passenger window shattered and fell out
Other Notable Effects	Sunroof shattered and fell out; Passenger seatback reclined due to button being depressed after impact event

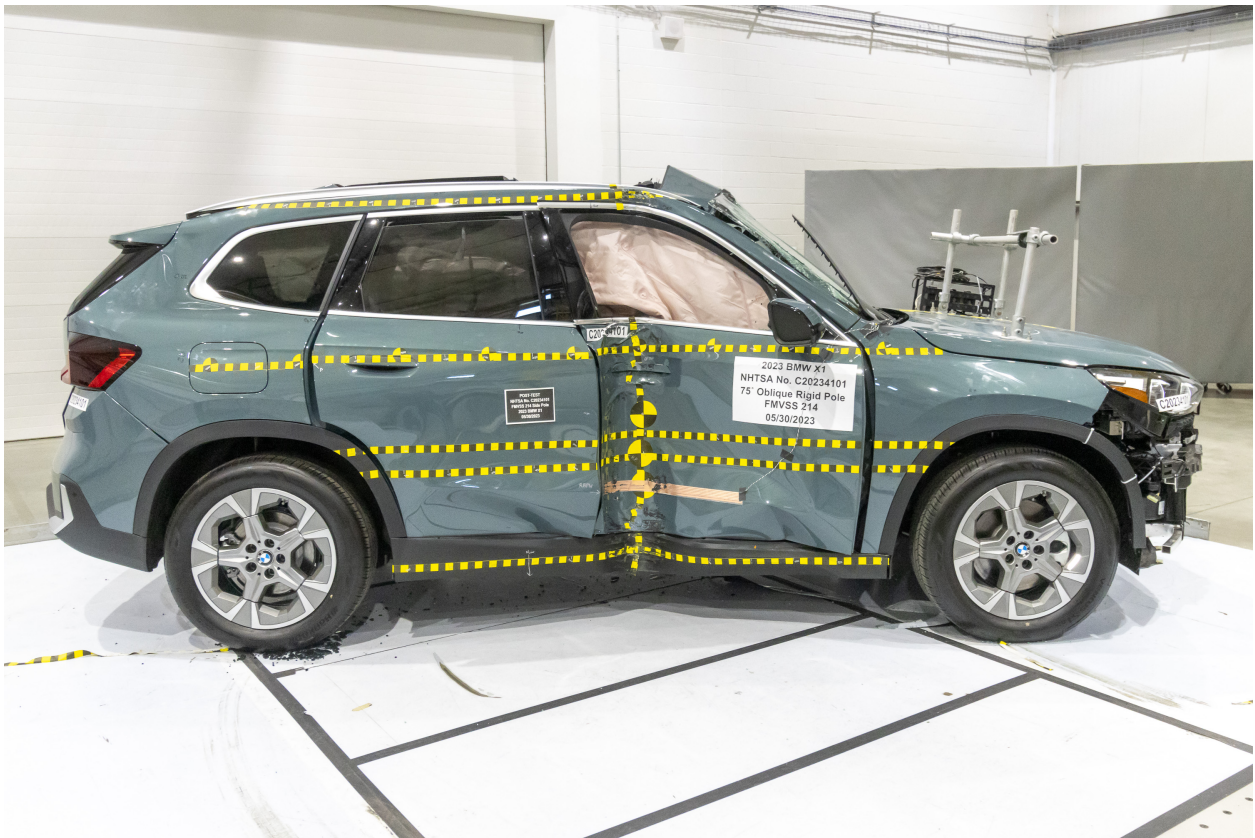
Figure A-6: Post-Test Impacted Side View of Test Vehicle

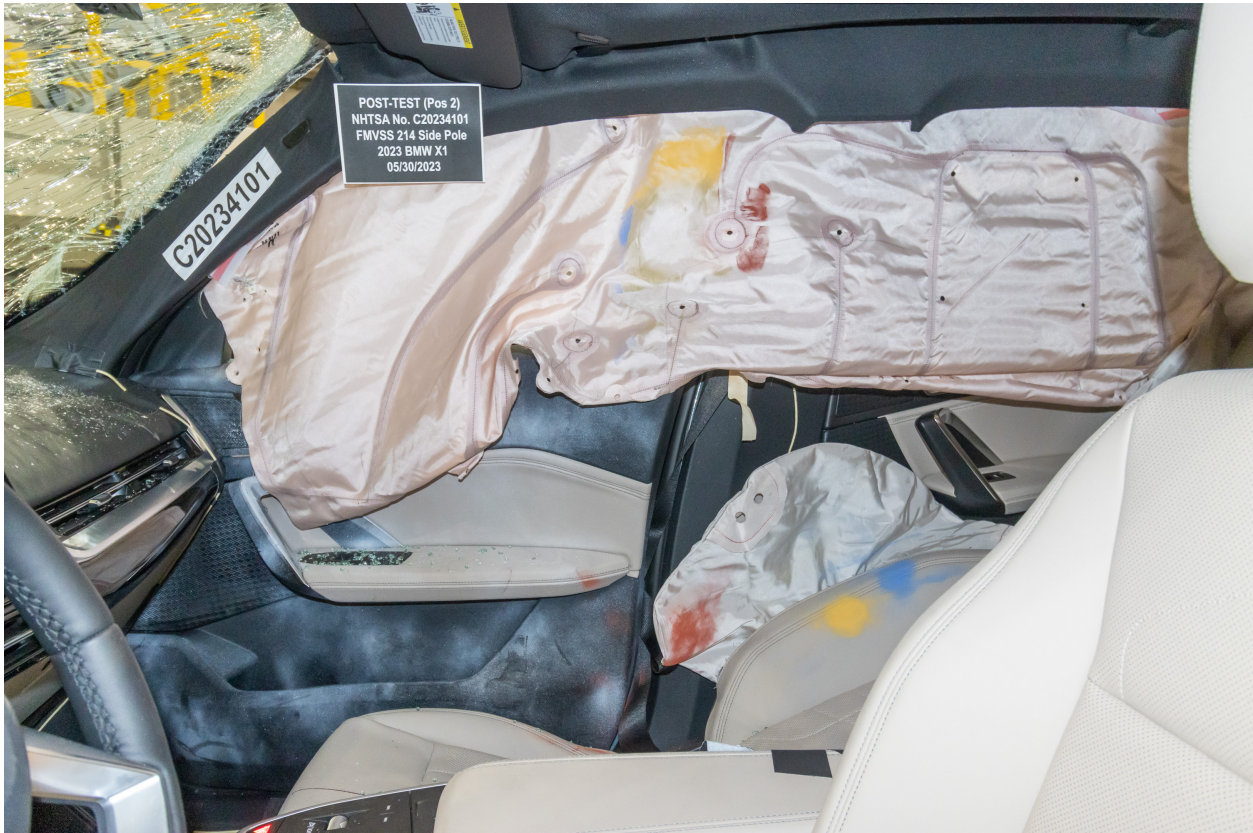
Figure A-19: Post-Test Interior of Front Door Showing Dummy Impact Locations

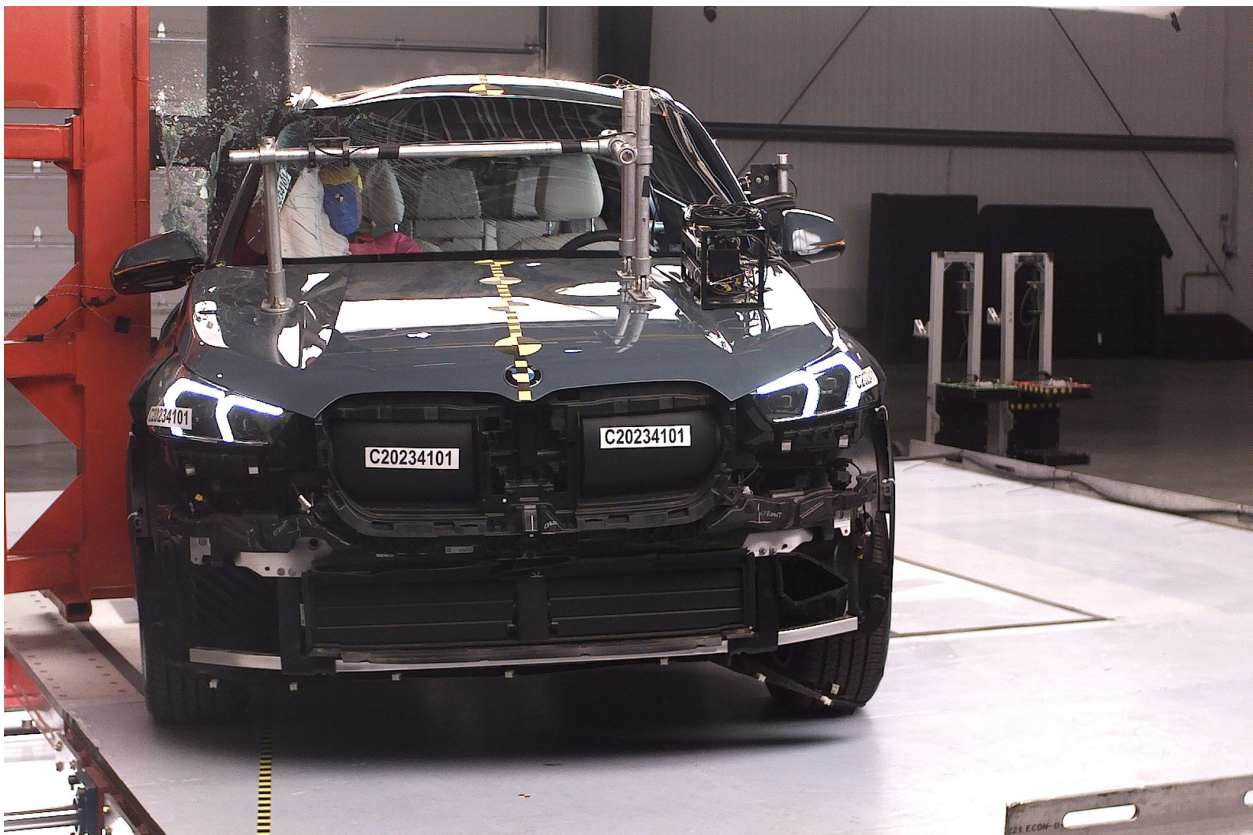
Figure A-20: Impact Event

A rigid pole side impact test was conducted on a 2023 BMW X1 xDrive28i 5 Door SUV. The subject vehicle was towed into the rigid pole at an angle of 285° and a velocity of 30.97 km/h. The test was conducted by Calspan Corporation's Transportation Test Operations facility in Buffalo, New York on May 30, 2023. Pre-test and post-test photographs of the test vehicle and side impact dummy (ES2re) are included in Appendix I of this report.

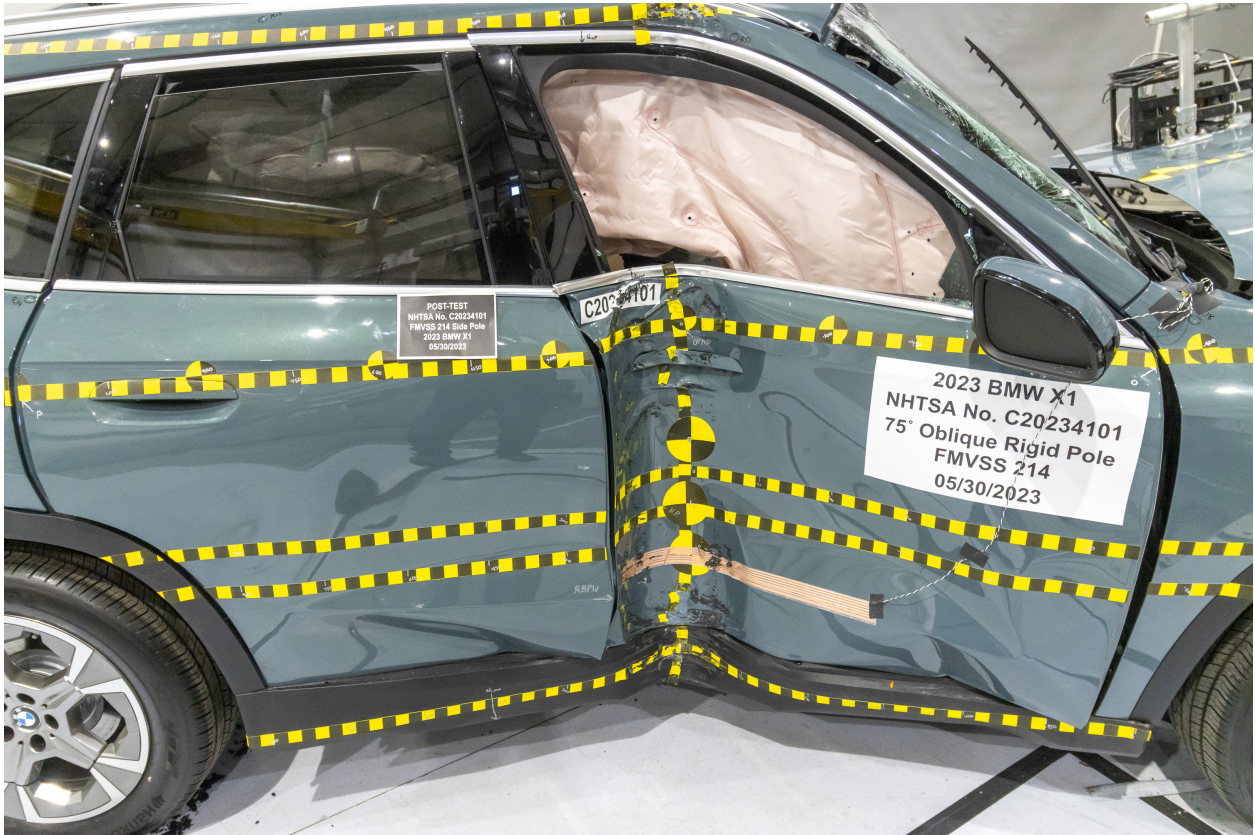
Figure A-21: Post-Test Impact Zone Close-Up View

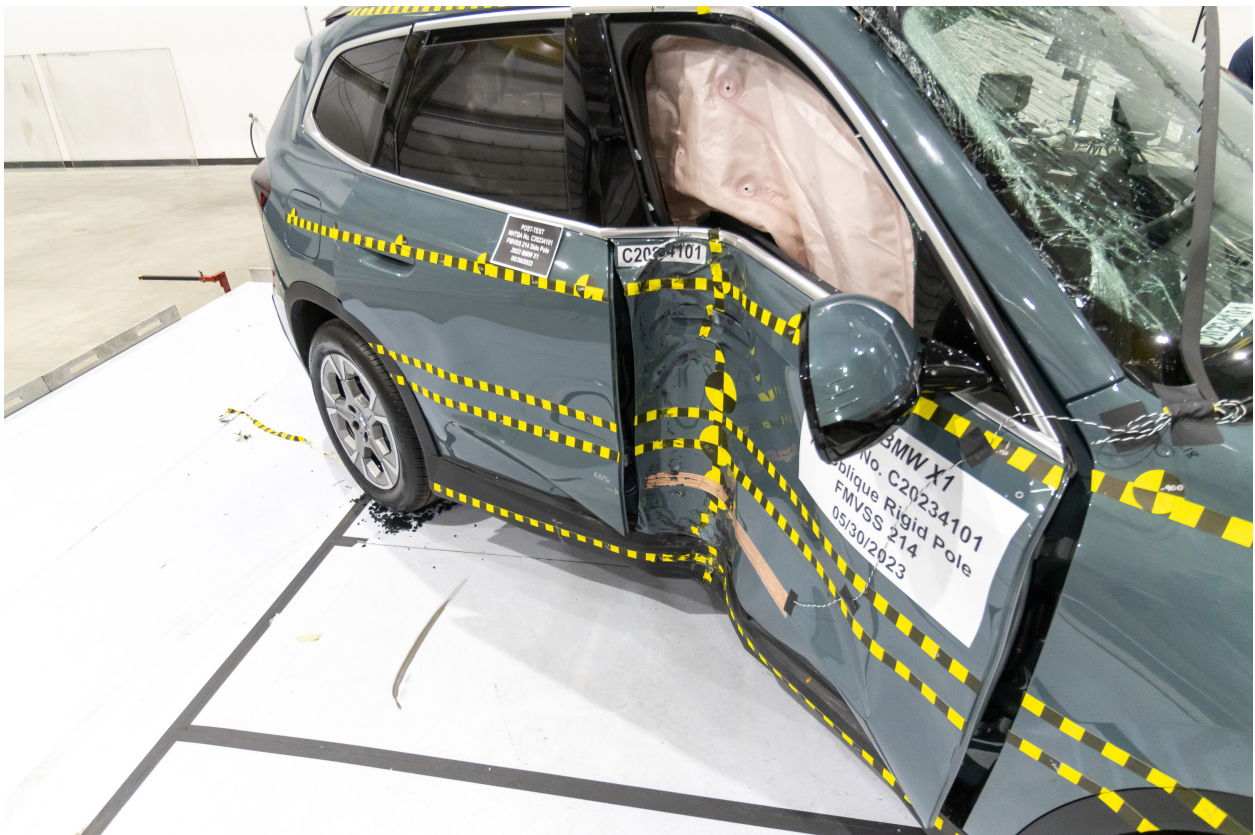
Figure A-22: Post-Test 3/4 Front View of Impact Zone

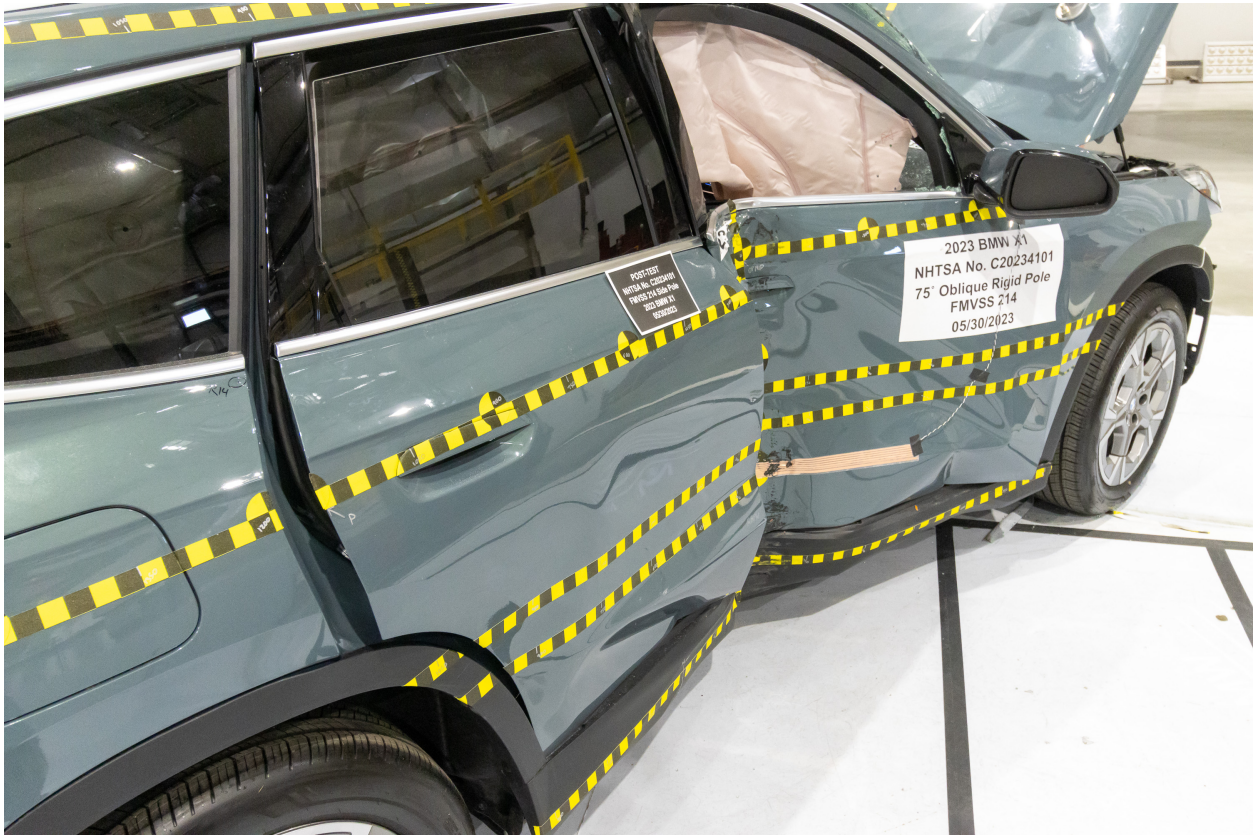
Figure A-23: Post-Test ¾ Rear View of Impact Zone

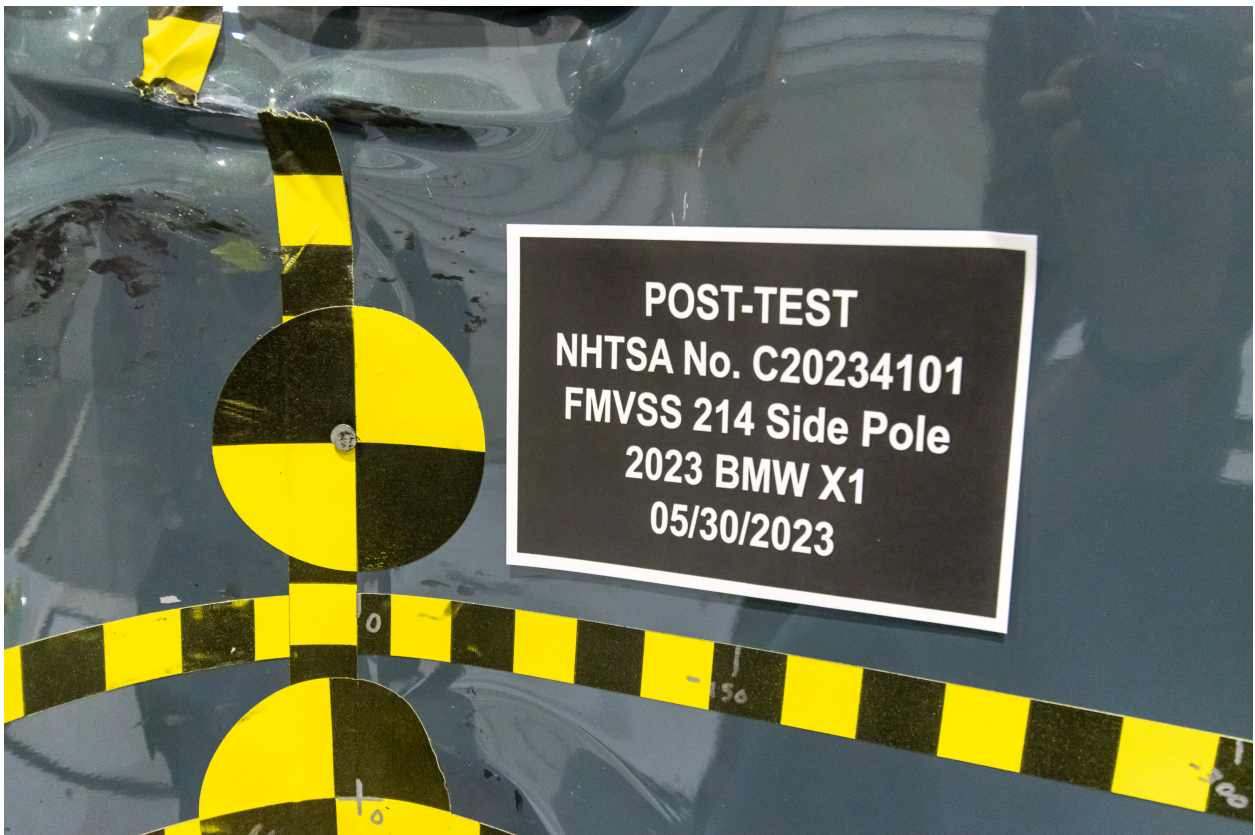
Figure A-24: Post-Test Close-Up View of Impact Point Target
