**REPORT NUMBER: 214P-CAL-24-010**

**SAFETY COMPLIANCE TESTING FOR FMVSS 214  
DYNAMIC SIDE IMPACT PROTECTION  
RIGID POLE TEST**

**Toyota Motor Corporation  
2024 Toyota Crown  
4 Door Sedan**

**NHTSA No: C20245103**

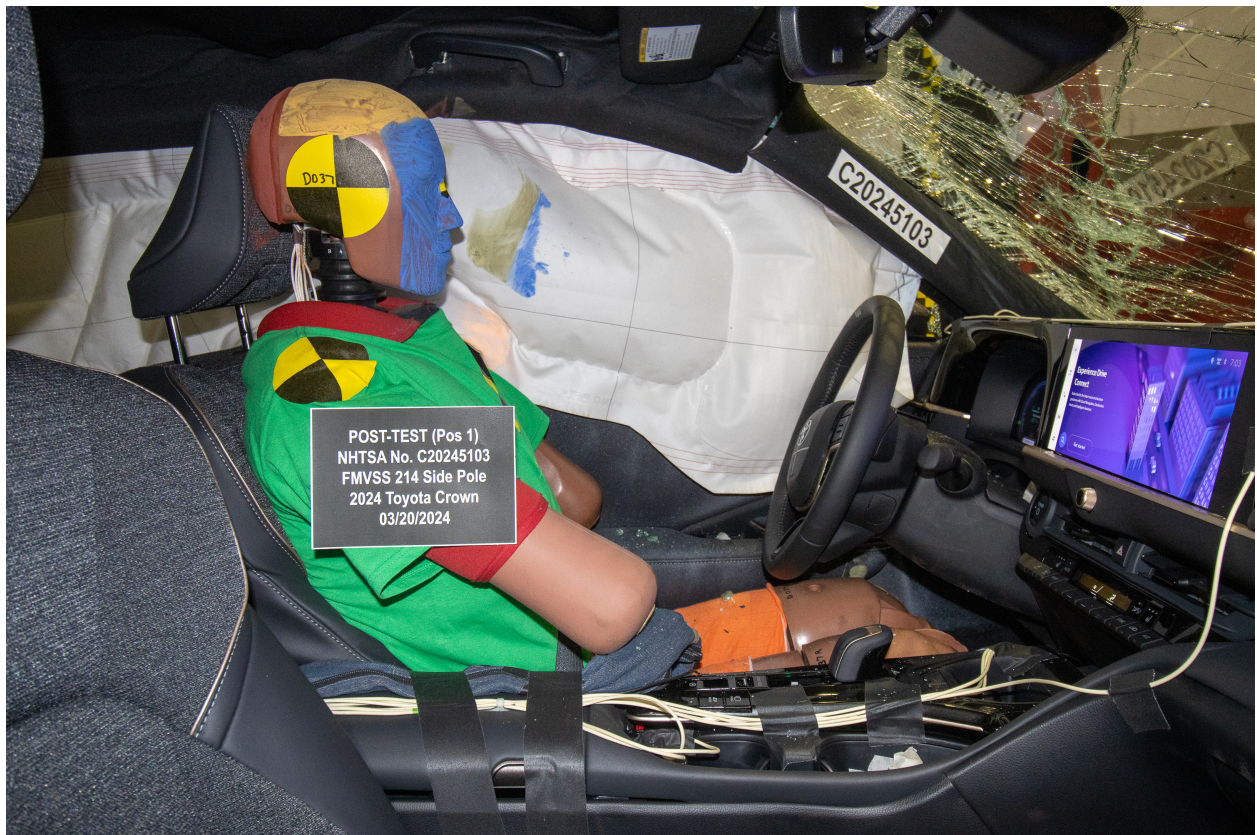
**Figure A-12: Post-Test Dummy Through Opposite Window**

| Critical Areas of Performance | Observations and Conclusions |
|---|---|
| Side Window Damage | Driver window shattered completely |
