**Report Number: NCAP-KAR-25-003**

**NEW CAR ASSESSMENT PROGRAM (NCAP)  
FRONTAL BARRIER IMPACT TEST**

**AUDI AG  
2025 AUDI Q6 E-TRON 5-DOOR SUV  
NHTSA NUMBER: M20255800**

**PREPARED BY:  
APPLUS+ IDIADA KARCO ENGINEERING, LLC.  
9270 HOLLY ROAD  
ADELANTO, CA 92301**

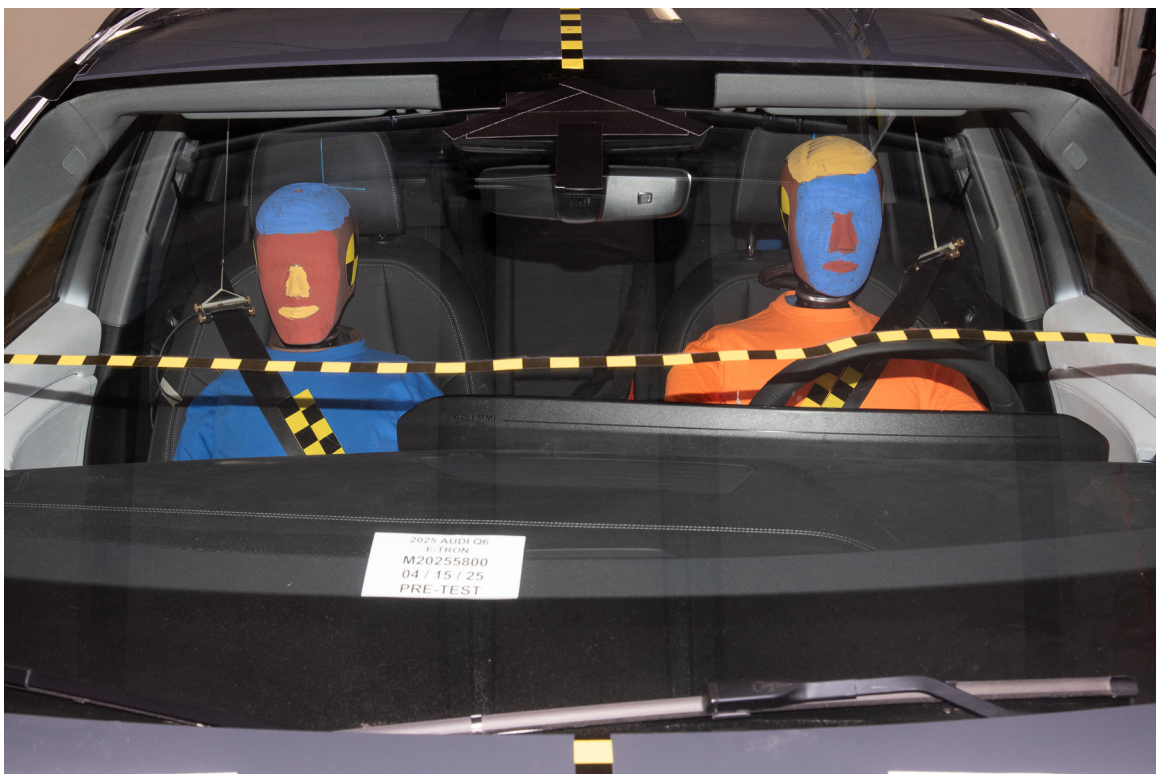
FIGURE 18. Pre-Test Windshield View

There was 100 percent windshield retention and no intrusion into the protected zone of the windshield during the event. There was no electrolyte leakage after the event or during any phase of the static rollover.
