**REPORT NUMBER: SideNCAPPole-MGA-25-019**

**NEW CAR ASSESSMENT PROGRAM (NCAP)  
Side Impact Pole Test**

**MAZDA TOYOTA MANUFACTURING U.S.A. INC.  
2025 Toyota Corolla Cross L 5-Door SUV  
NHTSA No.: M20255105**

**MGA RESEARCH CORPORATION  
5000 Warren Road  
Burlington, WI 53105**

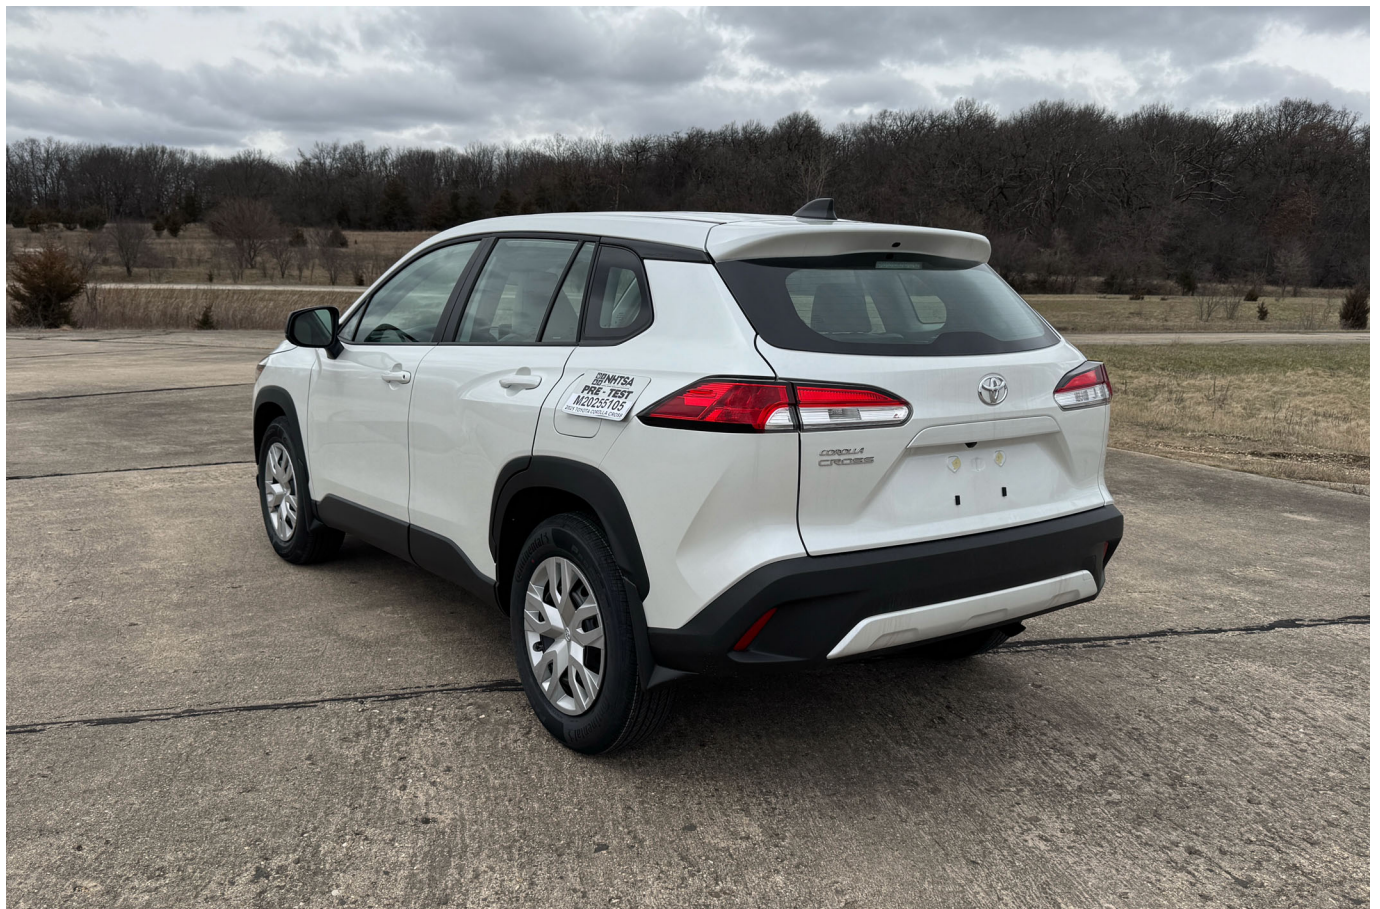
Photo No. 002 - As Delivered Left Rear Three-Quarter View of Test Vehicle

| | | <u>Page No.</u> |
|---|---|---|
| Photo No. 002 | As Delivered Left Rear $\frac{3}{4}$ View of Test Vehicle | A-1 |

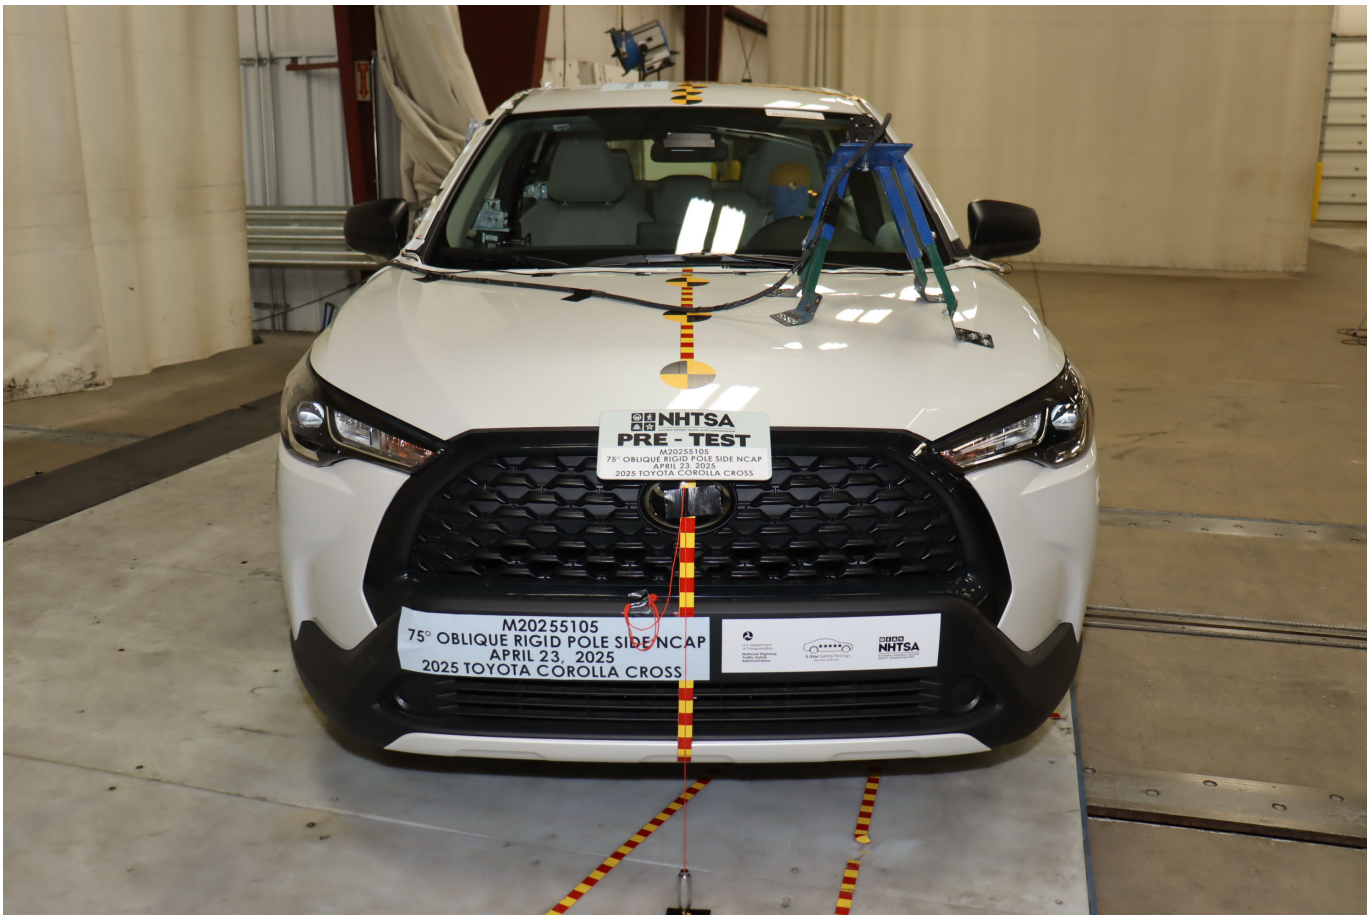
Photo No. 003 - Pre-Test Frontal View of Test Vehicle

| | | <u>Page No.</u> |
|---|---|---|
| Photo No. 003 | Pre-Test Frontal View of Test Vehicle | A-2 |

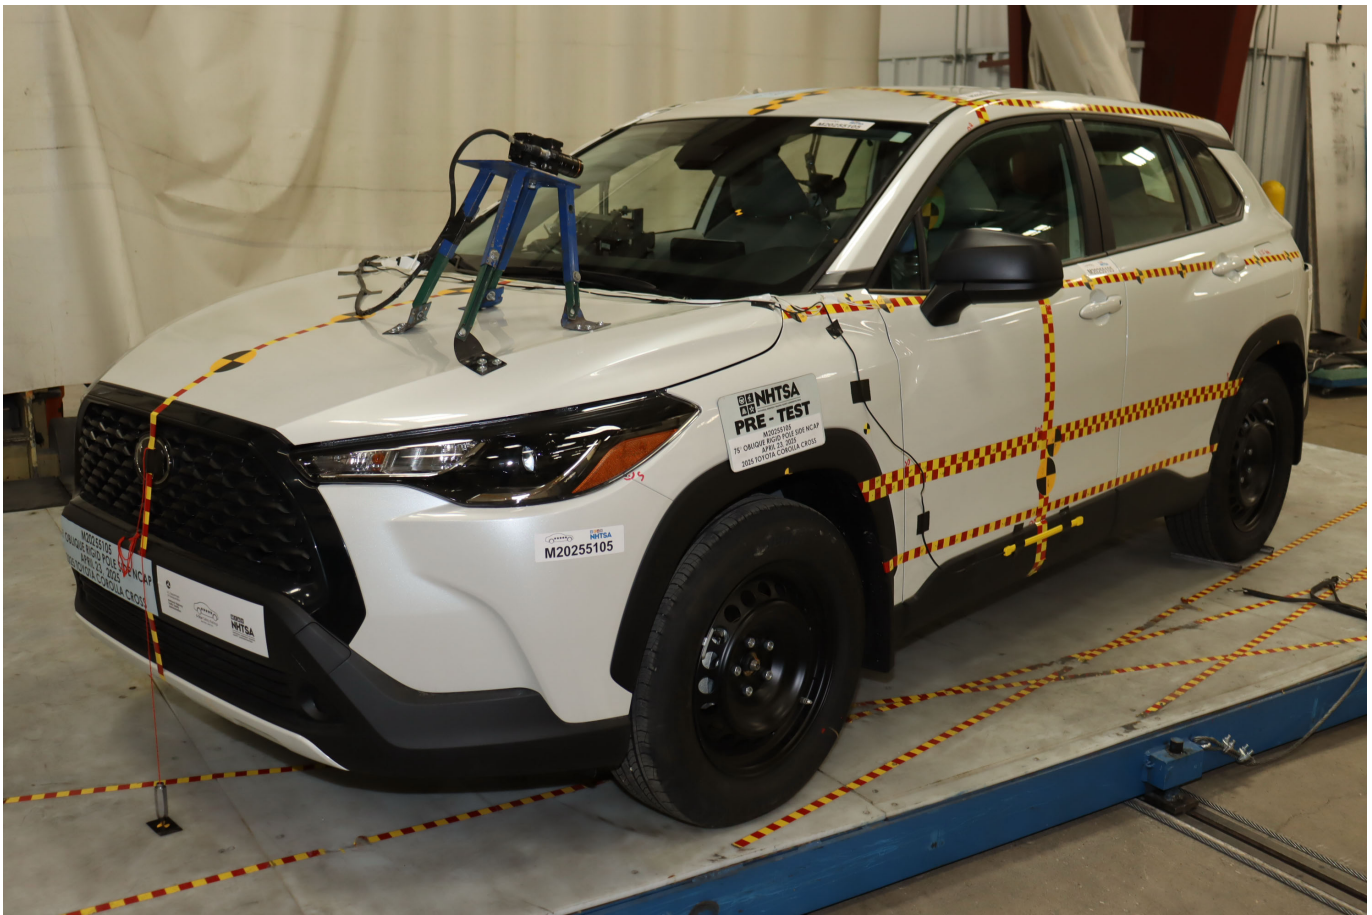
Photo No. 005 - Pre-Test Left Front Three-Quarter View of Test Vehicle

| | | <u>Page No.</u> |
|---|---|---|
| Photo No. 005 | Pre-Test Left Front $\frac{3}{4}$ View of Test Vehicle | A-3 |

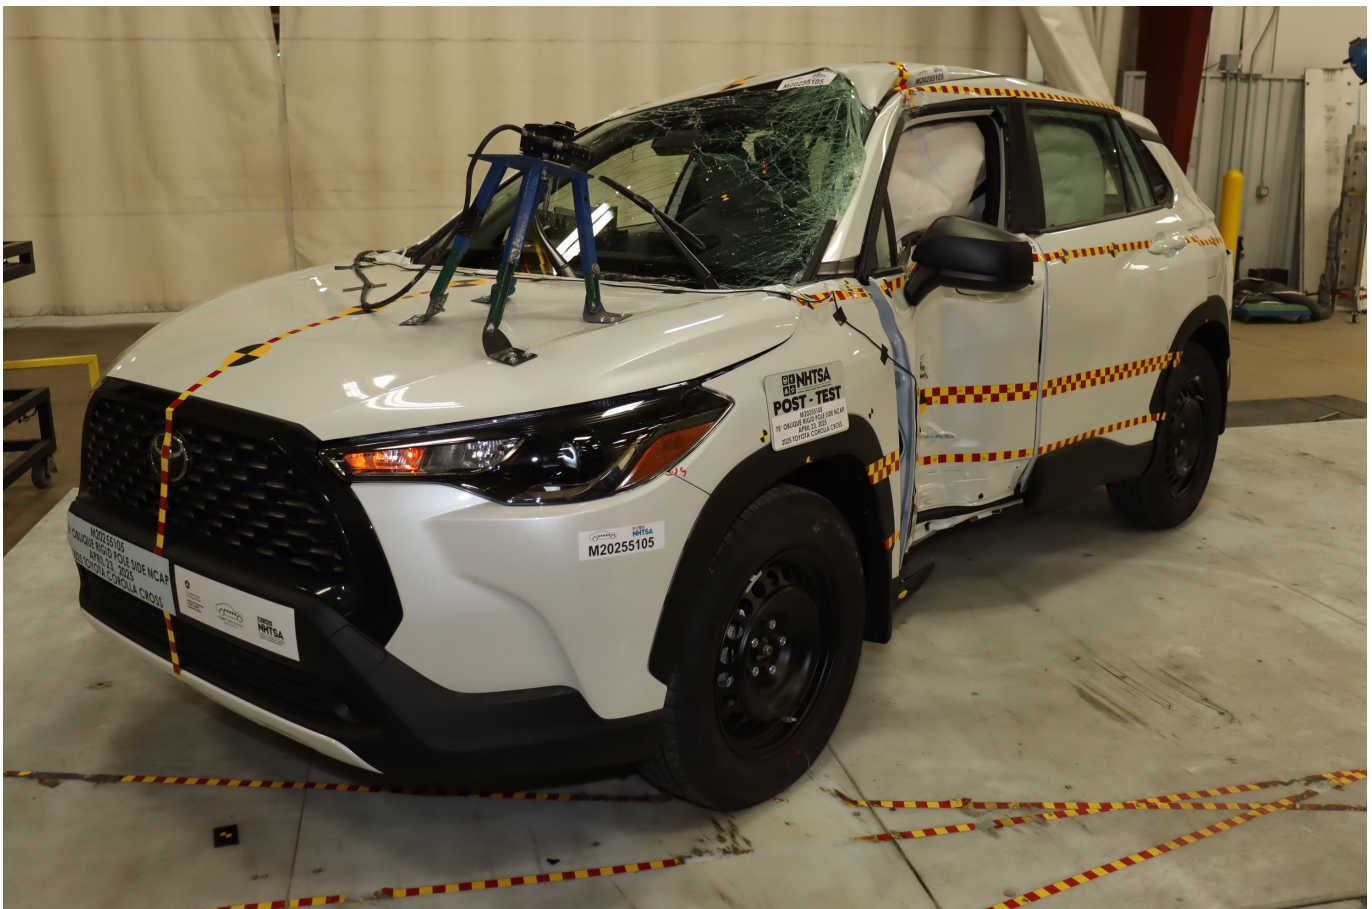
Photo No. 006 - Post-Test Left Front Three-Quarter View of Test Vehicle

| | | <u>Page No.</u> |
|---|---|---|
| Photo No. 006 | Post-Test Left Front $\frac{3}{4}$ View of Test Vehicle | A-3 |

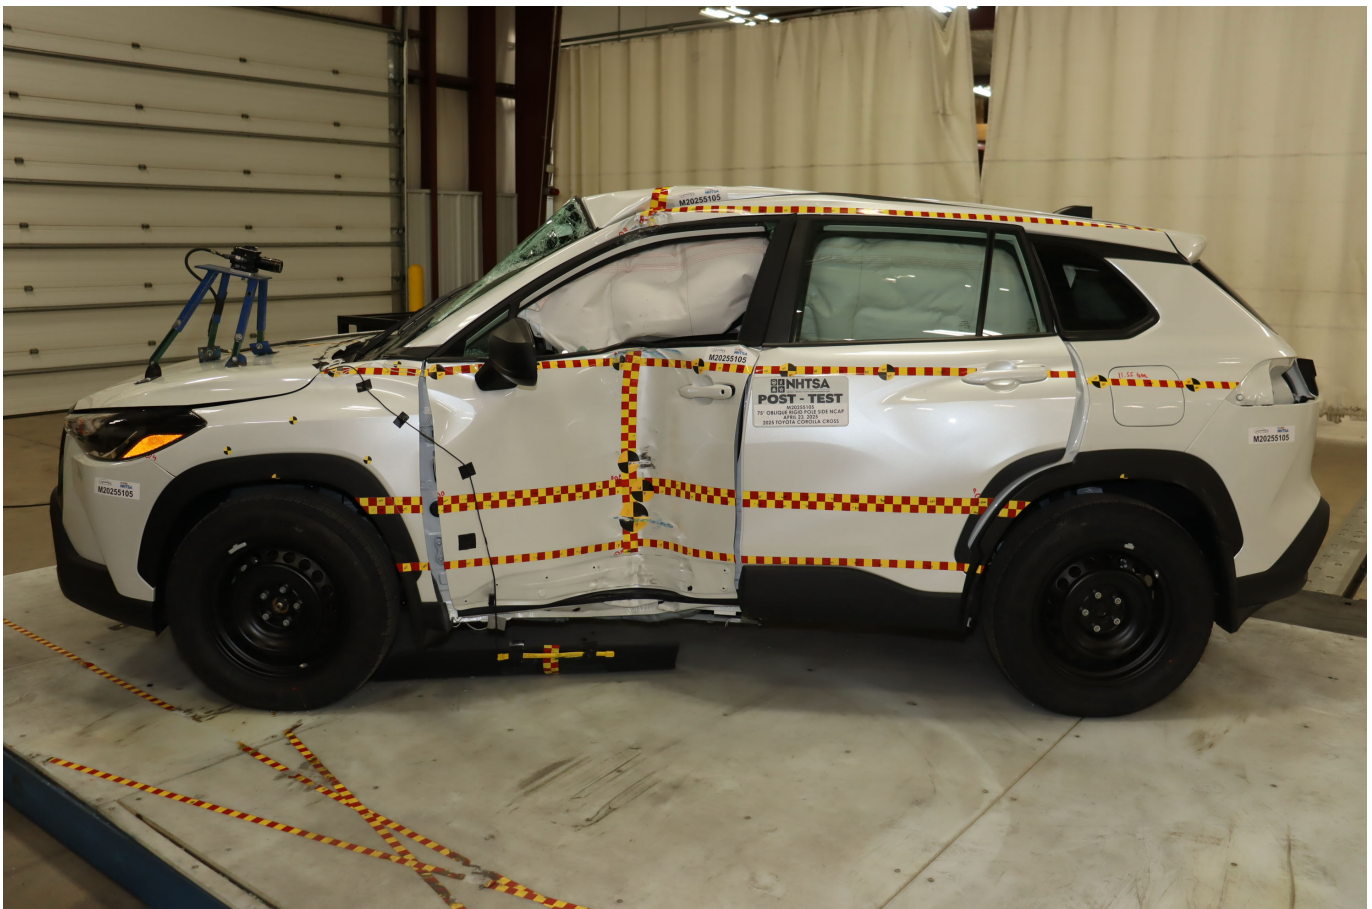
Photo No. 008 - Post-Test Left Side View of Test Vehicle

| | | <u>Page No.</u> |
|---|---|---|
| Photo No. 008 | Post-Test Left Side View of Test Vehicle | A-4 |

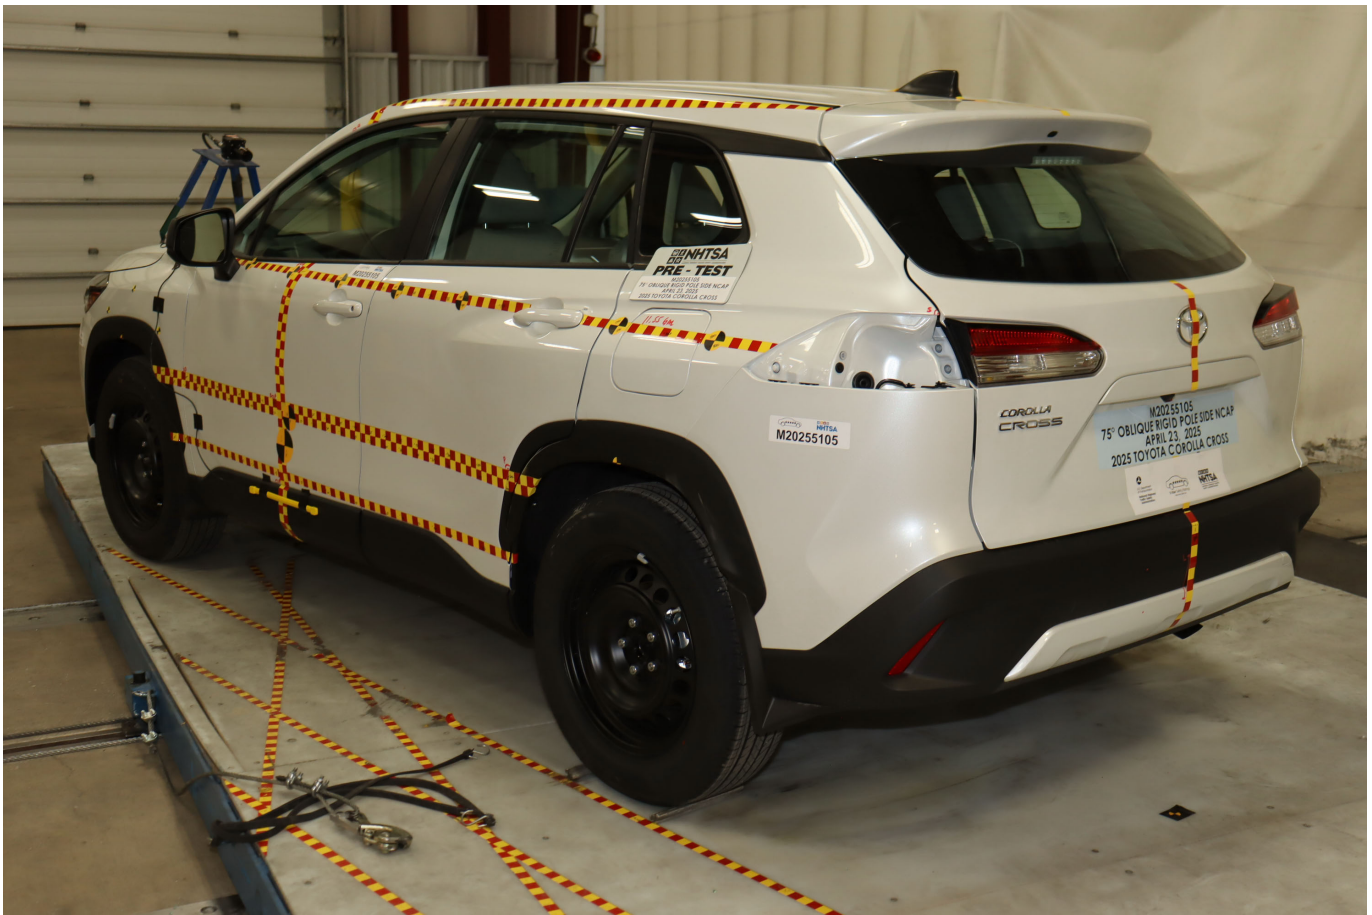
Photo No. 009 - Pre-Test Left Rear Three-Quarter View of Test Vehicle

| | | <u>Page No.</u> |
|---|---|---|
| Photo No. 009 | Pre-Test Left Rear $\frac{3}{4}$ View of Test Vehicle | A-5 |

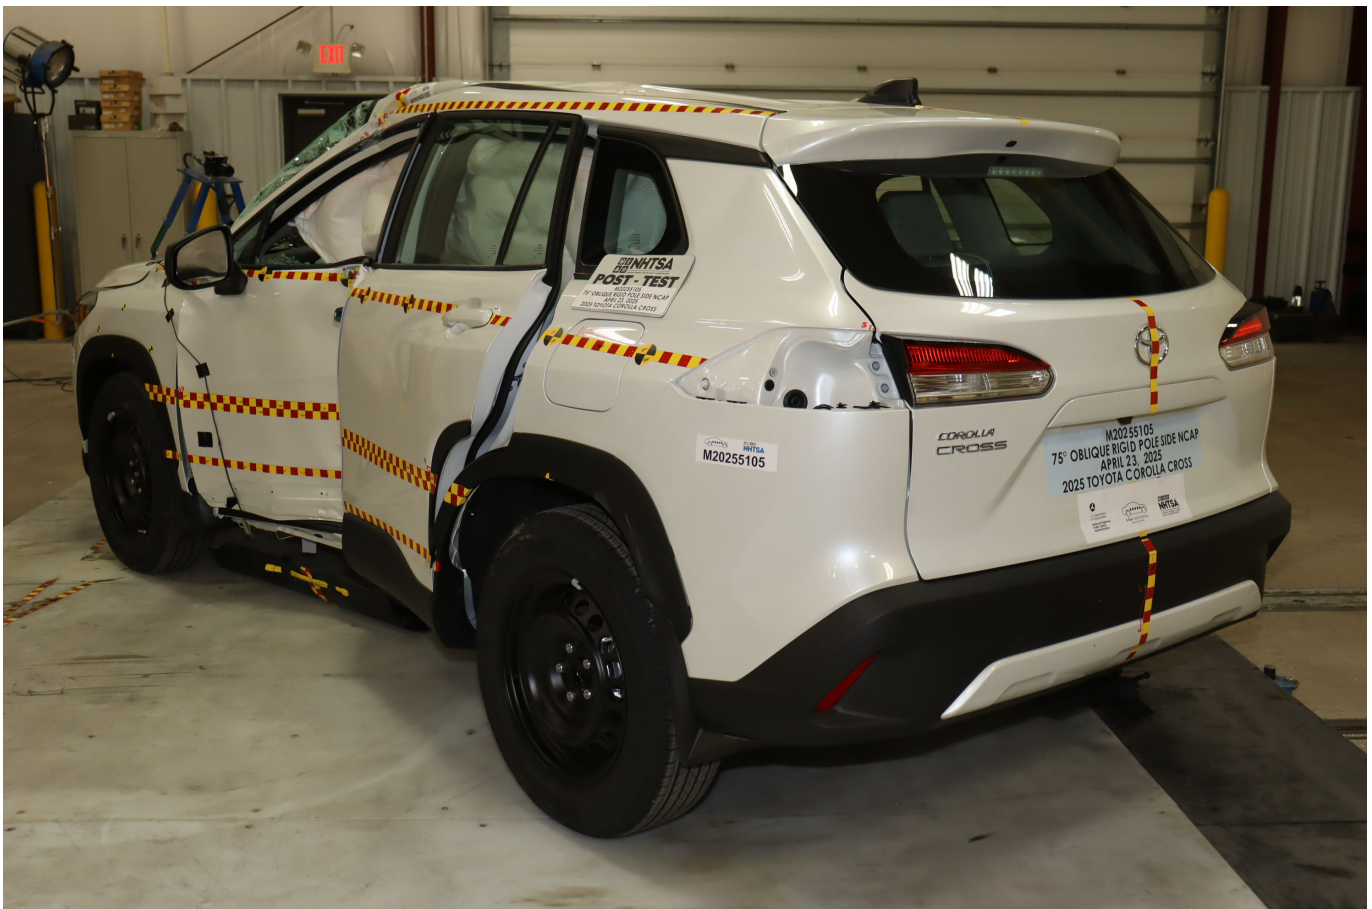
Photo No. 010 - Post-Test Left Rear Three-Quarter View of Test Vehicle

| | | <u>Page No.</u> |
|---|---|---|
| Photo No. 010 | Post-Test Left Rear $\frac{3}{4}$ View of Test Vehicle | A-5 |

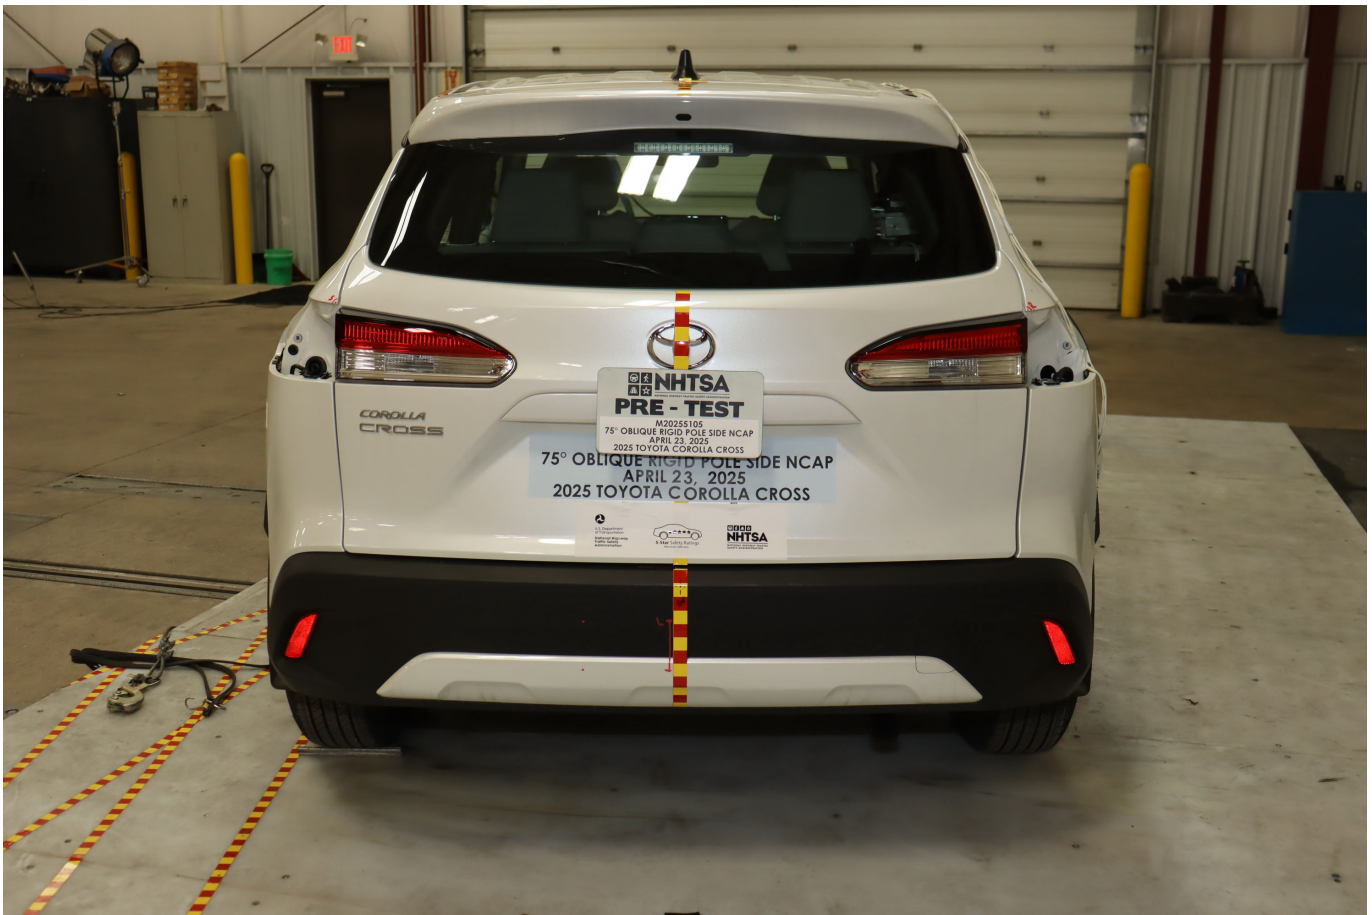
Photo No. 011 - Pre-Test Rear View of Test Vehicle

| | | <u>Page No.</u> |
|---|---|---|
| Photo No. 011 | Pre-Test Rear View of Test Vehicle | A-6 |

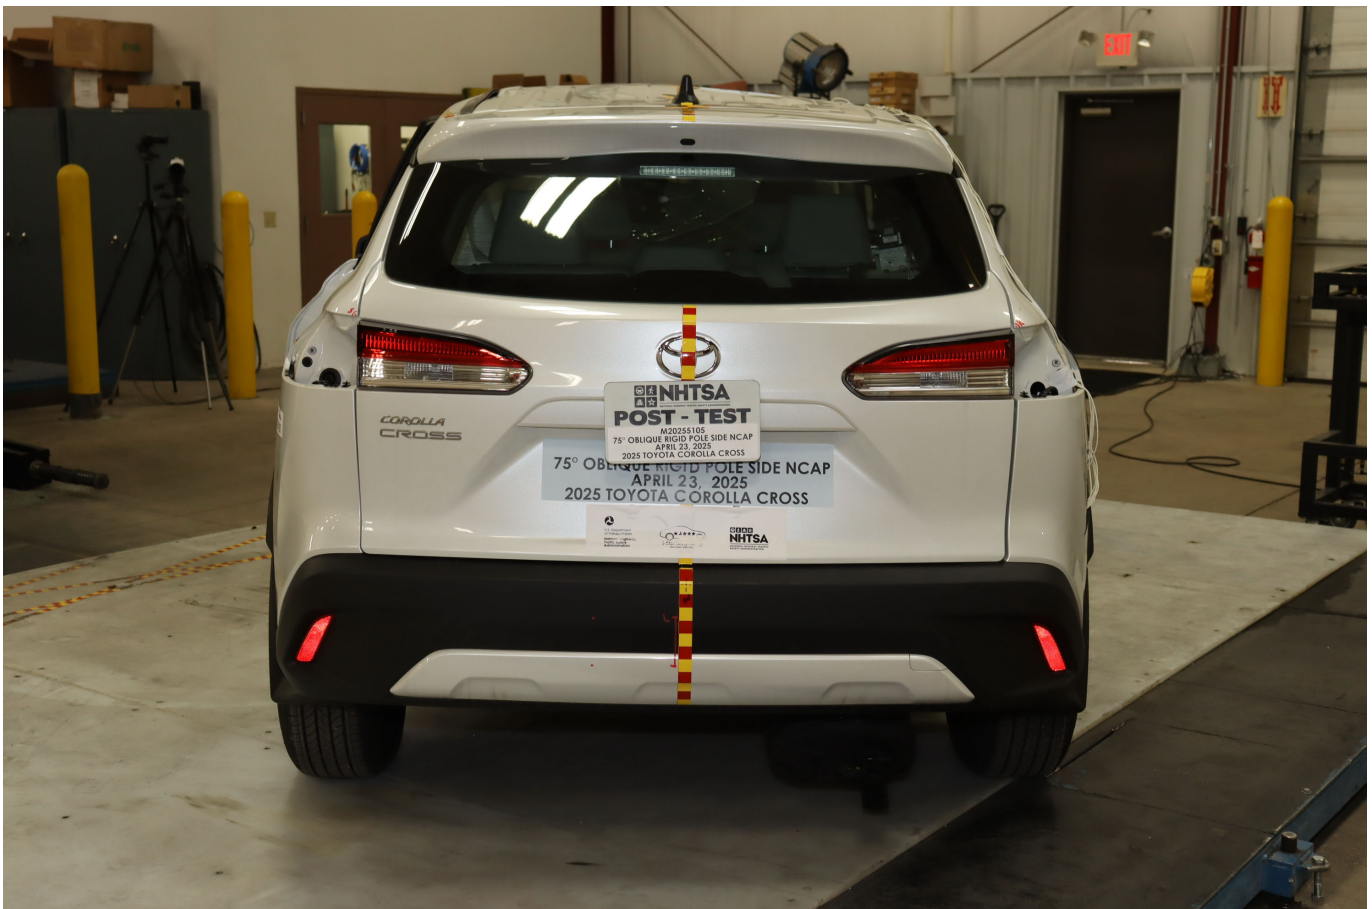
Photo No. 012 - Post-Test Rear View of Test Vehicle

| | | <u>Page No.</u> |
|---|---|---|
| Photo No. 012 | Post-Test Rear View of Test Vehicle | A-6 |

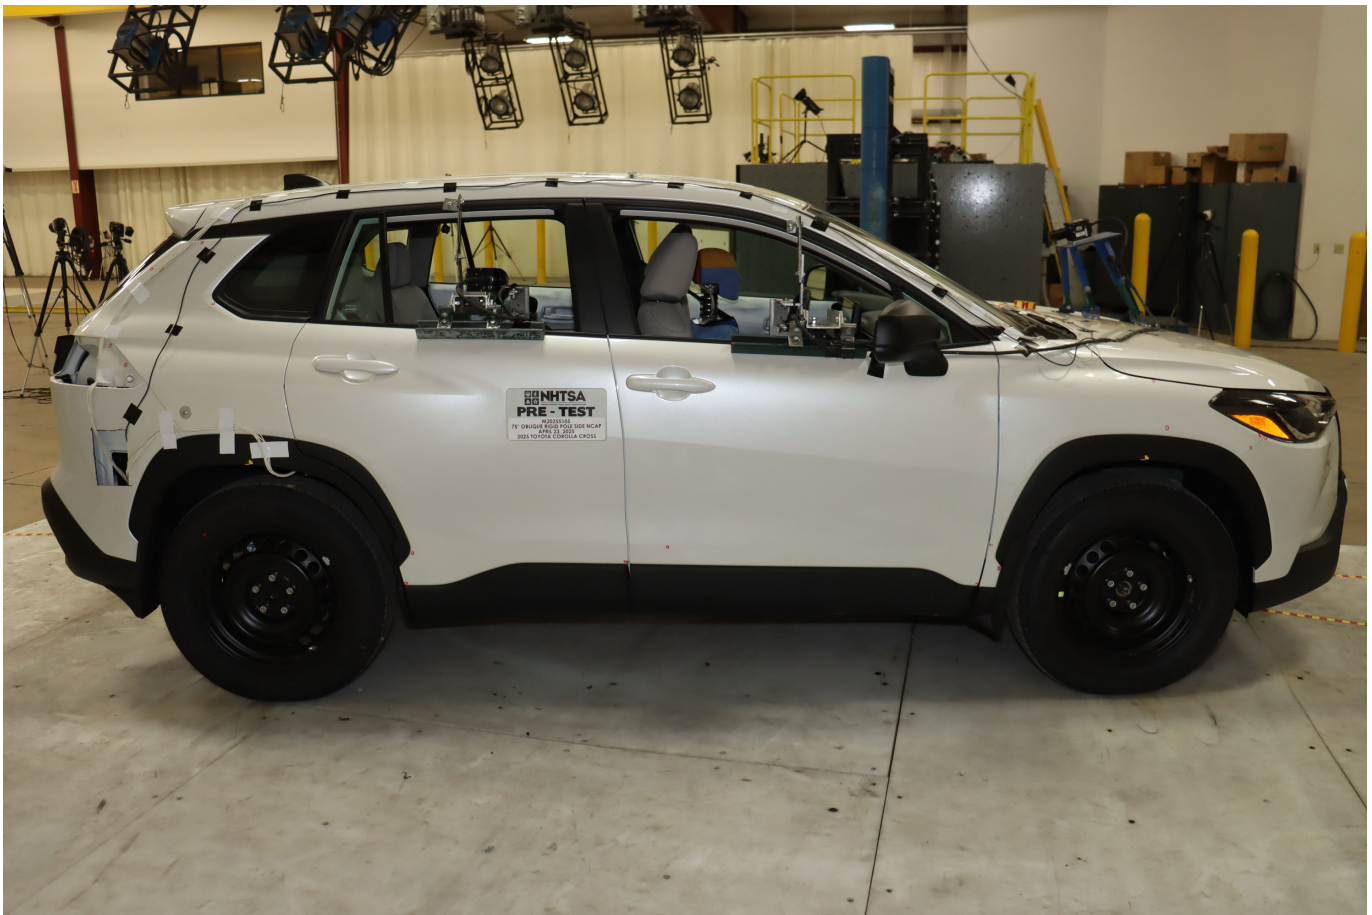
Photo No. 013 - Pre-Test Right Side View of Test Vehicle

| | | <u>Page No.</u> |
|---|---|---|
| Photo No. 013 | Pre-Test Right Side View of Test Vehicle | A-7 |

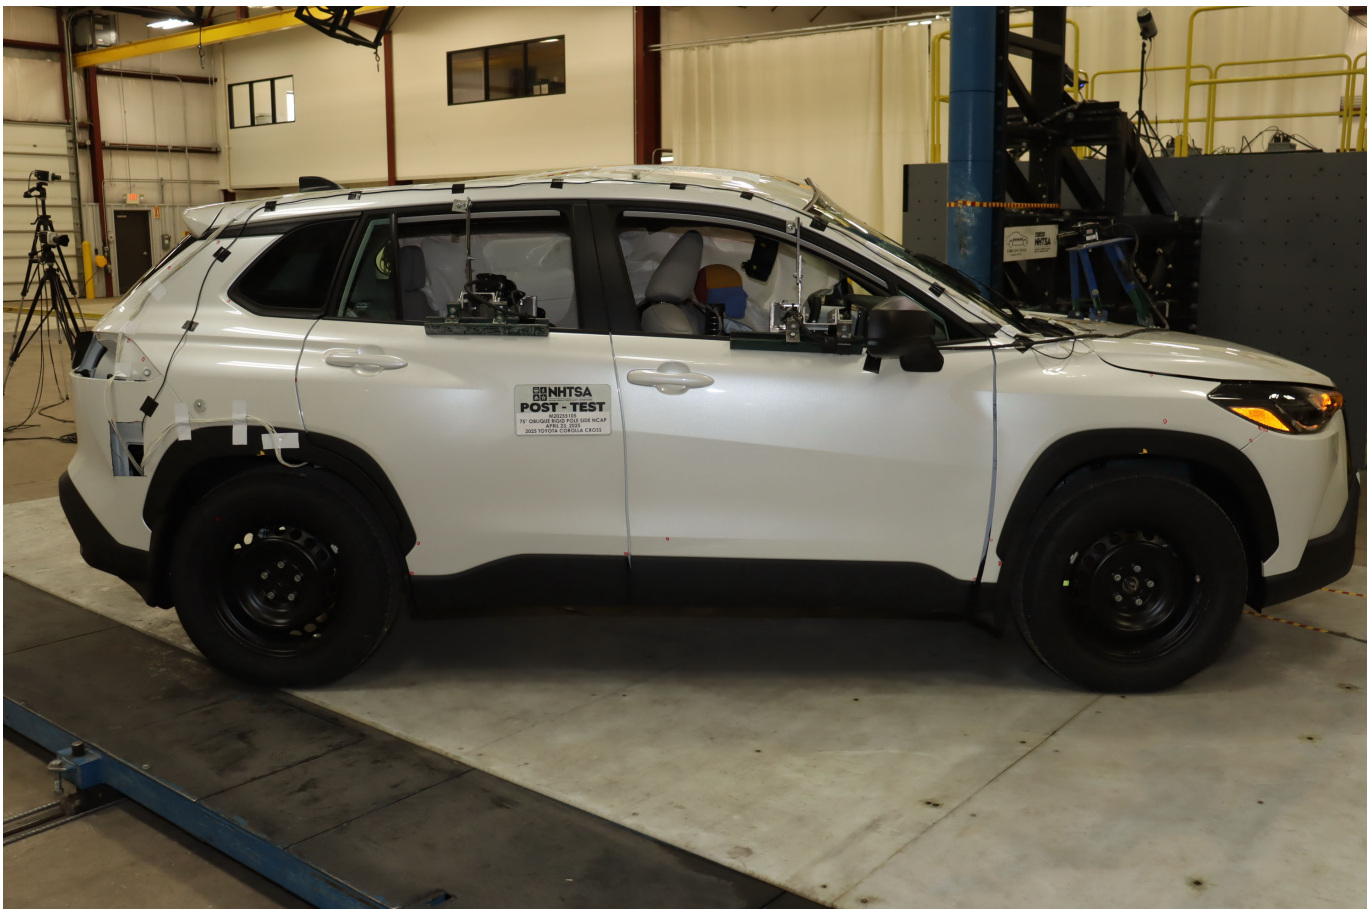
Photo No. 014 - Post-Test Right Side View of Test Vehicle

| | | <u>Page No.</u> |
|---|---|---|
| Photo No. 014 | Post-Test Right Side View of Test Vehicle | A-7 |

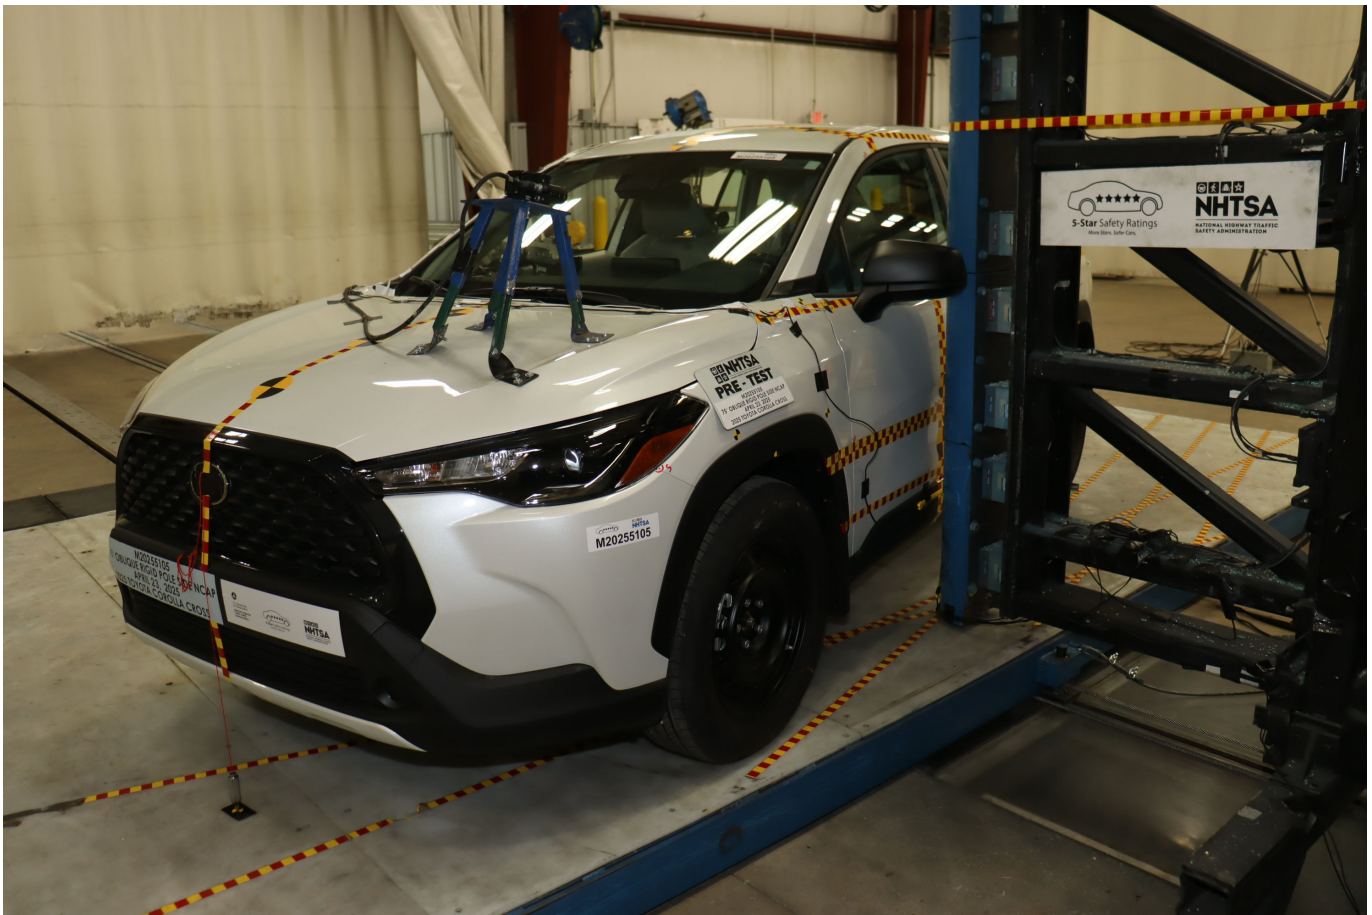
Photo No. 017 - Pre-Test Left Side View of Pole Positioned Against Side of Vehicle

| | | <u>Page No.</u> |
|---|---|---|
| Photo No. 017 | Pre-Test Left Side View of Pole Positioned Against Side of Vehicle | A-9 |

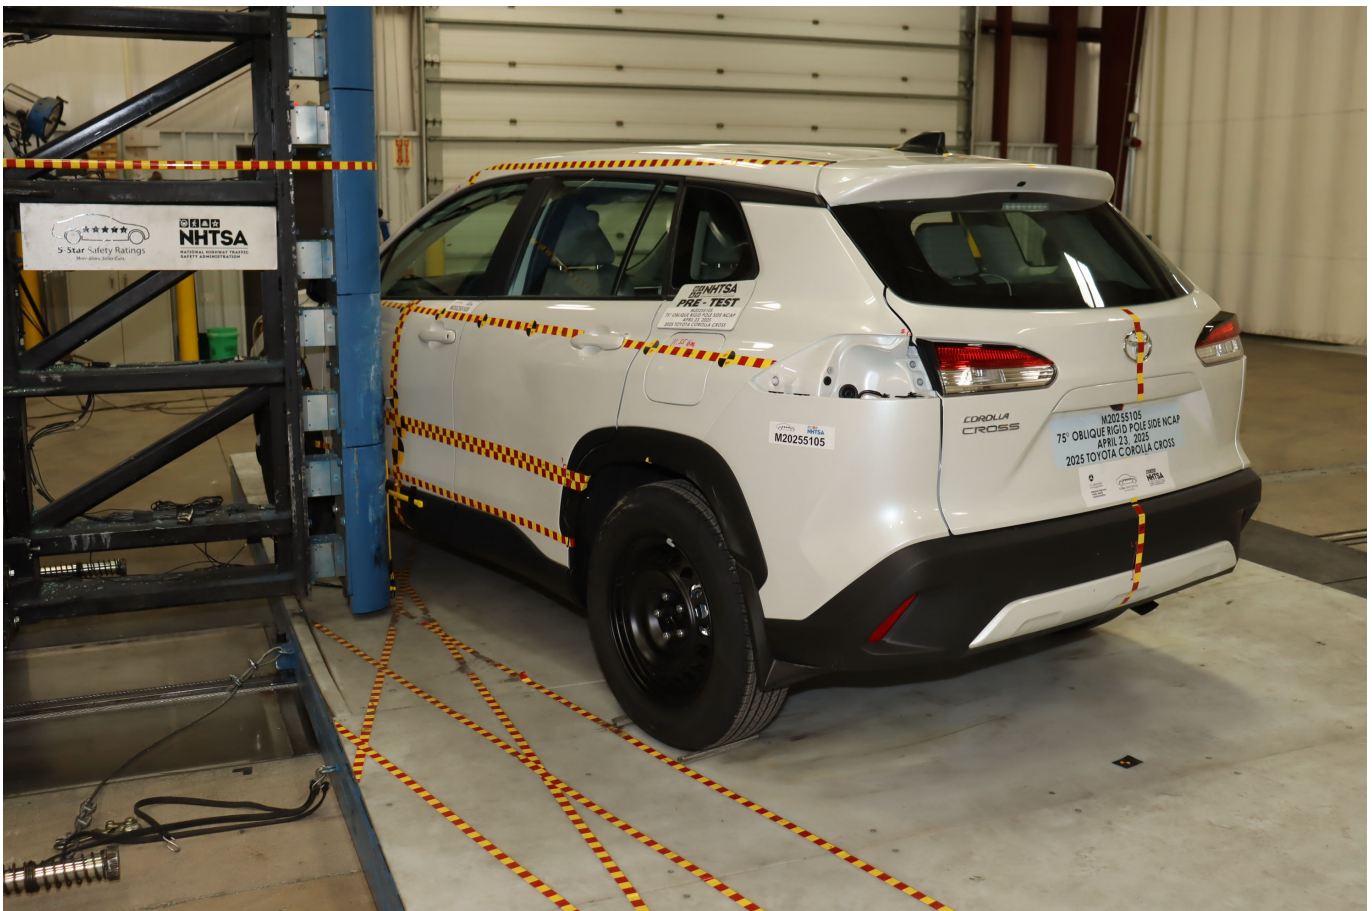
Photo No. 018 - Pre-Test Right Side View of Pole Positioned Against Side of Vehicle

| | | <u>Page No.</u> |
|---|---|---|
| Photo No. 018 | Pre-Test Right Side View of Pole Positioned Against Side of Vehicle | A-9 |

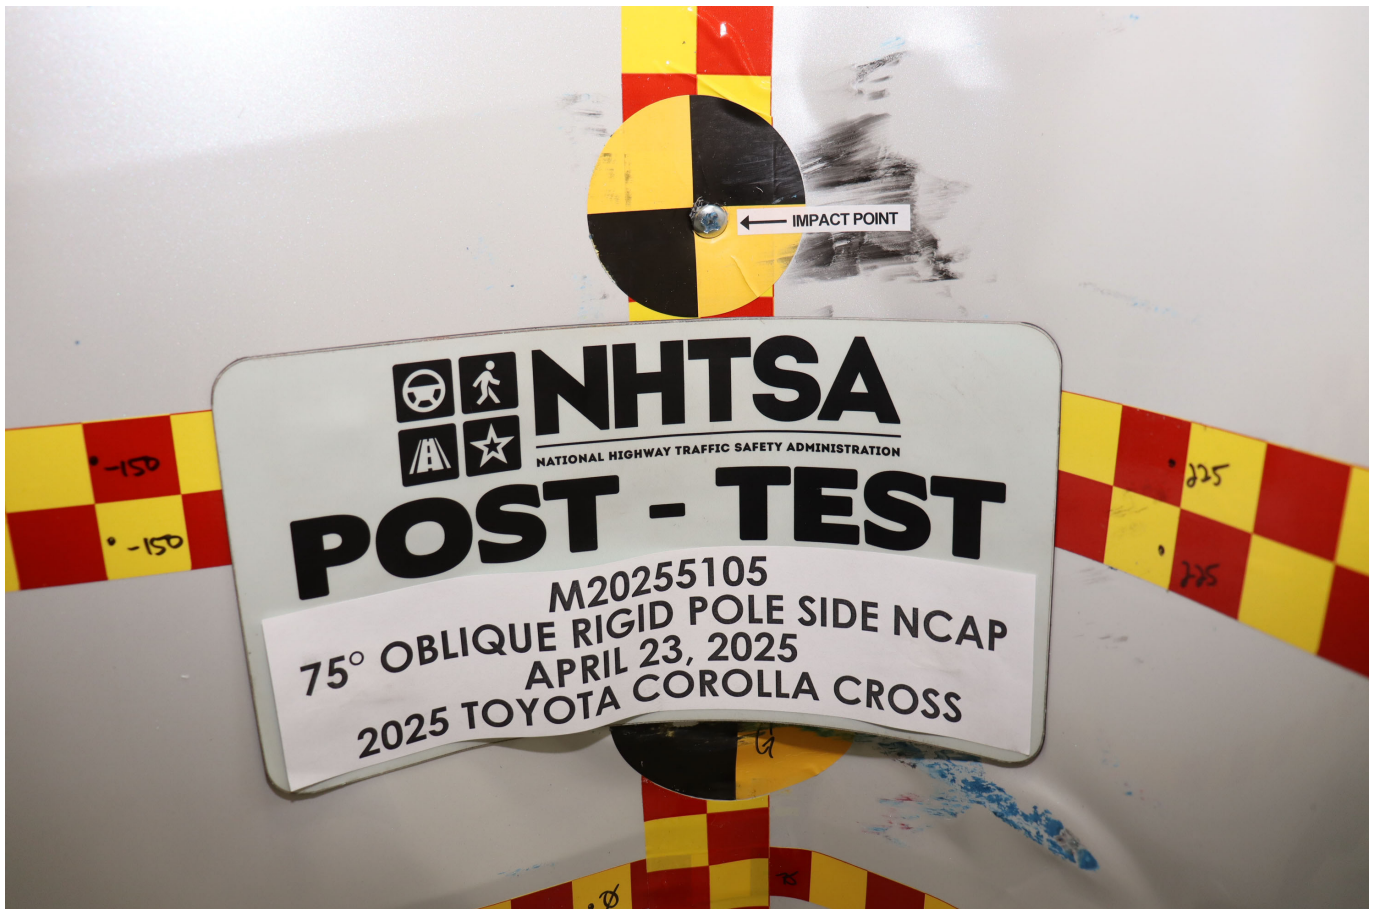
Photo No. 020 - Post-Test Close-Up View of Impact Point Target Showing Impact Location

| | | <u>Page No.</u> |
|---|---|---|
| Photo No. 020 | Post-Test Close-Up View of Impact Point Target Showing Impact Location | A-10 |

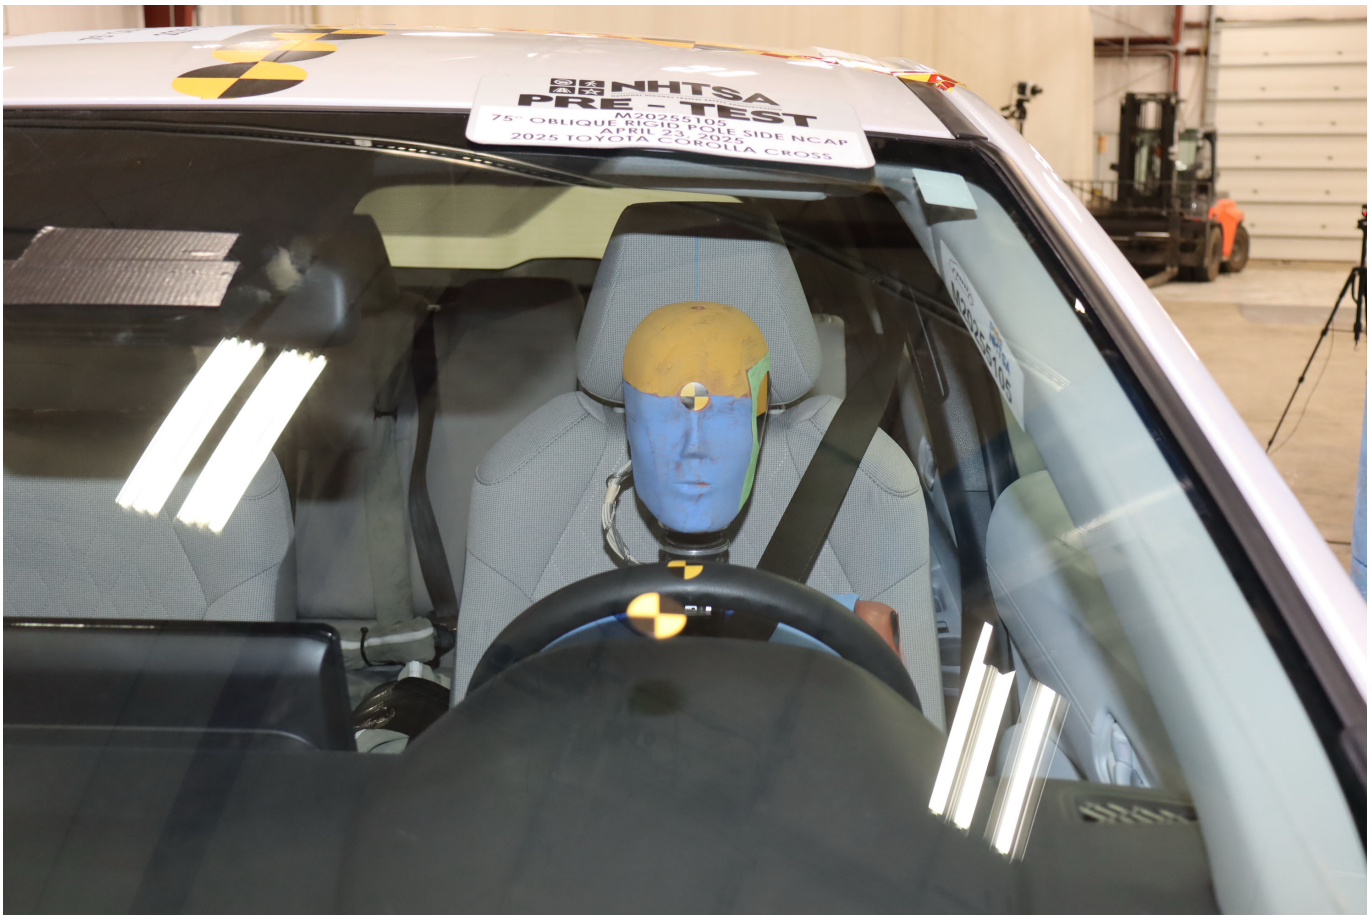
Photo No. 021 - Pre-Test Front Close-Up View of Dummy Head and Chest

| | | <u>Page No.</u> |
|---|---|---|
| Photo No. 021 | Pre-Test Front Close-Up View of Dummy Head and Chest | A-11 |

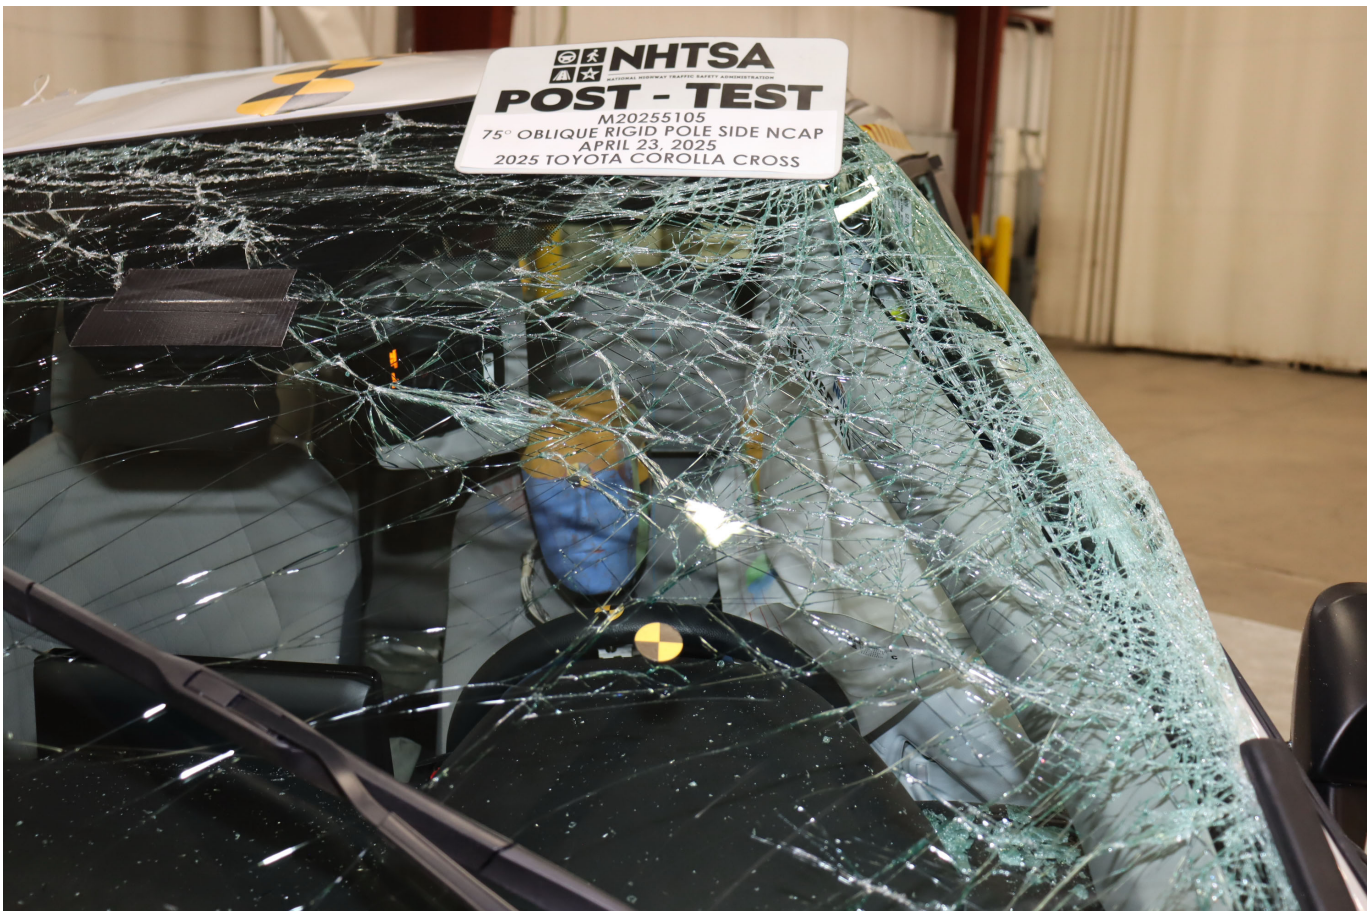
Photo No. 022 - Post-Test Front Close-Up View of Dummy

| | | <u>Page No.</u> |
|---|---|---|
| Photo No. 022 | Post-Test Front Close-Up View of Dummy | A-11 |

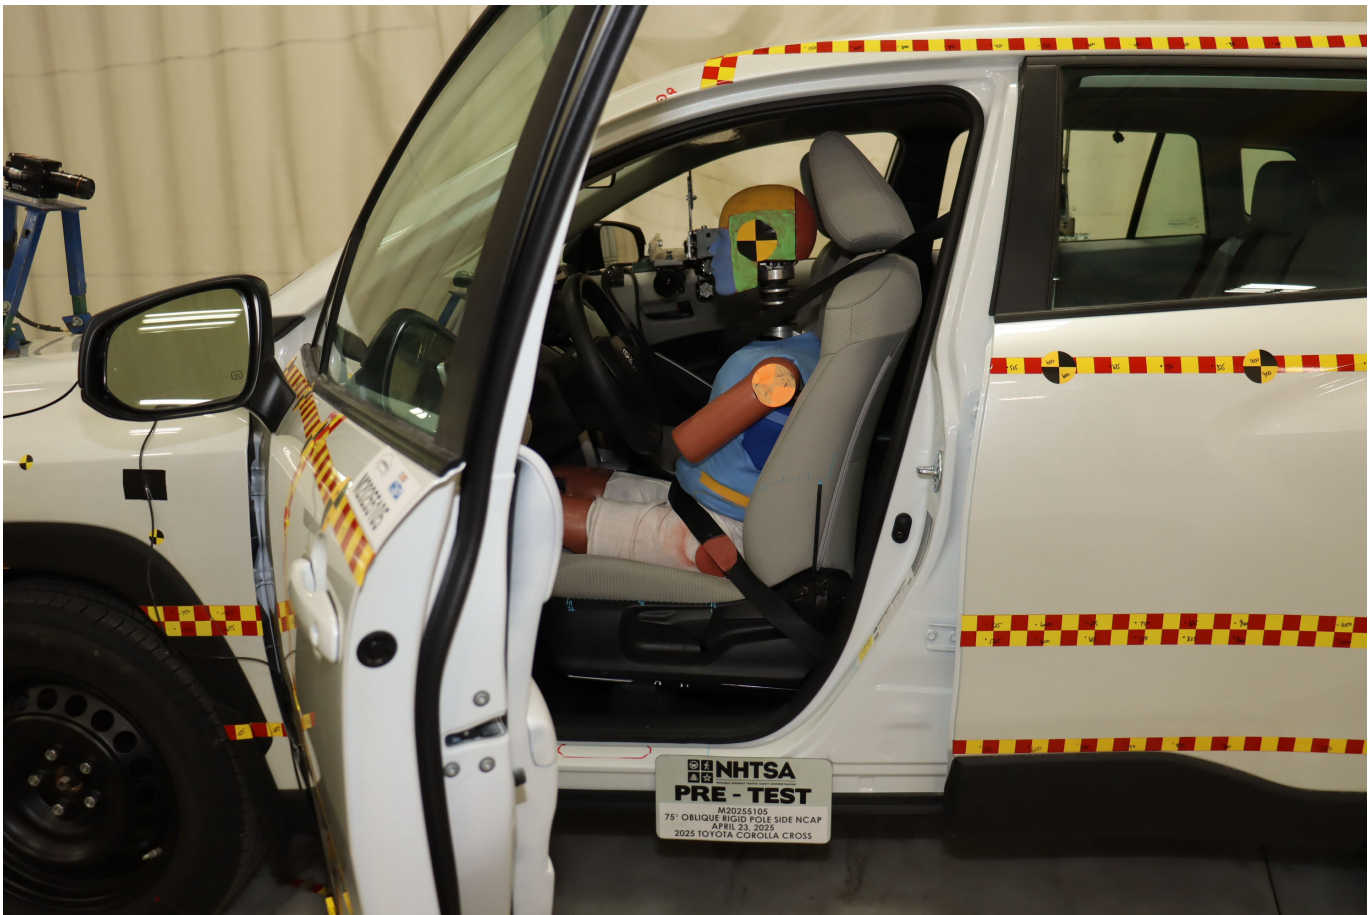
Photo No. 023 - Pre-Test Left Side View of Dummy Showing Belt and Chalking

| | | <u>Page No.</u> |
|---|---|---|
| Photo No. 023 | Pre-Test Left Side View of Dummy Showing Belt and Chalking | A-12 |
