**REPORT NUMBER: SideNCAPPole-MGA-25-019**

**NEW CAR ASSESSMENT PROGRAM (NCAP)  
Side Impact Pole Test**

**MAZDA TOYOTA MANUFACTURING U.S.A. INC.  
2025 Toyota Corolla Cross L 5-Door SUV  
NHTSA No.: M20255105**

**MGA RESEARCH CORPORATION  
5000 Warren Road  
Burlington, WI 53105**

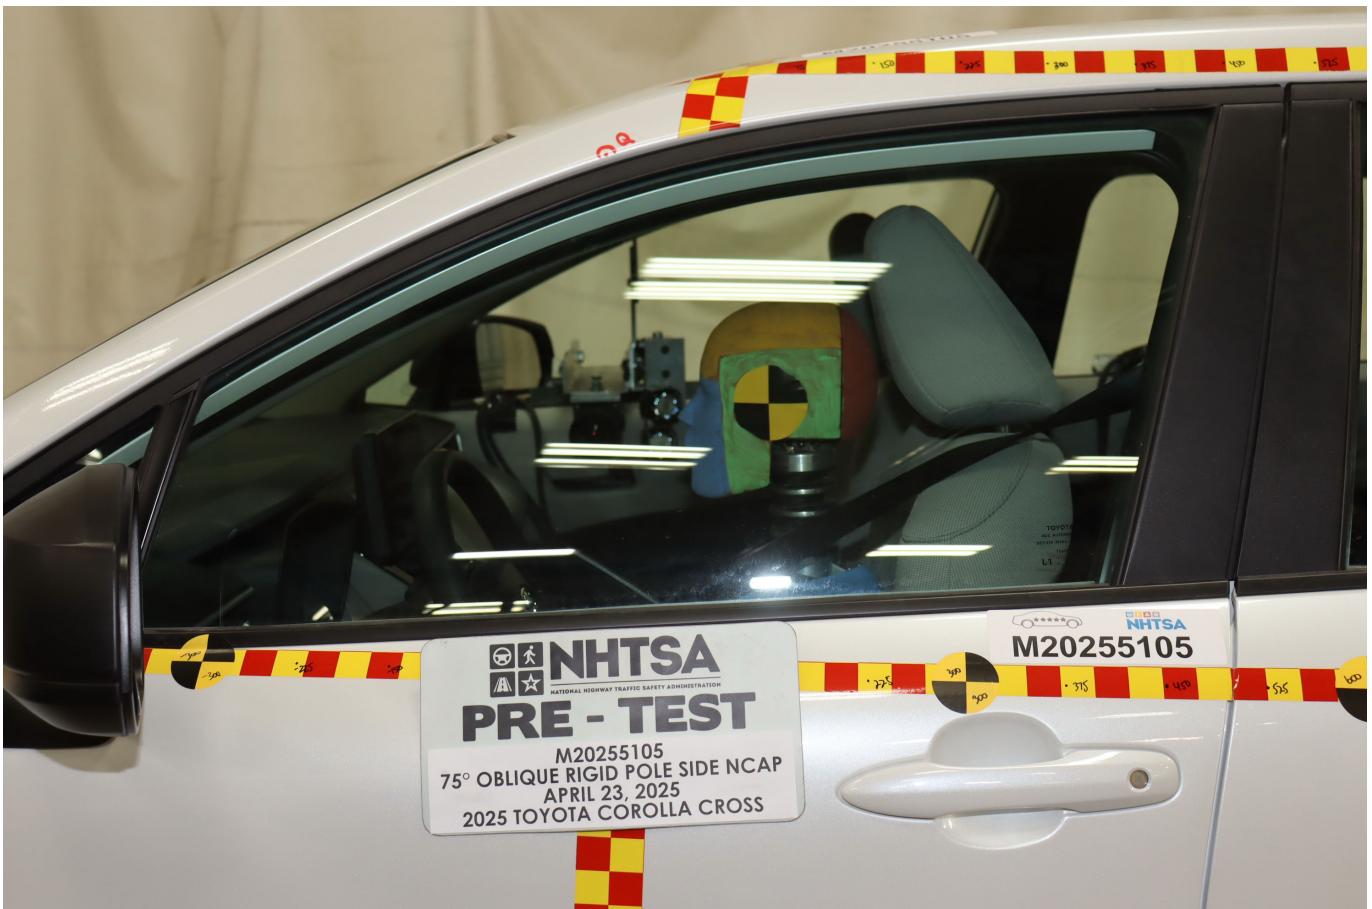
Photo No. 024 - Pre-Test Left Side View of Dummy Shoulder and Door Top View

| | | <u>Page No.</u> |
|---|---|---|
| Photo No. 024 | Pre-Test Left Side View of Dummy Shoulder and Door Top View | A-12 |

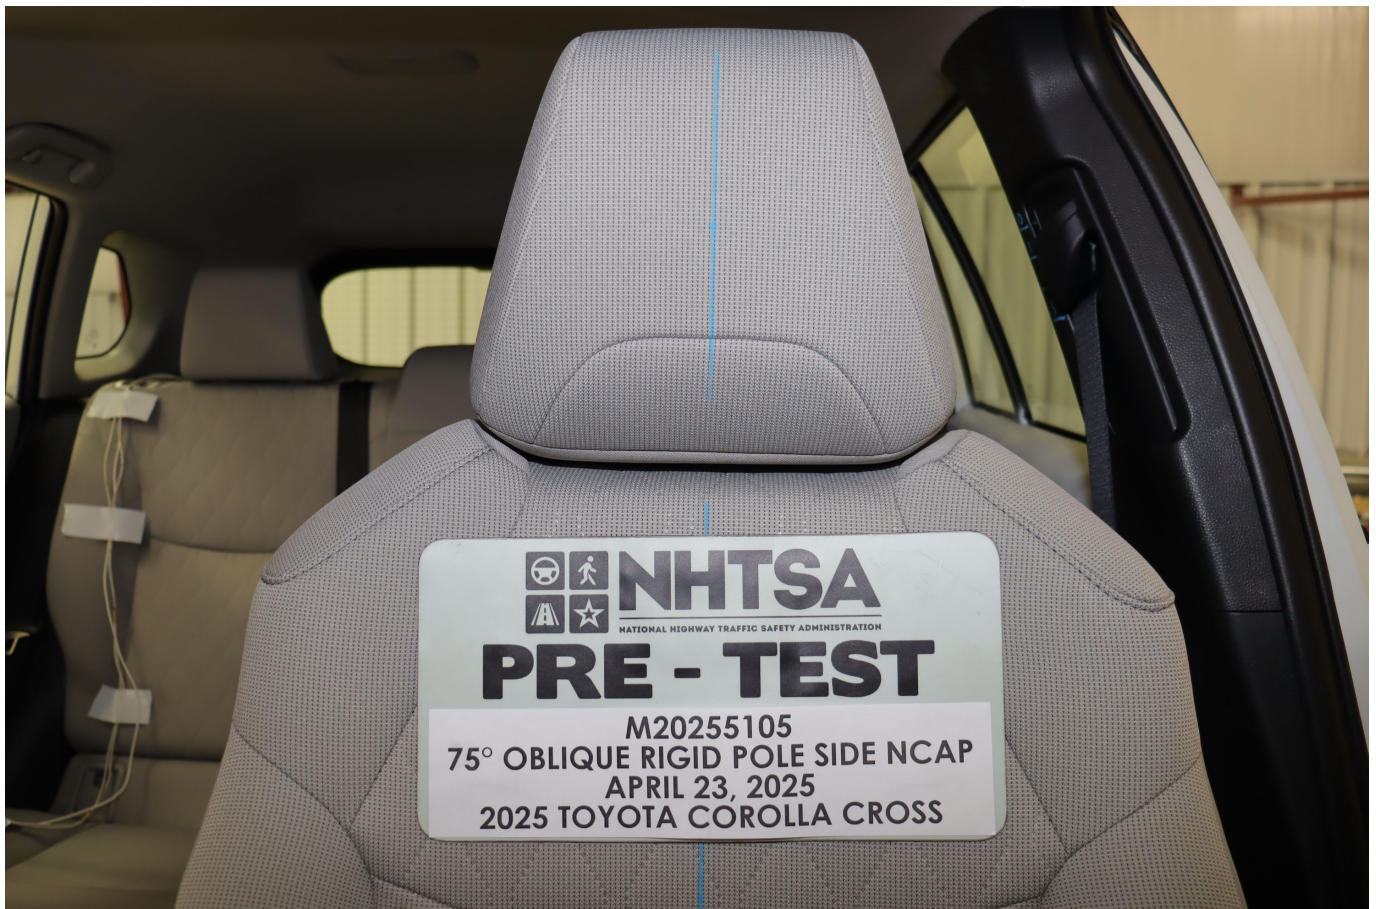
Photo No. 026 - Pre-Test Front View of Seat Back Prior to Dummy Positioning

| | | <u>Page No.</u> |
|---|---|---|
| Photo No. 026 | Pre-Test Front View of Seat Back Prior to Dummy Positioning | A-13 |

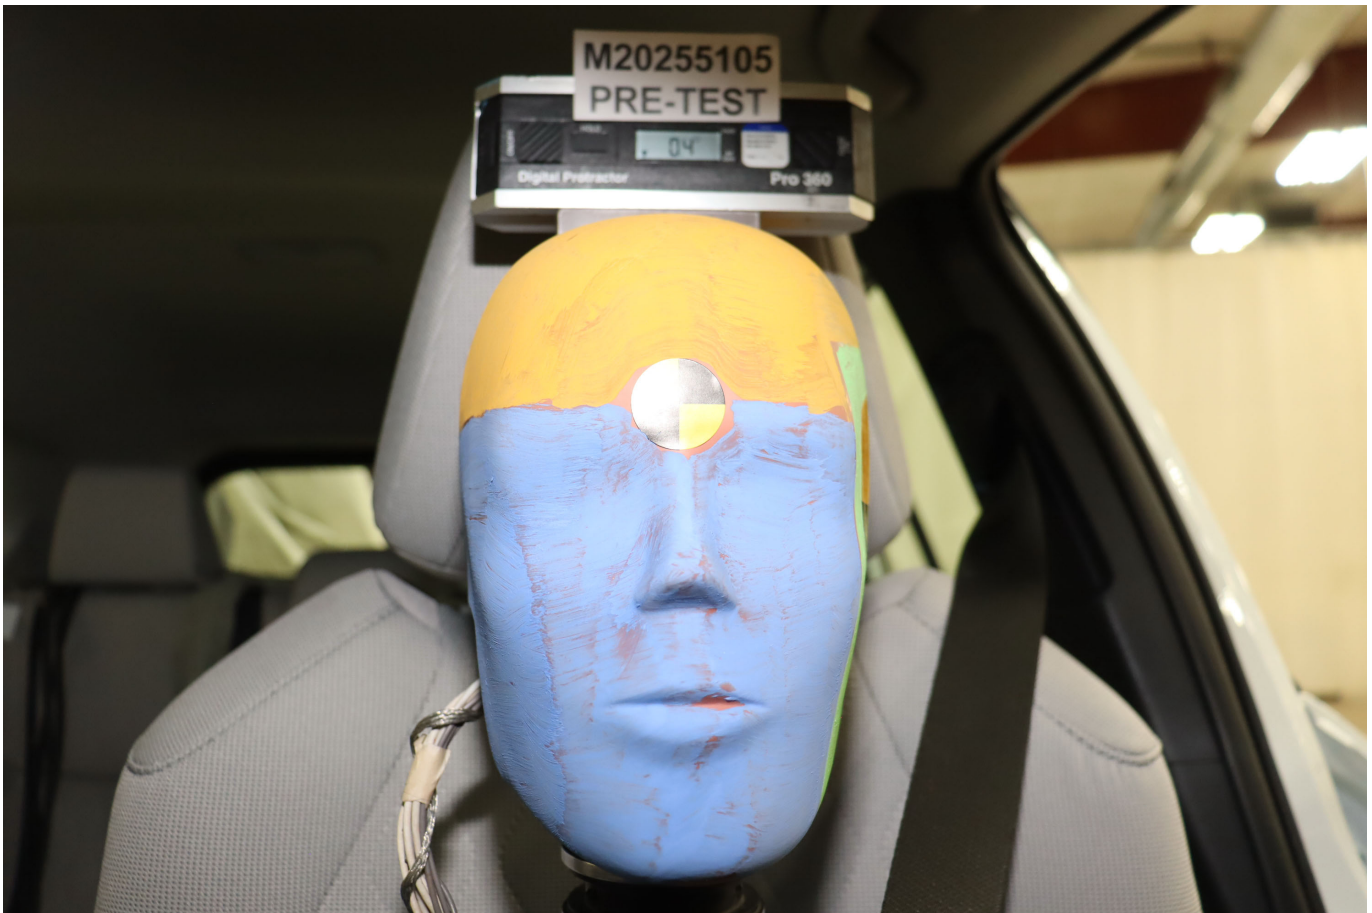
Photo No. 027 - Pre-Test Front Close-Up View of Dummy Head and Shoulders in Relation to Head Restraint

| | | <u>Page No.</u> |
|---|---|---|
| Photo No. 027 | Pre-Test Front Close-Up View of Dummy Head and Shoulders in Relation to Head Restraint | A-14 |

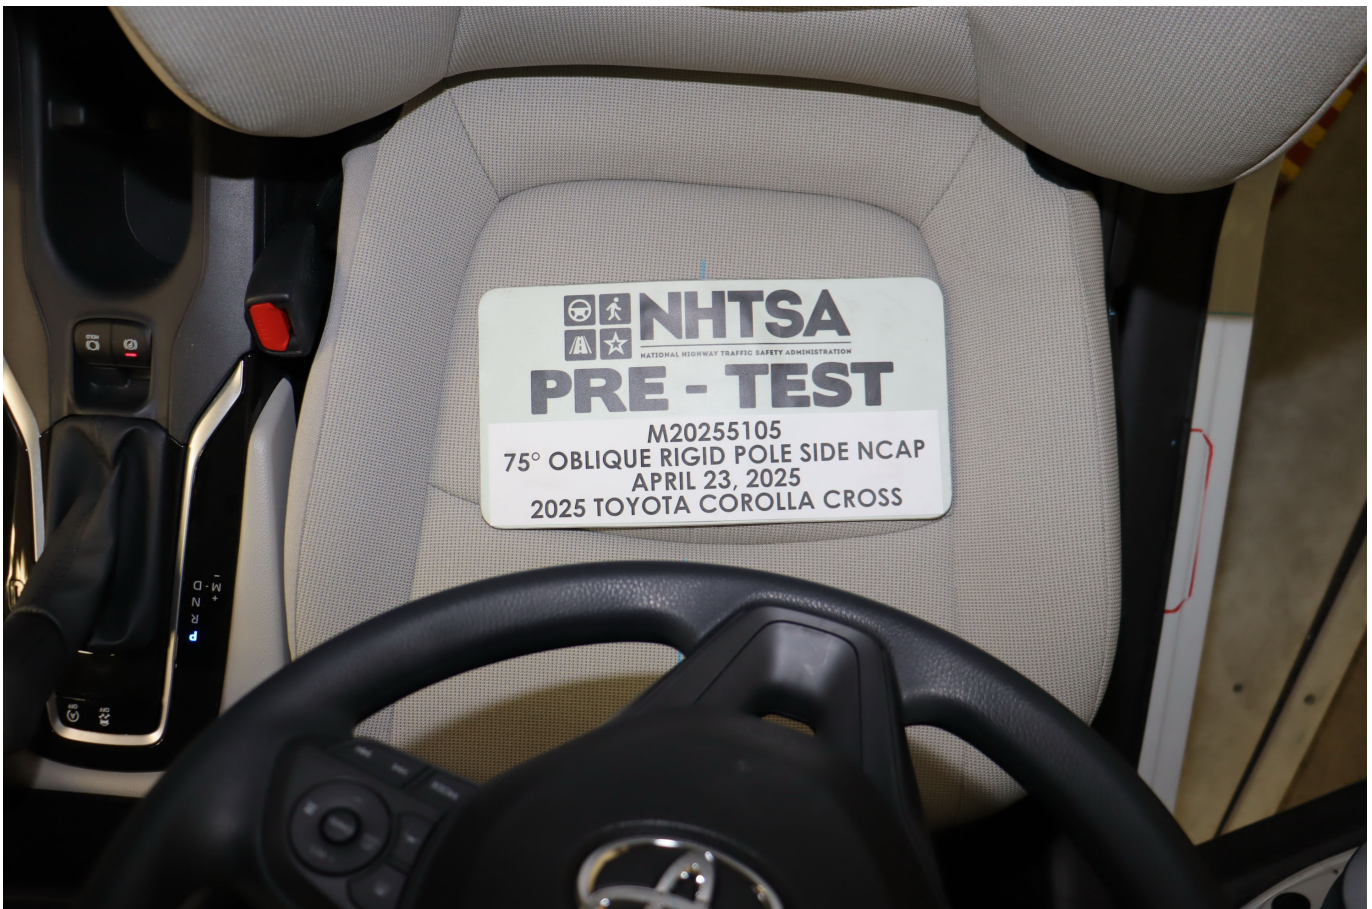
Photo No. 028 - Pre-Test Front View of Seat Pan Prior to Dummy Positioning

| | | <u>Page No.</u> |
|---|---|---|
| Photo No. 028 | Pre-Test Front View of Seat Pan Prior to Dummy Positioning | A-14 |

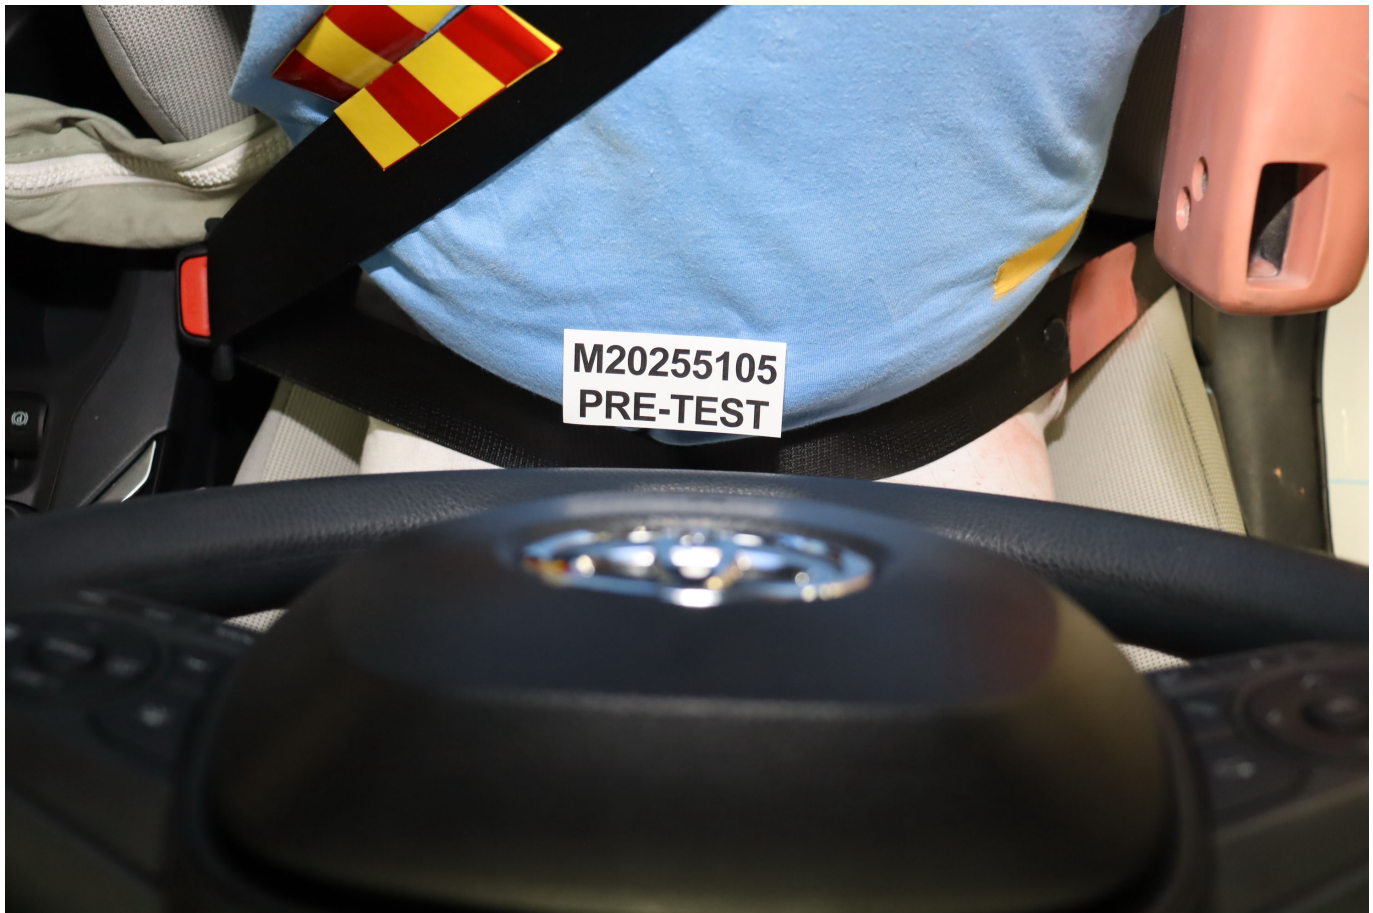
Photo No. 029 - Pre-Test Overhead View of Dummy Thighs on Seat Pan

| | | <u>Page No.</u> |
|---|---|---|
| Photo No. 029 | Pre-Test Overhead View of Dummy Thighs on Seat Pan | A-15 |

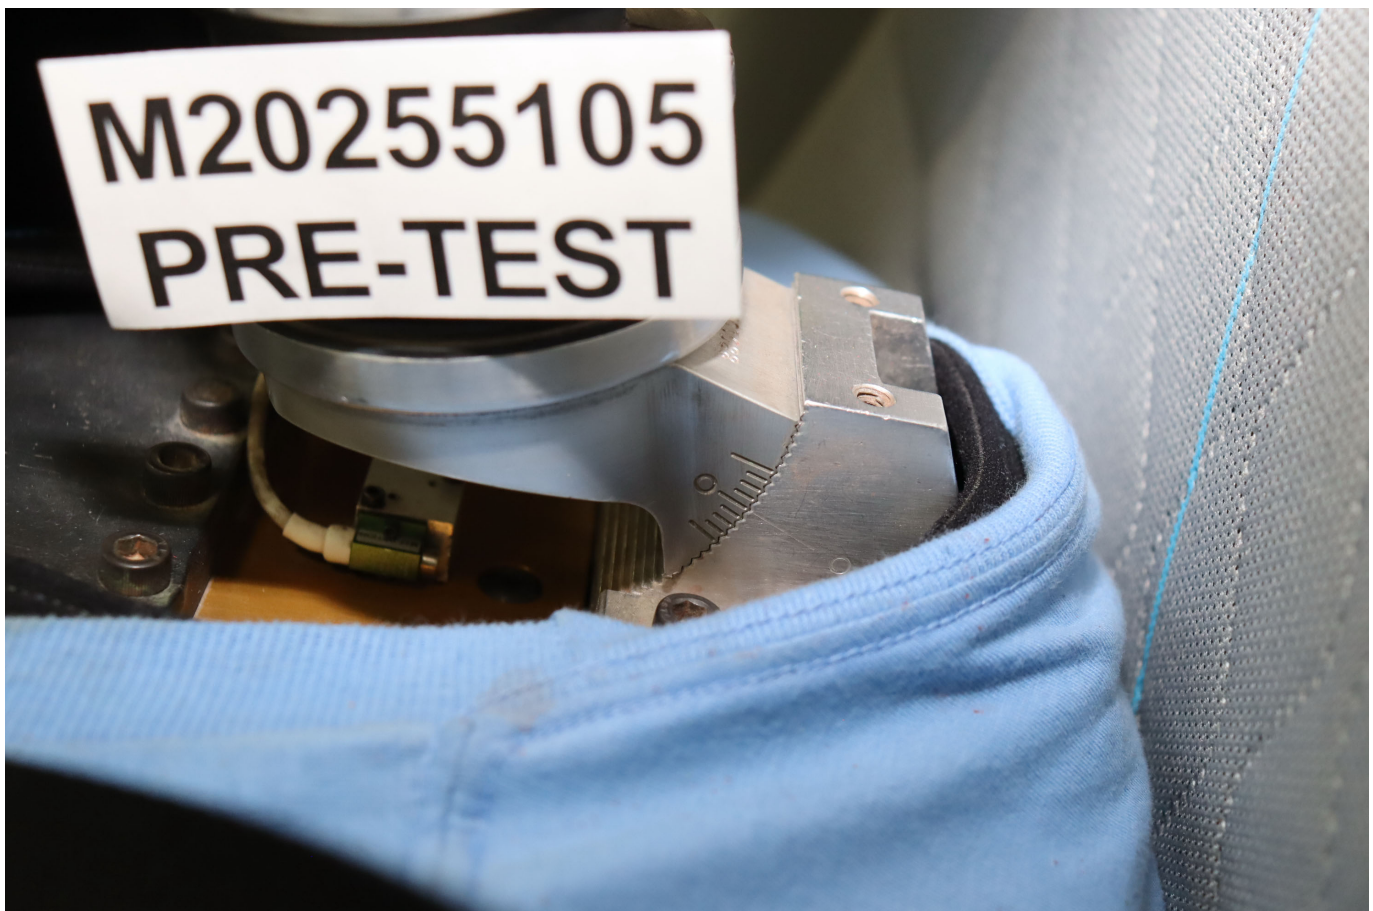
Photo No. 030 - Pre-Test Left Side View of Dummy's Neck Showing Position of Adjustable Neck Bracket

| | | <u>Page No.</u> |
|---|---|---|
| Photo No. 030 | Pre-Test Left Side View of Dummy's Neck Showing Position of Adjustable Neck Bracket | A-15 |

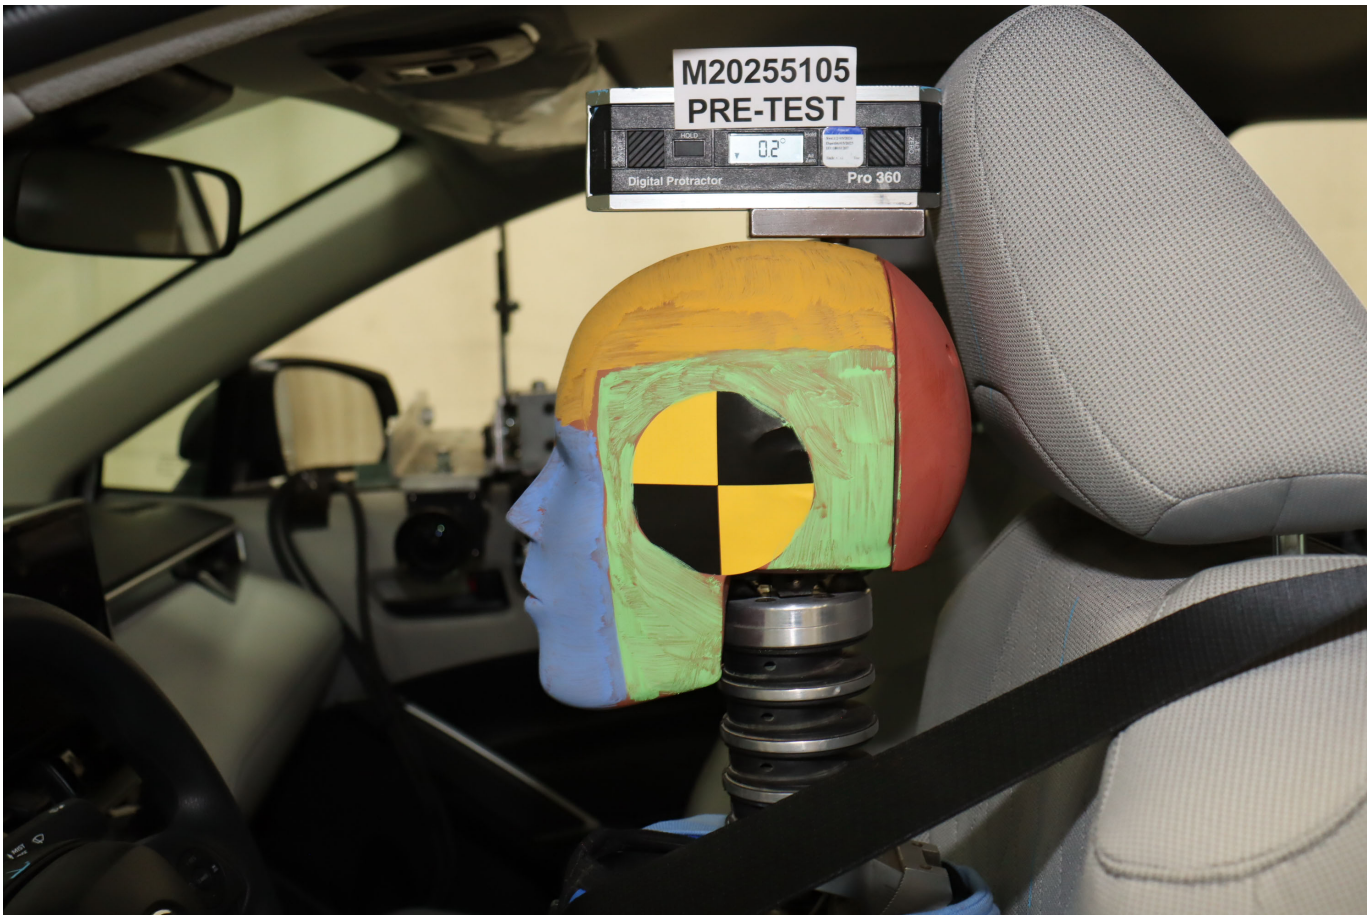
Photo No. 031 - Pre-Test Left Side View of Dummy's Head Showing Dummy's Head is Level

| | | <u>Page No.</u> |
|---|---|---|
| Photo No. 031 | Pre-Test Left Side View of Dummy's Head Showing Dummy's Head is Level | A-16 |

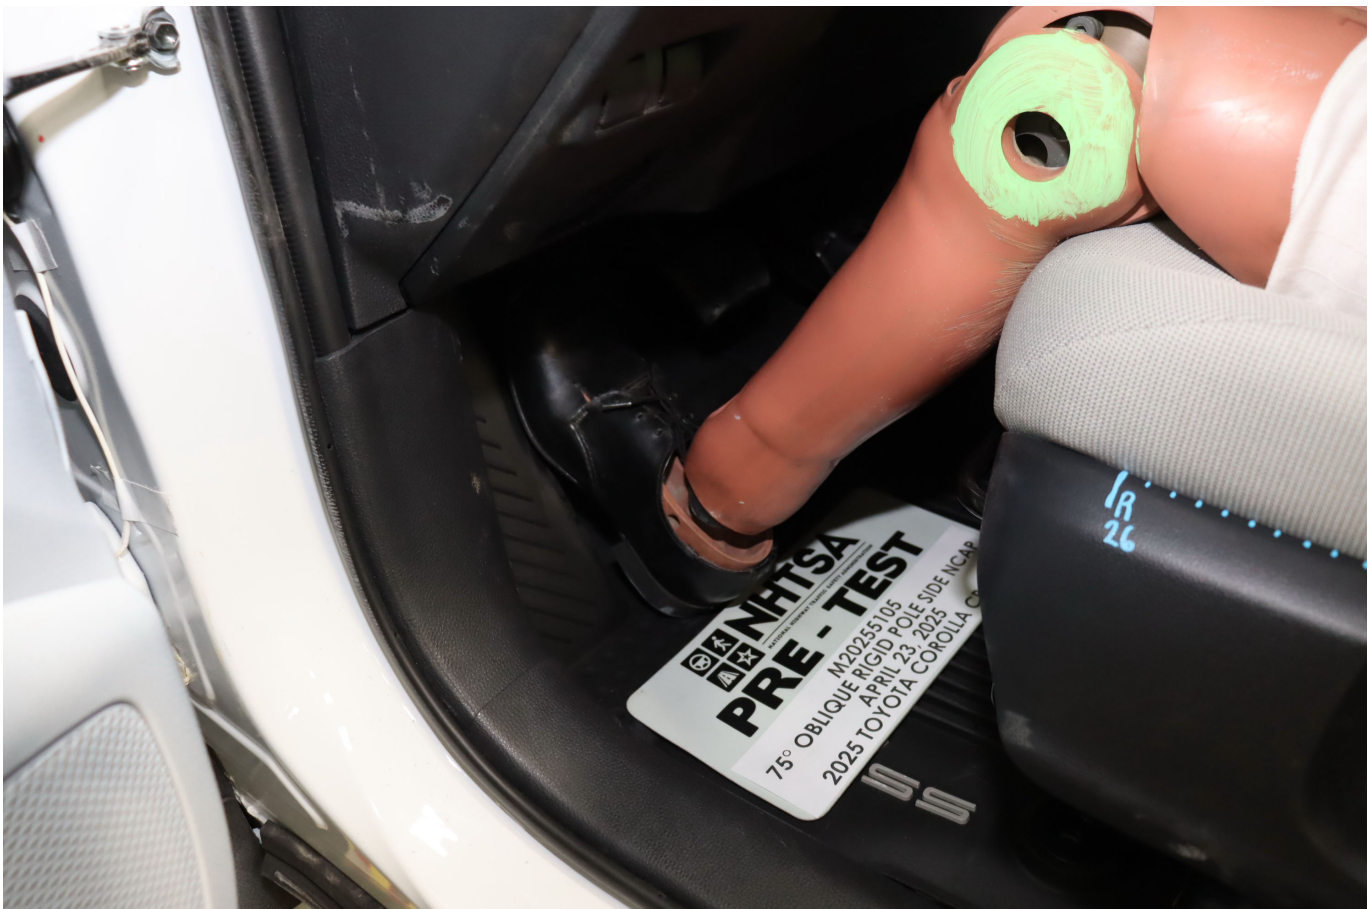
Photo No. 032 - Pre-Test Placement of Dummy's Feet

| | | <u>Page No.</u> |
|---|---|---|
| Photo No. 032 | Pre-Test Placement of Dummy's Feet | A-16 |

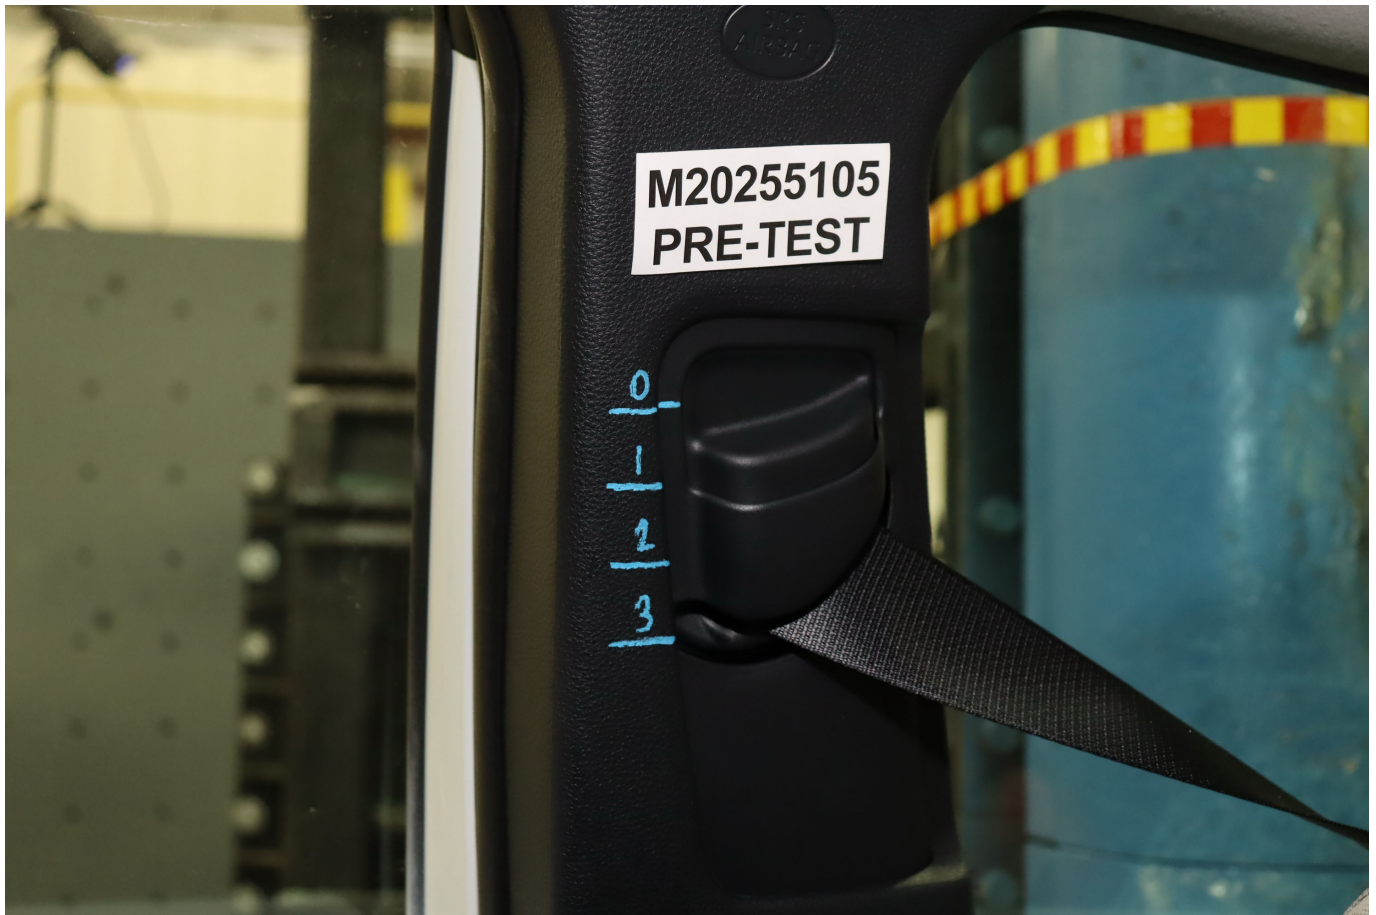
Photo No. 033 - Pre-Test View of Belt Anchorage for Dummy

| | | <u>Page No.</u> |
|---|---|---|
| Photo No. 033 | Pre-Test View of Belt Anchorage for Dummy | A-17 |

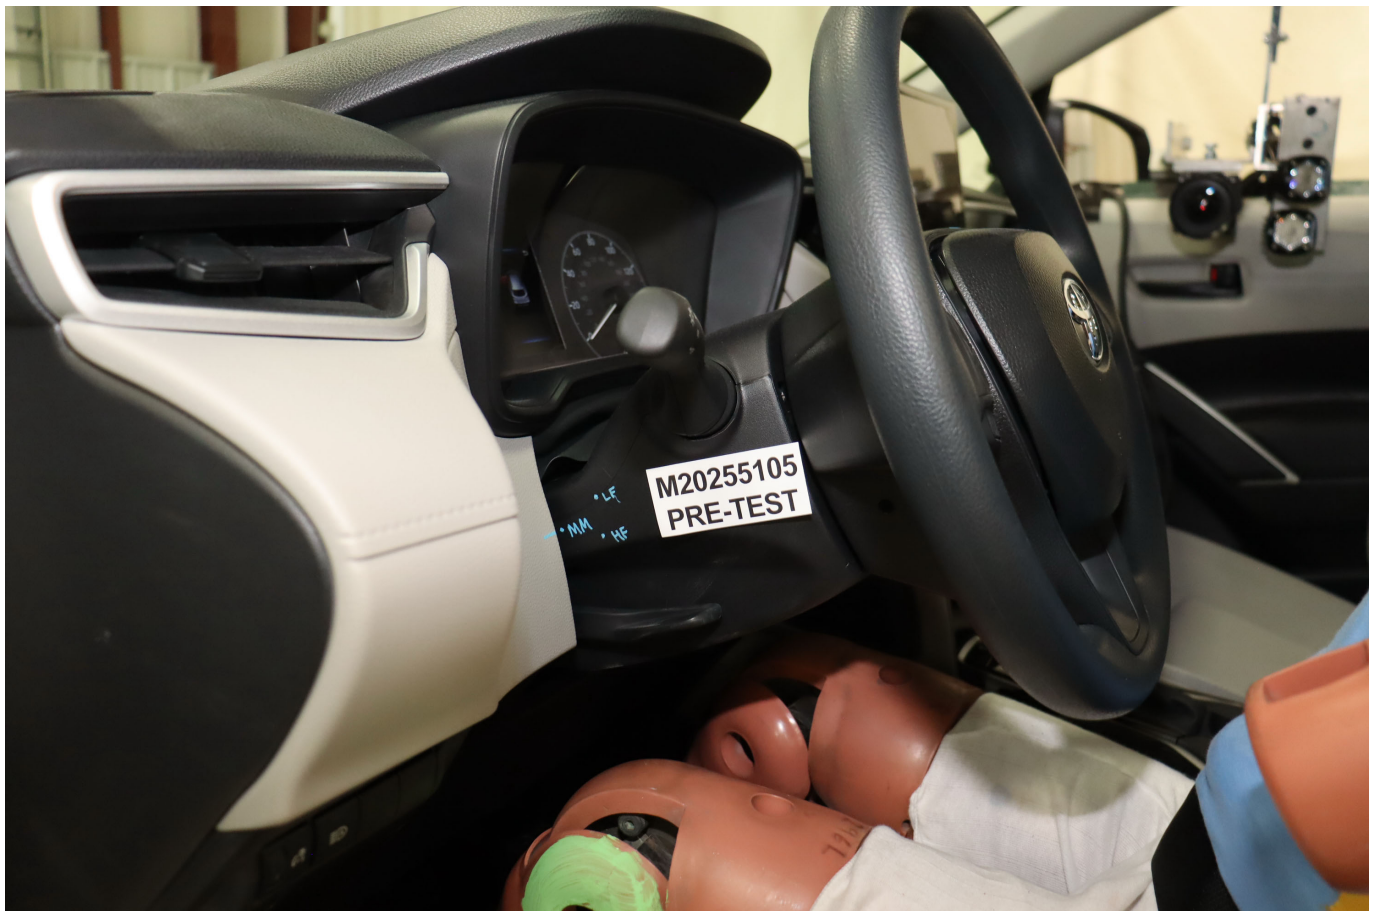
Photo No. 034 - Pre-Test Left Side View of Steering Wheel

| | | <u>Page No.</u> |
|---|---|---|
| Photo No. 034 | Pre-Test Left Side View of Steering Wheel | A-17 |

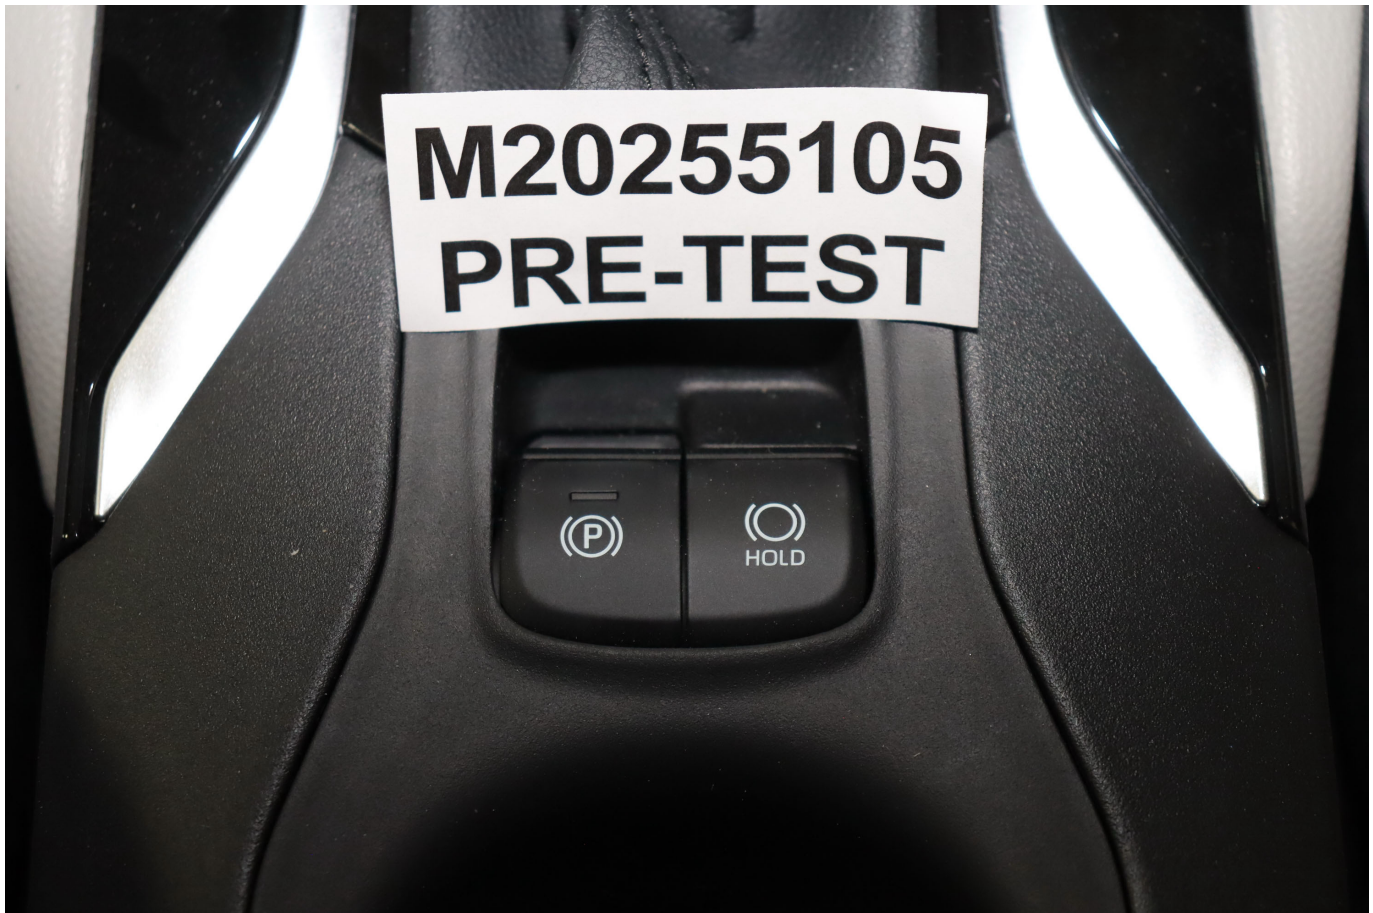
Photo No. 035 - Pre-Test View of Disengaged Parking Brake

| | | <u>Page No.</u> |
|---|---|---|
| Photo No. 035 | Pre-Test View of Disengaged Parking Brake | A-18 |

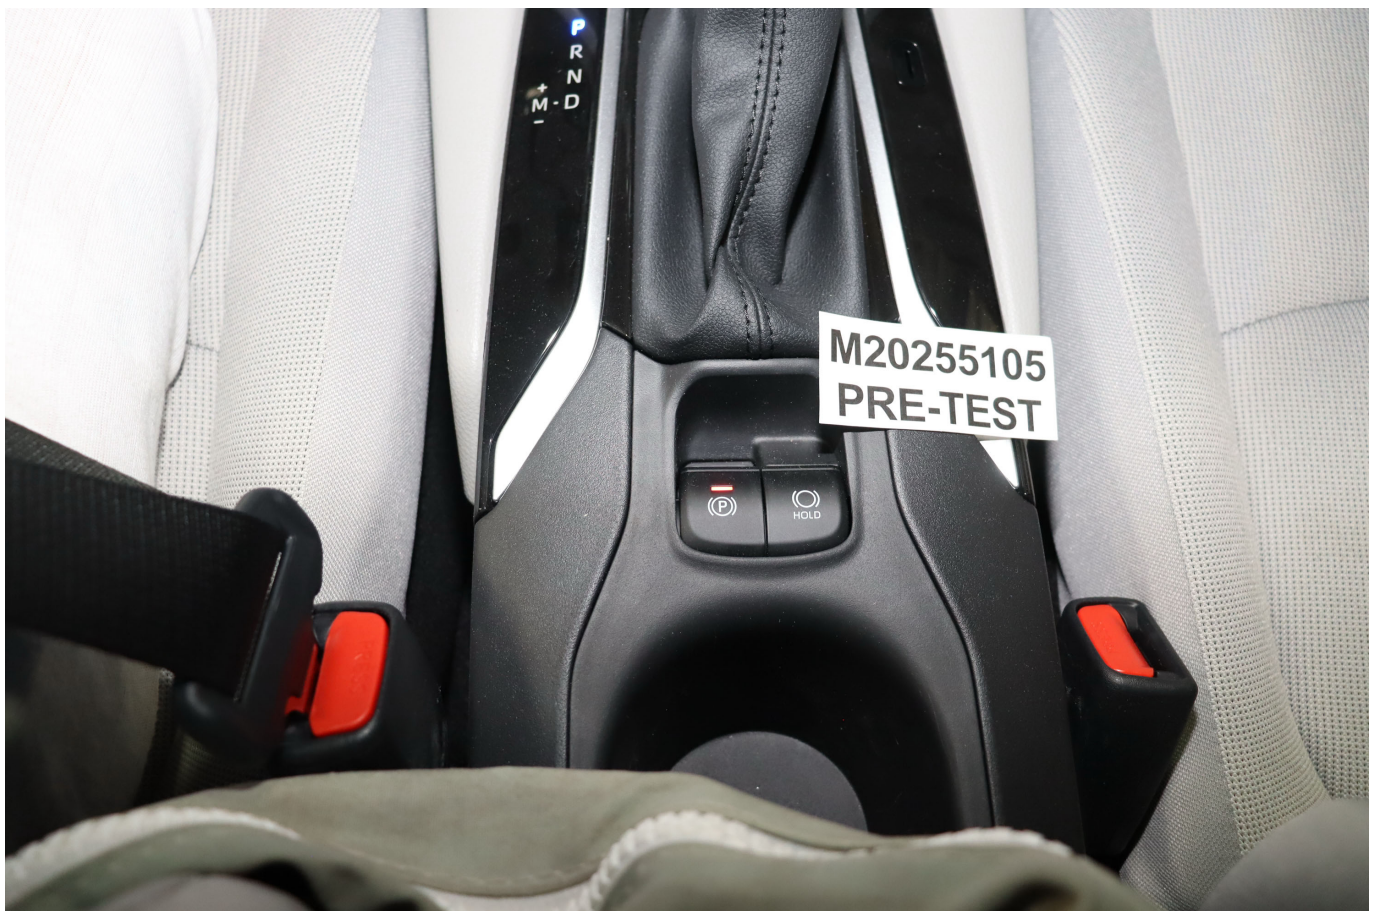
Photo No. 036 - Pre-Test View of Parking Brake

| | | <u>Page No.</u> |
|---|---|---|
| Photo No. 036 | Pre-Test View of Parking Brake | A-18 |

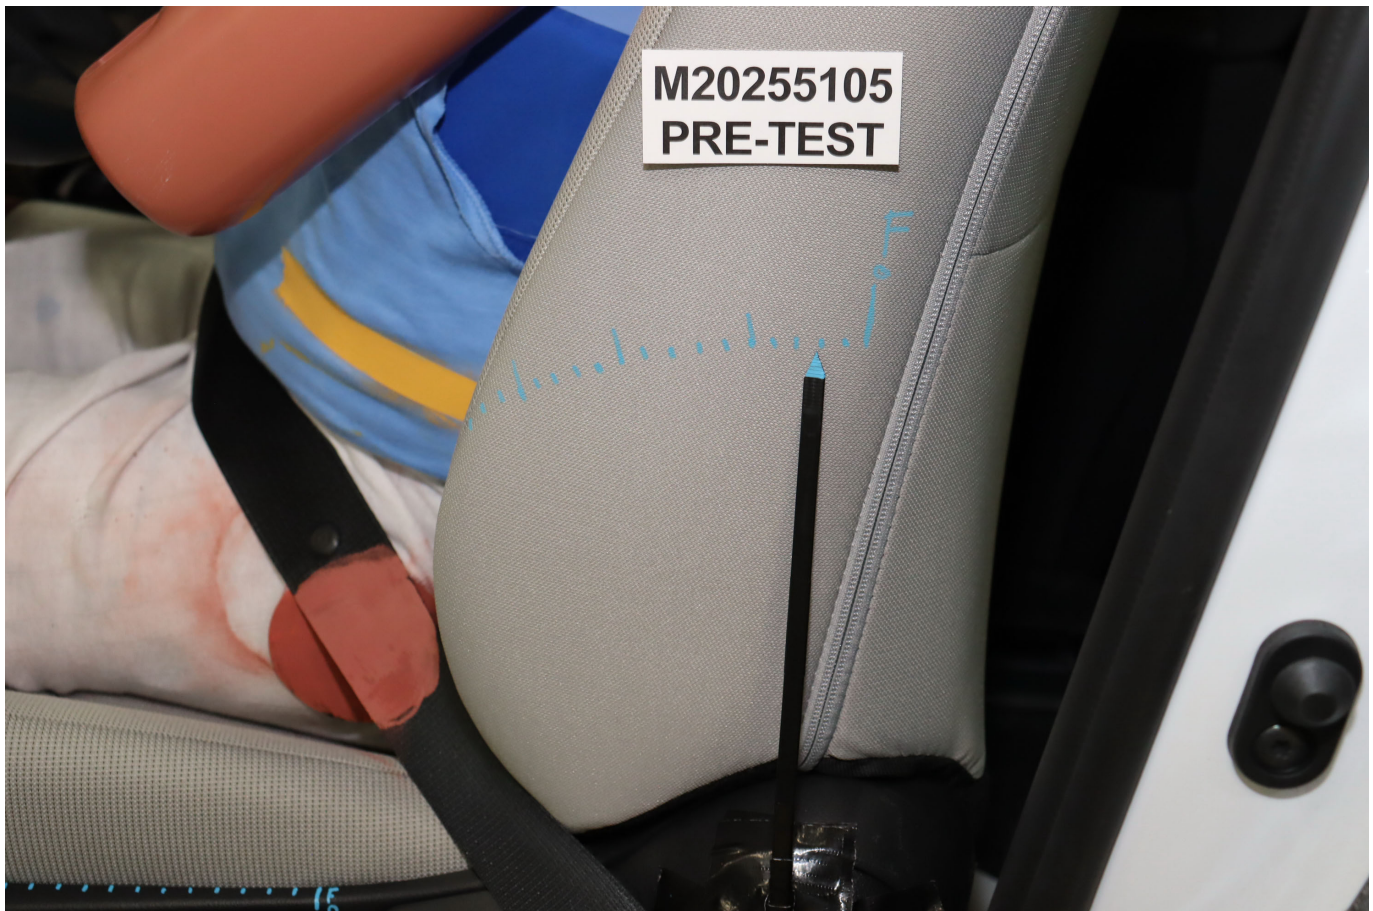
Photo No. 038 - Pre-Test Close-Up Left Side View of Driver Seat Back

| | | <u>Page No.</u> |
|---|---|---|
| Photo No. 038 | Pre-Test Close-Up Left Side View of Driver Seat Back | A-19 |

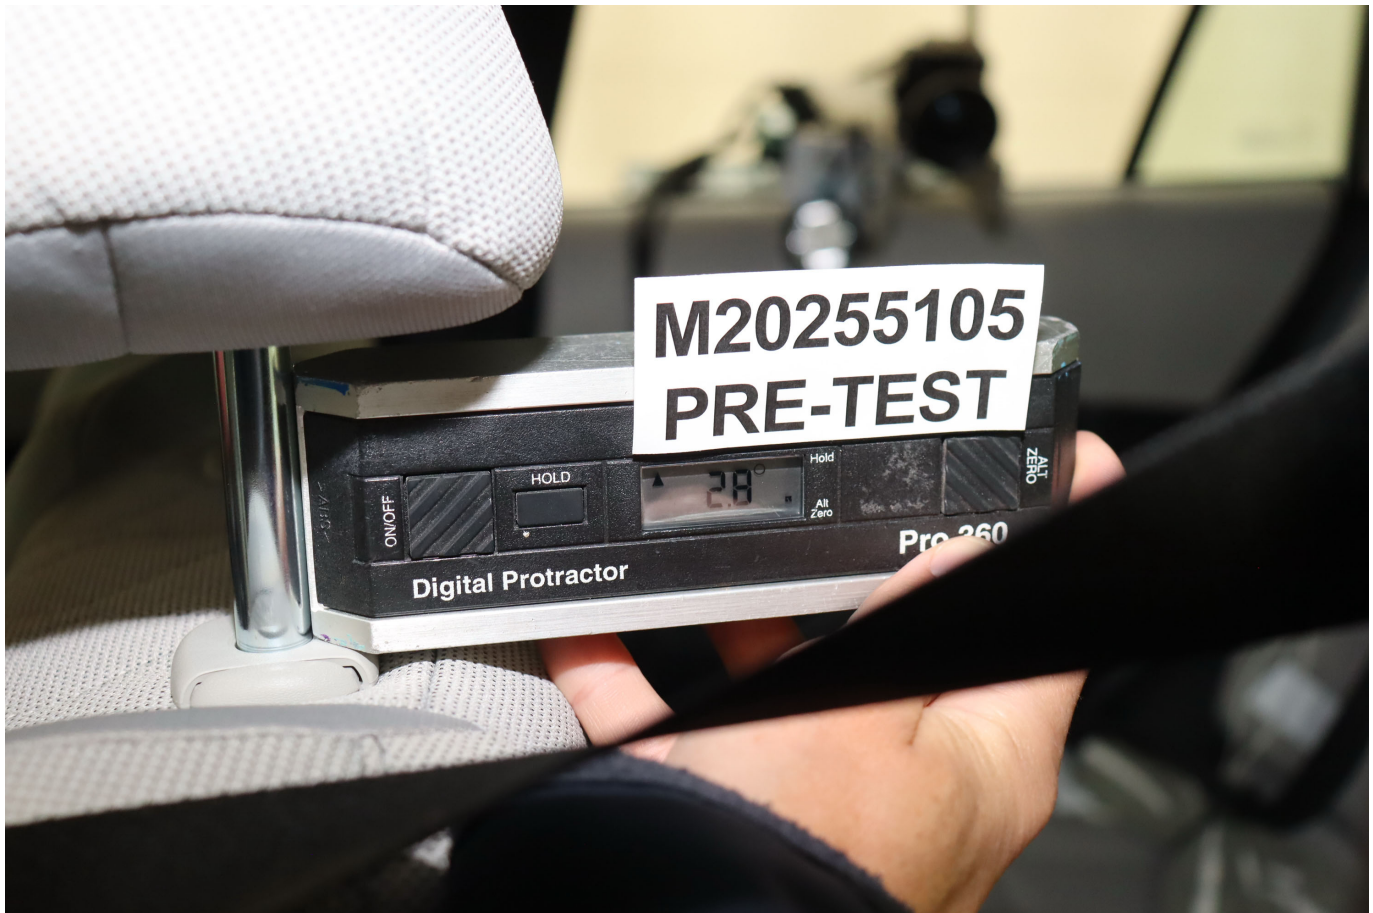
Photo No. 039 - Pre-Test Close-Up View of Driver Seat Back or Head Restraint

| | | <u>Page No.</u> |
|---|---|---|
| Photo No. 039 | Pre-Test Close-Up View of Driver Seat Back or Head Restraint | A-20 |

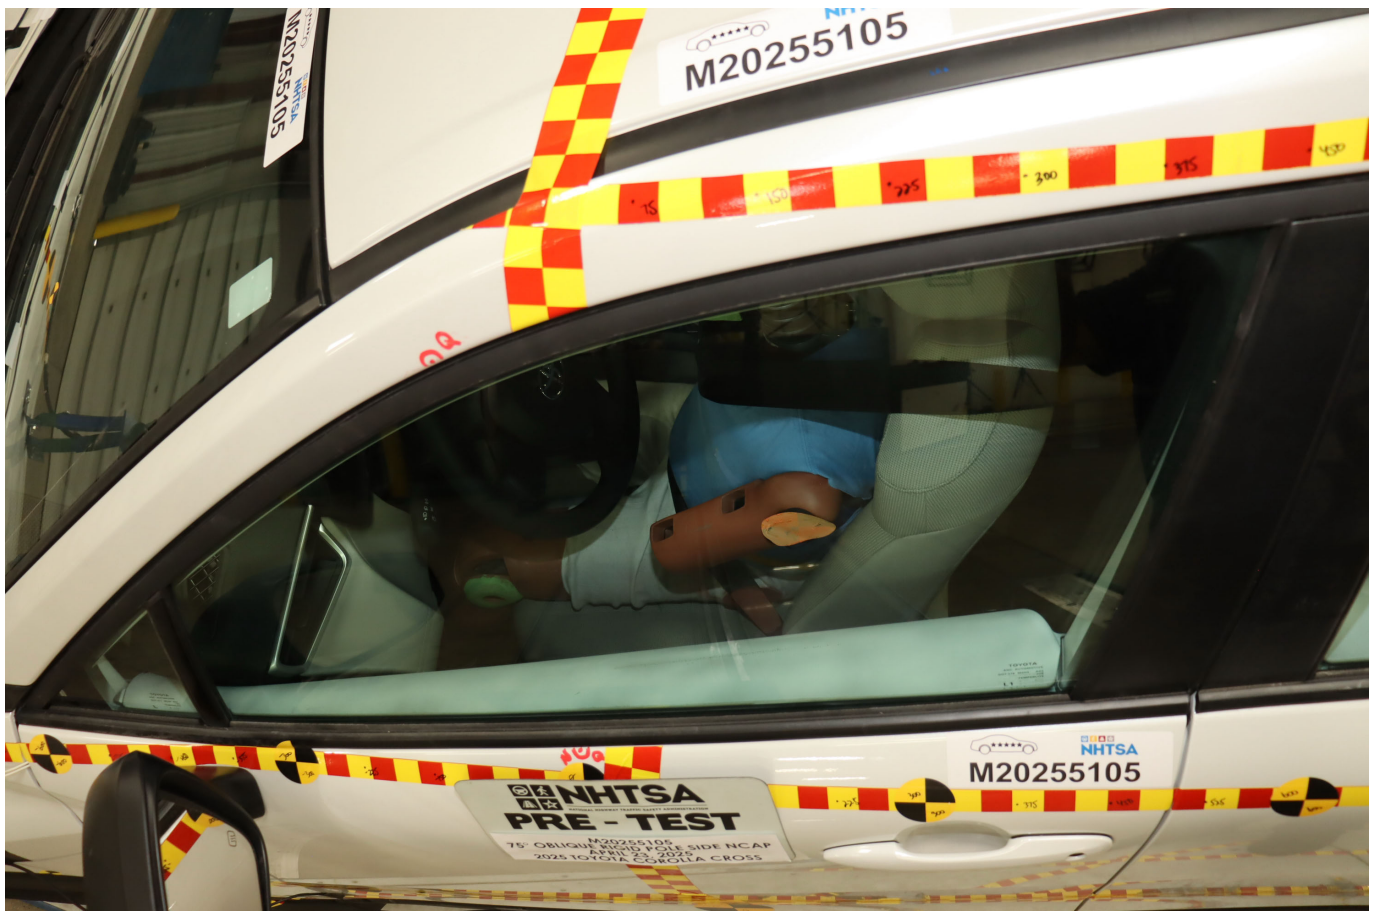
Photo No. 040 - Pre-Test Dummy and Door Clearance View

| | | <u>Page No.</u> |
|---|---|---|
| Photo No. 040 | Pre-Test Dummy and Door Clearance View | A-20 |

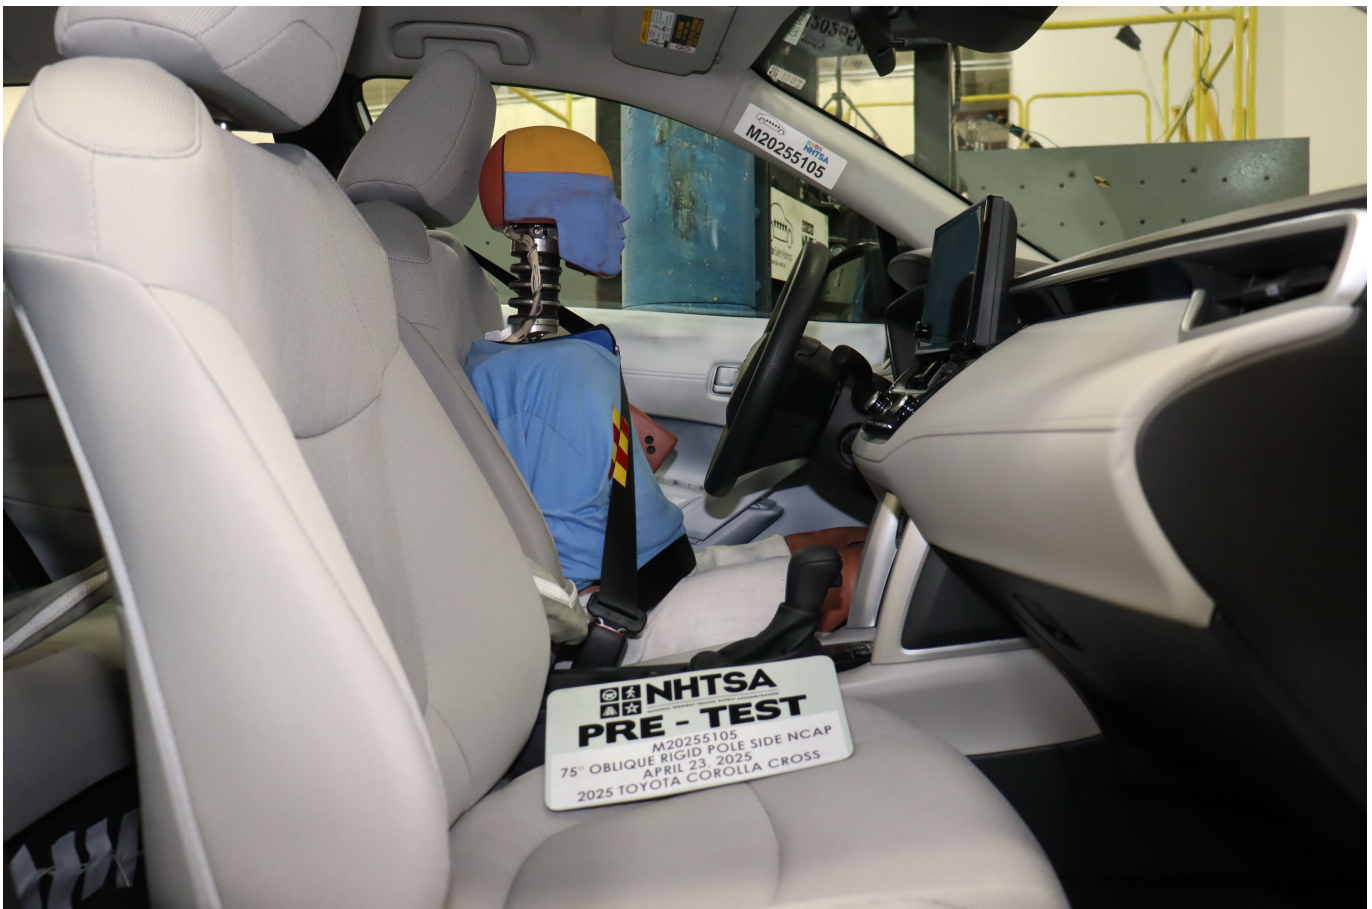
Photo No. 042 - Pre-Test Right Side View of Dummy and Front Seat of Occupant Compartment

| | | <u>Page No.</u> |
|---|---|---|
| Photo No. 042 | Pre-Test Right Side View of Dummy and Front Seat of Occupant Compartment | A-21 |

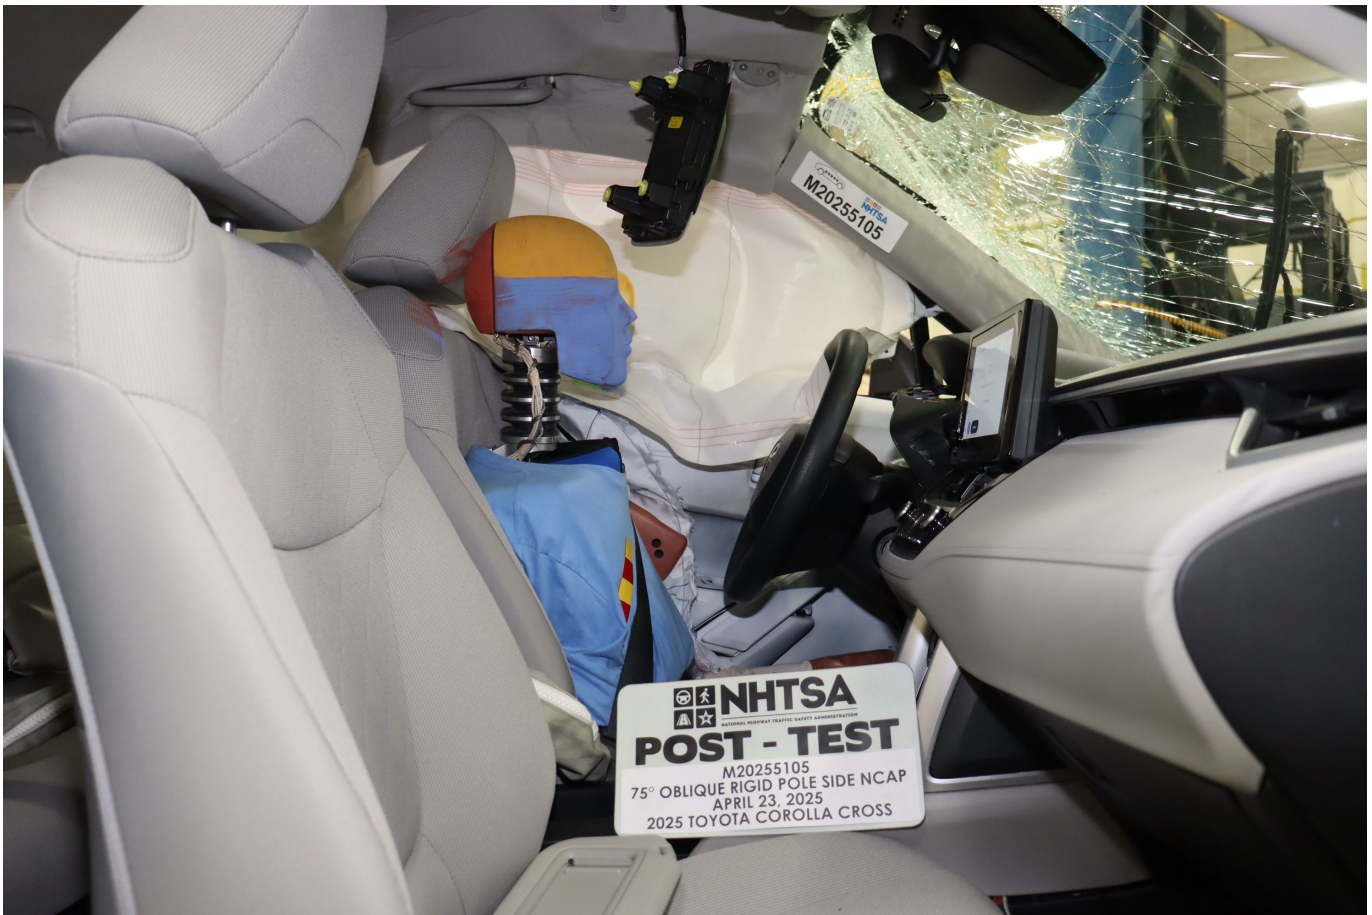
Photo No. 043 - Post-Test Right Side View of Dummy and Front Seat of Occupant Compartment

| | | <u>Page No.</u> |
|---|---|---|
| Photo No. 043 | Post-Test Right Side View of Dummy and Front Seat of Occupant Compartment | A-22 |
