**REPORT NUMBER: SideNCAPPole-MGA-25-019**

**NEW CAR ASSESSMENT PROGRAM (NCAP)  
Side Impact Pole Test**

**MAZDA TOYOTA MANUFACTURING U.S.A. INC.  
2025 Toyota Corolla Cross L 5-Door SUV  
NHTSA No.: M20255105**

**MGA RESEARCH CORPORATION  
5000 Warren Road  
Burlington, WI 53105**

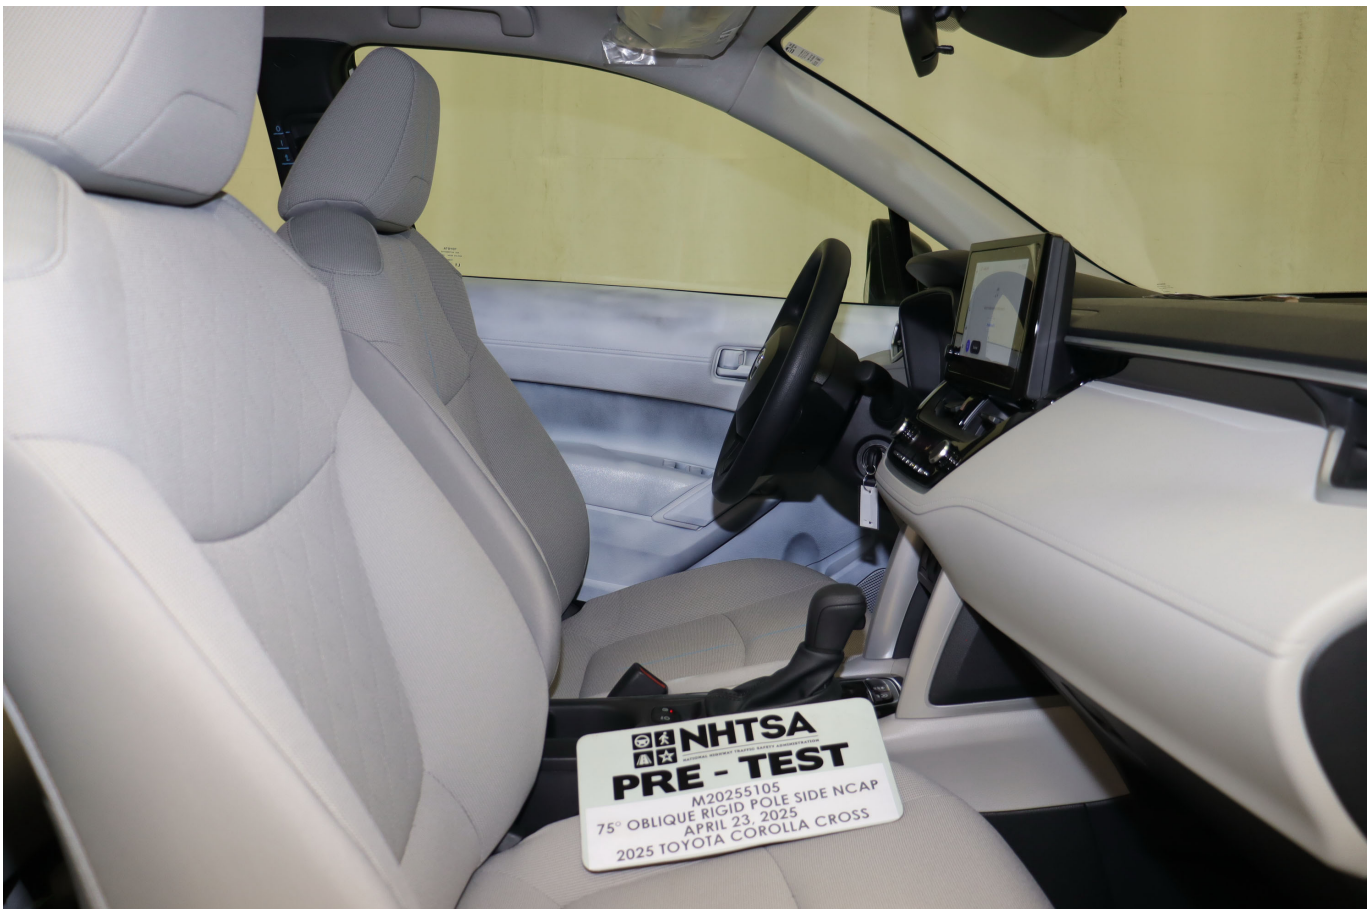
Photo No. 044 - Pre-Test Inner Door Panel View

| | | <u>Page No.</u> |
|---|---|---|
| Photo No. 044 | Pre-Test Inner Door Panel View | A-22 |

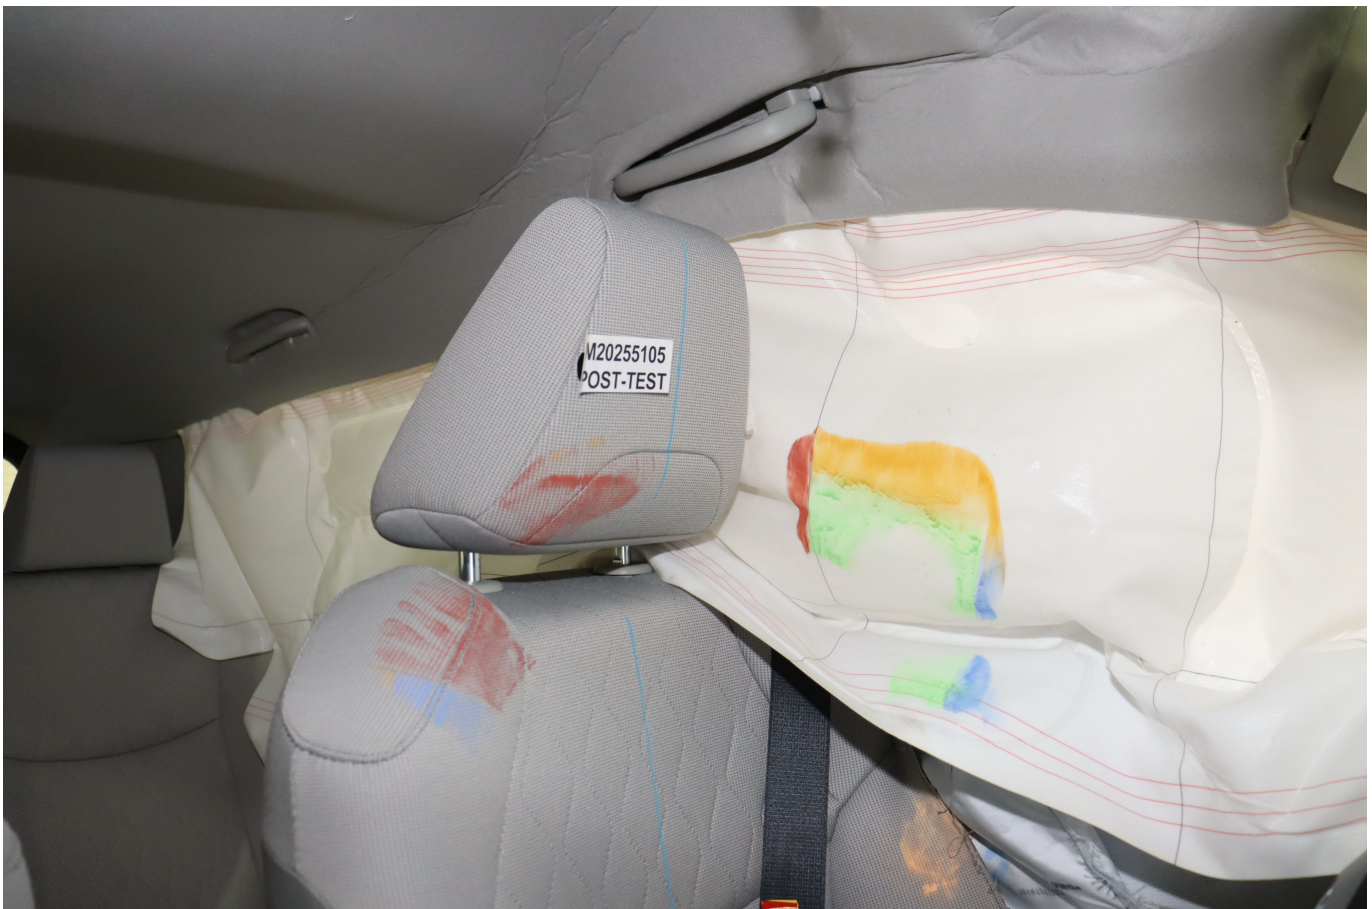
Photo No. 046 - Post-Test Dummy Close-Up Head Contact with Vehicle Interior View

| | | <u>Page No.</u> |
|---|---|---|
| Photo No. 046 | Post-Test Dummy Close-Up Head Contact with Vehicle Interior View | A-23 |

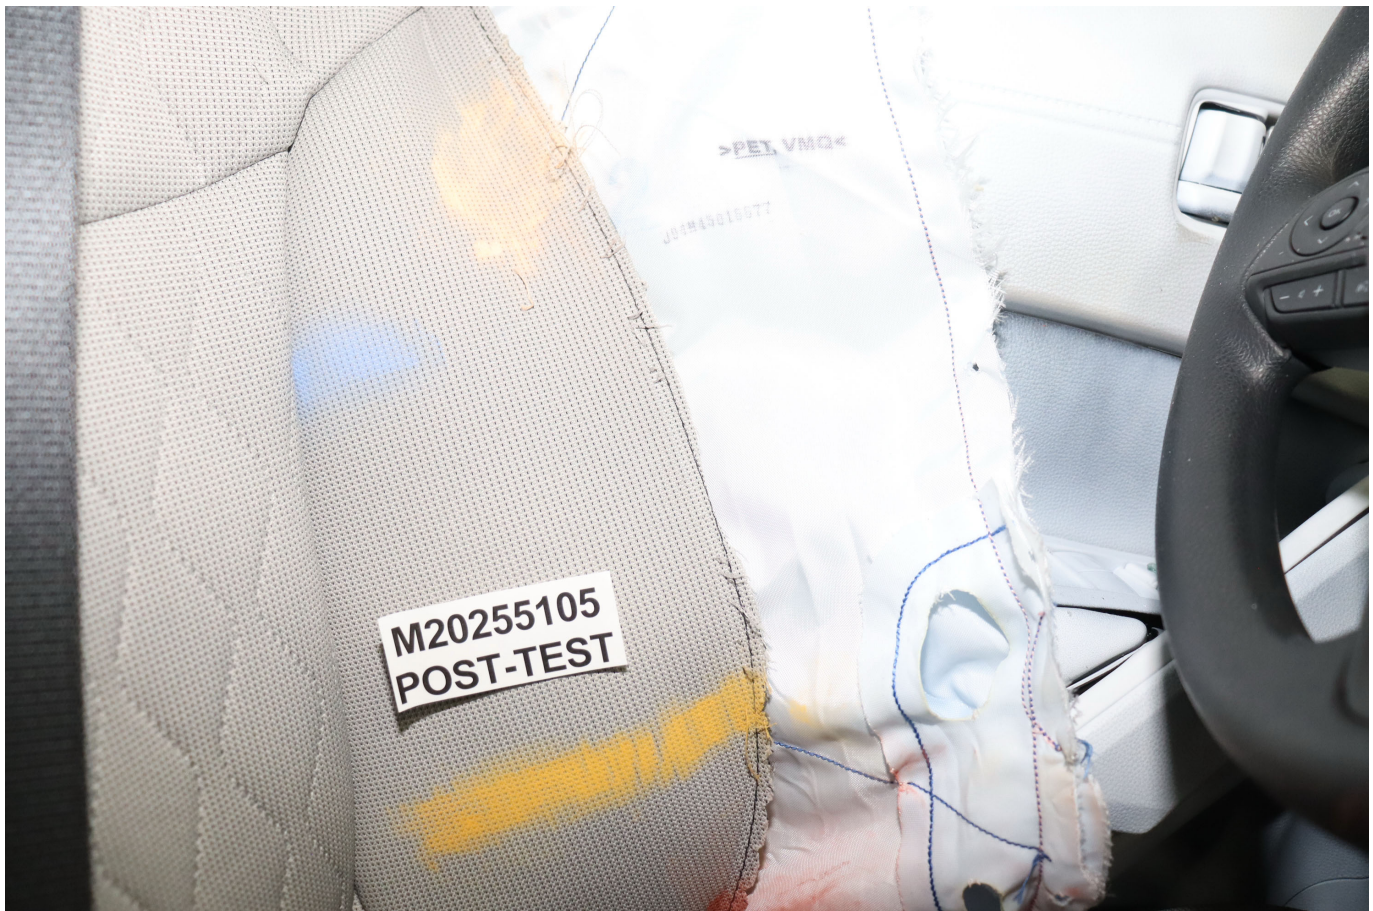
Photo No. 048 - Post-Test Dummy Close-Up Torso Contact with Vehicle Interior View

| | | <u>Page No.</u> |
|---|---|---|
| Photo No. 048 | Post-Test Dummy Close-Up Torso Contact with Vehicle Interior View | A-24 |

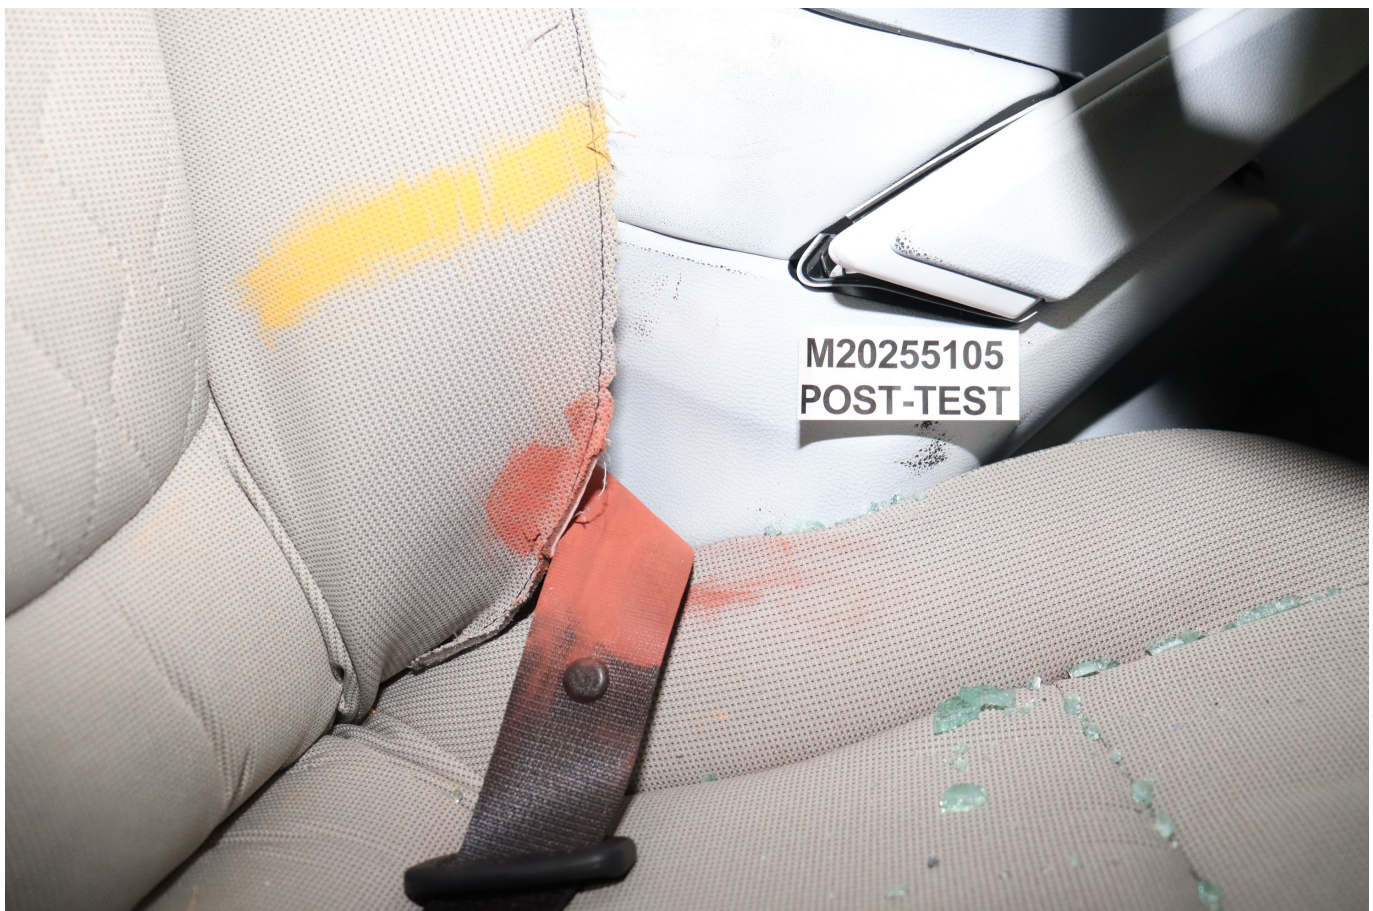
Photo No. 050 - Post-Test Dummy Close-Up Pelvis Contact with Vehicle Interior View

| | | <u>Page No.</u> |
|---|---|---|
| Photo No. 050 | Post-Test Dummy Close-Up Pelvis Contact with Vehicle Interior View | A-25 |

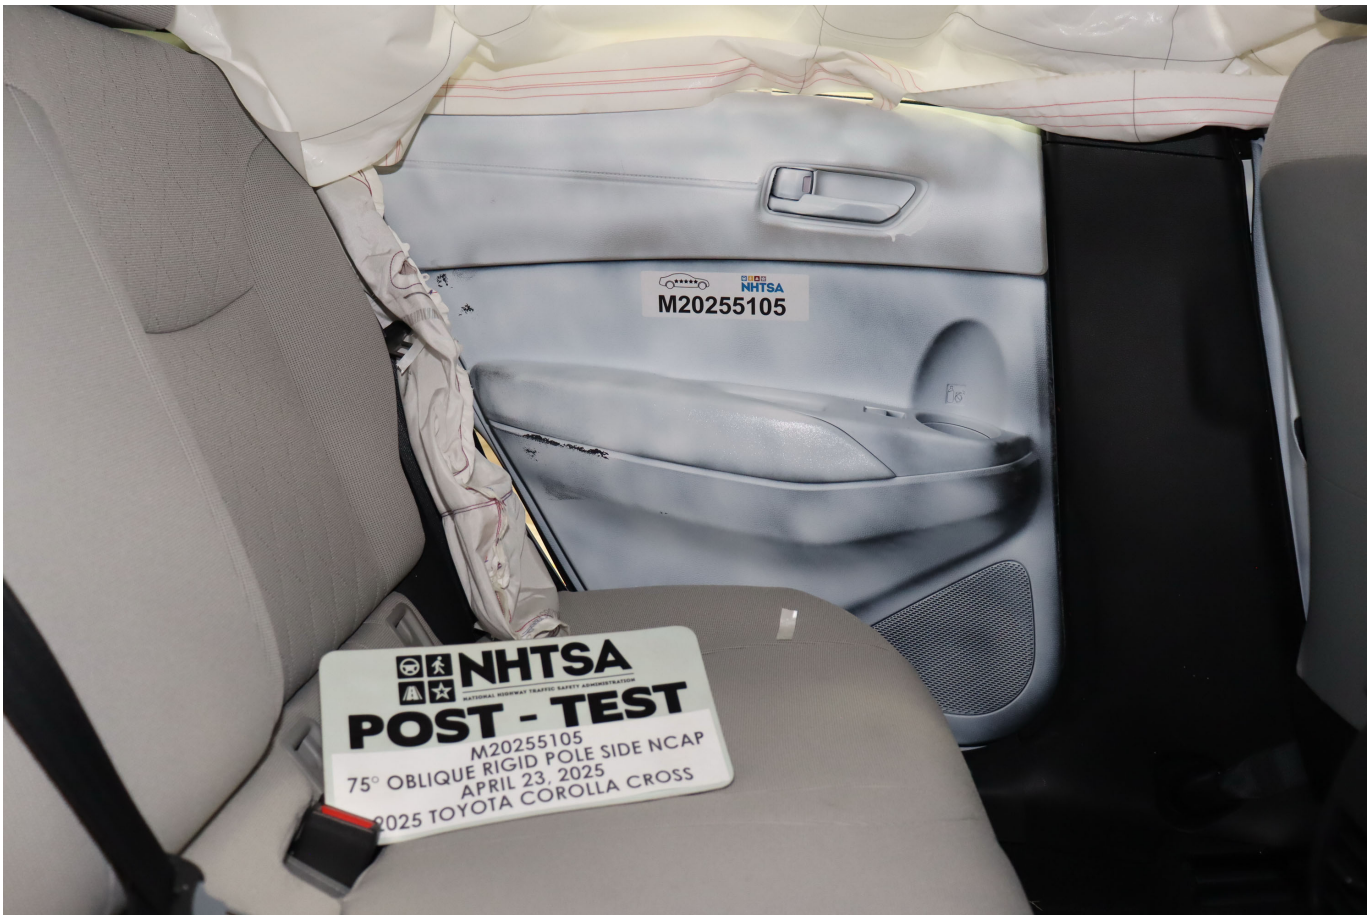
Photo No. 053 - Post-Test Right Side View of Dummy and Rear Seat of Occupant Compartment

| | | <u>Page No.</u> |
|---|---|---|
| Photo No. 053 | Post-Test Right Side View of Dummy and Rear Seat of Occupant Compartment | A-27 |

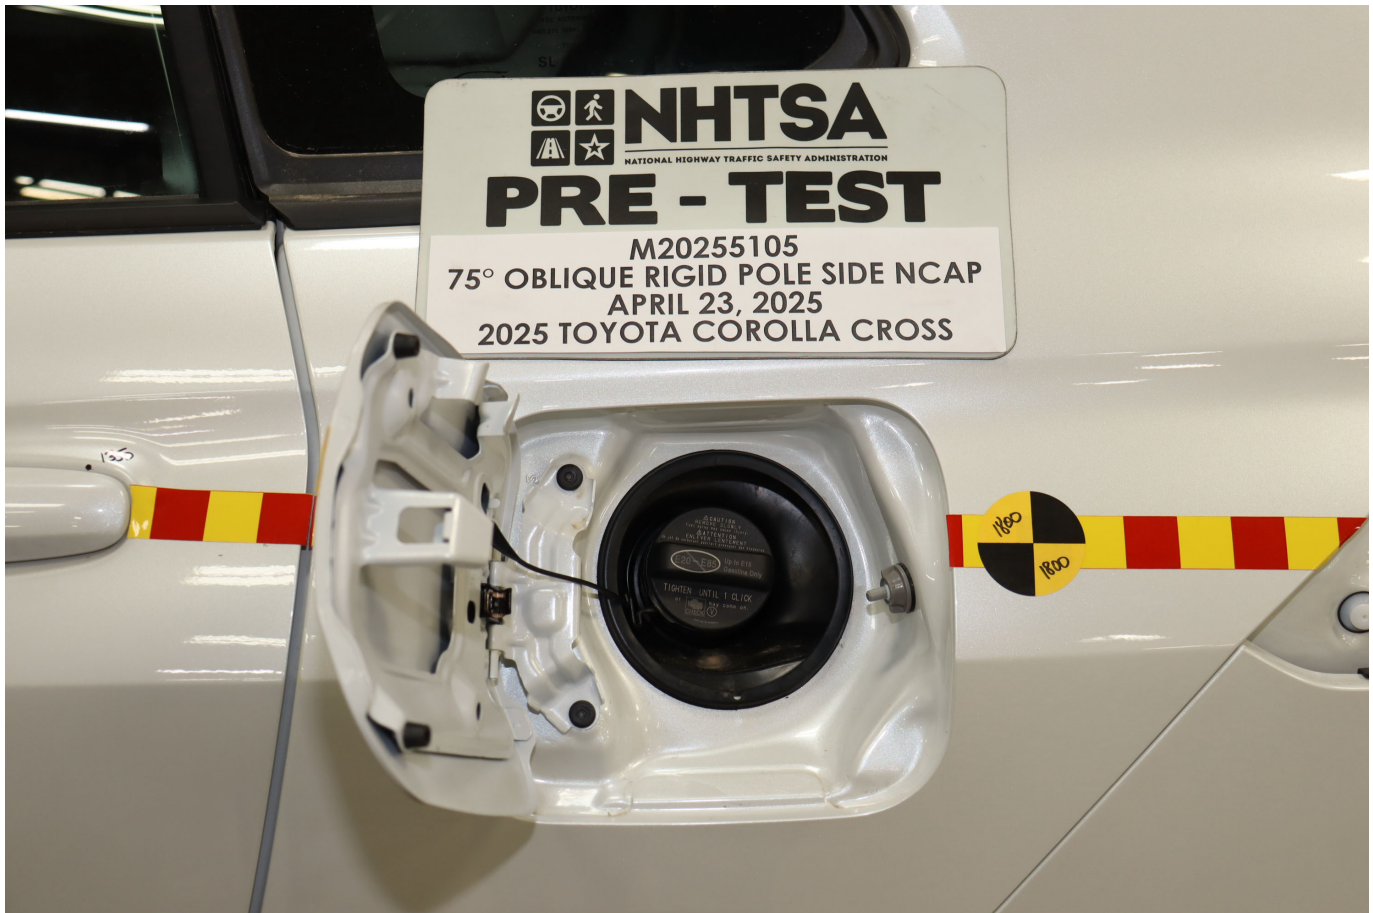
Photo No. 054 - Post-Test Inner Rear Passenger Torso Air Bag Deployment View

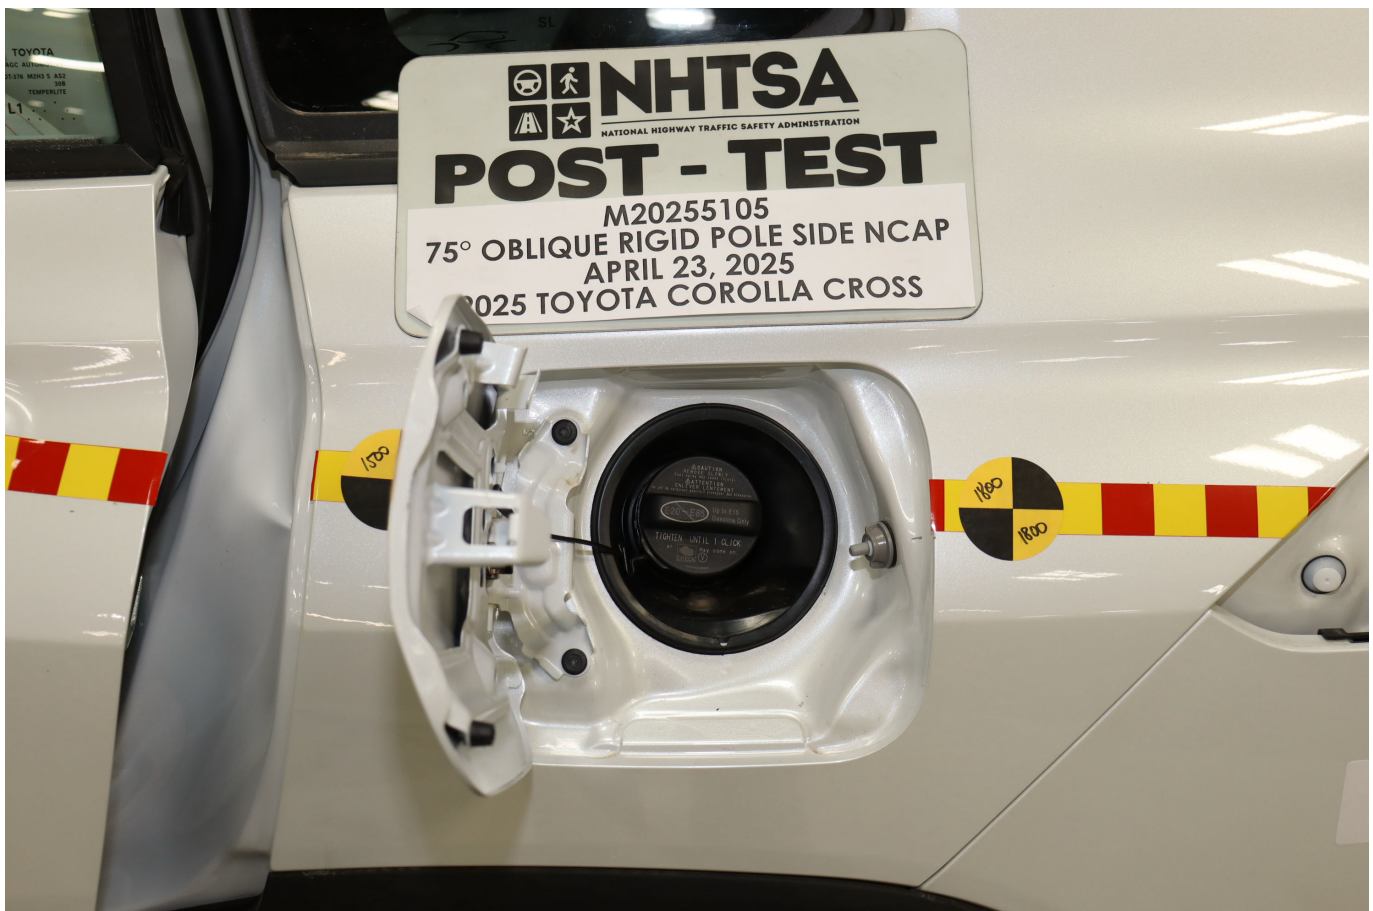
Photo No. 055 - Pre-Test View of Fuel Filler Cap or Fuel Filler Neck

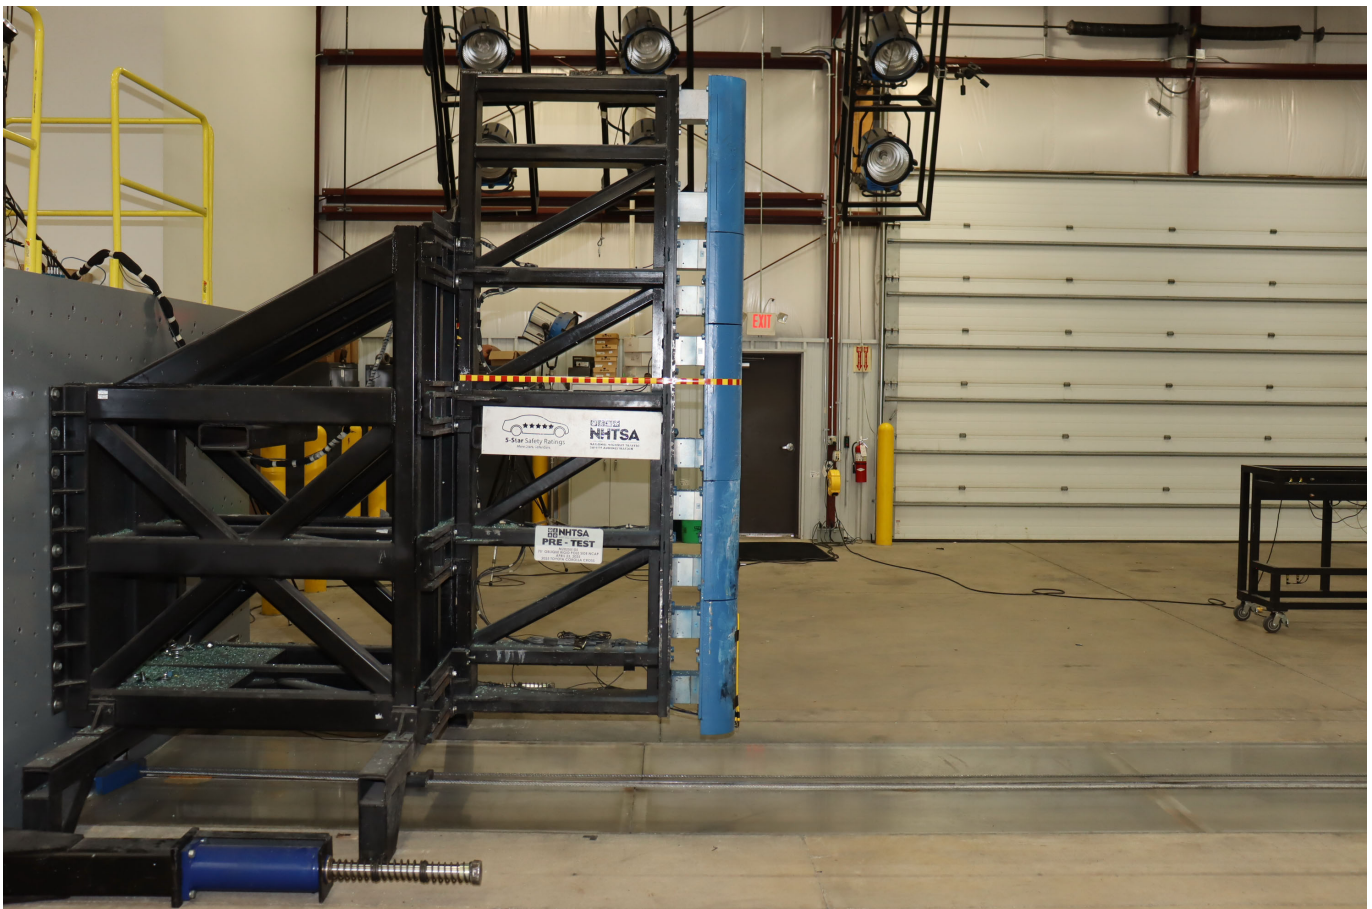
Photo No. 060 - Post-Test Pole Barrier Front View

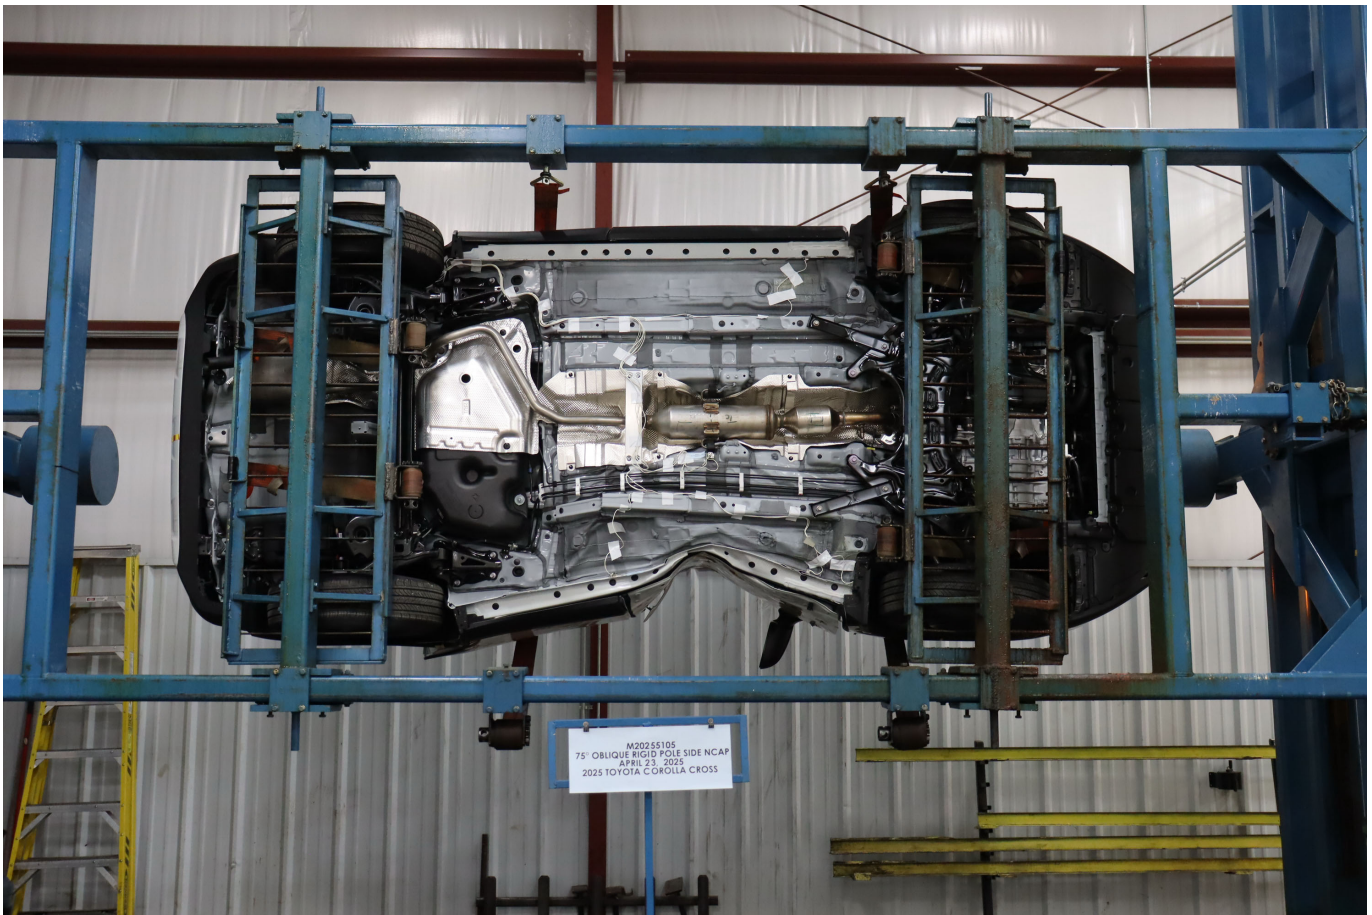
Photo No. 065 - FMVSS Photo No. 301 Static Rollover 0 Degrees

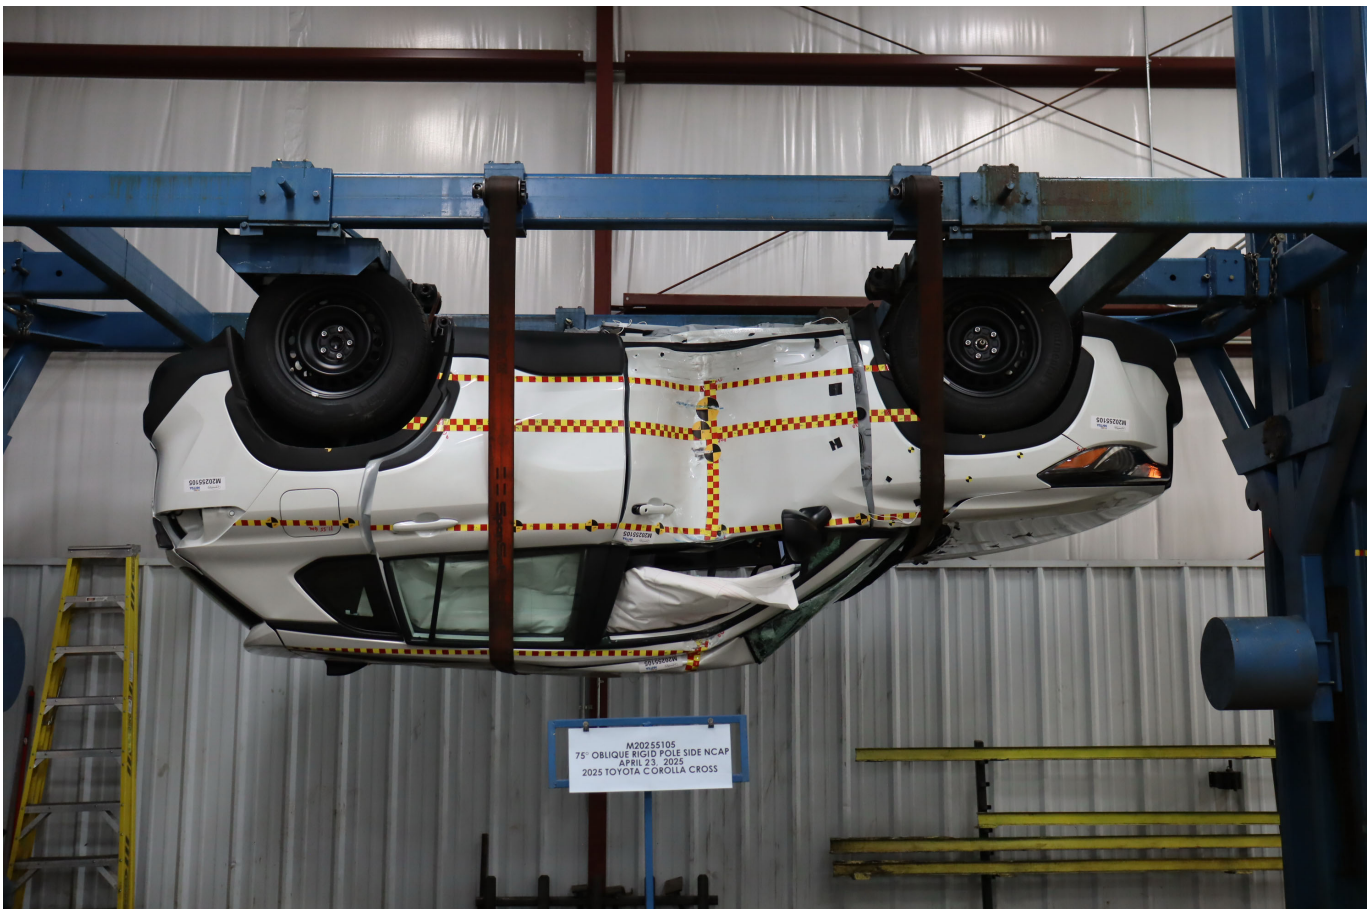
Photo No. 066 - FMVSS Photo No. 301 Static Rollover 90 Degrees

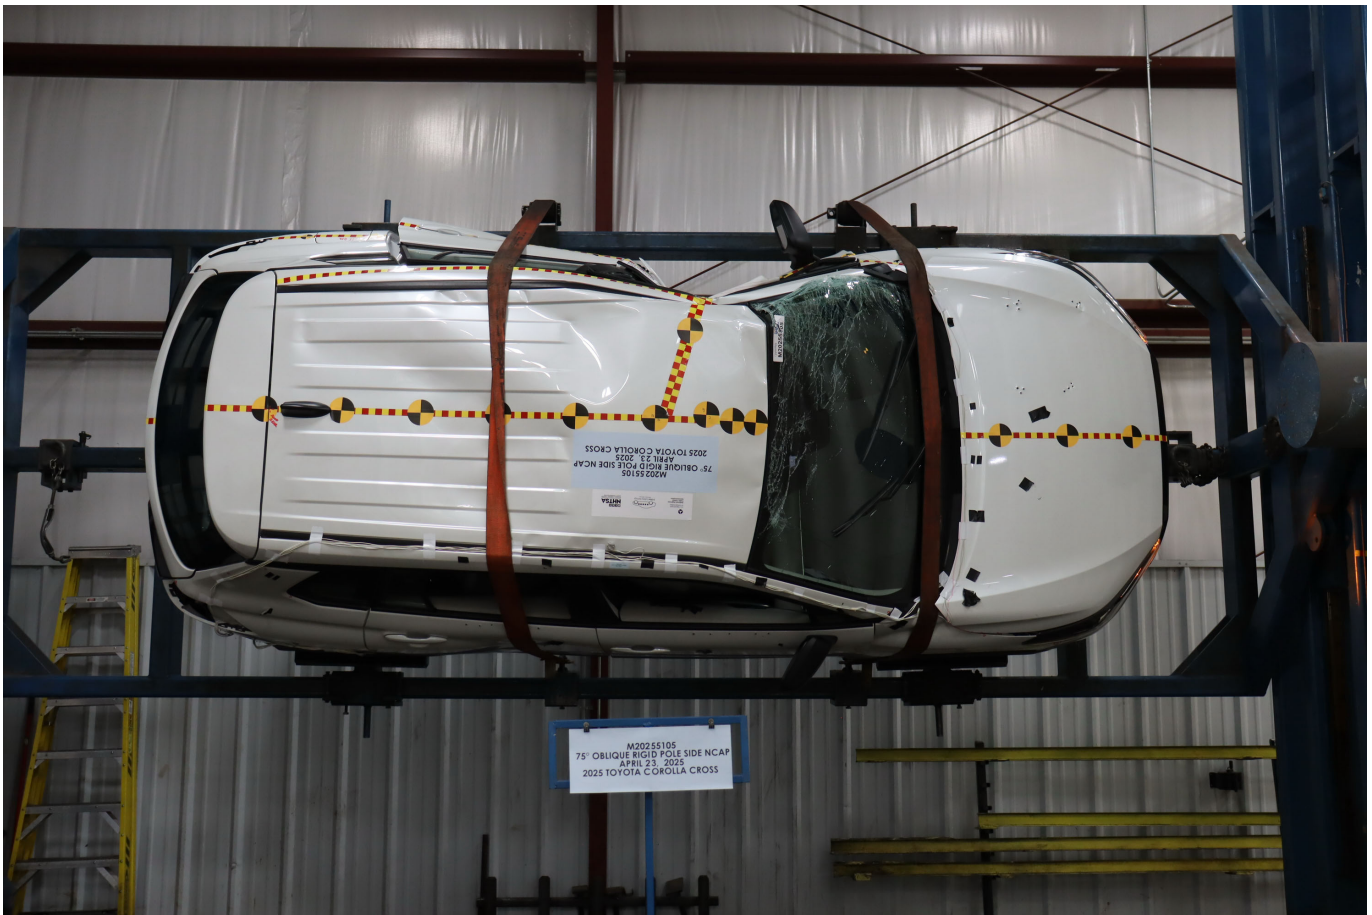
Photo No. 067 - FMVSS Photo No. 301 Static Rollover 180 Degrees

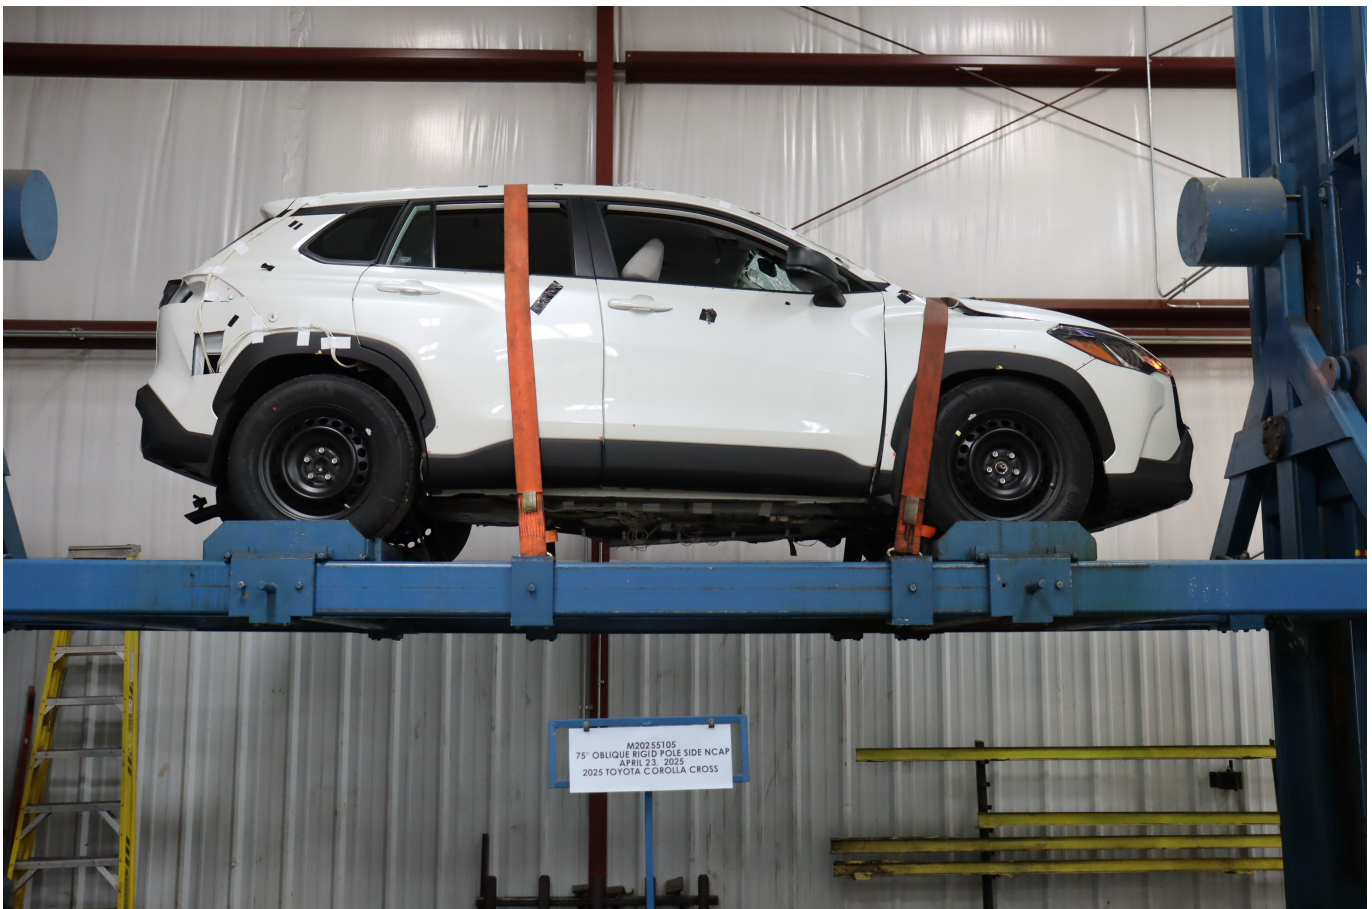
Photo No. 068 - FMVSS Photo No. 301 Static Rollover 270 Degrees
