**REPORT NUMBER: SideNCAPPole-KAR-25-005**  
**NEW CAR ASSESSMENT PROGRAM (NCAP)**  
**SIDE IMPACT POLE TEST**

**AUDI AG**  
**2025 AUDI Q6 E-TRON 5-DOOR SUV**

**NHTSA NO. M20255801**

**FINAL REPORT**

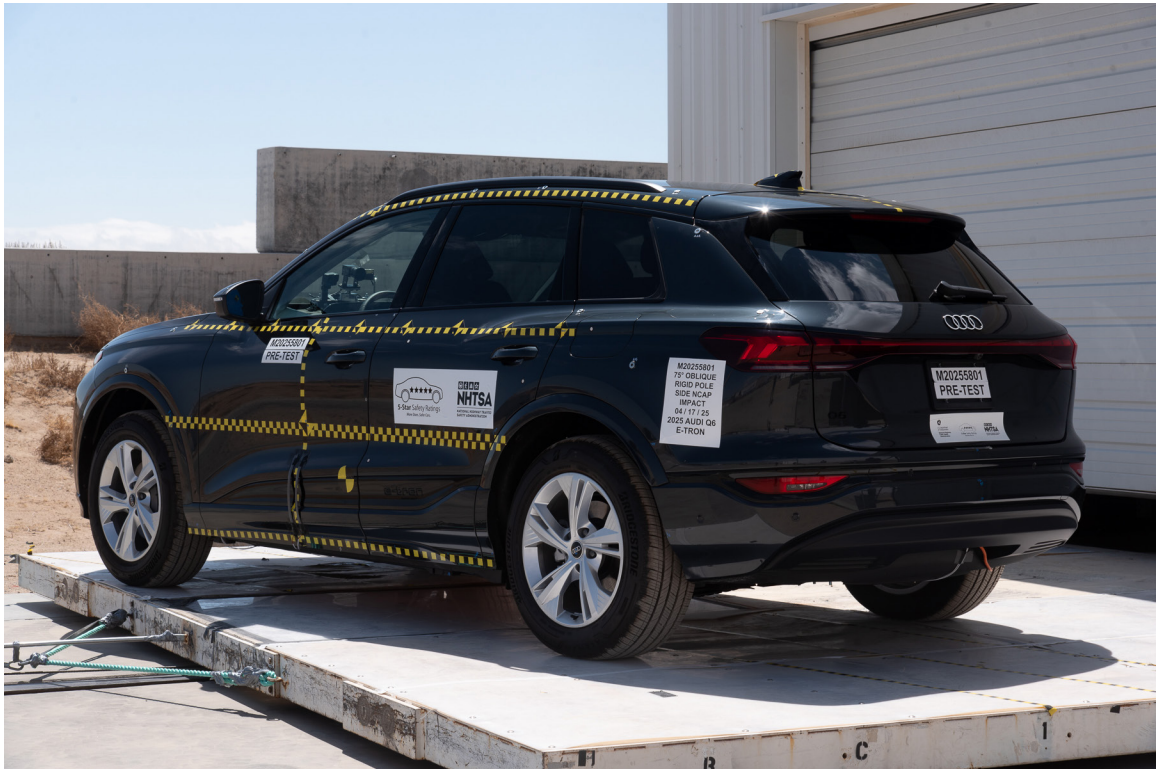
FIGURE 8. Post-Test Left Side View of Test Vehicle

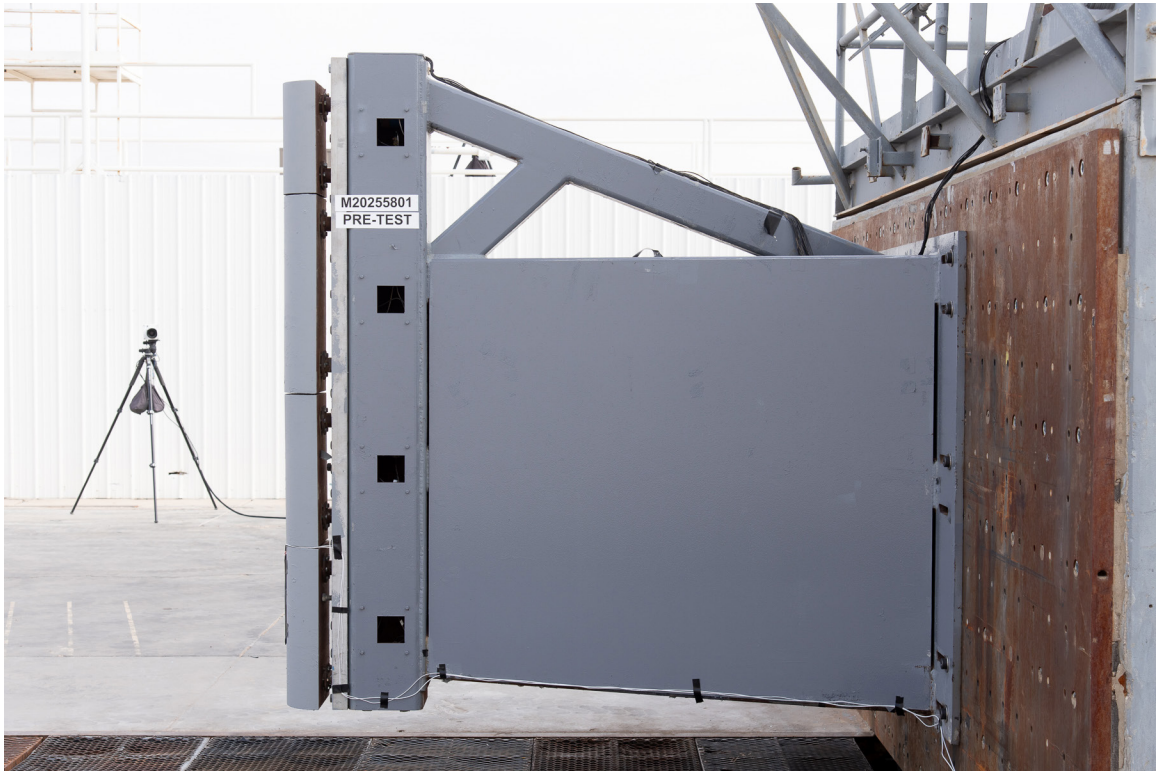
FIGURE 60. Post-Test Pole Barrier Front View
