**REPORT NUMBER: 208-2460538-TEST**

**DUMMY PERFORMANCE CALIBRATIONS  
FMVSS 208**

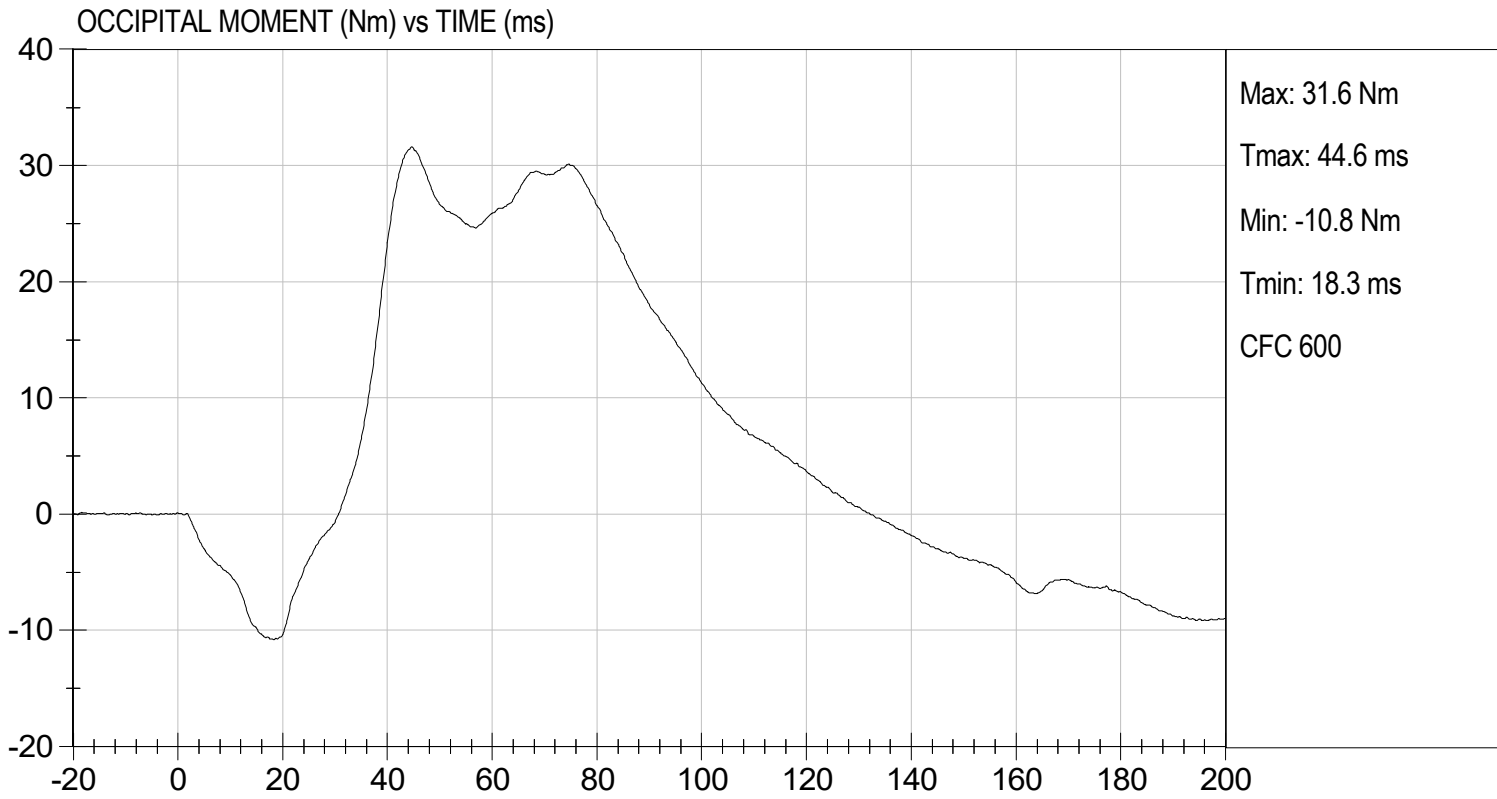
- X   6. Torque the jam nut (9000341) on the neck cable (127-1016) to  $0.23 \pm 0.02$  Nm ( $2.0 \pm 0.2$  in-lb). (572.123(c)(2))
- X   7. The data acquisition system, including transducers, conforms to the requirements of SAE Recommended Practice J211/1 MAR95. (572.127(k))
