**REPORT NUMBER: SINCAP-CAL-25-004**

**NEW CAR ASSESSMENT PROGRAM (NCAP)  
SIDE IMPACT POLE TEST**

**Ford Motor Co.  
2025 Ford Expedition  
5 Door SUV**

**FINAL REPORT**

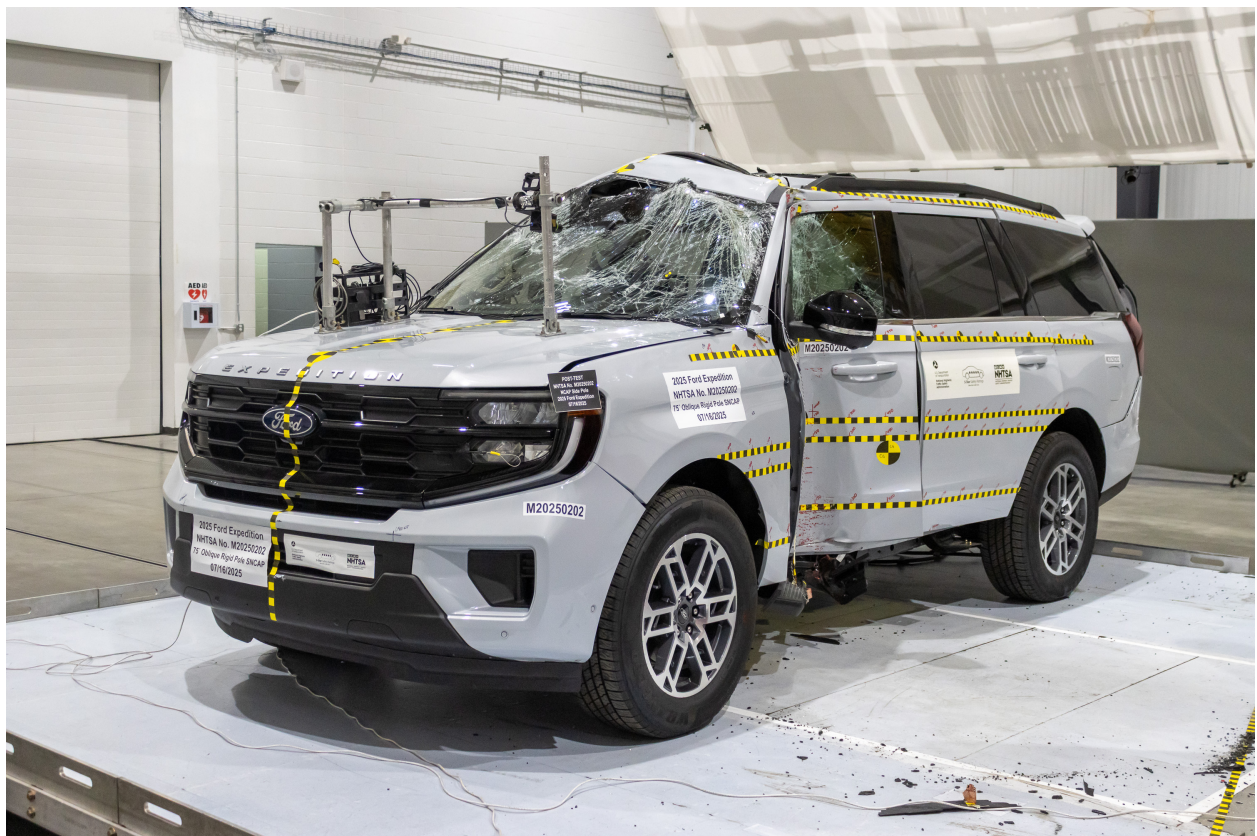
**Figure A-6: Post-Test Left Front  $\frac{3}{4}$  View of Test Vehicle**

| Critical Areas of Performance | Observations and Conclusions |
|---|---|
| Windshield Damage | Cracked Throughout, Separation along roof line |
| Side Window Damage | Driver door window shattered but remained laminated |

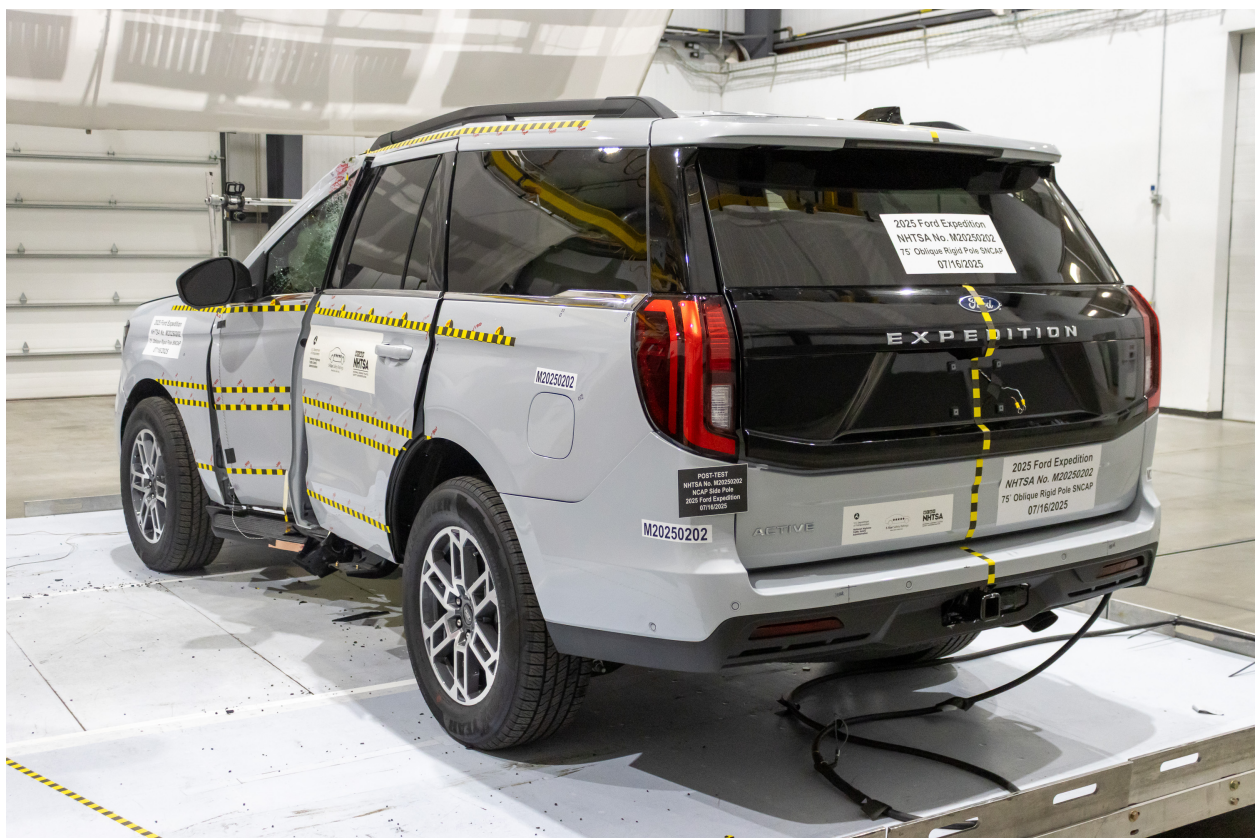
**Figure A-10: Post-Test Left Rear  $\frac{3}{4}$  View of Test Vehicle**

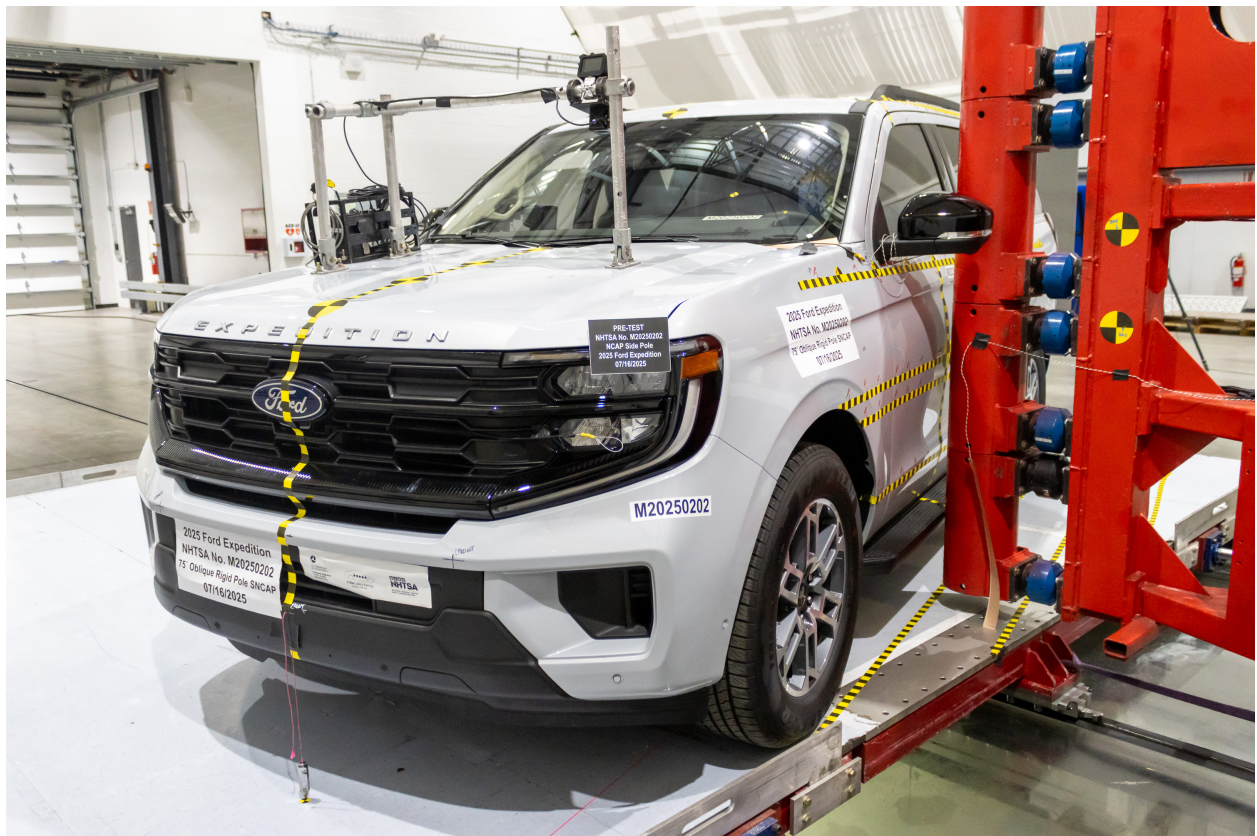
**Figure A-17: Pre-Test Left Side View of Pole Positioned Against Side of Vehicle**

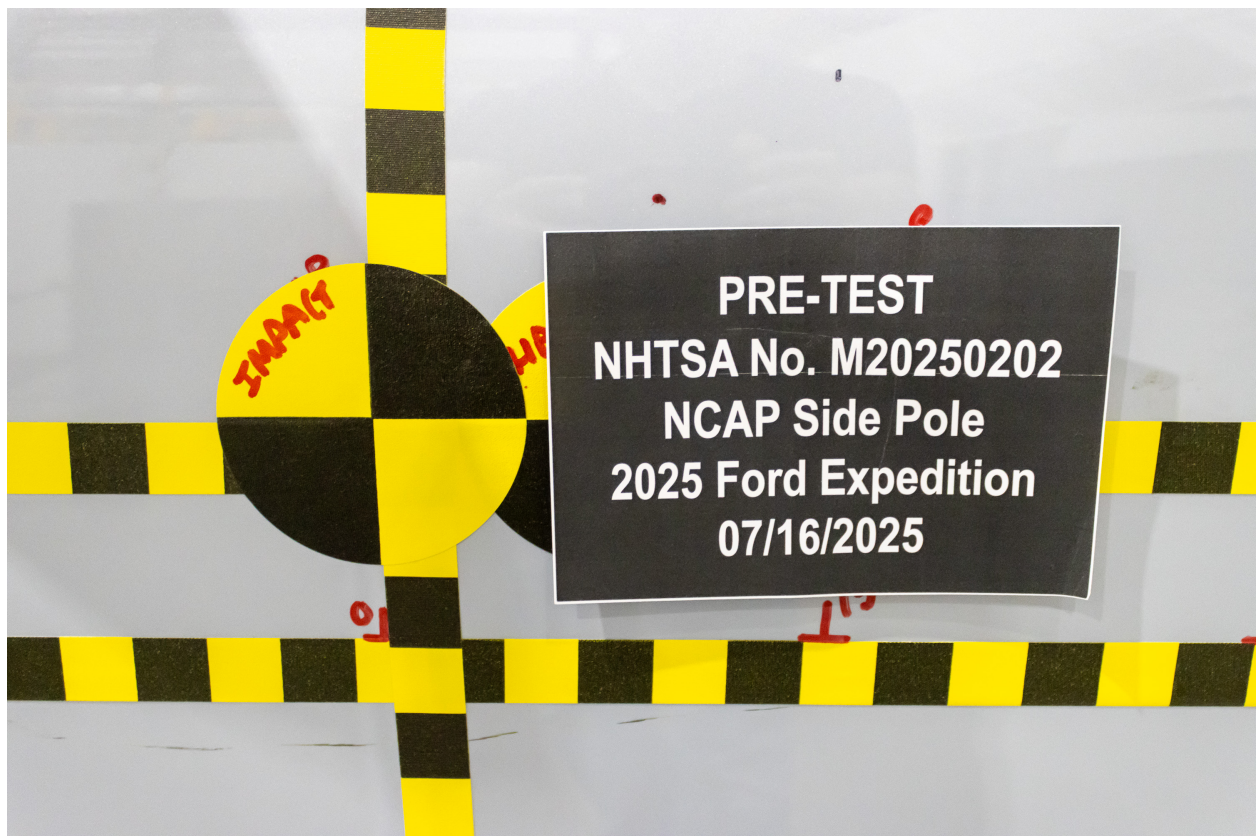
**Figure A-19: Pre-Test Close-Up View of Impact Point Target**

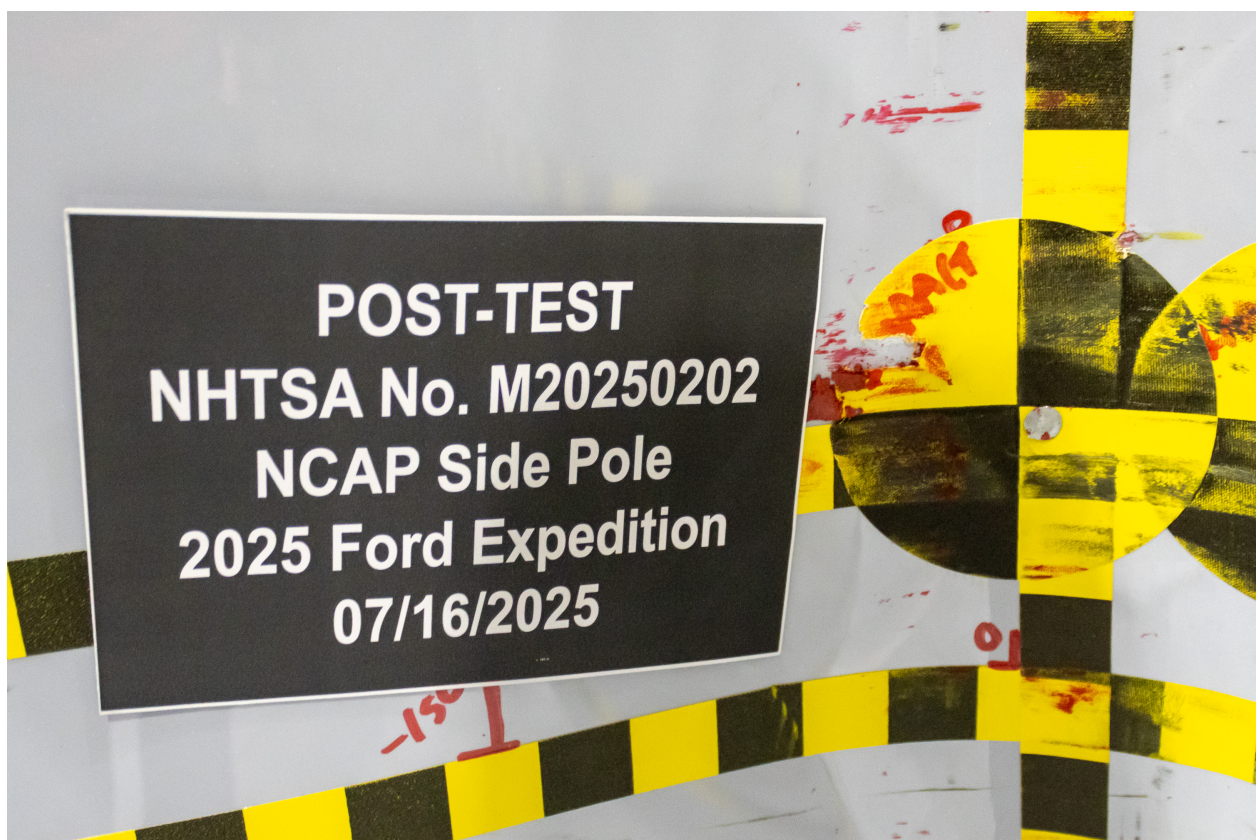
**Figure A-20: Post-Test Close-Up View of Impact Point Target Showing Impact Location**

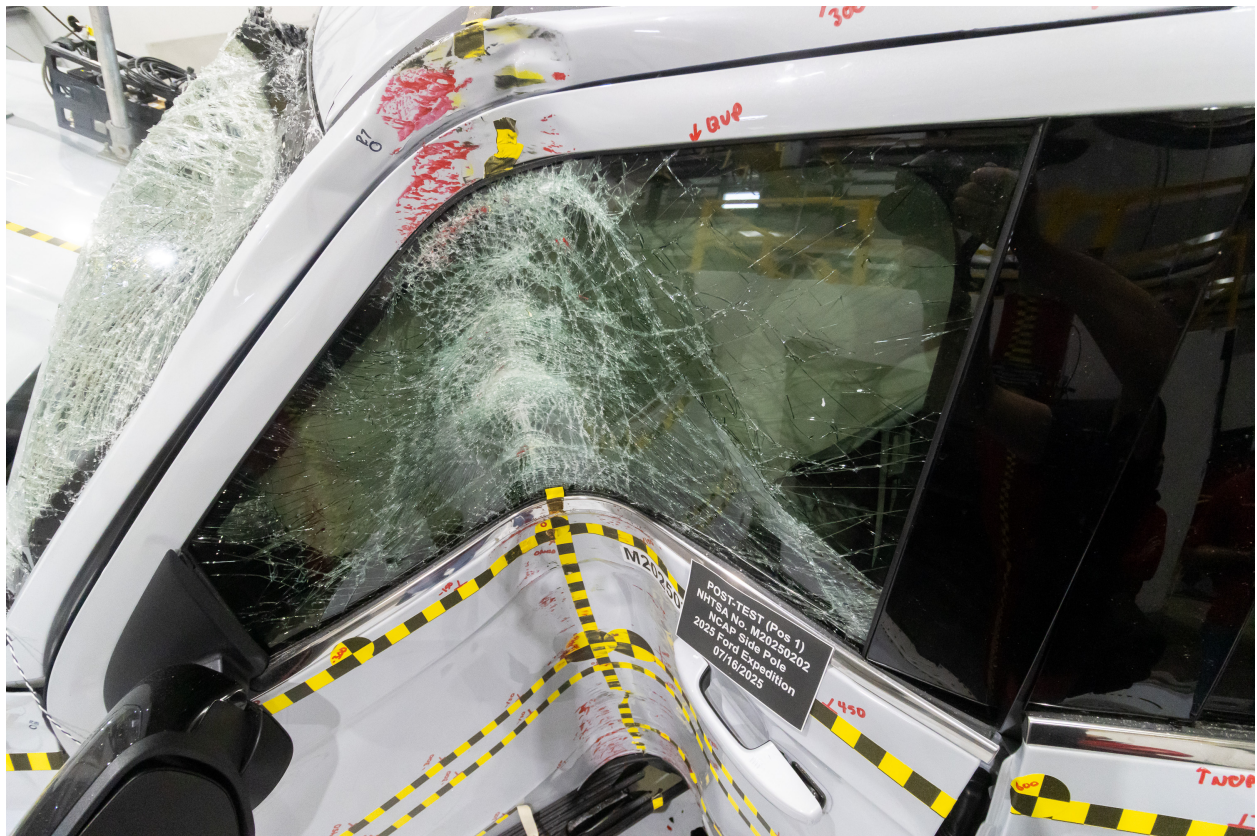
**Figure A-41: Post-Test Dummy and Door Clearance View**

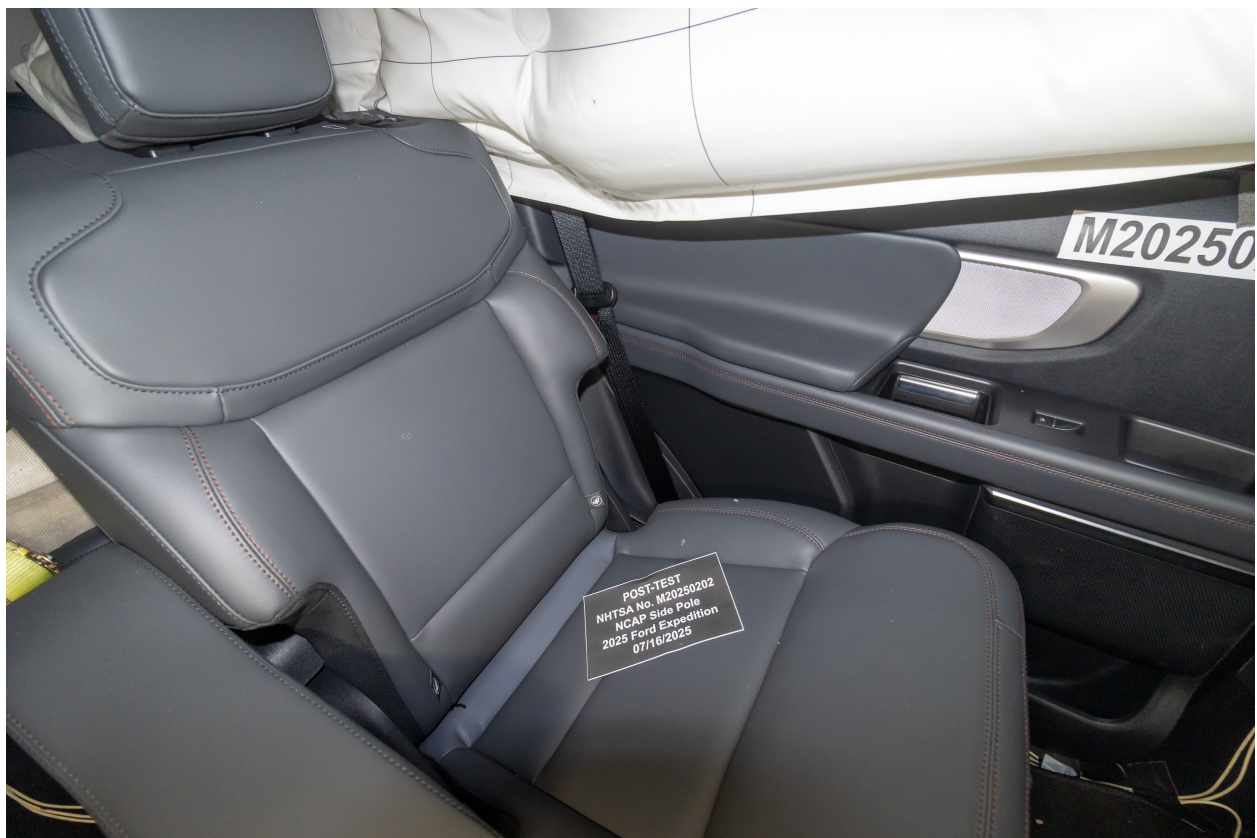
**Figure A-54: Post-Test Inner Rear Passenger Torso Air Bag Deployment View**

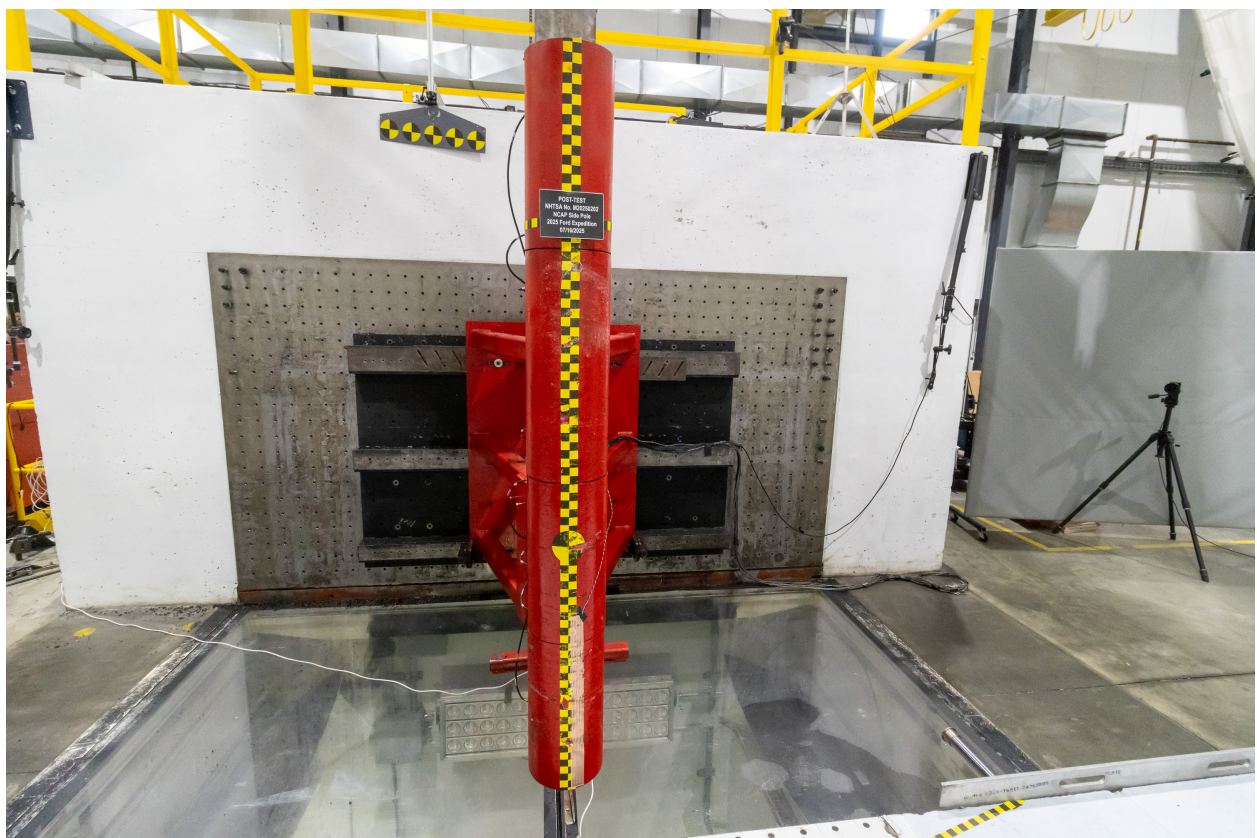
**Figure A-60: Post-Test Pole Barrier Front View**

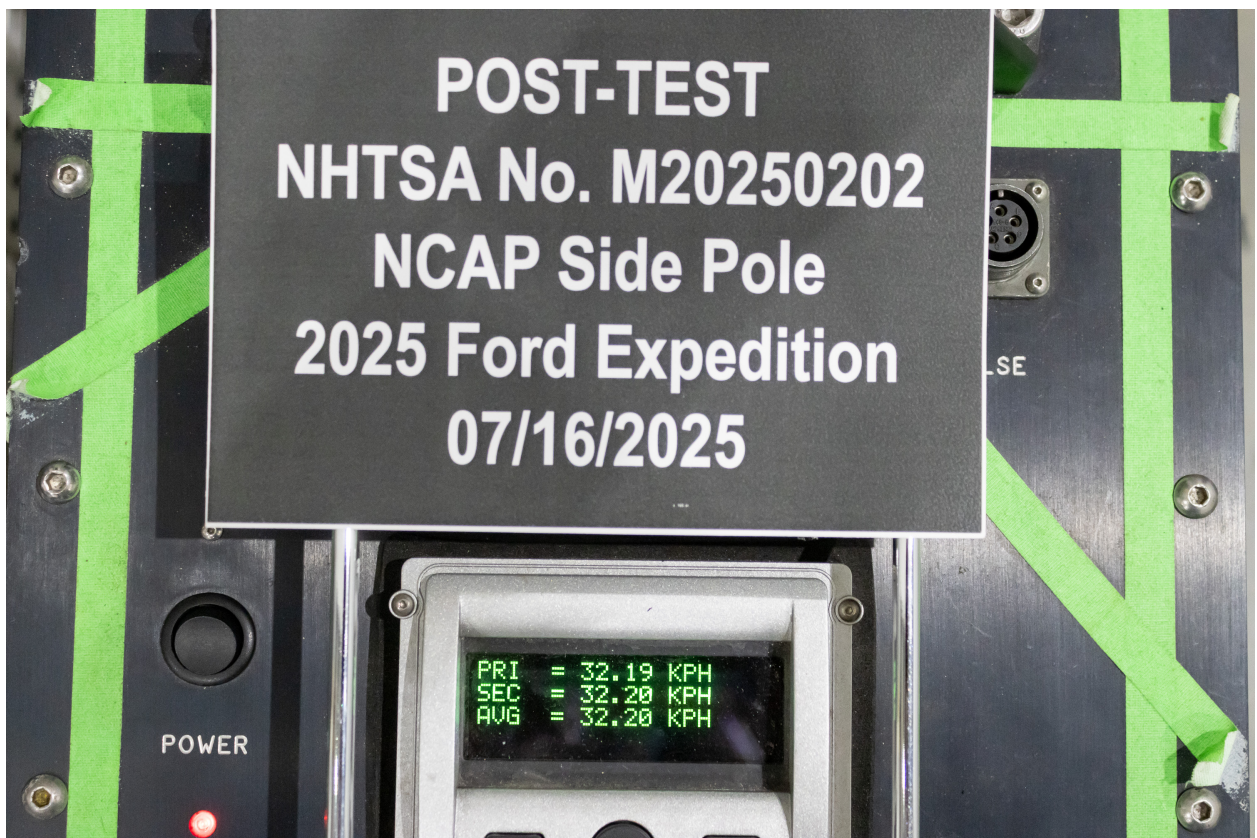
**Figure A-64: Post-Test Primary and Redundant Speed Trap Read-Out**
