**REPORT NUMBER: SPNCAP-CAL-25-005**

**NEW CAR ASSESSMENT PROGRAM (NCAP)  
SIDE IMPACT POLE TEST**

**Volkswagen de Mexico S.A. de C.V. Mexico  
2025 Volkswagen Tiguan  
5 Door SUV**

**NHTSA No: M20255804**

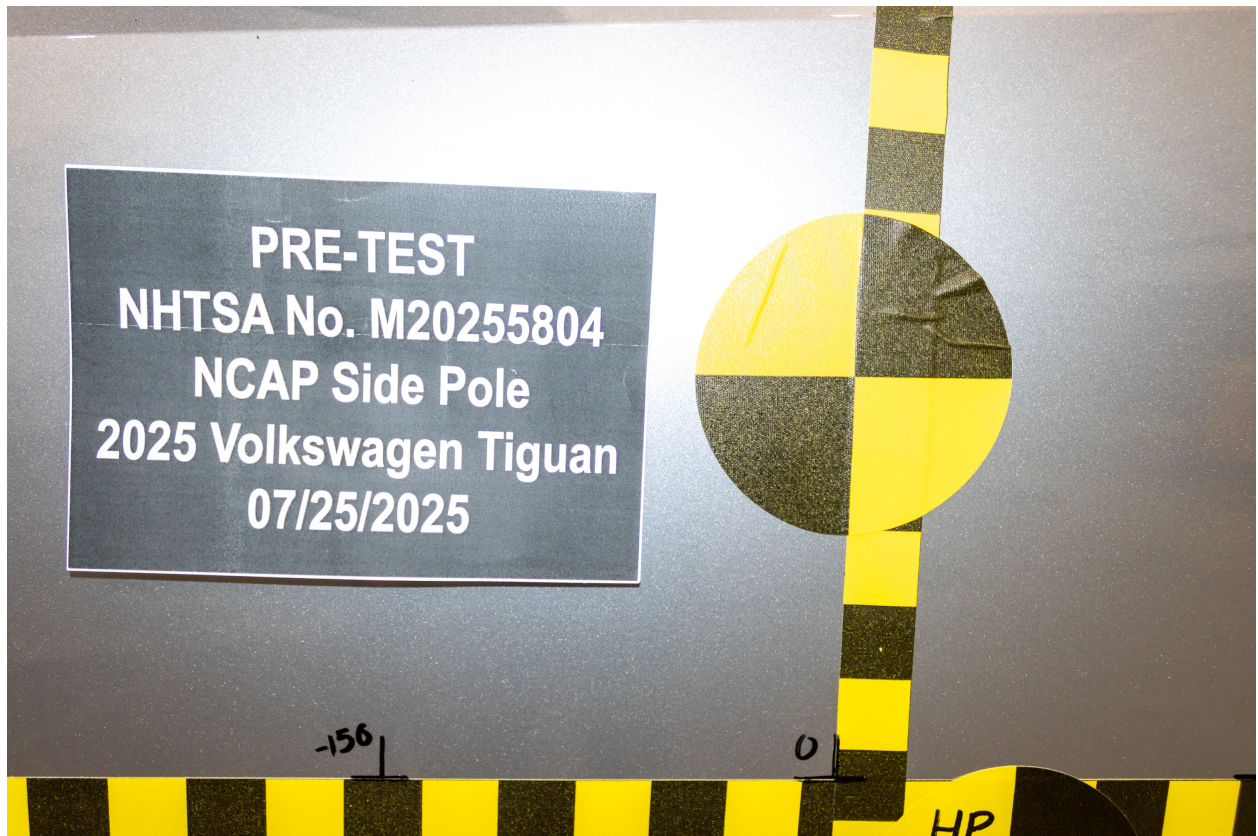
Figure A-19: Pre-Test Close-Up View of Impact Point Target

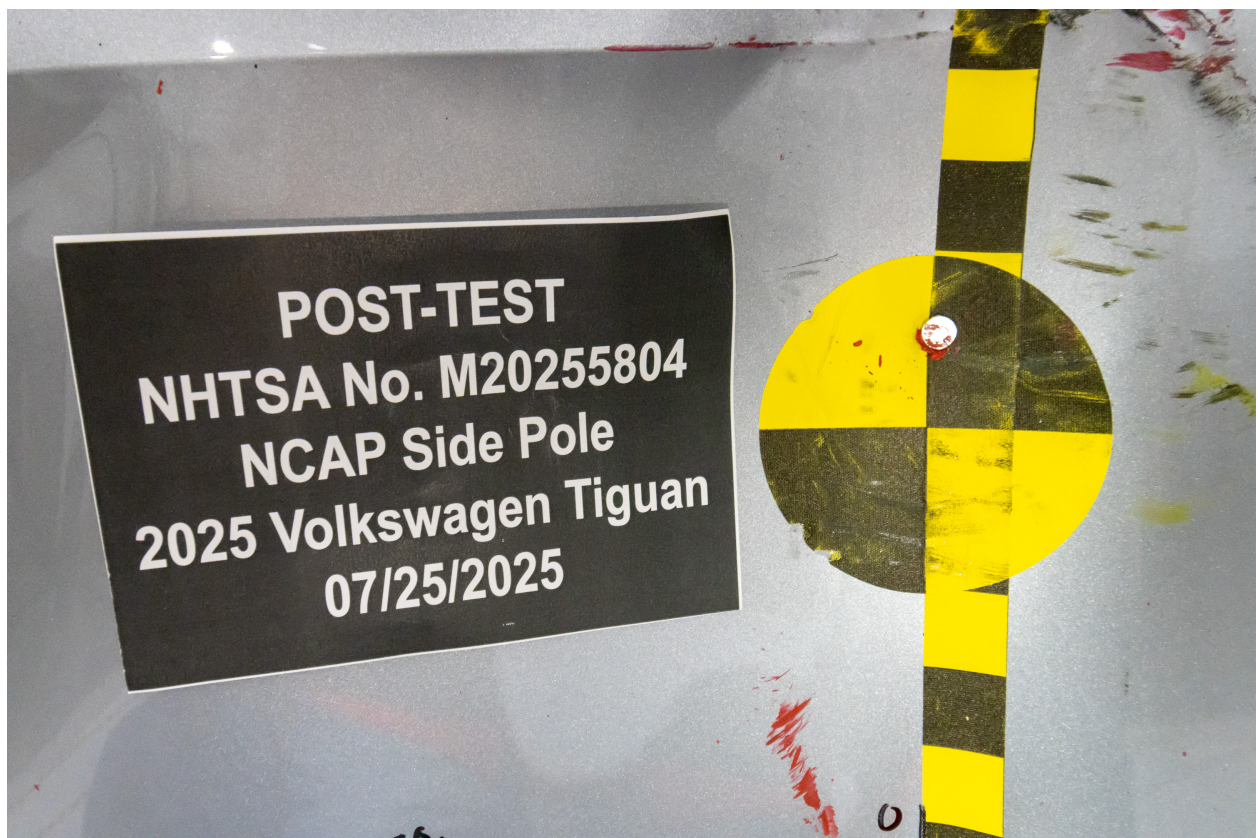
Figure A-20: Post-Test Close-Up View of Impact Point Target Showing Impact Location

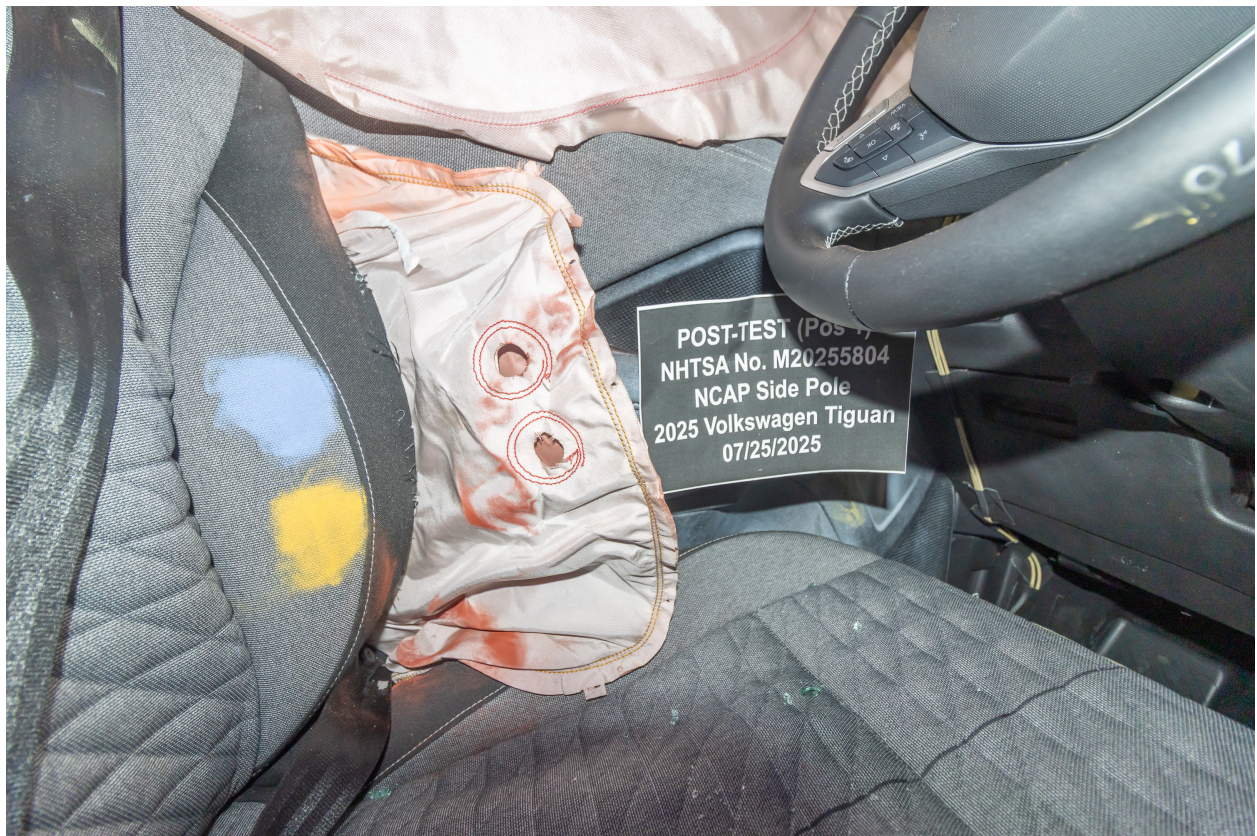
**Figure A-49: Post-Test Dummy Close-Up Torso Contact with Side Airbag View**

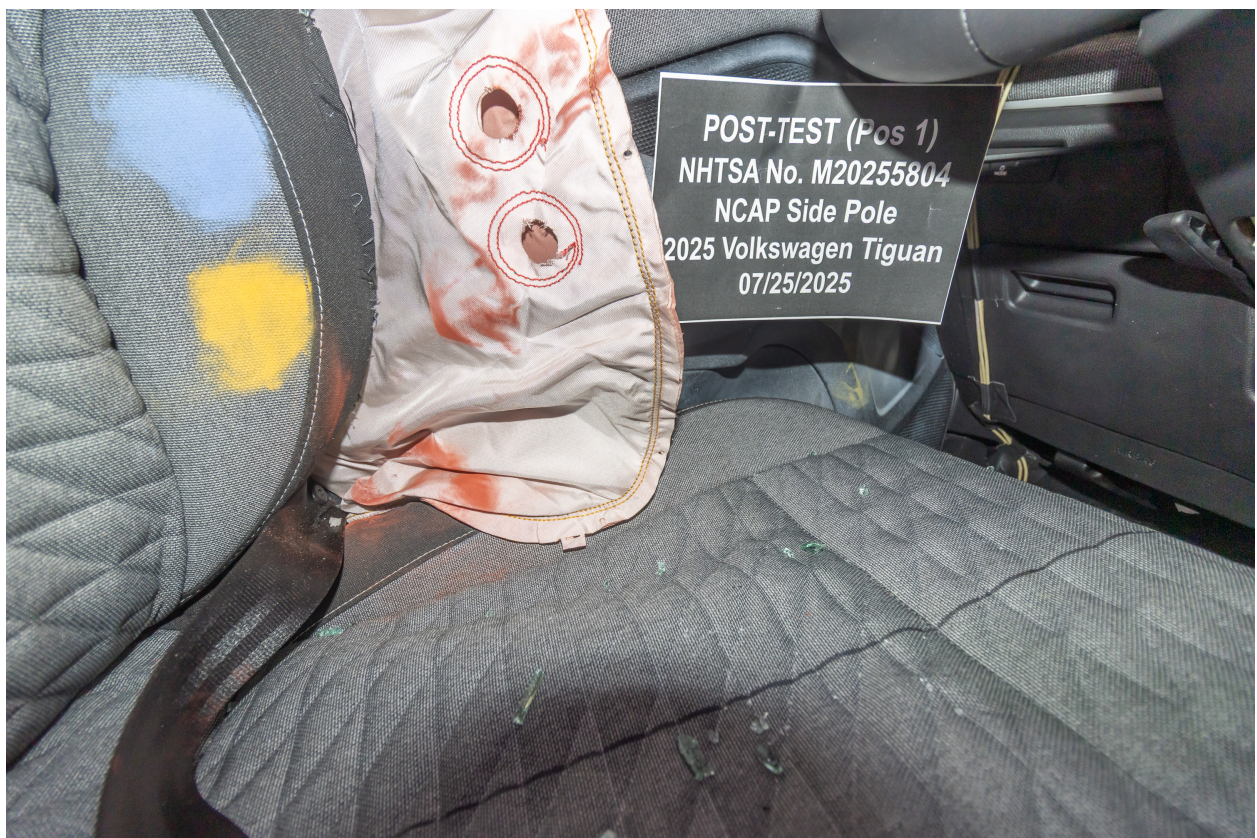
**Figure A-50: Post-Test Dummy Close-Up Pelvis Contact with Vehicle Interior View**

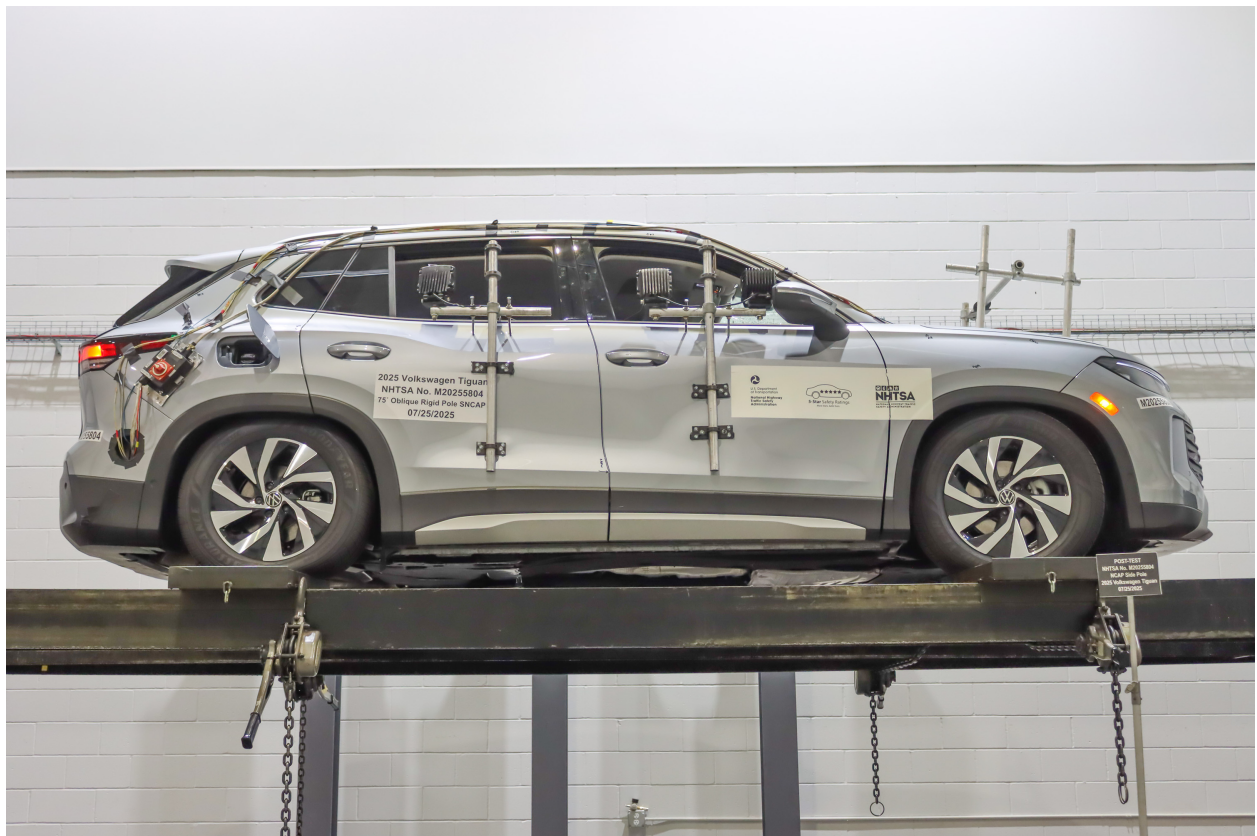
**Figure A-65: FMVSS No. 301 Static Rollover 0 Degrees**

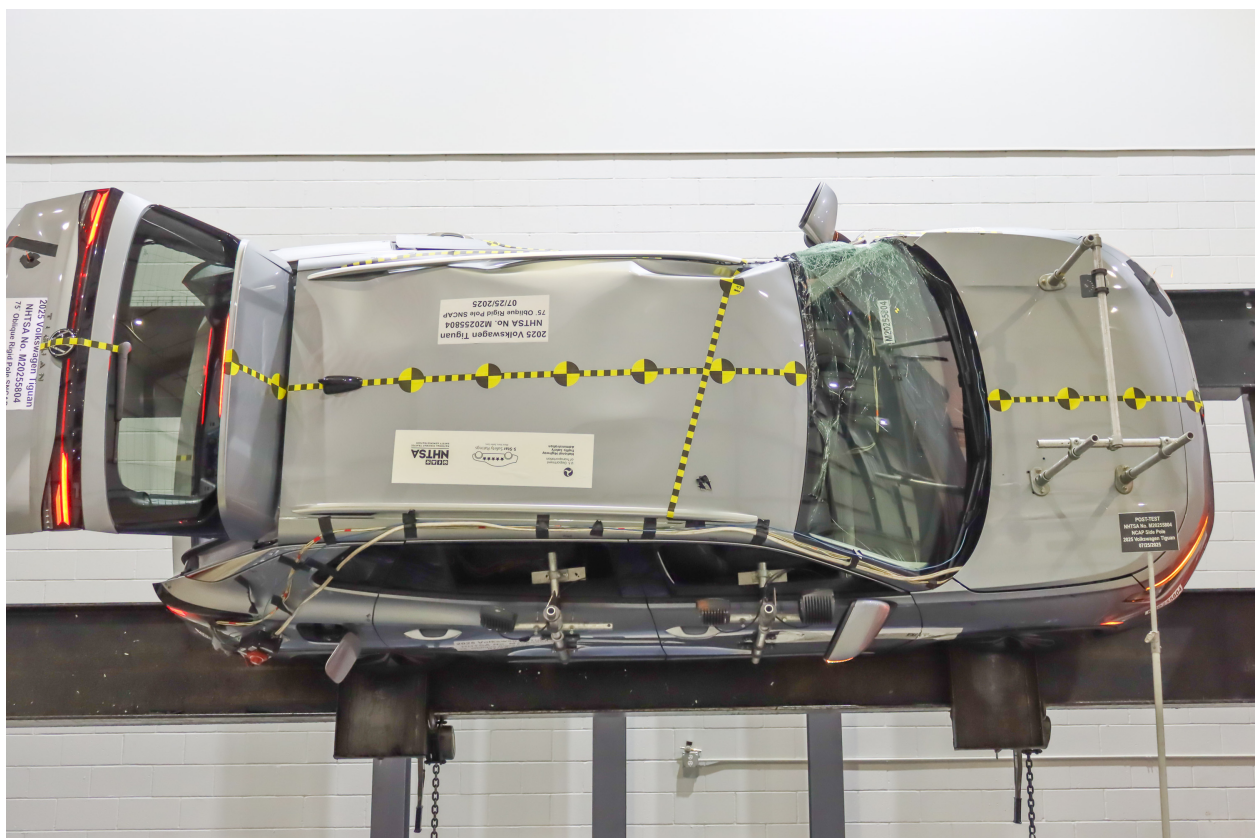
**Figure A-66: FMVSS No. 301 Static Rollover 90 Degrees**
