**REPORT NUMBER: 208-2360673-TEST**

**DUMMY PERFORMANCE CALIBRATIONS  
FMVSS 208**

**JAGUAR LAND ROVER LTD  
2023 LAND ROVER DEFENDER 110 MPV  
NHTSA NO.: C20234400**

**PREPARED BY:  
MGA RESEARCH CORPORATION  
5000 WARREN ROAD  
BURLINGTON, WI 53105**

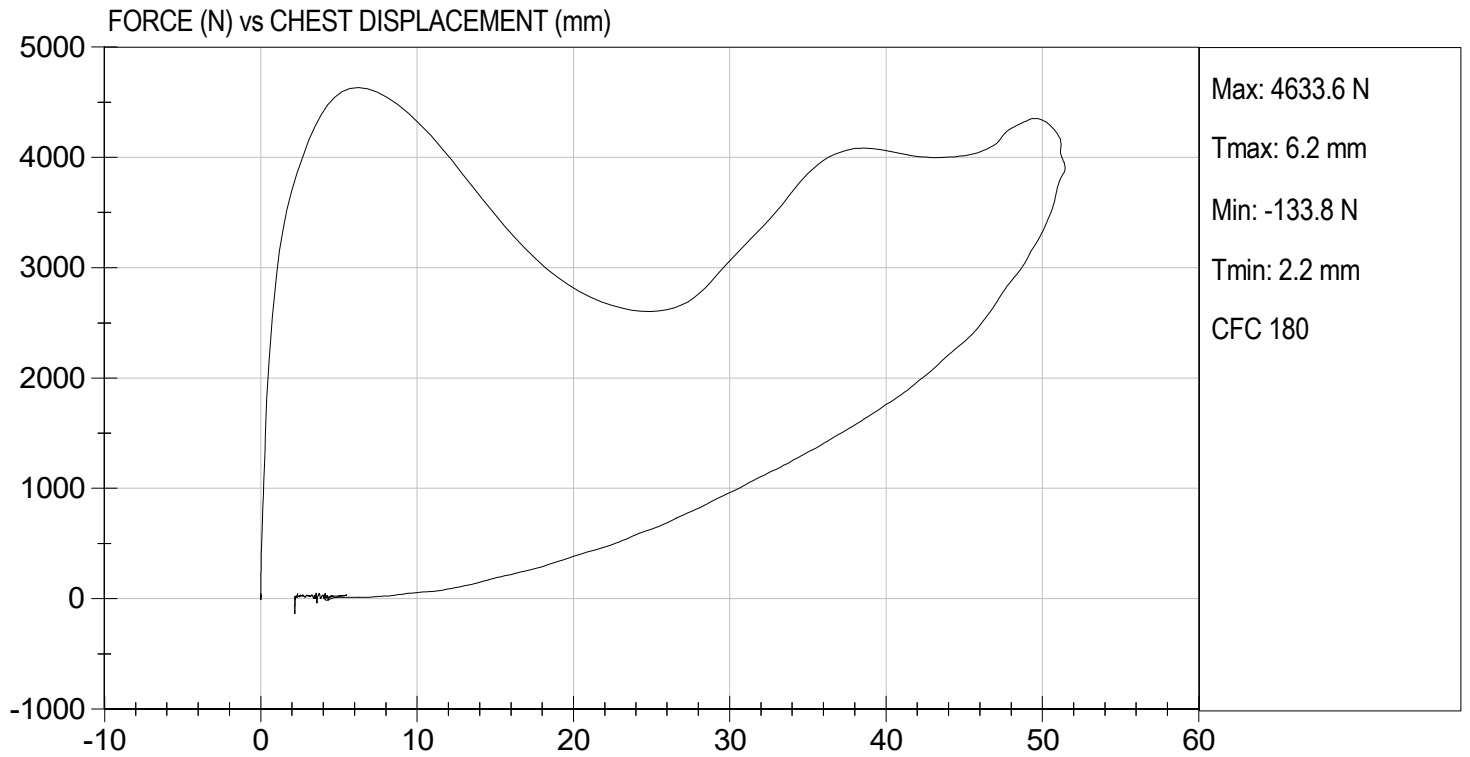
TEST DESC: THORAX IMPACT  
VELOCITY: 22.22 ft/s, 6.77 m/s

TEST DATE: 01/15/2024  
TEST #: D240134
