REPORT NUMBER: 208-MGA-2023-005

**DUMMY PERFORMANCE CALIBRATIONS
FMVSS 208**

**TOYOTA MOTOR CORPORATION
2023 SUBARU SOLTERRA
NHTSA NO.: C20235500**

**PREPARED BY:
MGA RESEARCH CORPORATION
5000 WARREN ROAD
BURLINGTON, WI 53105**

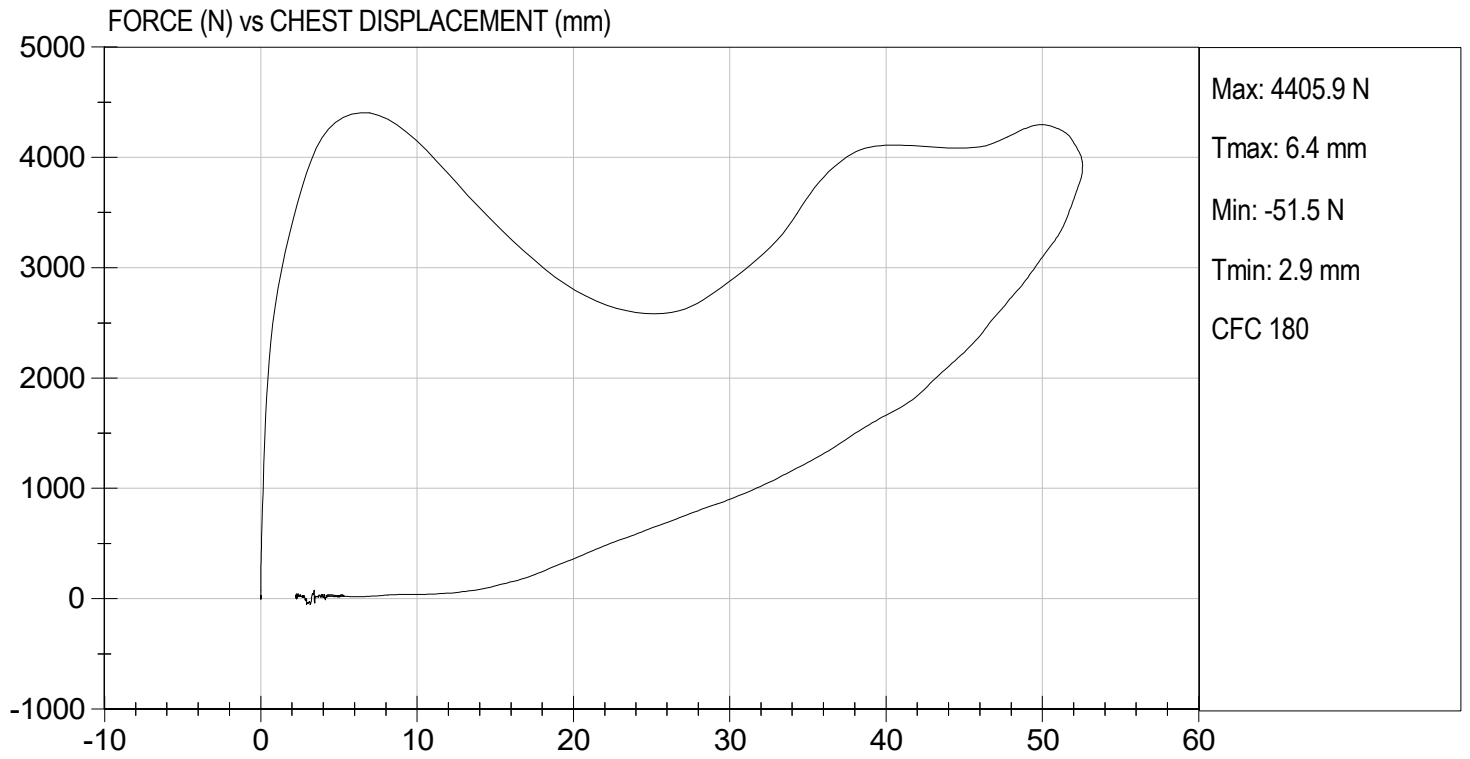
TEST DESC: THORAX IMPACT
VELOCITY: 21.65 ft/s, 6.60 m/s

TEST DATE: 09/28/2023
TEST #: D232694

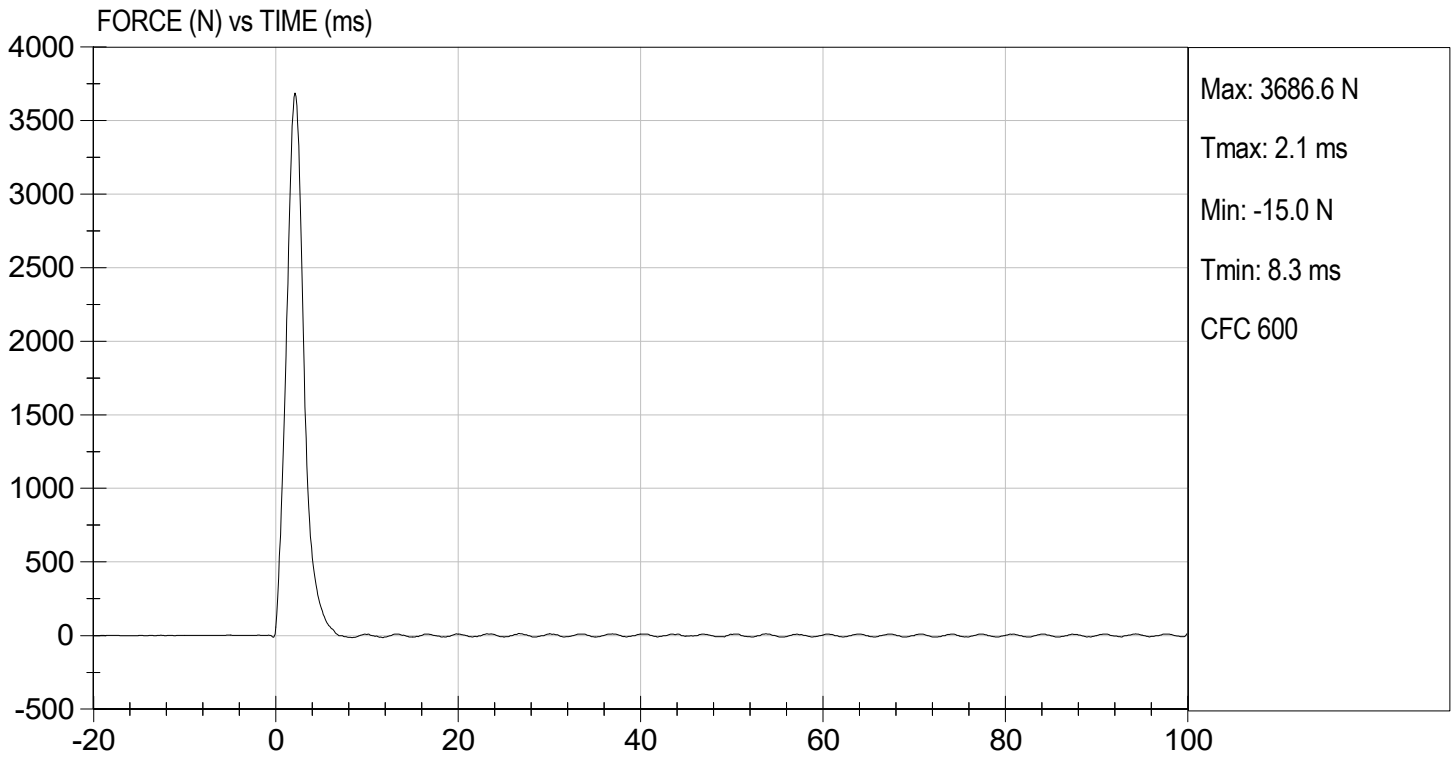
TEST DESC: LEFT KNEE
VELOCITY: 6.92 ft/s, 2.11 m/s

TEST DATE: 09/28/2023
TEST #: D232696

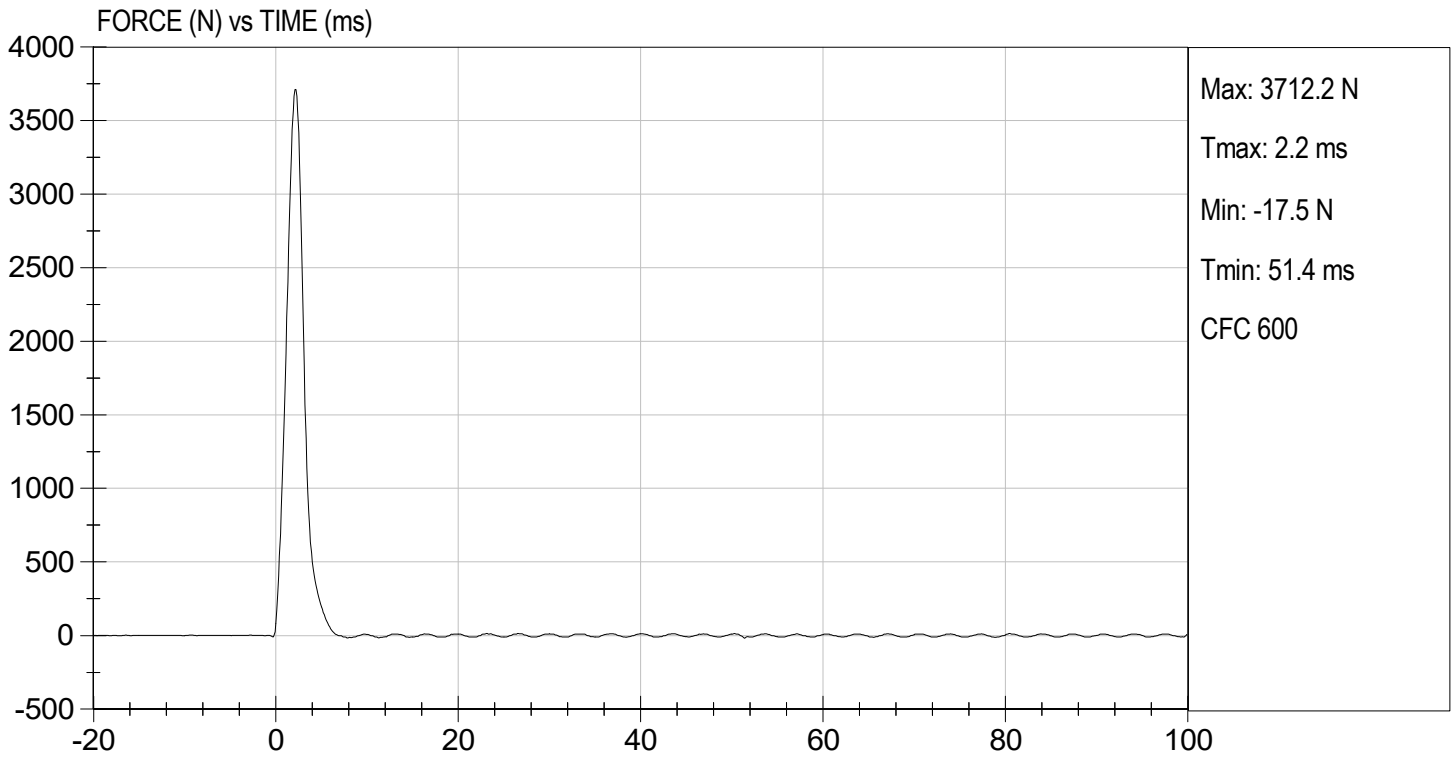
TEST DESC: RIGHT KNEE
VELOCITY: 6.94 ft/s, 2.12 m/s

TEST DATE: 09/28/2023
TEST #: D232695

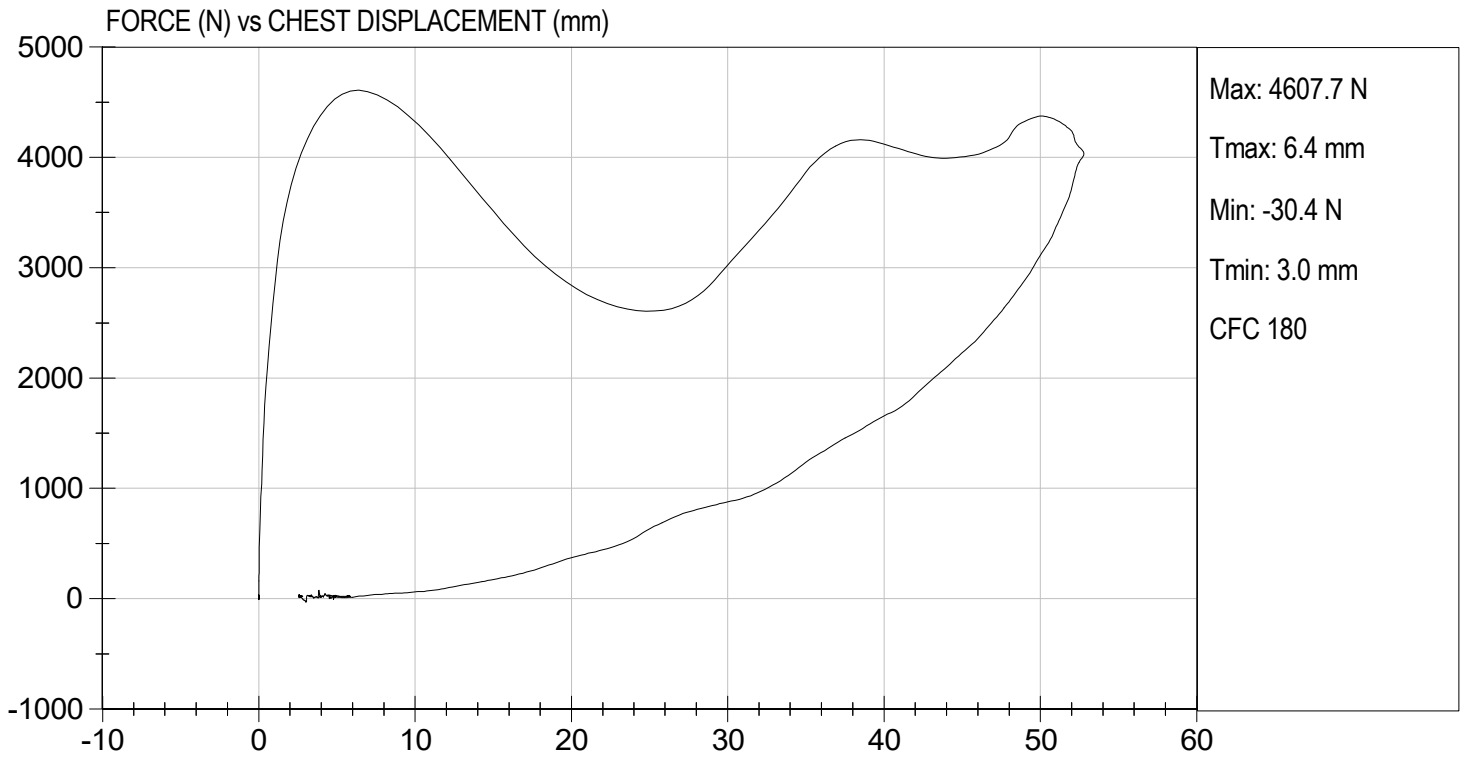
TEST DESC: THORAX IMPACT
VELOCITY: 21.93 ft/s, 6.68 m/s

TEST DATE: 09/20/2023
TEST #: D232604

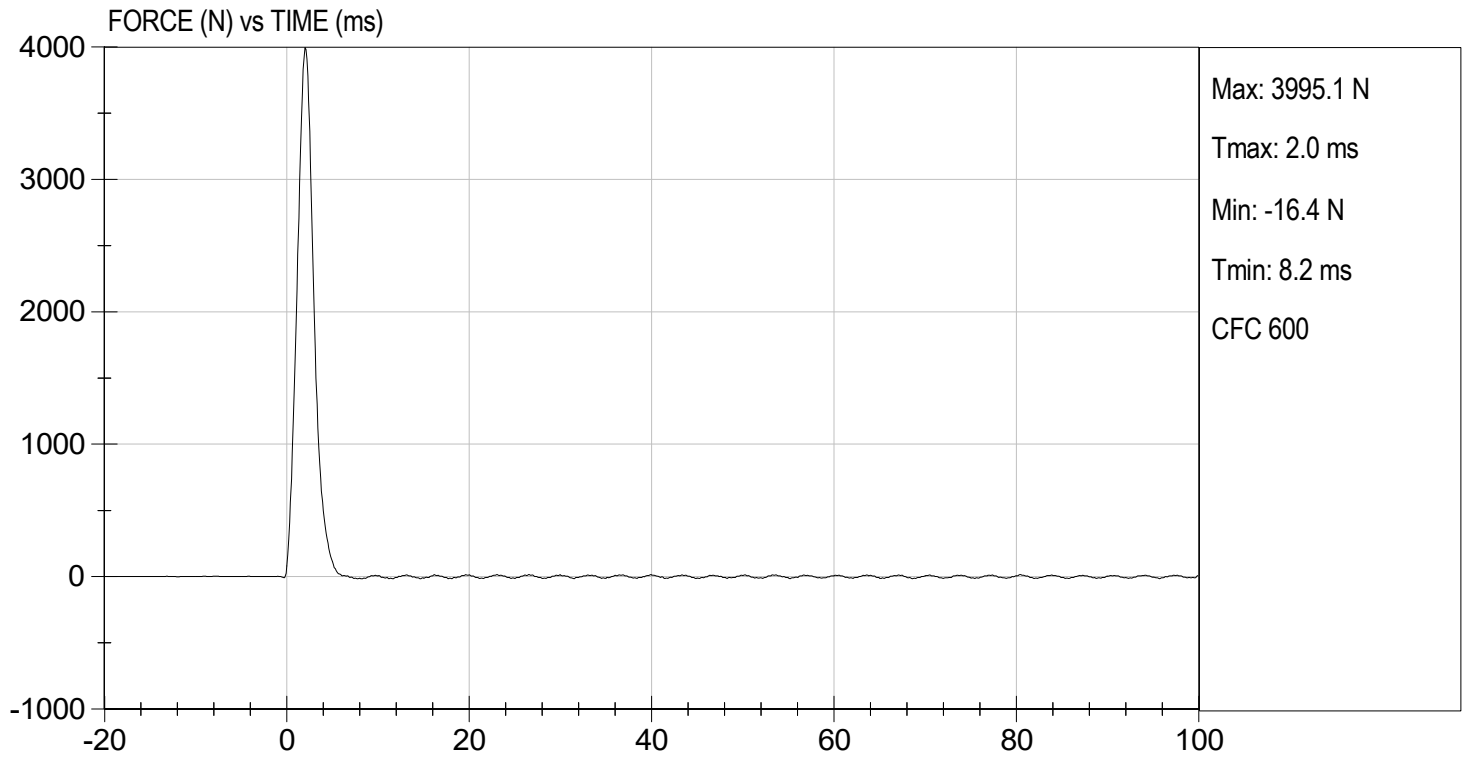
TEST DESC: LEFT KNEE
VELOCITY: 6.89 ft/s, 2.10 m/s

TEST DATE: 09/28/2023
TEST #: D232686

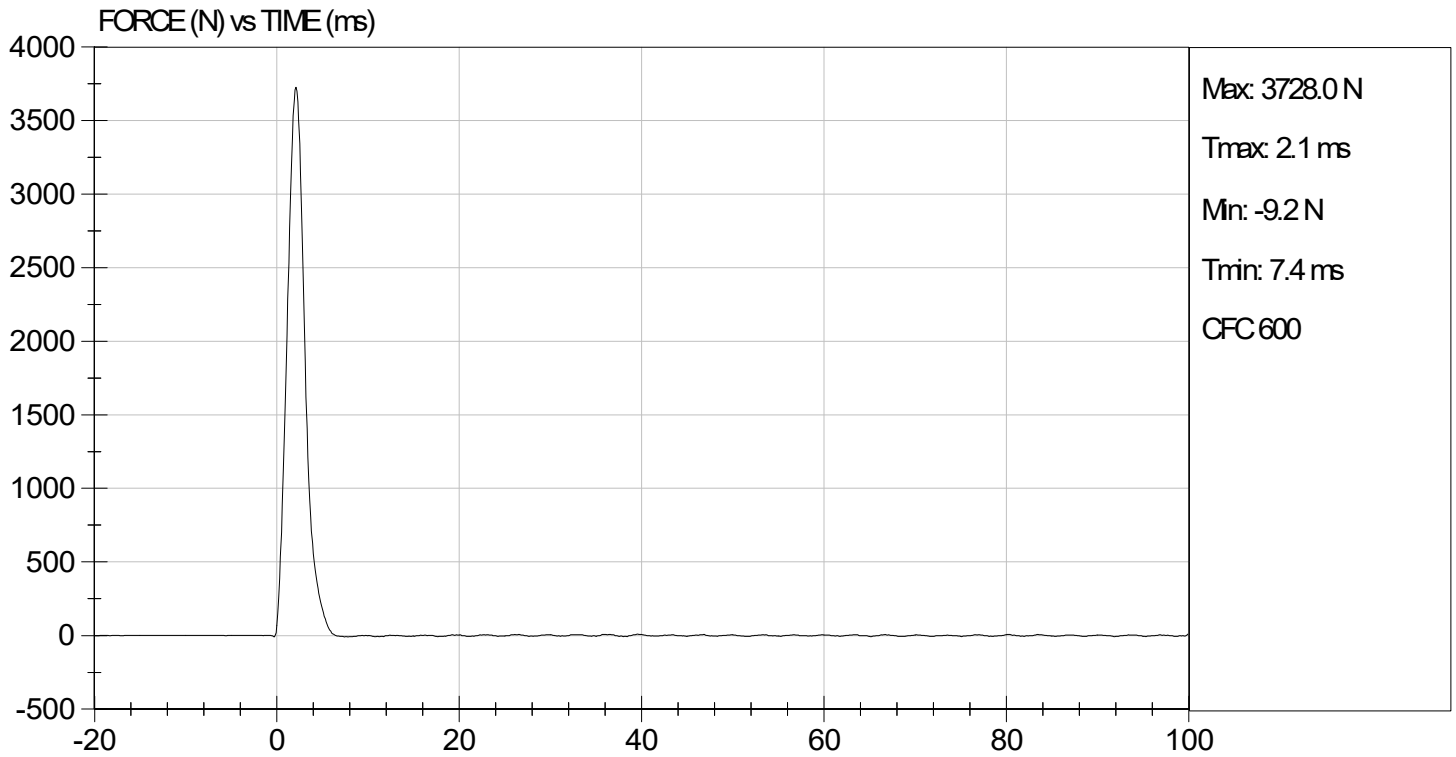
TEST DESC: RIGHT KNEE
VELOCITY: 6.92 ft/s, 2.11 m/s

TEST DATE: 09/28/2023
TEST #: D232685

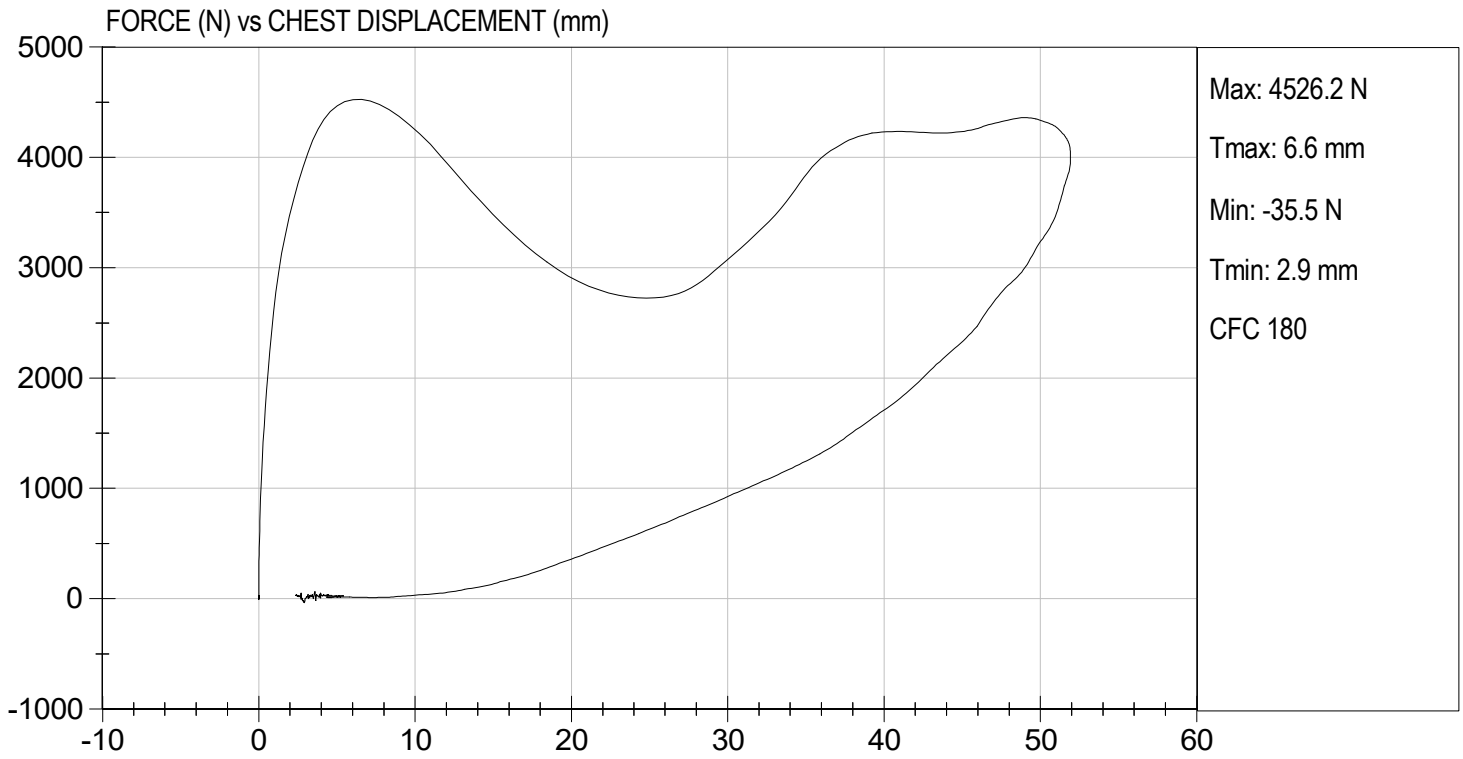
TEST DESC: THORAX IMPACT
VELOCITY: 22.22 ft/s, 6.77 m/s

TEST DATE: 07/28/2023
TEST #: D231994

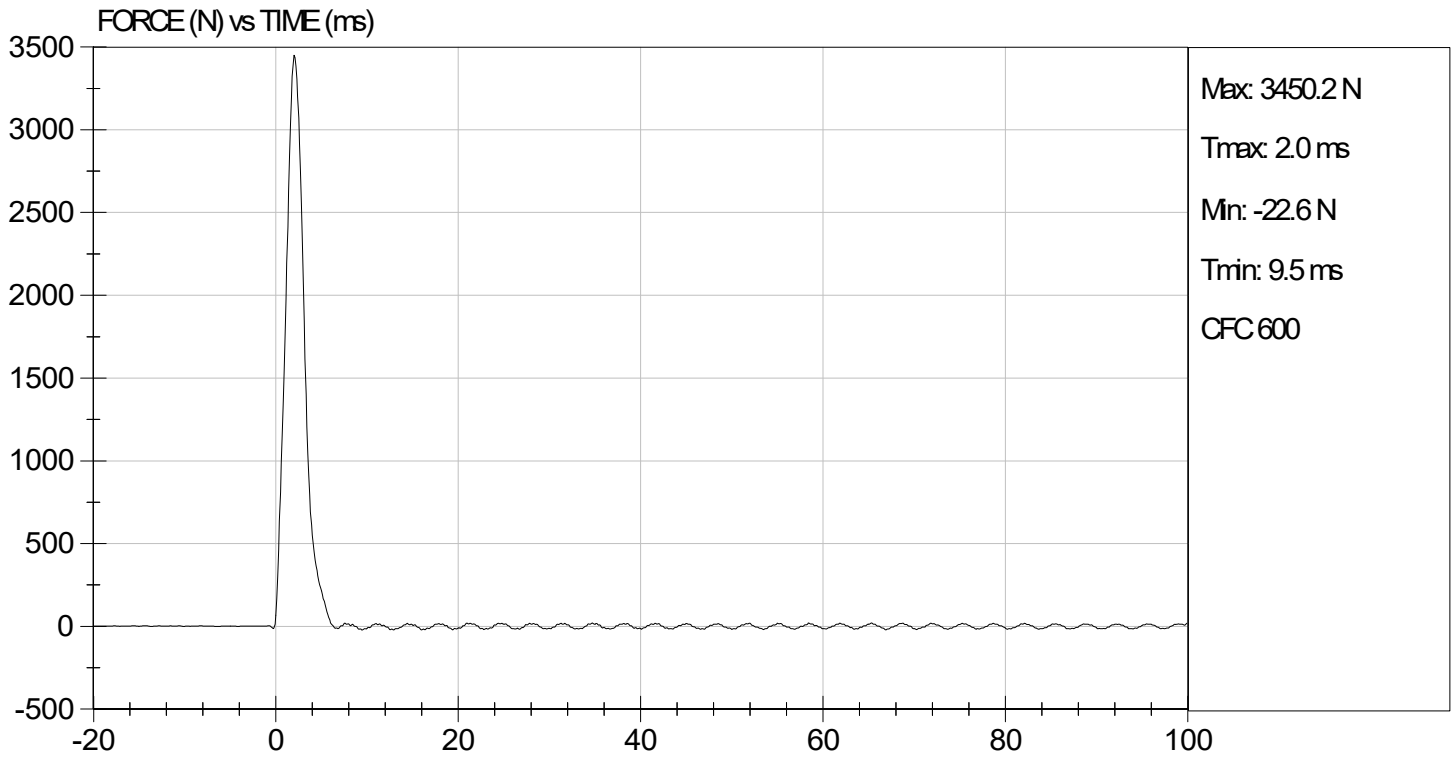
TEST DESC: LEFT KNEE
VELOCITY: 6.94 ft/s, 2.12 m/s

TEST DATE: 07/28/2023
TEST #: D231996

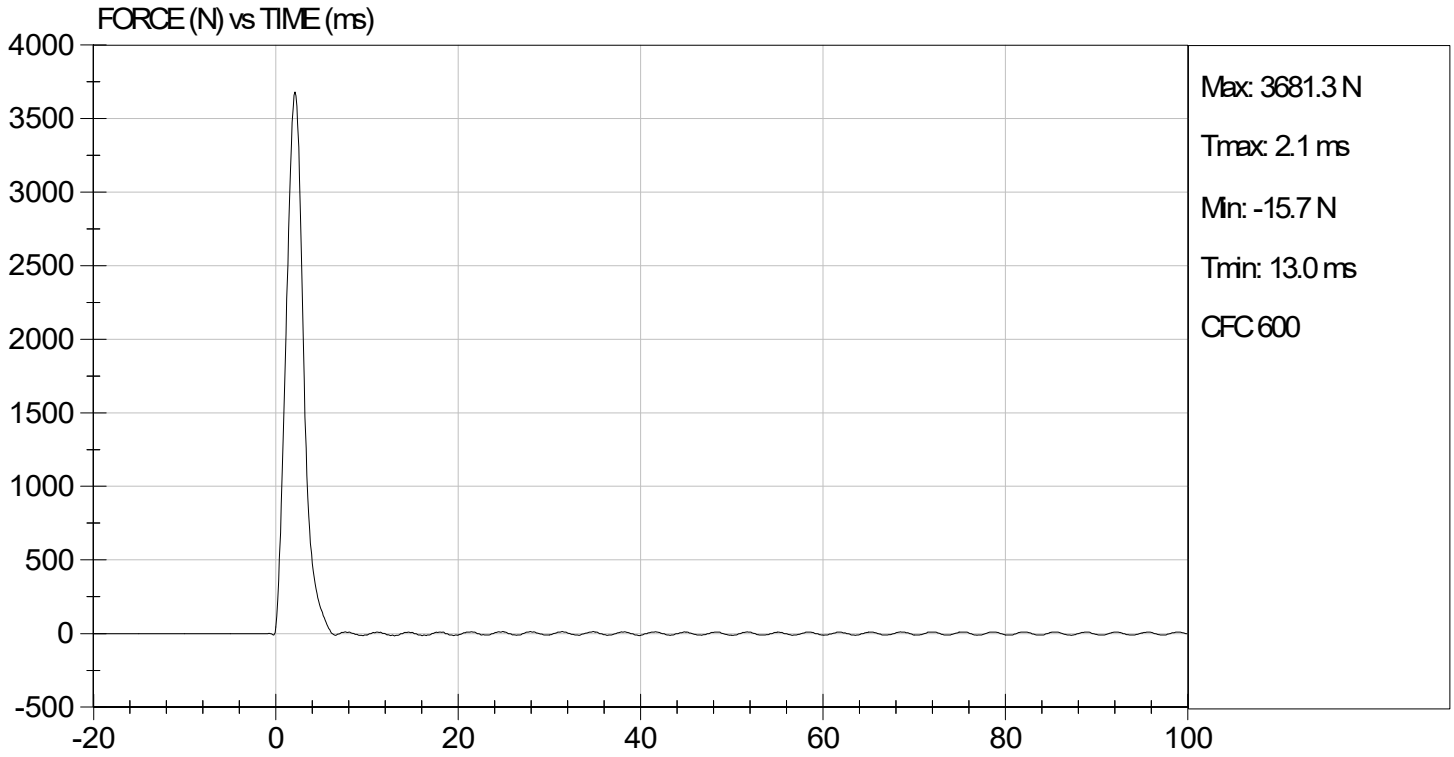
TEST DESC: RIGHT KNEE
VELOCITY: 6.92 ft/s, 2.11 m/s

TEST DATE: 07/28/2023
TEST #: D231995

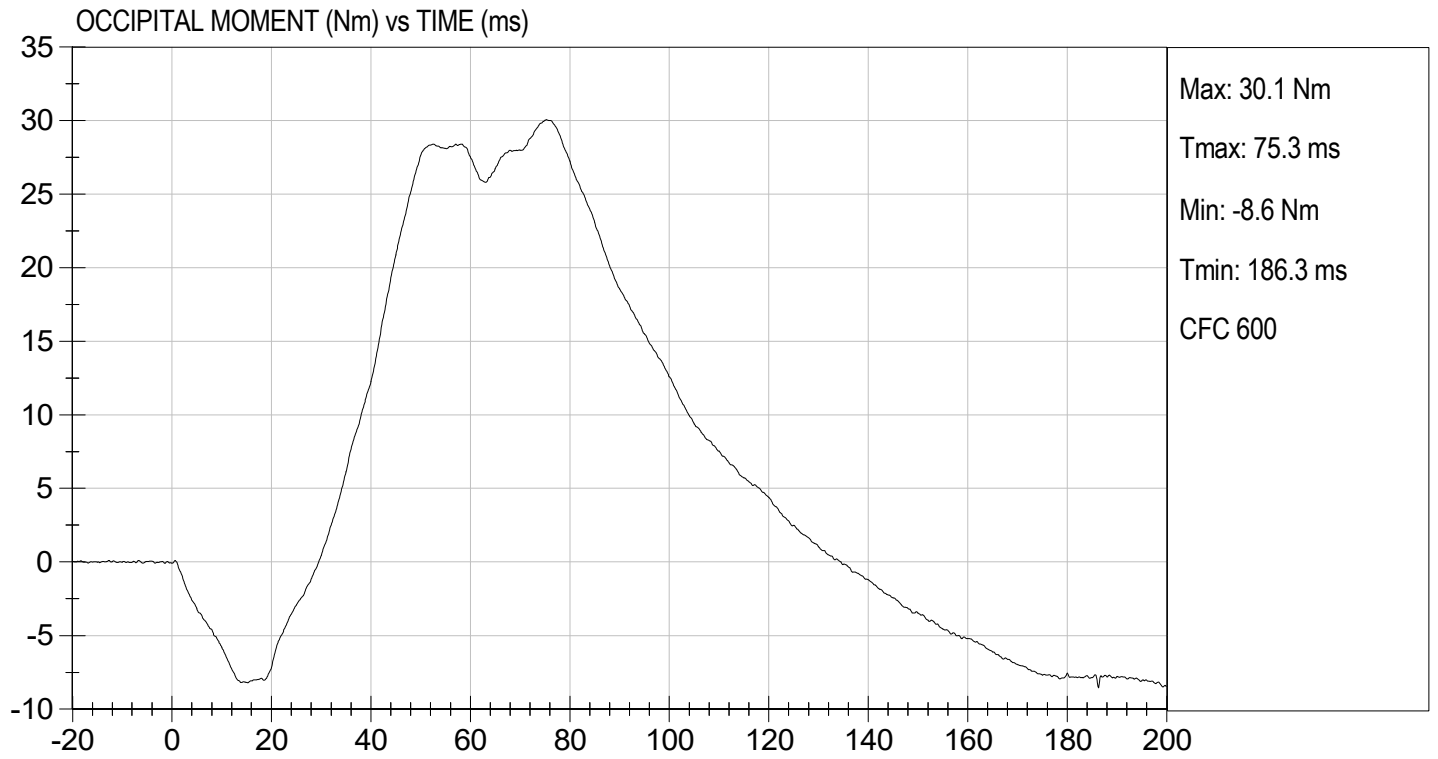
TEST DESC: NECK FLEXION
VELOCITY: 16.03 ft/s, 4.89 m/s

TEST DATE: 08/22/2023
TEST #: D232112
