**REPORT NUMBER: 208-MGA-2023-004**

**DUMMY PERFORMANCE CALIBRATIONS  
FMVSS 208**

**VOLVO CAR CORPORATION  
2023 VOLVO XC40  
NHTSA NO.: C20235900**

**PREPARED BY:  
MGA RESEARCH CORPORATION  
5000 WARREN ROAD  
BURLINGTON, WI 53105**

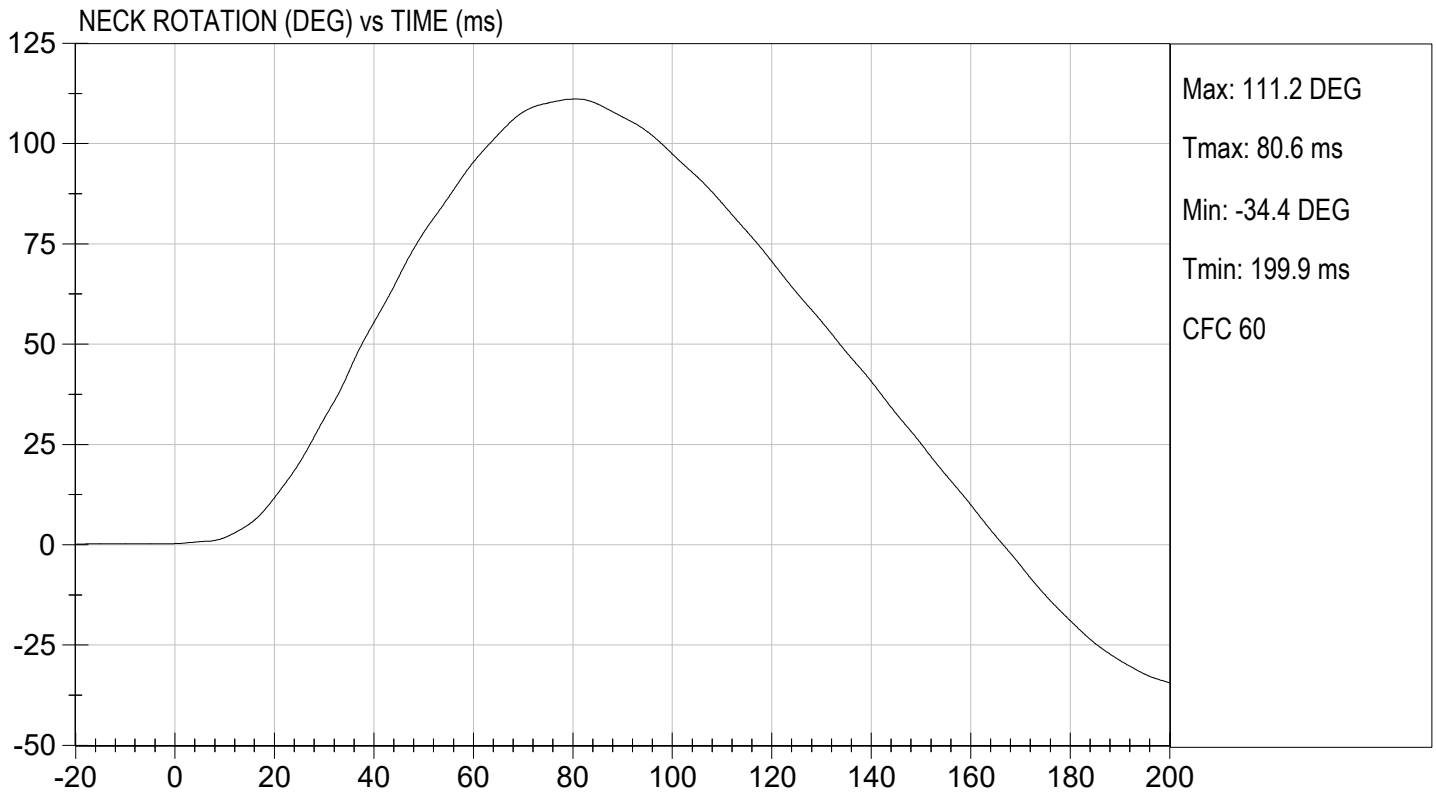
TEST DESC: NECK EXTENSION  
VELOCITY: 20.08 ft/s, 6.12 m/s

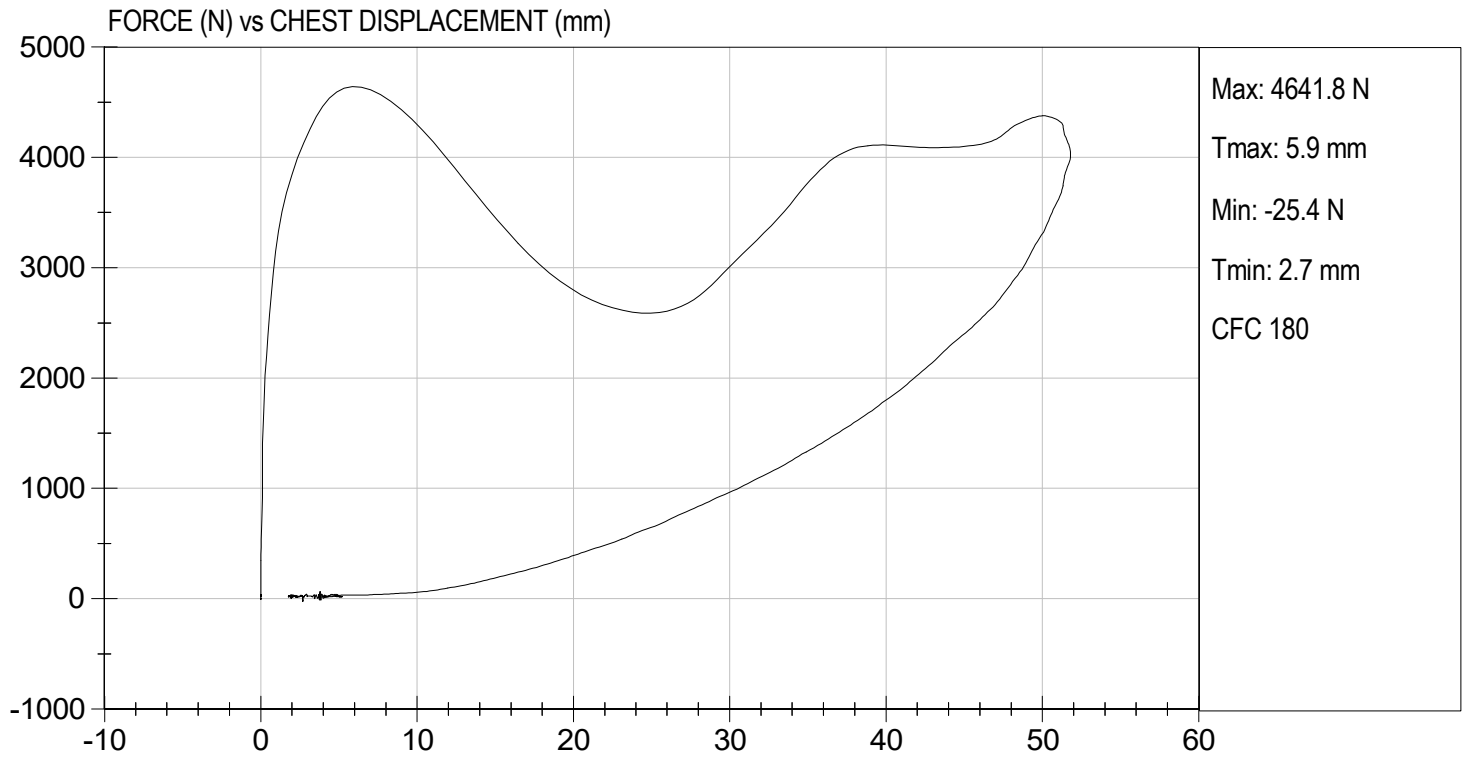
TEST DATE: 08/18/2023  
TEST #: D232234

TEST DESC: THORAX IMPACT  
VELOCITY: 21.93 ft/s, 6.68 m/s

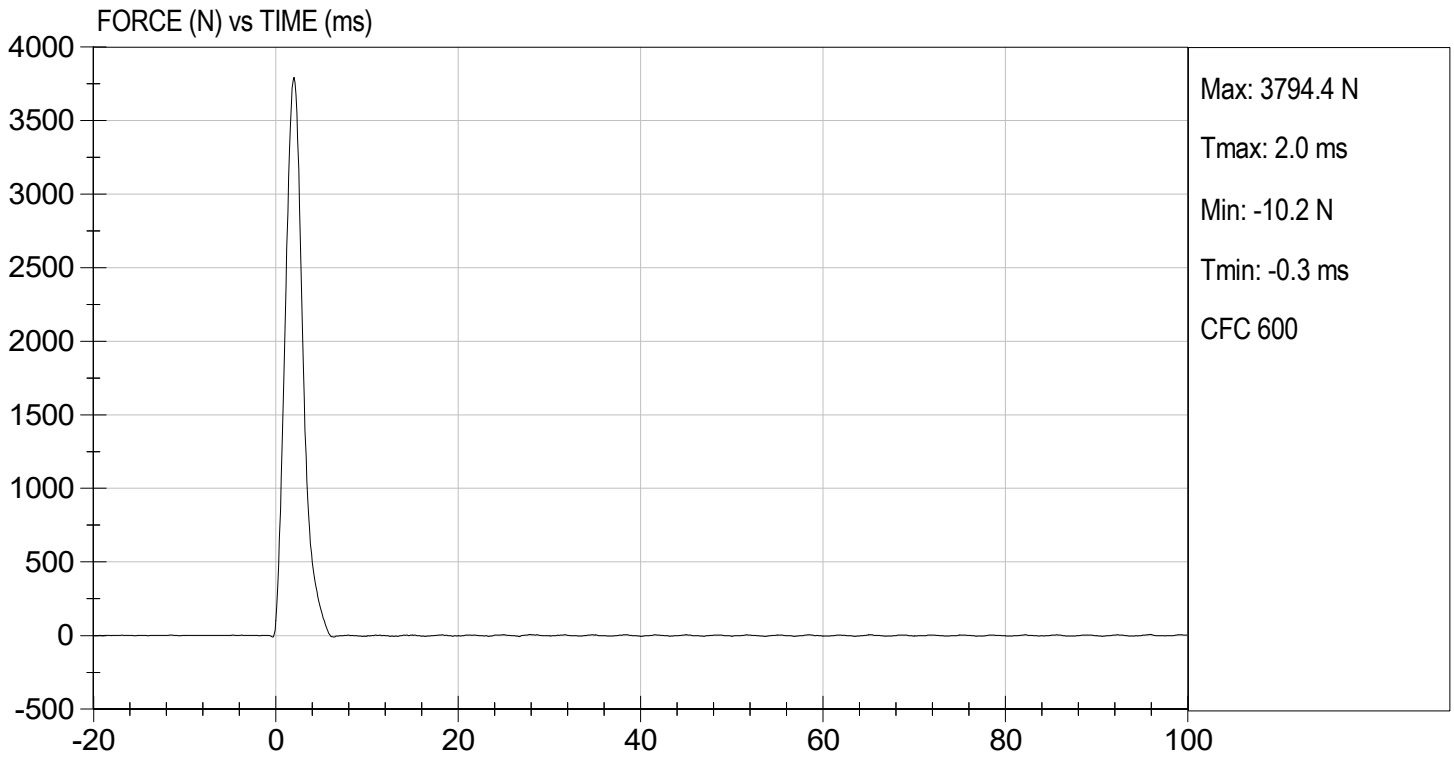
TEST DATE: 08/16/2023  
TEST #: D232236

TEST DESC: LEFT KNEE  
VELOCITY: 6.97 ft/s, 2.12 m/s

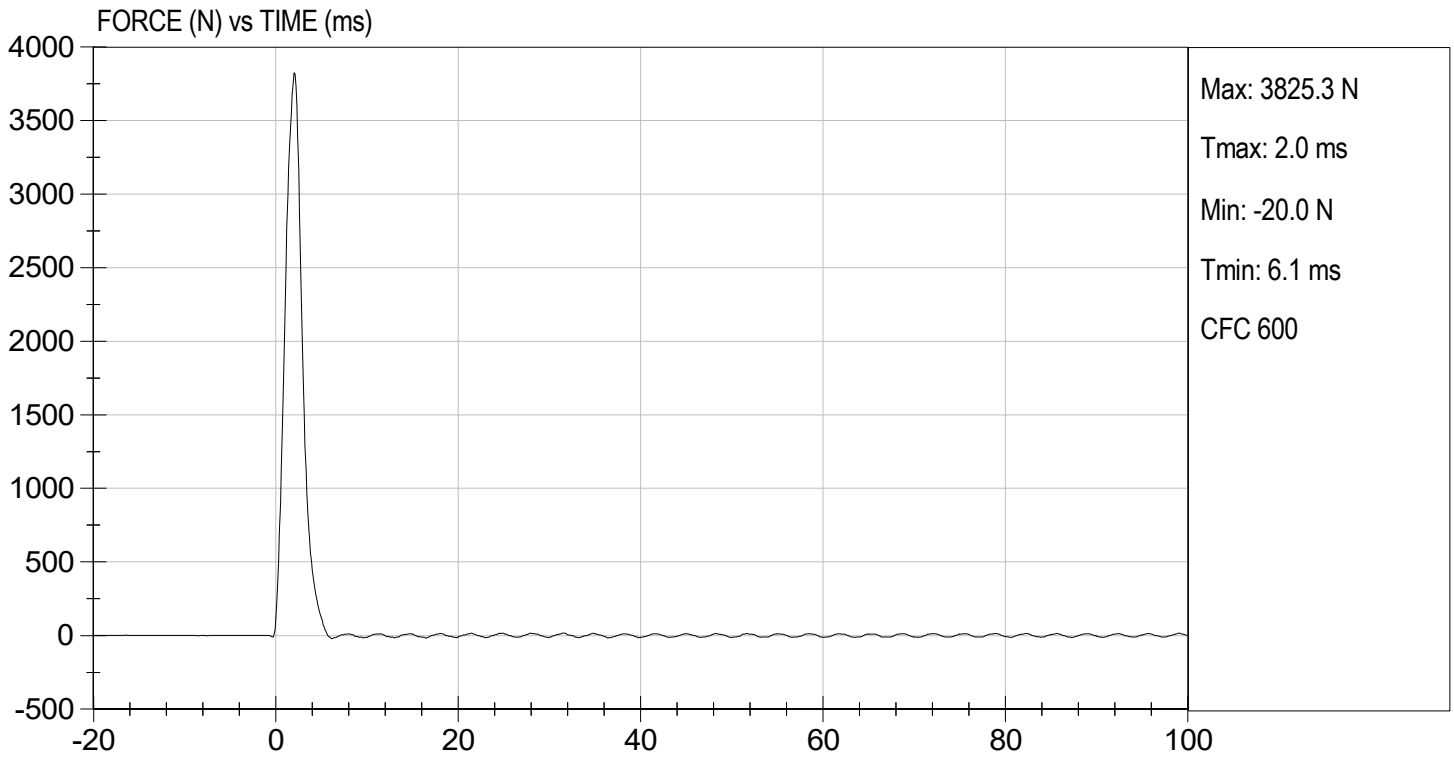
TEST DATE: 08/16/2023  
TEST #: D232235

TEST DESC: RIGHT KNEE  
VELOCITY: 6.97 ft/s, 2.12 m/s

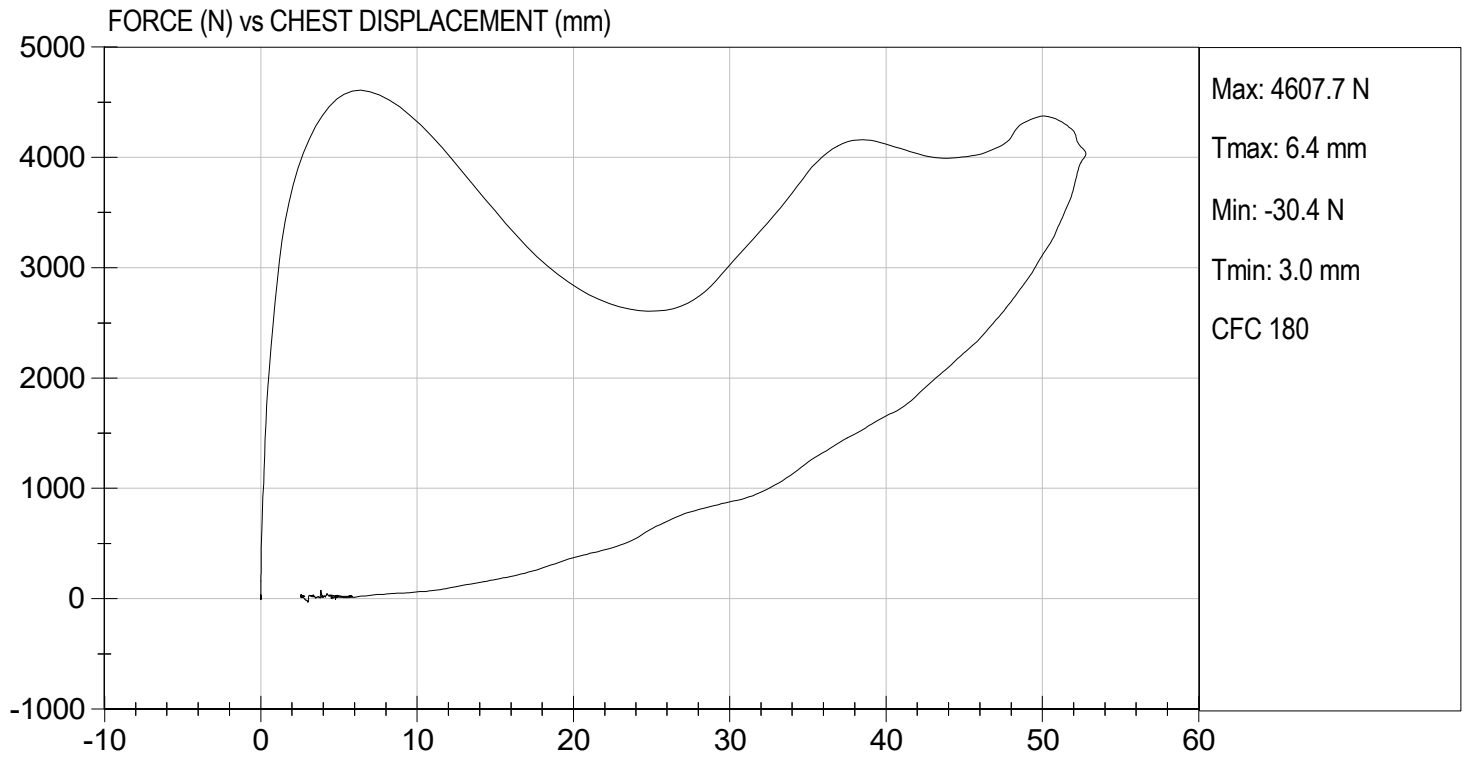
TEST DATE: 09/20/2023  
TEST #: D232604

TEST DESC: THORAX IMPACT  
VELOCITY: 21.93 ft/s, 6.68 m/s

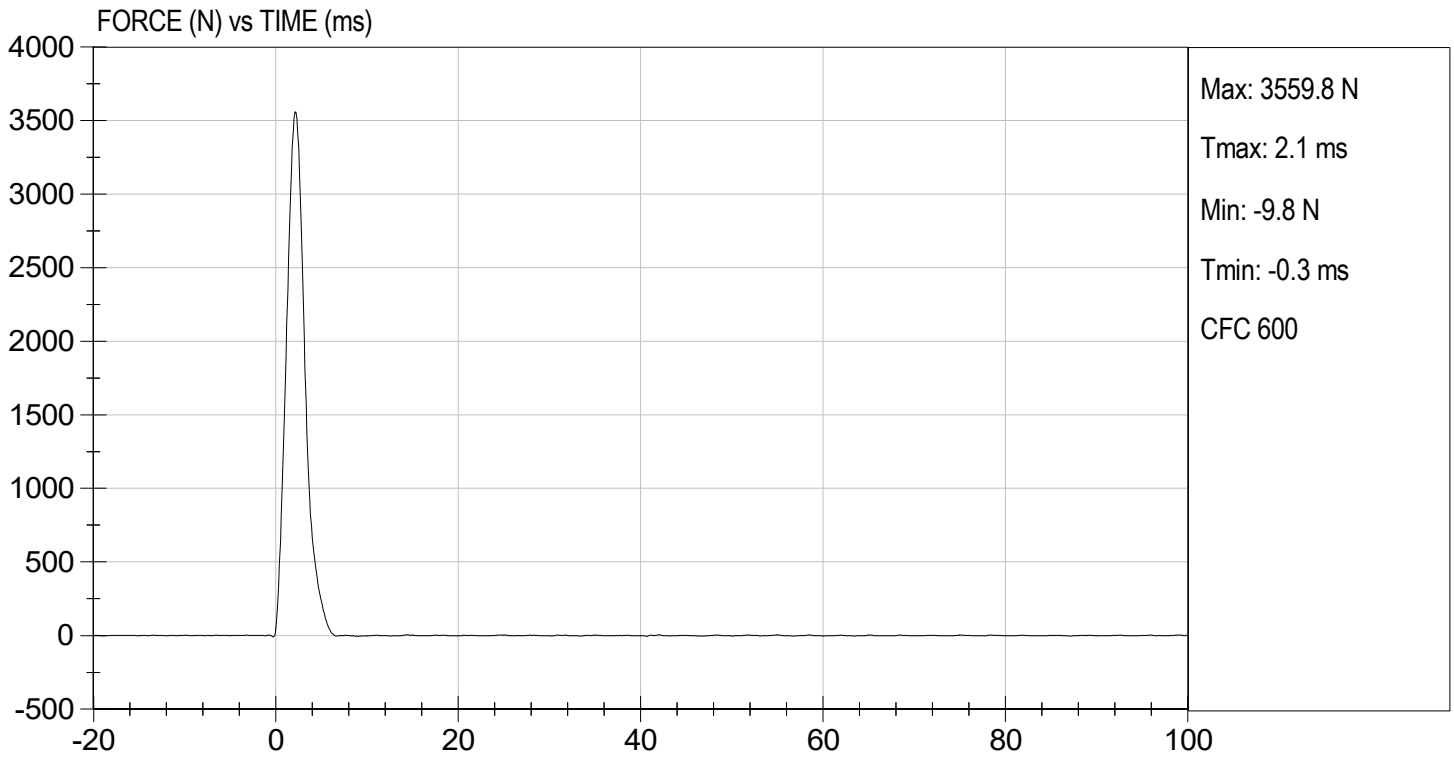
TEST DATE: 09/20/2023  
TEST #: D232606

TEST DESC: LEFT KNEE  
VELOCITY: 6.86 ft/s, 2.09 m/s

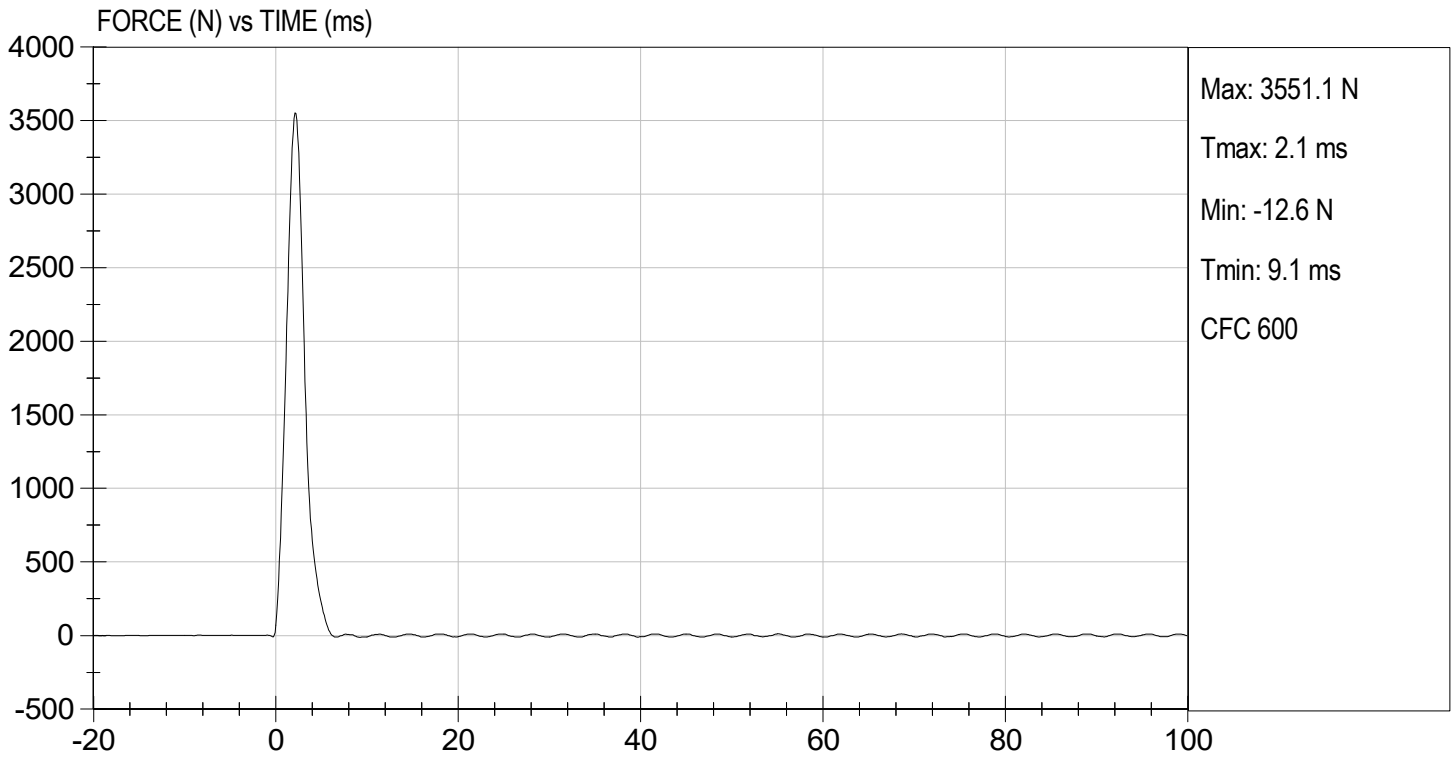
TEST DATE: 09/20/2023  
TEST #: D232605

TEST DESC: RIGHT KNEE  
VELOCITY: 6.86 ft/s, 2.09 m/s

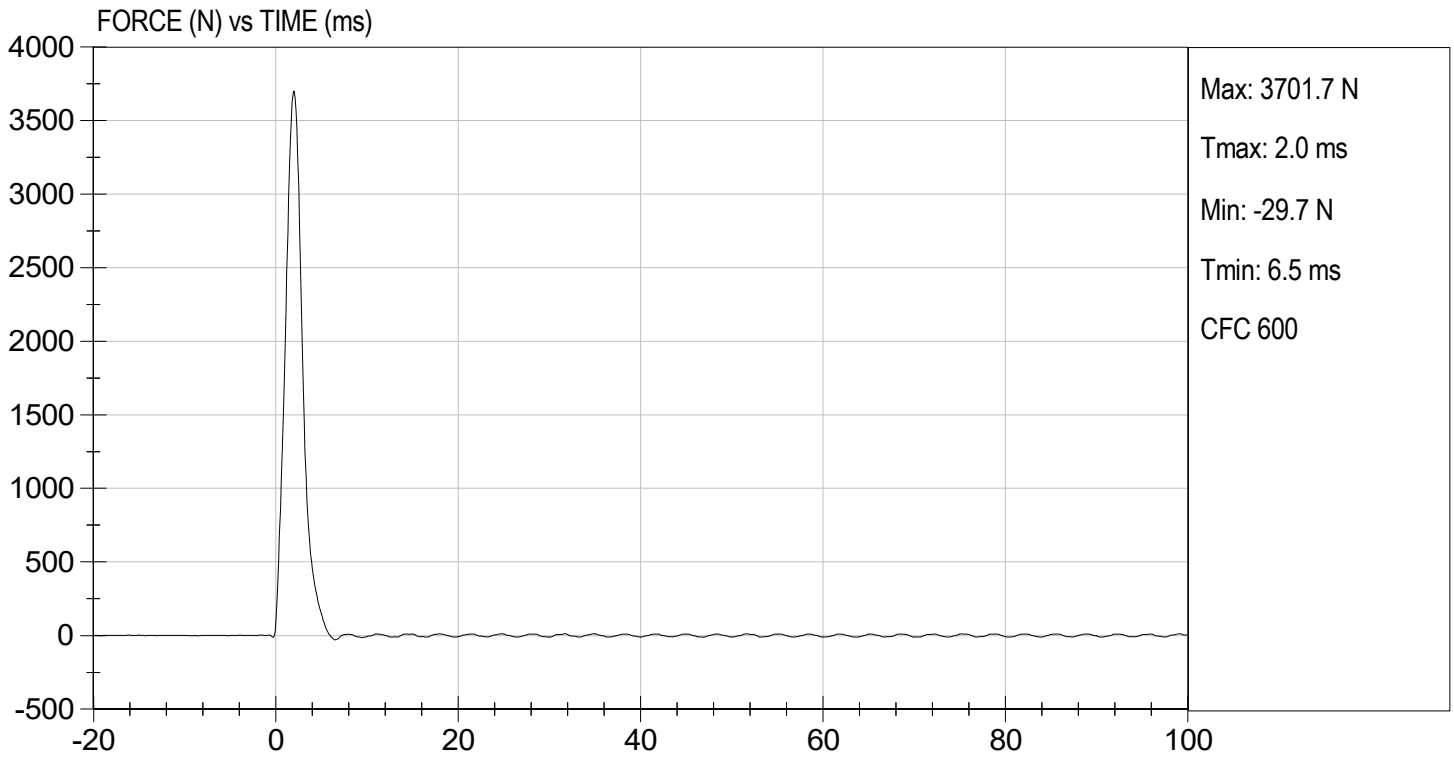
TEST DATE: 09/20/2023  
TEST #: D232616

TEST DESC: LEFT KNEE  
VELOCITY: 6.89 ft/s, 2.10 m/s

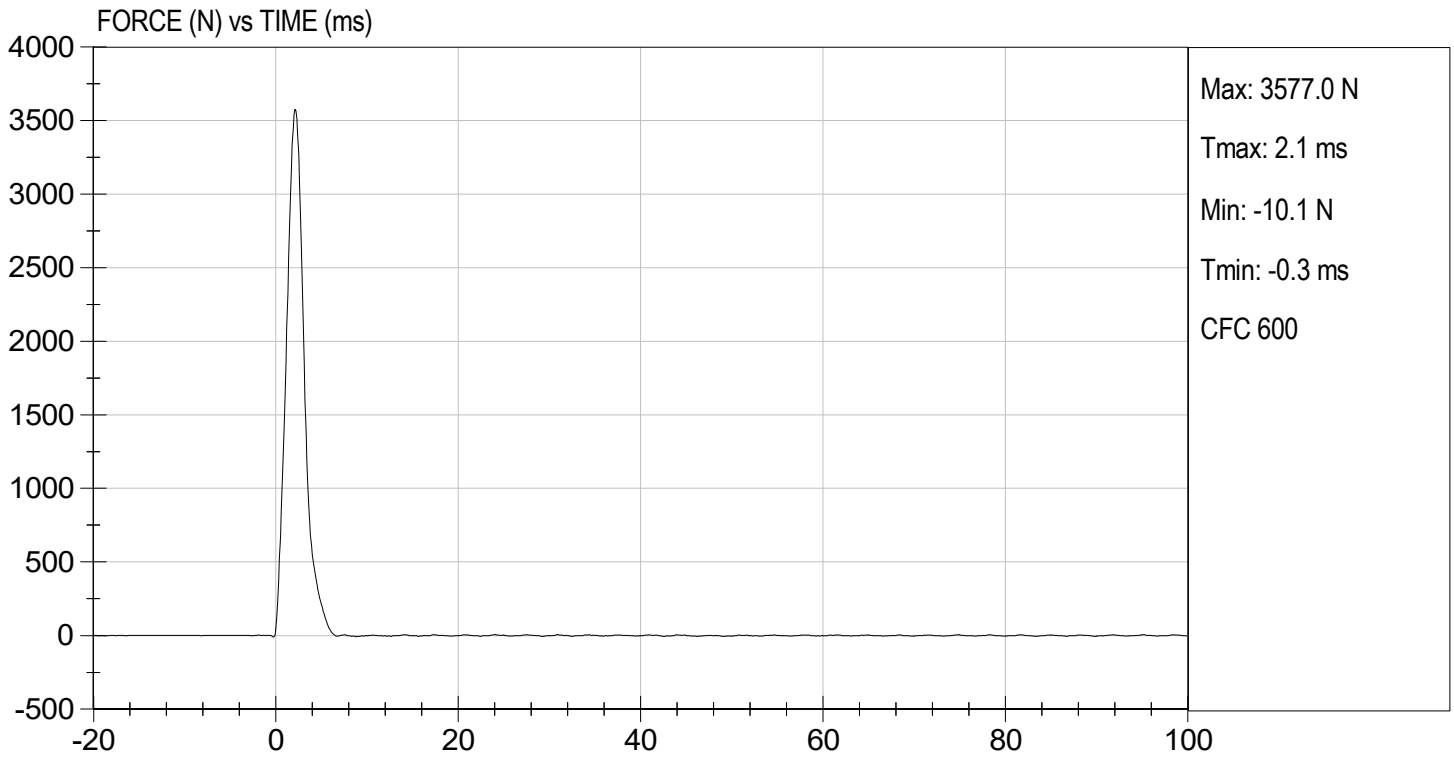
TEST DATE: 09/20/2023  
TEST #: D232615

TEST DESC: RIGHT KNEE  
VELOCITY: 6.83 ft/s, 2.08 m/s

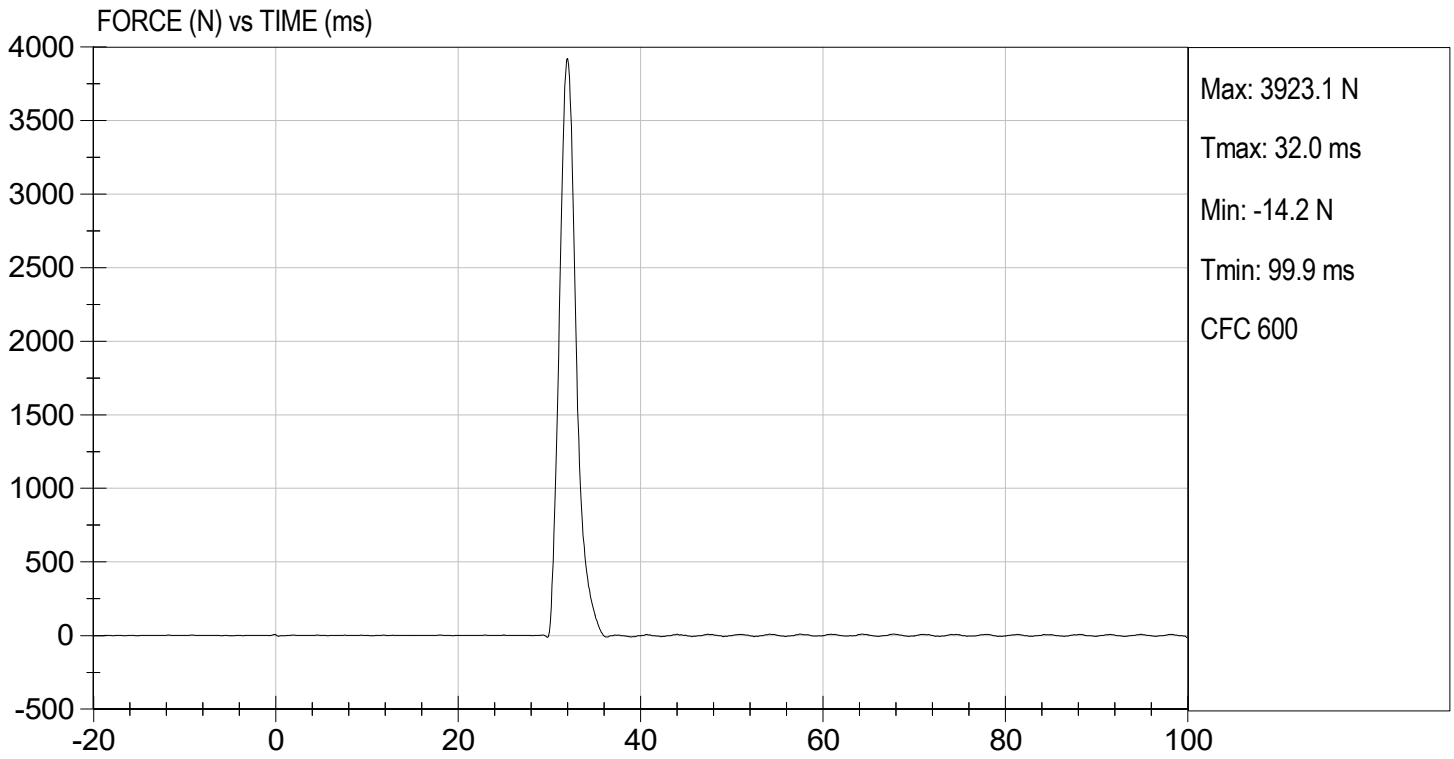
TEST DATE: 03/20/2023  
TEST #: D230726

TEST DESC: LEFT KNEE  
VELOCITY: 6.97 ft/s, 2.12 m/s

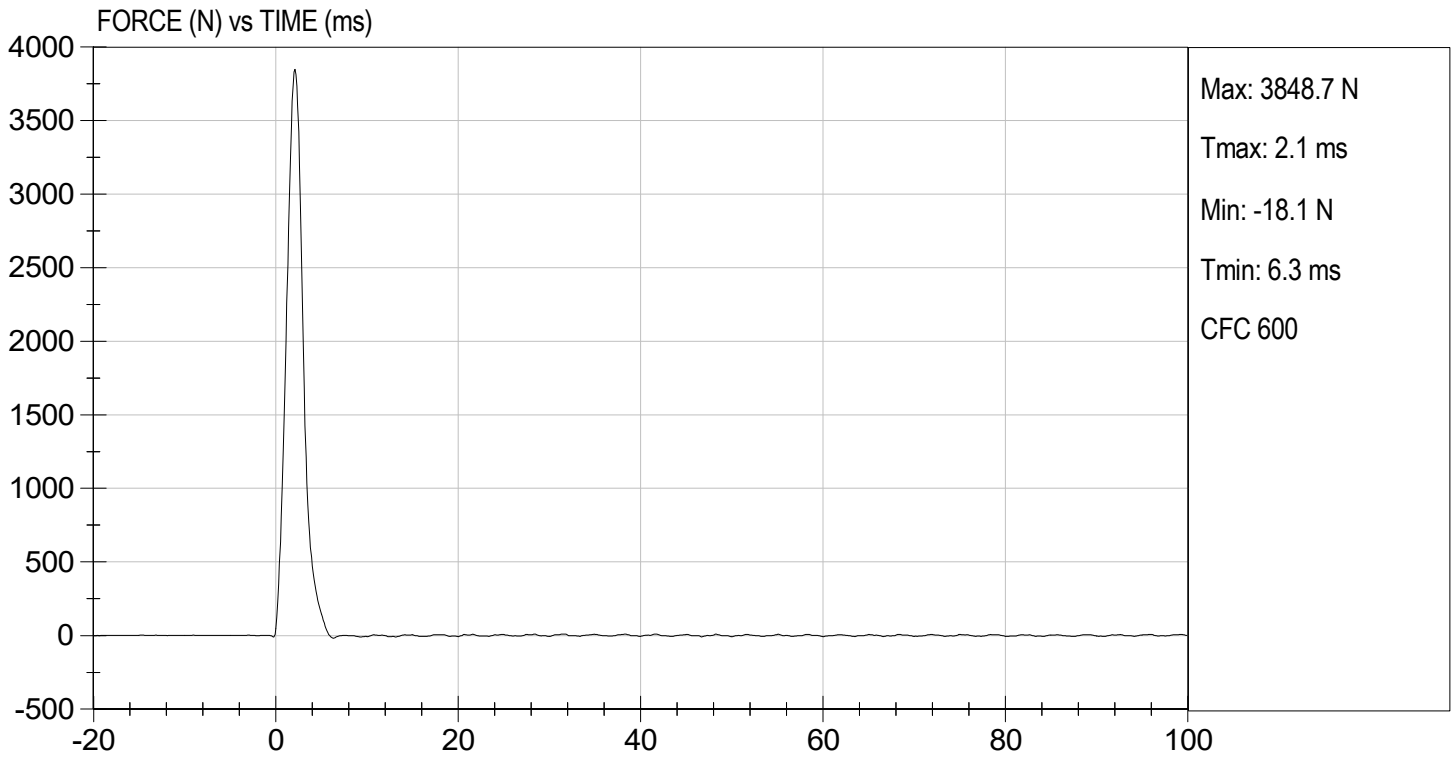
TEST DATE: 03/20/2023  
TEST #: D230725

TEST DESC: RIGHT KNEE  
VELOCITY: 6.94 ft/s, 2.12 m/s

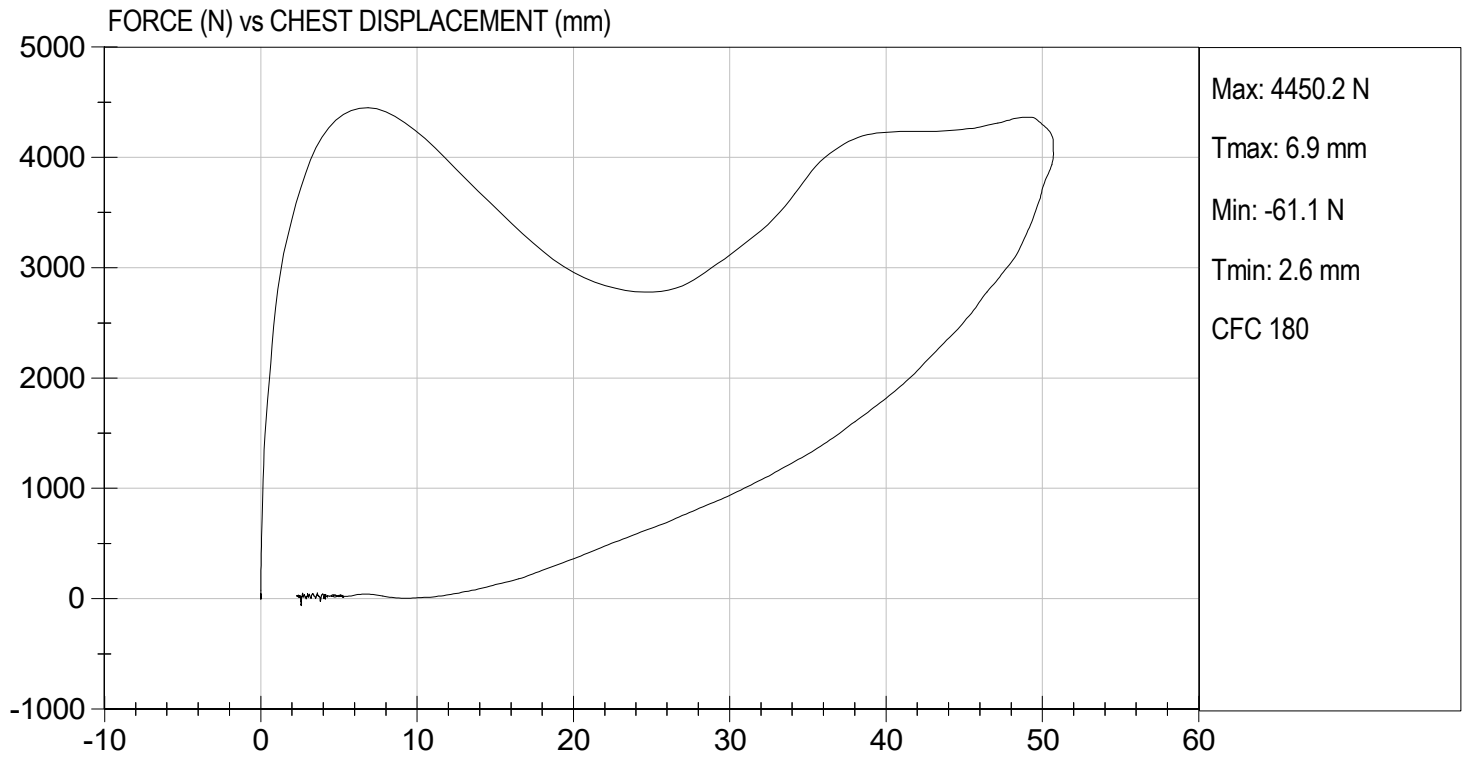
TEST DATE: 06/21/2023  
TEST #: D231594

TEST DESC: THORAX IMPACT  
VELOCITY: 21.93 ft/s, 6.68 m/s

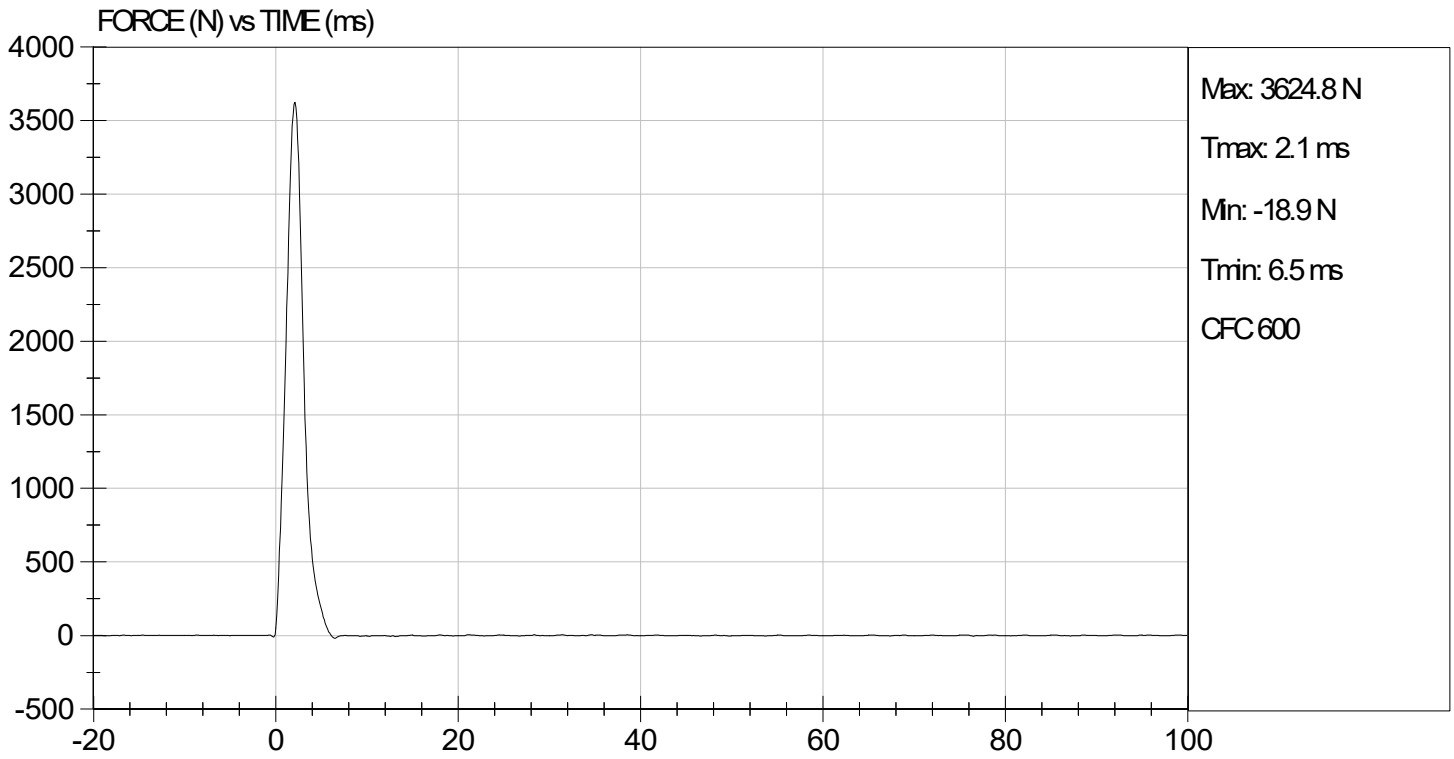
TEST DATE: 06/20/2023  
TEST #: D231596

TEST DESC: LEFT KNEE  
VELOCITY: 6.92 ft/s, 2.11 m/s

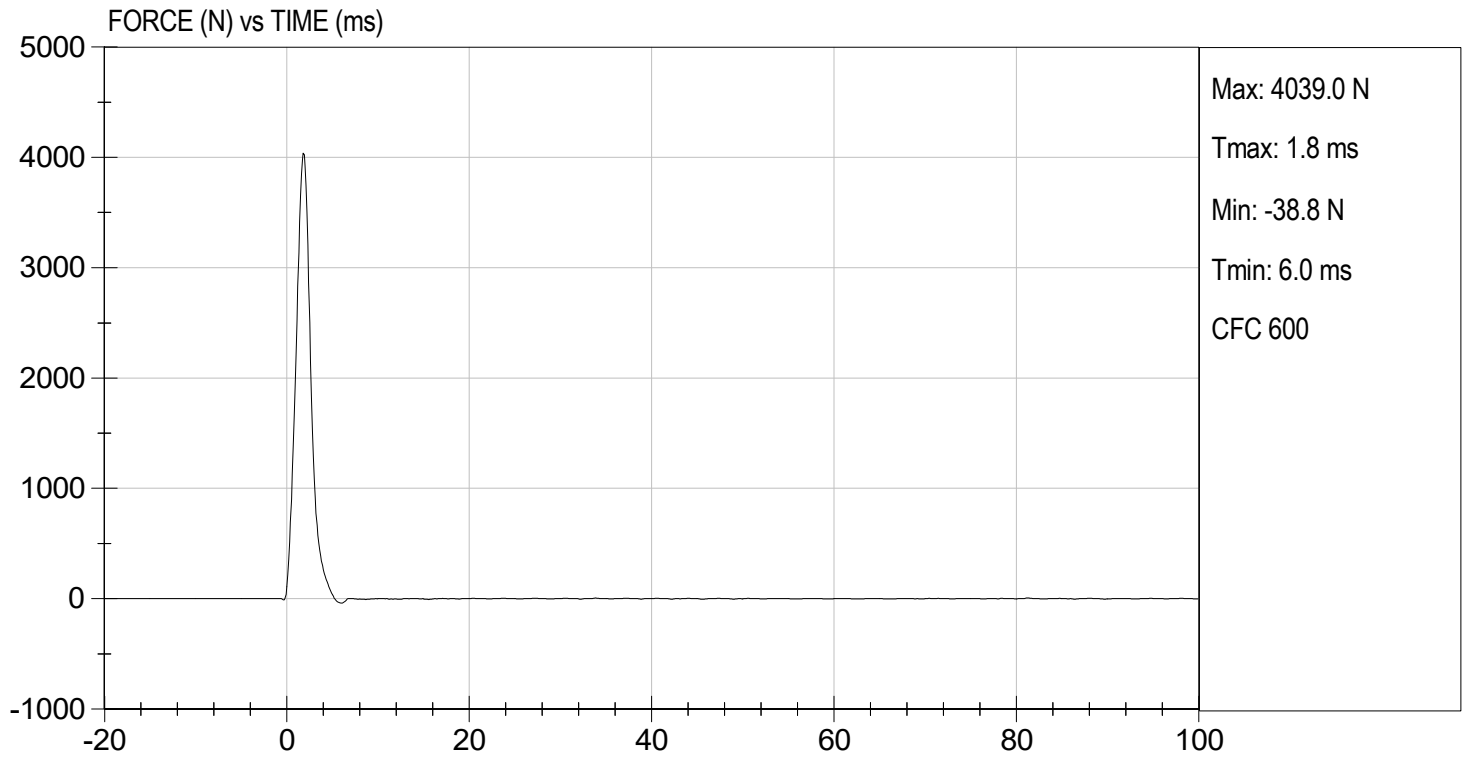
TEST DATE: 06/20/2023  
TEST #: D231595

TEST DESC: RIGHT KNEE  
VELOCITY: 6.89 ft/s, 2.10 m/s

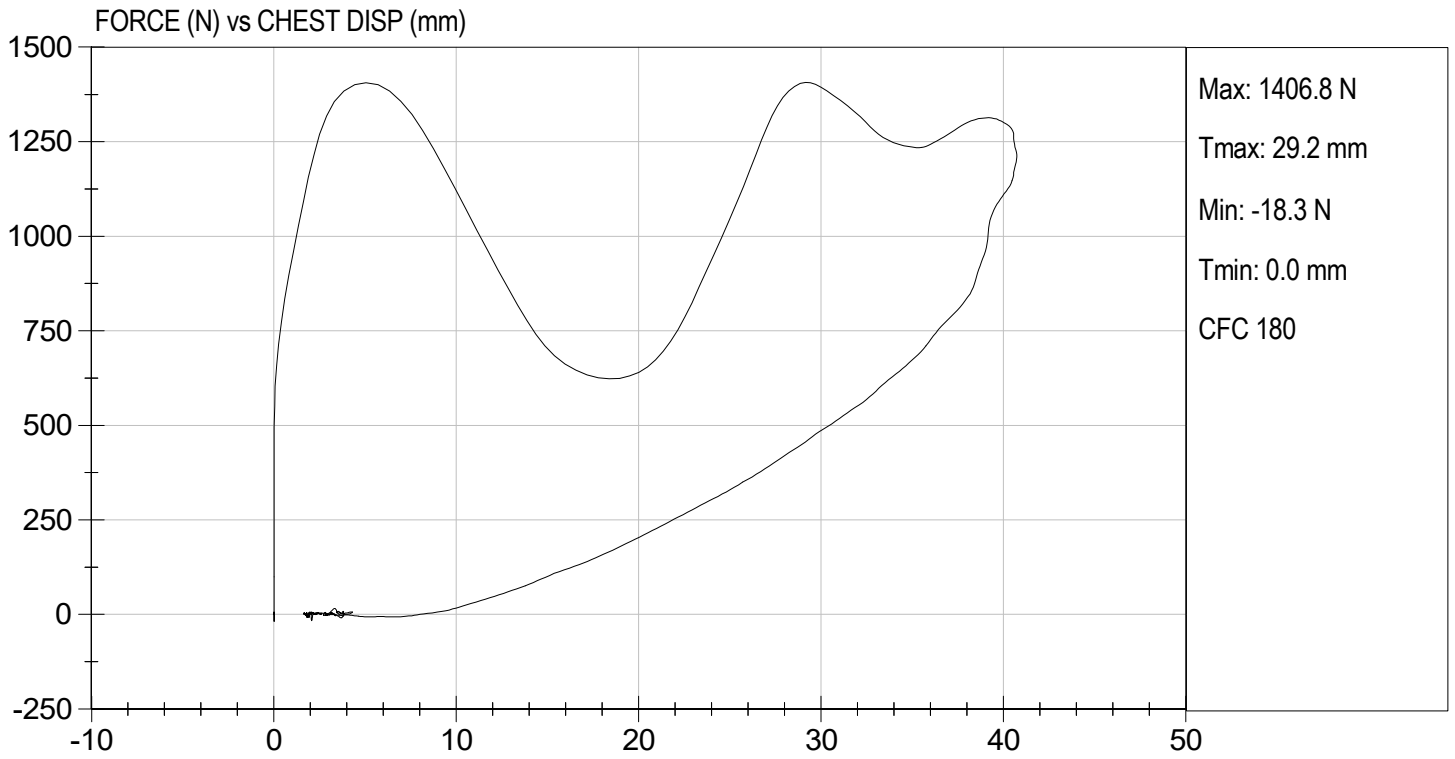
TEST DATE: 06/01/2023  
TEST #: D231384

TEST DESC: THORAX IMPACT  
VELOCITY: 22.22 ft/s, 6.77 m/s

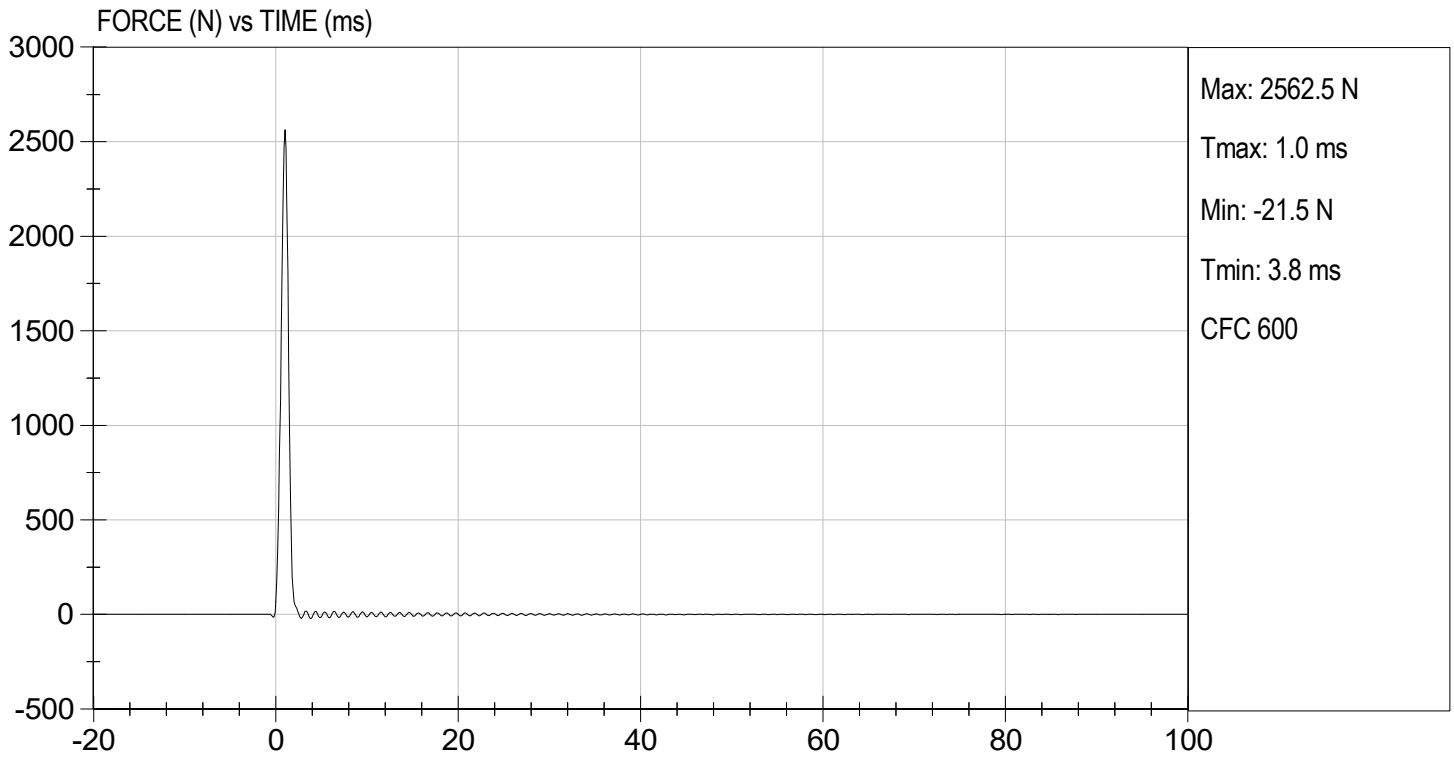
TEST DATE: 05/31/2023  
TEST #: D231386

TEST DESC: LEFT KNEE  
VELOCITY: 7.00 ft/s, 2.13 m/s

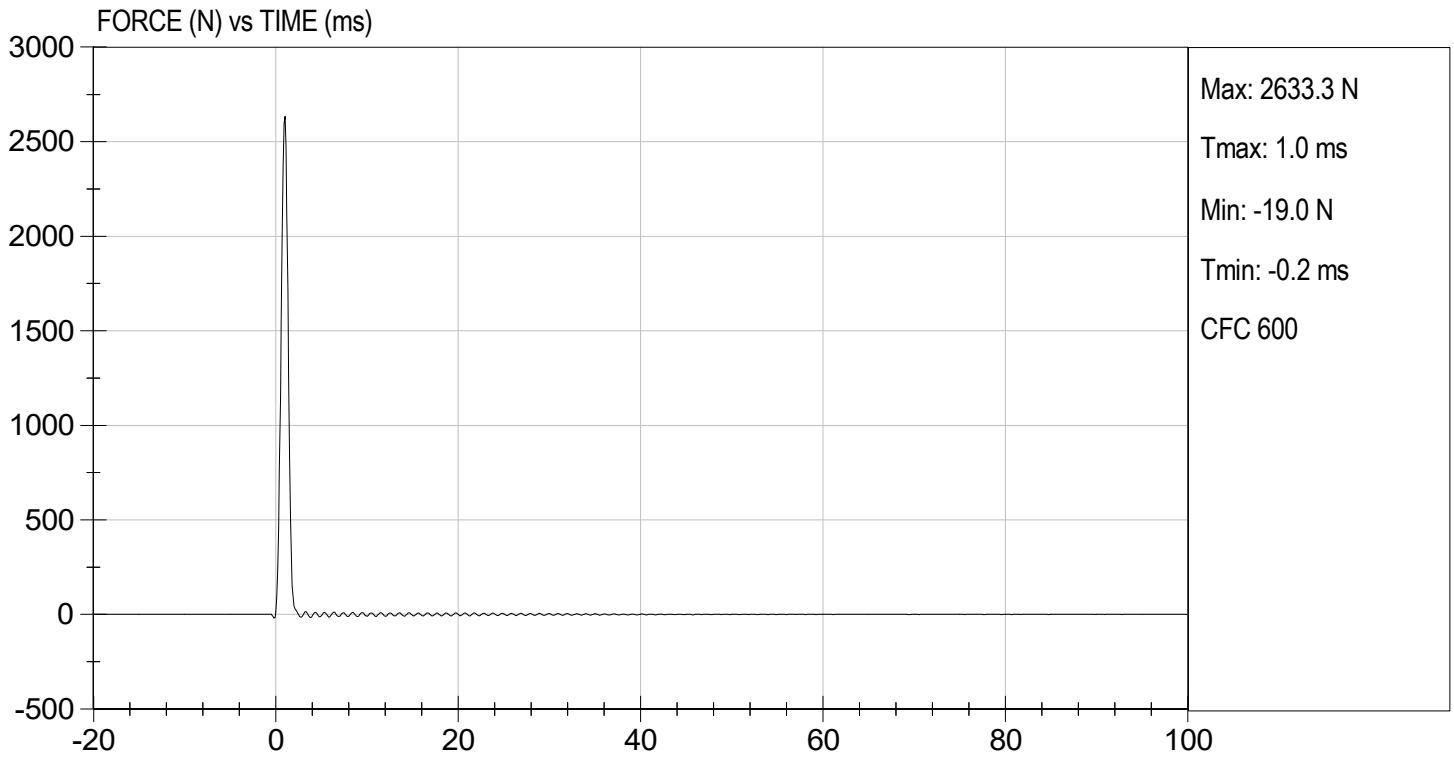
TEST DATE: 05/31/2023  
TEST #: D231385

TEST DESC: RIGHT KNEE  
VELOCITY: 6.89 ft/s, 2.10 m/s

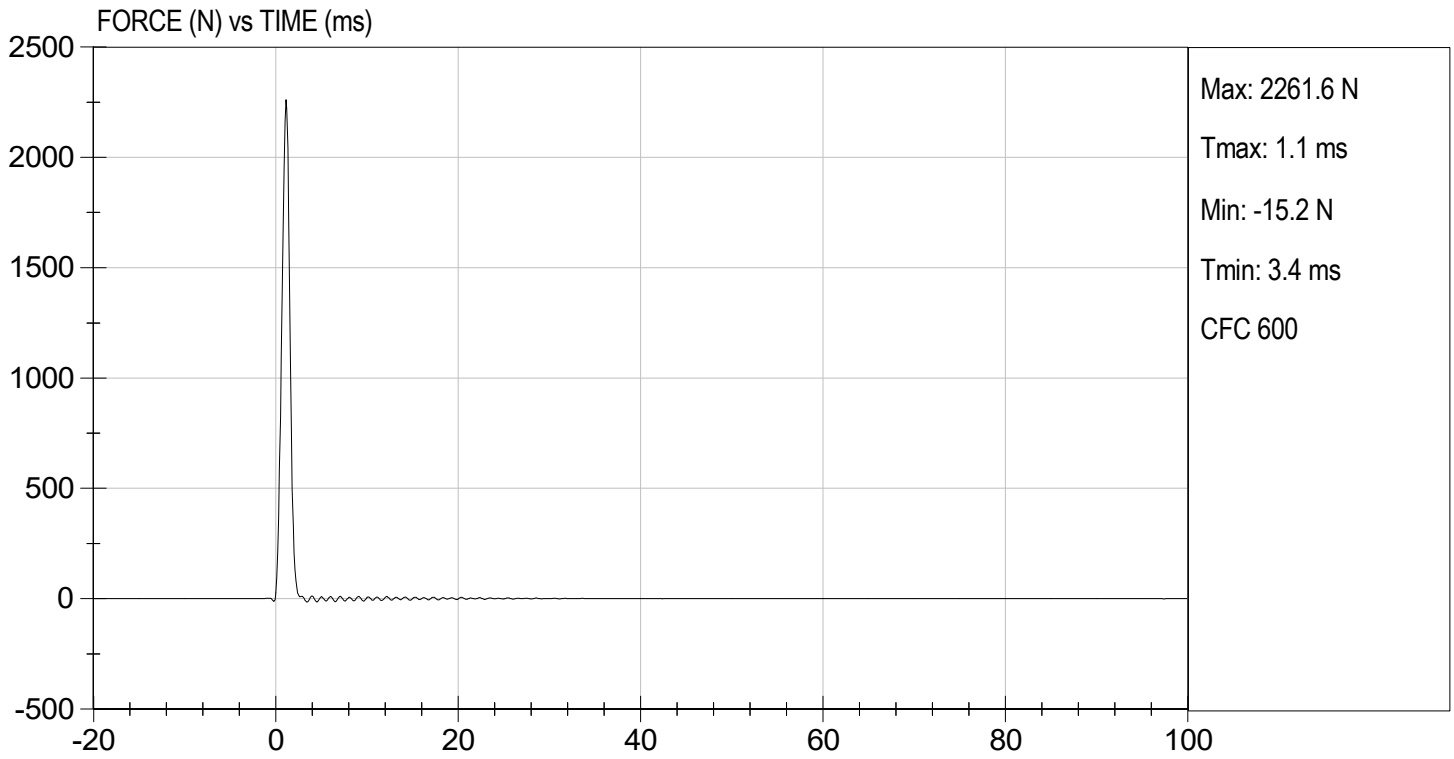
TEST DATE: 07/07/2023  
TEST #: D231646

TEST DESC: LEFT KNEE  
VELOCITY: 6.78 ft/s, 2.07 m/s
