**REPORT NUMBER: SideNCAPPole-MGA-25-024**

**NEW CAR ASSESSMENT PROGRAM (NCAP)  
Side Impact Pole Test**

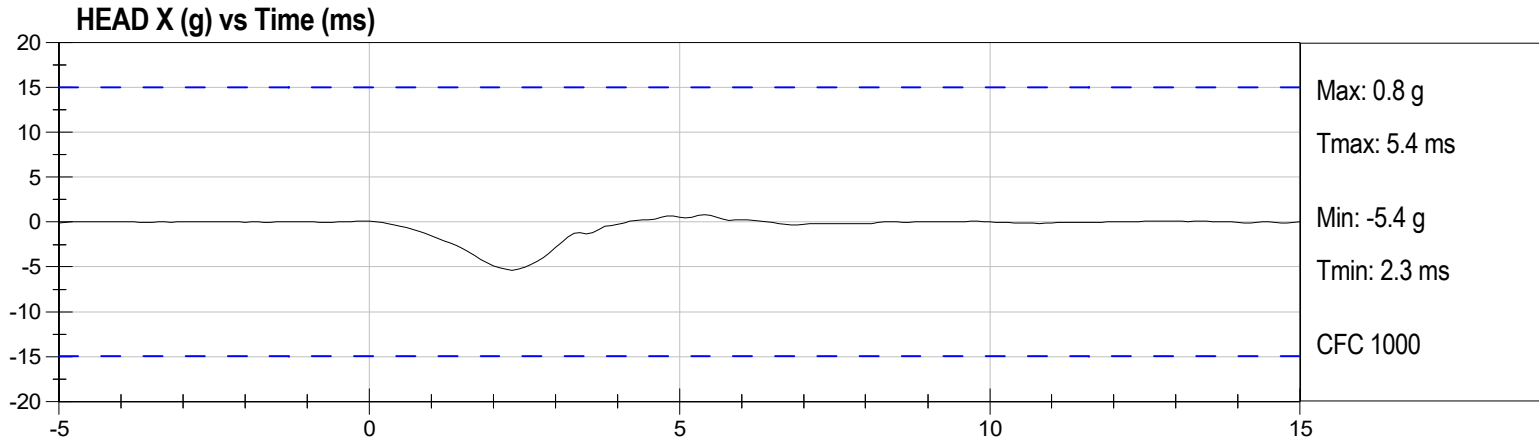
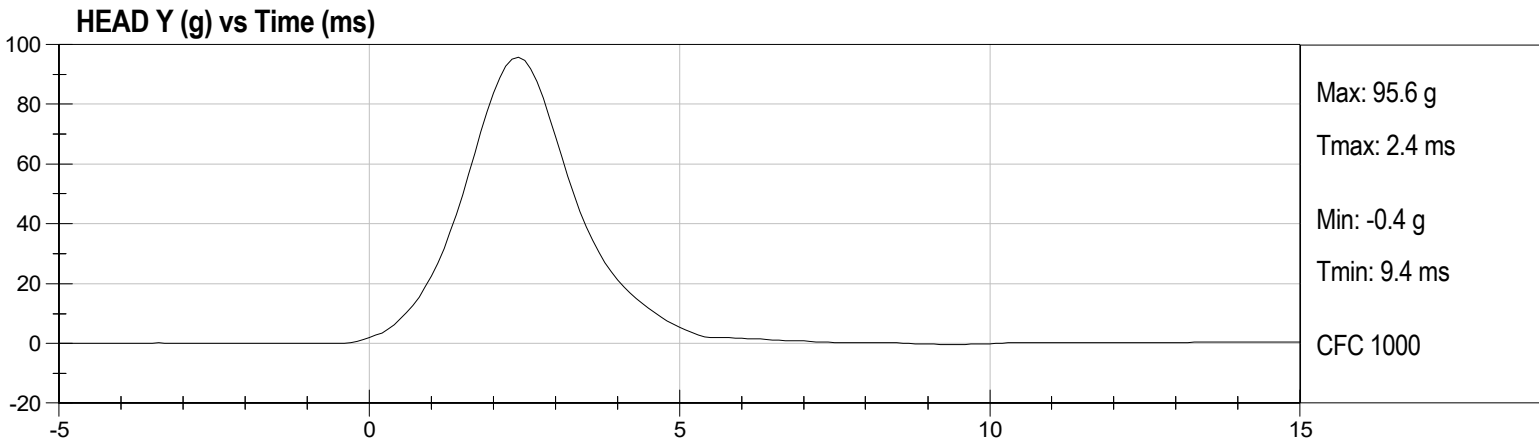
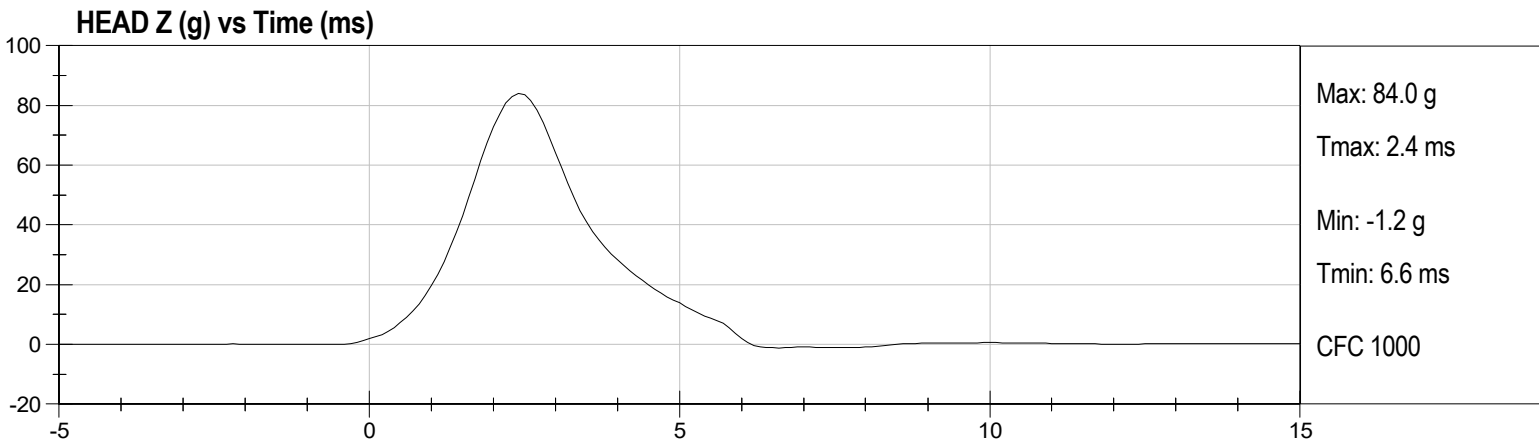
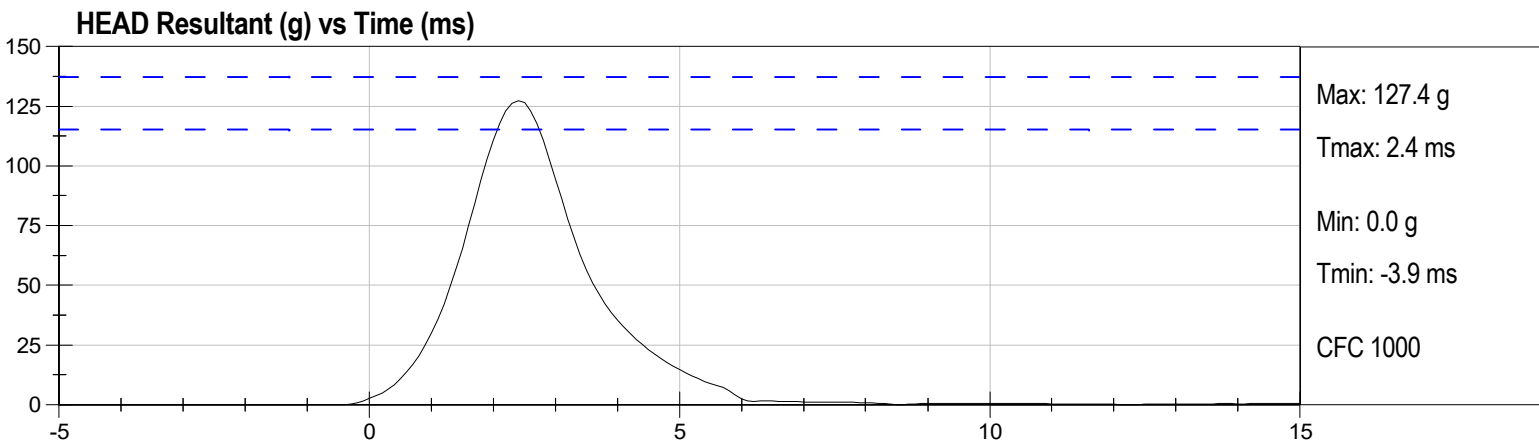
| Tested Parameter | Units | Specification | Result | Pass/Fail |

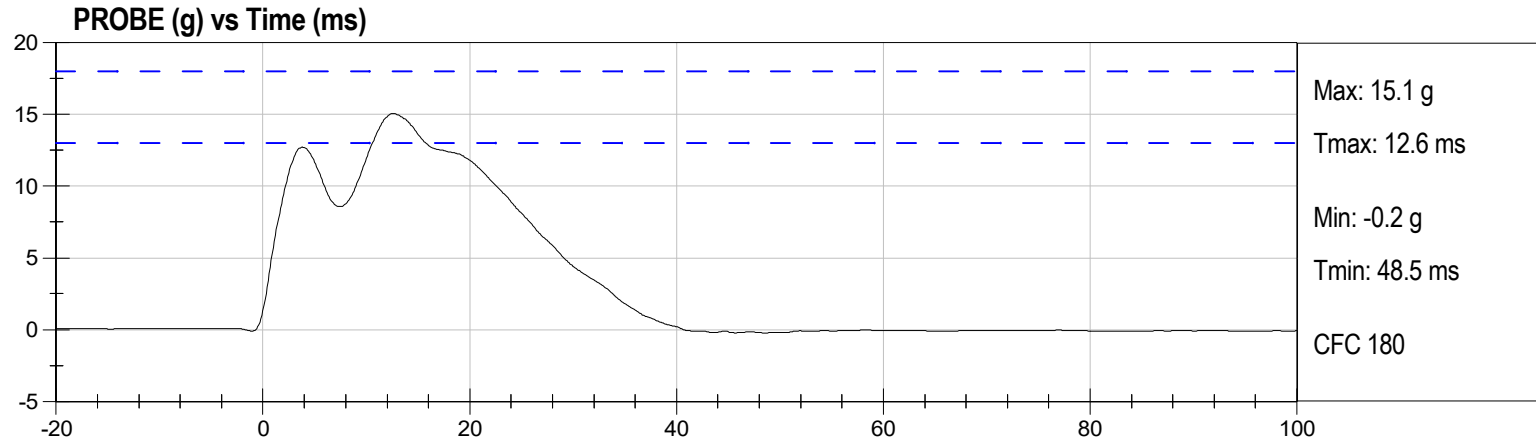
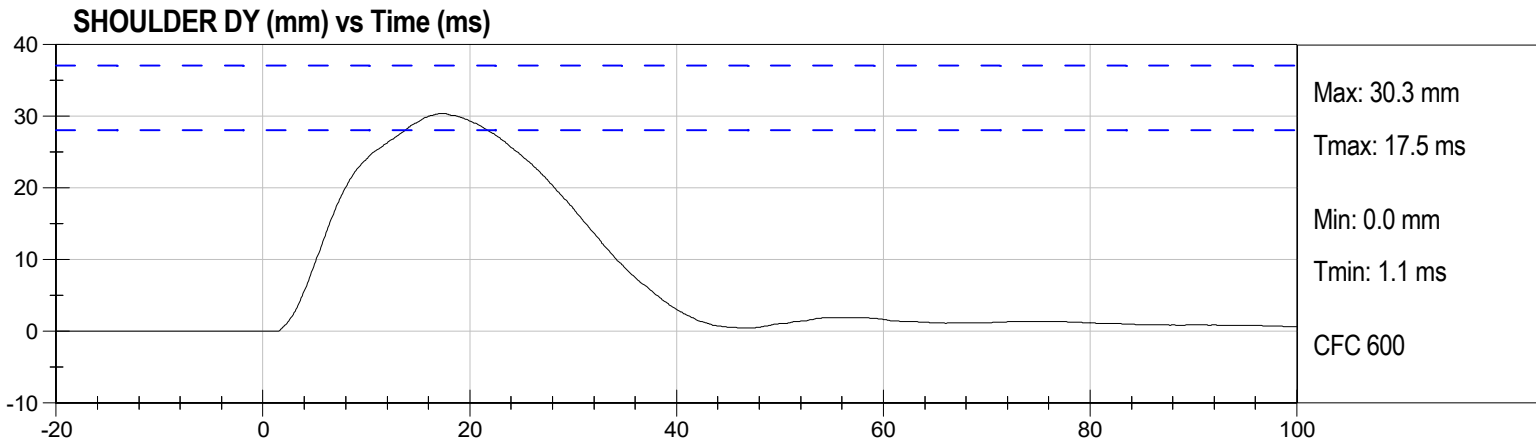
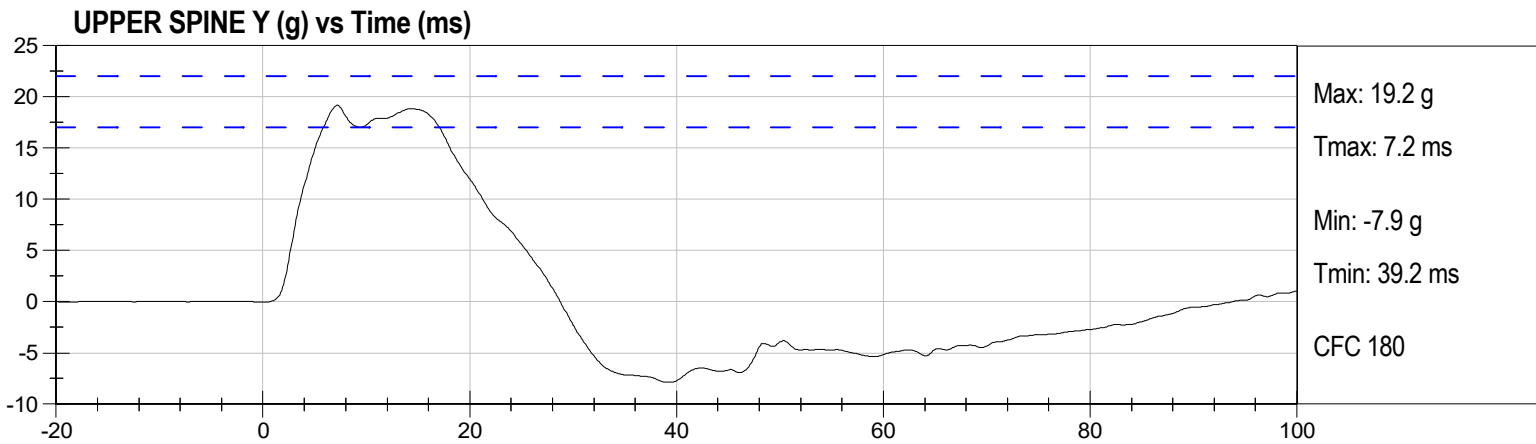
| Tested Parameter | Units | Specification | Result | Pass/Fail |

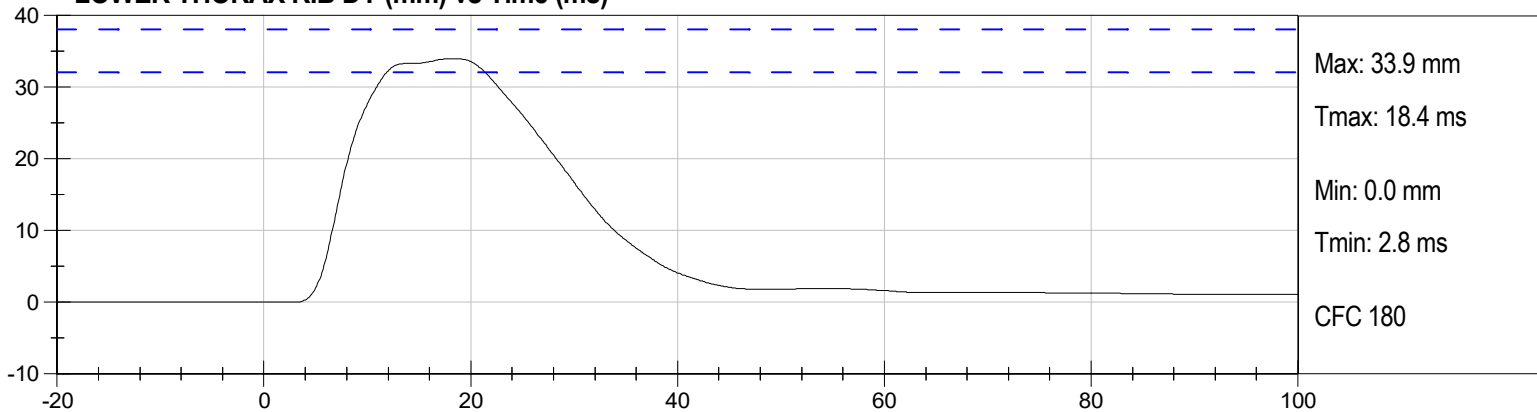
| Tested Parameter | Units | Specification | Result | Pass/Fail |

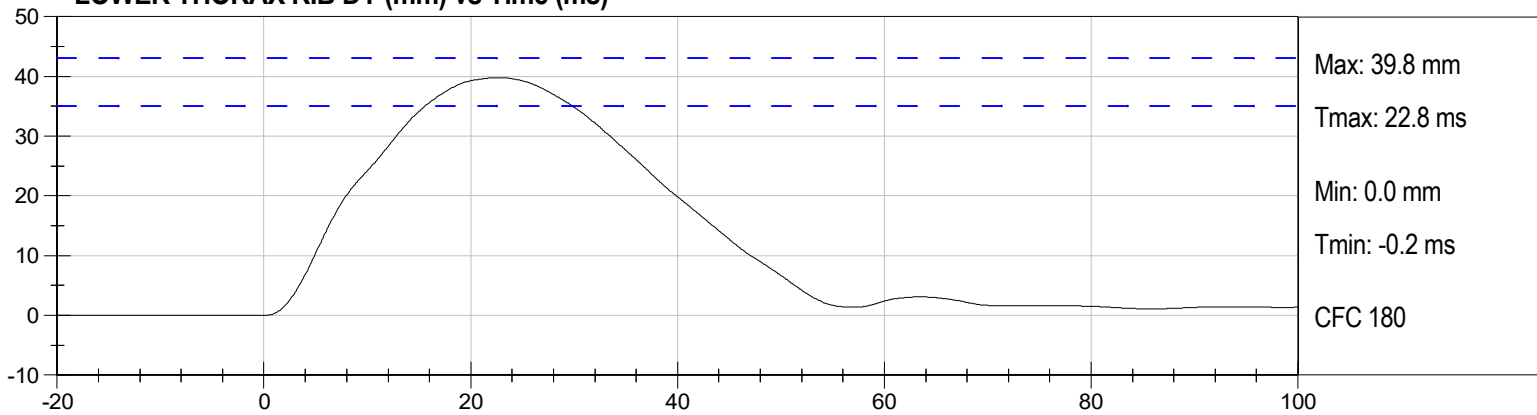
| Tested Parameter | Units | Specification | Result | Pass/Fail |

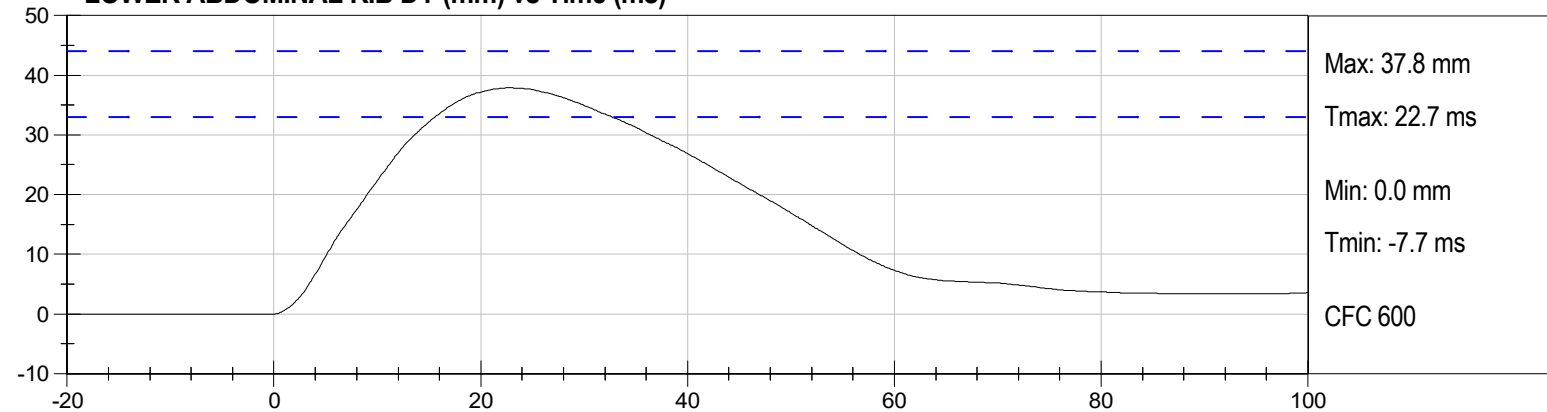
| Tested Parameter | Units | Specification | Result | Pass/Fail |

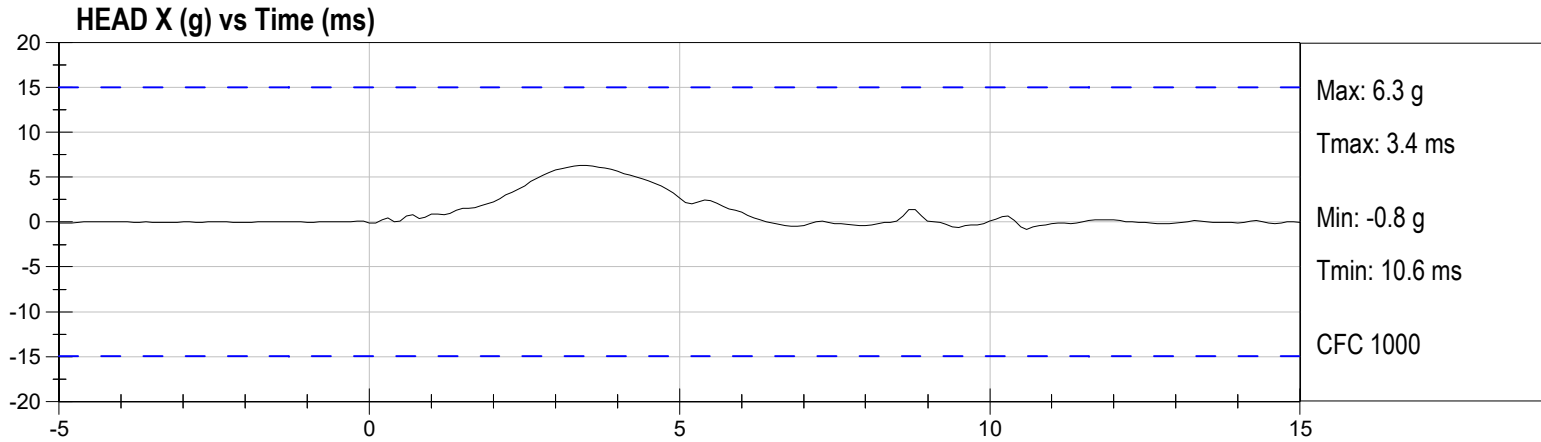
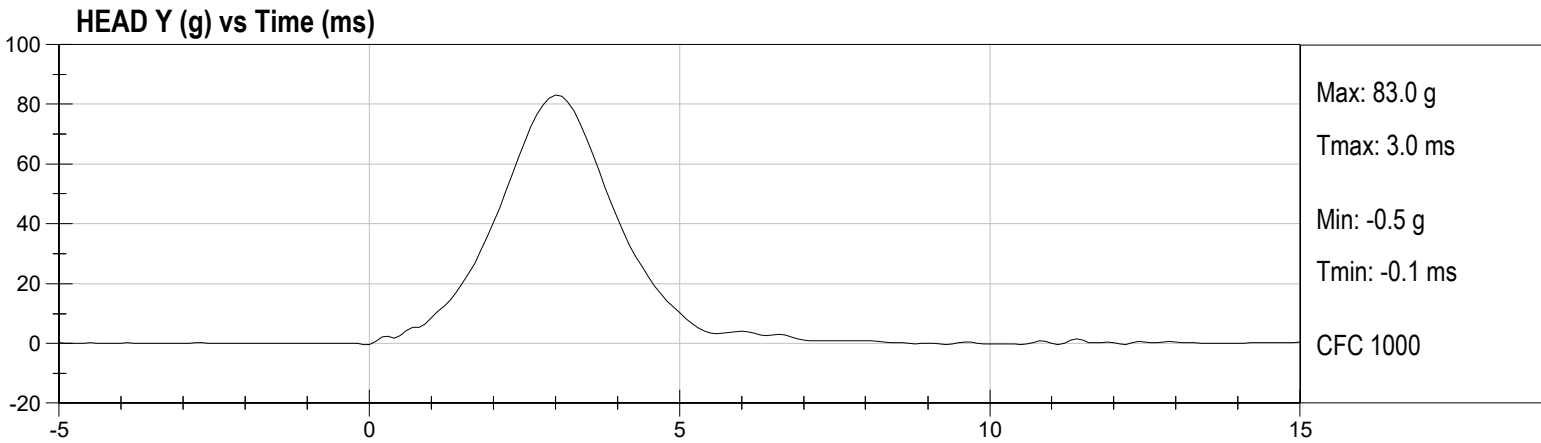
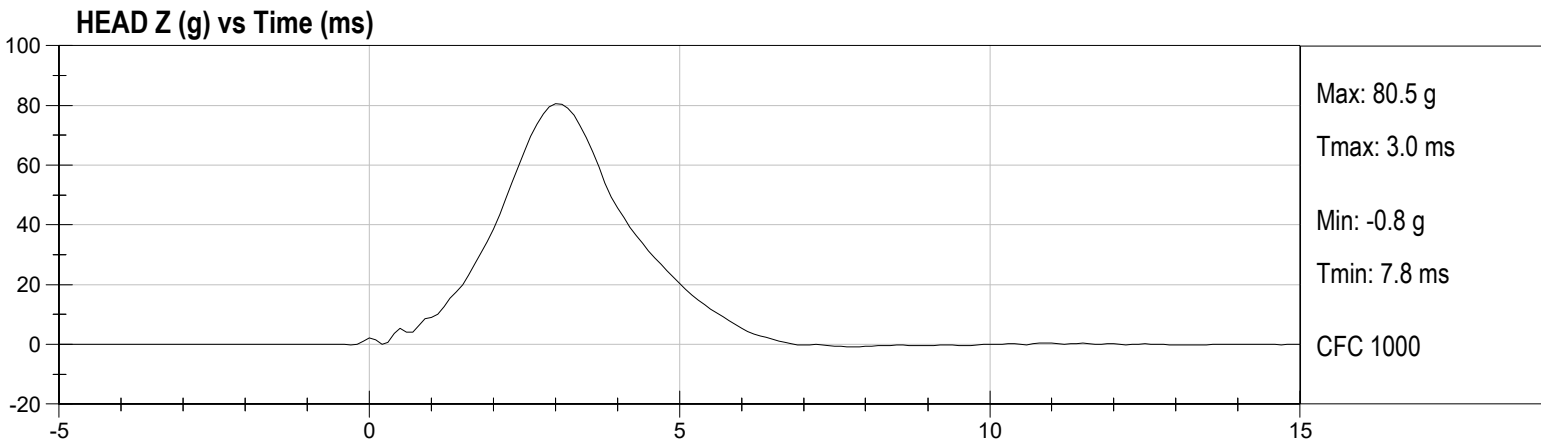
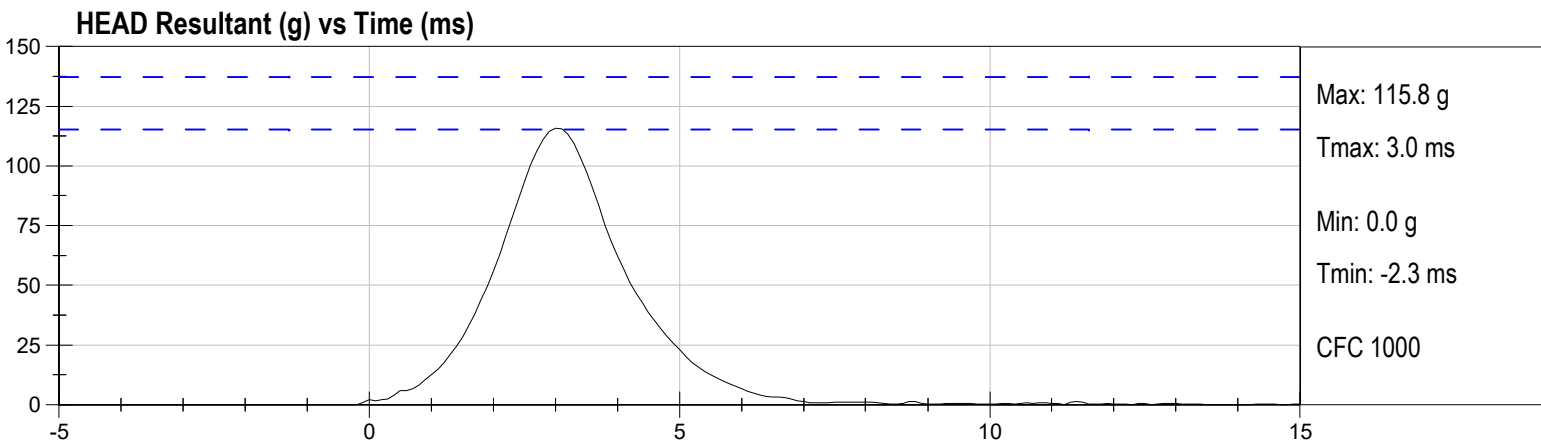
| Tested Parameter | Units | Specification | Result | Pass/Fail |

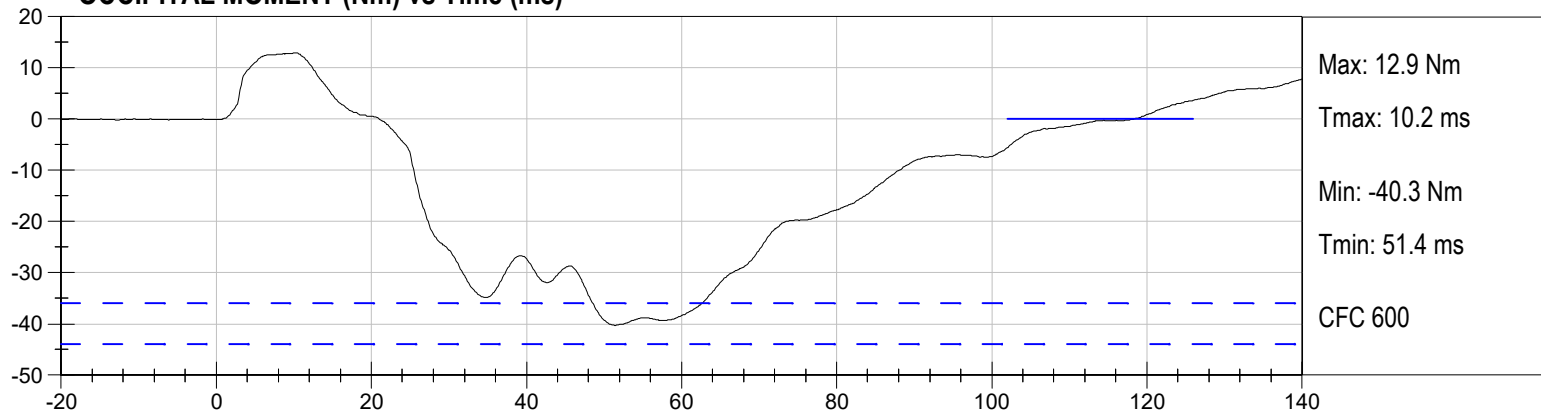
| Tested Parameter | Units | Specification | Result | Pass/Fail |

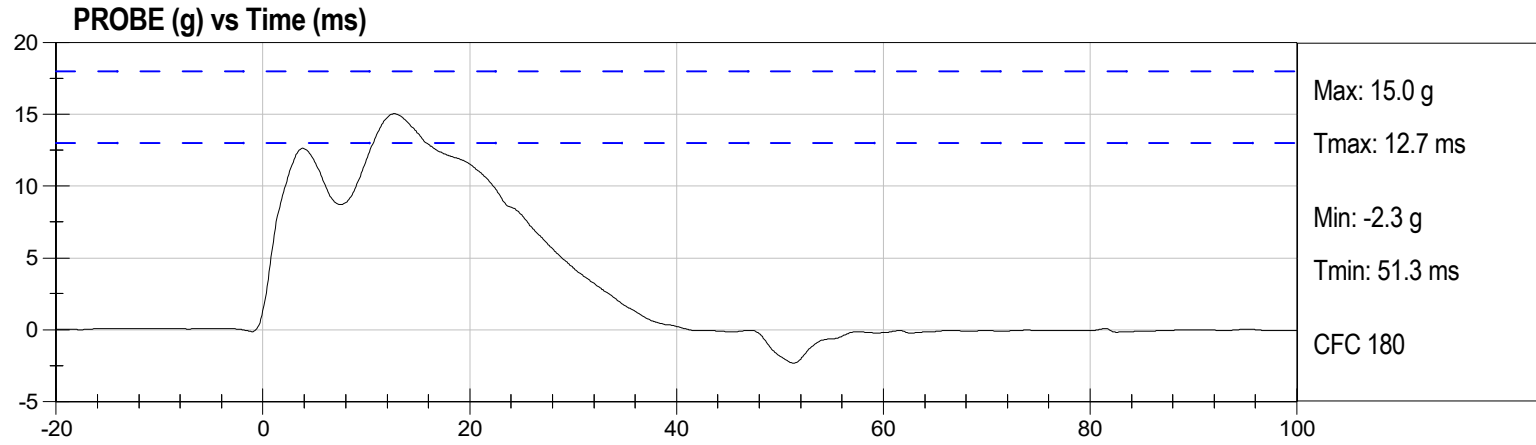
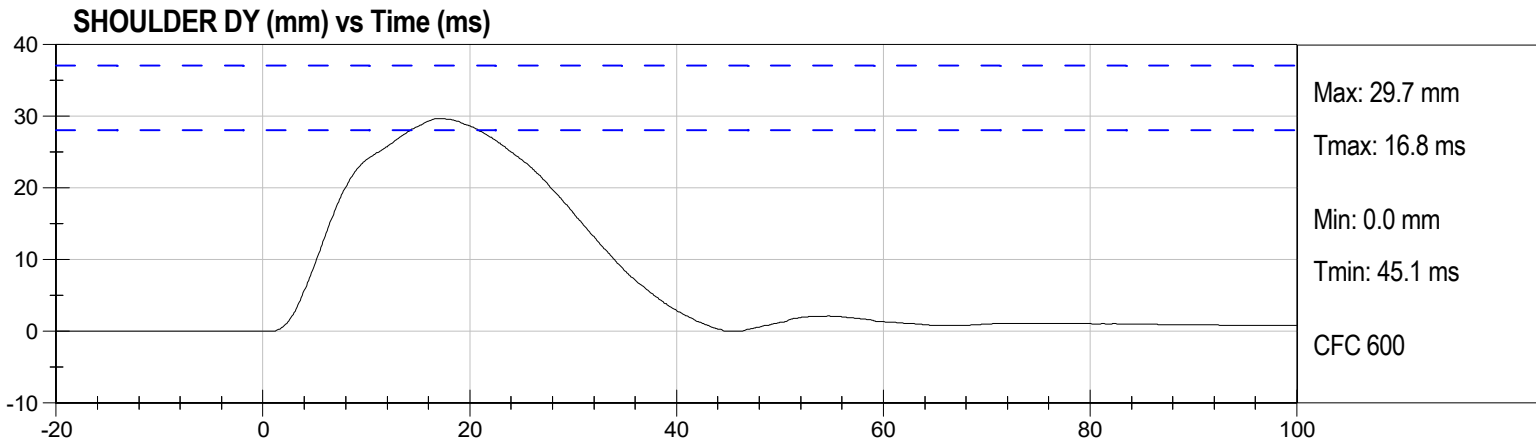
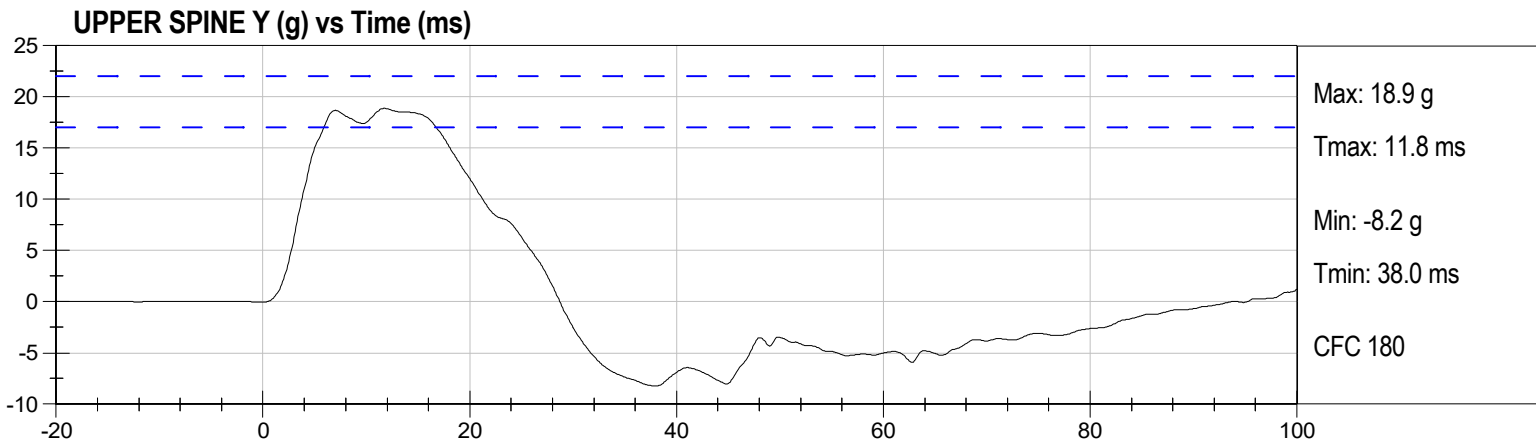
| Tested Parameter | Units | Specification | Result | Pass/Fail |

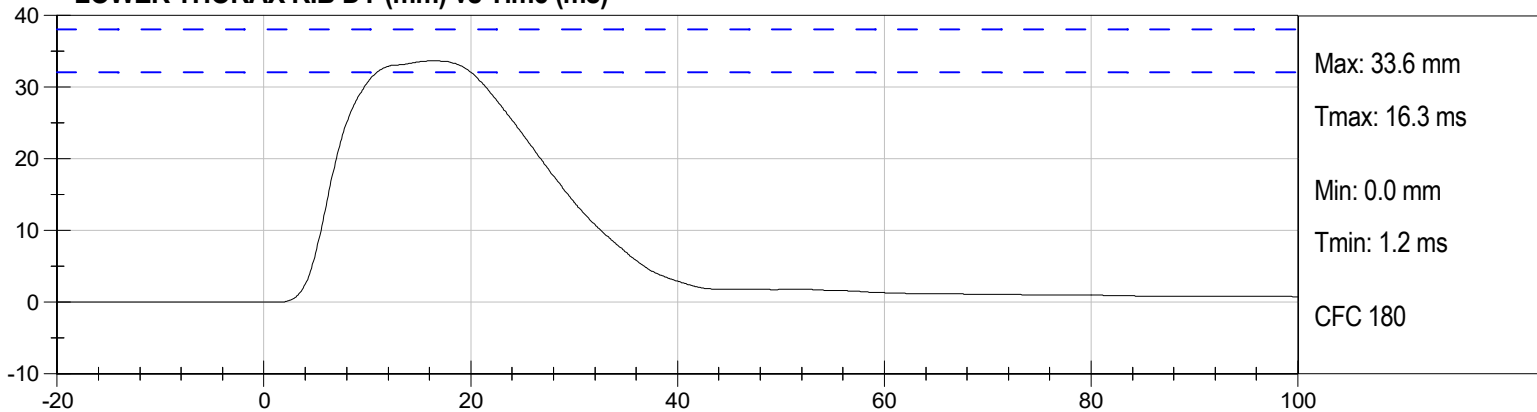
| Tested Parameter | Units | Specification | Result | Pass/Fail |

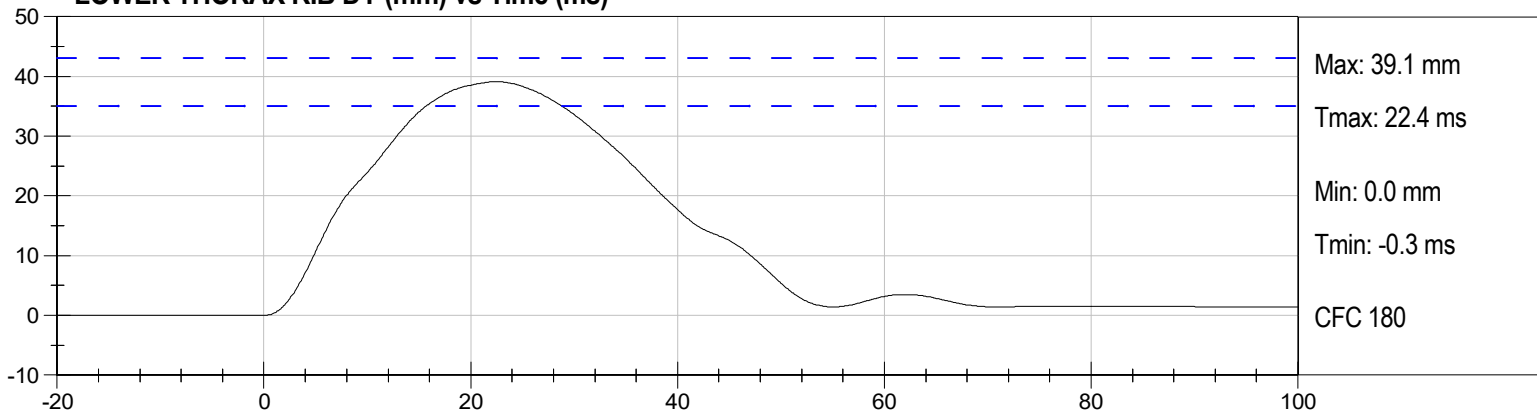
| Tested Parameter | Units | Specification | Result | Pass/Fail |

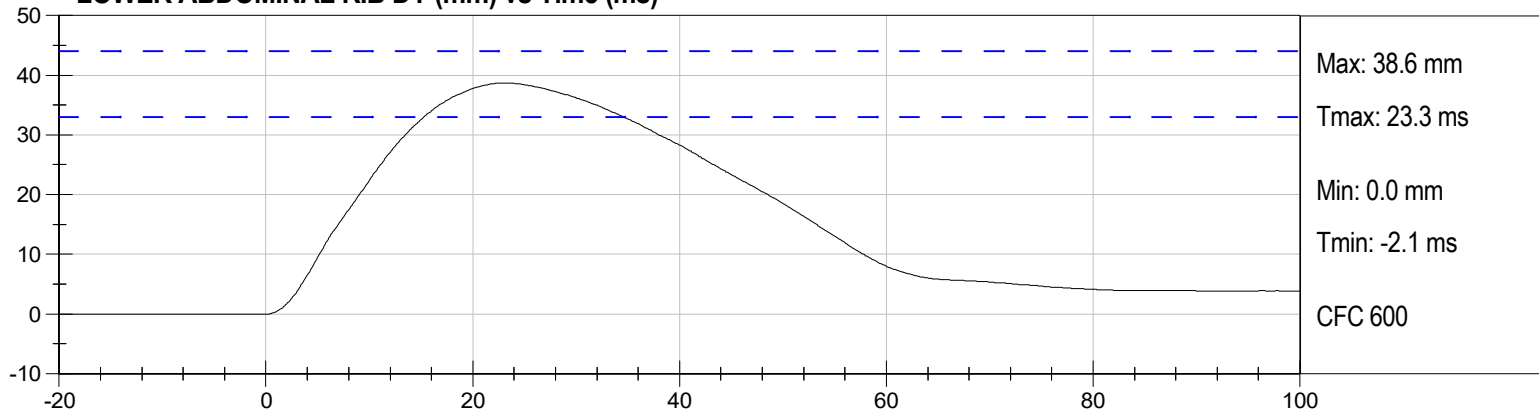
| Tested Parameter | Units | Specification | Result | Pass/Fail |

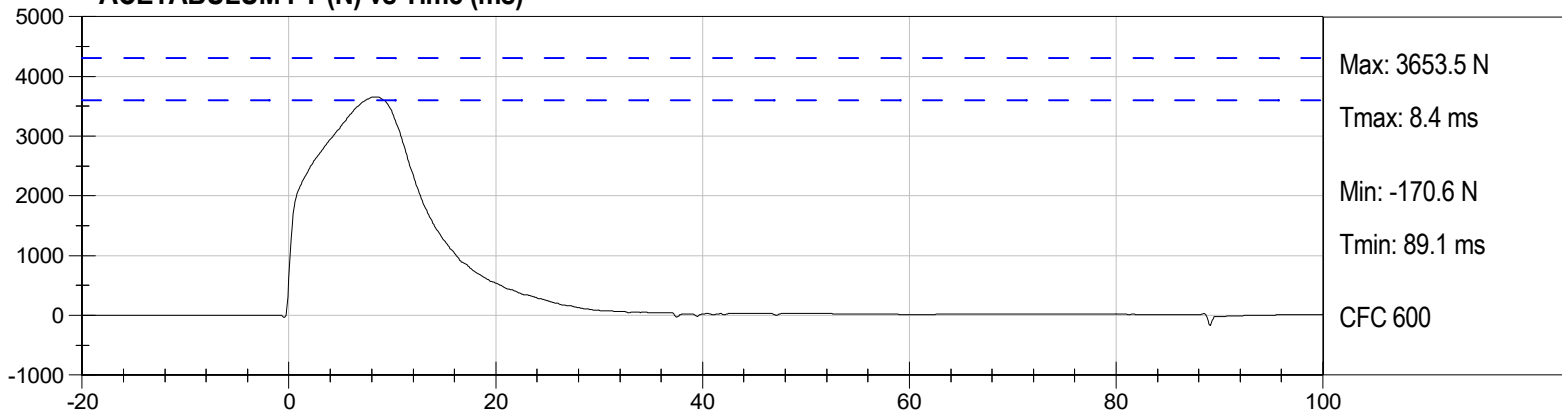
| Tested Parameter | Units | Specification | Result | Pass/Fail |
