**REPORT NUMBER: NCAP-MGA-25-025**

**NEW CAR ASSESSMENT PROGRAM (NCAP)  
Frontal Barrier Impact Test**

**TOYOTA MOTOR CORPORATION  
2025 Toyota 4Runner 4WD SR5 5-Door SUV  
NHTSA No.: M20255102**

**FINAL REPORT**

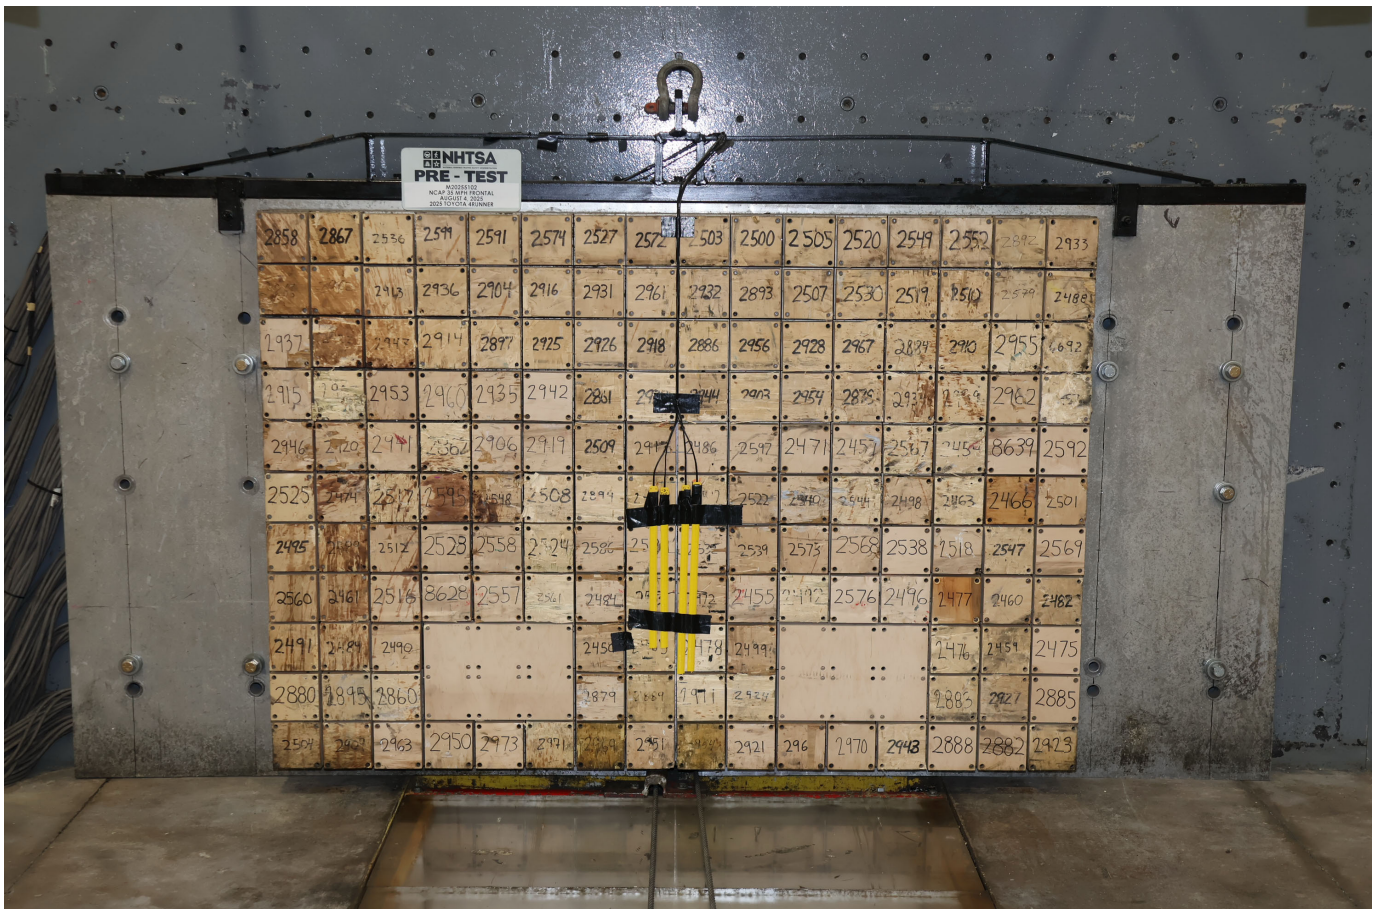
Photo No. 002 - Pre-Test Load Cell Wall

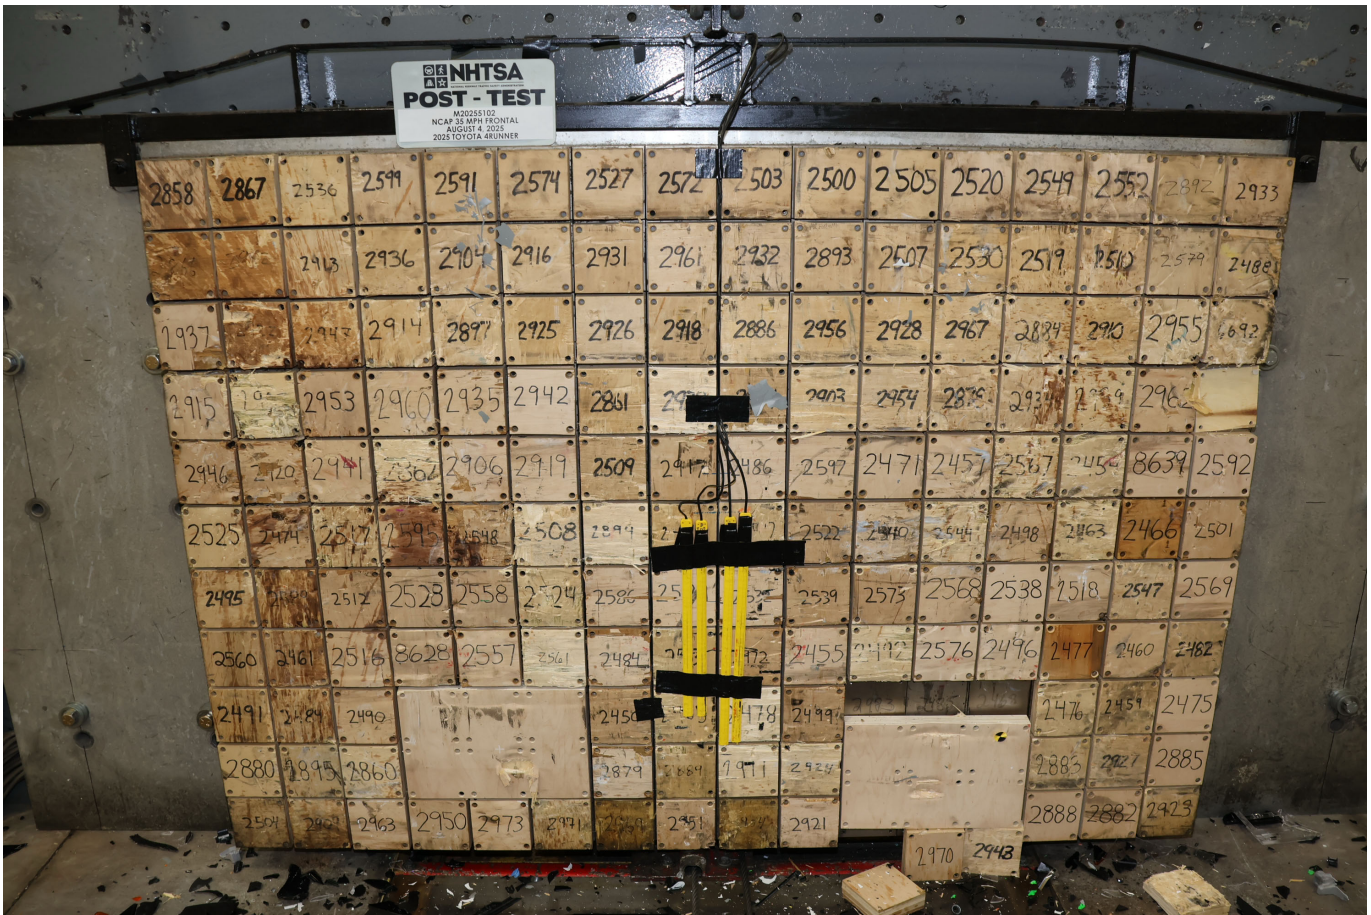
Photo No. 003 - Post-Test Load Cell Wall

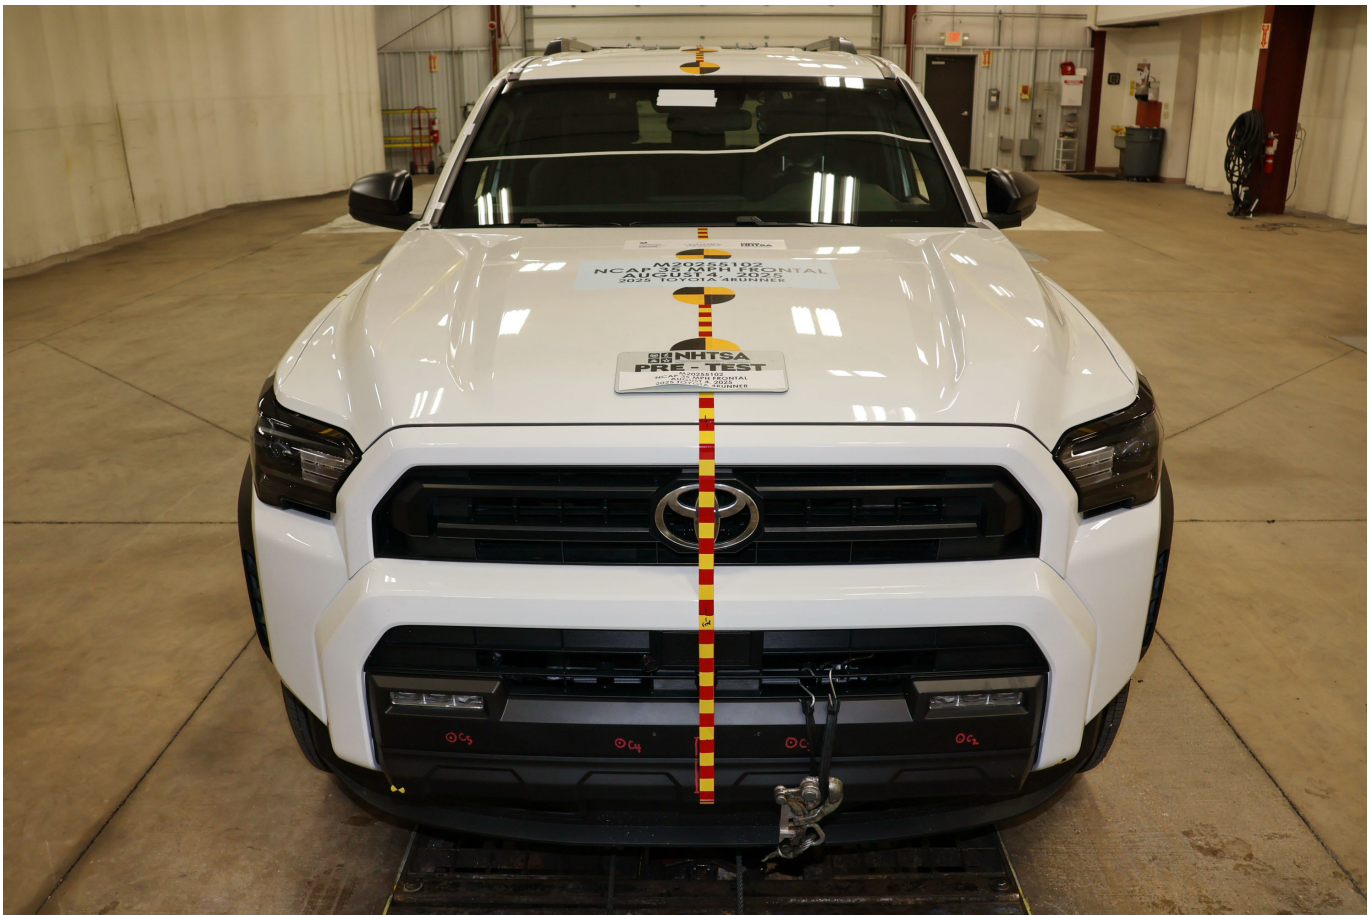
Photo No. 008 - Pre-Test Front View of Test Vehicle

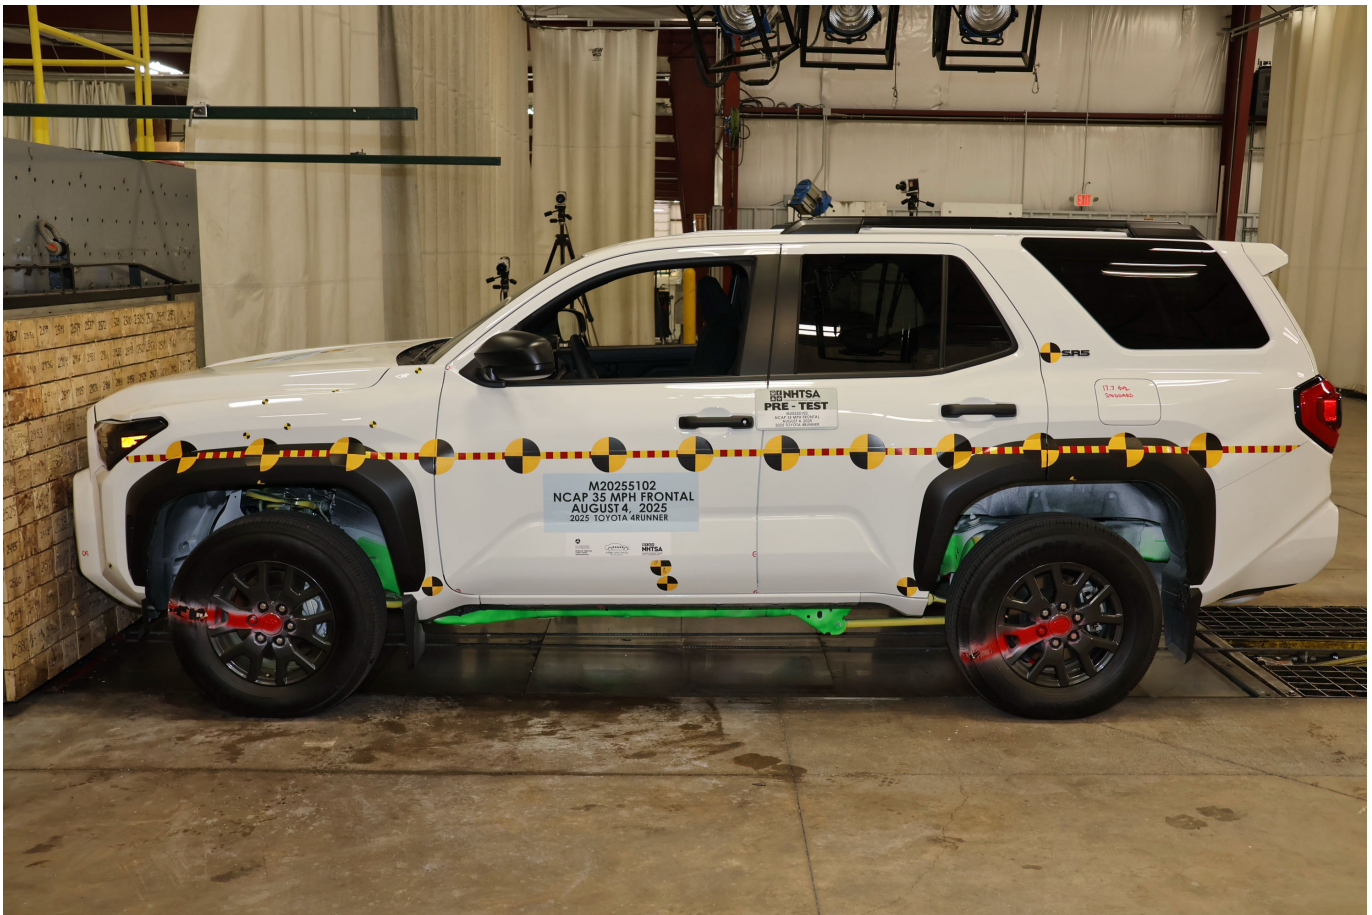
Photo No. 010 - Pre-Test Left View of Test Vehicle

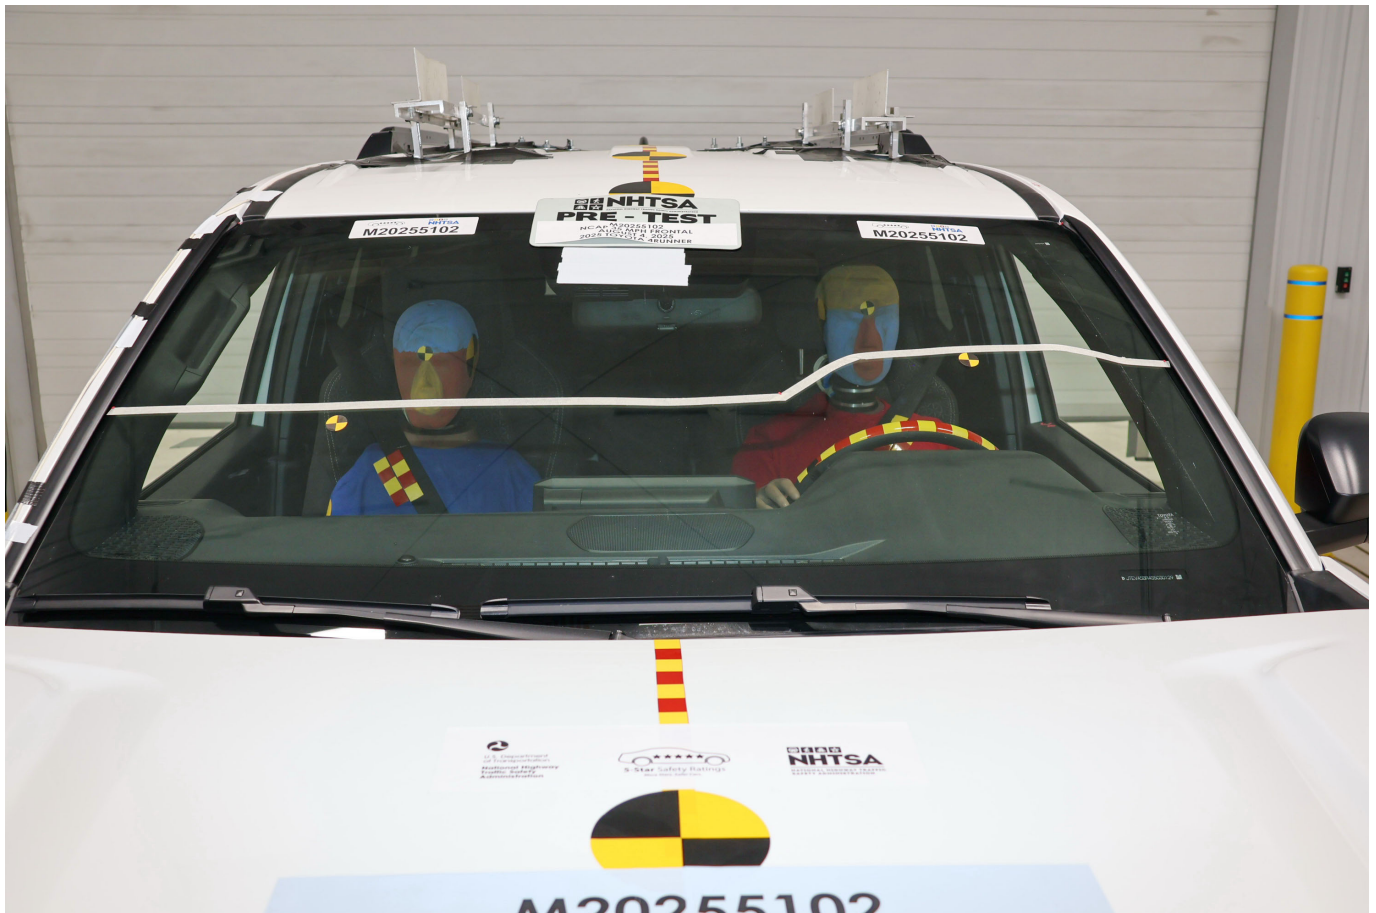
Photo No. 018 - Pre-Test Windshield View

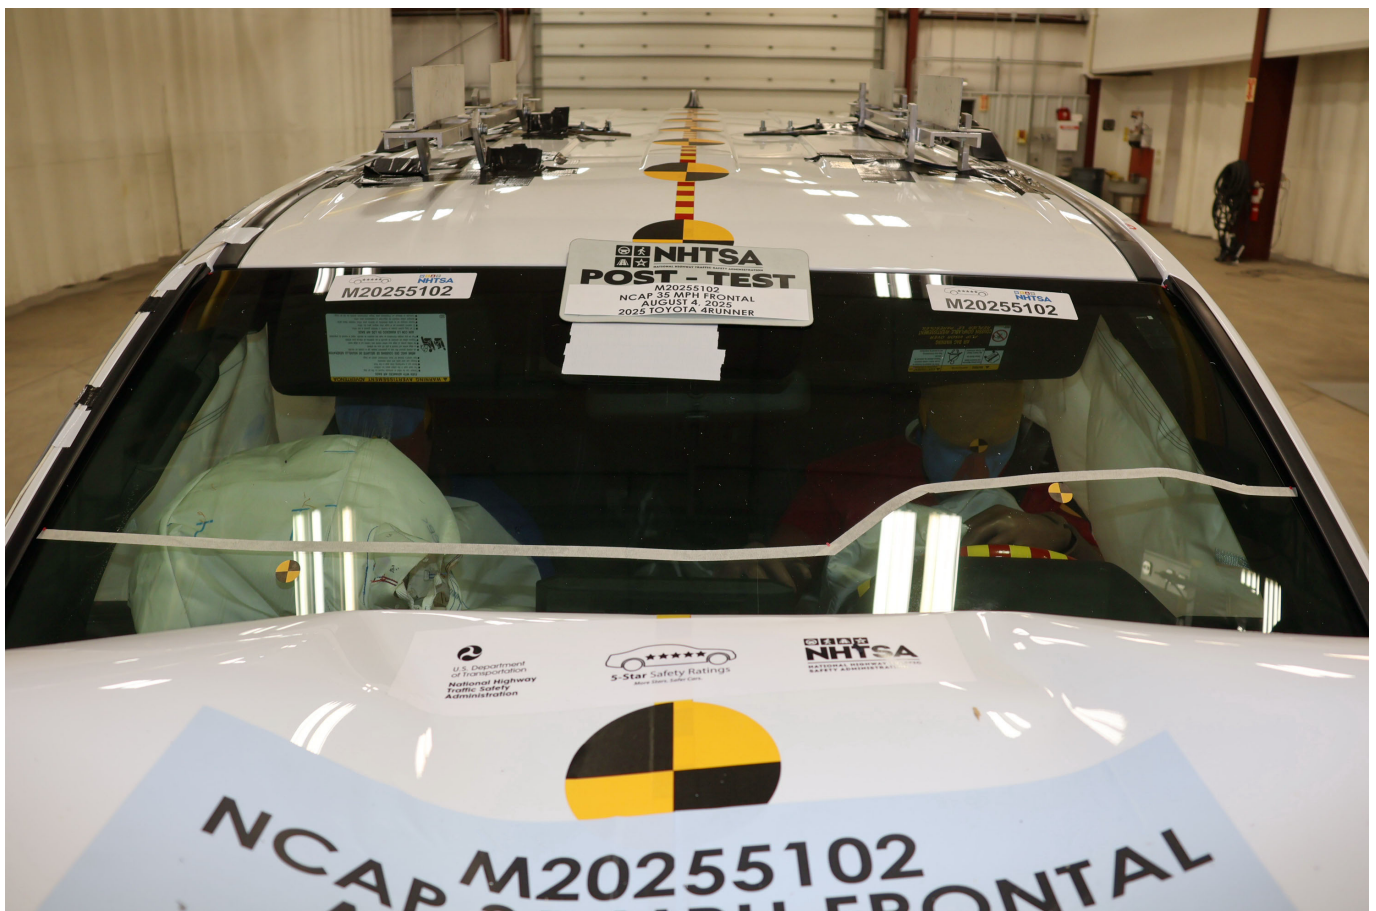
Photo No. 019 - Post-Test Windshield View

There was 100 percent windshield retention and no intrusion into the protected zone of the windshield during the event. There was no Stoddard Solvent leakage after the event or during any phase of the static rollover.

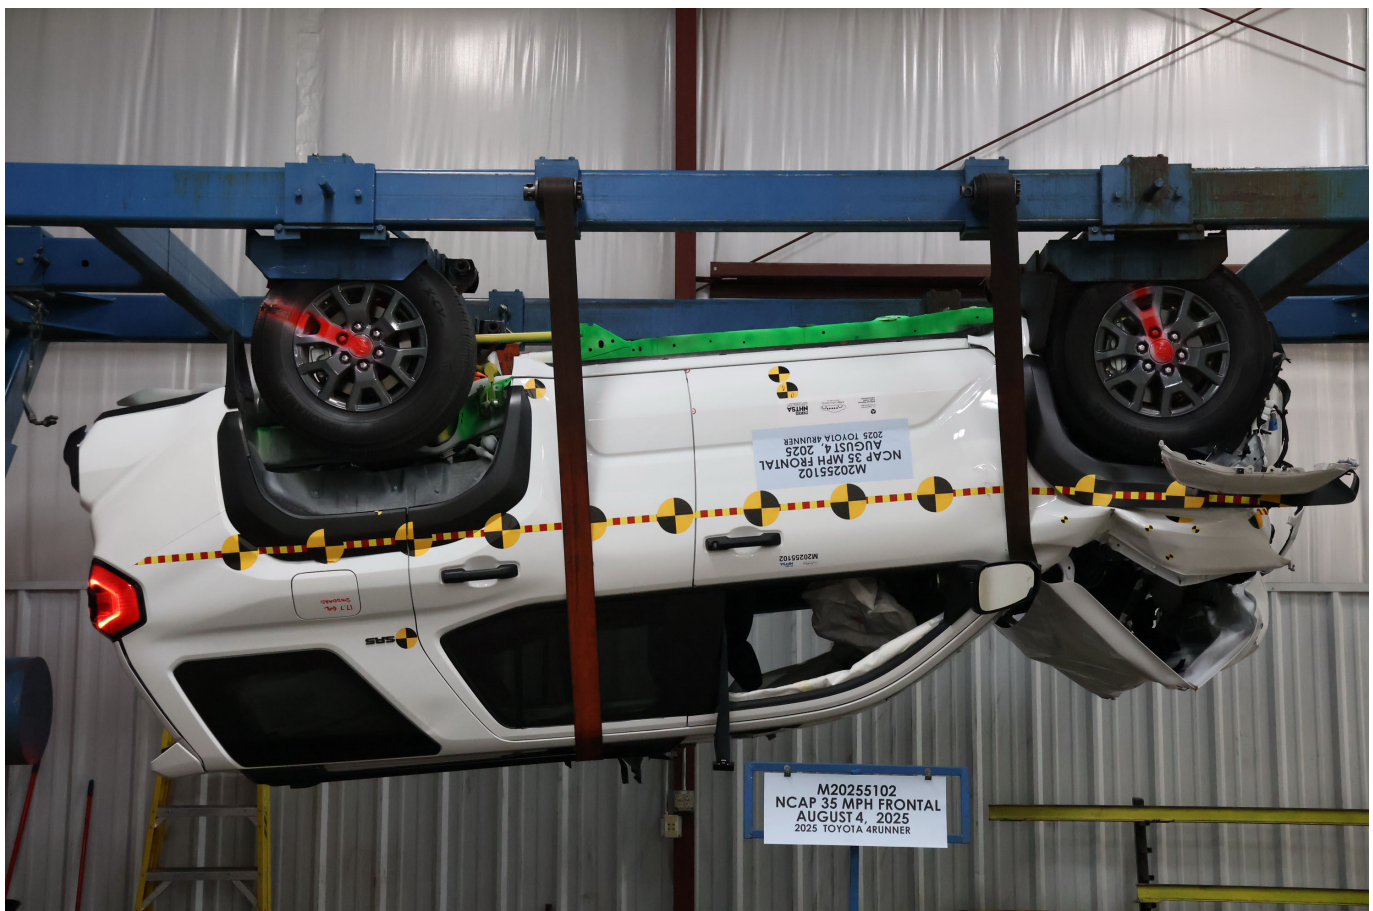
Photo No. 079 - Vehicle at 180 Degrees on Static Rollover Device

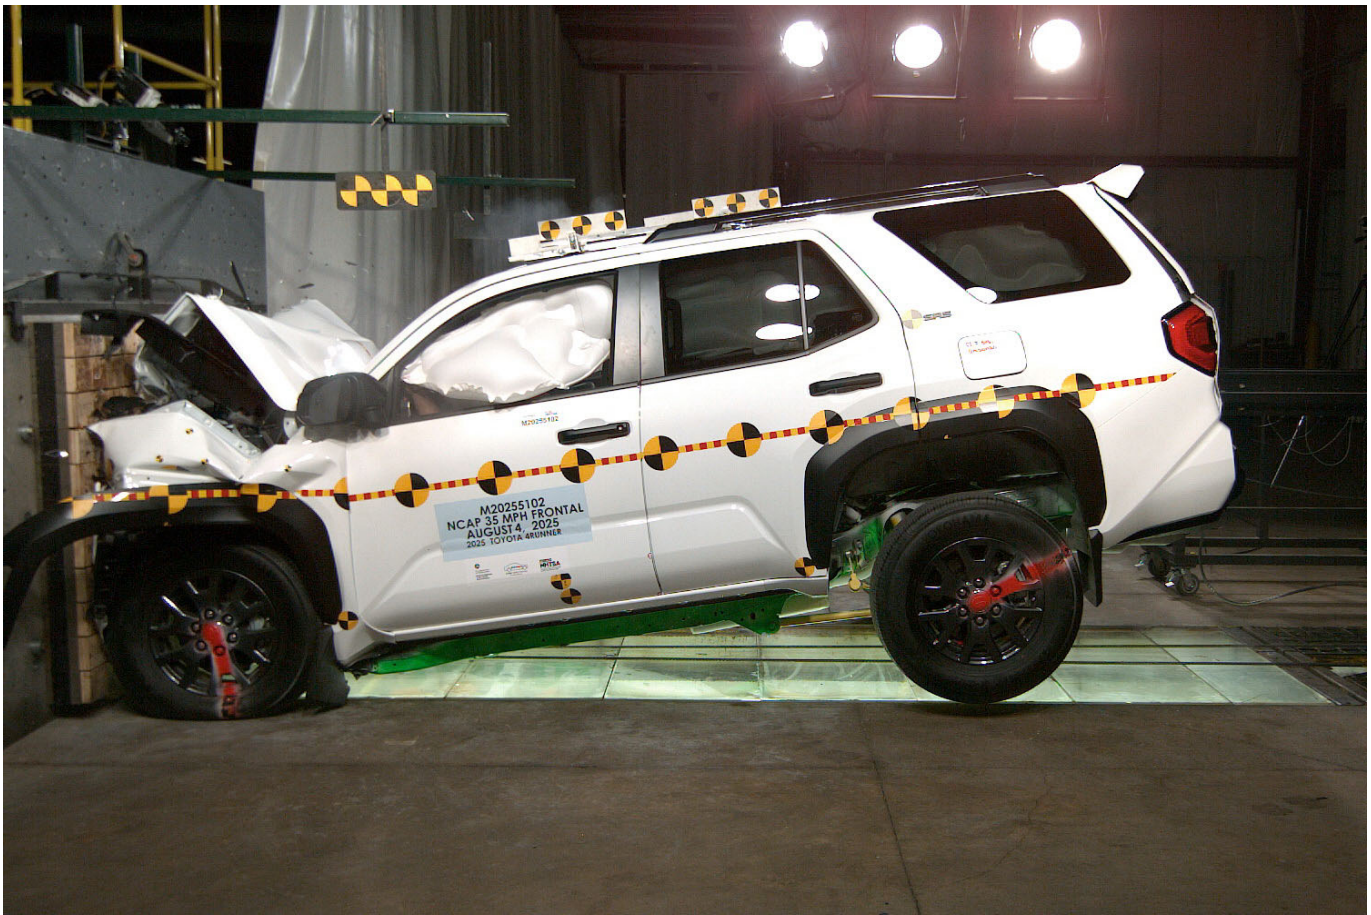
Photo No. 082 - 2025 Toyota 4Runner 4WD SR5 5-Door SUV Frontal Impact Event
