REPORT NUMBER: 208-2360530-TEST

**DUMMY PERFORMANCE CALIBRATIONS
FMVSS 208**

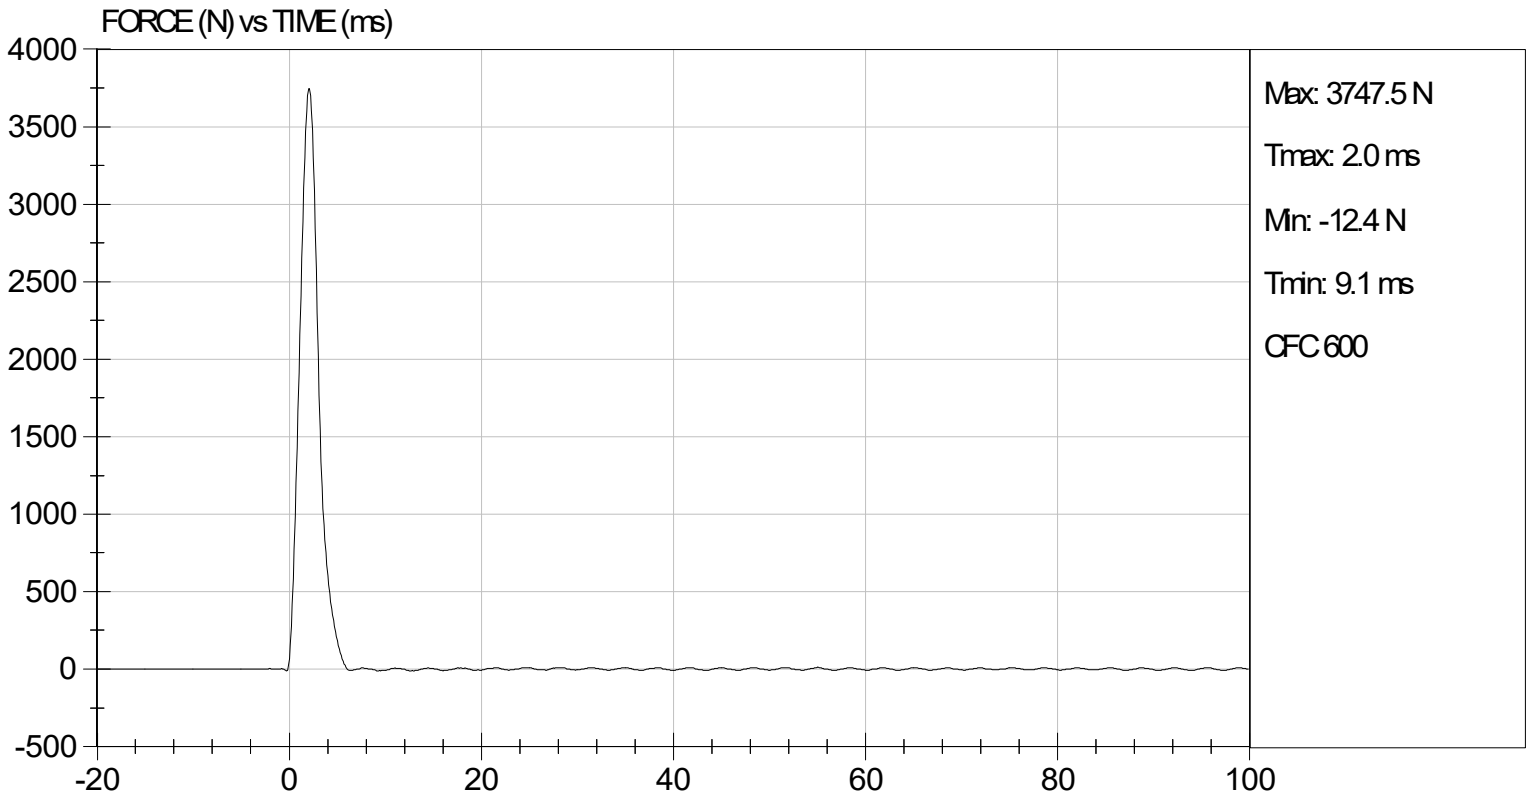
DATA SHEET B1
DUMMY DAMAGE CHECKLIST

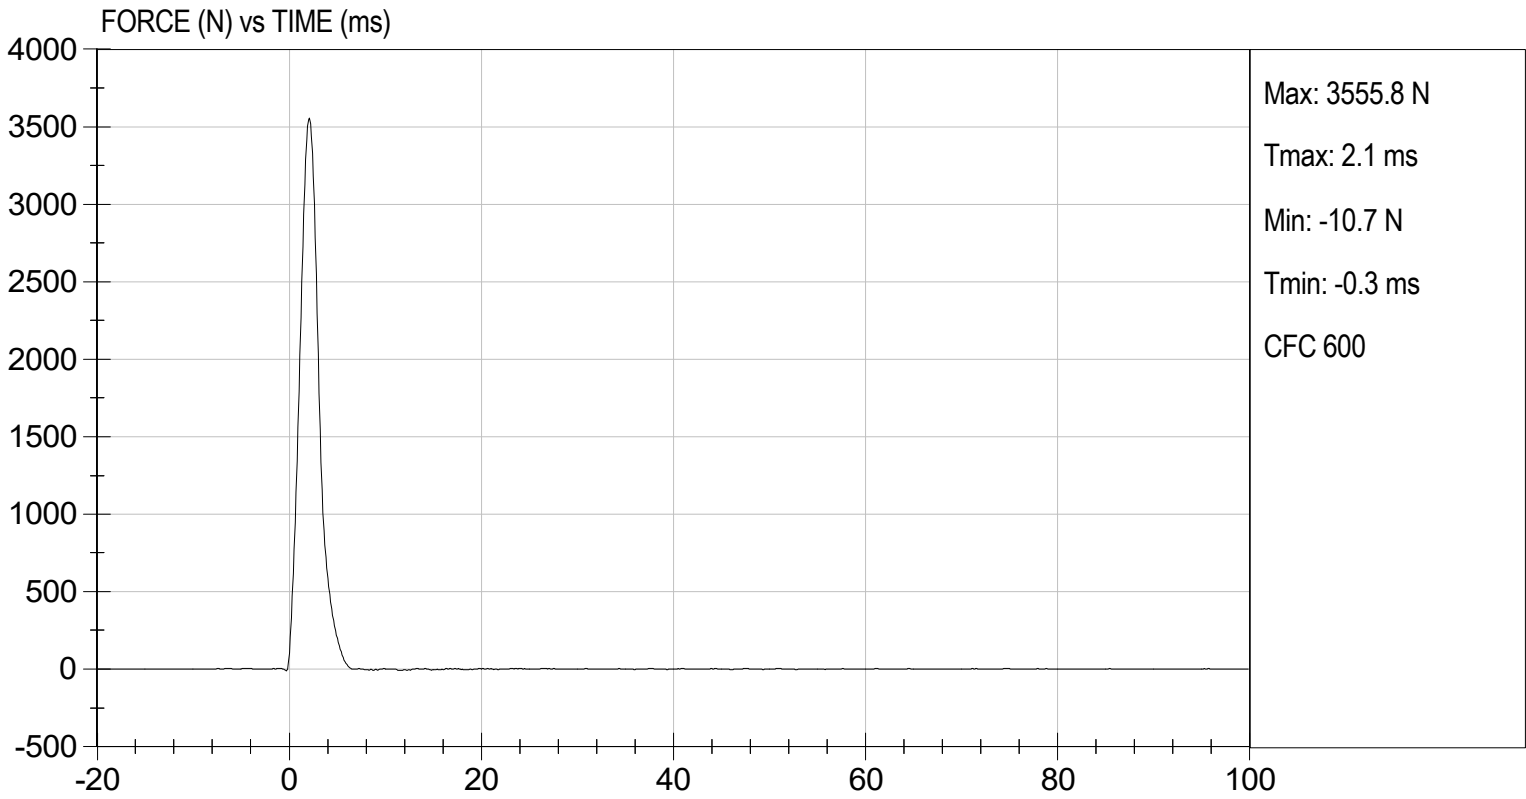
DATA SHEET B1
DUMMY DAMAGE CHECKLIST

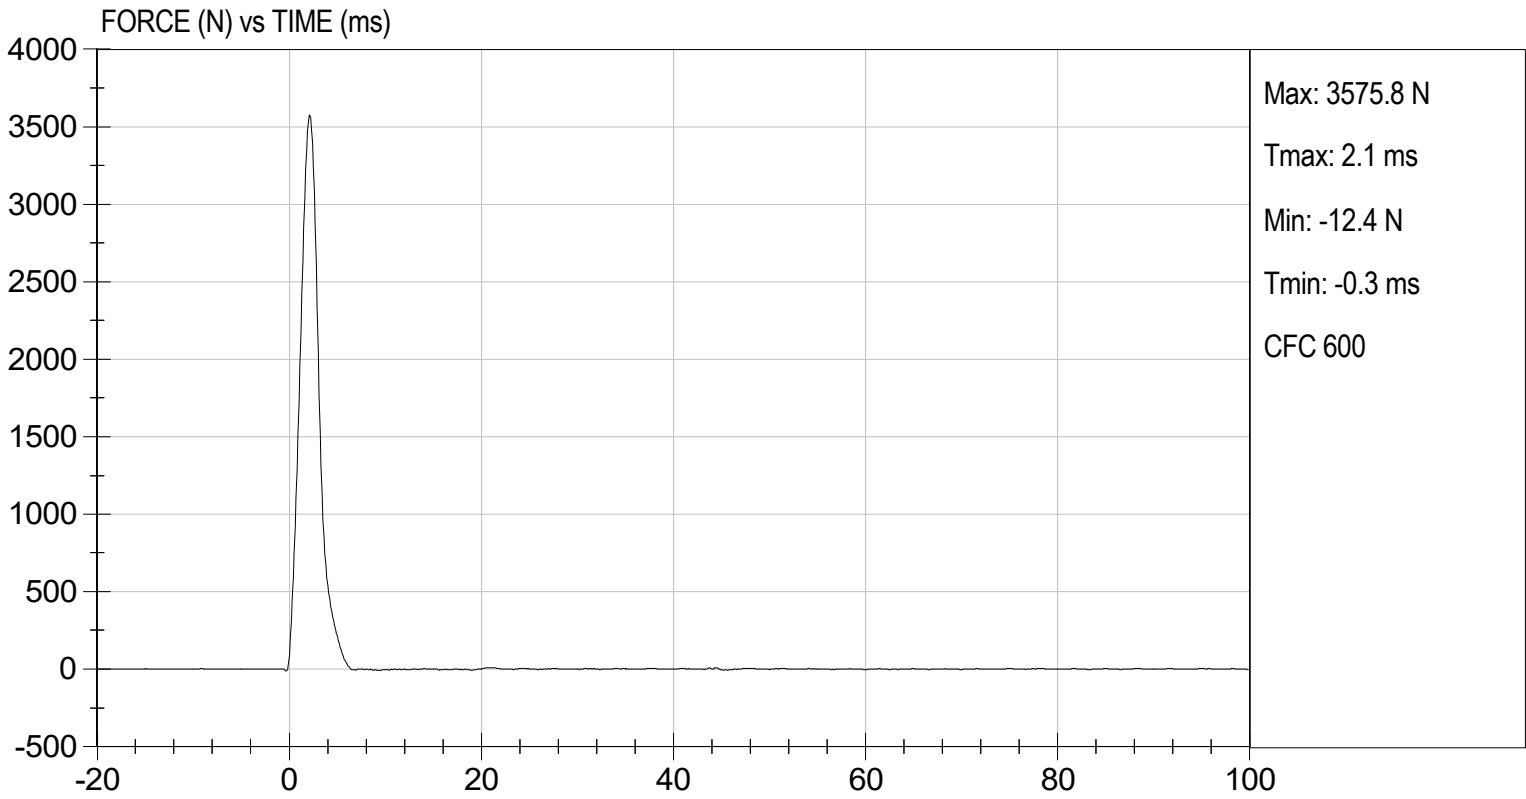
DATA SHEET B1
DUMMY DAMAGE CHECKLIST
