**REPORT NUMBER: SideNCAPMDB-MGA-25-028**

**NEW CAR ASSESSMENT PROGRAM (NCAP)  
Moving Deformable Barrier Side Impact Test**

**VOLKSWAGEN AG  
2025 Volkswagen ID.Buzz Pro S 5-Door SUV  
NHTSA No.: O20255802**

**FINAL REPORT**

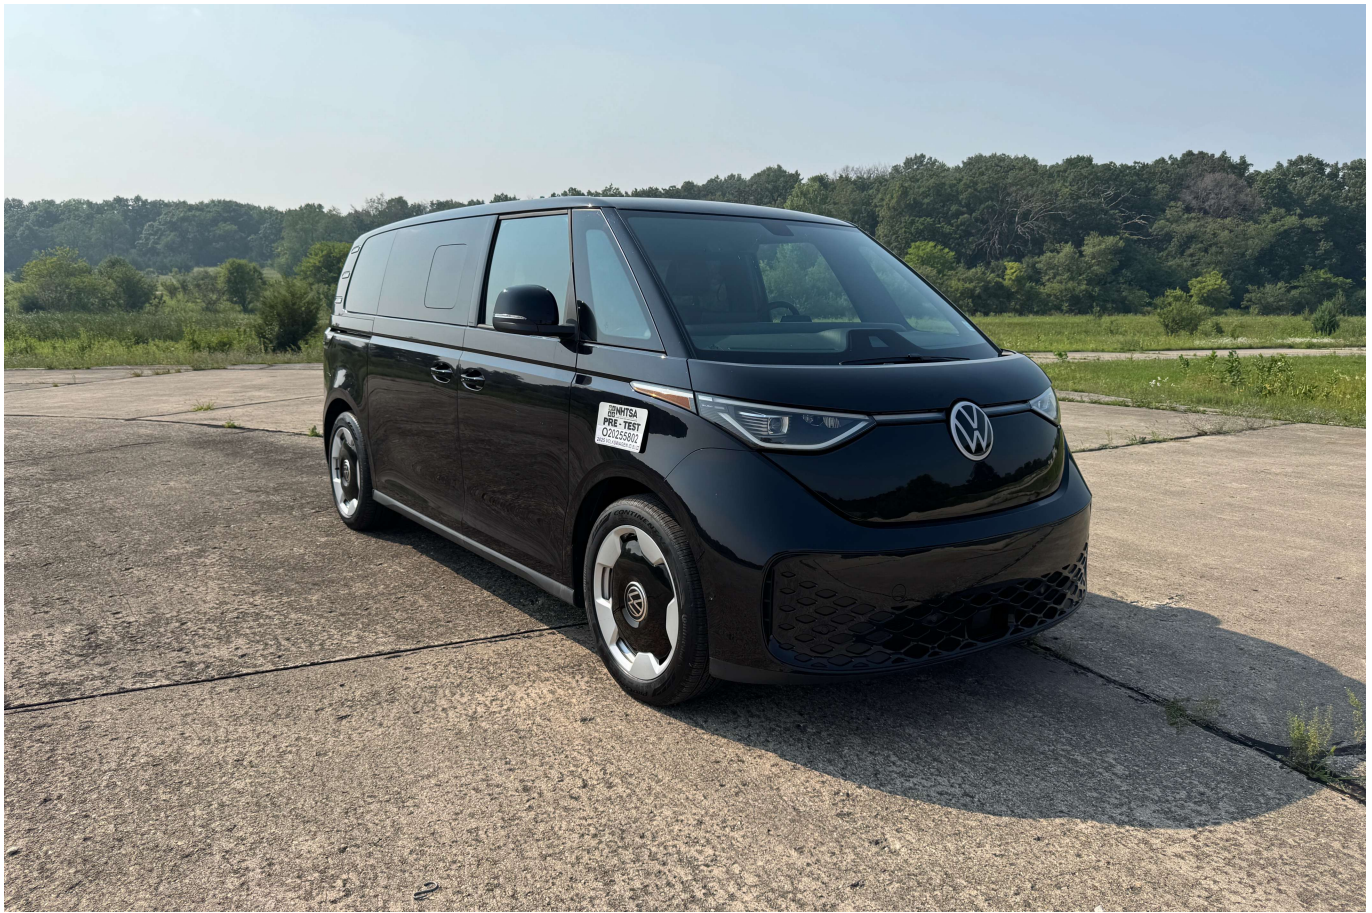
Photo No. 001 - As Delivered Right Front Three-Quarter View of Test Vehicle

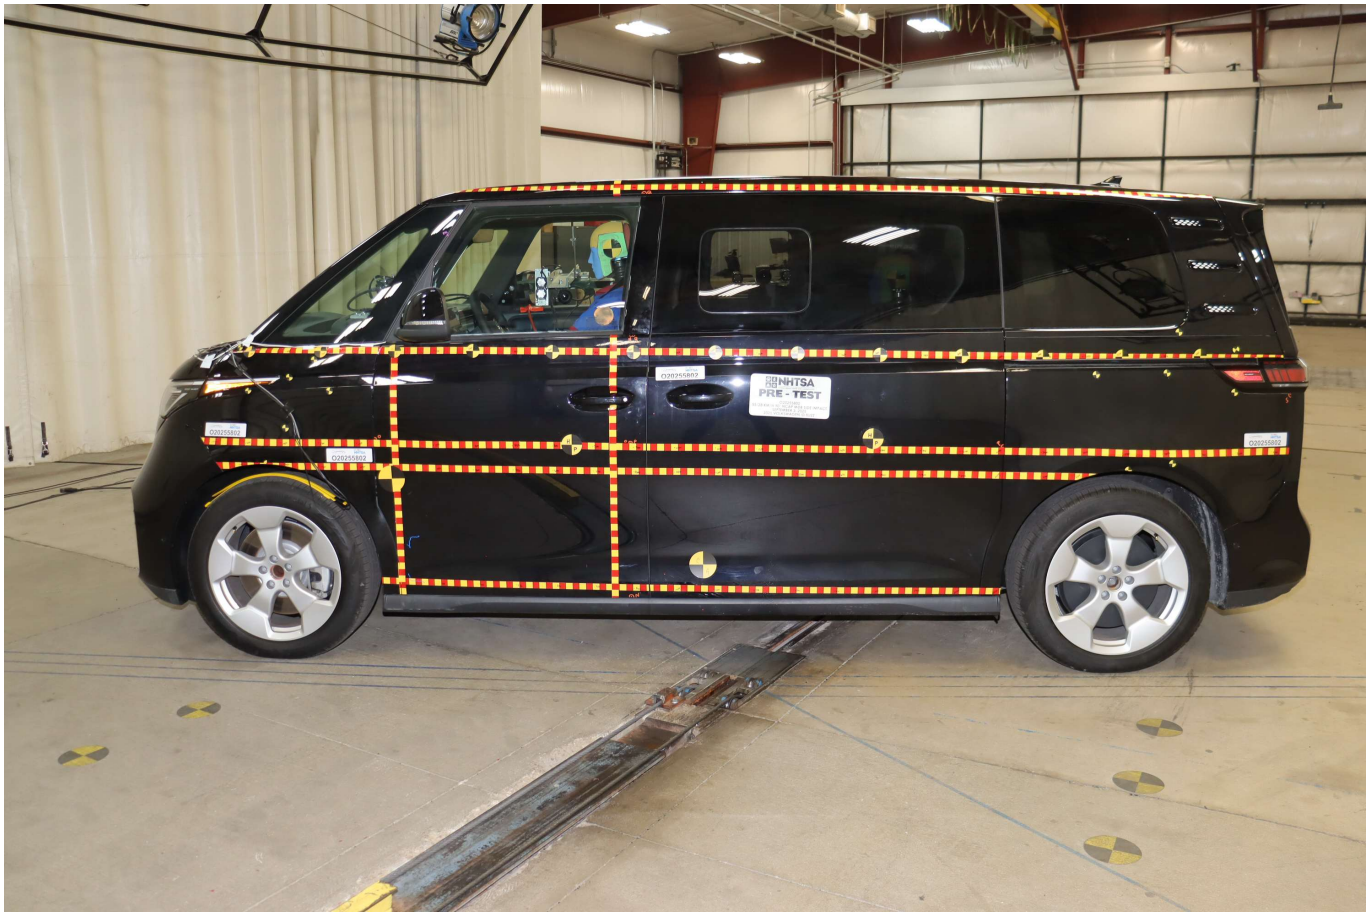
Photo No. 007 - Pre-Test Left Side View of Test Vehicle

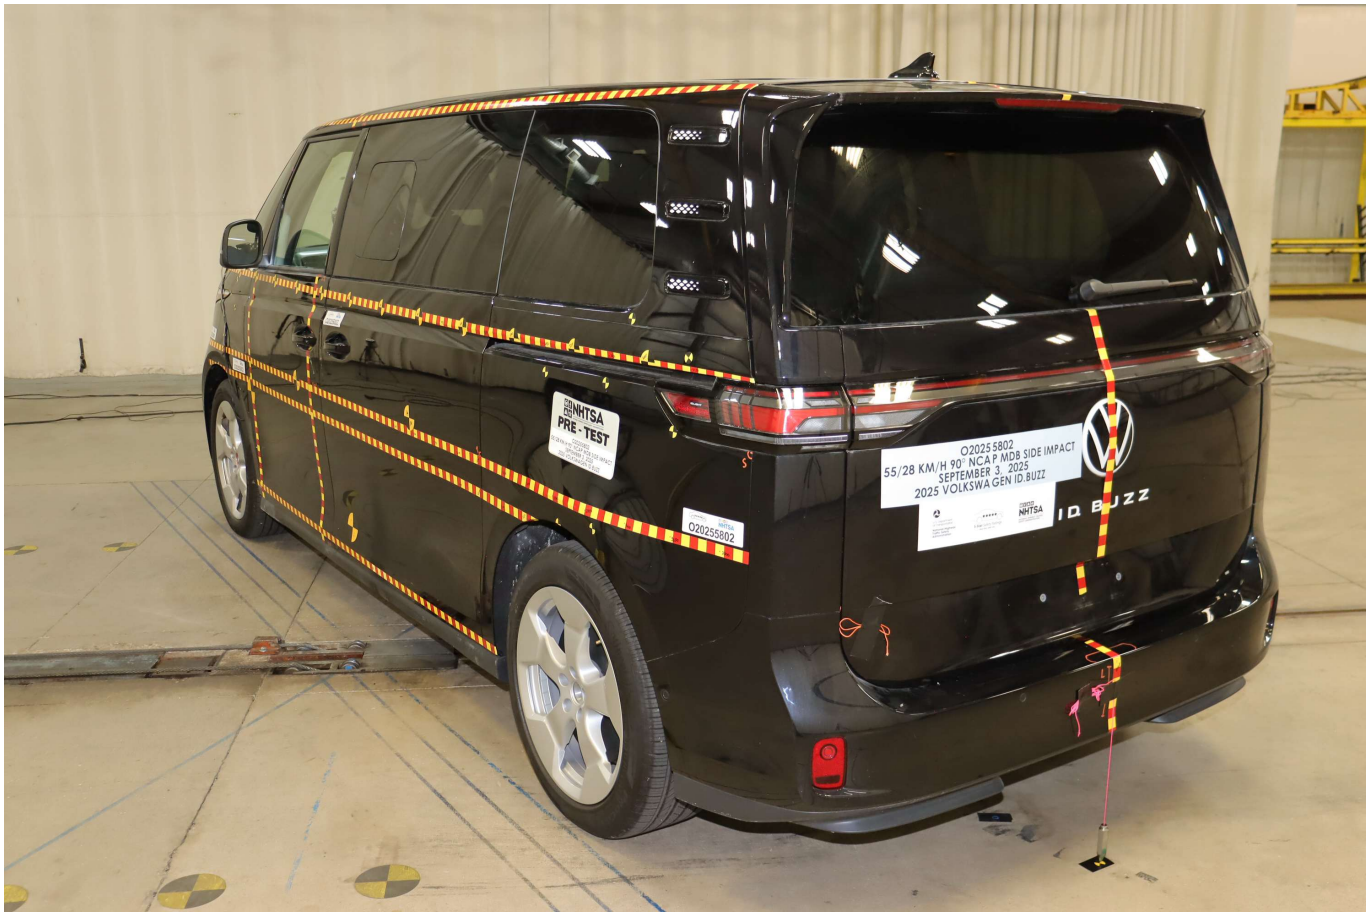
Photo No. 009 - Pre-Test Left Three-Quarter Rear View of Test Vehicle

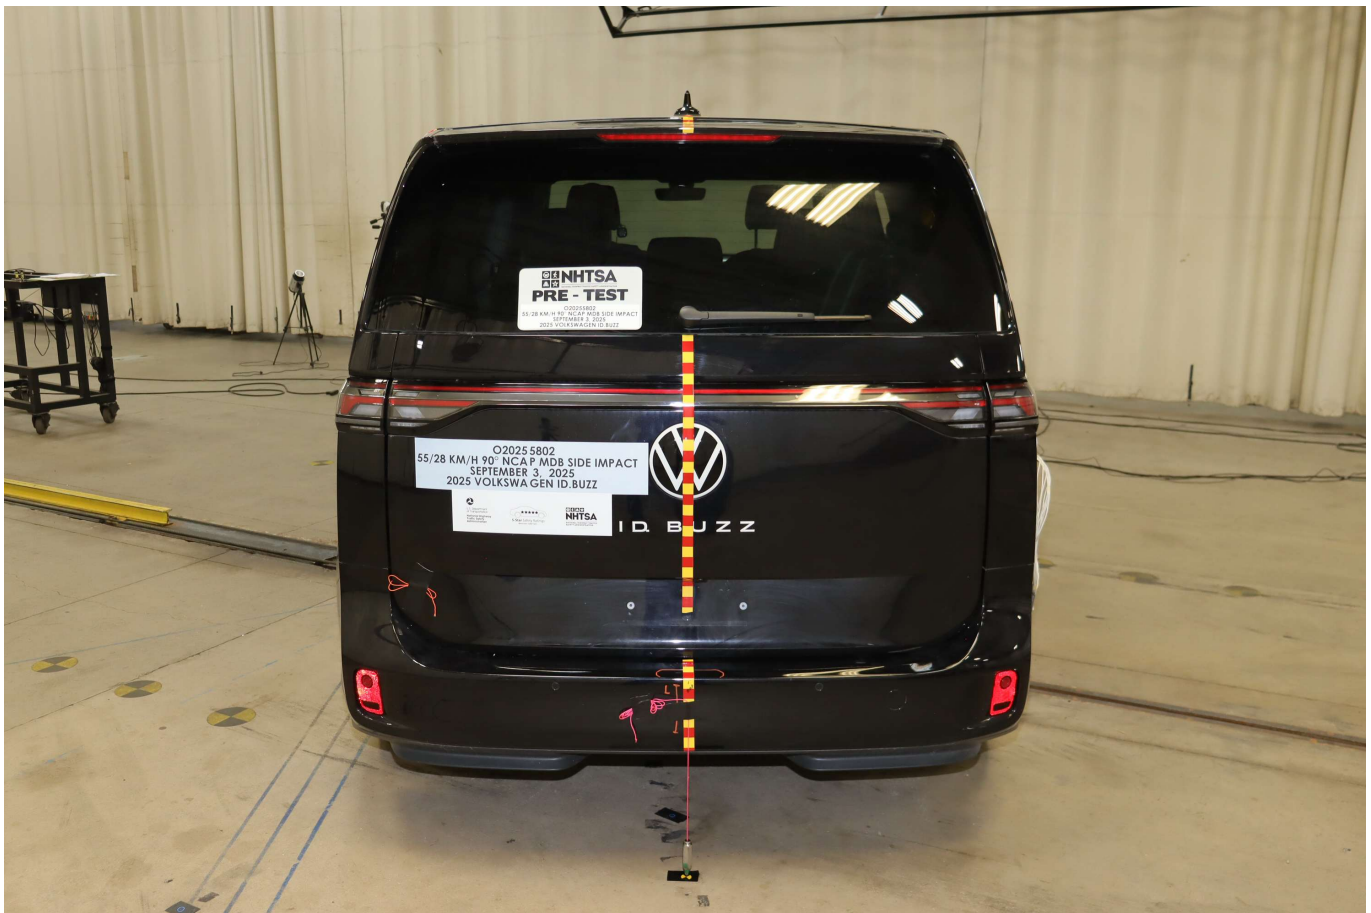
Photo No. 011 - Pre-Test Rear View of Test Vehicle

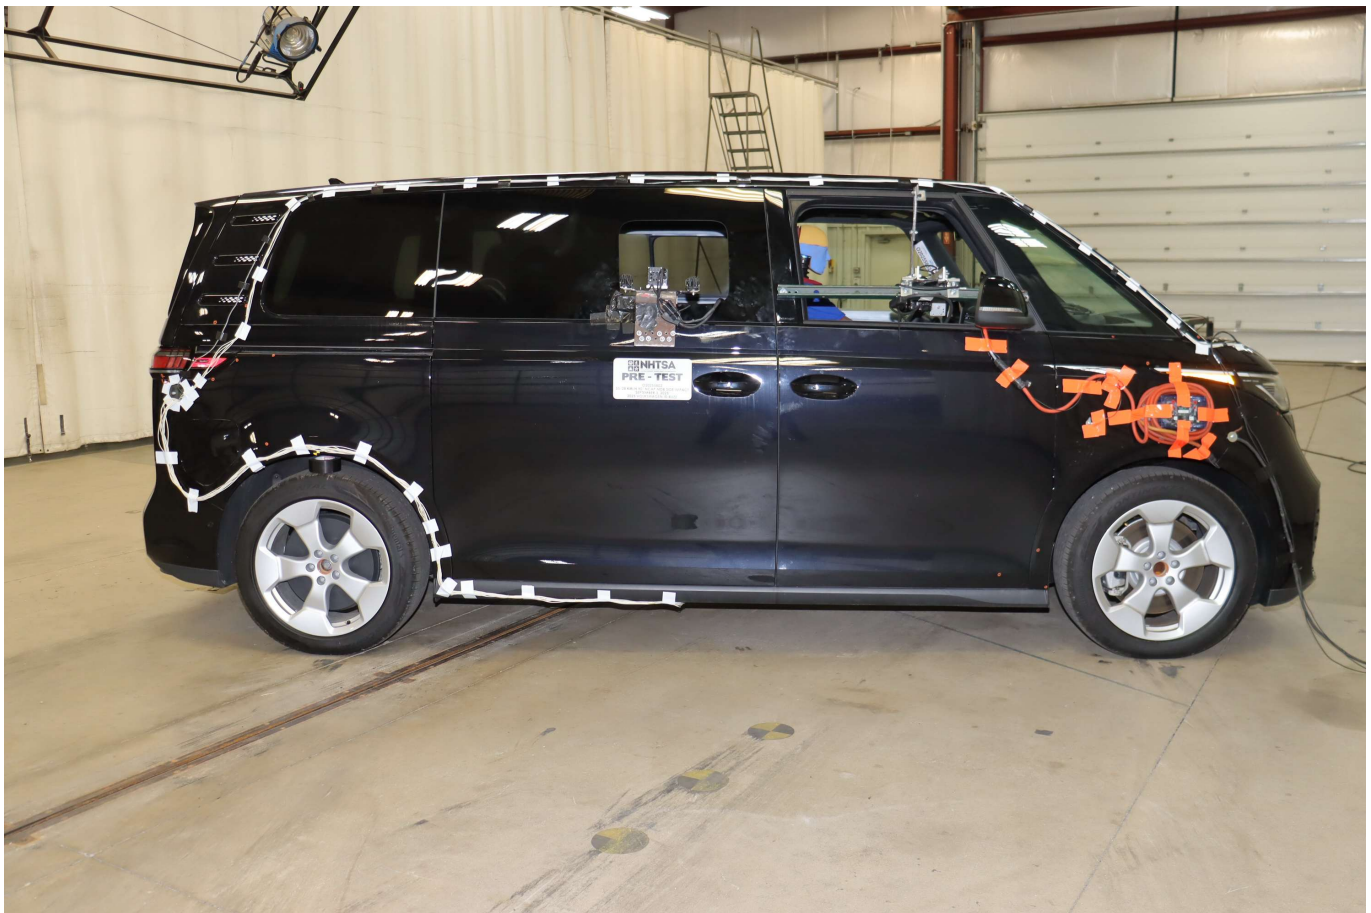
Photo No. 013 - Pre-Test Right Side View of Test Vehicle

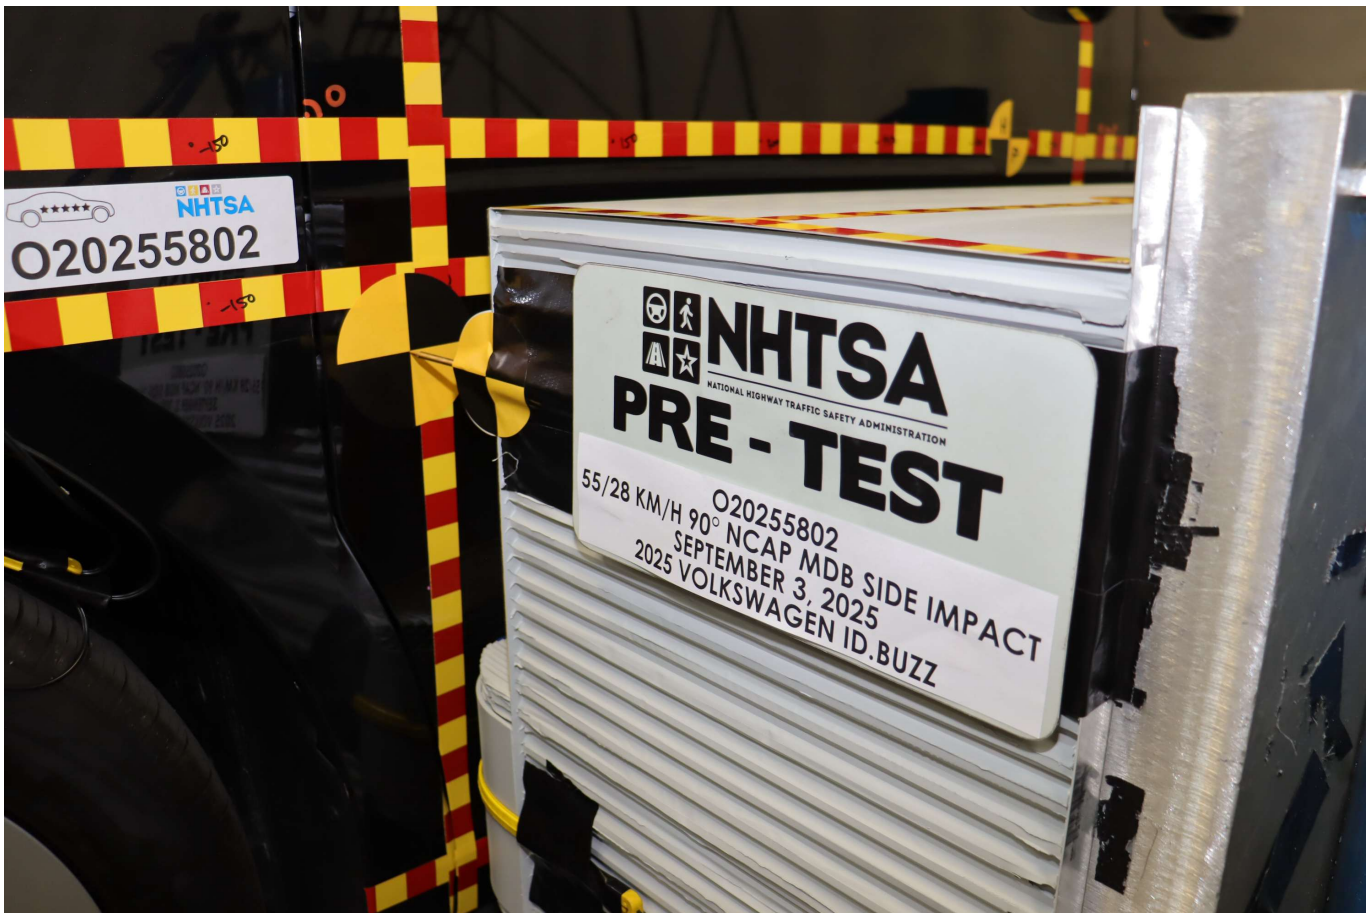
Photo No. 019 - Pre-Test Close-Up View of Impact Point Target

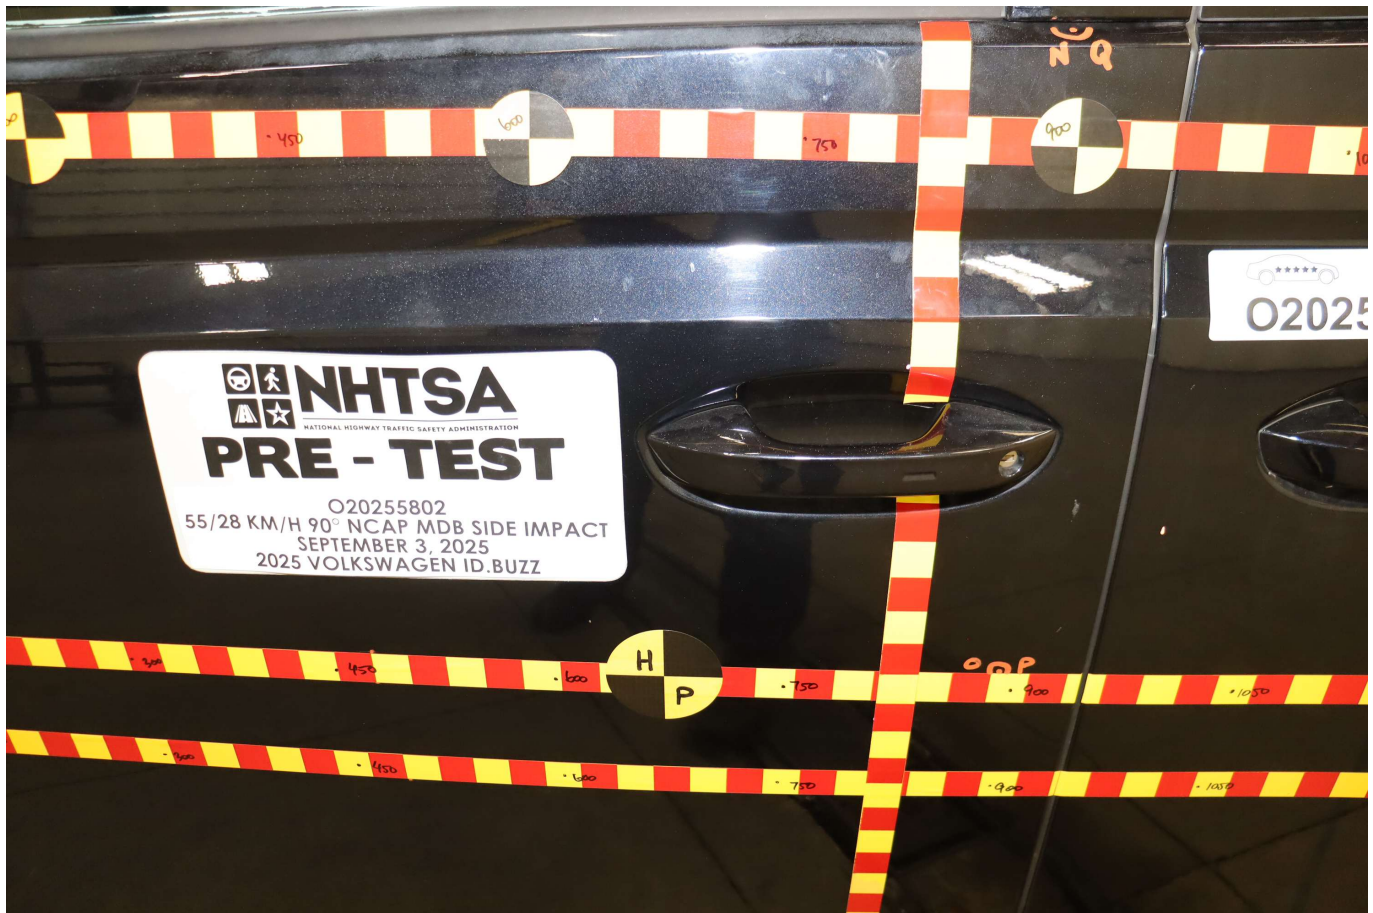
Photo No. 021 - Pre-Test Left Front Door Latch Close-Up

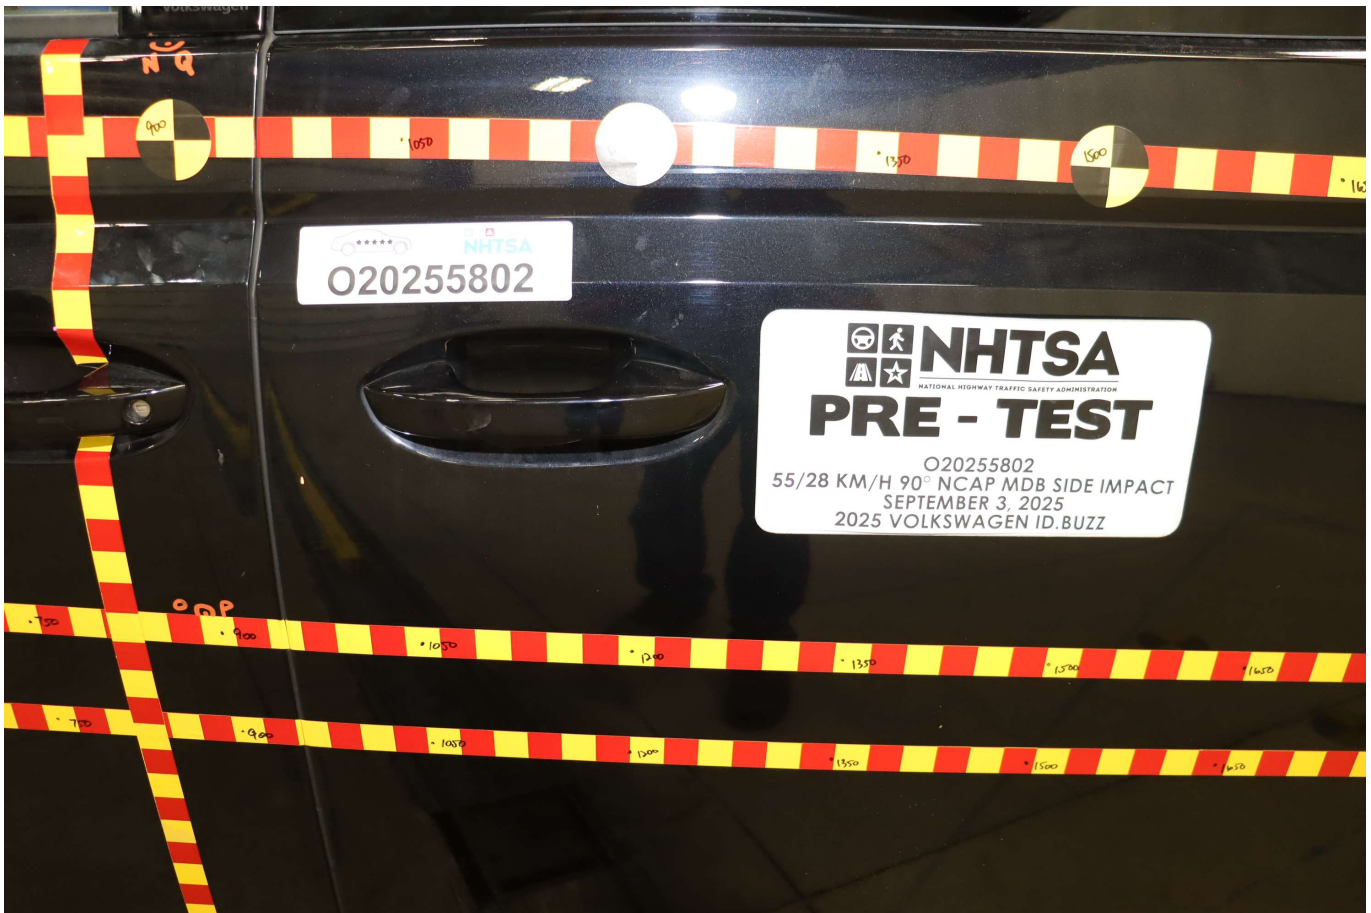
Photo No. 023 - Pre-Test Left Rear Door Latch Close-Up

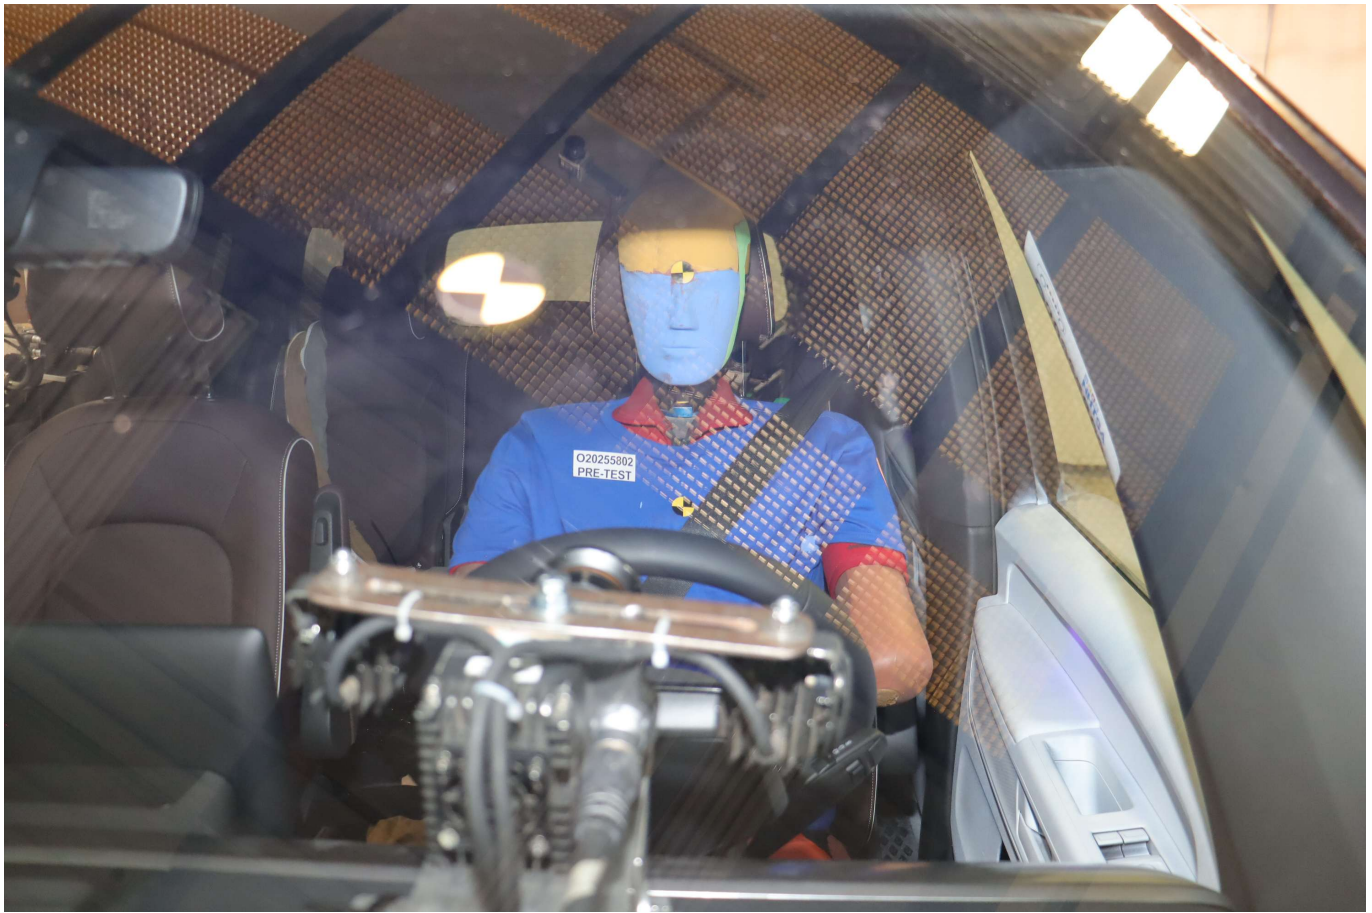
Photo No. 025 - Pre-Test Front Close-Up View of Driver Dummy

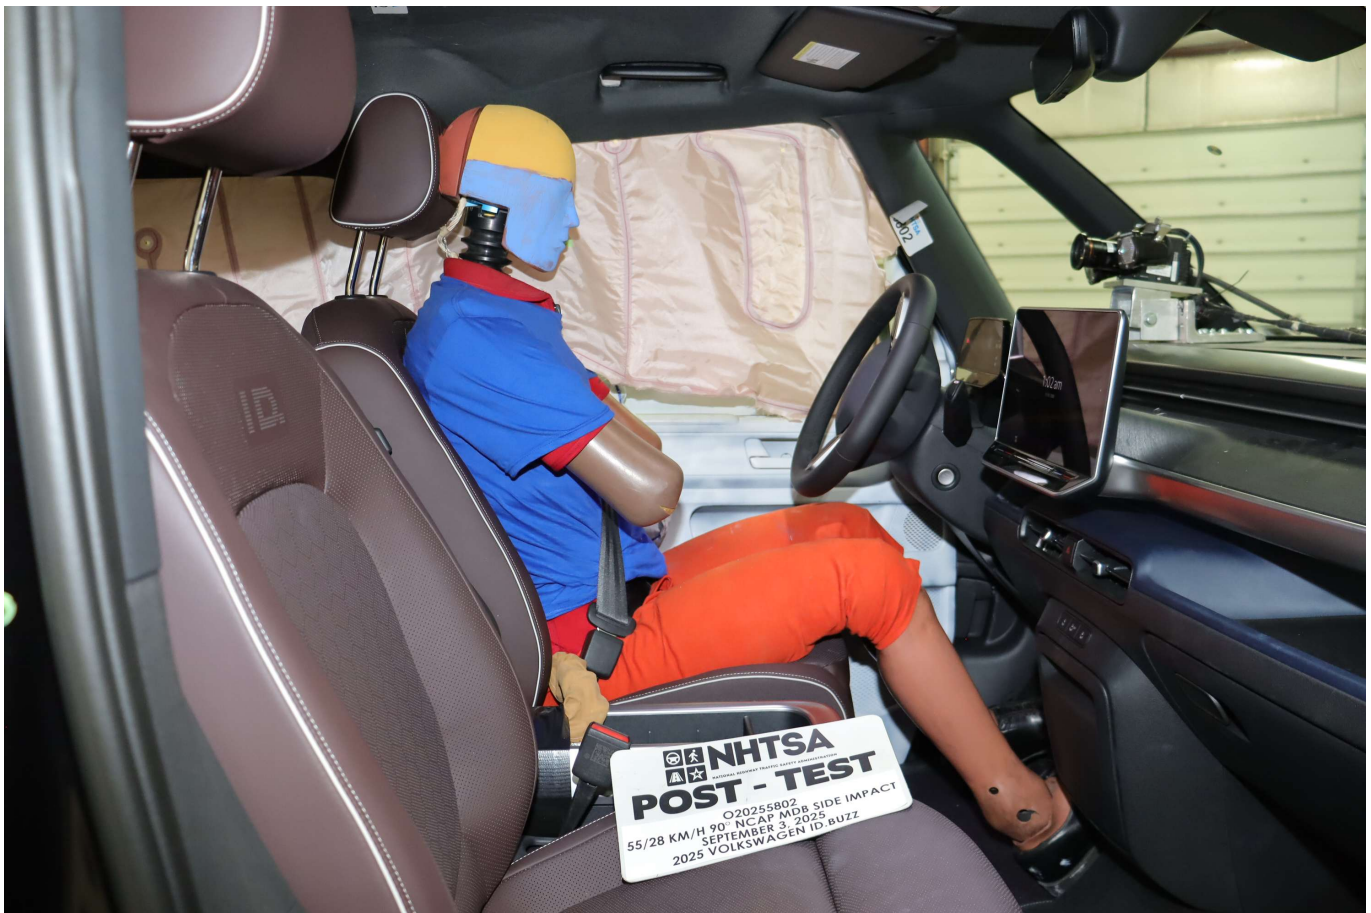
Photo No. 045 - Post-Test Right Side View of Driver Dummy and Front Seat of Occupant Compartment

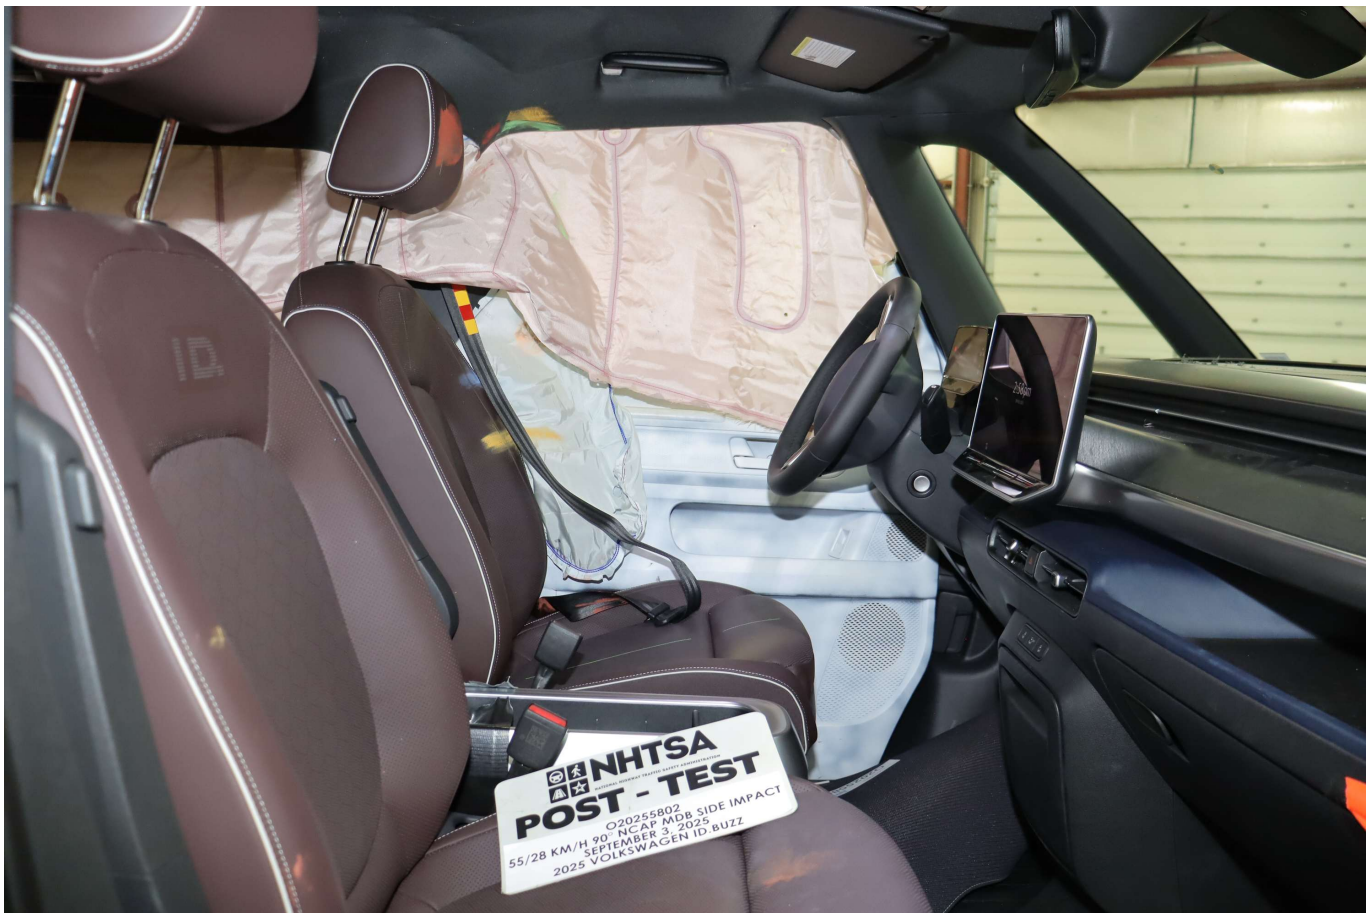
Photo No. 047 - Post-Test Driver Inner Door Panel View

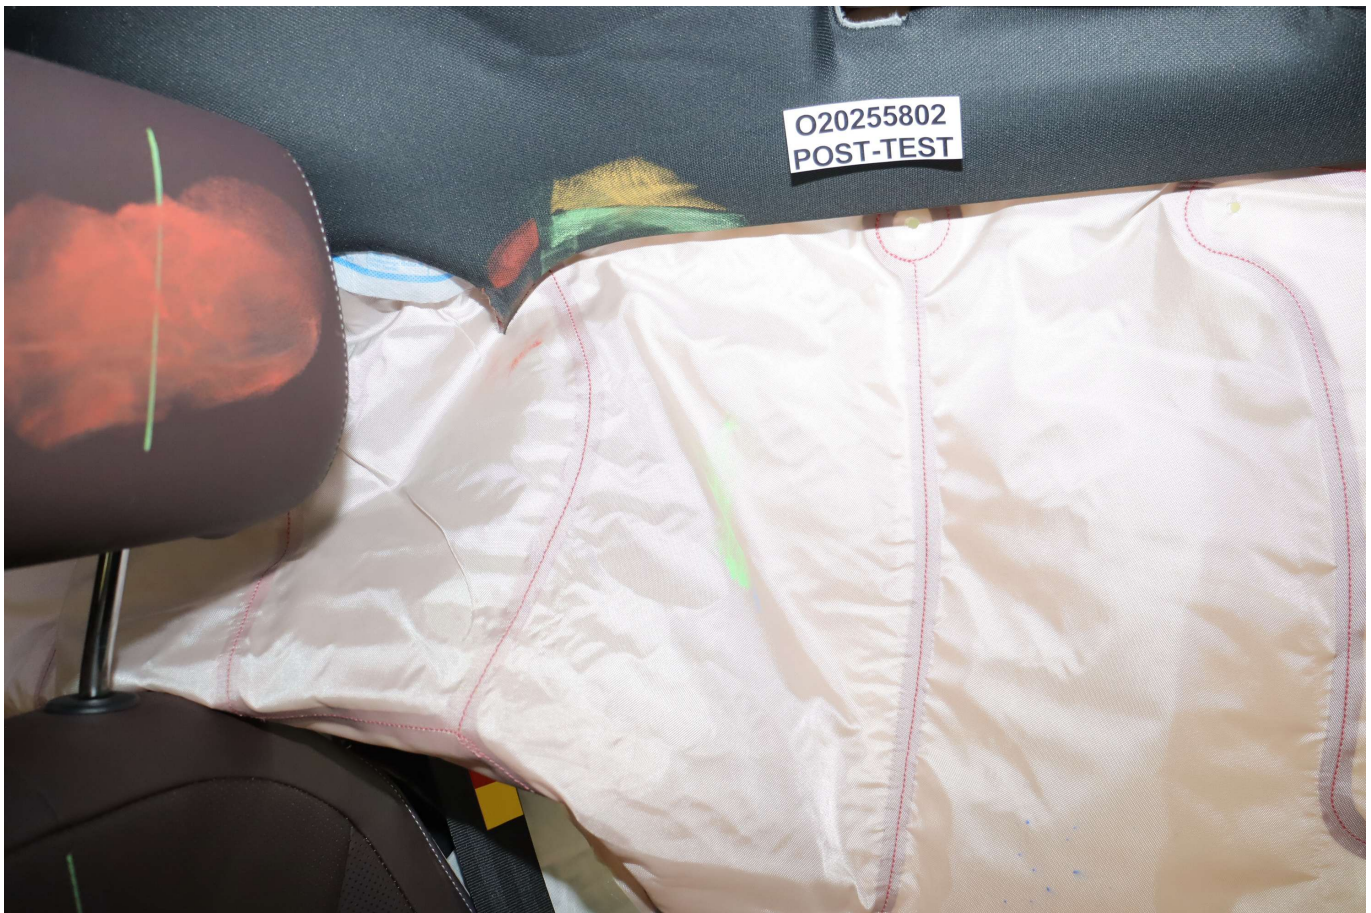
Photo No. 049 - Post-Test Driver Dummy Close-Up Head Contact with Side Airbag View

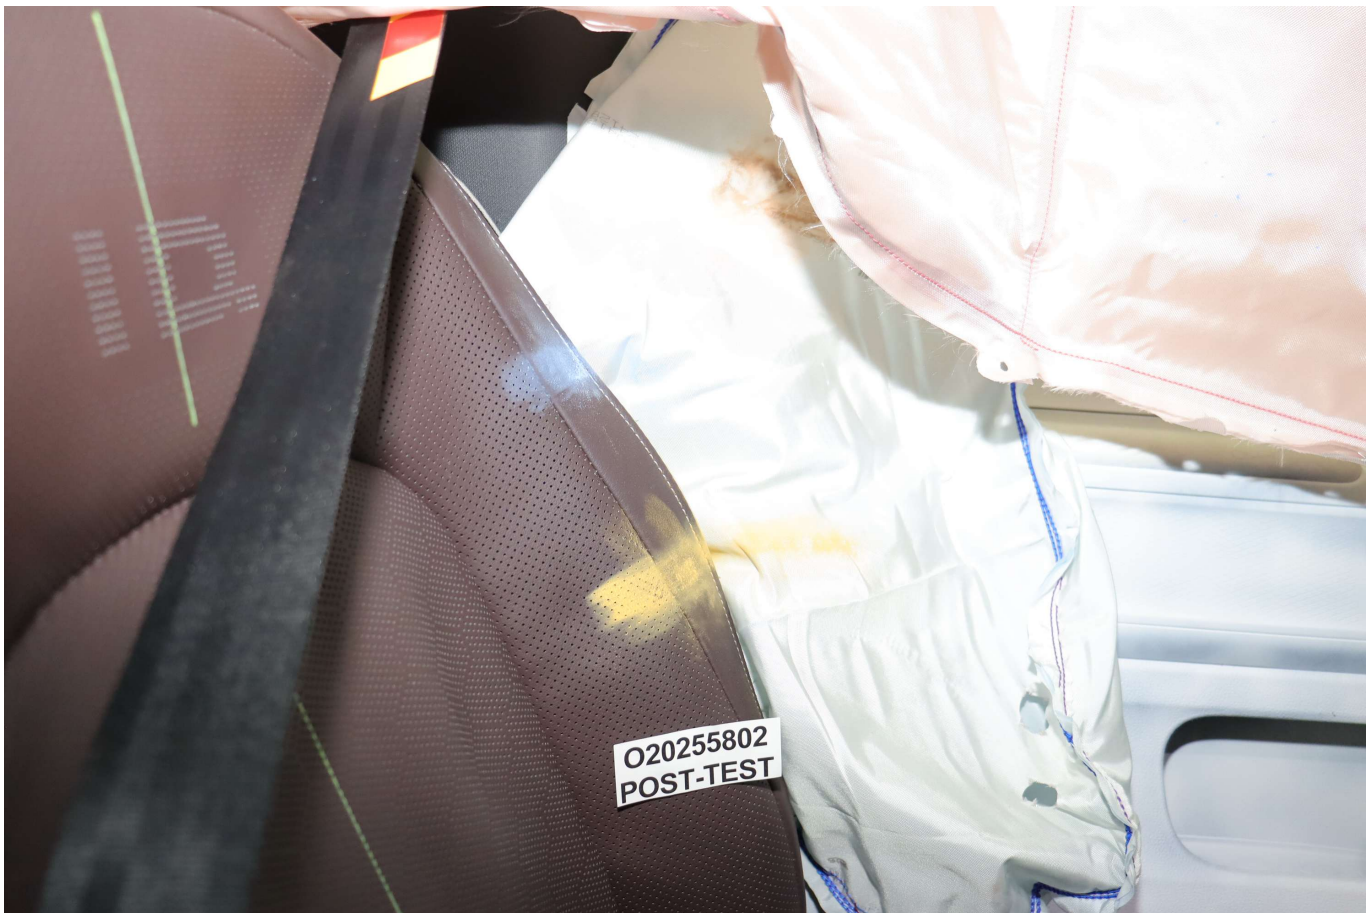
Photo No. 051 - Post-Test Driver Dummy Close-Up Torso Contact with Side Airbag View
