REPORT NUMBER: SideNCAPPole-MGA-25-030

**NEW CAR ASSESSMENT PROGRAM (NCAP)
Side Impact Pole Test**

**VOLKSWAGEN AG
2025 Volkswagen ID.Buzz 1st Edition 5-Door SUV
NHTSA No.: O20255801**

FINAL REPORT

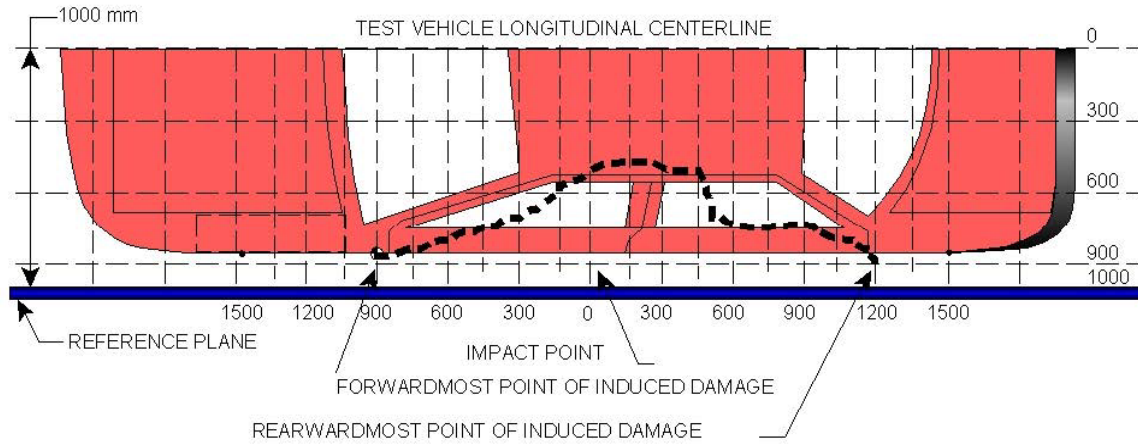
VEHICLE DAMAGE PROFILE DISTANCES

DPD	Distance from Impact Point (mm)	Level	Pre-Test (mm)	Post-Test (mm)	Max. Static Crush (mm)
1	225	3	141	24	117
2	129	3	192	24	168
3	26	3	219	25	194
4	-54	3	218	26	192
5	-137	3	187	27	160
6	-225	3	158	28	130

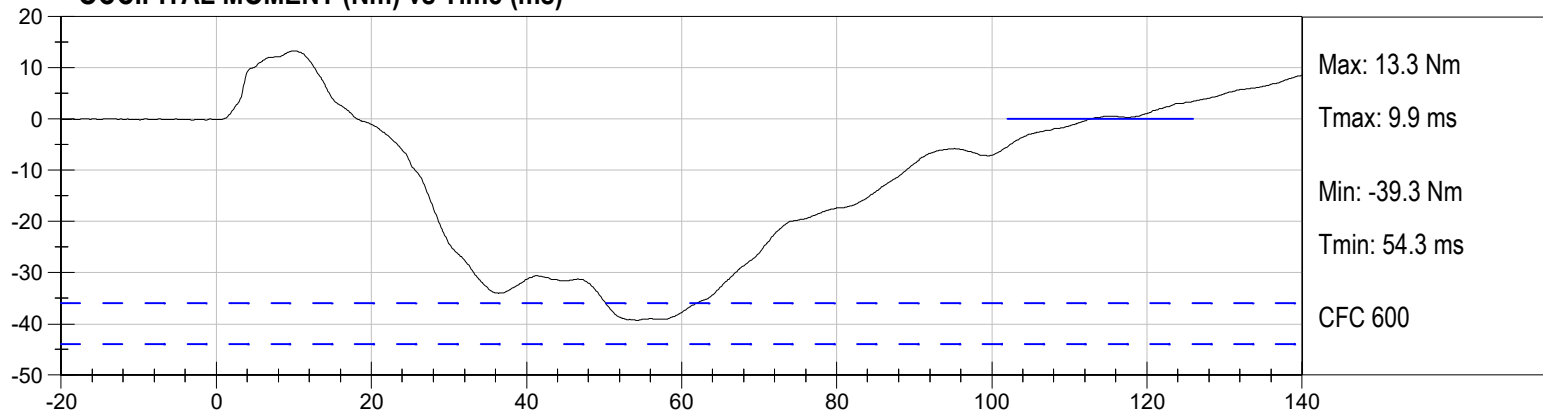
OCCIPITAL MOMENT (Nm) vs Time (ms)

Tested Parameter	Units	Specification	Result	Pass/Fail
Laboratory Temperature	°C	20.6 to 22.2	21.2	Pass
Laboratory Relative Humidity	%	10 to 70	46	Pass
Impact Velocity	m/s	5.51 to 5.63	5.52	Pass
Pendulum Velocity at 10 ms	m/s	2.20 to 2.80	2.25	Pass
Pendulum Velocity at 15 ms	m/s	3.30 to 4.10	3.46	Pass
Pendulum Velocity at 20 ms	m/s	4.40 to 5.40	4.85	Pass
Pendulum Velocity at 25 ms	m/s	5.40 to 6.10	5.84	Pass
Peak Pendulum Velocity from 25 to 100 ms	m/s	5.50 to 6.20	5.87	Pass
Maximum "D" Plane Rotation	deg	71 to 81	73	Pass
Time of Maximum "D" Plane Rotation	ms	50 to 70	64	Pass
Maximum Moment About Occipital Condyle	Nm	-44 to -36	-39	Pass
Time of Moment Decay Time To 0 Nm	ms	102 to 126	113	Pass

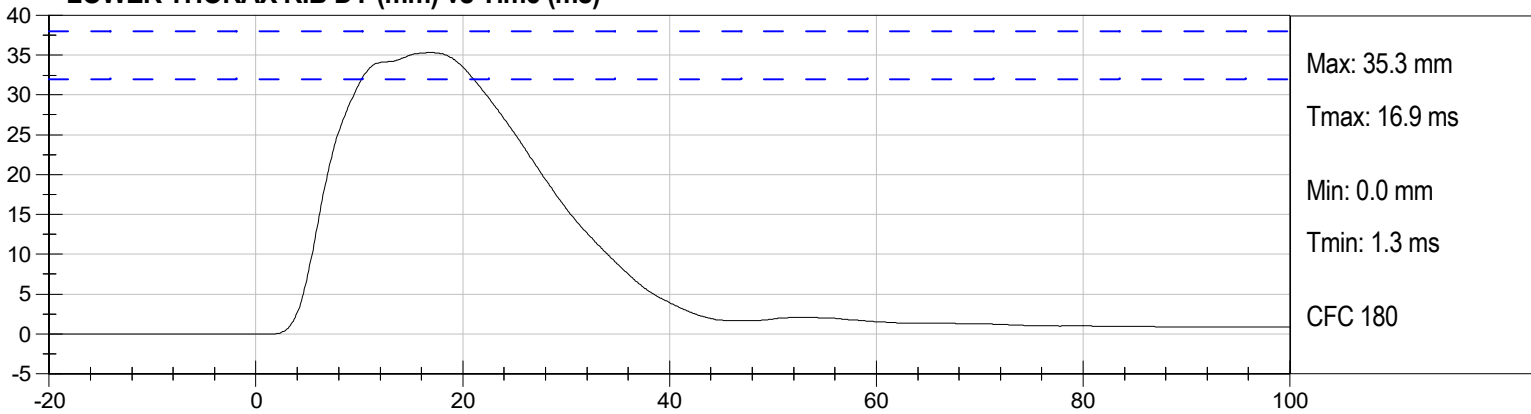
LOWER THORAX RIB DY (mm) vs Time (ms)

Tested Parameter	Units	Specification	Result	Pass/Fail
Laboratory Temperature	°C	20.6 to 22.2	21.3	Pass
Laboratory Relative Humidity	%	10 to 70	44	Pass
Impact Velocity	m/s	6.6 to 6.8	6.77	Pass
Peak Probe Acceleration after 5 ms	g	30 to 36	34	Pass
Upper Spine (T1) Y Acceleration	g	34 to 43	38	Pass
Lower Spine (T12) Y Acceleration	g	29 to 37	33	Pass
Shoulder Displacement	mm	31 to 40	35	Pass
Upper Thorax Rib Displacement	mm	25 to 32	28	Pass
Middle Thorax Rib Displacement	mm	30 to 36	33	Pass
Lower Thorax Rib Displacement	mm	32 to 38	35	Pass

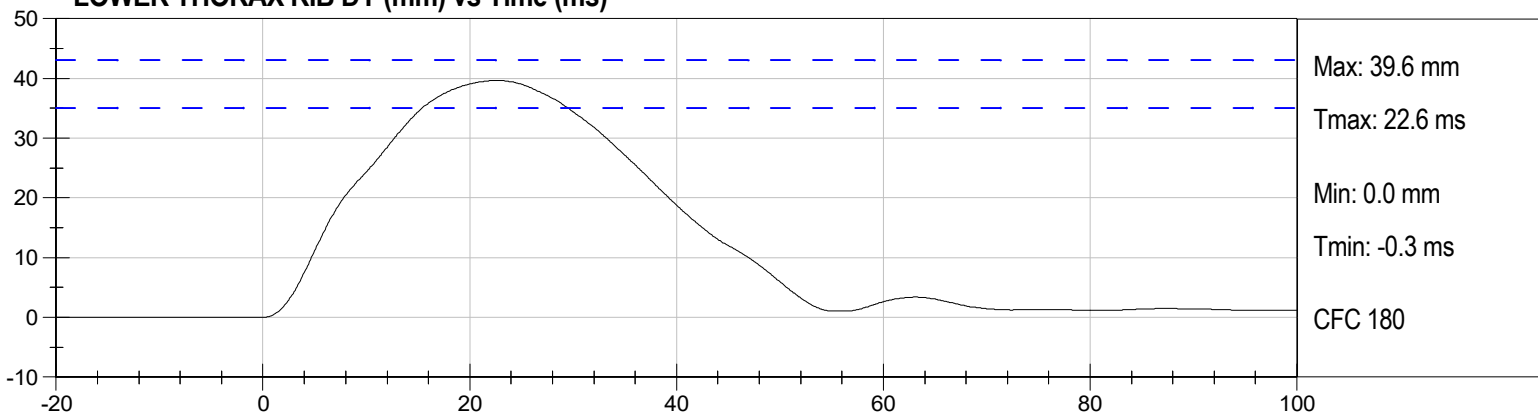
LOWER THORAX RIB DY (mm) vs Time (ms)

Tested Parameter	Units	Specification	Result	Pass/Fail
Laboratory Temperature	°C	20.6 to 22.2	21.2	Pass
Laboratory Relative Humidity	%	10 to 70	45	Pass
Impact Velocity	m/s	4.2 to 4.4	4.31	Pass
Peak Probe Acceleration	g	14 to 18	15	Pass
Upper Spine (T1) Y Acceleration	g	13 to 17	15	Pass
Lower Spine (T12) Y Acceleration	g	7 to 11	10	Pass
Upper Thorax Rib Displacement	mm	32 to 40	37	Pass
Middle Thorax Rib Displacement	mm	39 to 45	42	Pass
Lower Thorax Rib Displacement	mm	35 to 43	40	Pass

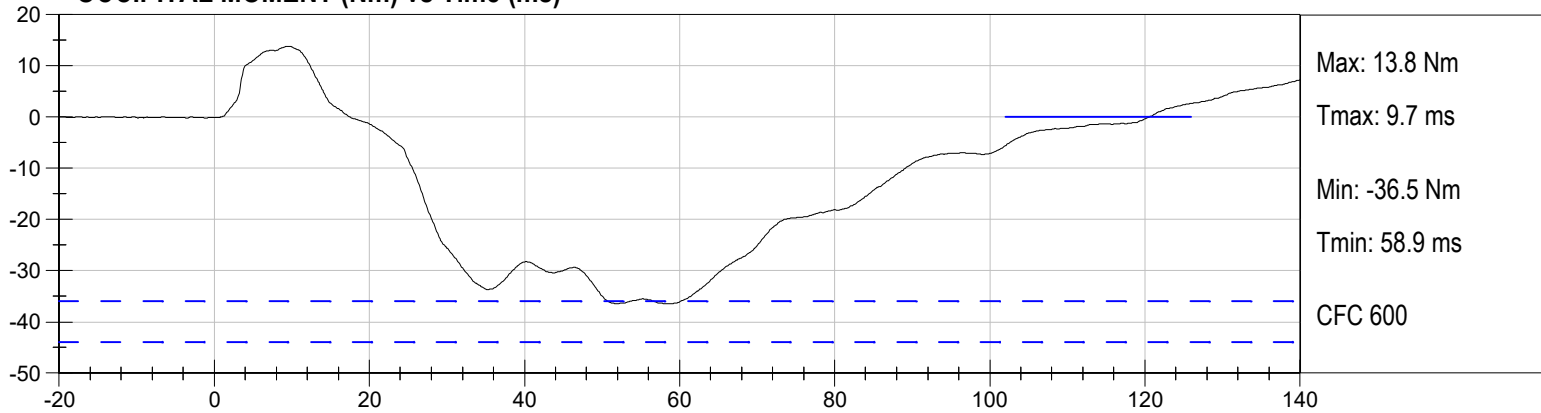
OCCIPITAL MOMENT (Nm) vs Time (ms)

Tested Parameter	Units	Specification	Result	Pass/Fail
Laboratory Temperature	°C	20.6 to 22.2	21.1	Pass
Laboratory Relative Humidity	%	10 to 70	41	Pass
Impact Velocity	m/s	5.51 to 5.63	5.52	Pass
Pendulum Velocity at 10 ms	m/s	2.20 to 2.80	2.33	Pass
Pendulum Velocity at 15 ms	m/s	3.30 to 4.10	3.54	Pass
Pendulum Velocity at 20 ms	m/s	4.40 to 5.40	5.02	Pass
Pendulum Velocity at 25 ms	m/s	5.40 to 6.10	5.90	Pass
Peak Pendulum Velocity from 25 to 100 ms	m/s	5.50 to 6.20	5.90	Pass
Maximum "D" Plane Rotation	deg	71 to 81	76	Pass
Time of Maximum "D" Plane Rotation	ms	50 to 70	64	Pass
Maximum Moment About Occipital Condyle	Nm	-44 to -36	-37	Pass
Time of Moment Decay Time To 0 Nm	ms	102 to 126	121	Pass

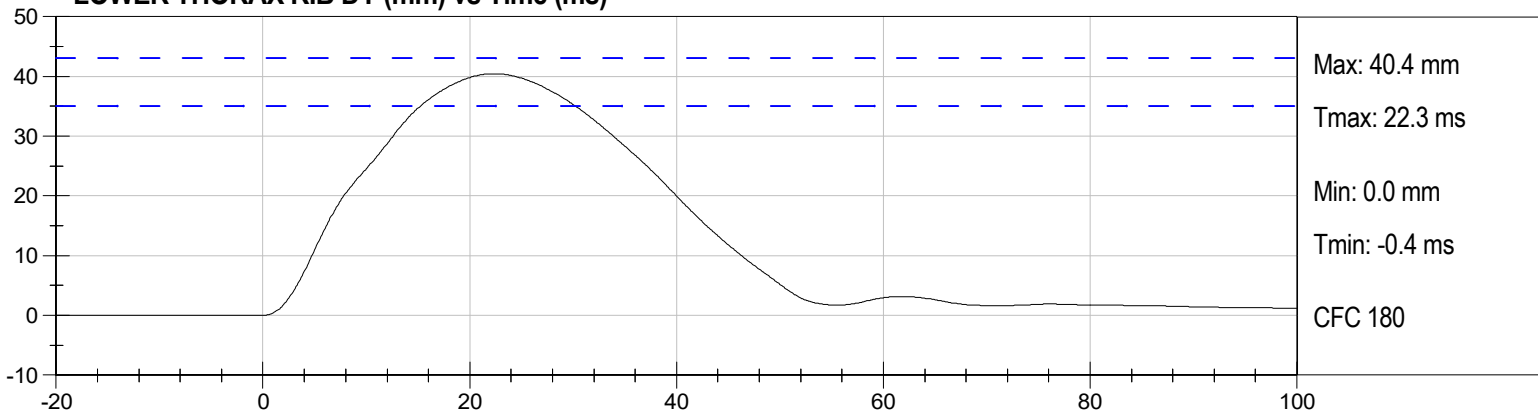
LOWER THORAX RIB DY (mm) vs Time (ms)

Tested Parameter	Units	Specification	Result	Pass/Fail
Laboratory Temperature	°C	20.6 to 22.2	21.1	Pass
Laboratory Relative Humidity	%	10 to 70	39	Pass
Impact Velocity	m/s	4.2 to 4.4	4.31	Pass
Peak Probe Acceleration	g	14 to 18	16	Pass
Upper Spine (T1) Y Acceleration	g	13 to 17	15	Pass
Lower Spine (T12) Y Acceleration	g	7 to 11	10	Pass
Upper Thorax Rib Displacement	mm	32 to 40	38	Pass
Middle Thorax Rib Displacement	mm	39 to 45	43	Pass
Lower Thorax Rib Displacement	mm	35 to 43	40	Pass
