**REPORT NUMBER: SideNCAPMDB-KAR-25-009**

**NEW CAR ASSESSMENT PROGRAM (NCAP)  
MOVING DEFORMABLE BARRIER SIDE IMPACT TEST**

**SUBARU CORPORATION  
2026 SUBARU IMPREZA 5-DOOR HATCHBACK**

**NHTSA No: O20265502**

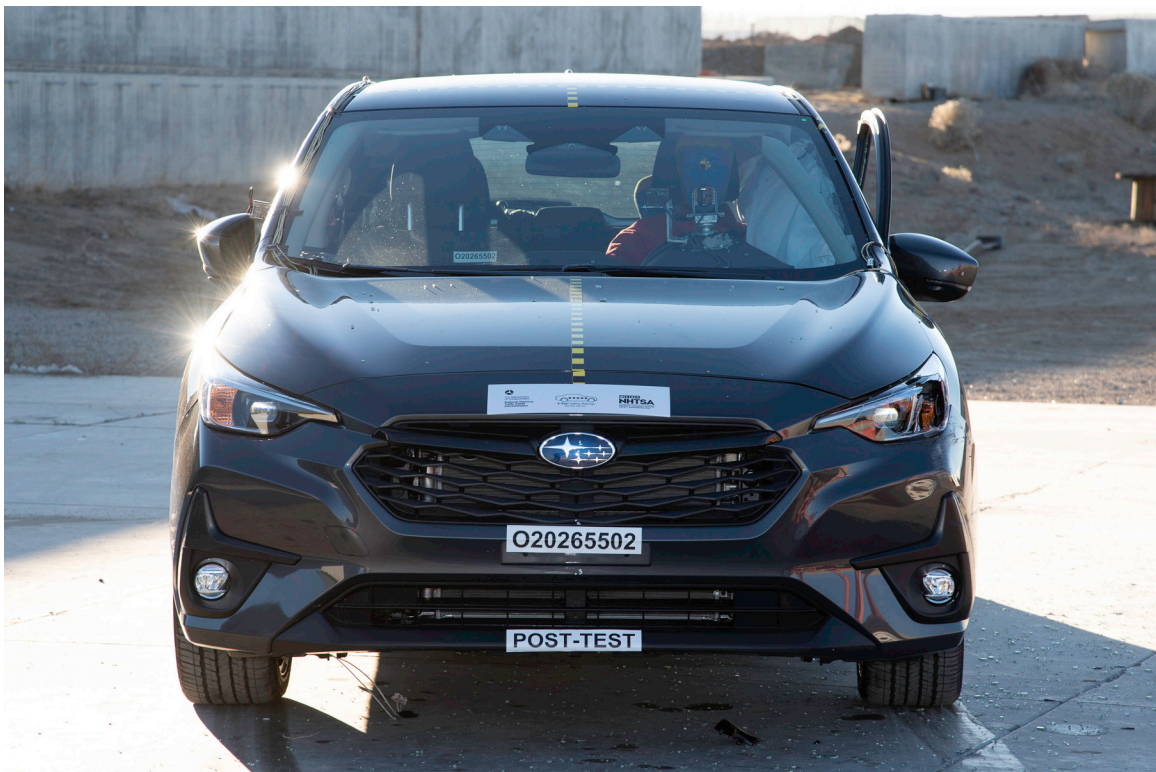
FIGURE 4. Post-Test Frontal View of Test Vehicle

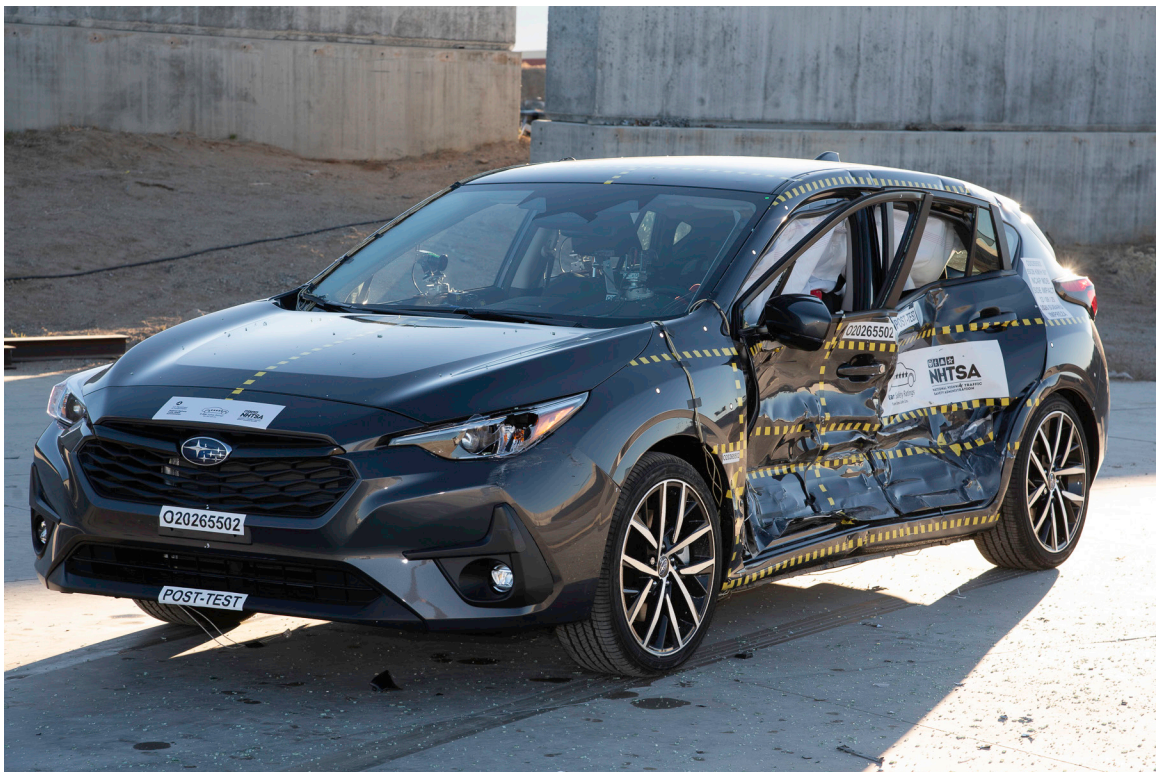
FIGURE 6. Post-Test Left Front 3/4 View of Test Vehicle

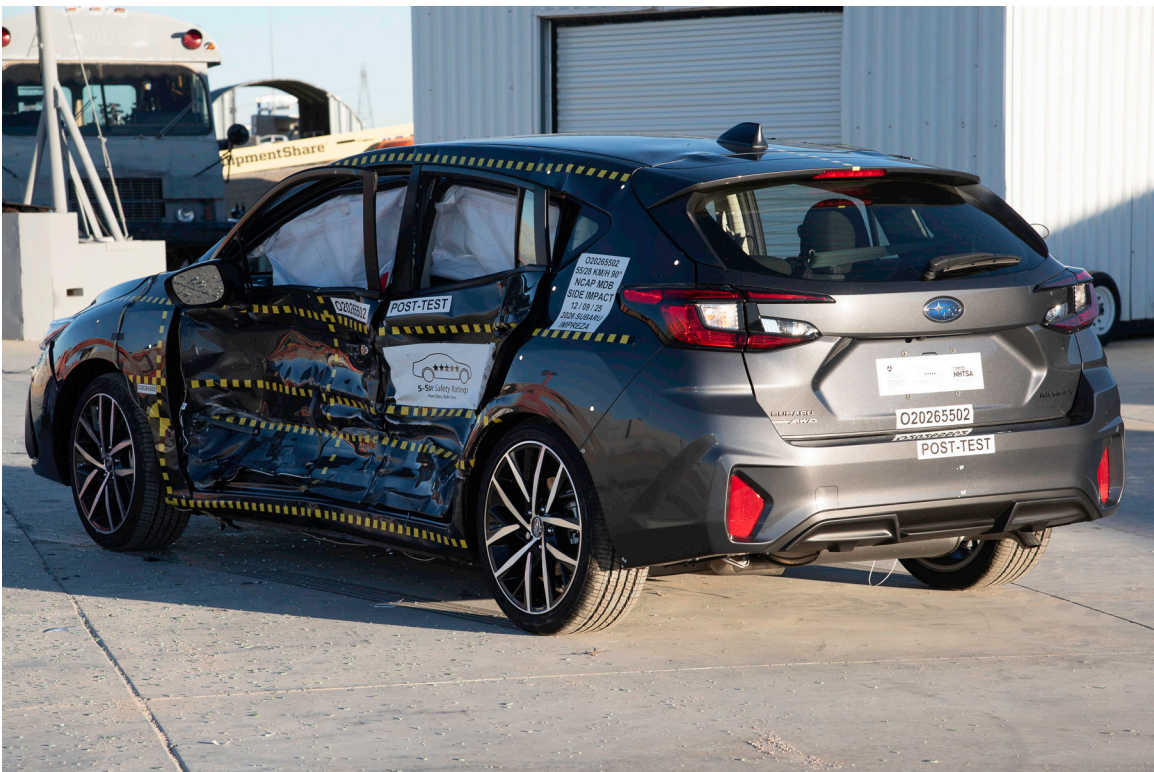
FIGURE 10. Post-Test Left Rear 3/4 View of Test Vehicle

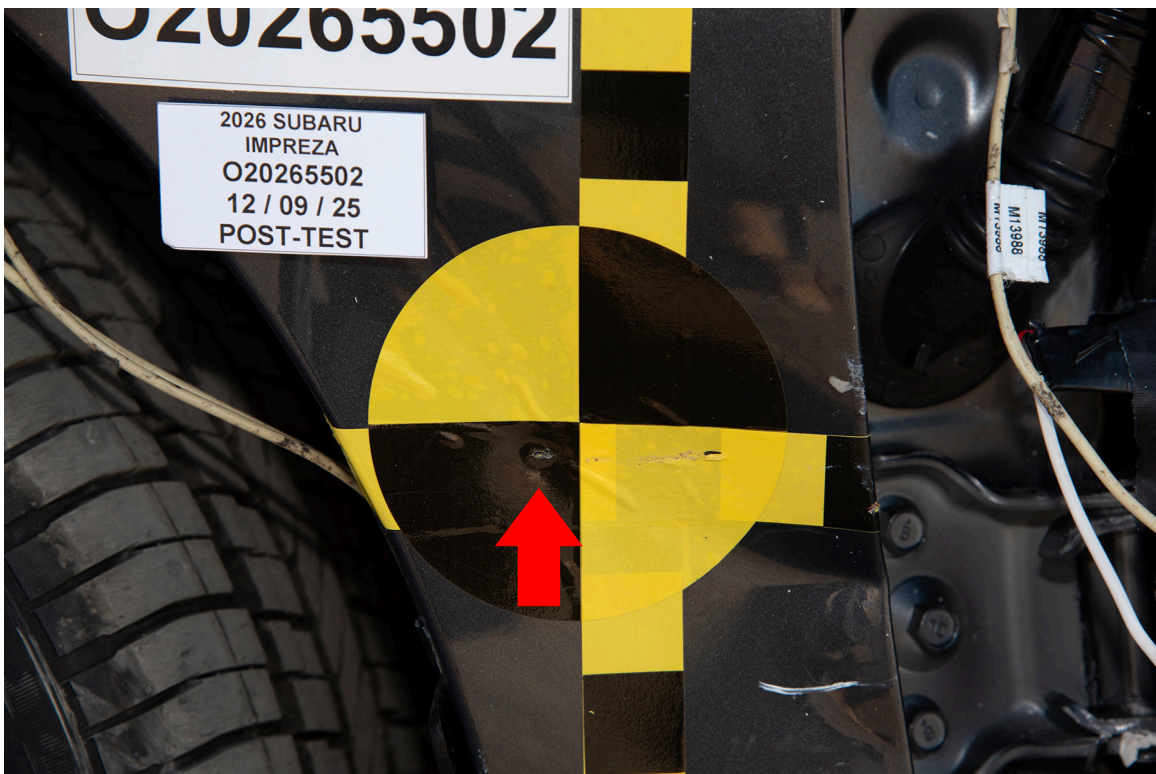
FIGURE 20. Post-Test Close-Up View of Impact Point Target

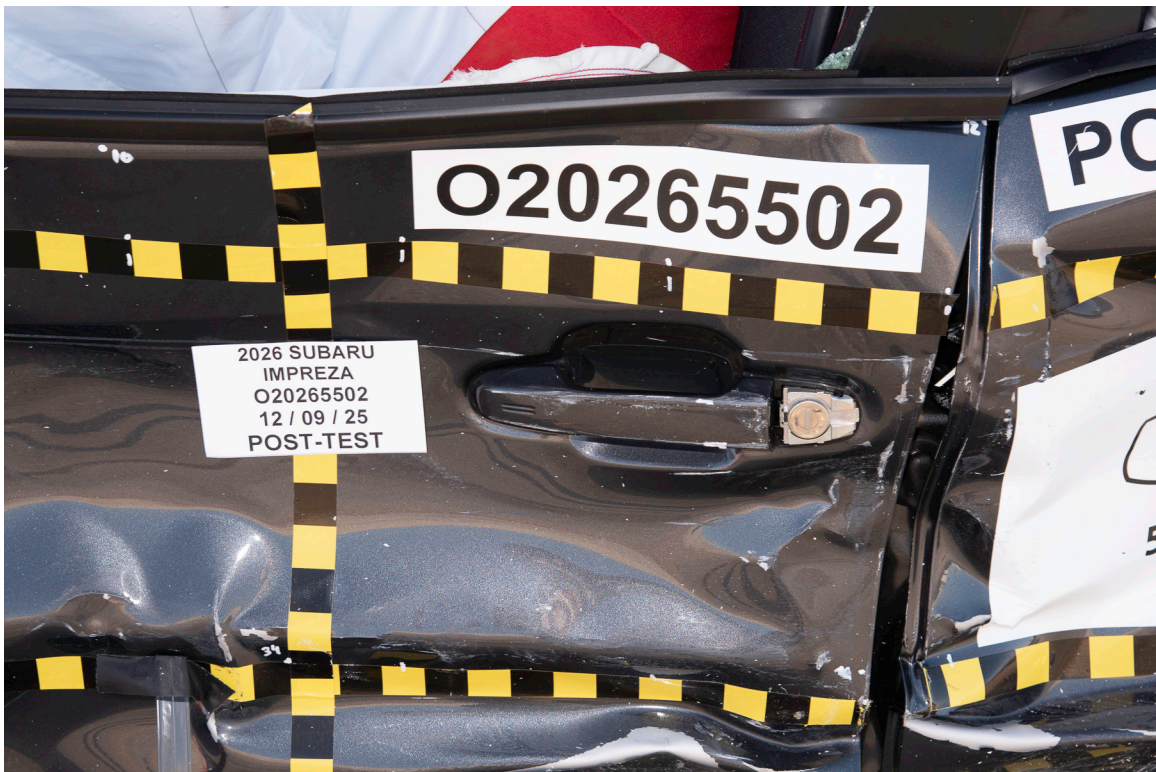
FIGURE 22. Post-Test Left Front Door Latch Close-Up

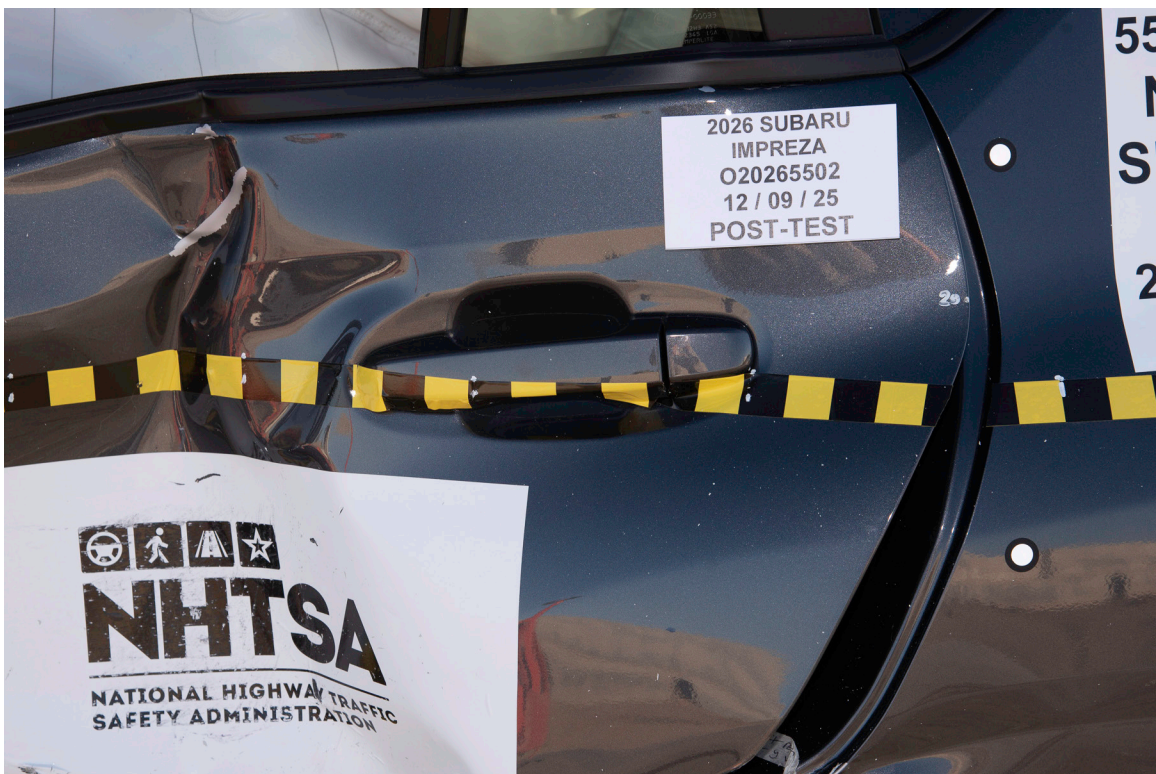
FIGURE 24. Post-Test Left Rear Door Latch Close-Up

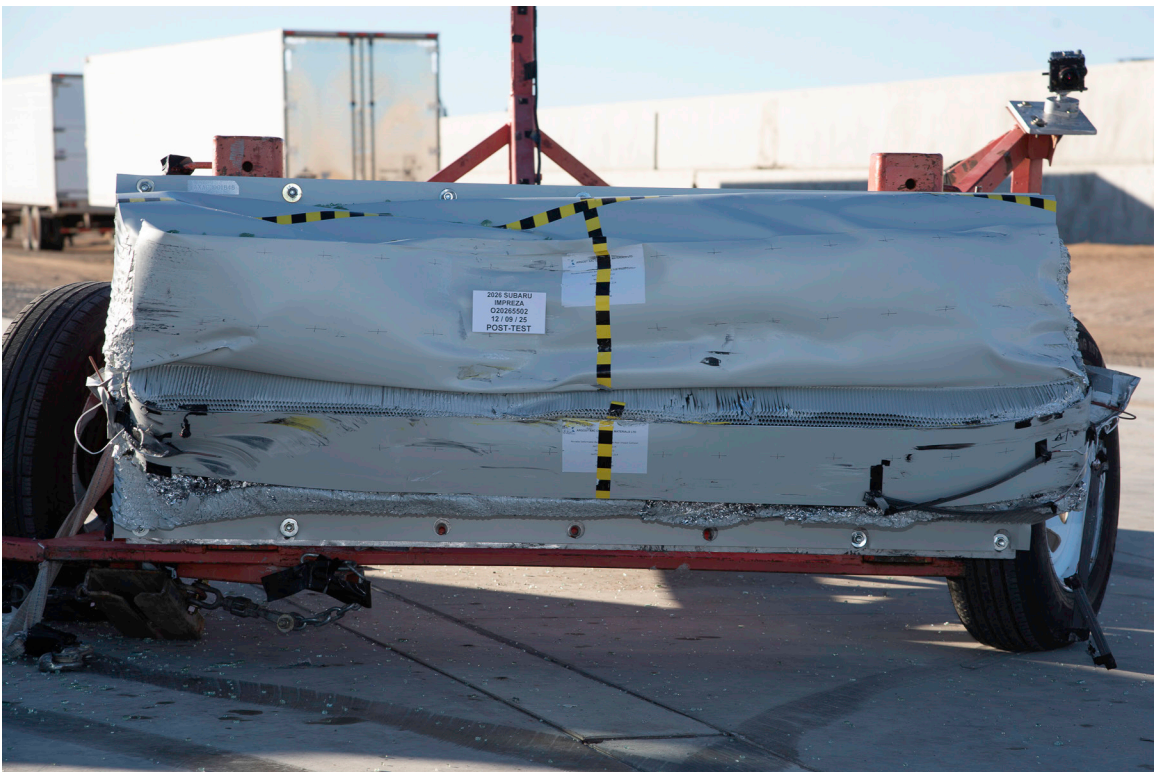
FIGURE 85. Post-Test Front View of MDB Impactor Face

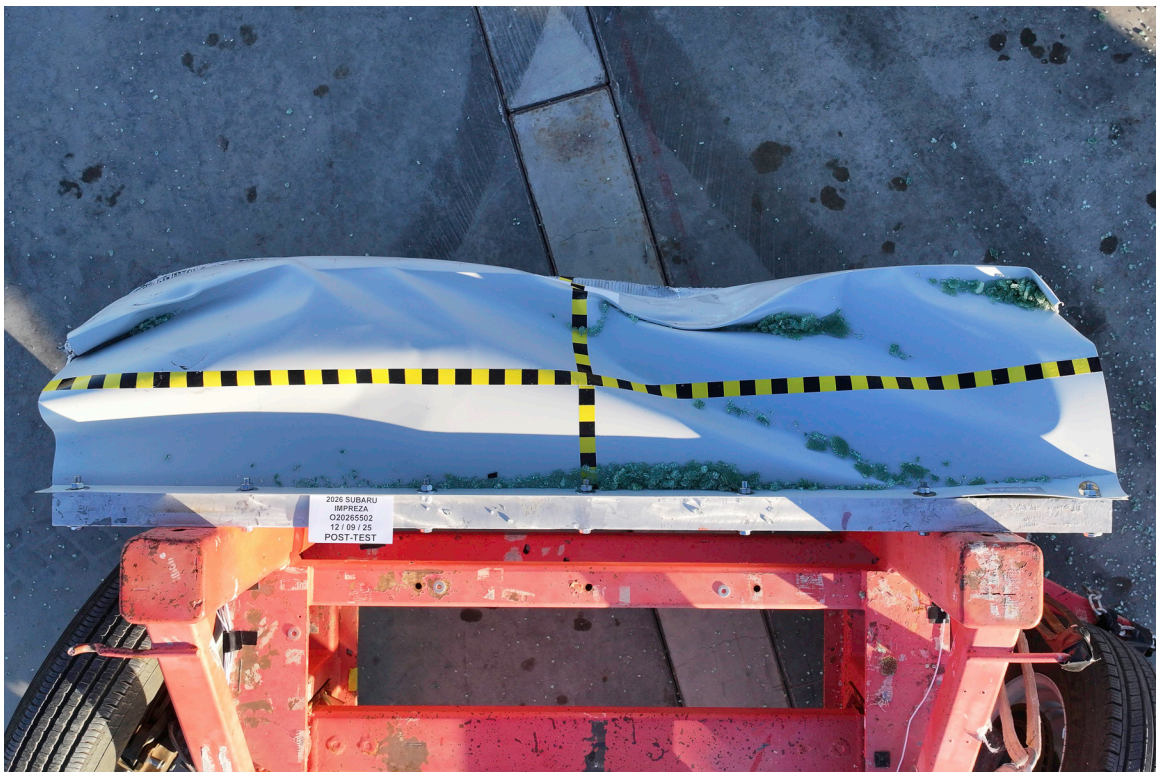
FIGURE 87. Post-Test Top View of MDB Impactor Face

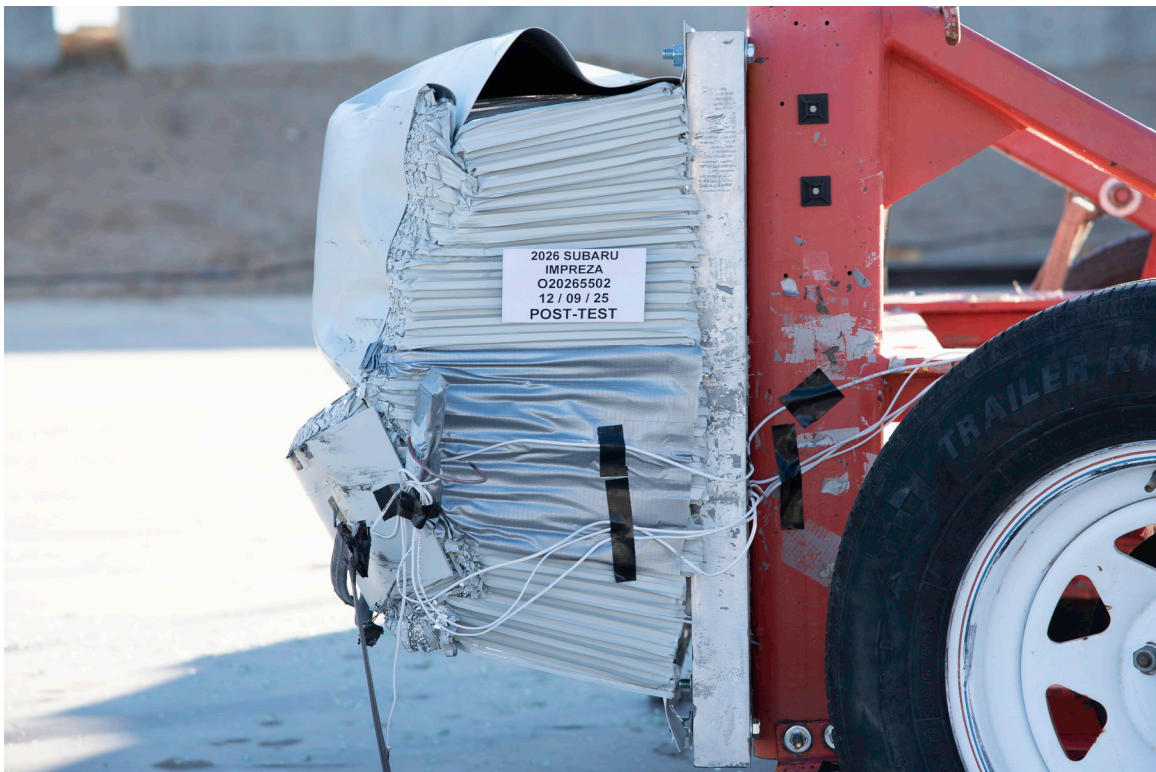
FIGURE 89. Post-Test Left Side View of MDB Impactor Face
