**REPORT NUMBER: SideNCAPPole-MGA-25-033**

**NEW CAR ASSESSMENT PROGRAM (NCAP)  
Side Impact Pole Test**

**VOLVO CAR CORPORATION  
2025 Volvo EX90 Ultra 5-Door SUV  
NHTSA No.: O20255901**

**FINAL REPORT**

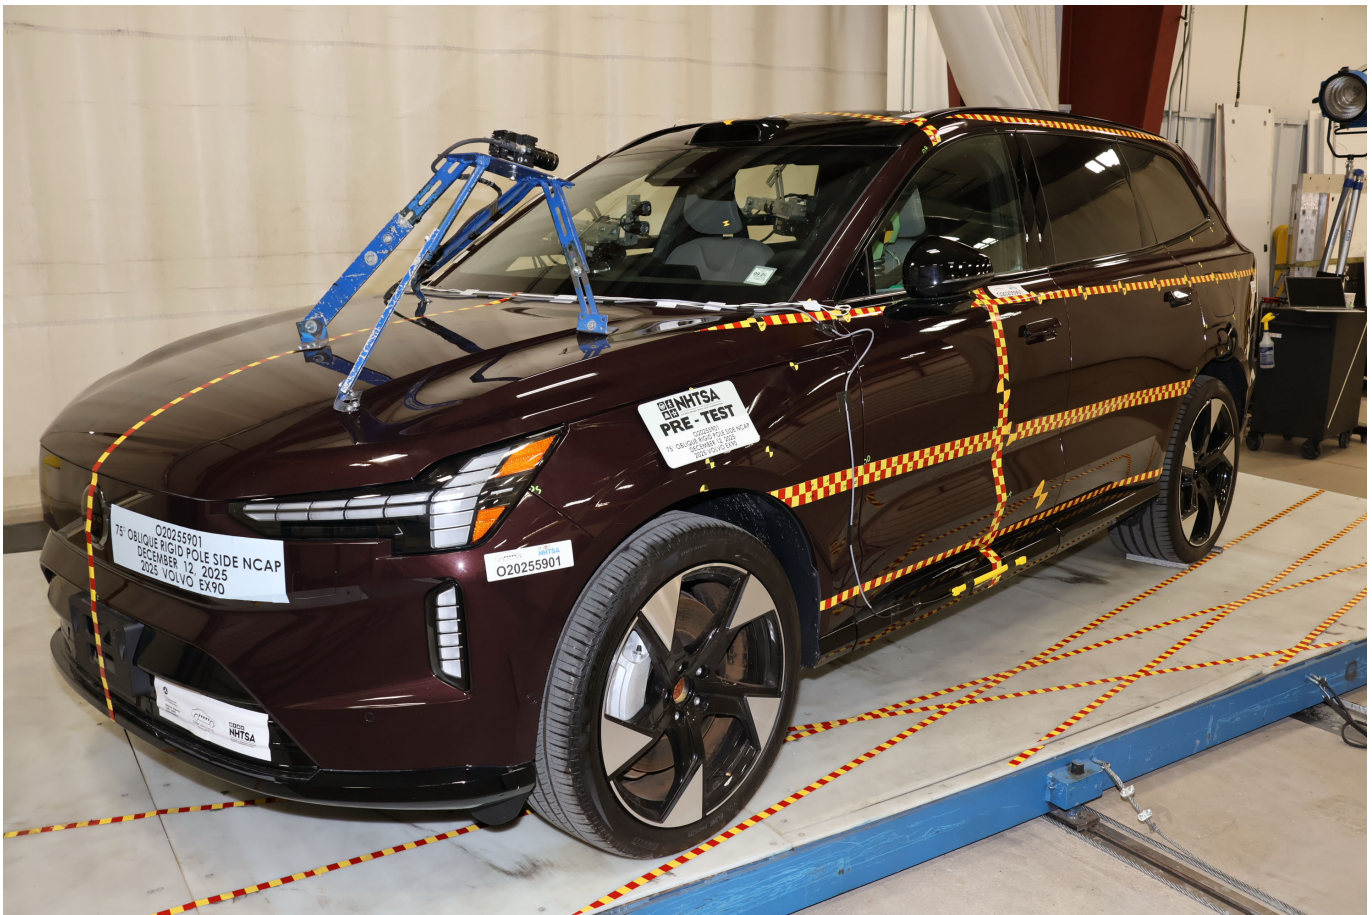
Photo No. 004 - Post-Test Frontal View of Test Vehicle

| Critical Areas of Performance | Observations and Conclusions |
|---|---|
| Windshield Damage | Cracked |
