**REPORT NUMBER: 214P-CAL-25-010**

**SAFETY COMPLIANCE TESTING FOR FMVSS 214  
DYNAMIC SIDE IMPACT PROTECTION  
RIGID POLE TEST**

**Volkswagen de Mexico S.A. de C.V. Mexico  
2025 Volkswagen Taos  
5 Door SUV**

**NHTSA No: C20255800**

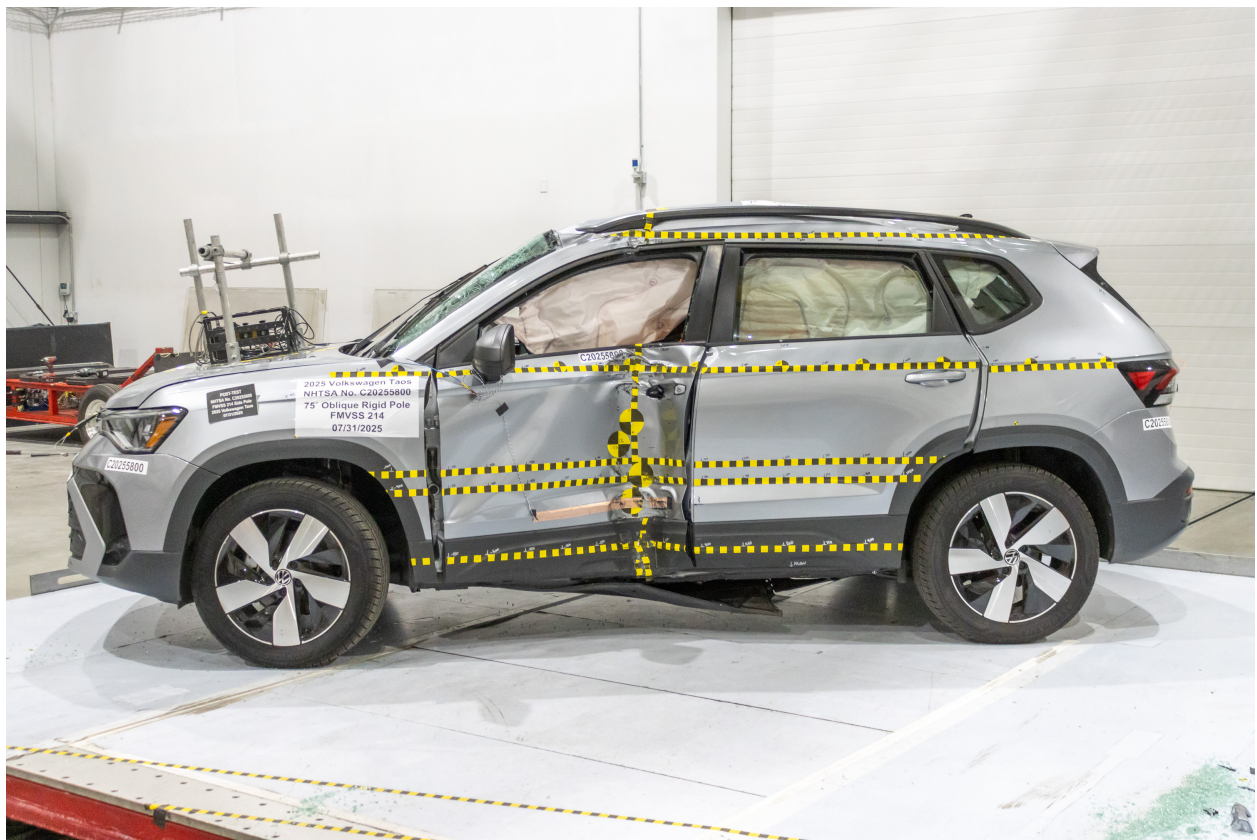
**Figure A-6: Post-Test Impacted Side View of Test Vehicle**

| Critical Areas of Performance | Observations and Conclusions |
|---|---|
| Side Window Damage | Driver door window shattered |

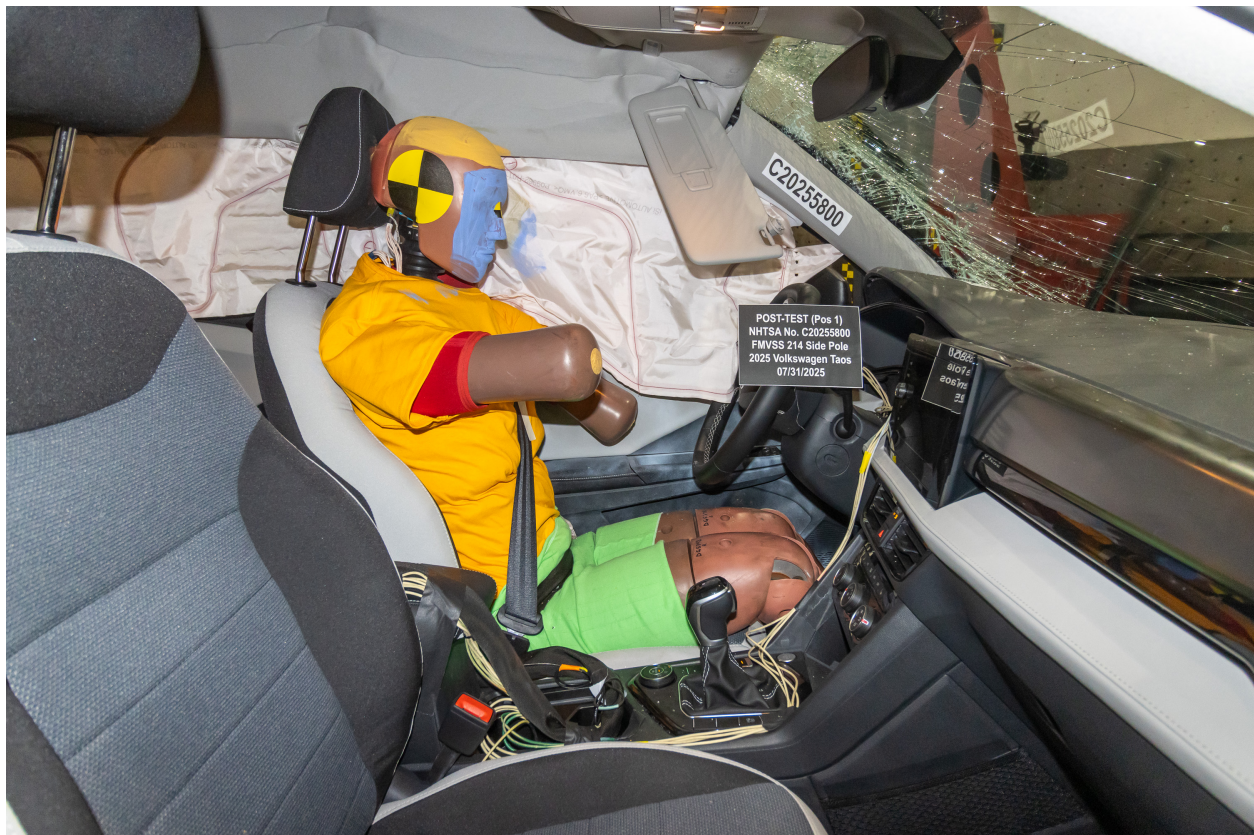
**Figure A-12: Post-Test Dummy Through Opposite Window**

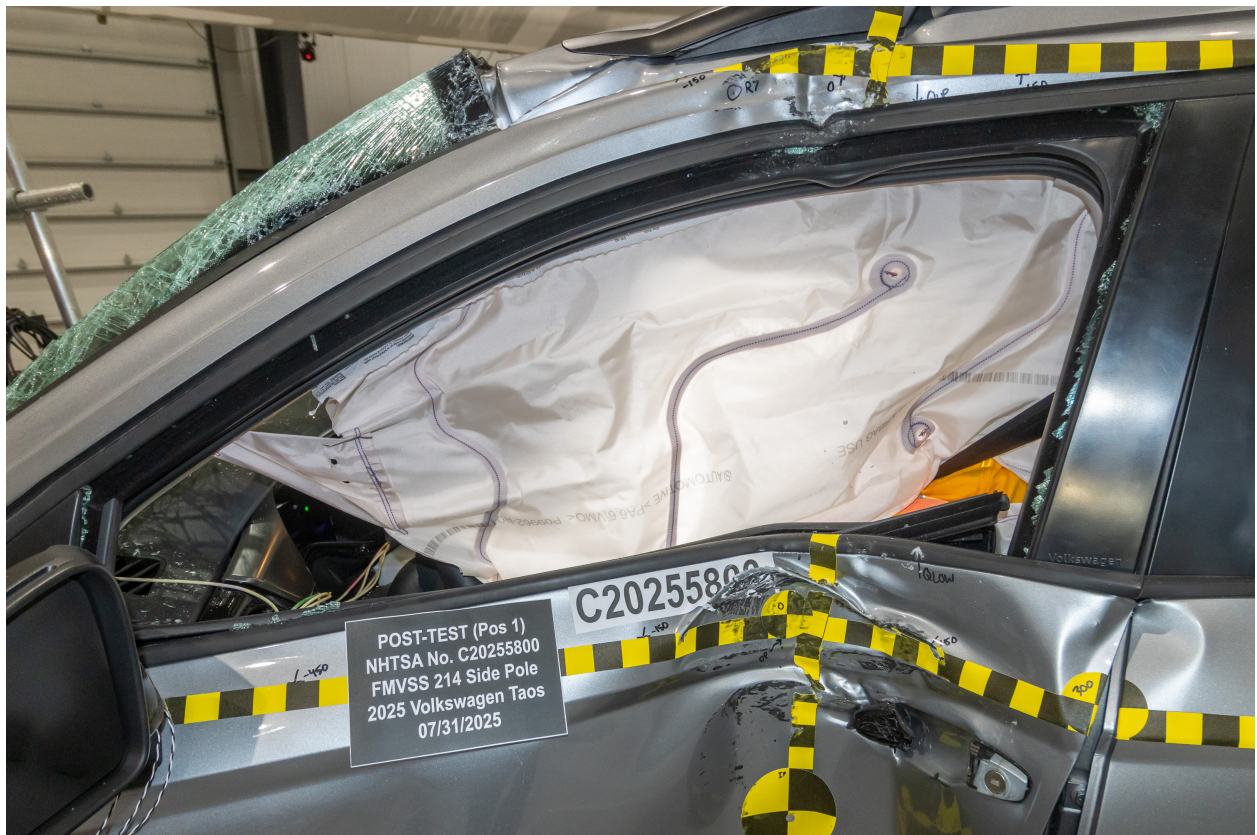
**Figure A-14: Post-Test Close-Up of Dummy with Door Closed (Impact Side)**

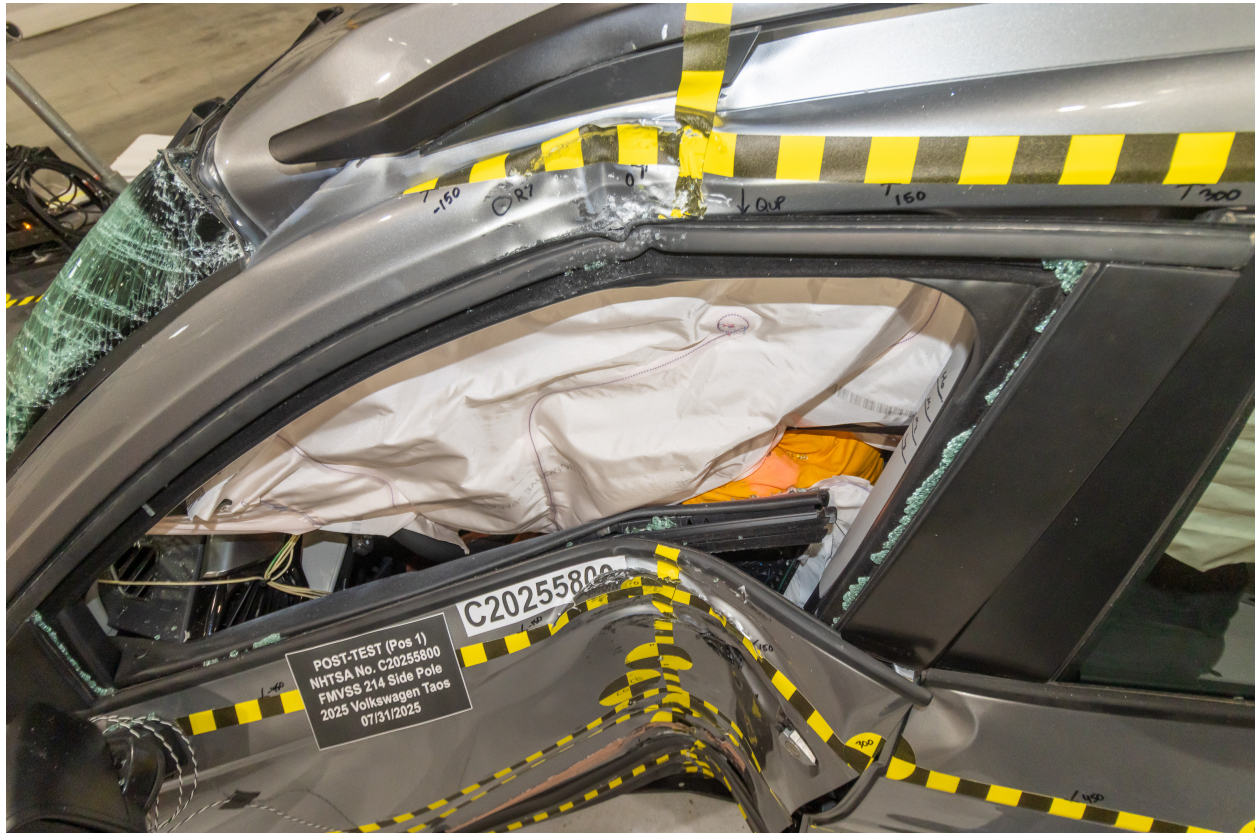
**Figure A-17: Post-Test Dummy Shoulder and Door Top View**

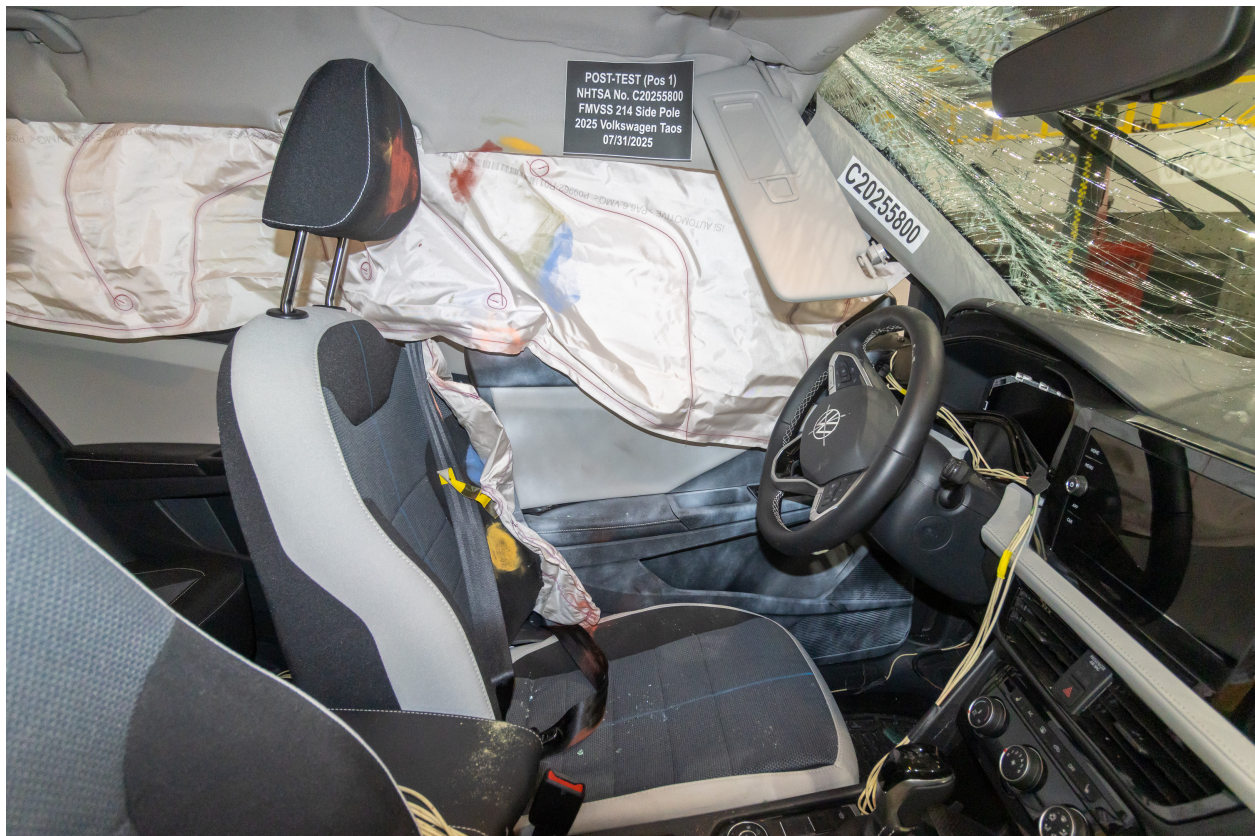
**Figure A-19: Post-Test Interior of Front Door Showing Dummy Impact Locations**

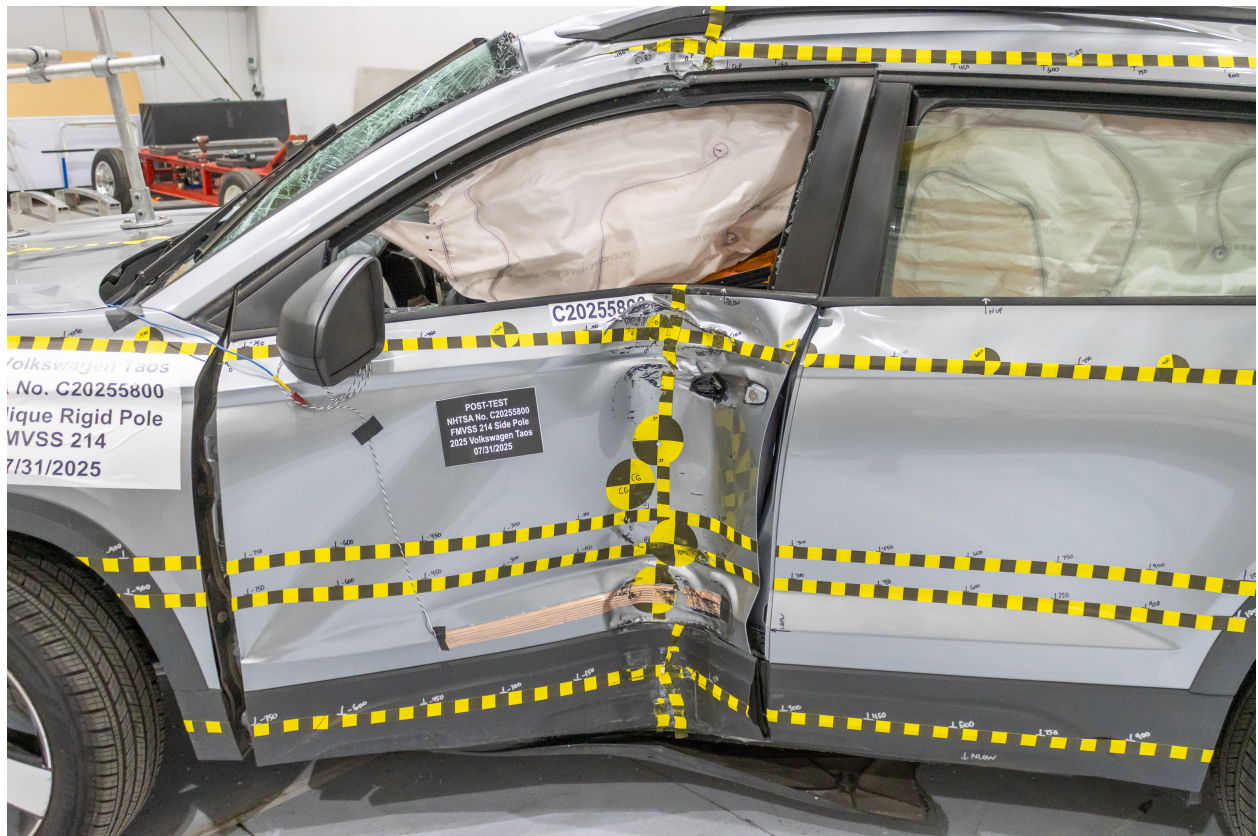
**Figure A-21: Post-Test Impact Zone Close-Up View**

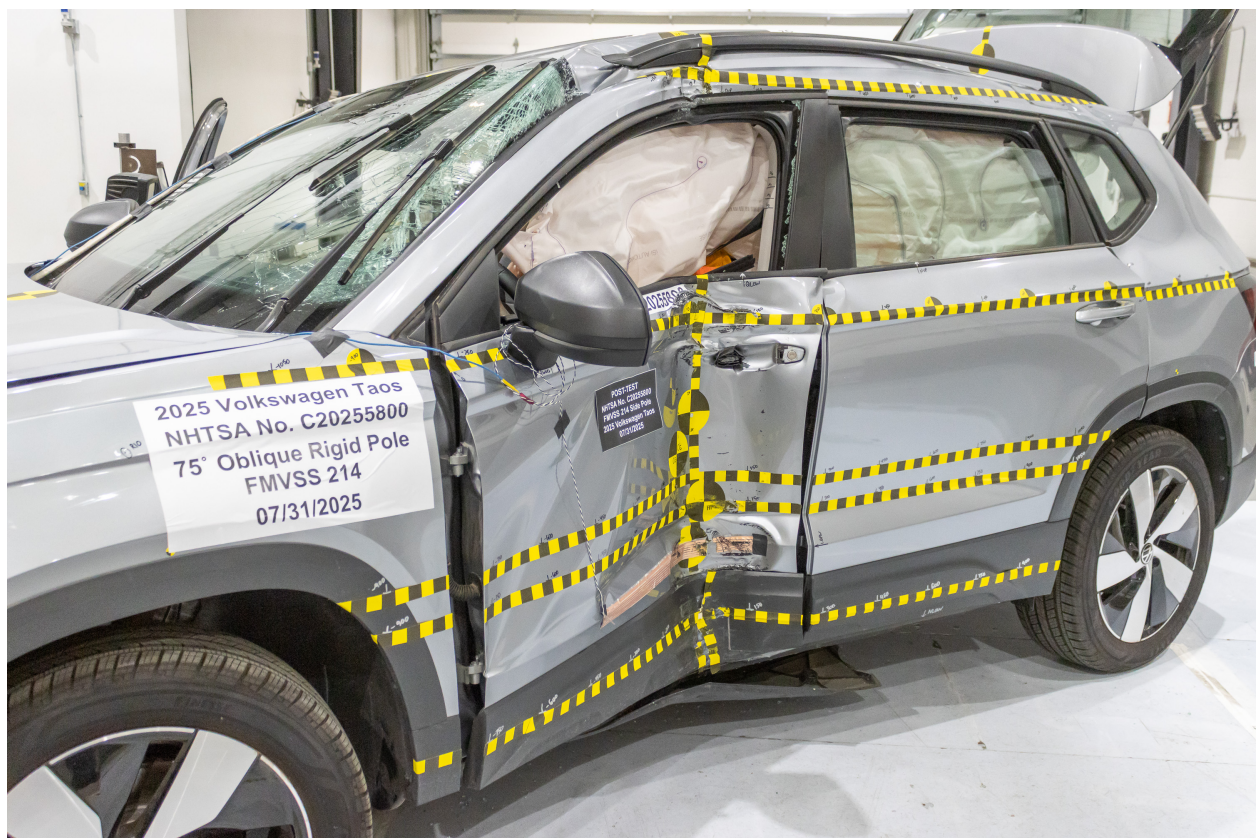
**Figure A-22: Post-Test  $\frac{3}{4}$  Front View of Impact Zone**

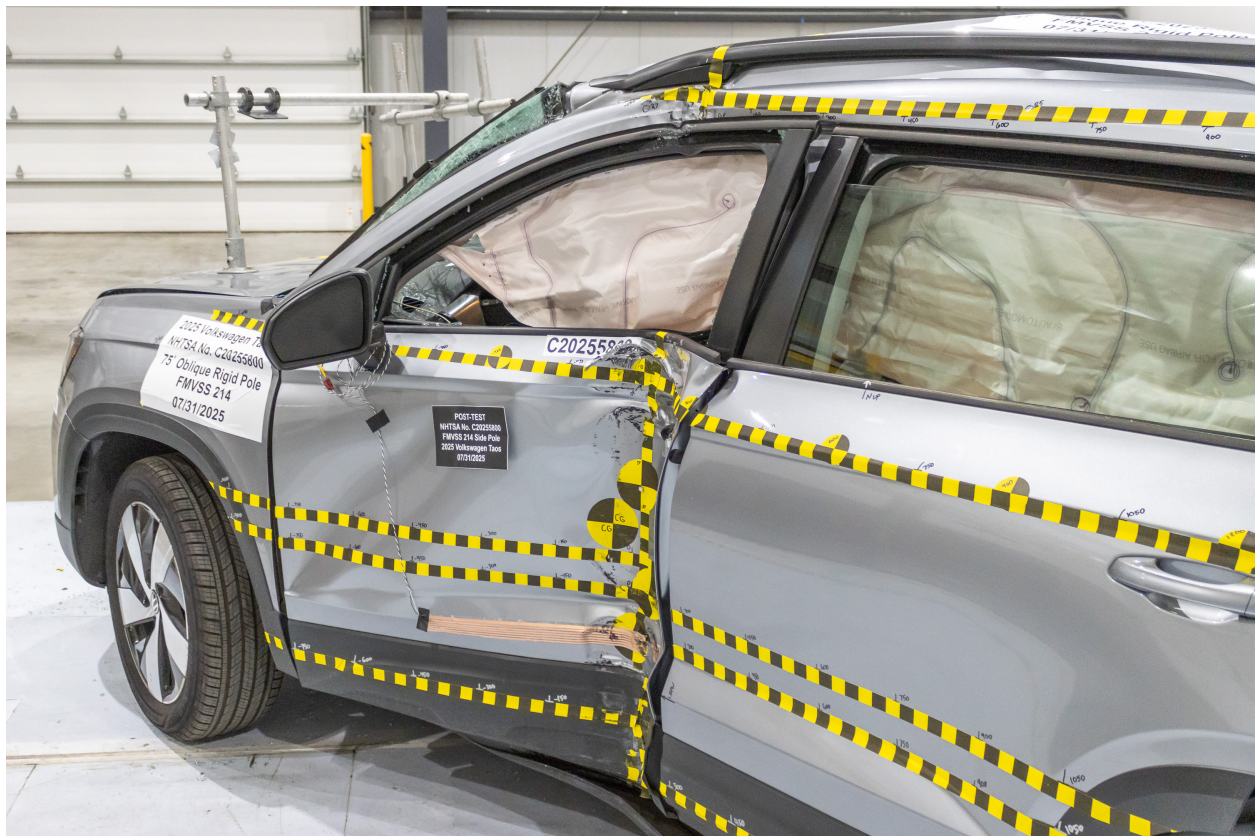
**Figure A-23: Post-Test ¾ Rear View of Impact Zone**

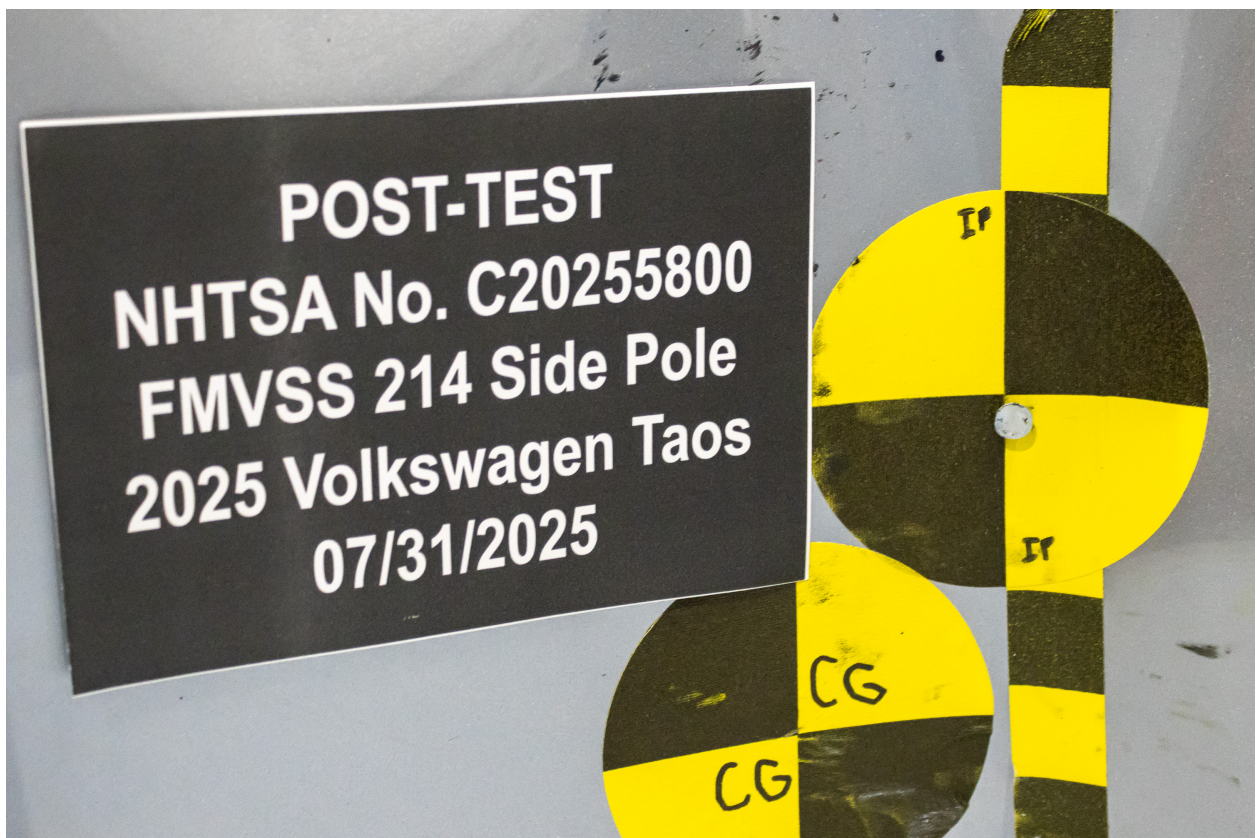
**Figure A-24: Post-Test Close-Up View of Impact Point Target**
