REPORT NO. MGA-94-DC005

FMVSS 214 - SIDE IMPACT TEST

CHRYSLER CORPORATION
1994 DODGE INTREPID 4 DOOR SEDAN
NHTSA NO. CR0312

FINAL REPORT

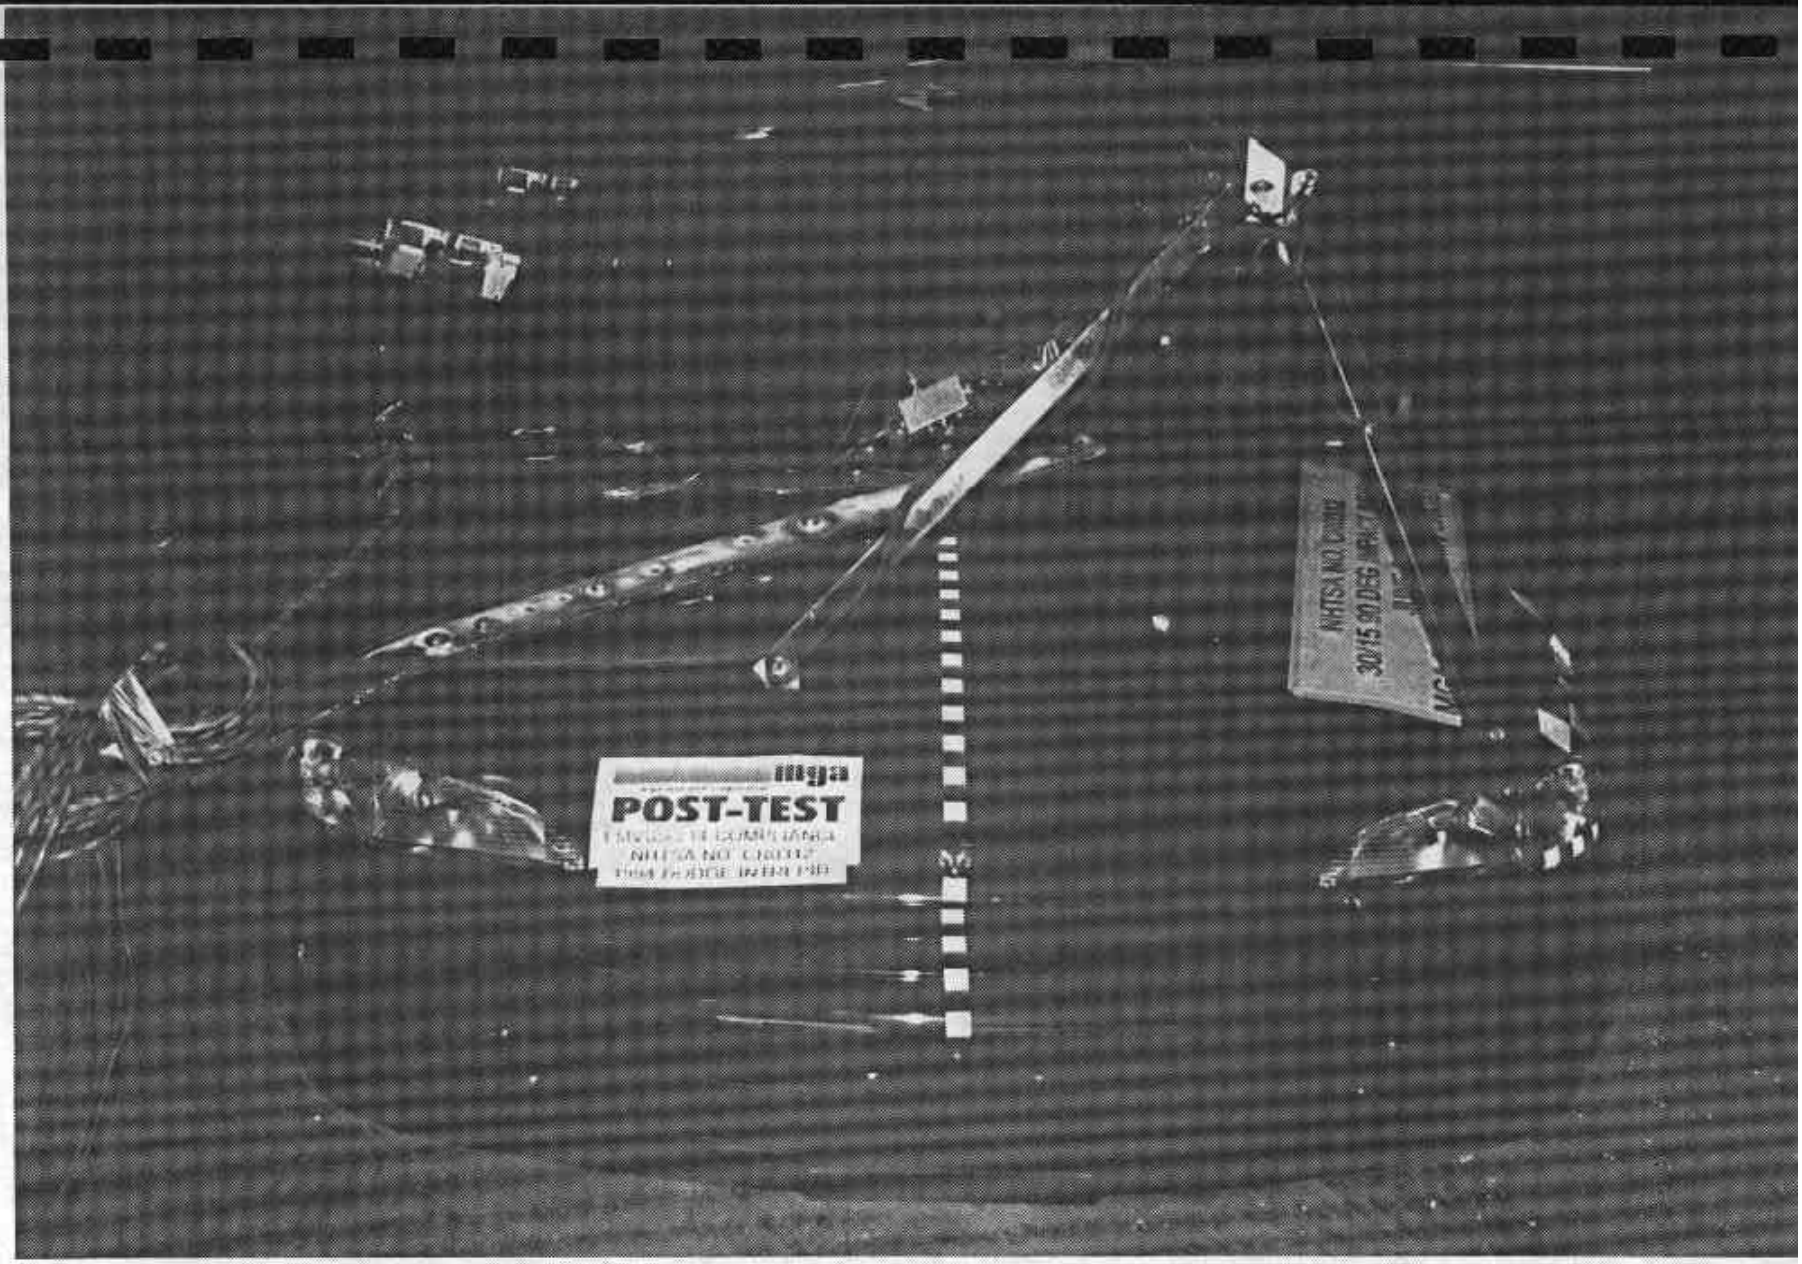
Windshield cracked, both front and rear door glass broken

Photo No. A-2 - Post-Test Front View of Test Vehicle

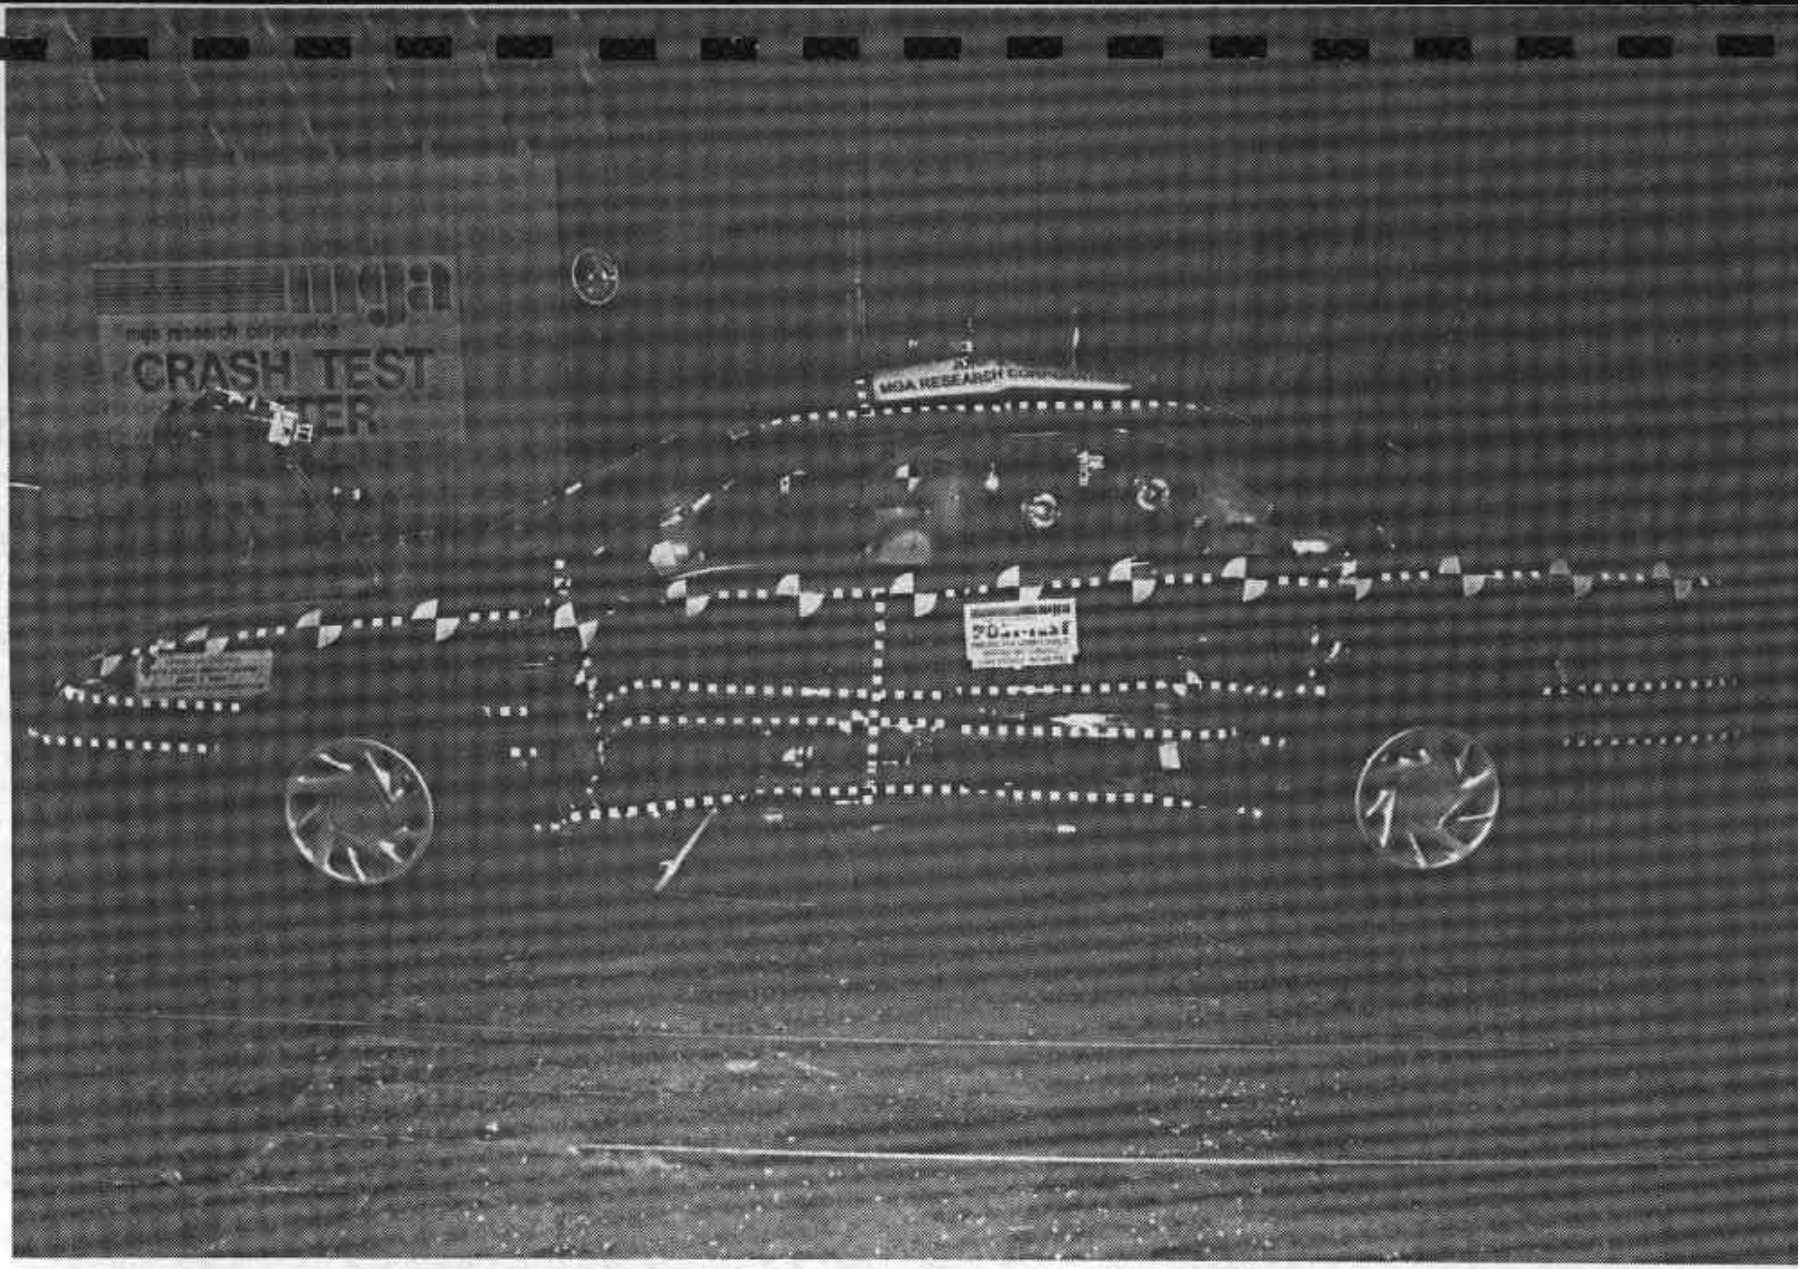
Maximum Post-Test Intrusion = 14.7 in

Photo No. A-6 - Post-Test Left Side View of Test Vehicle

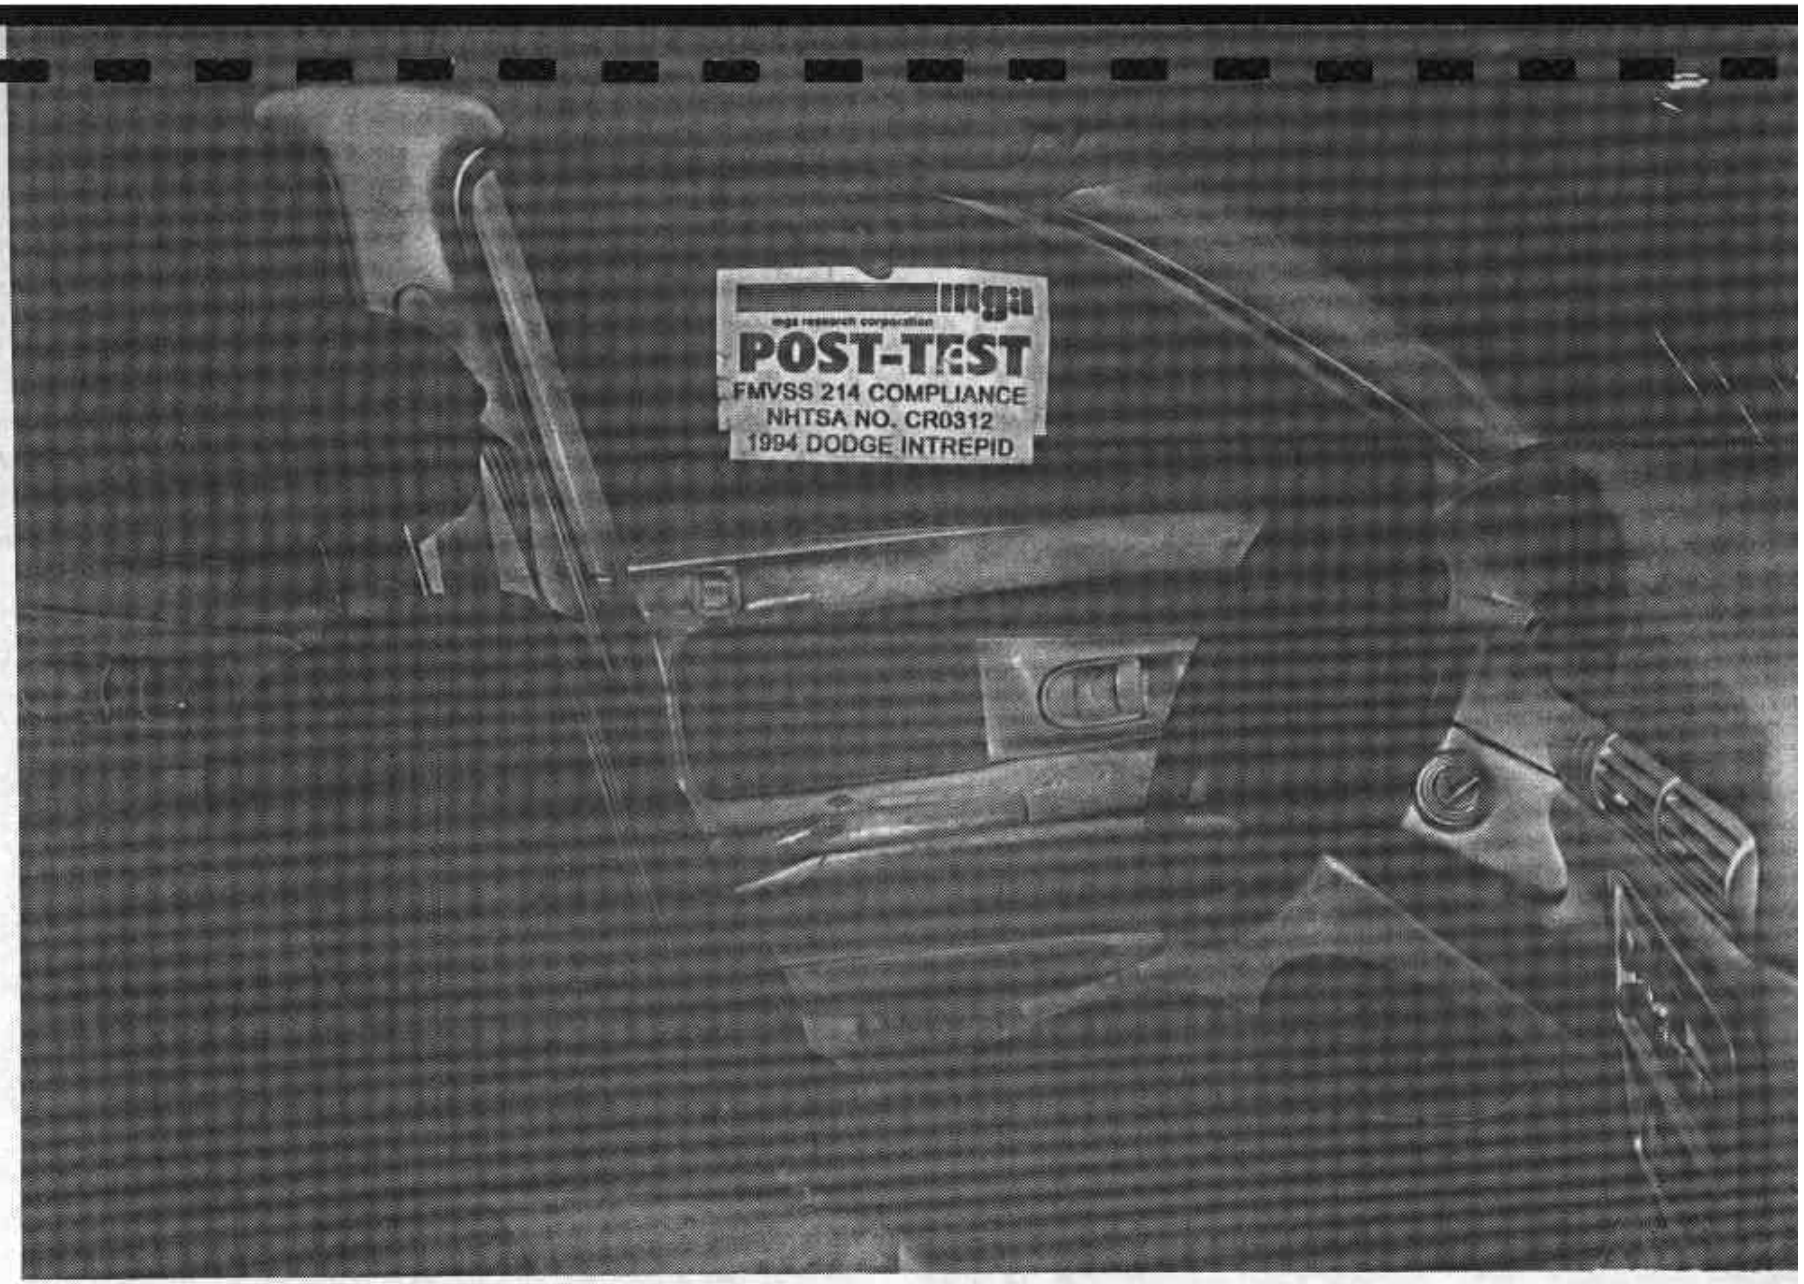
Photo No. A-26 - Post-Test Driver Dummy Impact

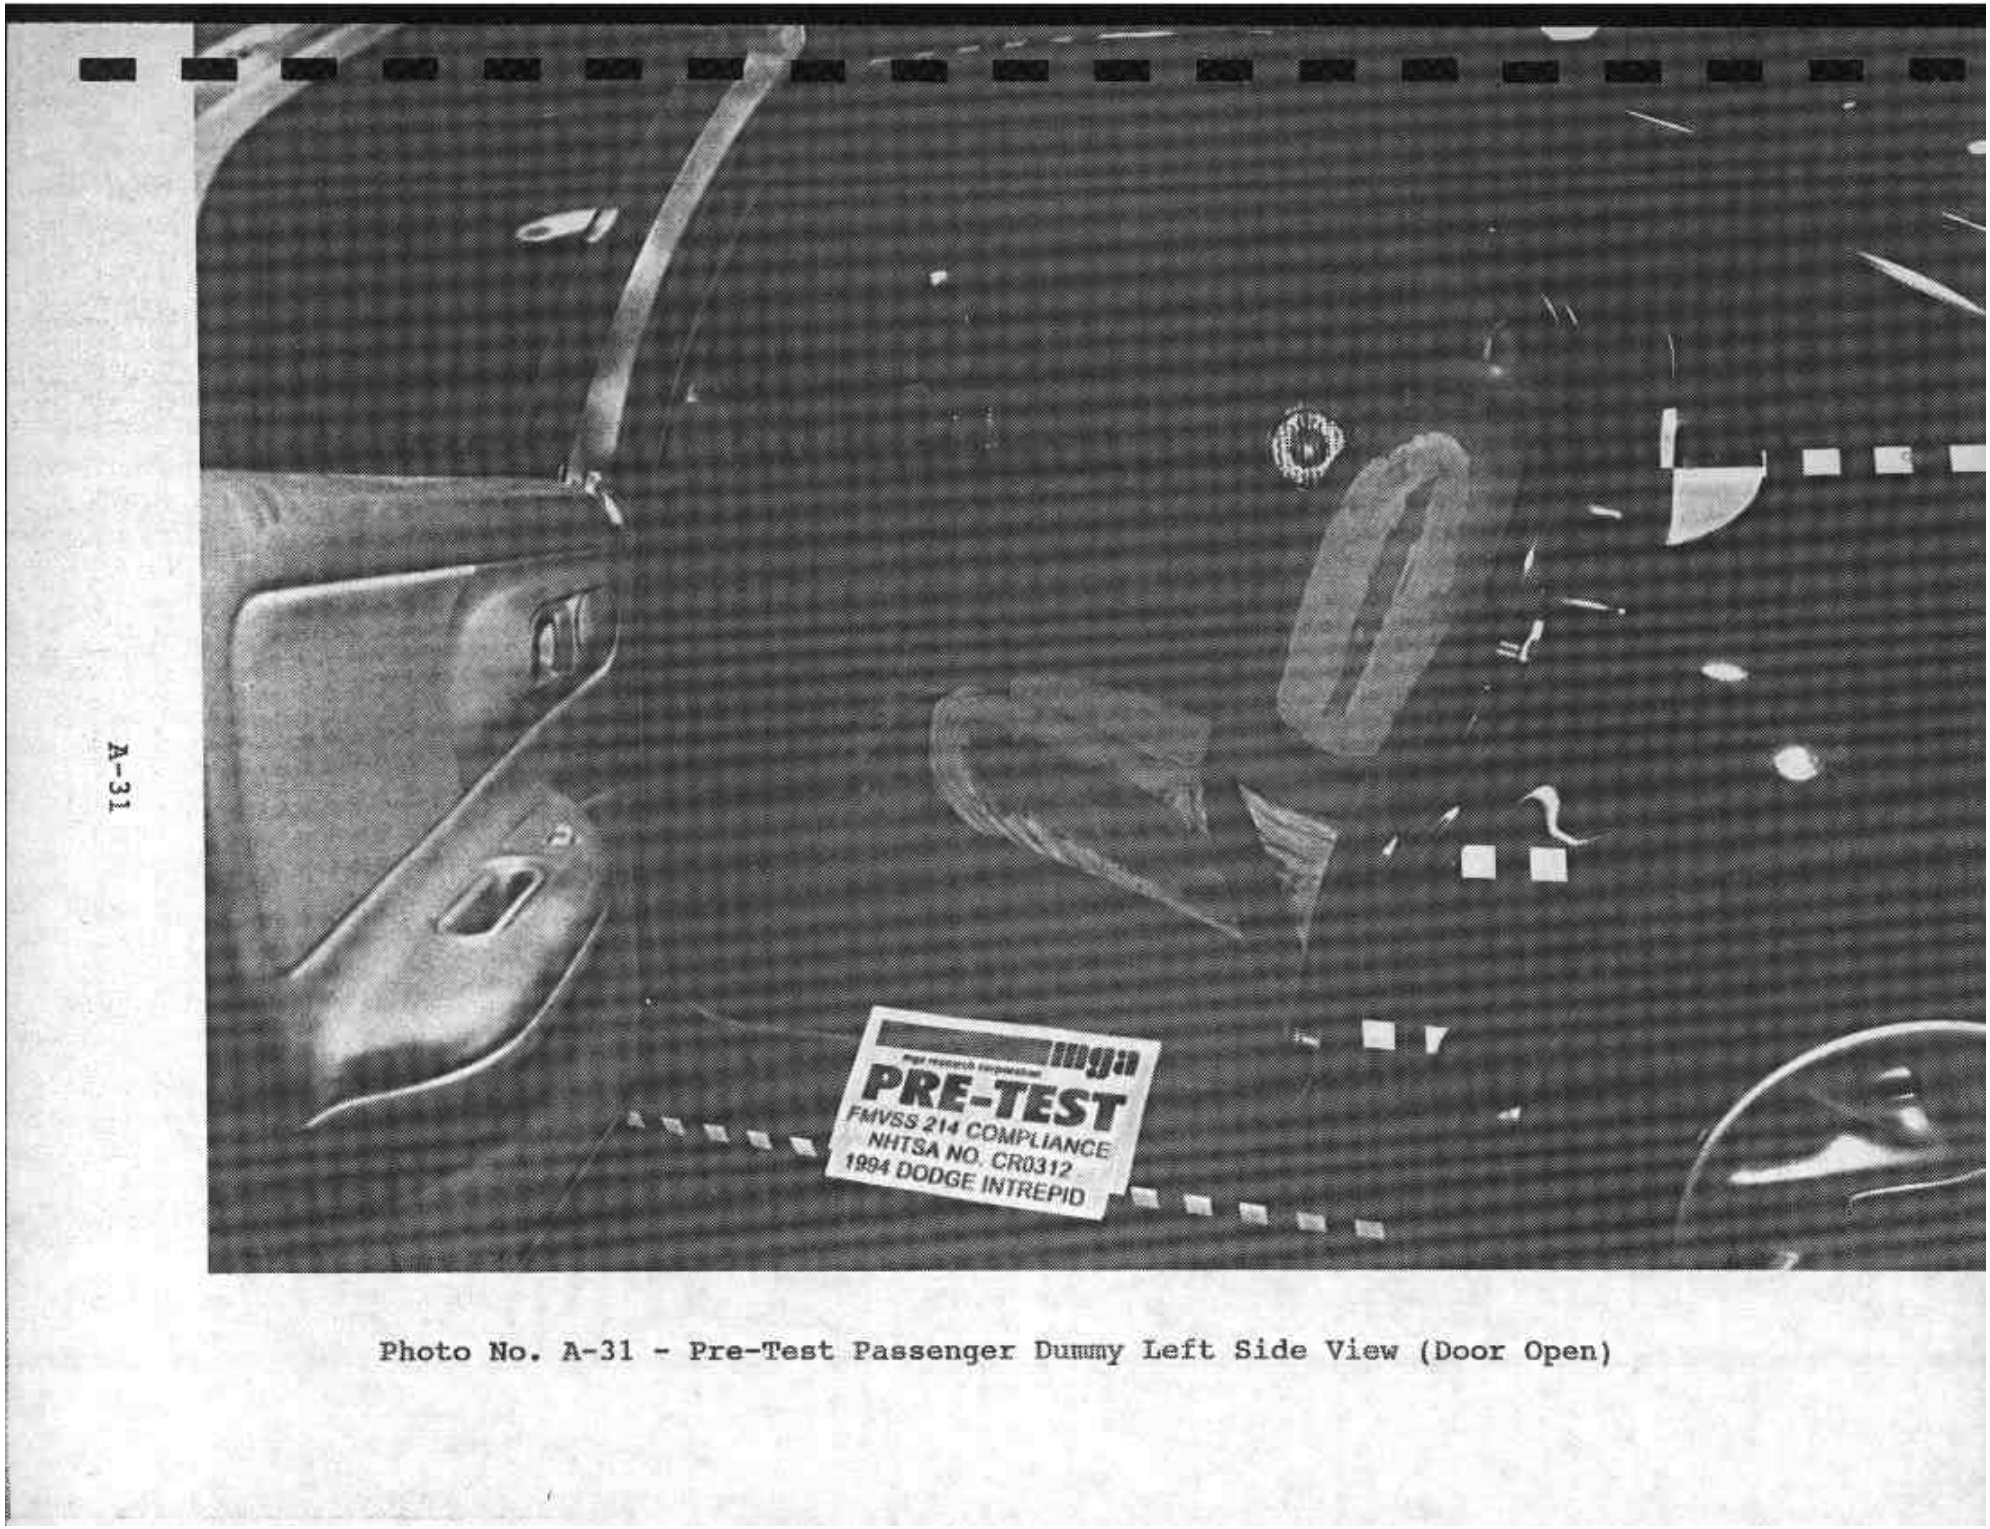
Photo No. A-30 - Post-Test Passenger Dummy Left Side View

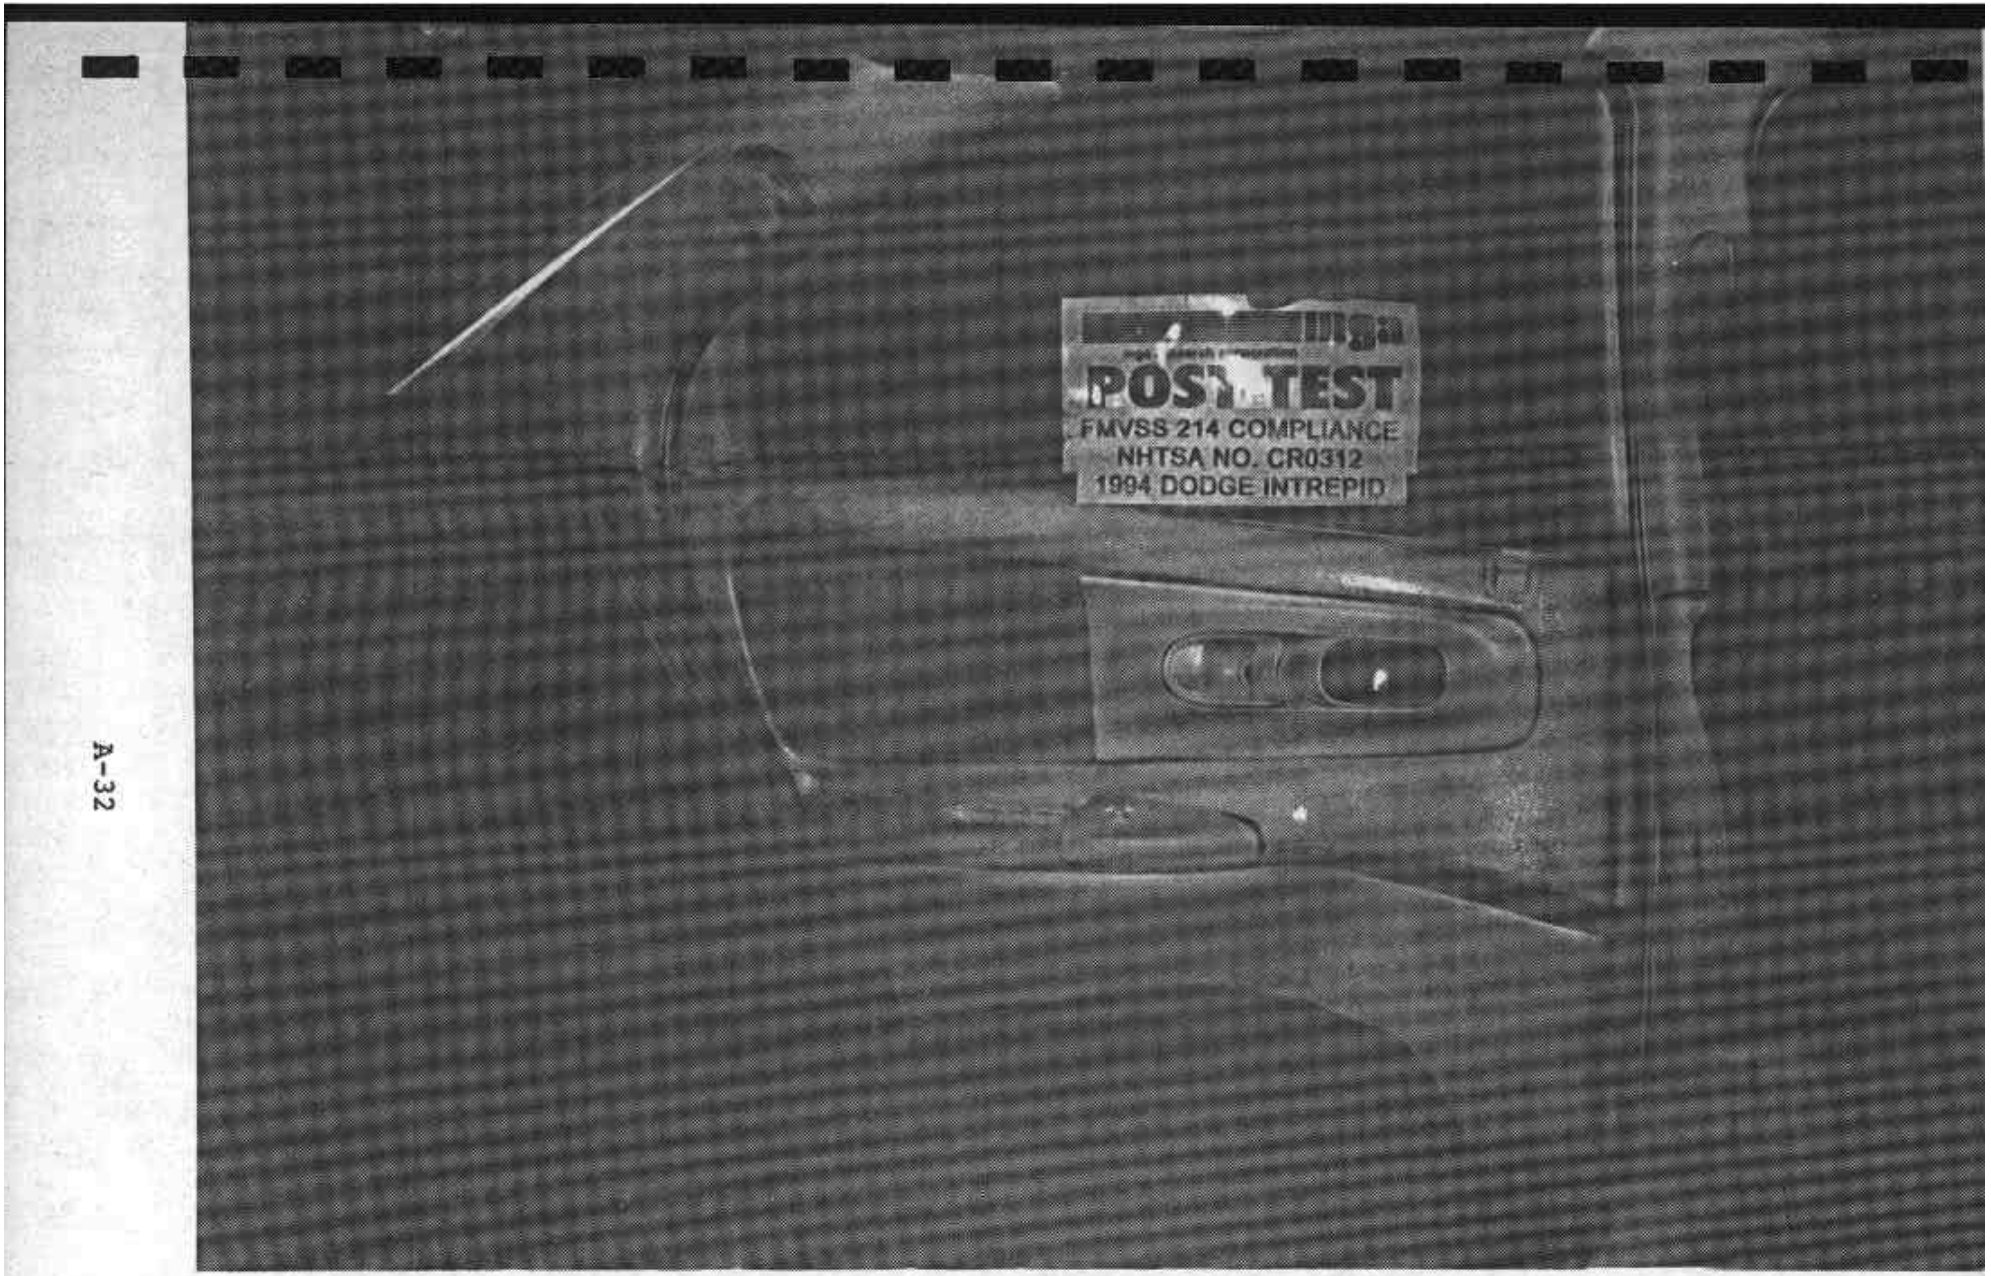
Photo No. A-32 - Post-Test Passenger Dummy Impact

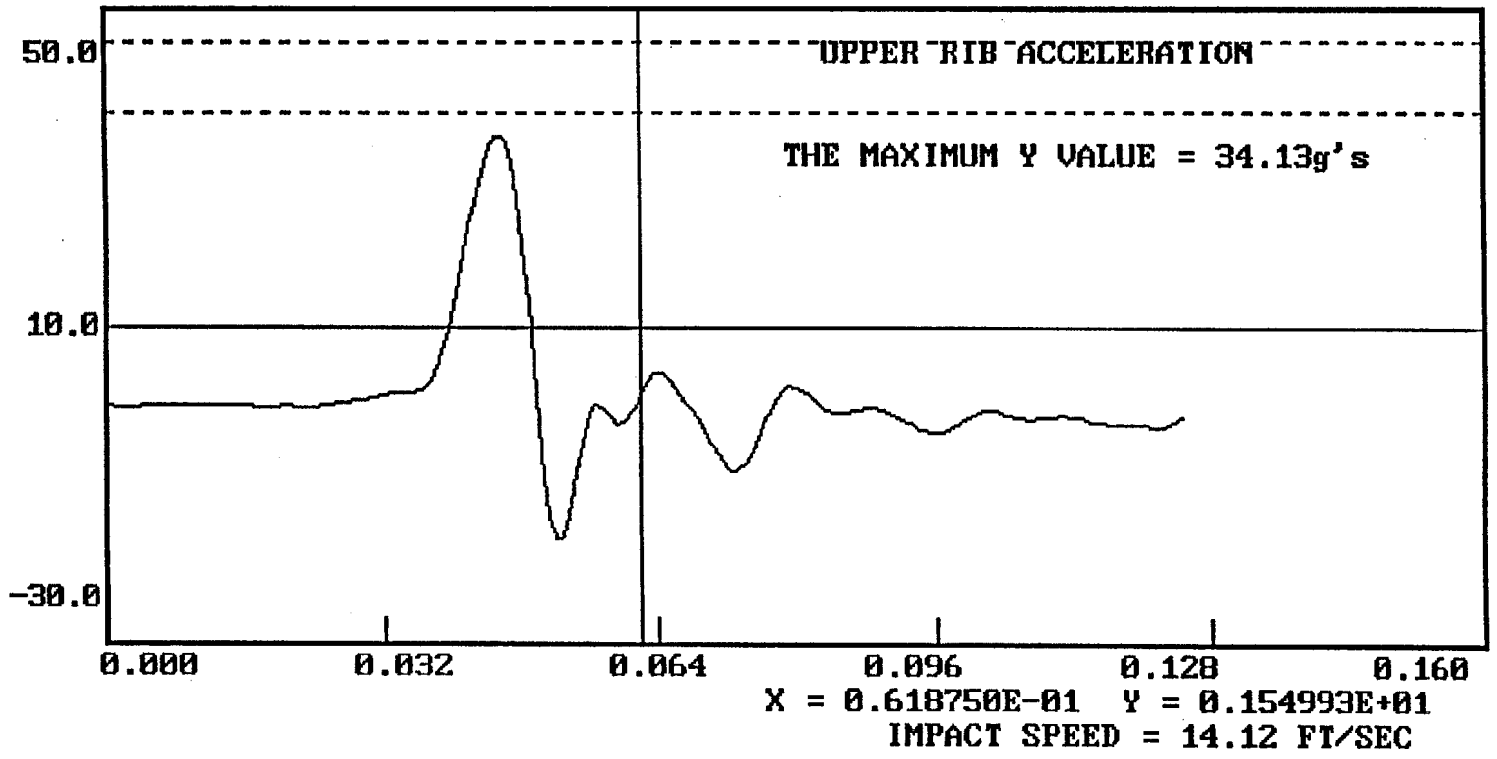
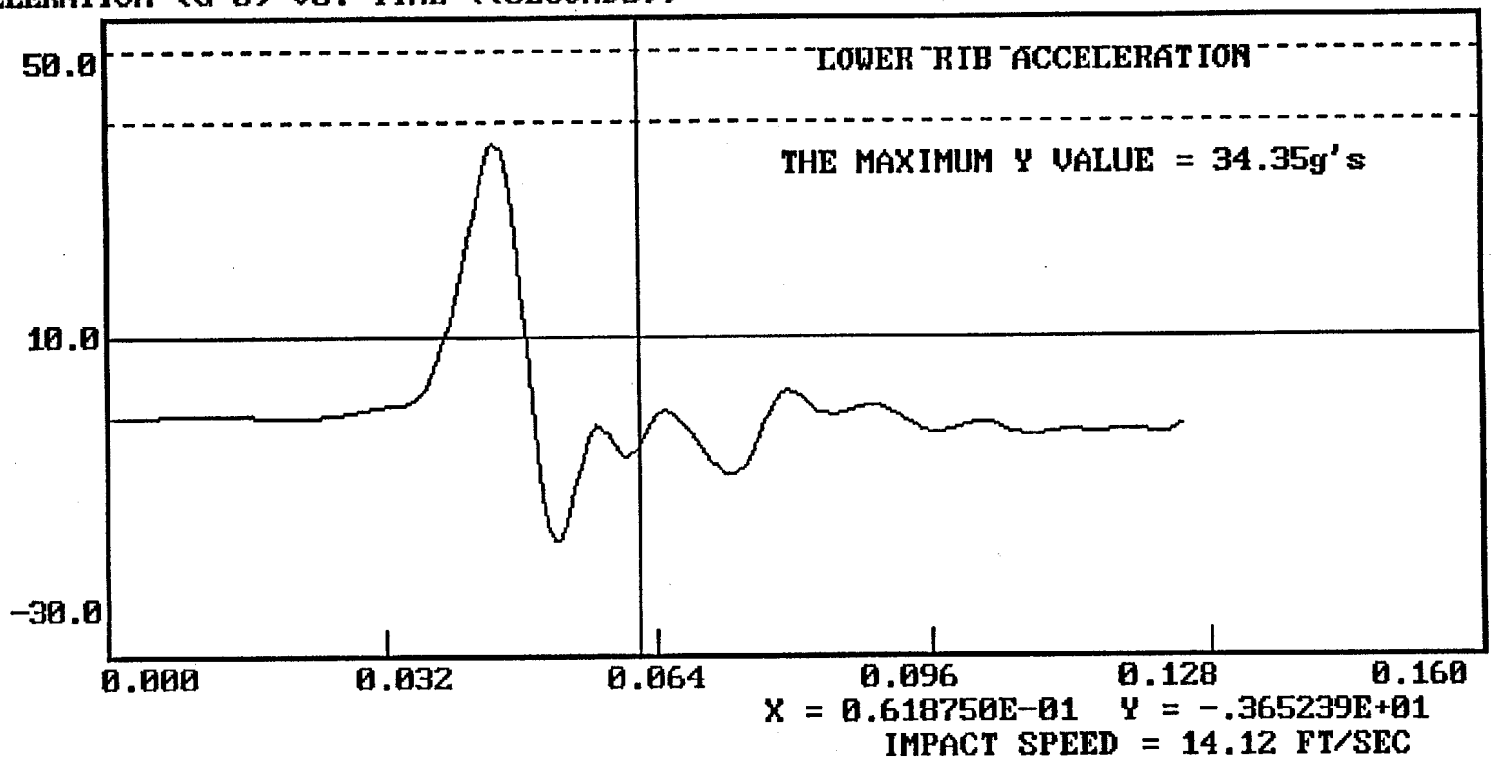
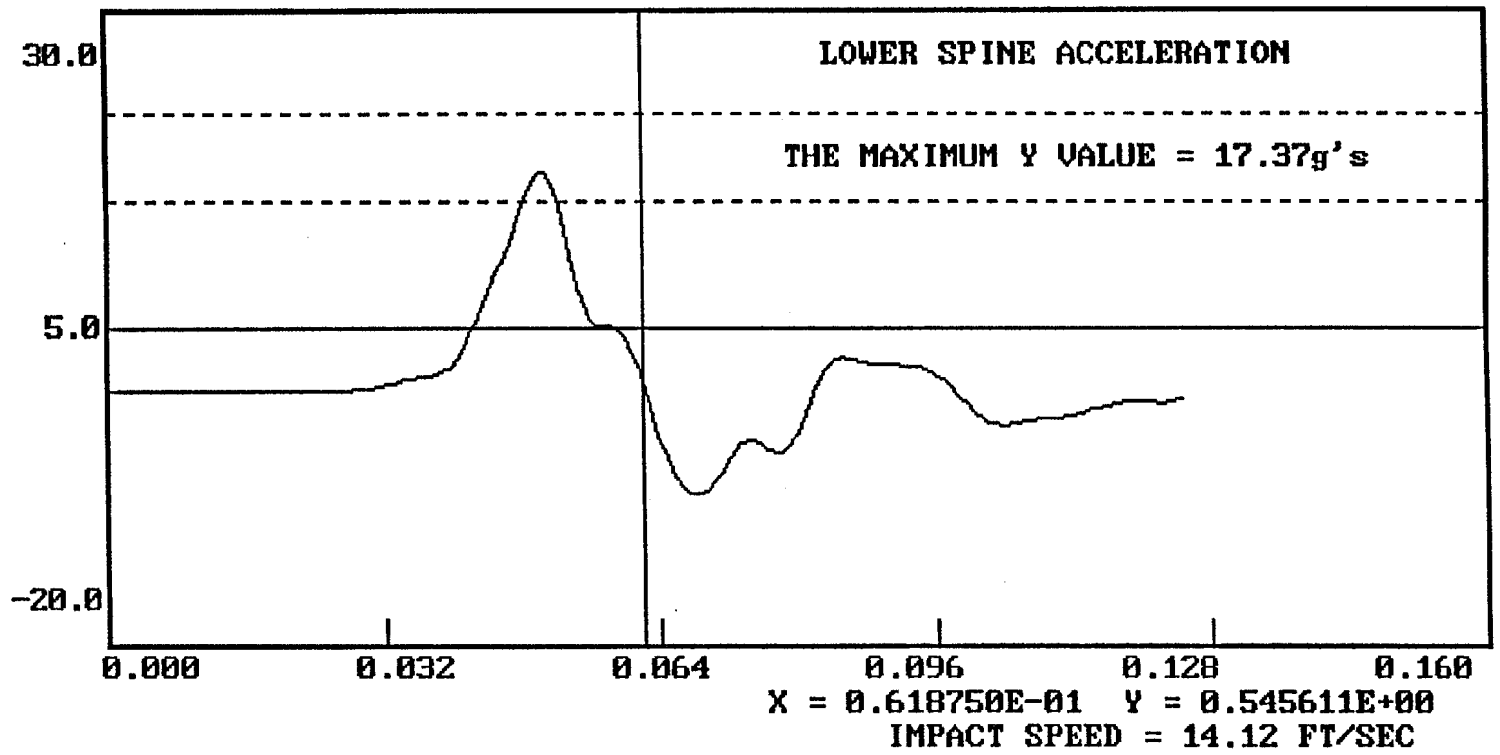
DUMMY CALIBRATION - THORAX IMPACT 06-06-1994 14:32
DUMMY # 269
ACCELERATION (G'S) VS. TIME ((SECONDS))

* The thorax would not pass post-test impact requirements. The Vector Rib Wrap Assembly was replaced with a FTSS Rib Wrap Assembly. The ensuing thorax impacts did meet all test requirements and this data was used as pre-test calibration data for the next test.

TEST PARAMETER	SPECIFICATION	TEST RESULTS
TEMPERATURE	66 - 78° F	72°
RELATIVE HUMIDITY	10 - 70%	38%
PROBE SPEED	13.8 - 14.2 fps	14.1
UPPER RIB	37 - 46 g's	34*
LOWER RIB	37 - 46 g's	34*
LOWER SPINE	15 - 22 g's	17

Four rivets on postior side of rib wrap assembly failed. See post-test thorax impact for explanation.

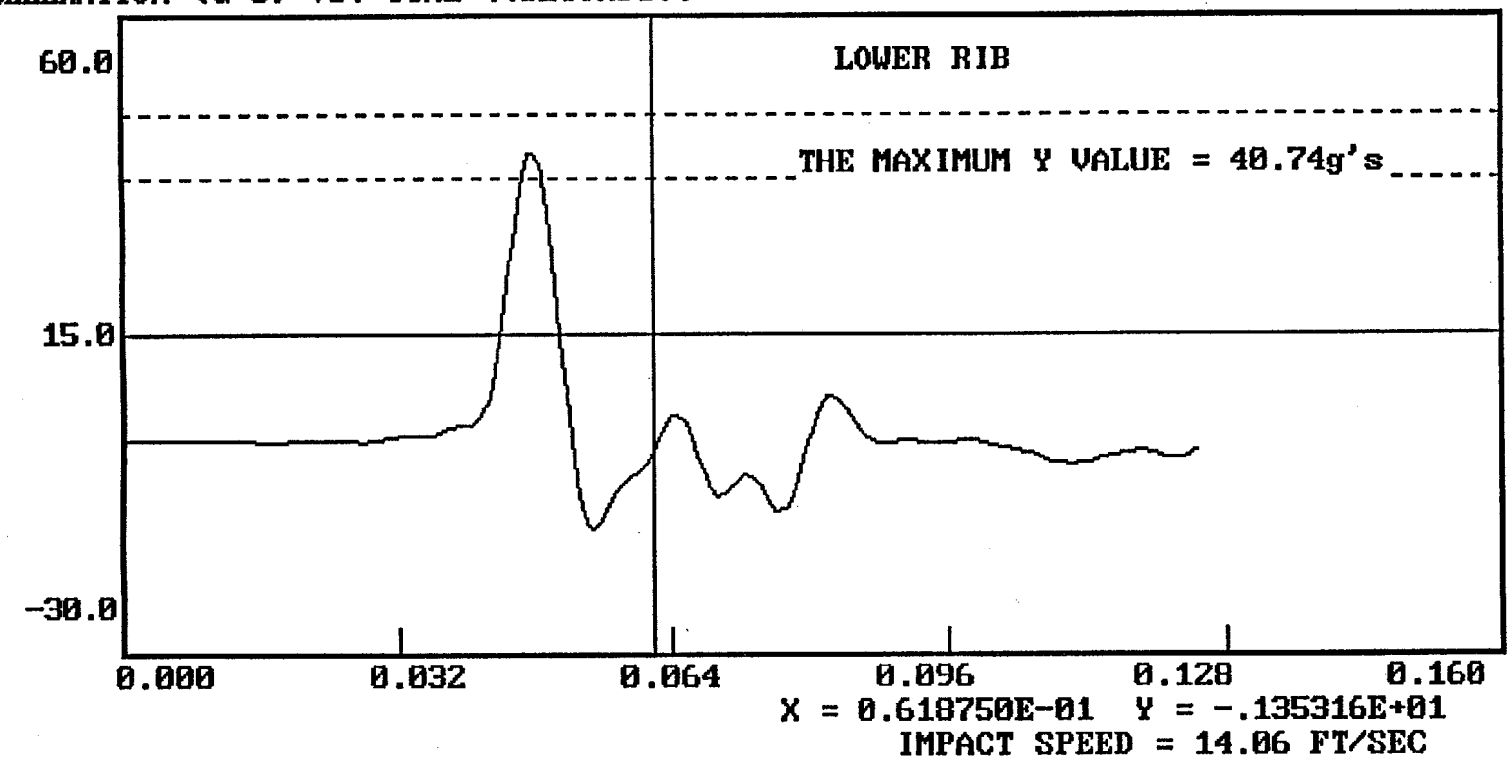
DUMMY CALIBRATION - THORAX IMPACT 06-06-1994 14:09
DUMMY # 271
ACCELERATION (G'S) VS. TIME ((SECONDS))

TEST PARAMETER	SPECIFICATION	TEST RESULTS
TEMPERATURE	66 - 78° F	72°
RELATIVE HUMIDITY	1Ø - 7Ø%	38%
PROBE SPEED	13.8 - 14.2 fps	14.1
UPPER RIB	37 - 46 g's	42
LOWER RIB	37 - 46 g's	41
LOWER SPINE	15 - 22 g's	2Ø

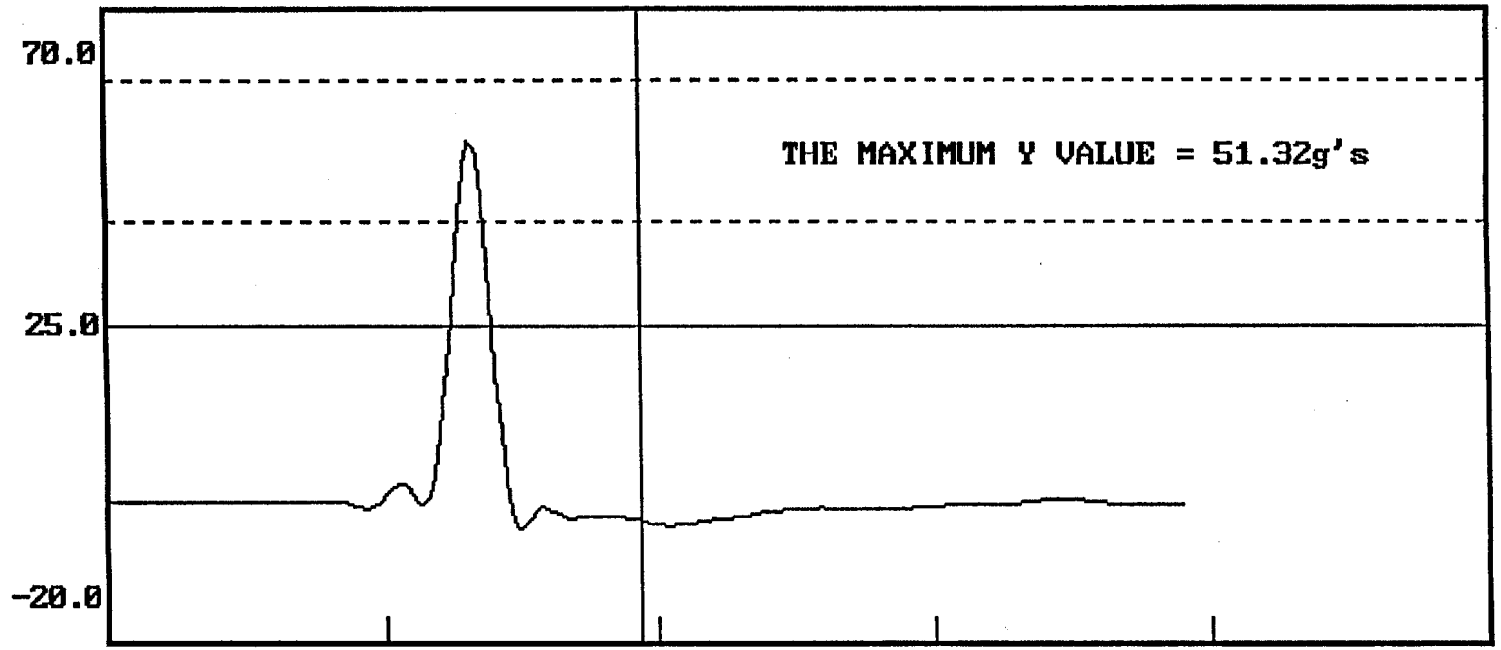
DUMMY CALIBRATION - PELVIS IMPACT 06-06-1994 16:14
DUMMY # 271
ACCELERATION (G'S) VS. TIME ((SECONDS))

TEST PARAMETER	SPECIFICATION	TEST RESULTS
TEMPERATURE	66 - 78° F	72°
RELATIVE HUMIDITY	10 - 70%	38%
PROBE SPEED	13.8 - 14.2 fps	14.0
PELVIS ACCELERATION	40 - 60 g's	51

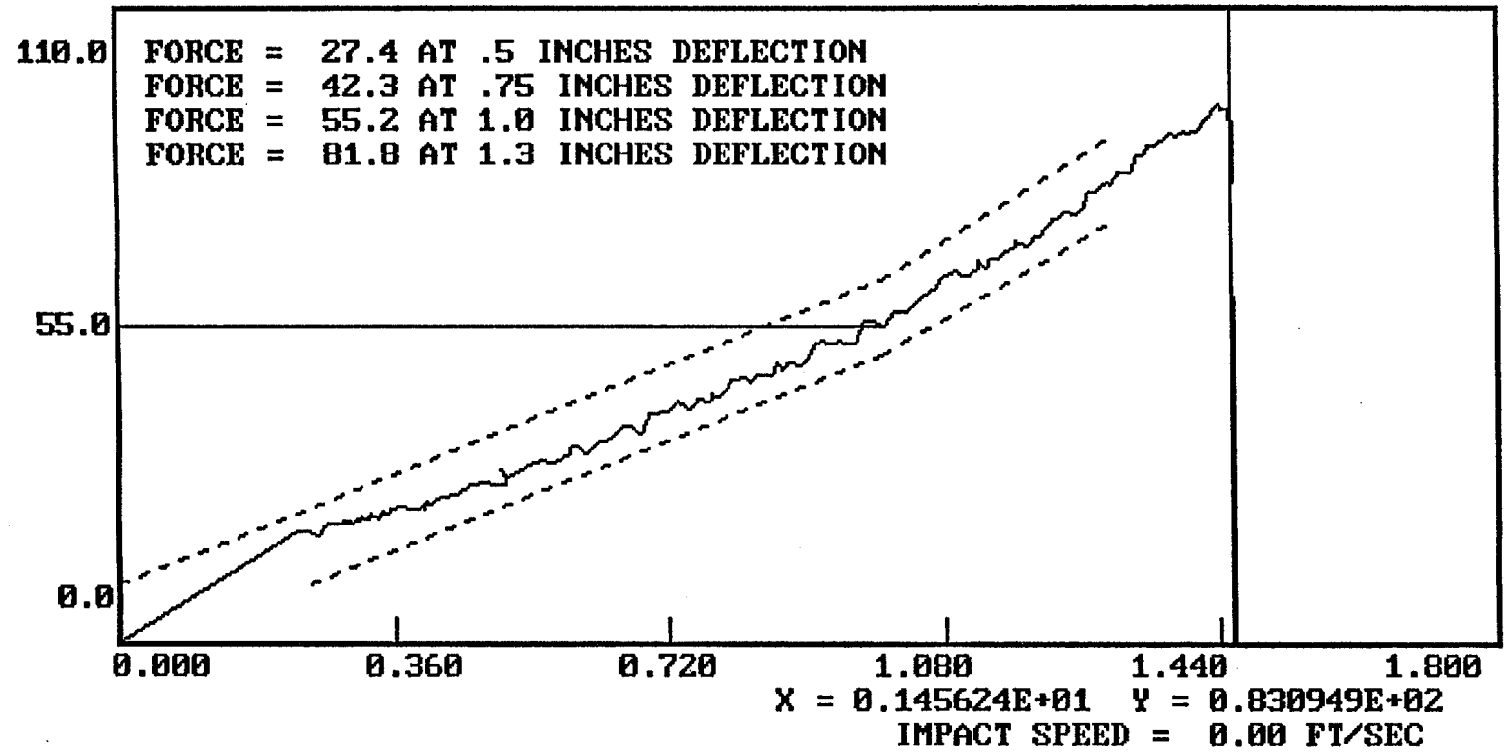
DUMMY CALIBRATION - ABDOMEN COMPRESSION 06-07-1994 10:30
DUMMY # 271
ABDOMEN FORCE () VS. ABDOMEN DISPLACEMENT (INCHES)

TEST PARAMETER	SPECIFICATION	TEST RESULTS
TEMPERATURE	66 - 78° F	70°
RELATIVE HUMIDITY	10 - 70%	40%
FORCE @ 0.5 in	23.3 - 36.5 lbs	27.4
FORCE @ 0.75 in	36.7 - 49.8 lbs	42.3
FORCE @ 1.0 in	50 - 63 lbs	55
FORCE @ 1.3 in	73 - 88 lbs	82

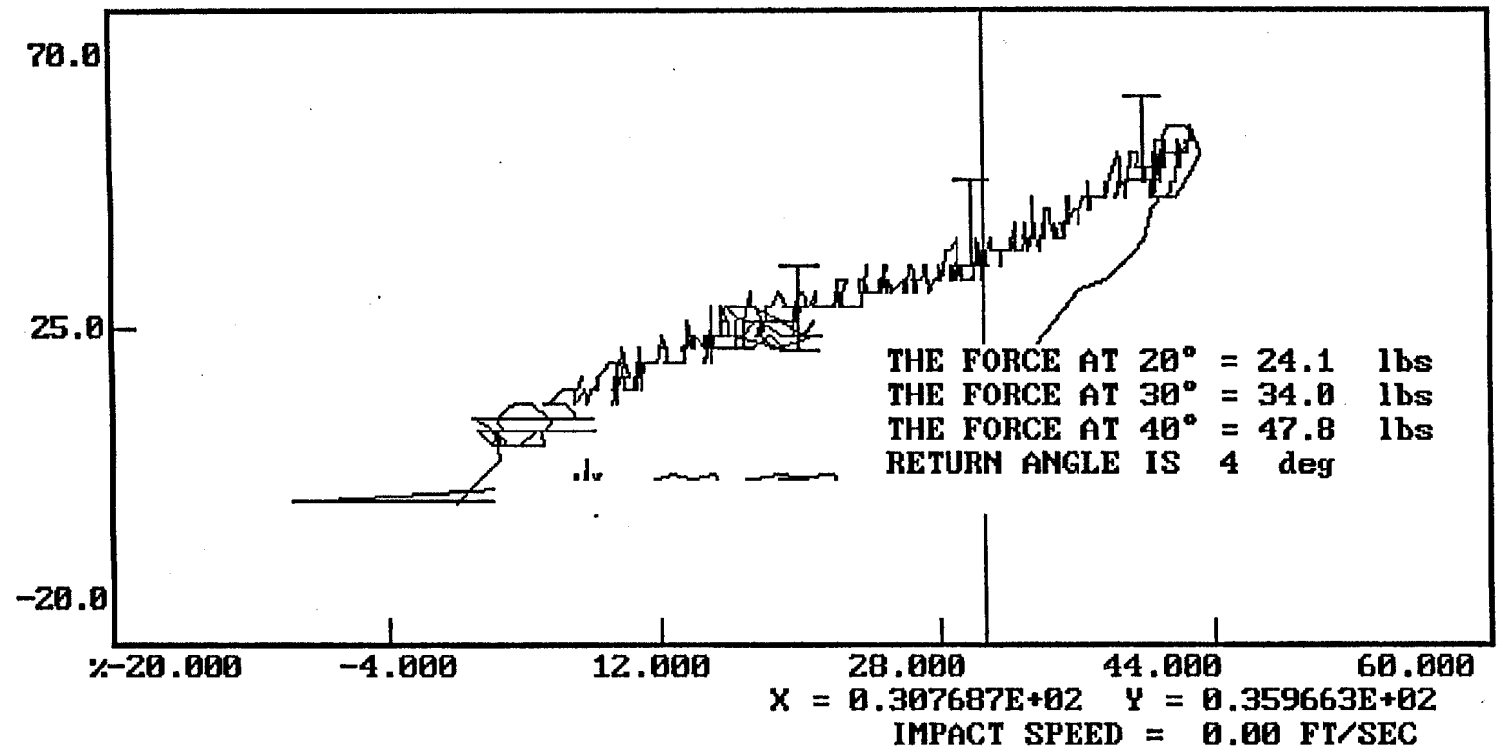
DUMMY CALIBRATION - LUMBAR FLEXION 06-07-1994 11:04
DUMMY # 271
FORCE () VS. TORSO ROTATION (DEGREES)

TEST PARAMETER	SPECIFICATION	TEST RESULTS
TEMPERATURE	66 - 78° F	70°
RELATIVE HUMIDITY	10 - 70%	40%
FORCE @ 0°	0 - 6 lbs	0
FORCE @ 20°	22 - 34 lbs	24
FORCE @ 30°	34 - 46 lbs	34
FORCE @ 40°	46 - 58 lbs	48
RETURN ANGLE	12° maximum	4°
