Insurance Institute for Highway Safety
Crashworthiness Evaluation

Crash Test Report
1998 Volkswagen New Beetle (CF98010)

Vehicle identification number: 3VWBB61CXWM005465
Body style: Small two-door hatchback
Engine/transmission: Transverse 2.0-liter 4-cylinder, 5-speed manual, front-wheel drive

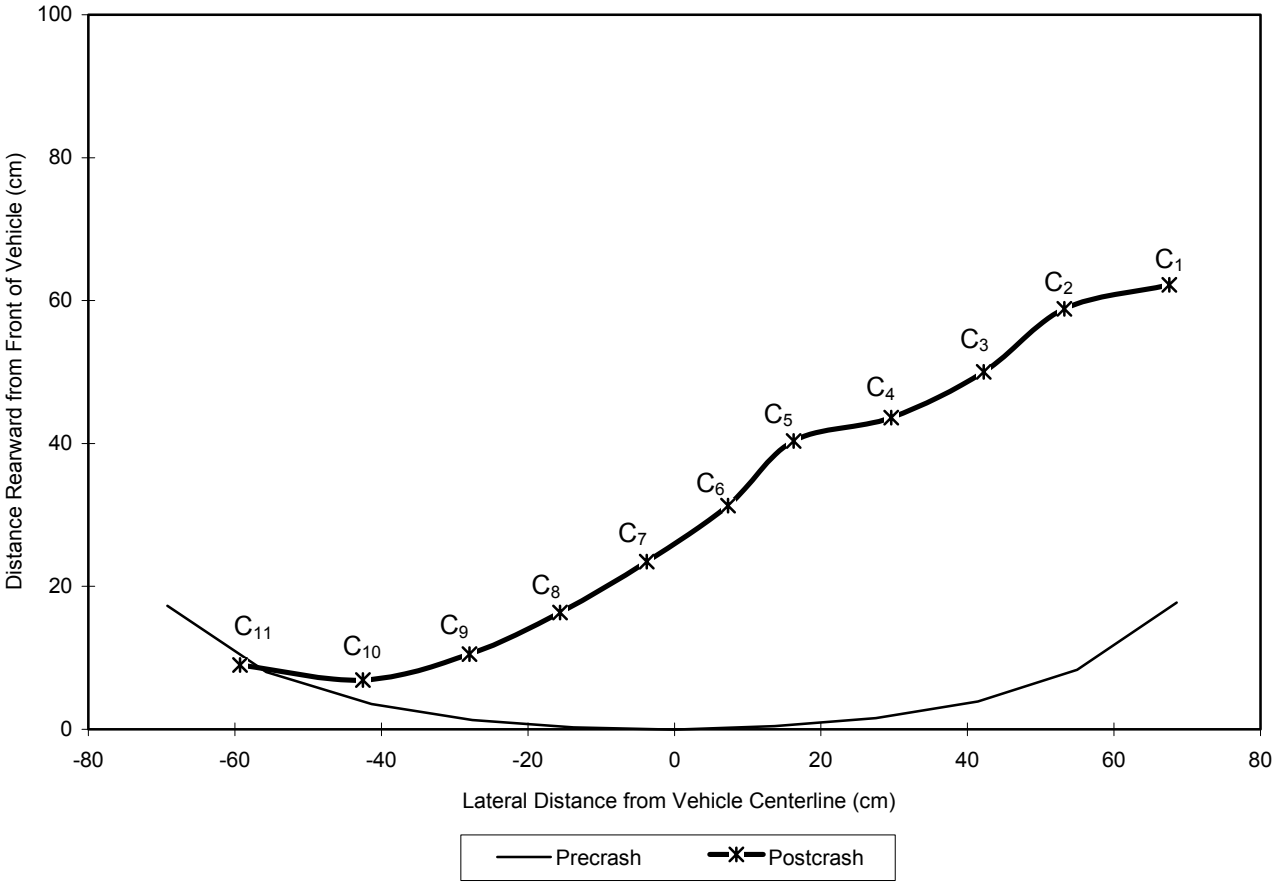
Figure 3
Front Bumper Cover Crush Contour — 1998 Volkswagen New Beetle

C_1	C_2	C_3	C_4	C_5	C_6	C_7	C_8	C_9	C_{10}	C_{11}
Postcrash Contour (cm)	62	59	50	44	40	31	23	16	11	7	9
Precrash Contour (cm)	18	8	4	2	0	0	0	1	4	8	17
Resulting Crush (cm)	44	51	46	42	40	31	23	15	7	-1	-8

The length of the reference line was 138 cm precrash and 127 cm postcrash.
