REPORT NUMBER: 214D-CAL-24-002

NEW CAR ASSESSMENT PROGRAM (NCAP)
MOVING DEFORMABLE BARRIER SIDE IMPACT TEST

Hyundai Motor Company
2024 Genesis GV60
5 Door SUV

NHTSA No: O20244210

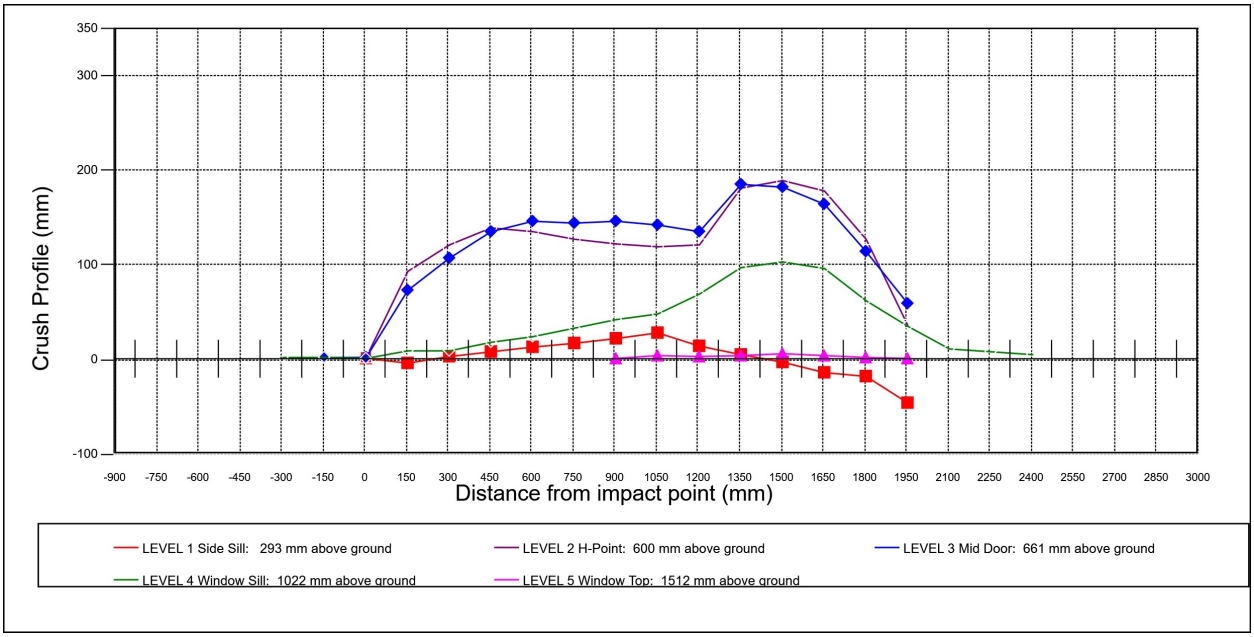
Vehicle Exterior Crush Measurements - Visual Representation

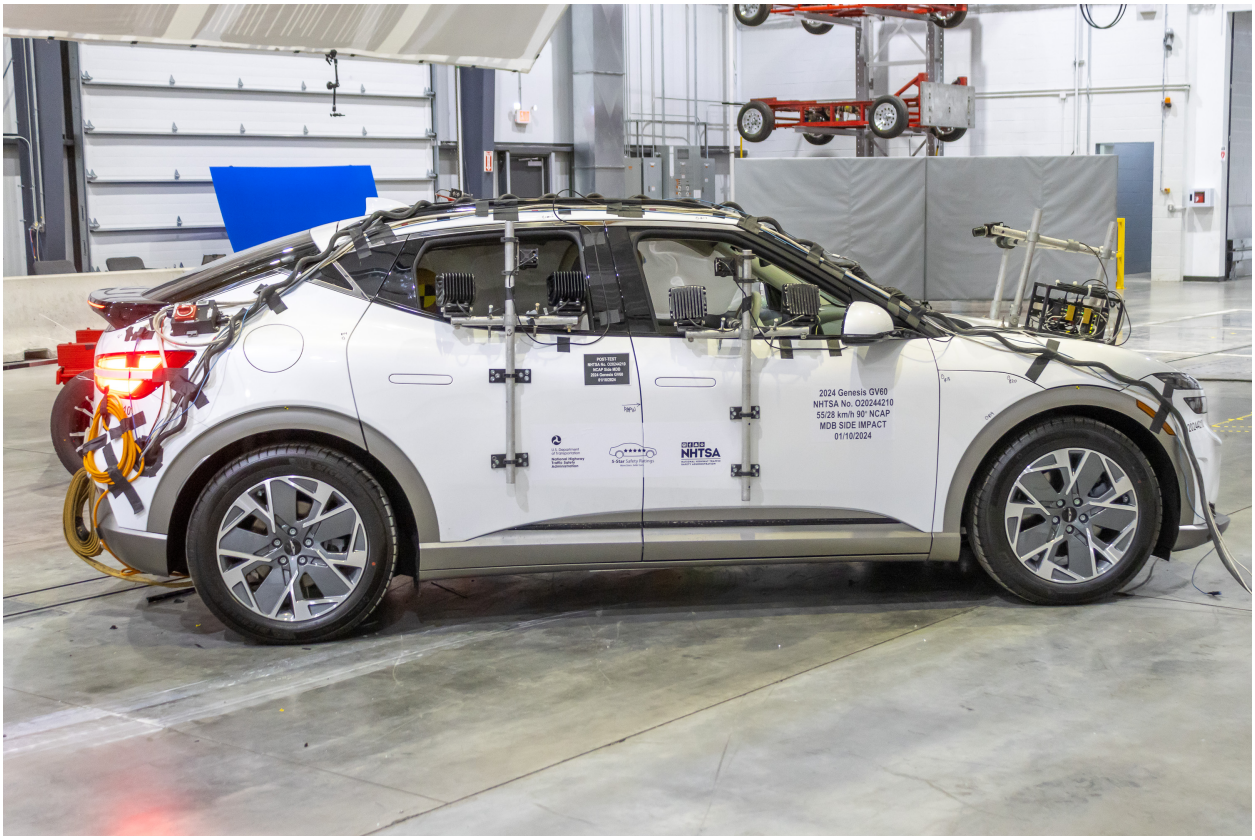
Figure A-14: Post-Test Right Side View of Test Vehicle

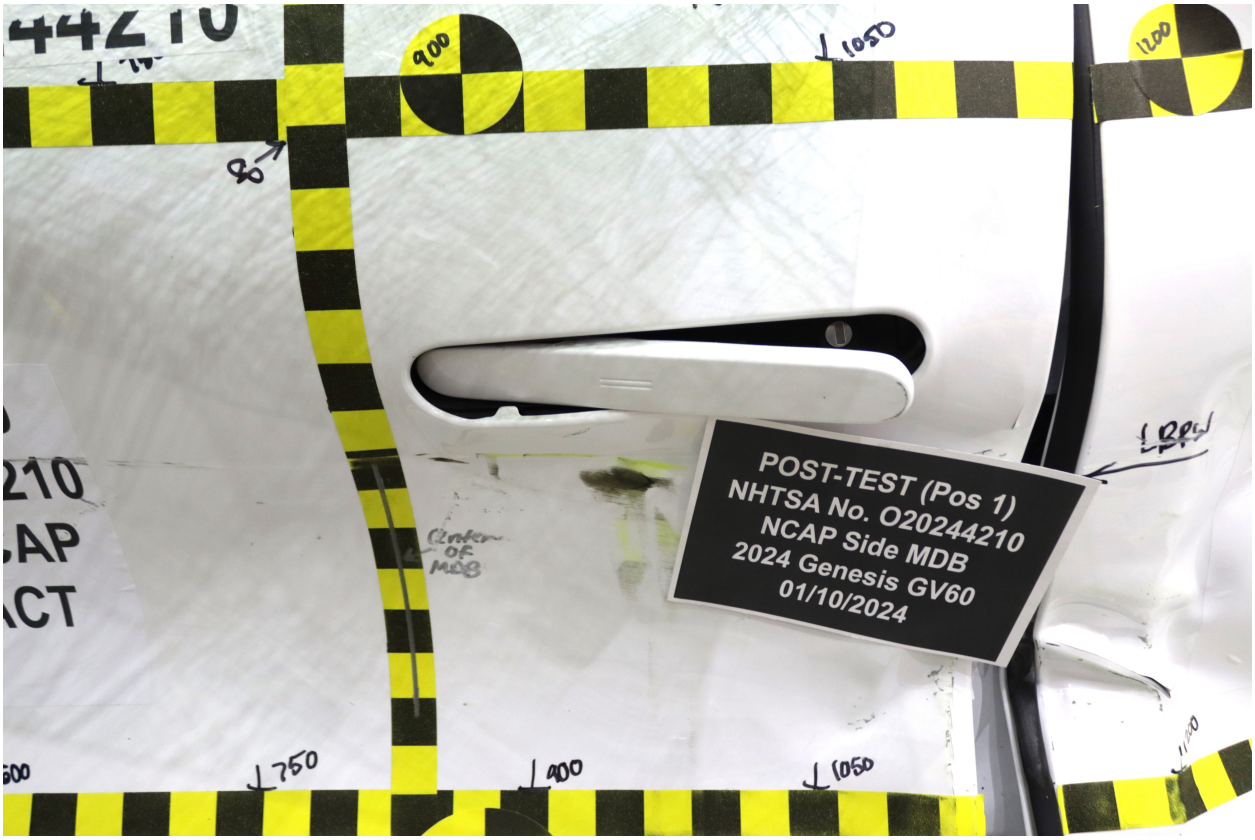
Figure A-22: Post-Test Left Front Door Latch Close-Up

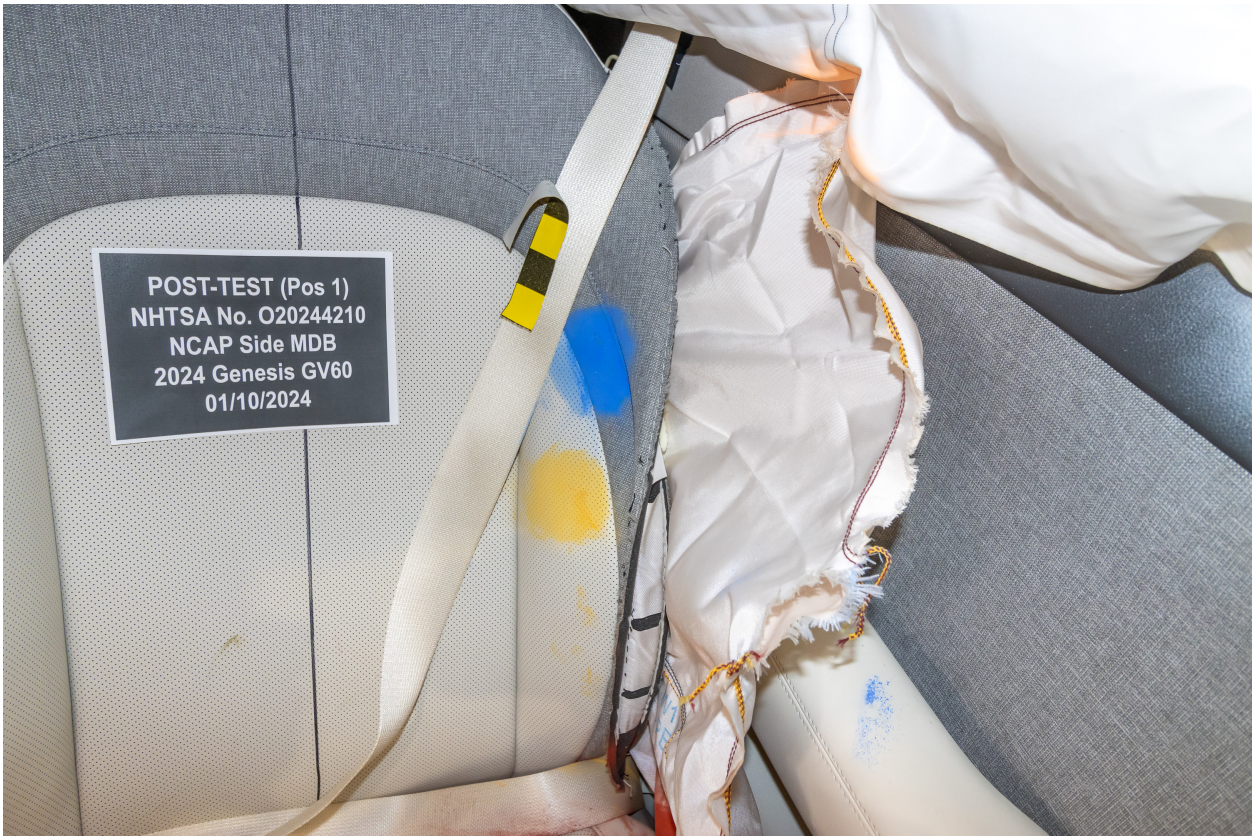
Figure A-50: Post-Test Driver Dummy Close-Up Torso Contact with Vehicle Interior View

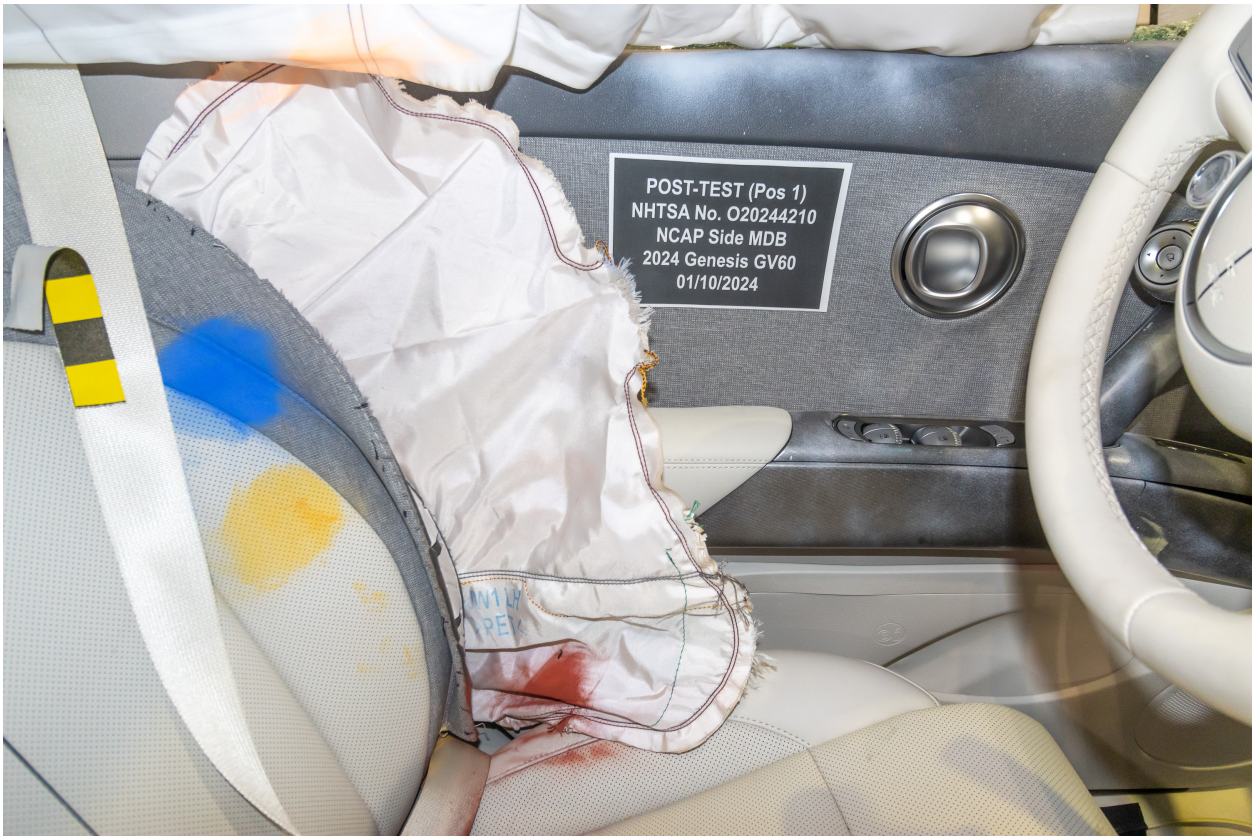
Figure A-51: Post-Test Driver Dummy Close-Up Torso Contact with Side Air Bag View

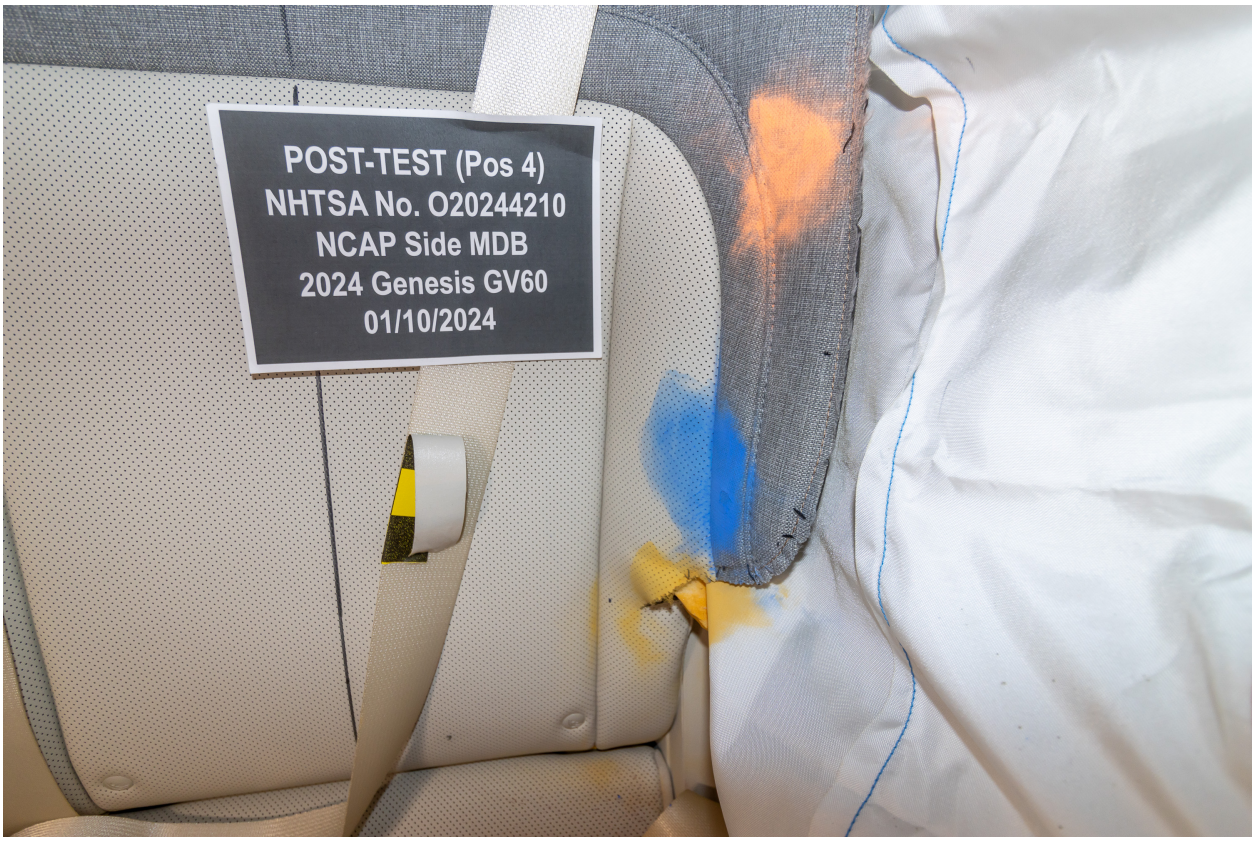
Figure A-77: Post-Test Rear Passenger Dummy Close-Up Torso Contact with Vehicle Interior View

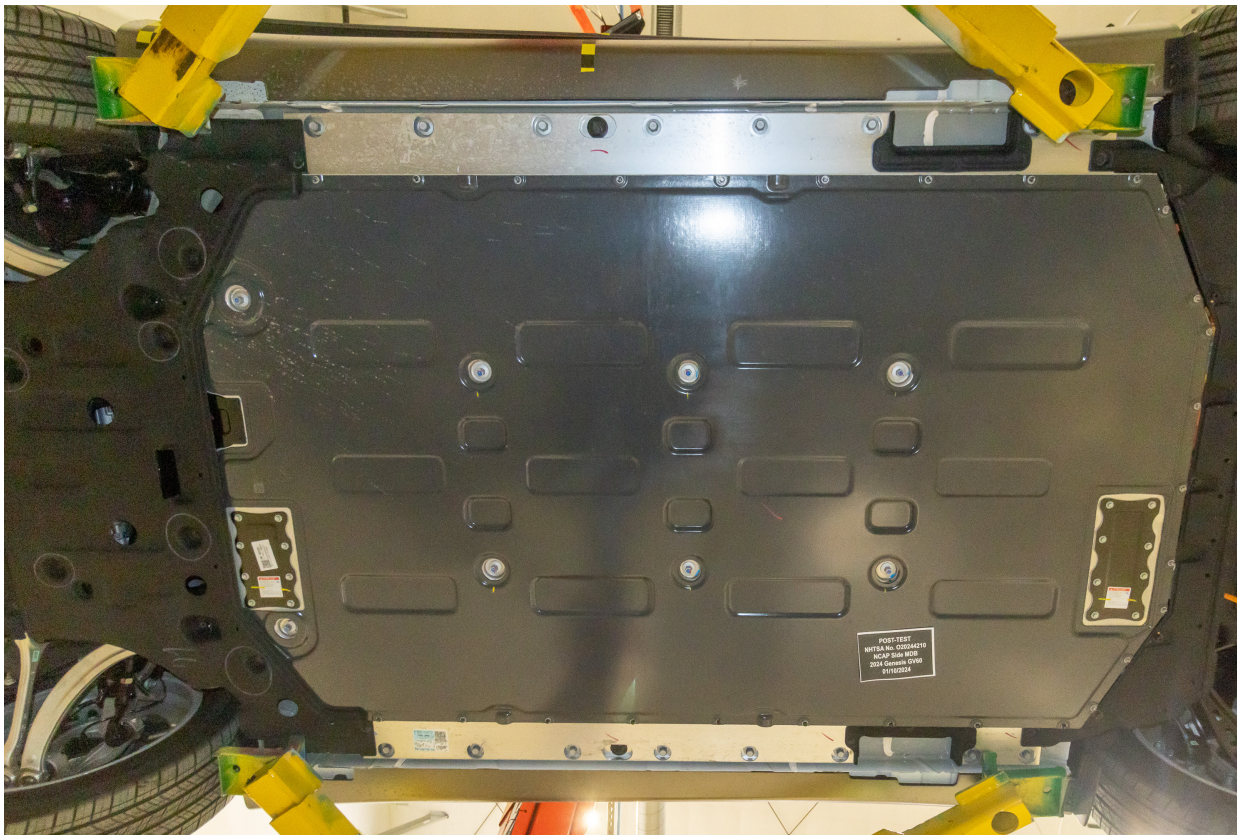
Figure 305-15: Post-Impact View of Propulsion Battery Module(s)

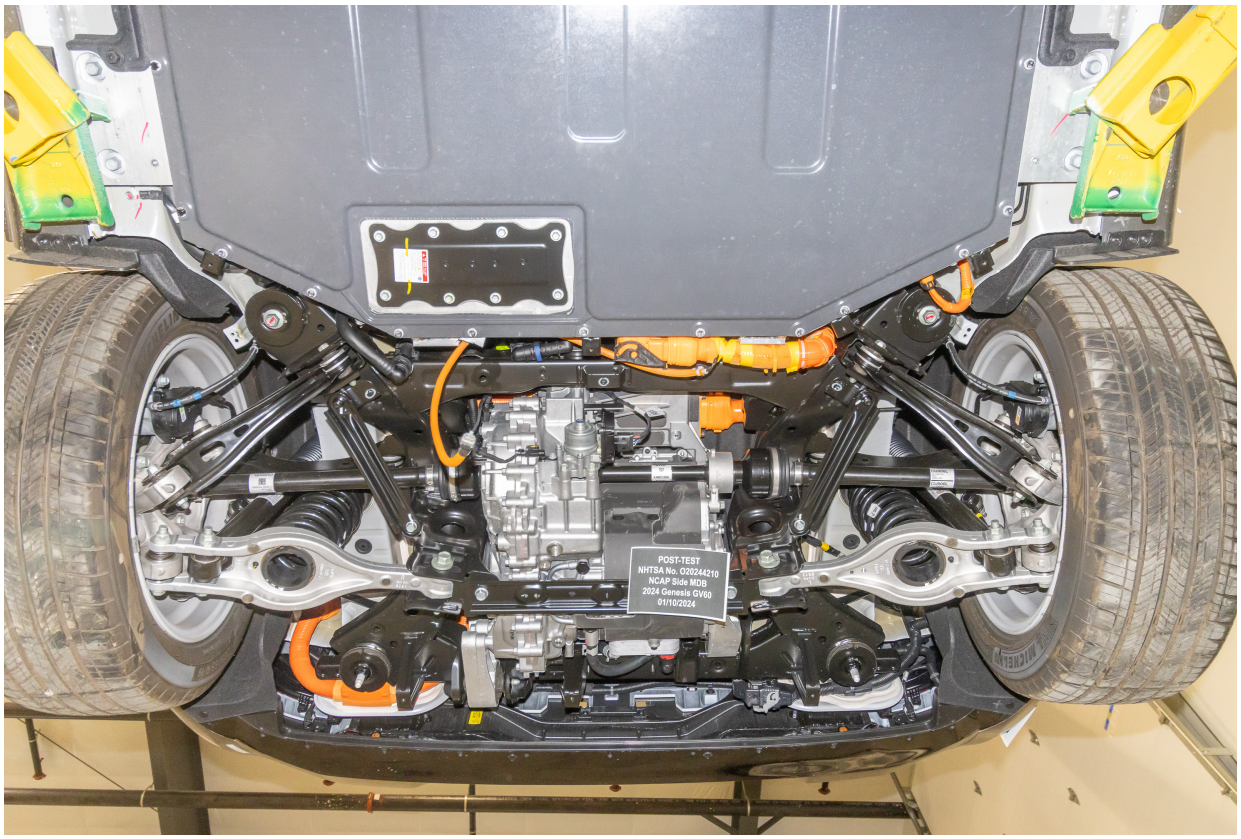
Figure 305-17: Post-Impact View of Electric Propulsion Drive
