REPORT NO. 301-AETL-80-009-971-3882-9

NEW VEHICLE ASSESSMENT  
AND  
STANDARDS ENFORCEMENT INDICANT TESTING

FMVSS 301-75

GENERAL MOTORS CORPORATION  
1980 OLDSMOBILE CUTLASS LS - 4 DOOR SEDAN  
NHTSA 800111

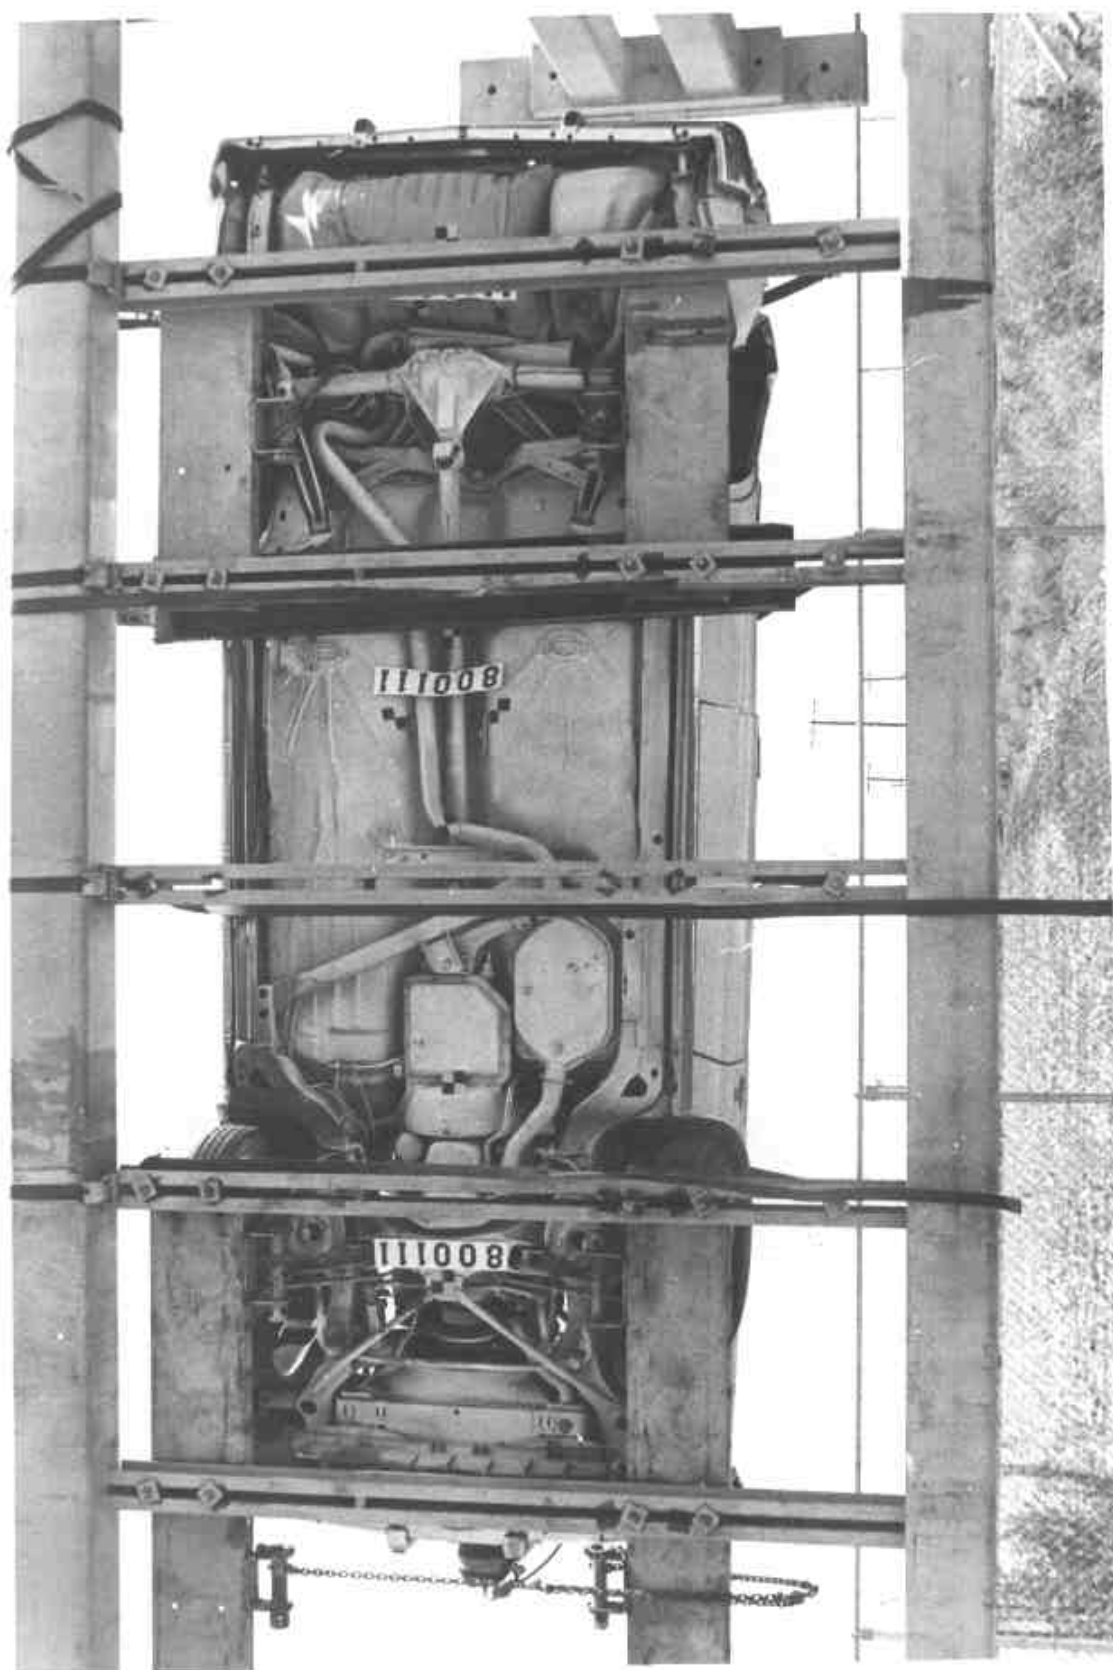
Figure 3-7

No fuel spillage was recorded following the test vehicle impact, nor during the time period before the start of the rollover test. No fuel spillage was recorded during the rollover test increment time periods.

Post-Impact, Rollover Test, 90° Increment

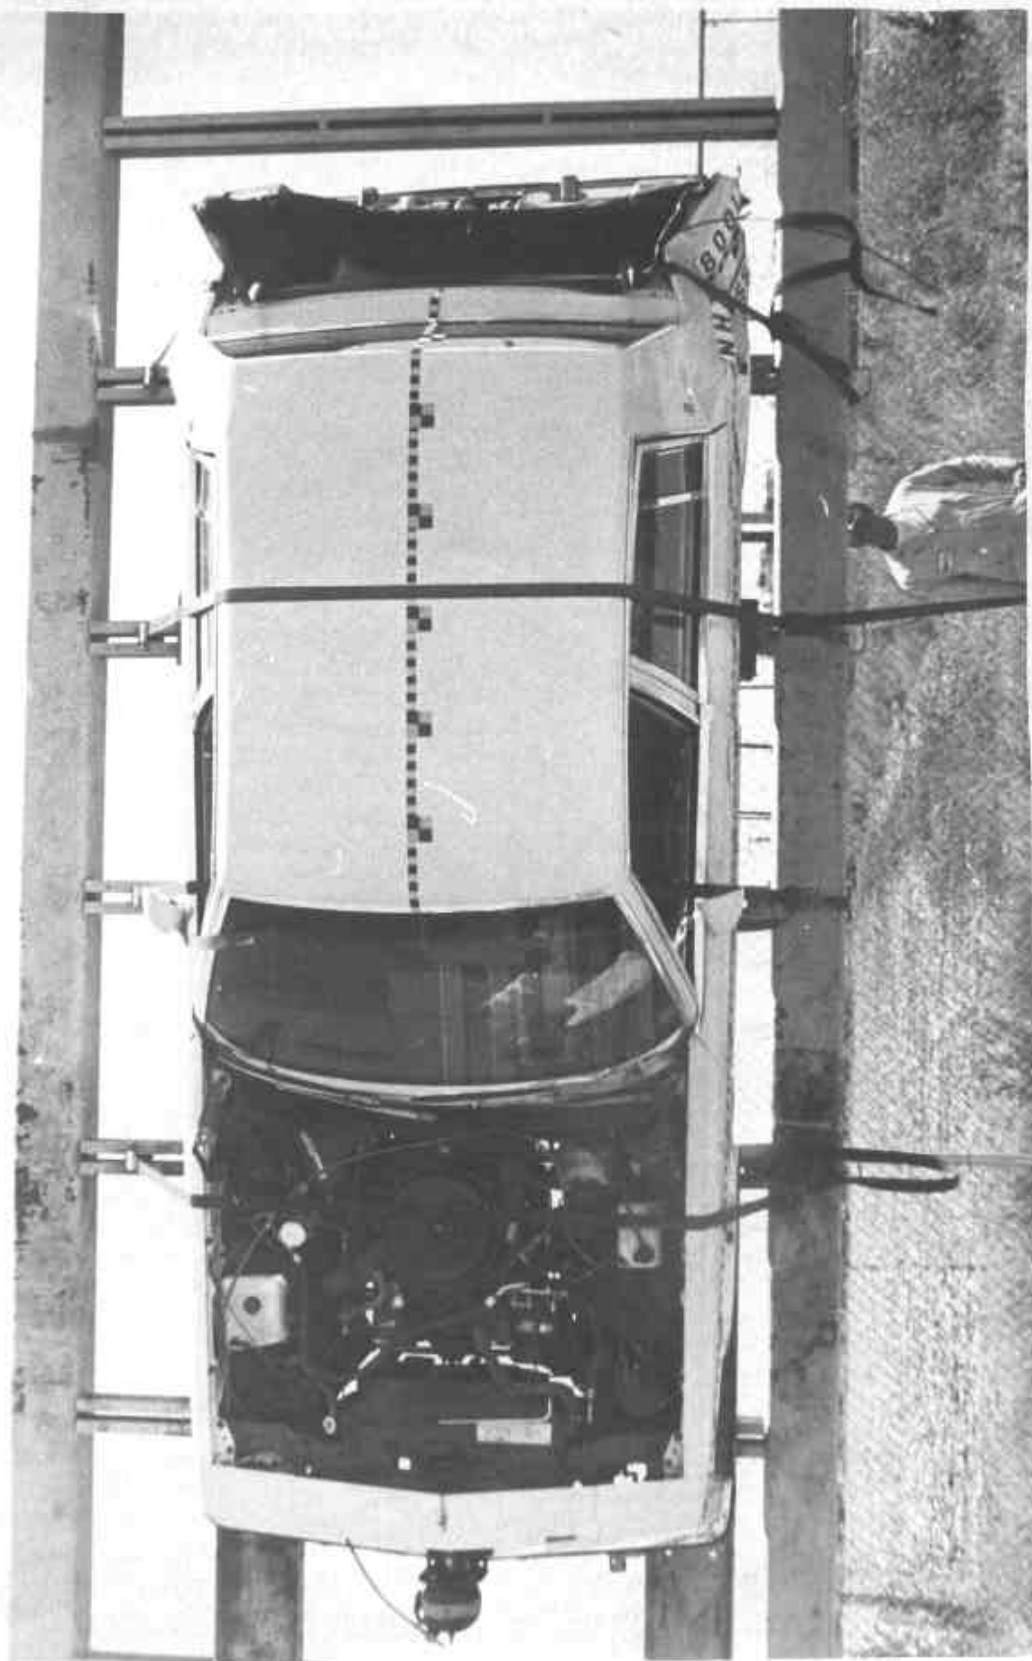
Figure 3-8

Post-Impact, Rollover Test, 270° Increment
