TEST REPORT 5  
60° SIDE IMPACTOR-TO-OLDSMOBILE  
CUTLASS TEST 4.7 AT 35 MPH  
Contract DOT-HS-8-01933

J. Beharrell  
R. Cropper  
S. Davis

December 1979

| 15. Supplementary Notes<br>Test Number 8321-4.7 | | | |

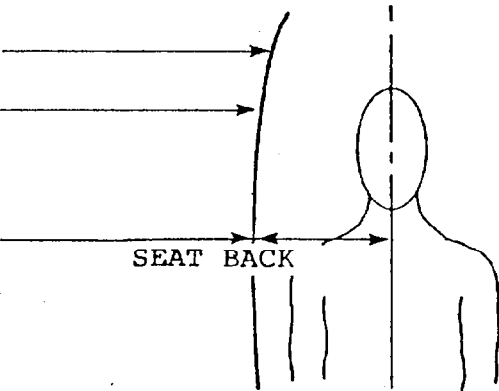
| | | PRE-TEST | POST-TEST |
|---|---|---|---|
| <p>MOLDING ABOVE WINDOW →</p> <p>B-PILLAR →</p> <p>MEASURED ALONG TOP OF SEAT BACK FROM <math>\bar{C}</math> OF DUMMY BODY TO B-PILLAR</p> <p>RIGHT FOREARM OF DUMMY CONTACTING SIDE OF DOOR ARM REST</p> <p>RIGHT FRONT DUMMY</p> | | 7.0 | 16.3 |

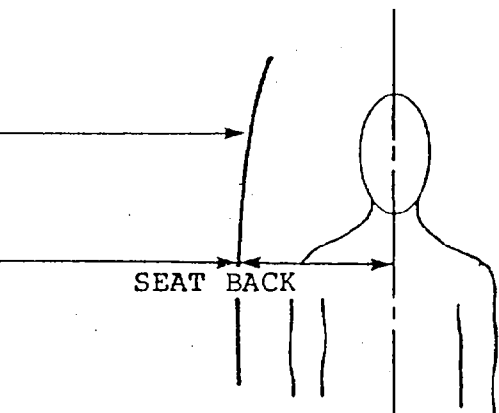
| | | PRE-TEST | POST-TEST |
|---|---|---|---|
| <p>SIDE OF HEAD TO C-PILLAR →</p> <p>MEASURED ALONG TOP OF SEAT BACK FROM <math>\bar{C}</math> OF DUMMY BODY TO C-PILLAR</p> <p>RIGHT FOREARM OF DUMMY TO SIDE OF DOOR</p> <p>RIGHT REAR DUMMY</p> | | 9.8 | 14.6 |

As may be seen from Table C-1, the injury criteria levels for both dummies are well below the maximum allowed in FMVSS 208, although the head injury levels for the rear dummy were caused by its head striking the C-pillar during the impact.

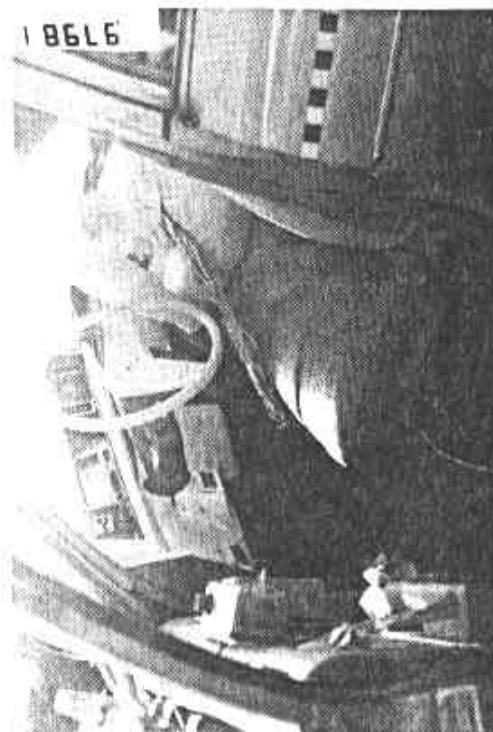
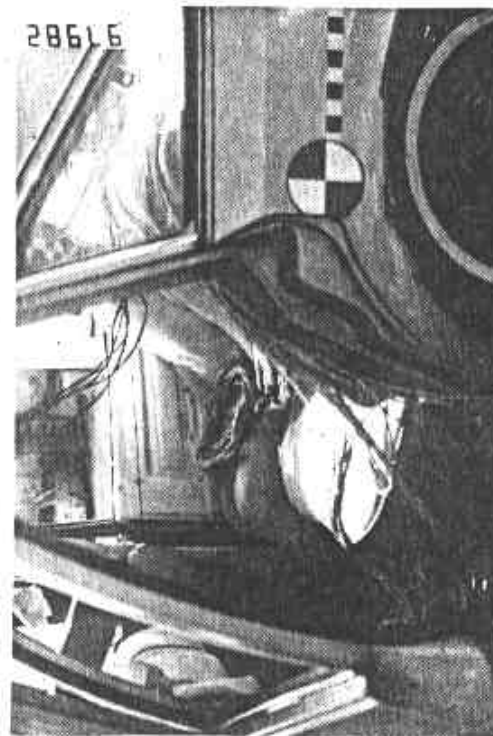
b) Post-test Front Passenger

d) Post-test Rear Passenger

General Observations: Front door pushed over rocker sill and approximately 18 inches into the occupant compartment. Welds at top of B-pillar all broken. The hinges on the front door were bent but still attached to the A-pillar. Vehicles 44 feet apart post-impact. Side impactor bumper pulled out on left side due to tensile failure of honeycomb.
