TEST REPORT NO. 2  
STRAIGHT SIDE IMPACTOR-TO  
MODIFIED VW RABBIT  
FRONT-TO-SIDE TESTS @ 60°

TESTS 8327-6.5 AND 8327-6.6  
APPENDICES A, B, C, D, E, F

CONTRACT NO. DOT-HS-8-01933 (II)

U.S. DEPARTMENT OF TRANSPORTATION  
NATIONAL HIGHWAY TRAFFIC SAFETY ADMINISTRATION  
WASHINGTON, D.C. 20590

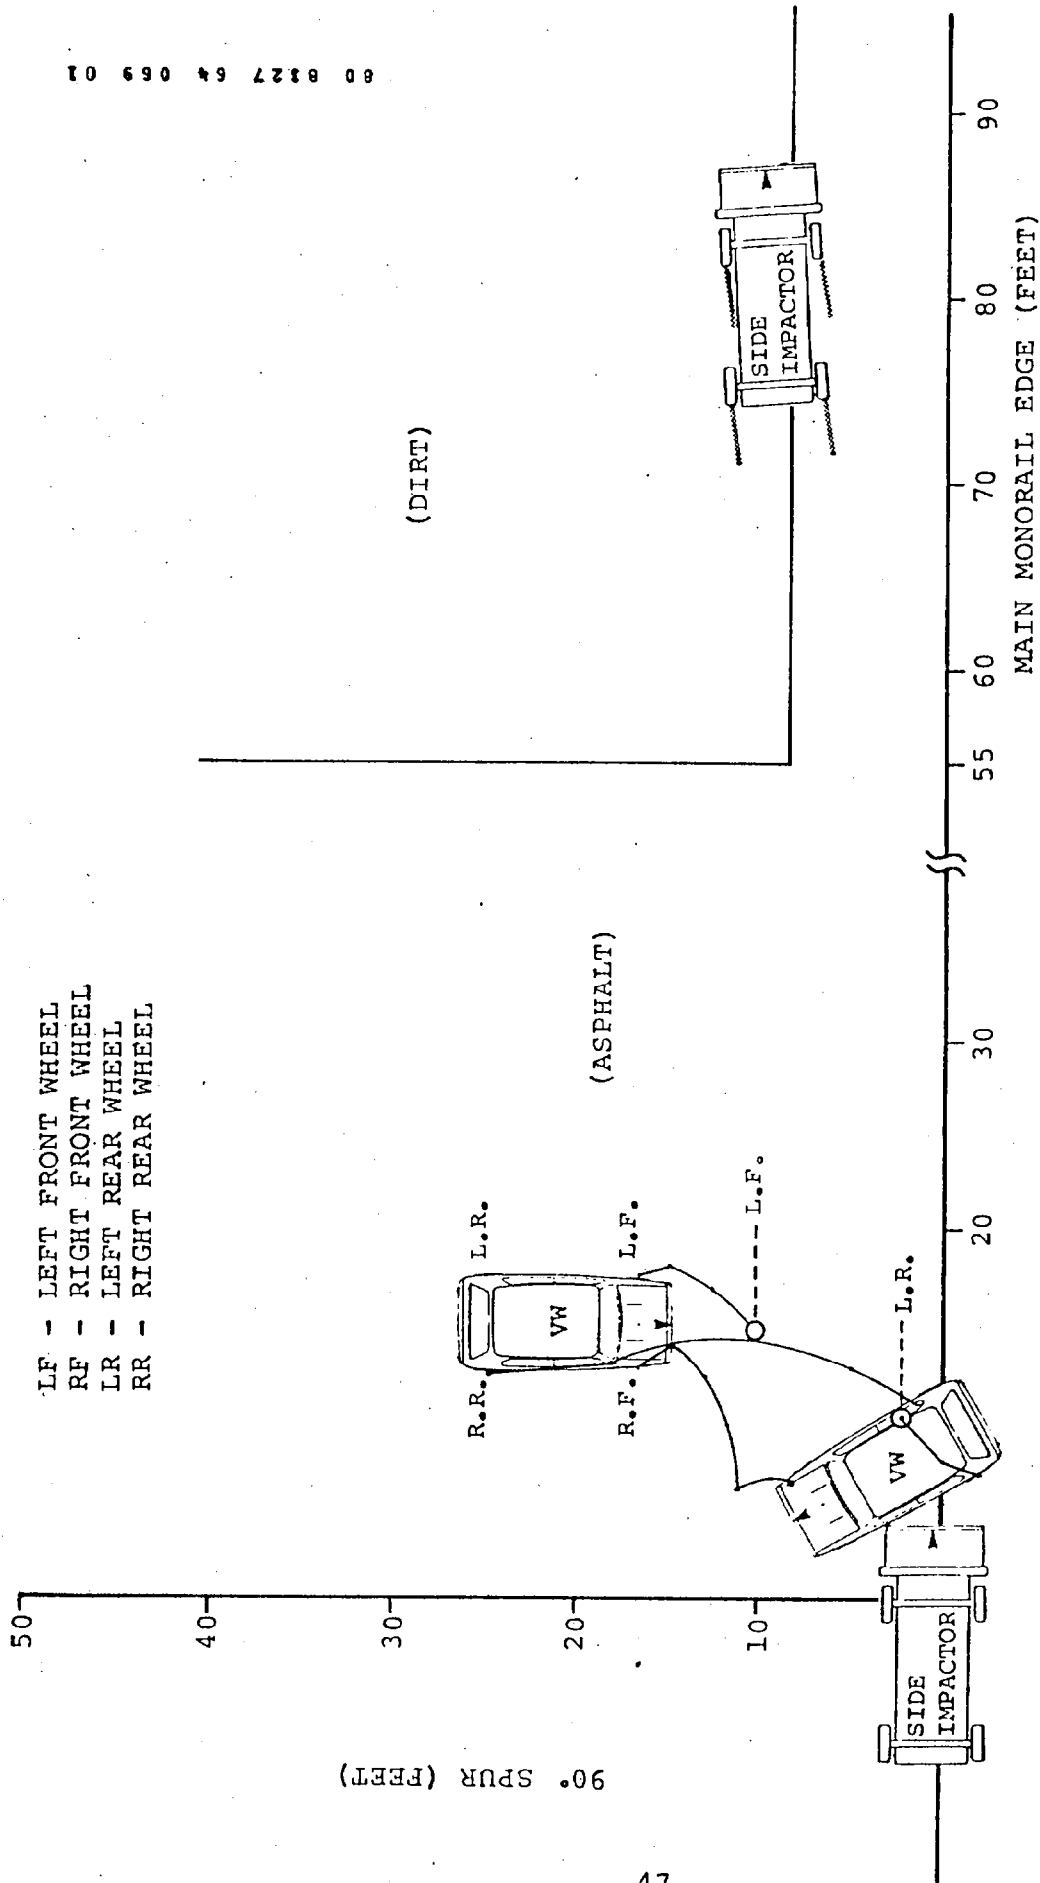
General Observations: Impact point 13.9 inches aft of DOR (target point 6.0 inches aft of DOR). Buckle in roof over left side B-pillar. 5 inches of left rear wheel rim bent outwards - tire flat. All interior padding and backing sheets remained intact and in place. Steering wheel was not pinned by door metal; remained operational.

FIGURE 4-1. VEHICLE PRE- AND POST-TEST POSITIONS (TEST 6.6)

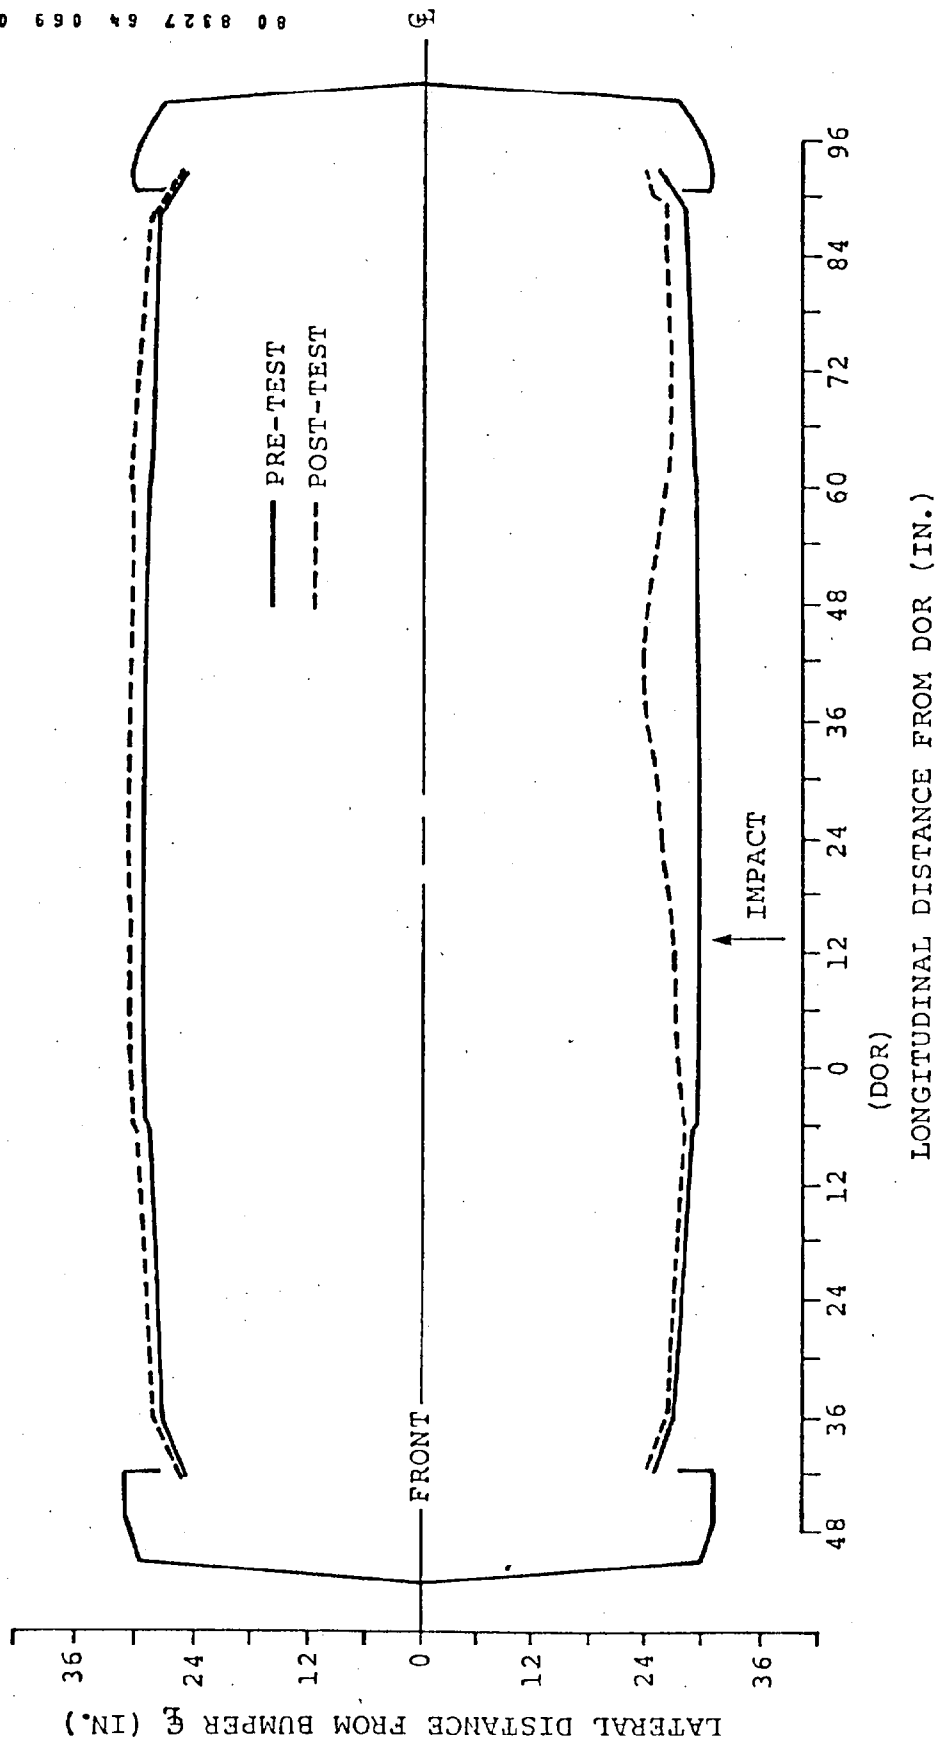
FIGURE 4-4. PRE- AND POST-TEST EXTERIOR PROFILES AT 12.0" ABOVE GROUND LEVEL FOR VW RABBIT (TEST 6.6).

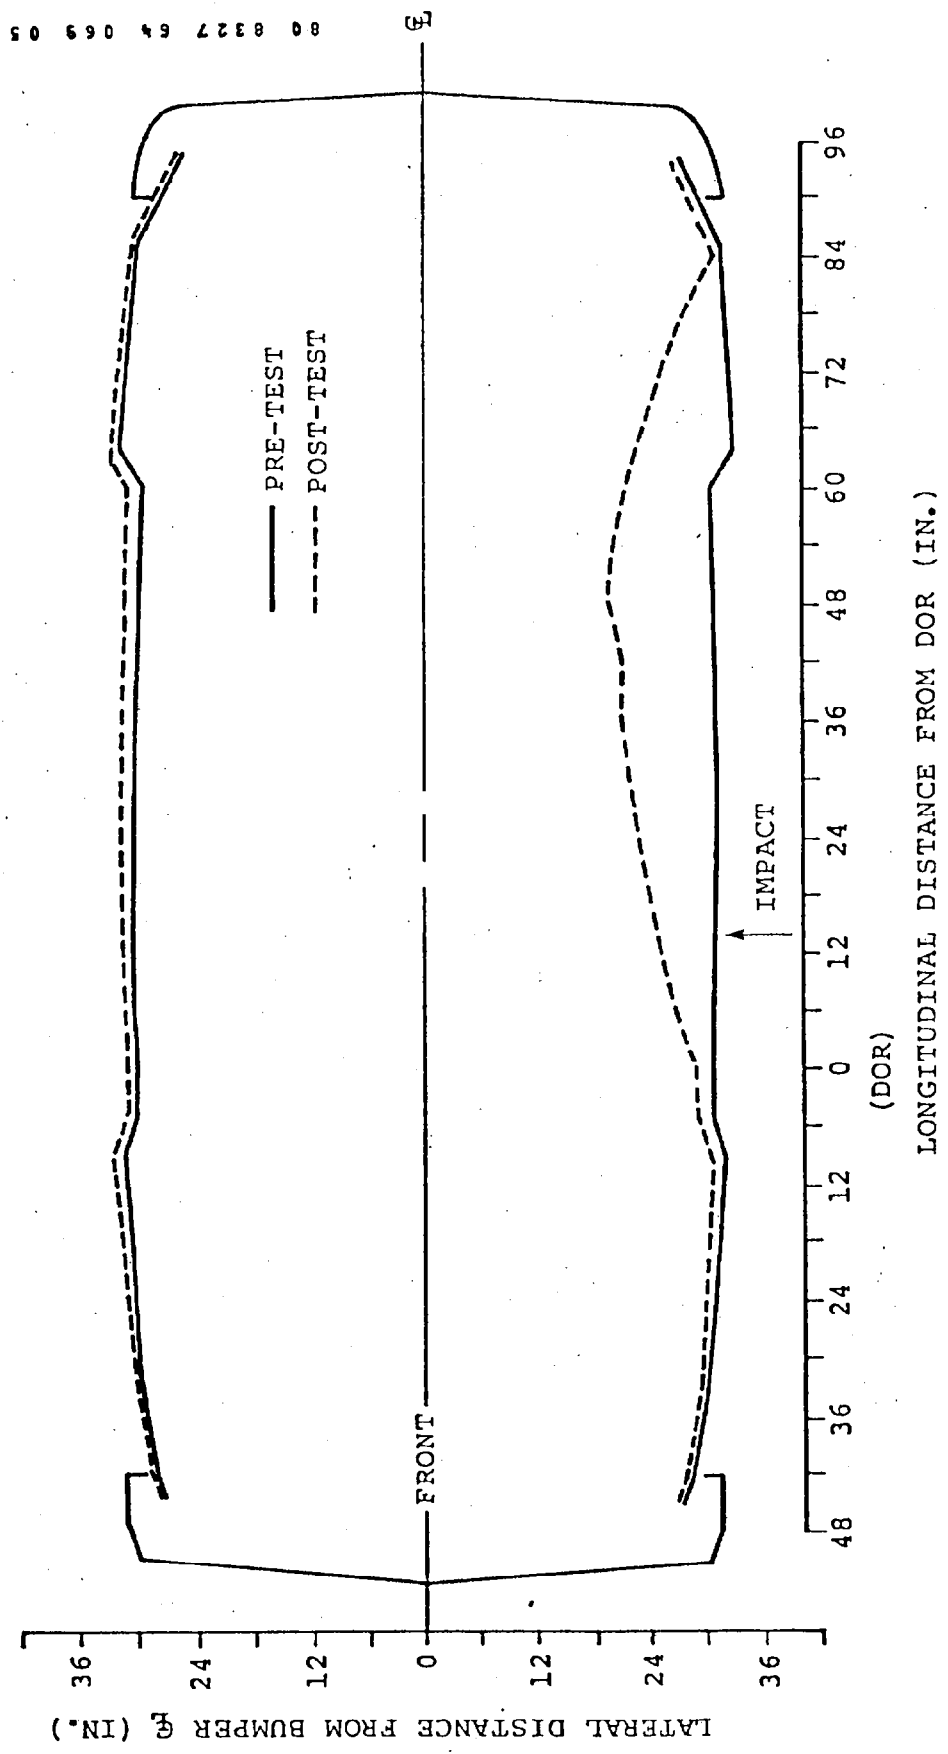
FIGURE 4-5. PRE- AND POST-TEST EXTERIOR PROFILES AT 20.0" ABOVE GROUND LEVEL FOR VW RABBIT (TEST 6.6).

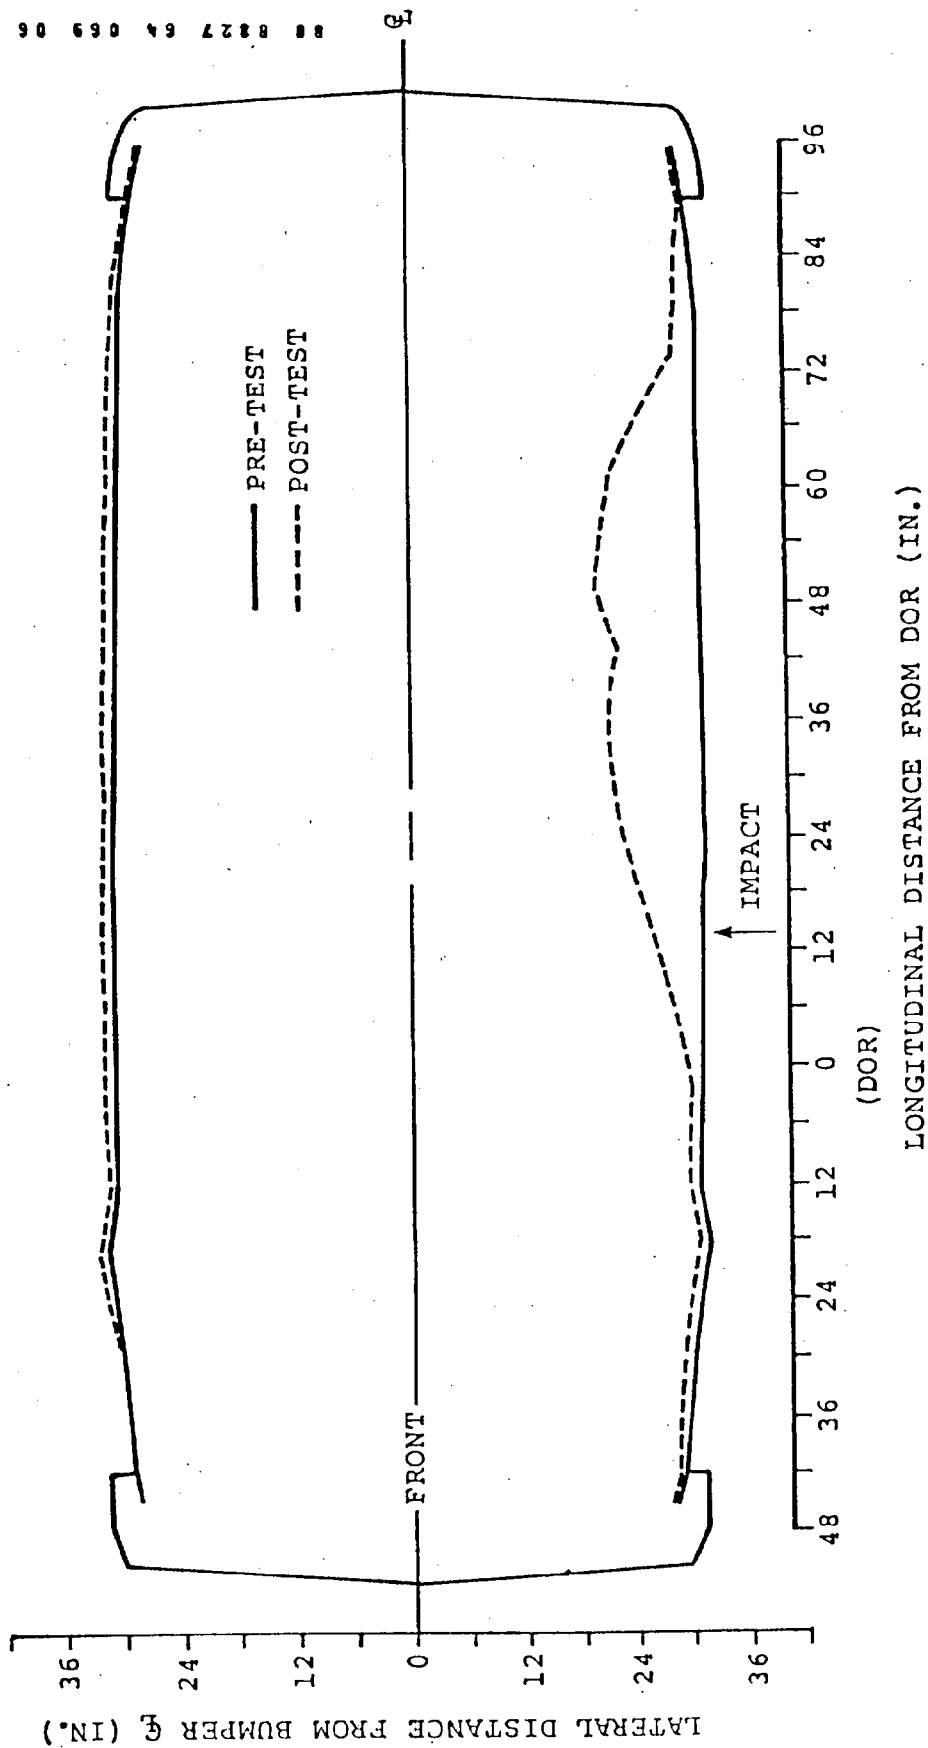
FIGURE 4-6. PRE- AND POST-TEST EXTERIOR PROFILES AT 26.0" ABOVE GROUND LEVEL FOR VW RABBIT (TEST 6.6).

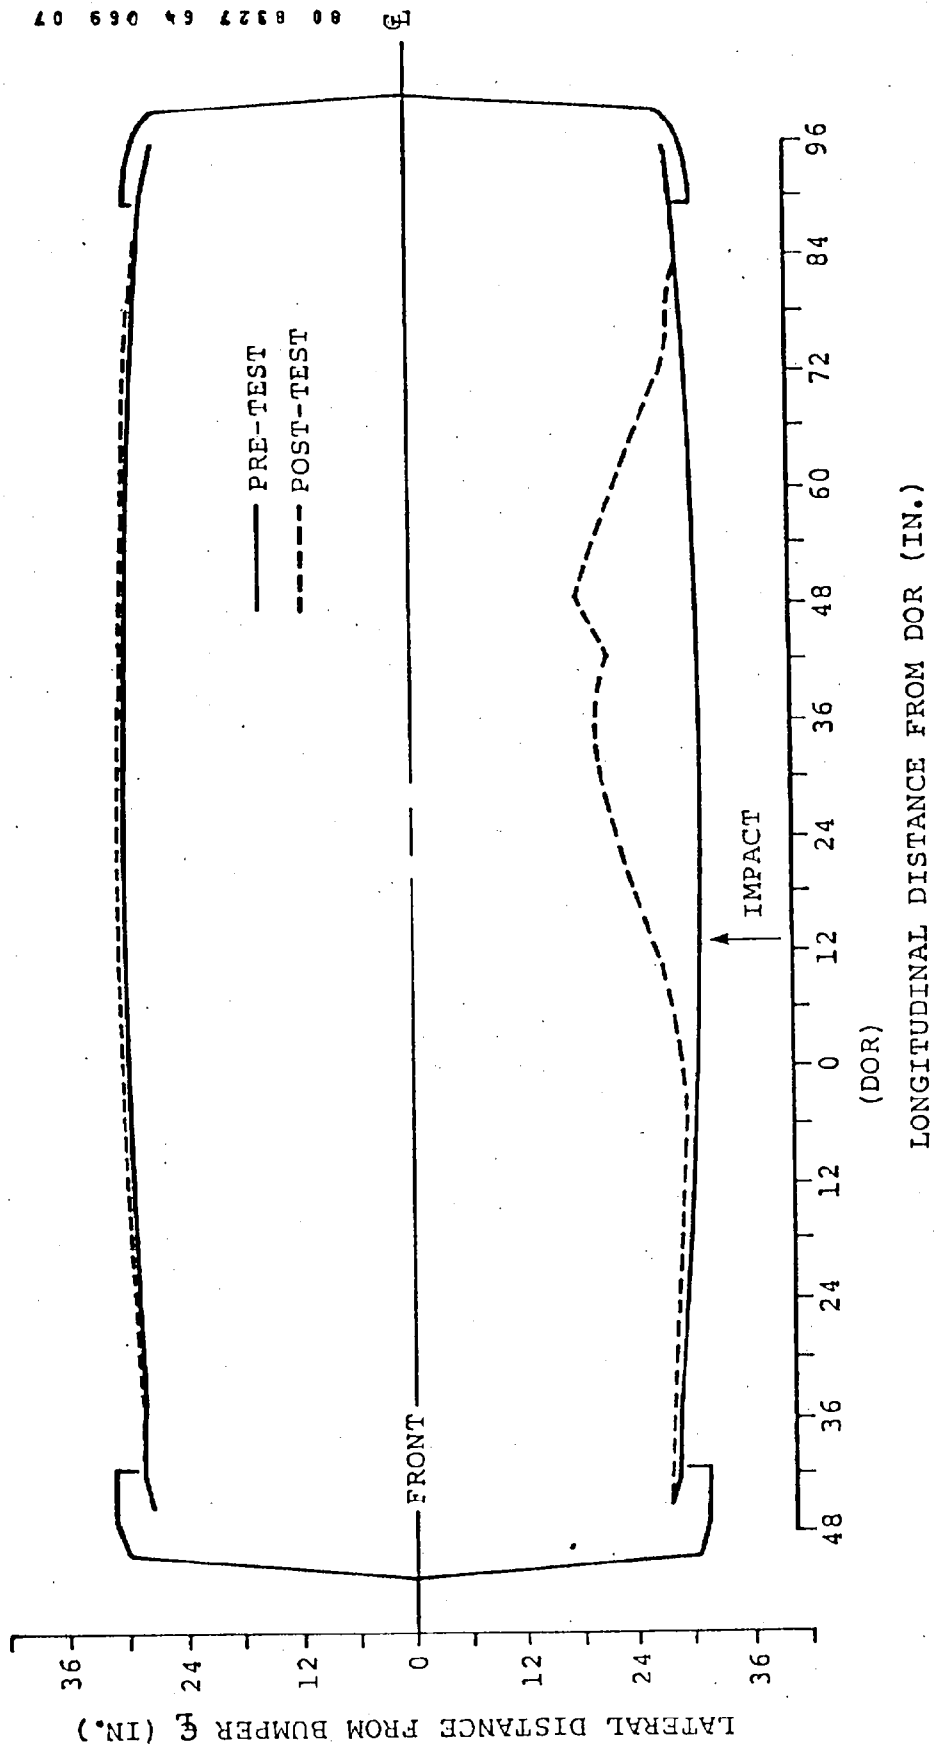
FIGURE 4-7. PRE-AND POST-TEST EXTERIOR PROFILES AT 32.0" ABOVE GROUND LEVEL FOR VW RABBIT (TEST 6.6).

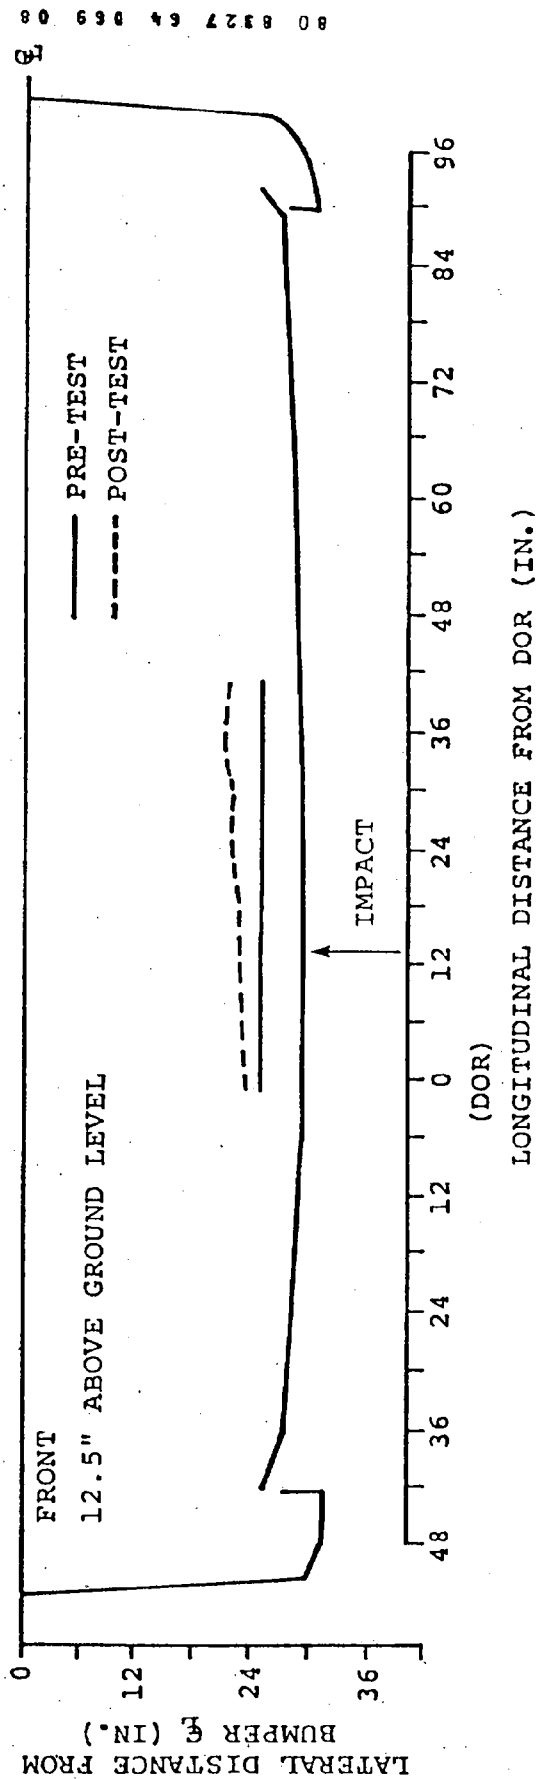
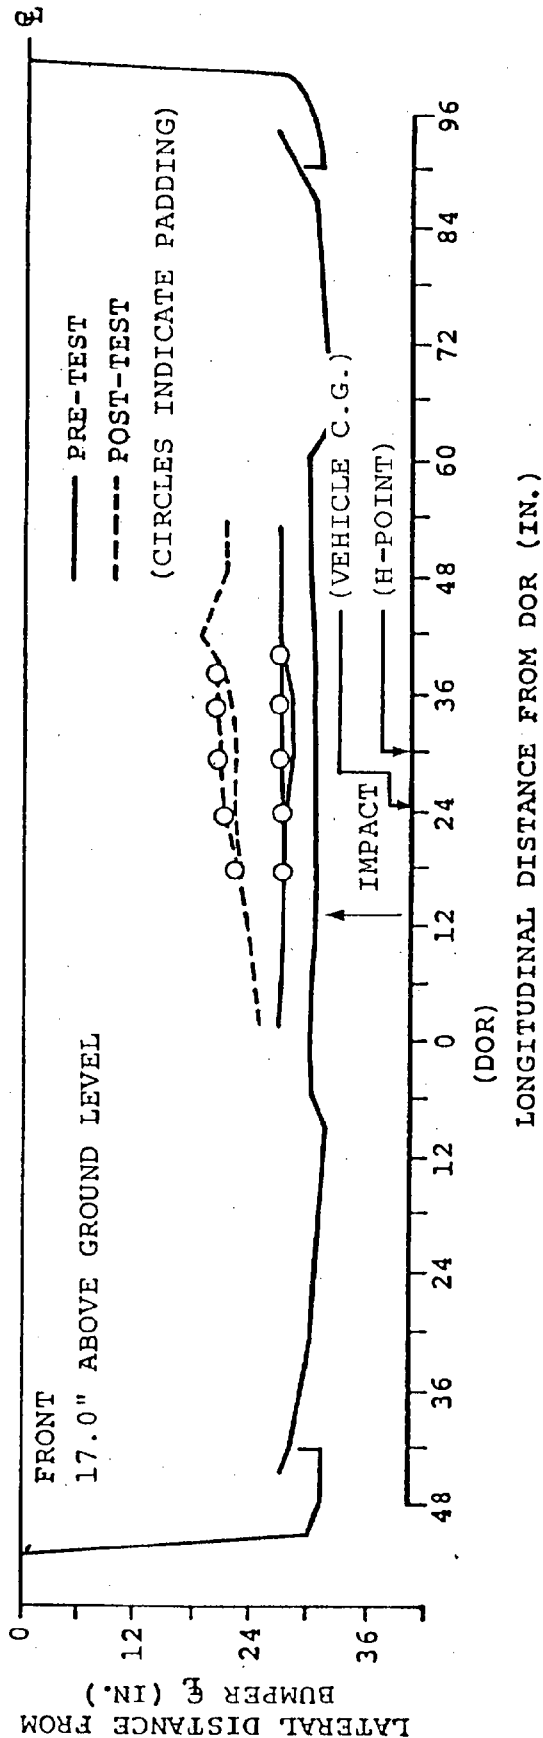
FIGURE 4-8. PRE- AND POST-TEST INTERIOR PROFILES FOR VW RABBIT (TEST 6.6).

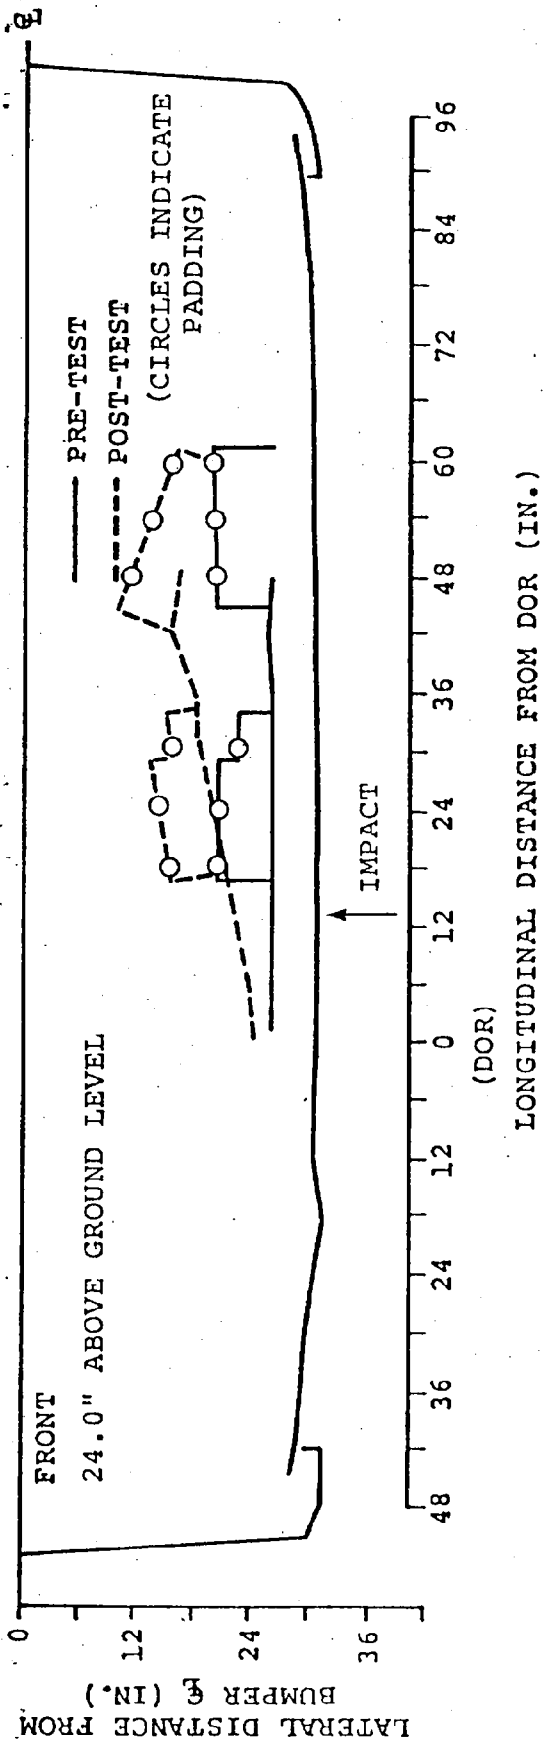
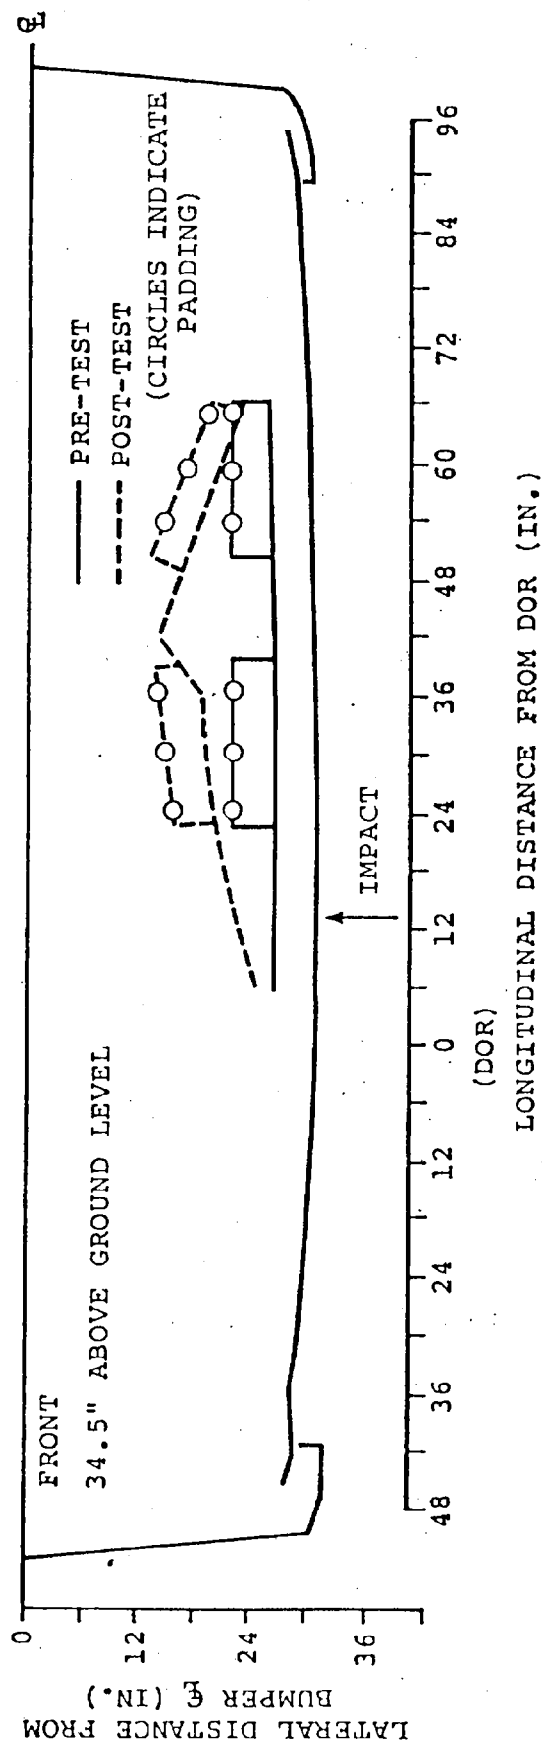
FIGURE 4-9. PRE- AND POST-TEST INTERIOR PROFILES FOR VW RABBIT (TEST 6.6).

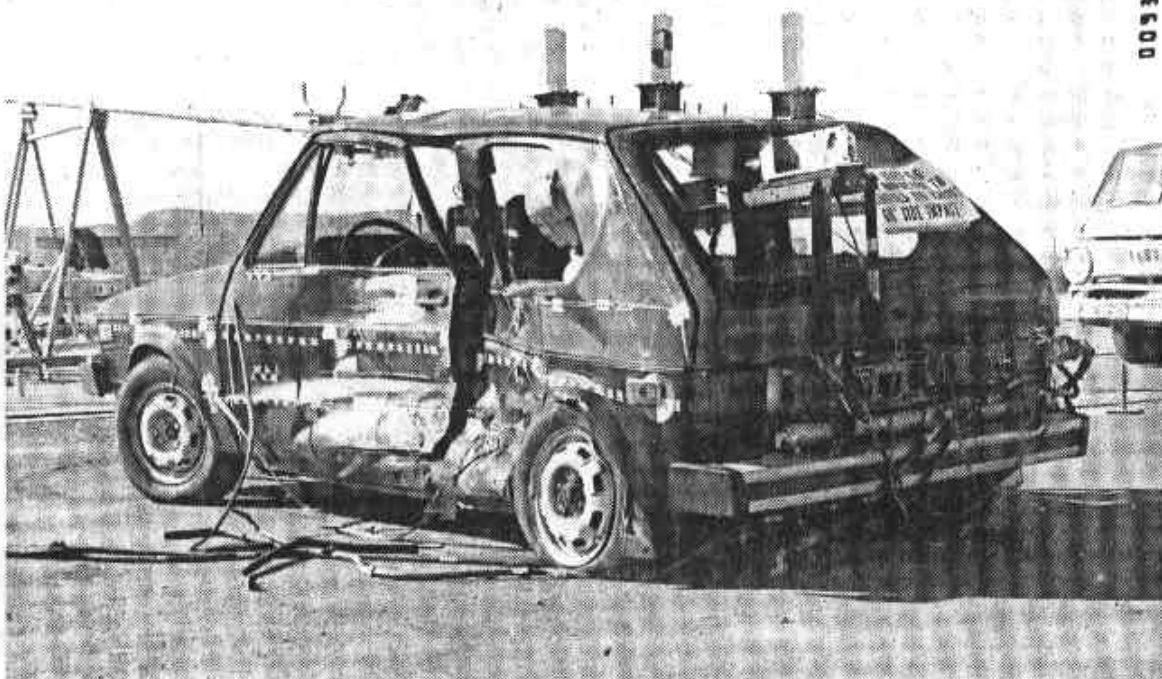
FIGURE 4-14. POST-TEST VW RABBIT REAR THREE-QUARTER VIEW (TEST 6.6).

Glazing: Windshield cracked along left side, especially upper left corner. Left side door window shattered. Left rear window forced out of frame. All other glass remained retained and unbroken.

Doors: Left side door and "B" pillar severely damaged; door partly open post-test. Right side door operated normally.

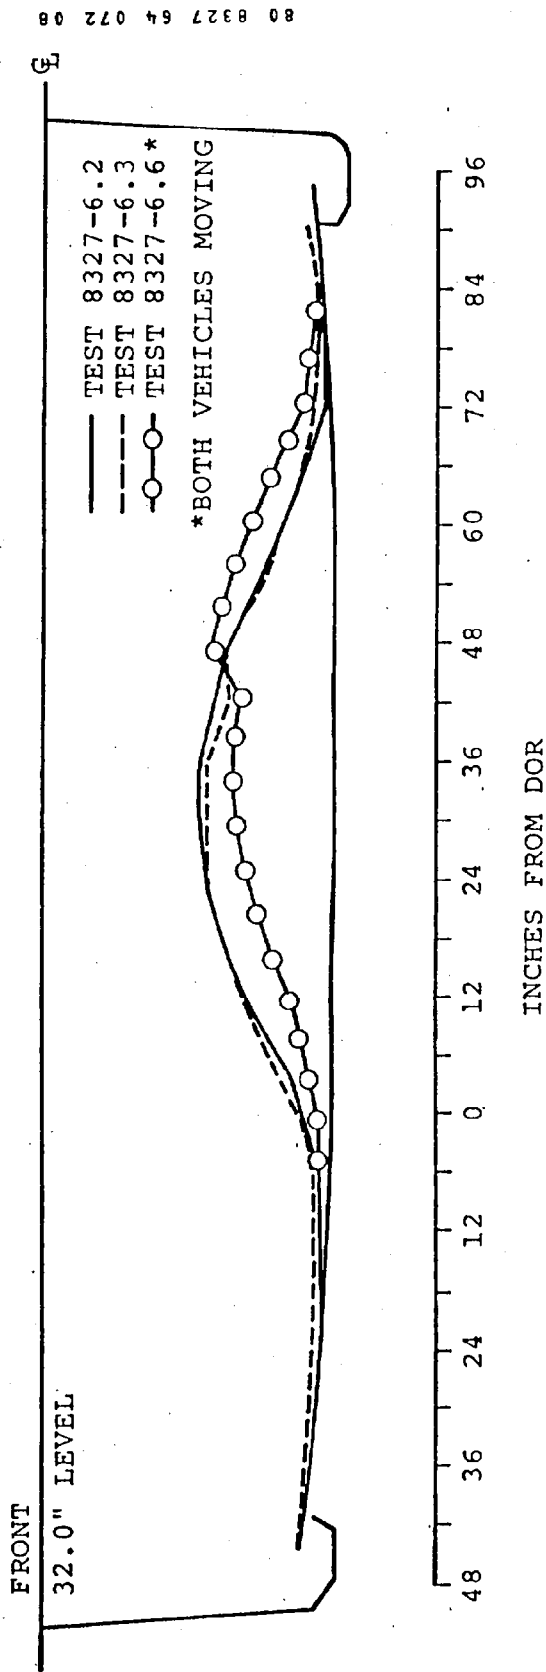
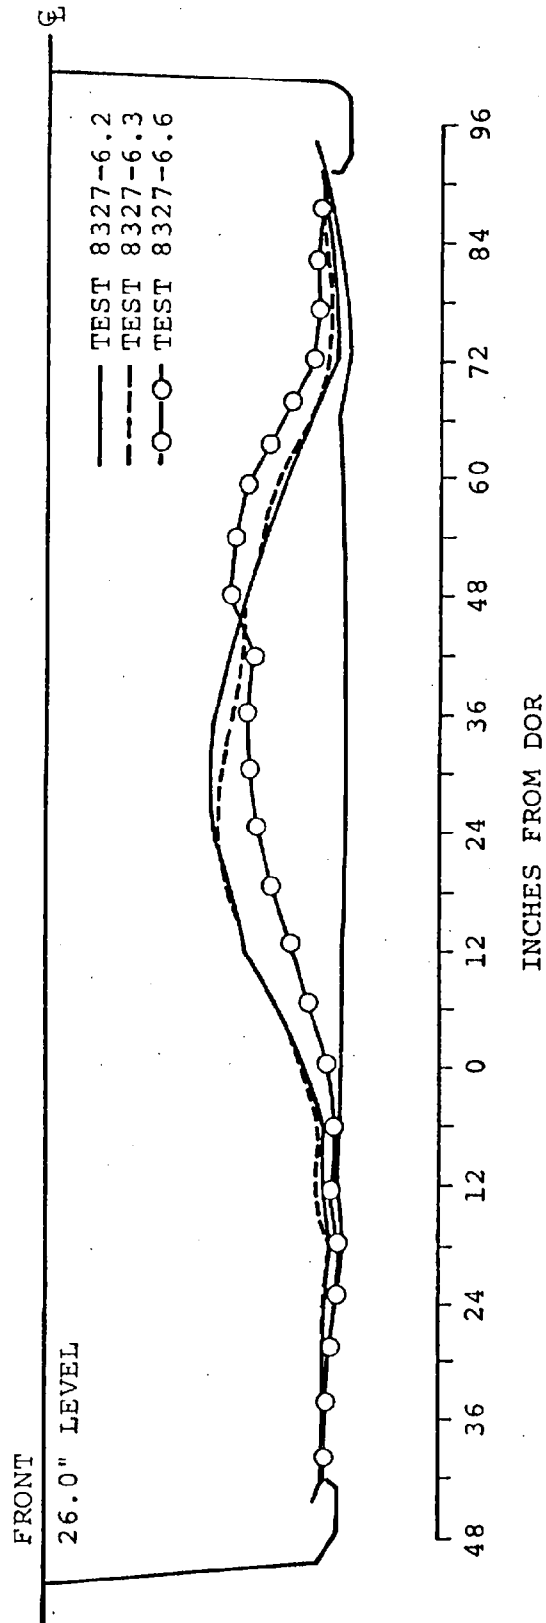
In Figures 5-9 and 5-10 it can be seen that the post-test crush profile in Test 6.6 is indeed more severe further rearward than in Tests 6.2 and 6.3.

FIGURE 5-9. POST-TEST VW CRUSH AT 32" LEVEL (TESTS 6.2, 6.3, AND 6.6).

FIGURE 5-10. POST-TEST VW CRUSH AT 26" LEVEL (TESTS 6.2, 6.3, AND 6.6).

Close examination of Figures 5-9 and 5-10 indicates that even at the B-Pillar (DOR + 48"), the difference in crush is not substantial, and it is only rear of the B-Pillar that the greater deformation in Test 6.6 becomes apparent. If there were any structural accelerometers aft of the B-Pillar, it would be expected that they would also exhibit a greater response.

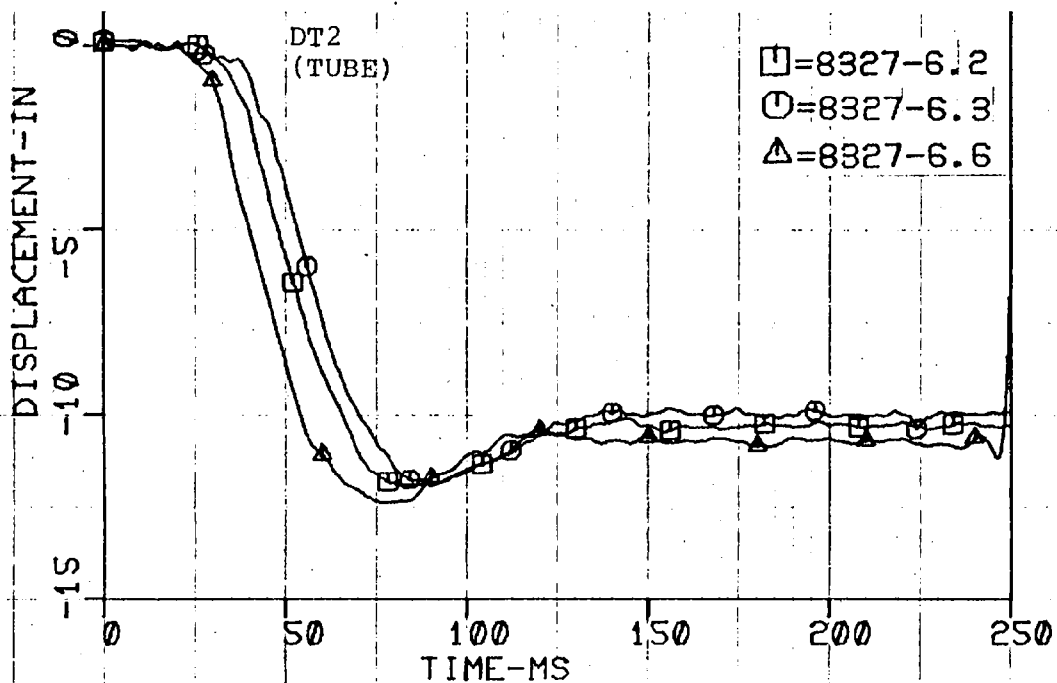
FIGURE 5-18. INTRUSION AT VW B-PILLAR  
(TESTS 6.2, 6.3, AND 6.6).

Due to the greater rear area post-test crush for Test 6.6, exhibited in Figures 5-9 and 5-10, it was expected that vehicle dynamic response and rear seat dummy response in this area would be greater in Test 6.6. In Figure 5-17, velocities at the B-Pillar are compared. The Test 6.6 velocity does not appear to be of greater magnitude or duration than in Tests 6.2 and 6.3. However, Figure 5-18 compares intrusion at the B-pillar, (same as Location 12) as measured by the scratch tube, and these curves do indicate that Test 6.6 produced somewhat more intrusion further rearward.

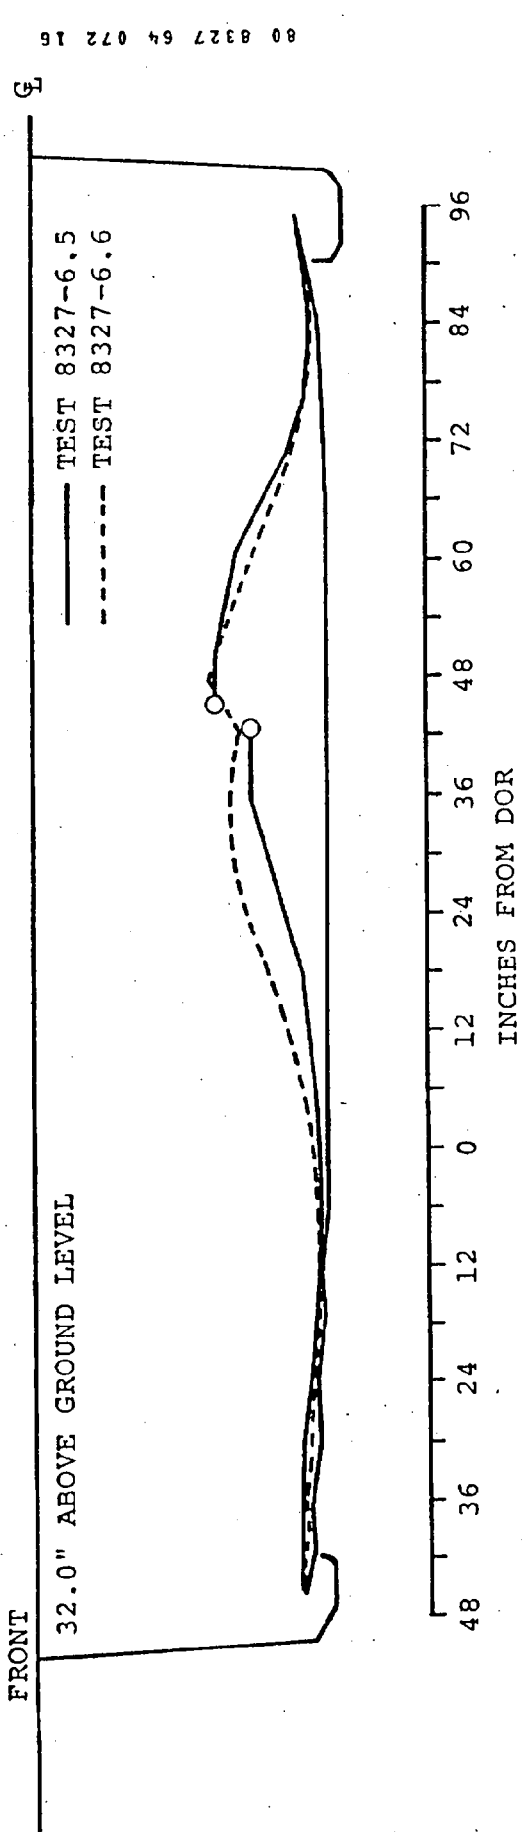
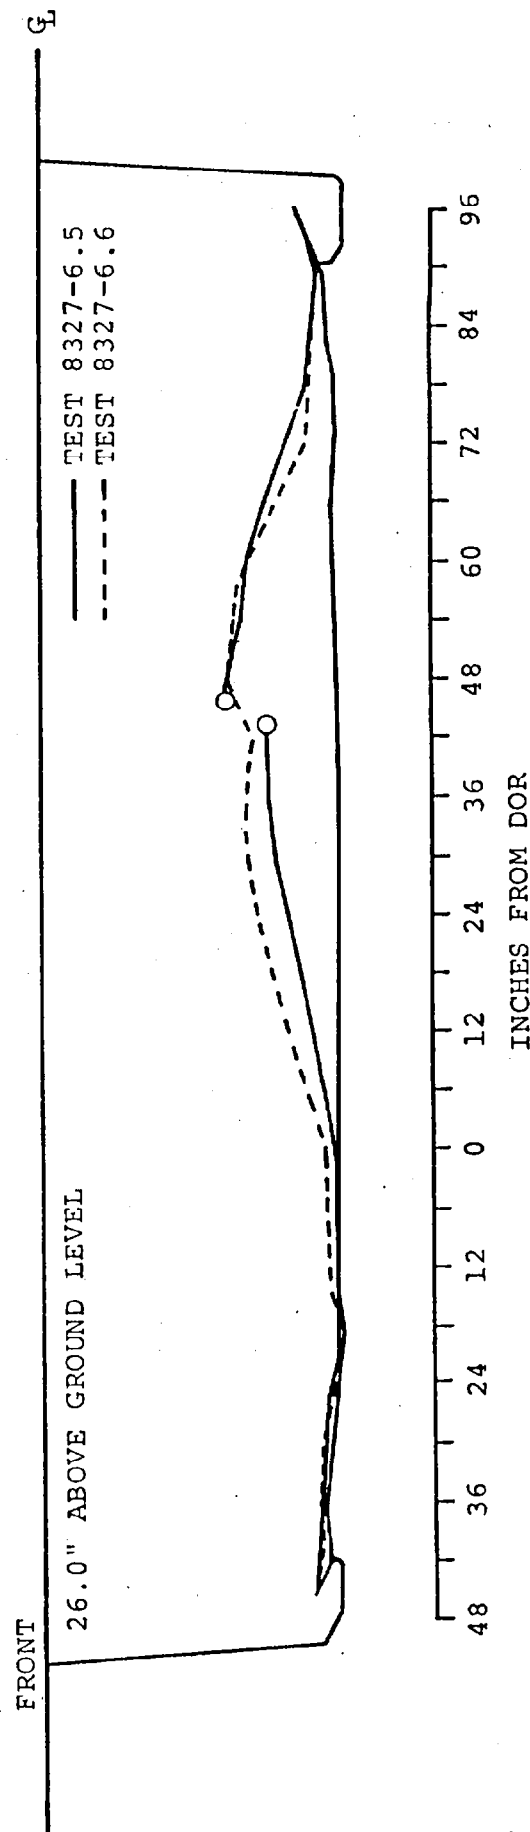
It was expected that, in Test 6.5, in which the impact point was even further rearward, the same pattern would be repeated, namely less severe response toward the front of the target vehicle and more toward the rear. Figures 5-22 and 5-23 compare post-test crush in Tests 6.5 and 6.6. In Test 6.5, as in Test 6.6, the door ended up partly open, distorting the crush profiles, but there is enough difference from DOR to DOR + 48" to justify the conclusion.

FIGURE 5-22. POST-TEST VW SIDE CRUSH AT 32" LEVEL (TESTS 6.5 AND 6.6).

FIGURE 5-23. POST-TEST VW SIDE CRUSH AT 26" LEVEL (TESTS 6.5 AND 6.6).

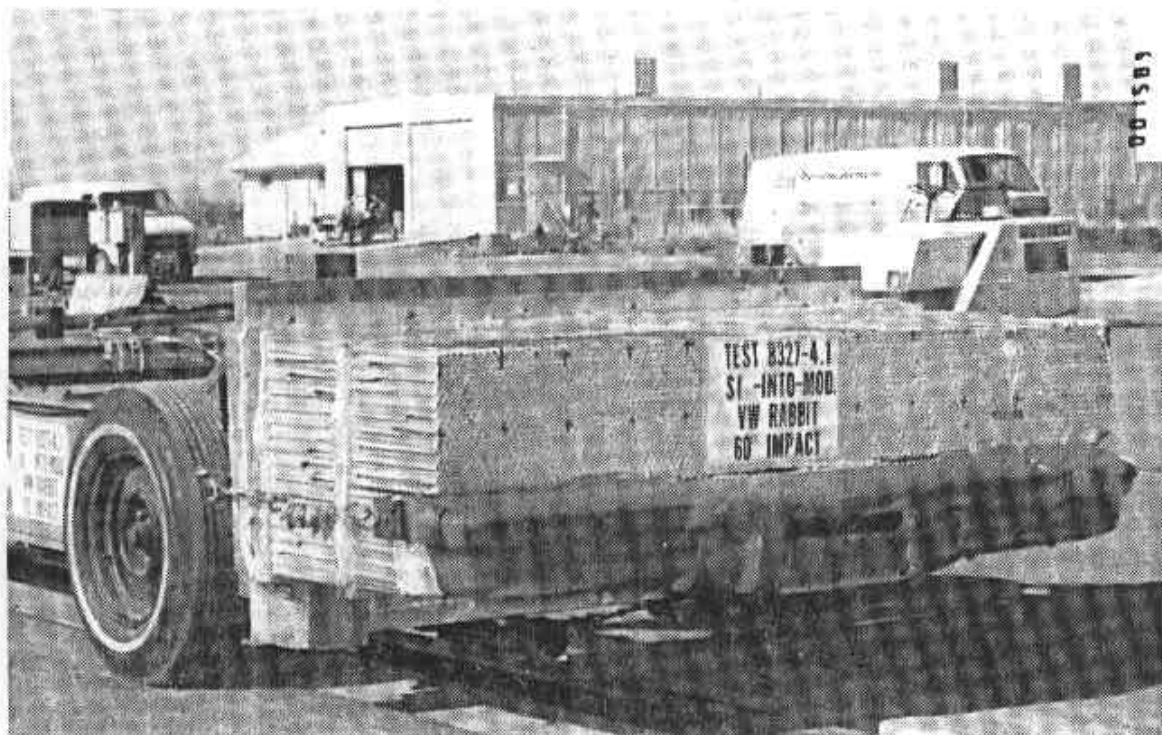
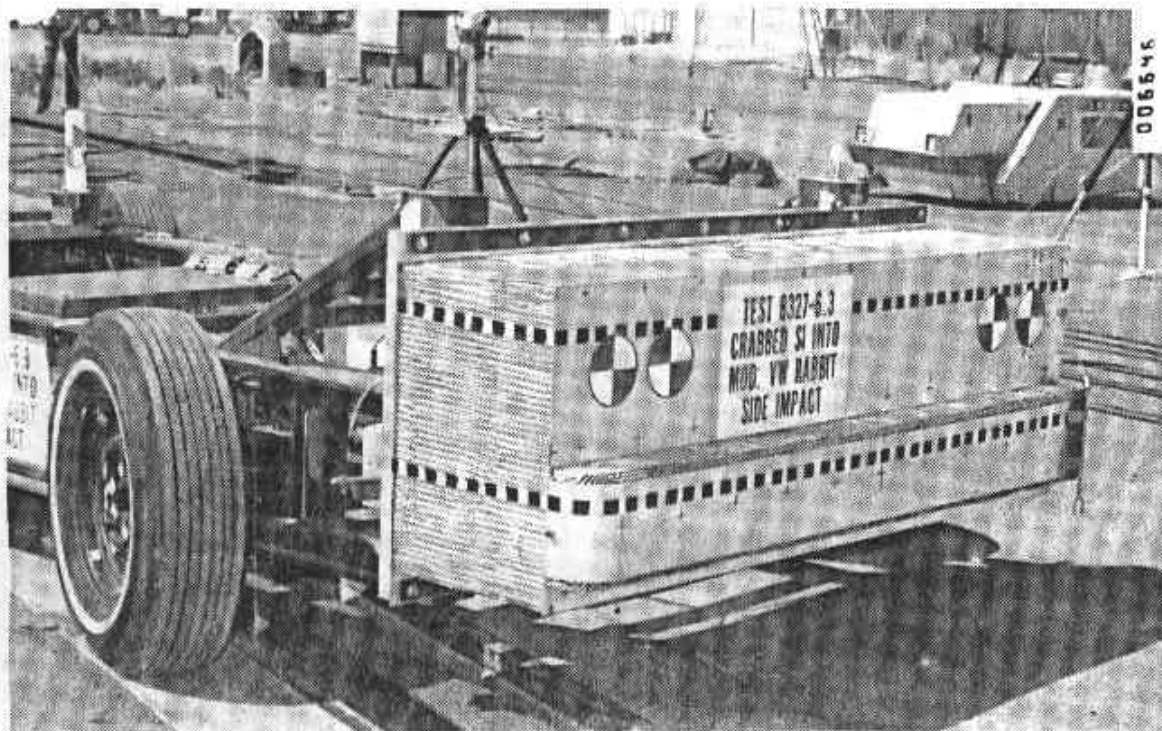
FIGURE 5-29. SIDE IMPACTOR FACE.

First, the Phase I face was rather weak in the 30 degree crush direction. Second, the presence of a hood on automobiles proved to be a major factor in side impacts, and the Side Impactor had no such structure. Therefore, in Task 5 of Phase II, the Energy Absorbing Face underwent design changes to correct these deficiencies. First, an aluminum sheet was bonded over the entire Energy Absorbing Face to spread the loading, both longitudinal and lateral, over more of the honeycomb structure, thereby stiffening the face. Second, the height of the face was increased and a simulated "hood surface" was incorporated, theoretically presenting a surface for the target vehicle dummy to strike its head on, as was observed in some tests involving two actual cars. Figure 5-29 shows the Phase I face and the Task 5 face.

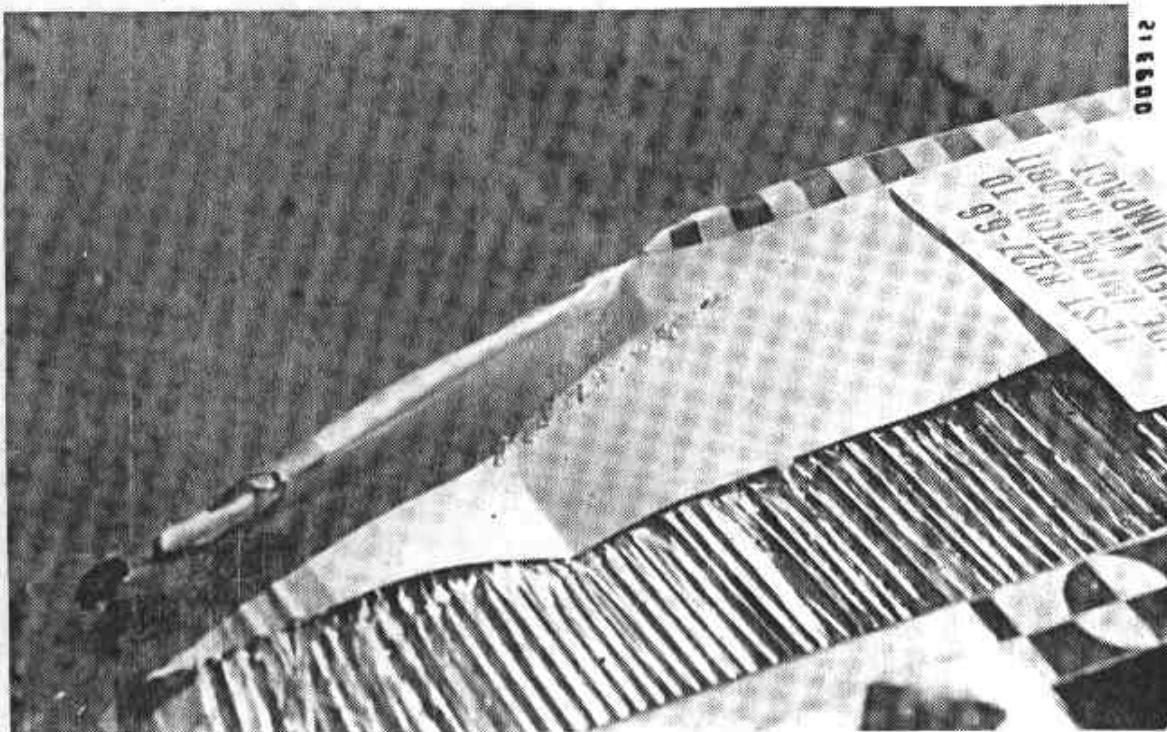
B) TEST 8327-6.6.

Side Impactor Face because, in all six tests, the "hood" surface buckled and bent instead of bowing up, as was noted in the Task 5 component testing (Reference 3). This has resulted in the surface becoming a series of very stiff ridges of sheet aluminum, as shown in Figure 5-31, by the time a head strike occurs, and could result in a somewhat stiffer surface than was originally designed for when the aluminum was intended to bow up.

FIGURE 5-31. SIDE IMPACTOR "HOOD" SURFACE DEFORMATION (TESTS 6.1 AND 6.6).

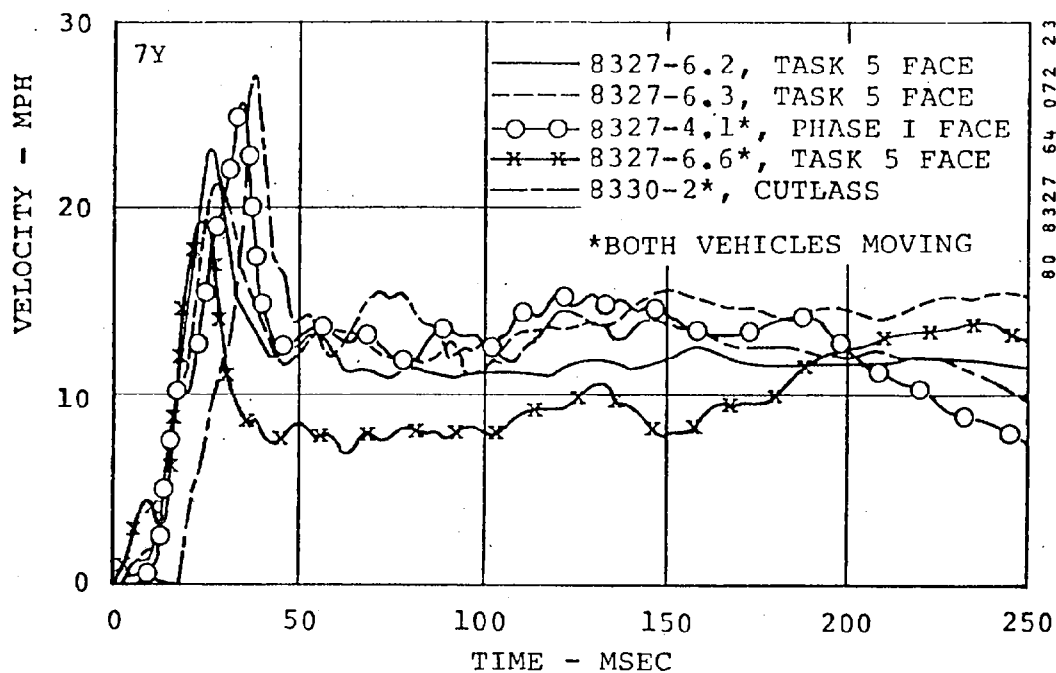
Figures 5-35 and 5-36 compare door velocities at the mid-door locations (7Y and 10Y). Figure 5-35 shows that the Task 5 face produces the same velocity profile as did the Phase I face and the Oldsmobile Cutlass. The peak velocities for Tests 8327-4.1 and 8330-2 are somewhat higher than in the Task 6 tests and occur somewhat later. However, following the discussion in Section 5.1, this result would be expected because the impact point in Test 8327-4.1 and 8330-2 was farther forward than in Tests 6.2 and 6.3. In Figure 5-36 the same pattern is apparent, except that the Oldsmobile Cutlass trace has a noticeably different profile, which was a result of the rather unique crushing pattern of the Oldsmobile Cutlass (Reference 2).

FIGURE 5-35. COMPARISON OF LATERAL VELOCITY AT MODIFIED VW RABBIT DOOR CENTER.
