TEST REPORT NO. 2  
STRAIGHT SIDE IMPACTOR-TO  
MODIFIED VW RABBIT  
FRONT-TO-SIDE TESTS @ 60°

TESTS 8327-6.5 AND 8327-6.6  
APPENDICES A, B, C, D, E, F

CONTRACT NO. DOT-HS-8-01933 (II)

U.S. DEPARTMENT OF TRANSPORTATION  
NATIONAL HIGHWAY TRAFFIC SAFETY ADMINISTRATION  
WASHINGTON, D.C. 20590

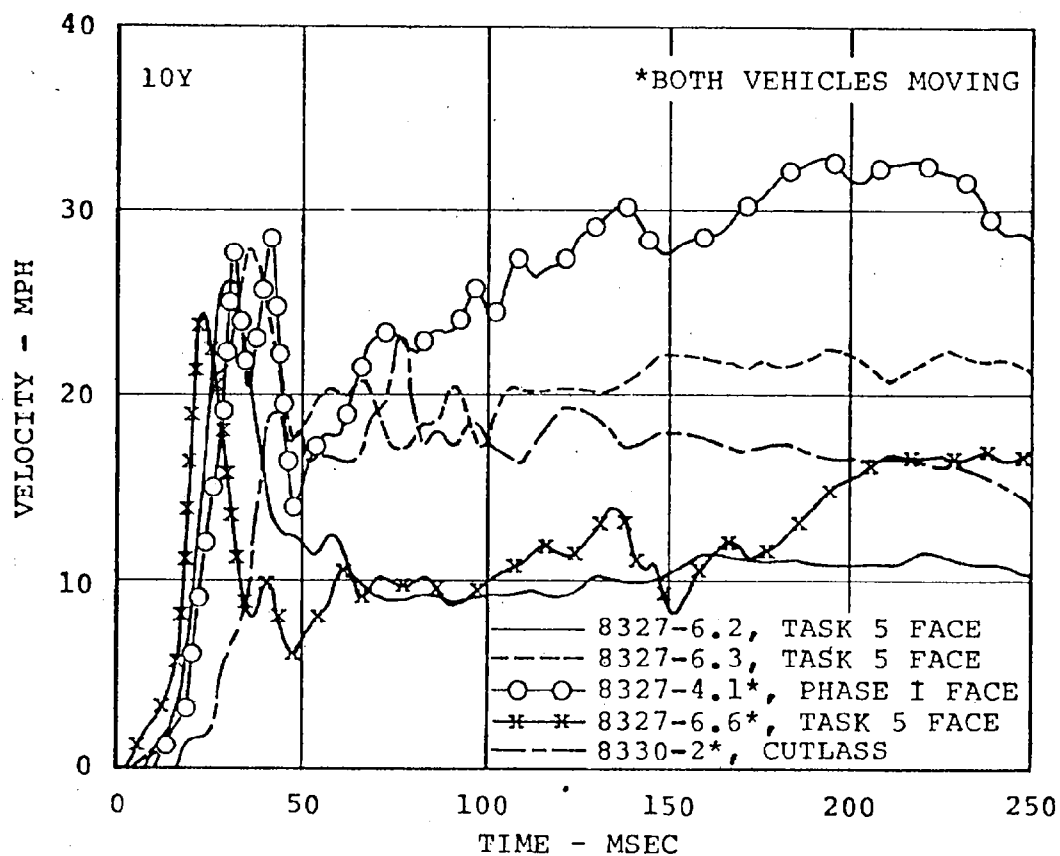
Figures 5-35 and 5-36 compare door velocities at the mid-door locations (7Y and 10Y). Figure 5-35 shows that the Task 5 face produces the same velocity profile as did the Phase I face and the Oldsmobile Cutlass. The peak velocities for Tests 8327-4.1 and 8330-2 are somewhat higher than in the Task 6 tests and occur somewhat later. However, following the discussion in Section 5.1, this result would be expected because the impact point in Test 8327-4.1 and 8330-2 was farther forward than in Tests 6.2 and 6.3. In Figure 5-36 the same pattern is apparent, except that the Oldsmobile Cutlass trace has a noticeably different profile, which was a result of the rather unique crushing pattern of the Oldsmobile Cutlass (Reference 2).

FIGURE 5-36. COMPARISON OF LATERAL VELOCITY AT MID-DOOR, WINDOWSILL LEVEL OF MODIFIED VW RABBIT.

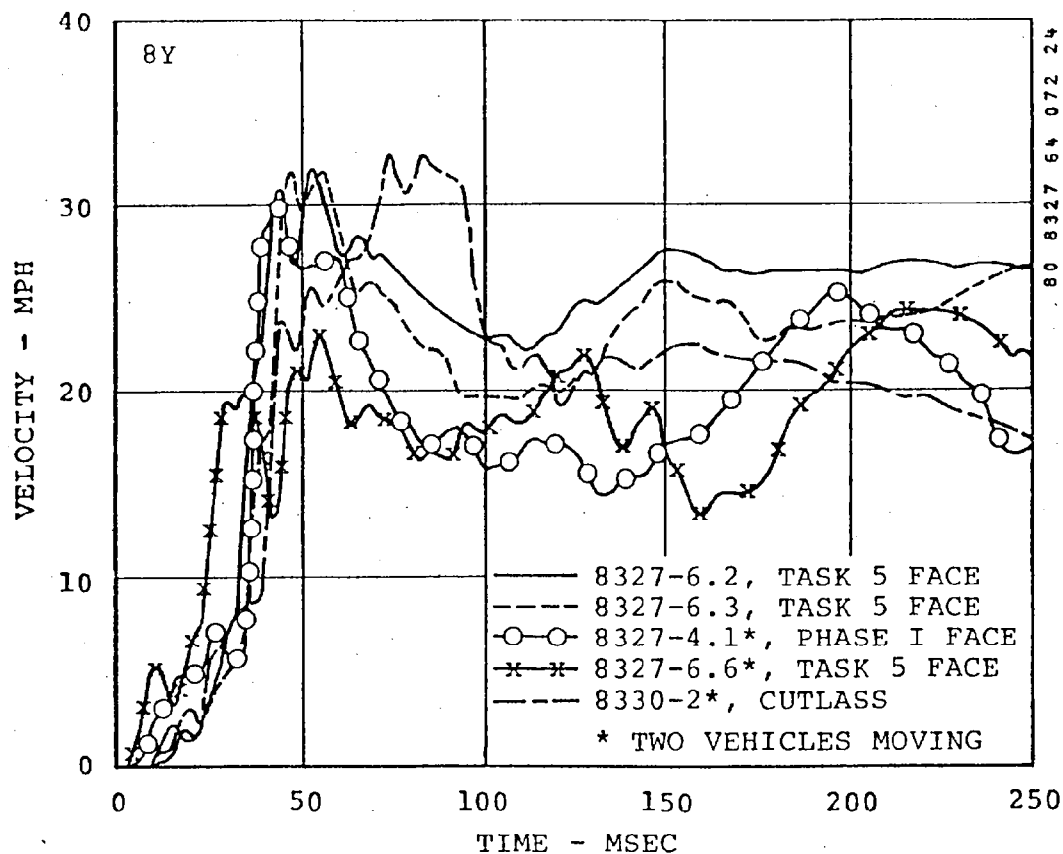
Figures 5-37 and 5-38 continue the comparison of velocities at struck side accelerometer locations, with the same results as just discussed. In these figures, the peak velocities are very comparable except for Test 6.6, location 8Y. The duration of high velocity in the Tests utilizing the Task 5 face is greater than in Test 4.1, which indicates greater intrusion as expected. These figures also more clearly point out the unique crushing pattern caused by the Cutlass.

FIGURE 5-37. COMPARISON OF LATERAL VELOCITY AT UPPER REAR CORNER OF MODIFIED VW RABBIT DOOR.

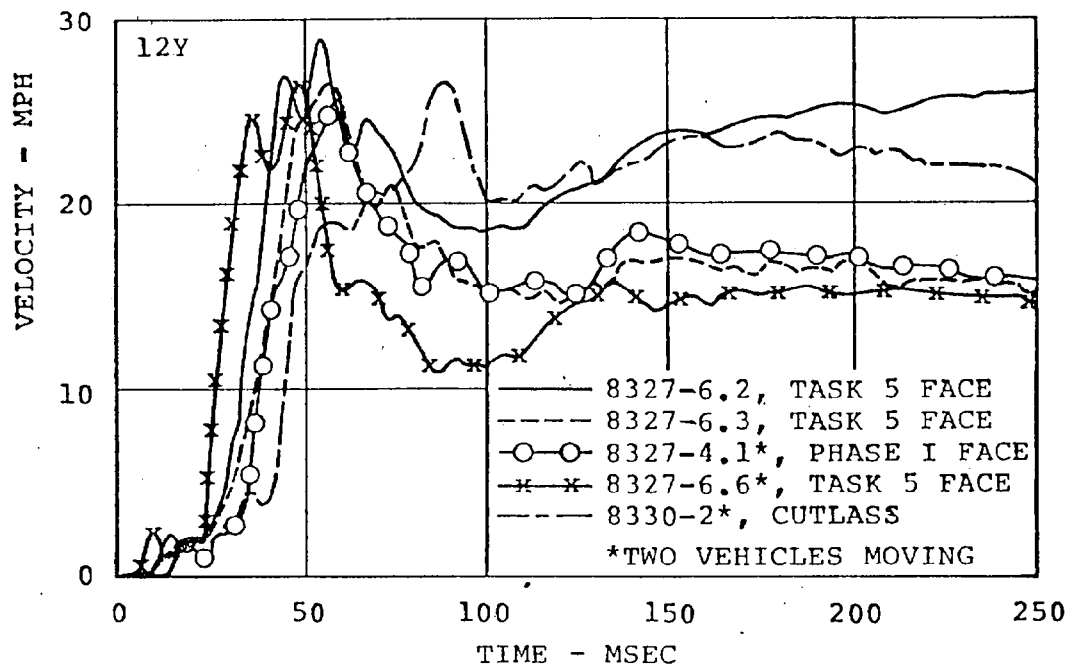
FIGURE 5-38. COMPARISON OF LATERAL VELOCITY AT B-PILLAR OF MODIFIED VW RABBIT.

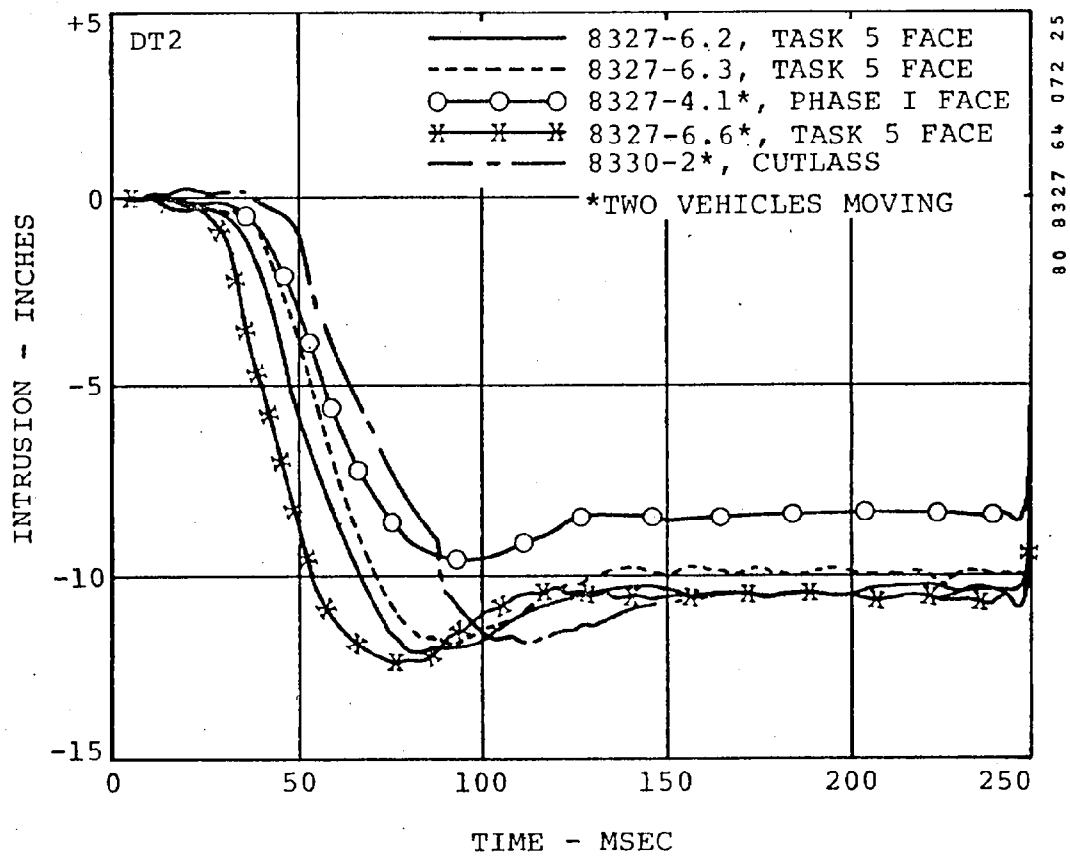
In Figure 5-39, intrusion at the B-Pillar, as measured by the scratch tube, is compared. It is obvious that the Task 5 face created a greater intrusion at the B-Pillar location than did the Phase I face.

FIGURE 5-39. COMPARISON OF INTRUSION AT MODIFIED VW RABBIT B-PILLAR.
