NEW VEHICLE ASSESSMENT AND STANDARDS
ENFORCEMENT INDICANT TESTING
FMVSS NOS. 212, 219, AND 301-75

Ford-Werke AG
1979 Ford Fiesta
NHTSA - 790547

FINAL REPORT

1. REPORT NO. 212-MSE-79-004-TR-04 219-MSE-79-004-TR-04 301-MSE-79-004-TR-04		2. GOVERNMENT ACCESSION NO.	
		3. RECIPIENT'S CATALOG NO.	
4. TITLE AND SUBTITLE Safety Compliance Test Program FMVSS 212, 219, 301-75 1979 Ford Fiesta		5. REPORT DATE October, 1979

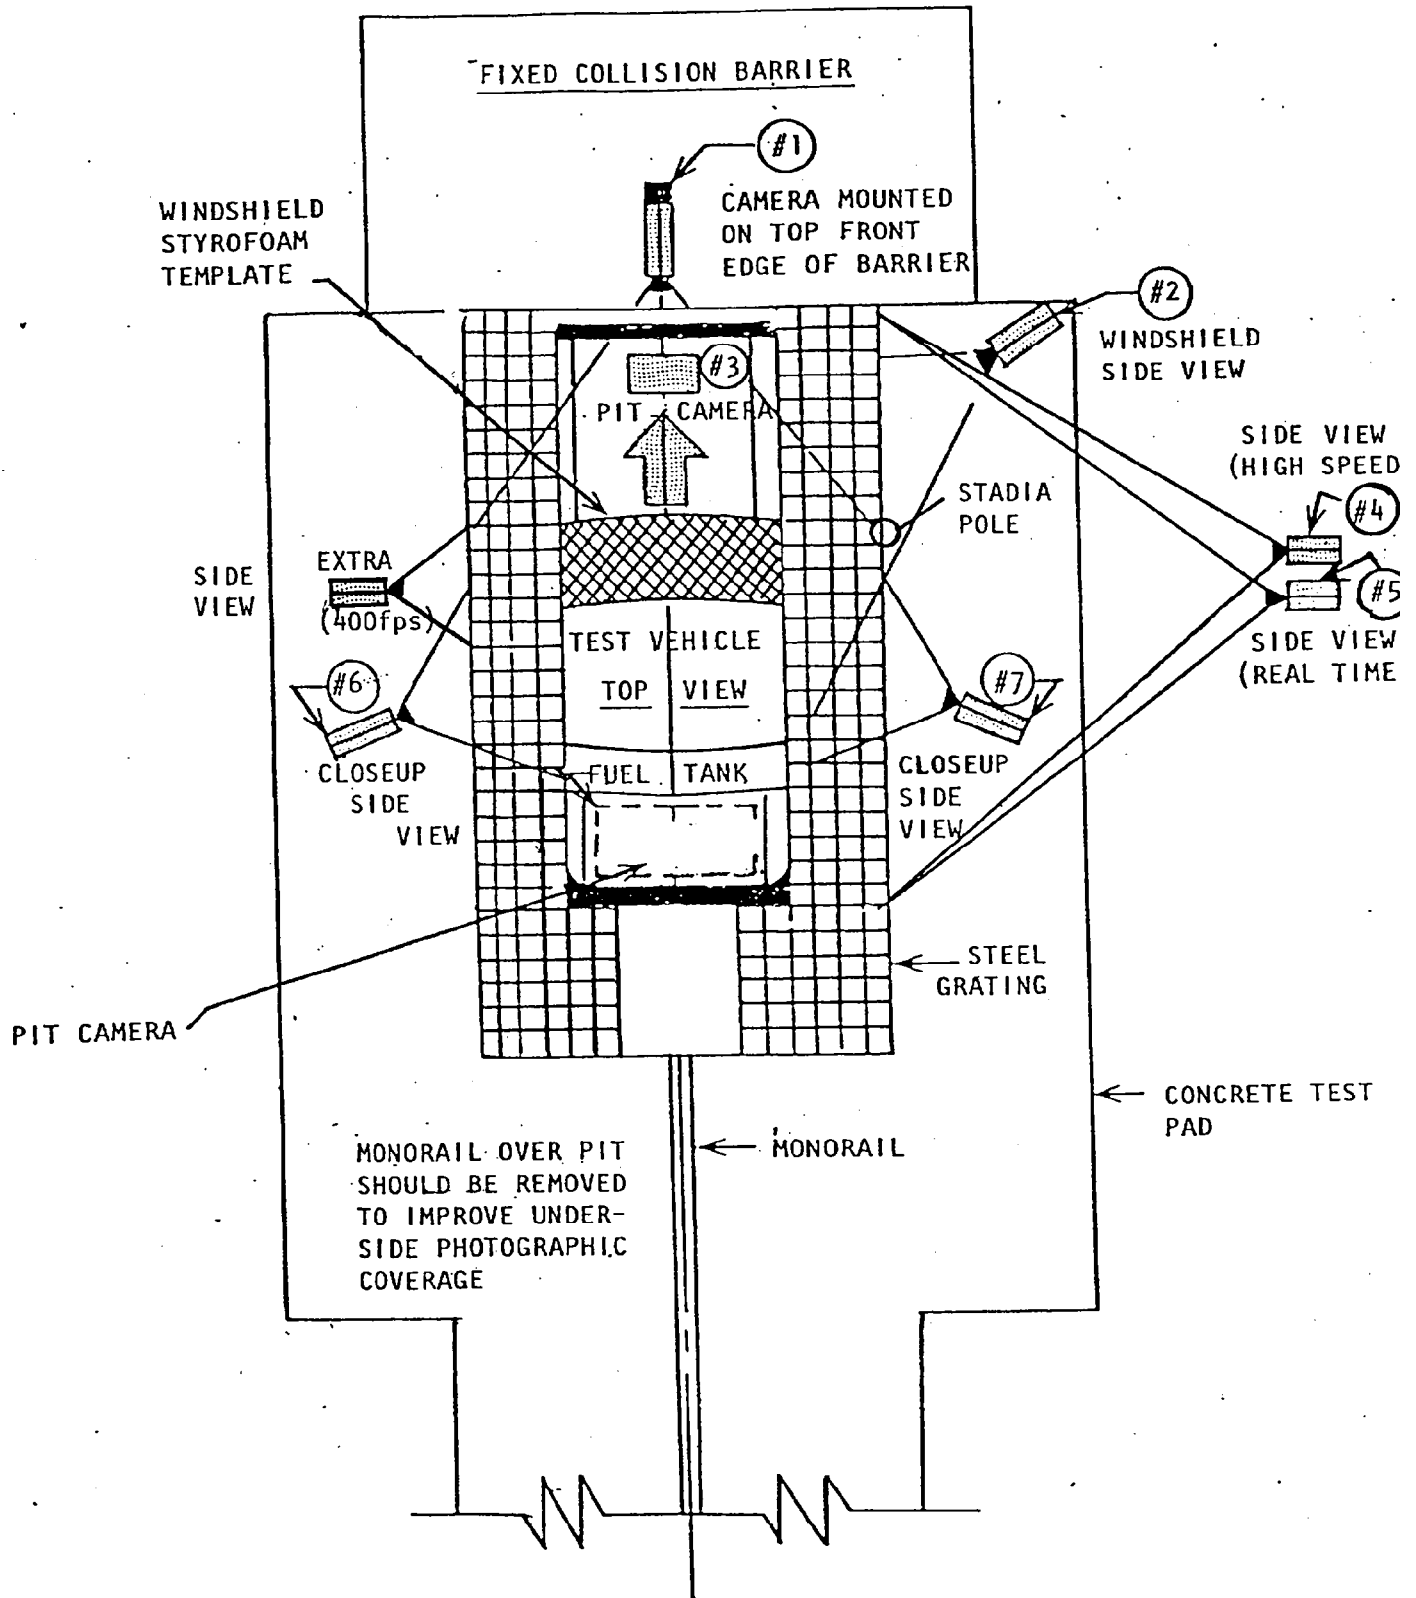
FIGURE 8 CAMERA POSITIONS

High speed film data was required from camera locations as shown in Figure 8. Data were not acquired from the camera located overhead (No 1). This camera failed because of loss of power to it during the test event.

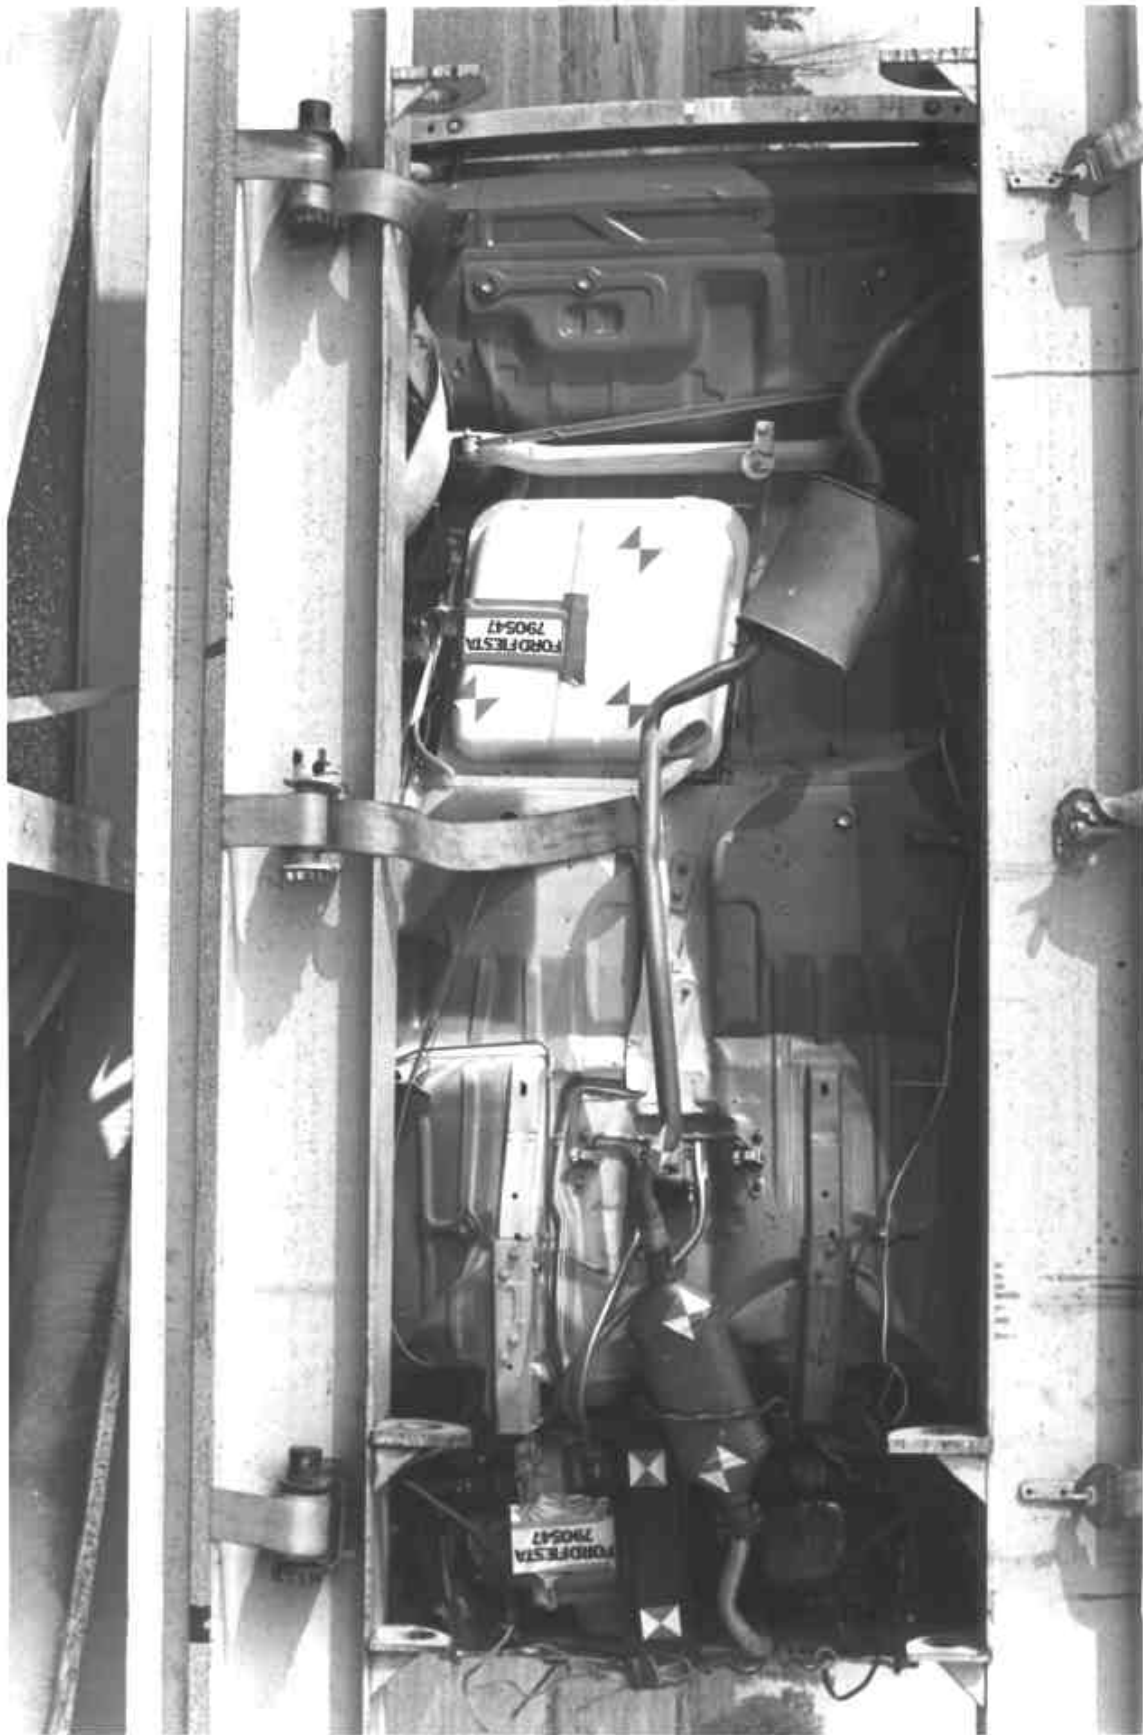
FIGURE 20 FULL UNDERBODY VIEW - POSTTEST

The vehicle data and test data are presented in Tables 4 through 9. General posttest views of the vehicle are shown in Figures 19 and 20. The time interval measured for traverse through the 4.007 ft. time trap was 78.186 ms and through the 4.006 ft. trap was 78.217 ms. These data were used to calculate the impact speeds of 34.94 mph and 34.92 mph respectively. The average of the two, 34.93 mph, is the reported impact velocity. Based on past data the velocity at the point of impact could have varied from this measured velocity by ± 0.06 mph.

As the data sheets show, there was no fuel loss of any measureable amount as a result of the test event. No fuel leakage was observed at any location during the rollover testing.

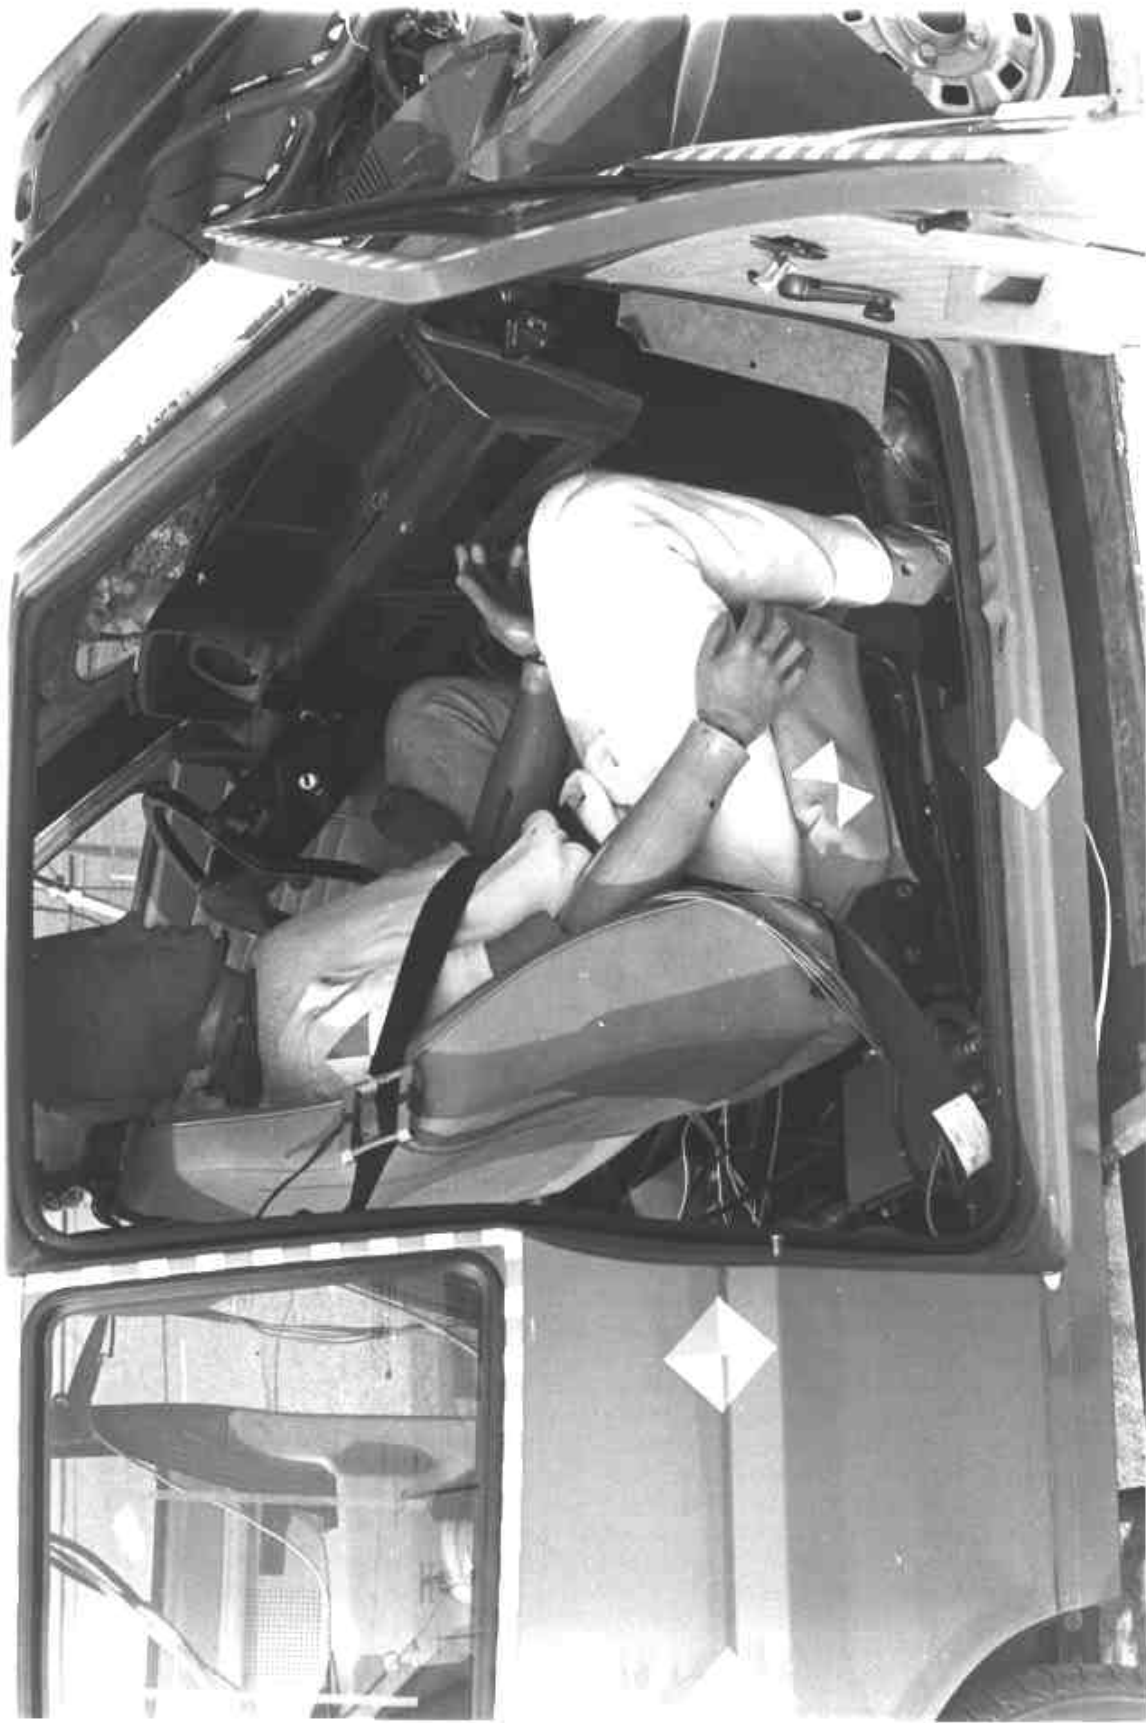
FIGURE 25: PASSENGER DUMMY POSITION AND INTERIOR VIEW - POSTTEST

Posttest examination of the vehicle interior showed that the driver dummy's head struck the steering wheel at the top of the rim and the chest struck the hub and bent the lower half of the rim forward. The primary impact point for the passenger dummy's head was the top edge of the dash board. Contact was also made with the front (vertical) surface of the dash board. Posttest photographs of the dummies are shown in Figure 24. The damage to the instrument panel and dash board are also shown in Figure 24. As is shown the steering column remained attached to the instrument panel. The steering column shows very little collapse if any and the end of the column, where the steering wheel is attached, was bent downward significantly by the impact.
