# **CALSPAN ADVANCED TECHNOLOGY CENTER**

## **IMPROVED LIGHTWEIGHT SUBCOMPACT SIDE STRUCTURE CRASH TEST REPORT**

Calspan Report No. 6225-V-22

TEST: TEST NO. 19  
TYPE OF TEST: CAR-TO-CAR FRONT-TO-SIDE OBLIQUE  
TEST DATE: 15 JANUARY 1981

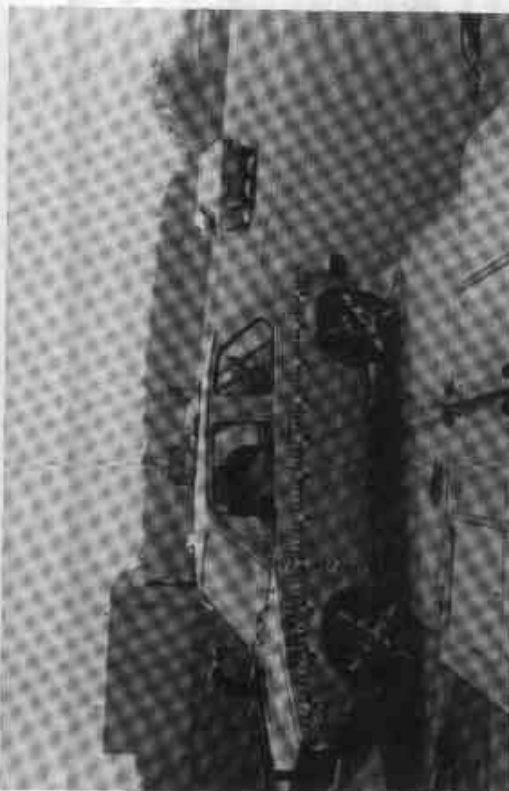
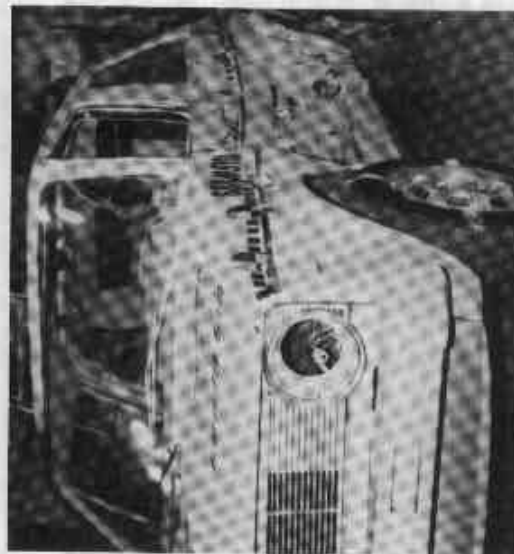
Figure 3 VEHICLE 2 (1975 VW RABBIT) - PRE- AND POST-TEST FRONT THREE-QUARTER VIEW

**GLAZING** Windshield is cracked; Driver side front window is broken out; Driver side rear window (plastic) is intact.

**GENERAL COMMENTS** VW Structure - A-pillar is buckled approximately 9" above the sill and the connection between A-pillar and sill is damaged. The A-pillar window post and the roof line are undamaged. The sill is rolled upward between the A and B-pillars due to the action of the door interlocks. The B-pillar external surface looks quite good with maximum deformation approximately 15" above the sill. Left side damage extends from the A-pillar to the rear wheel well. The left front fender is damaged due to a secondary collision with the Impala. Maximum exterior deformation is approximately 8" rearward of the A-pillar at window sill height. Generally the maximum deformation extends in a vertical line from the sill to the window sill approximately 8" rearward of the A-pillar and in a horizontal line at Impala bumper height.

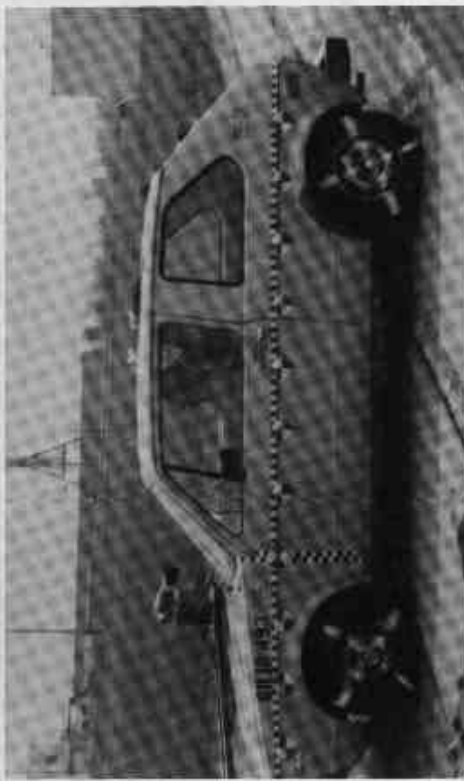
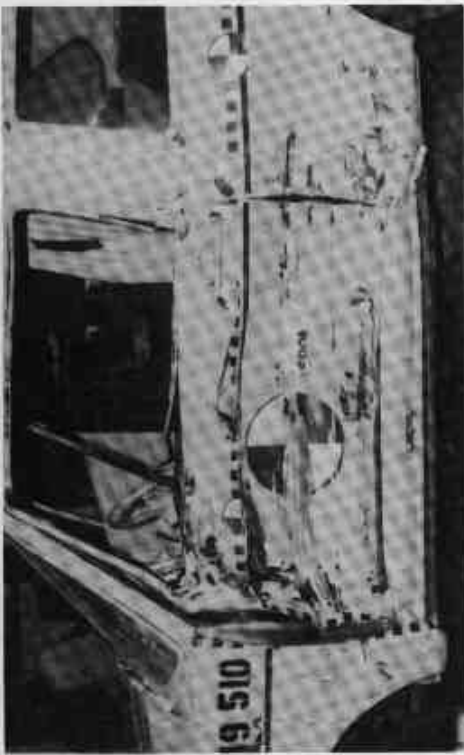
Figure 4 VEHICLE 2 (1976 VW RABBIT) - PRE- AND POST-TEST SIDE VIEW

**DOORS** Driver side door is jammed closed; Passenger side door is undamaged.

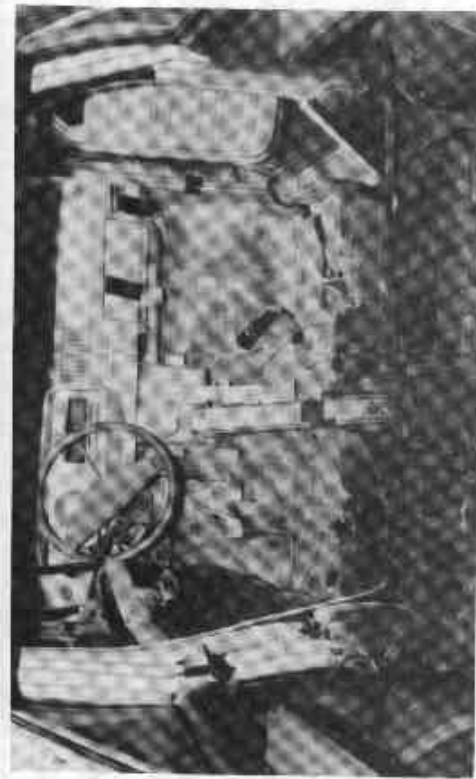
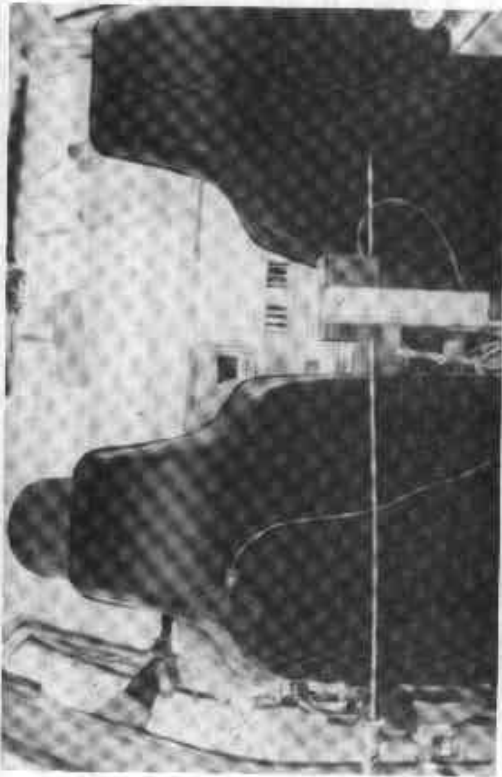
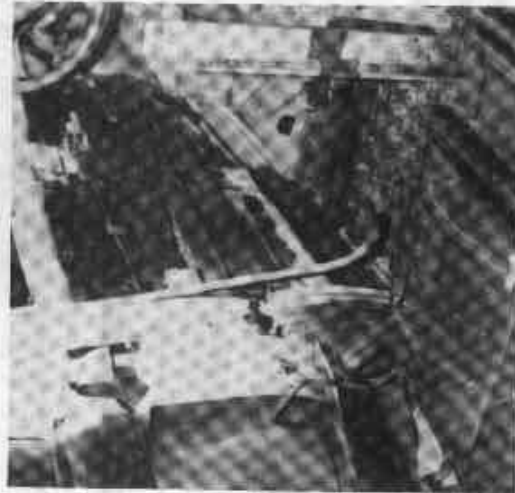
Figure 6 VEHICLE 2 (1976 VW RABBIT) - PRE- AND POST-TEST INTERIOR VIEWS

The B-pillar is buckled, on the interior, at the top of the gusset between the floor and the B-pillar. The maximum B-pillar intrusion is also located at that point. The rear floor pan and the seat riser are badly deformed. The steering wheel and column are bent inboard due to intrusion at the window sill level. The roof and roll bar are undamaged.

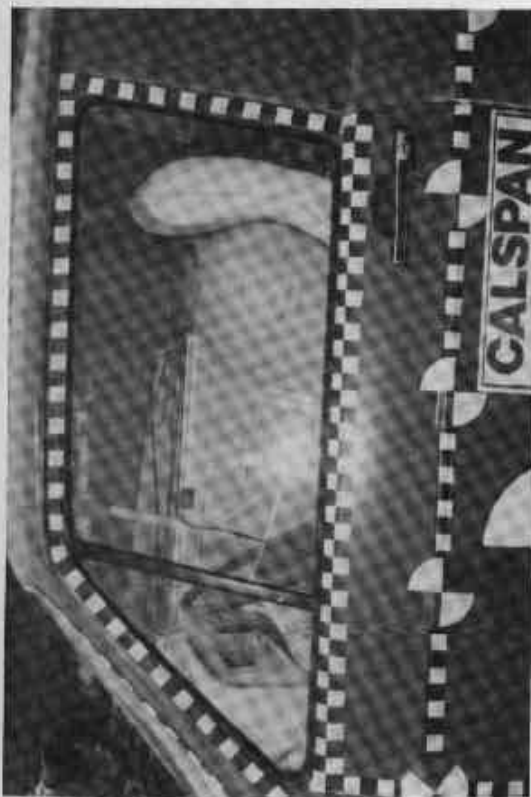
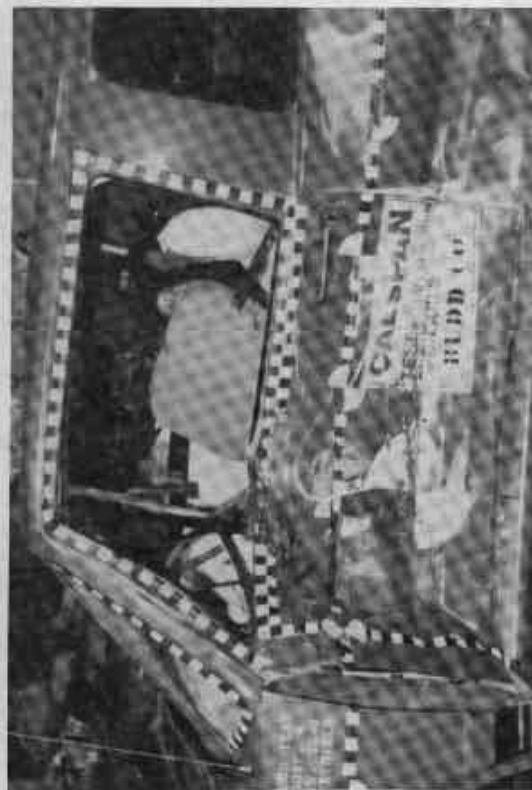
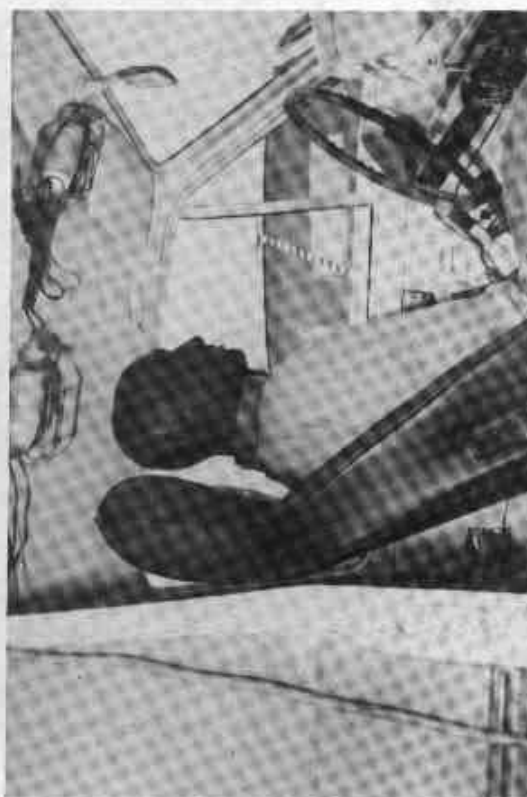
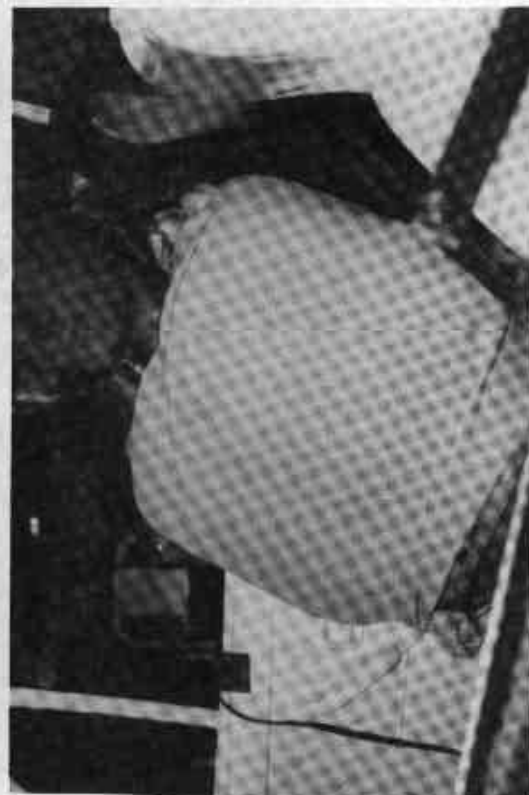
Figure 7 VEHICLE 2 (1976 VW RABBIT) - PRE AND POST-TEST OCCUPANT POSITION

VW Occupant - The SID driver occupant travelled across the vehicle and came to rest in the passenger seat with its feet in front of the driver's seat. The driver's head broke through the side window and struck the hood of the oncoming Impala as shown by chalk marks. A summary of the response is shown in Table 10.

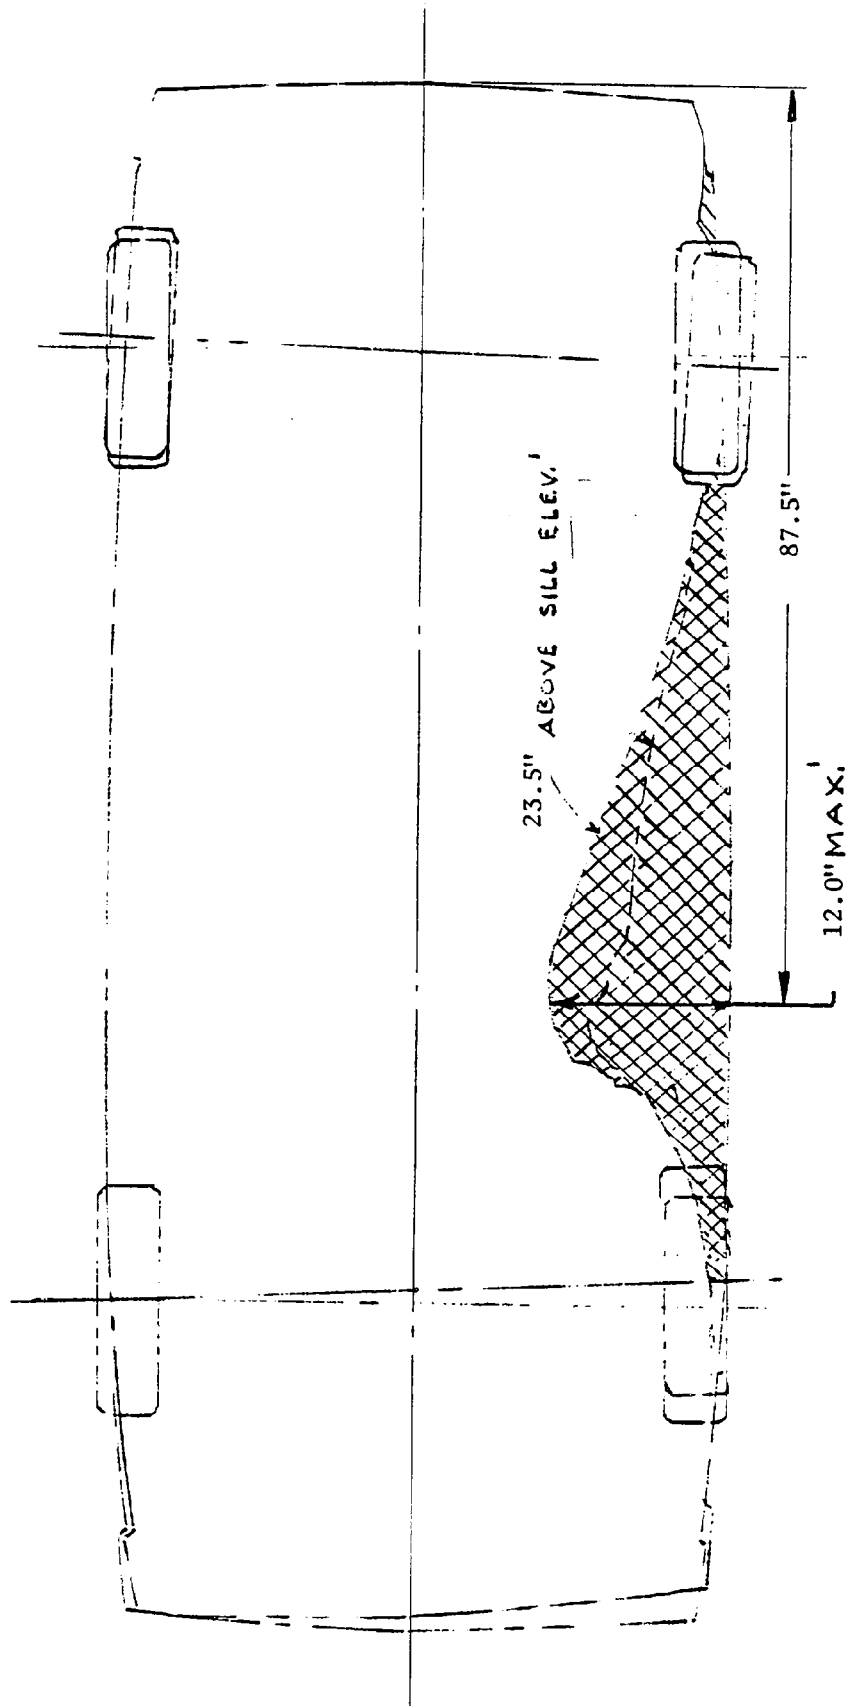
Figure 15 PRE- & POST-TEST MAX. EXTERIOR DEFORMATION

| | VEH. NO. 1 | VEH. NO. 2 |
|---|---|---|
| MAX. CRUSH (in) | <u>7.4"</u> | <u>12.0" at Window Sill Height</u> |
