REPORT NO. 301-AETL-81-040-971-3882-40

NEW VEHICLE ASSESSMENT
AND
STANDARDS ENFORCEMENT INDICANT TESTING

FMVSS 301-75

ISUZU MOTORS LIMITED
1981 ISUZU I-MARK DELUXE - 2 DOOR COUPE
NHTSA 810503

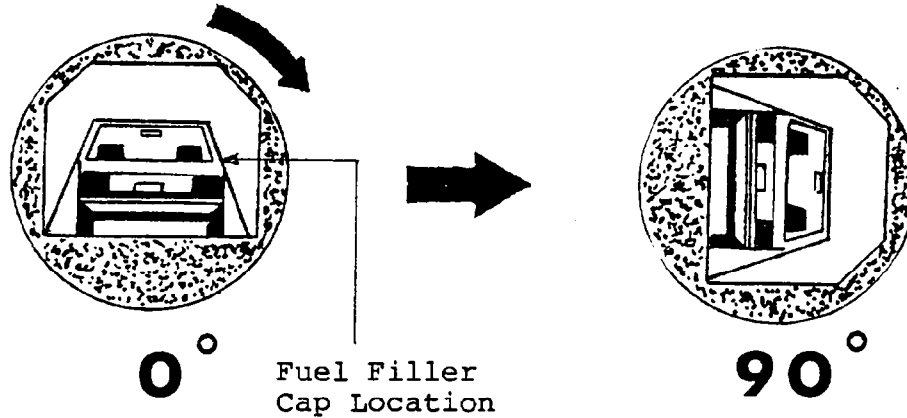
TABLE VII
FUEL SYSTEM INTEGRITY - FMVSS 301-75
STATIC ROLLOVER

Actual	Max. Allowed
Rollover fixture 90° rotation time	2 minutes, 14 seconds	1 to 3 Minutes
Fuel spillage during 5 minute period from onset of rotation	3.34 oz.	5 ounces
Fuel spillage during 6th minute period from onset of rotation	2.86 oz.	1 ounce
Fuel spillage during 7th minute period from onset of rotation	4.91 oz.	1 ounce

Fuel Spillage Location: Emission canister in engine compartment.

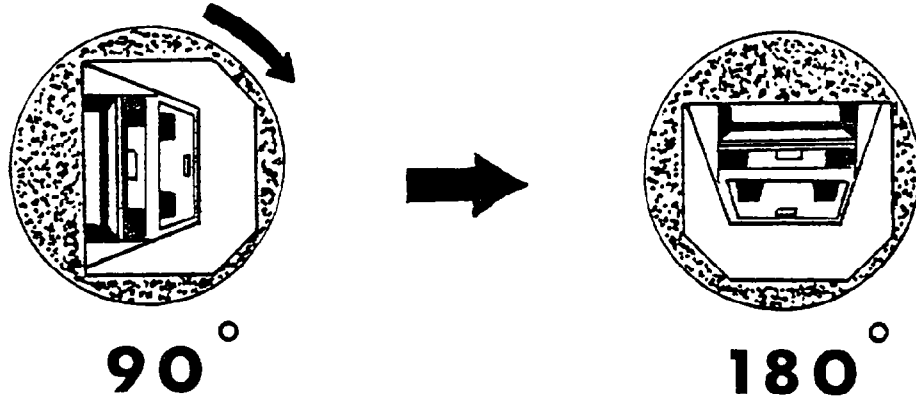
TABLE VIII
FUEL SYSTEM INTEGRITY - FMVSS 301-75
STATIC ROLLOVER

Actual	Max. Allowed
Rollover fixture 90° rotation time	2 minutes, 13 seconds	1 to 3 Minutes
Fuel spillage during 5 minute period from onset of rotation	35.47 oz.	5 ounces
Fuel spillage during 6th minute period from onset of rotation	0.62 oz.	1 ounce
Fuel spillage during 7th minute period from onset of rotation	0.21 oz.	1 ounce

Fuel Spillage Location: Carburetor air cleaner assembly.

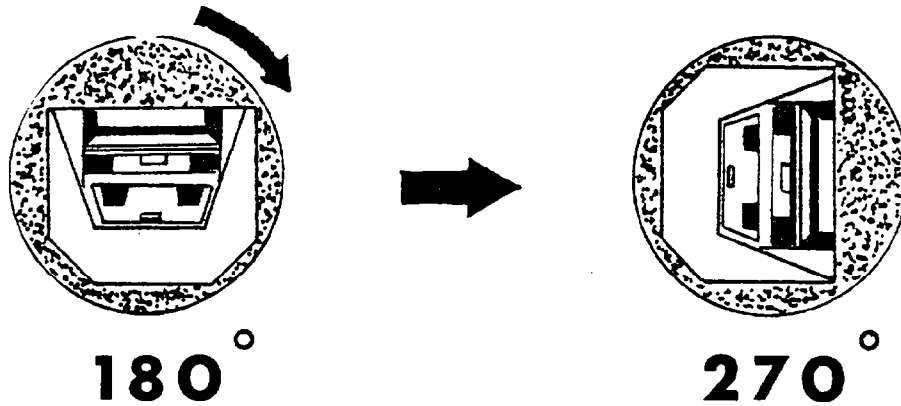
TABLE IX

Actual	Max. Allowed
Rollover fixture 90° rotation time	2 minutes, 18 seconds	1 to 3 Minutes
Fuel spillage during 5 minute period from onset of rotation	1.83 oz.	5 ounces
Fuel spillage during 6th minute period from onset of rotation	0.14 oz.	1 ounce
Fuel spillage during 7th minute period from onset of rotation	0.26 oz.	1 ounce

Fuel Spillage Location: Carburetor air cleaner assembly.

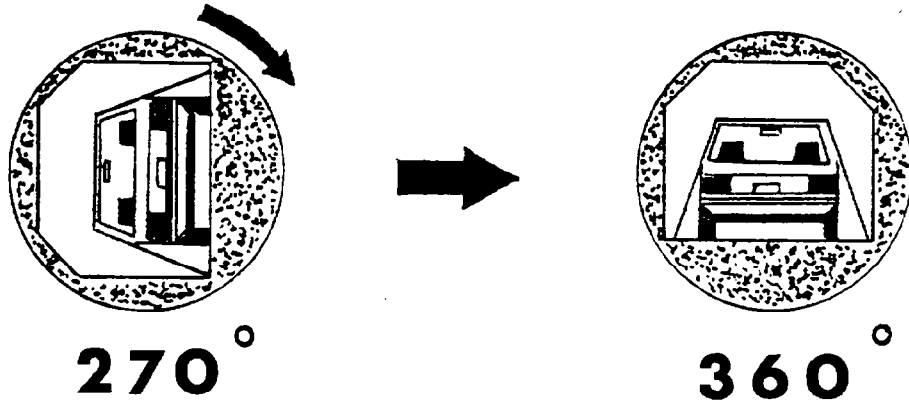
TABLE X

Actual	Max. Allowed
Rollover fixture 90° rotation time	2 minutes, 12 seconds	1 to 3 Minutes
Fuel spillage during 5 minute period from onset of rotation	10.10 oz.	5 ounces
Fuel spillage during 6th minute period from onset of rotation.	immeasurable	1 ounce
Fuel spillage during 7th minute period from onset of rotation	immeasurable	1 ounce

Fuel Spillage Location: Engine compartment area.

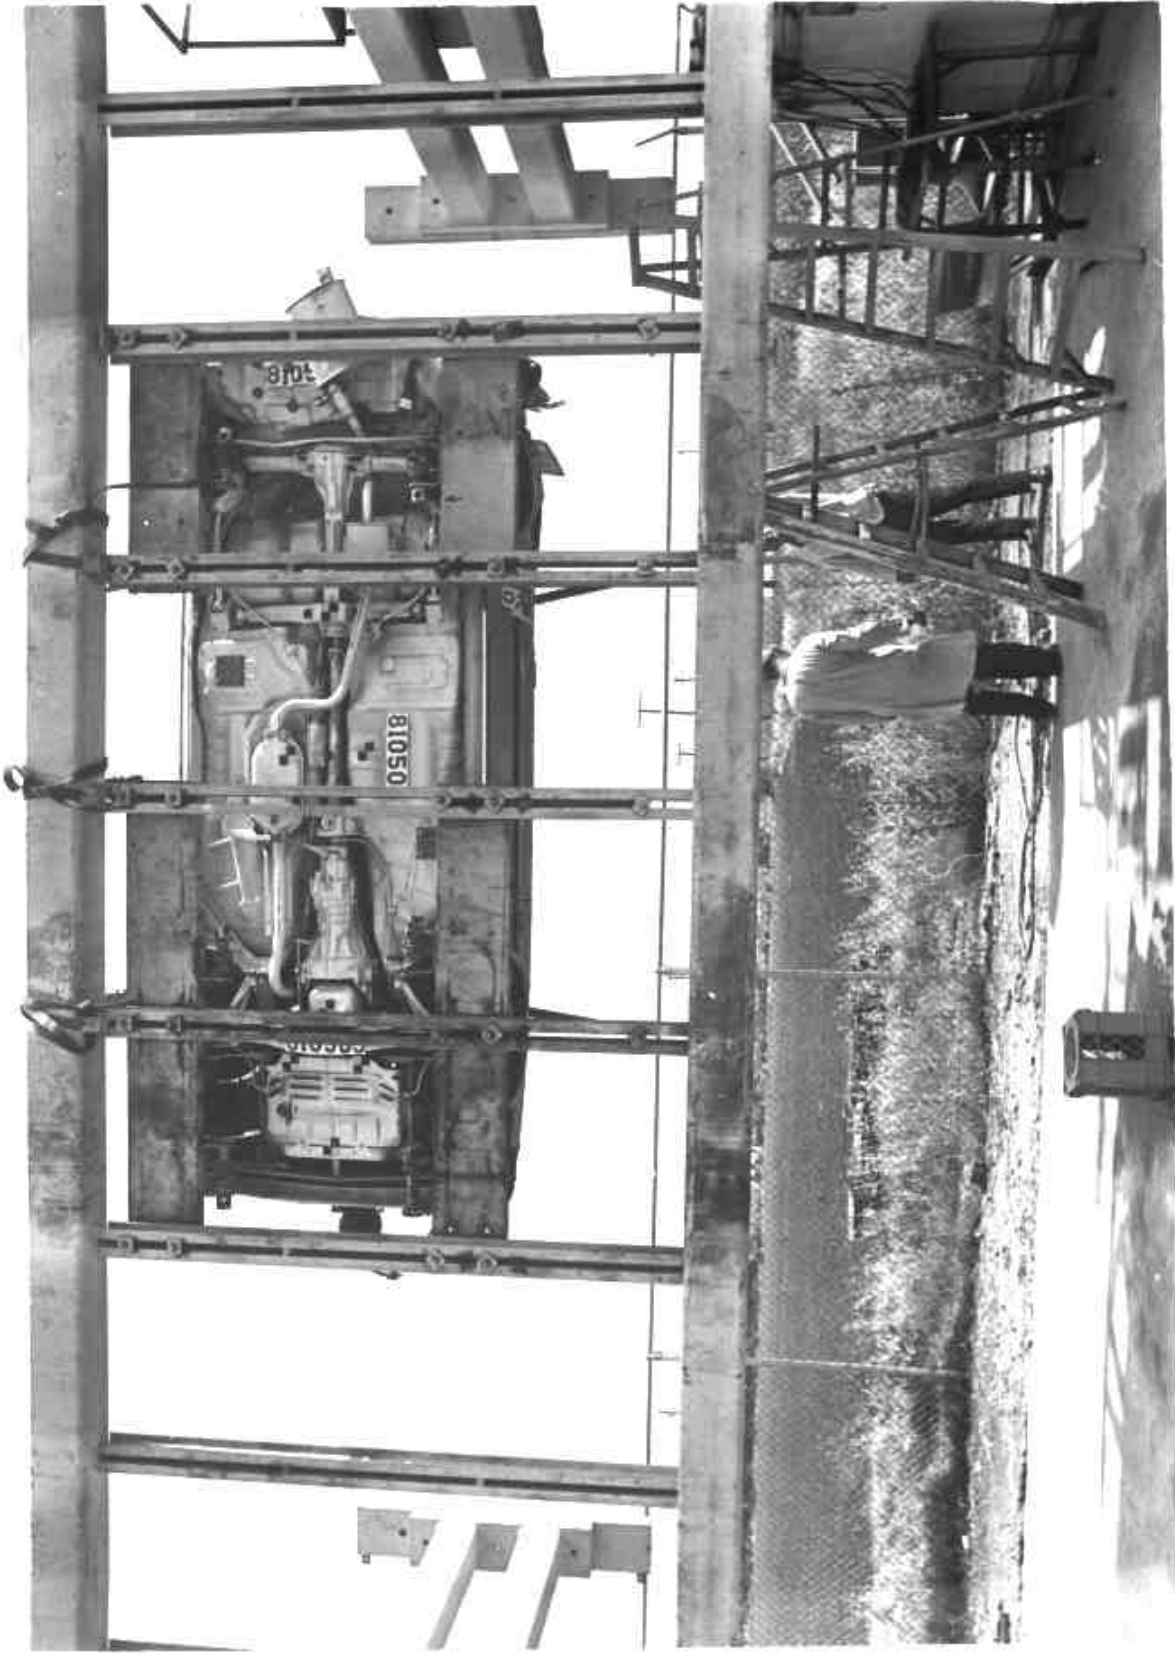
Figure 3-7

No fuel spillage was noted following the moving barrier impact, nor during the time period before the start of the rollover test. However, fuel spillage was noted emitting from the emission canister, located in the engine compartment, after the vehicle had obtained the first 90° test increment (right side down). The fuel spillage continued during the 90° test increment time period, however, the fuel spillage from the emission canister ceased, after the onset of rotation to the 180°

Post-Impact, Rollover Test, 90° Increment

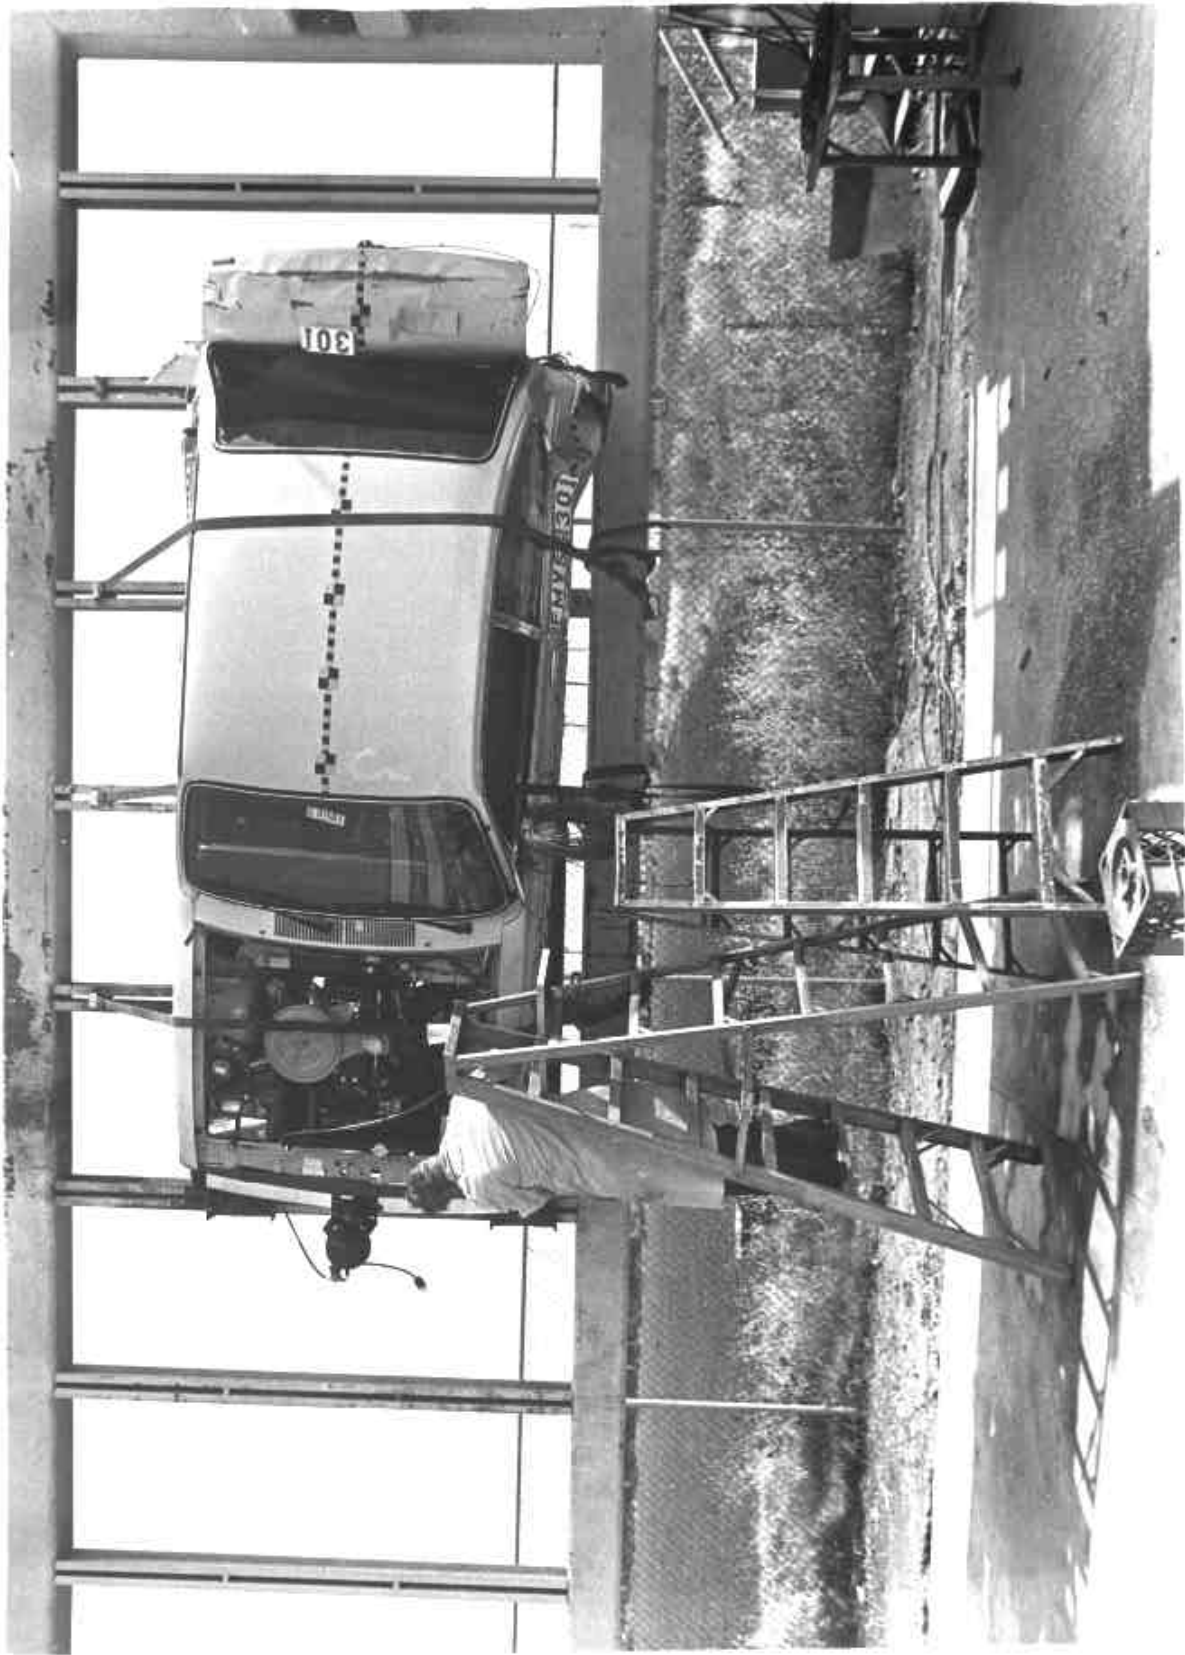
Figure 3-10

test increment, and fuel spillage appeared emitting from the carburetor air cleaner assembly. The fuel spillage continued as recorded during the remaining rollover test increment time periods.

Post-Impact, Rollover Test, 270° Increment
