# **CALSPAN ADVANCED TECHNOLOGY CENTER**

## *IMPROVED LIGHTWEIGHT SUBCOMPACT SIDE STRUCTURE TEST REPORT*

Calspan Report No. 6225-V-8

| <b>TEST:</b> | <b>TEST NO. 7</b> |

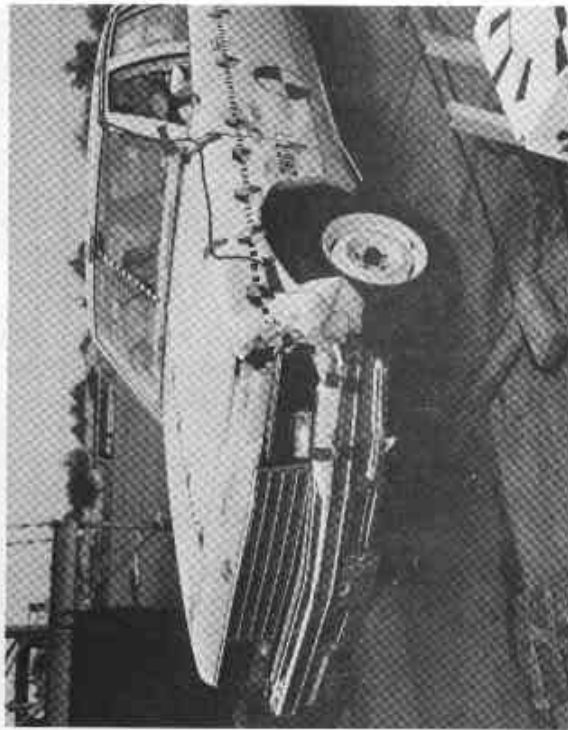
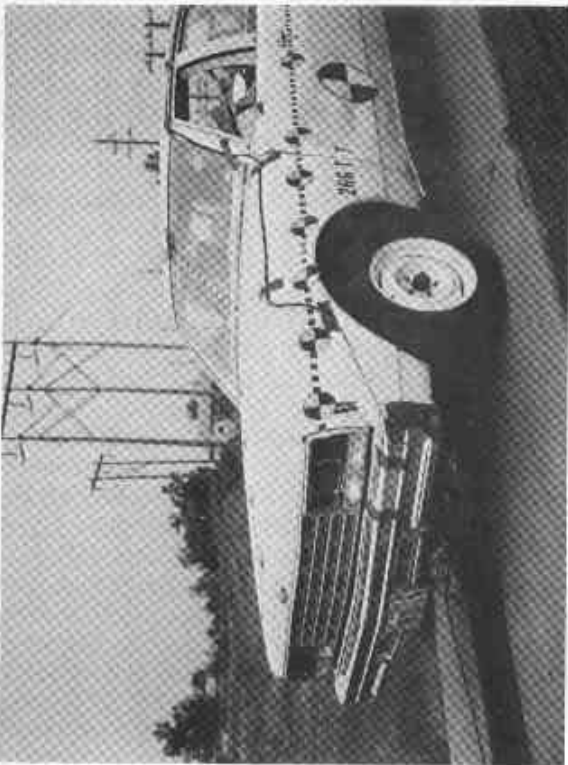
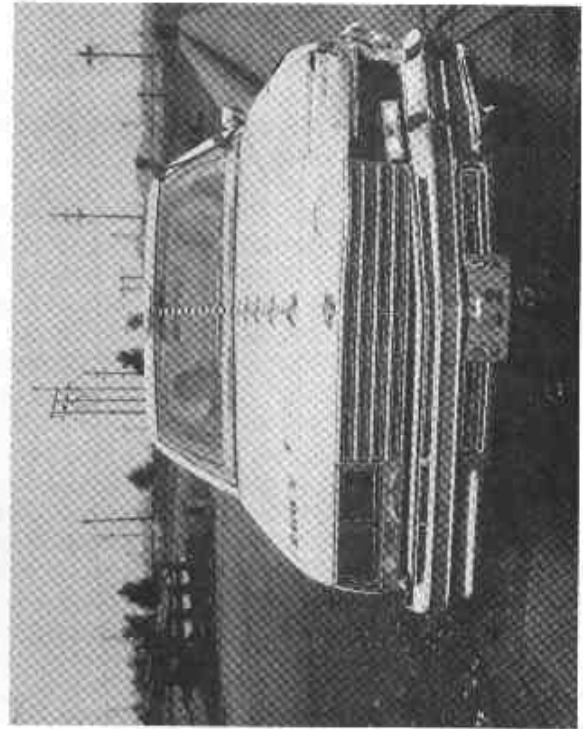
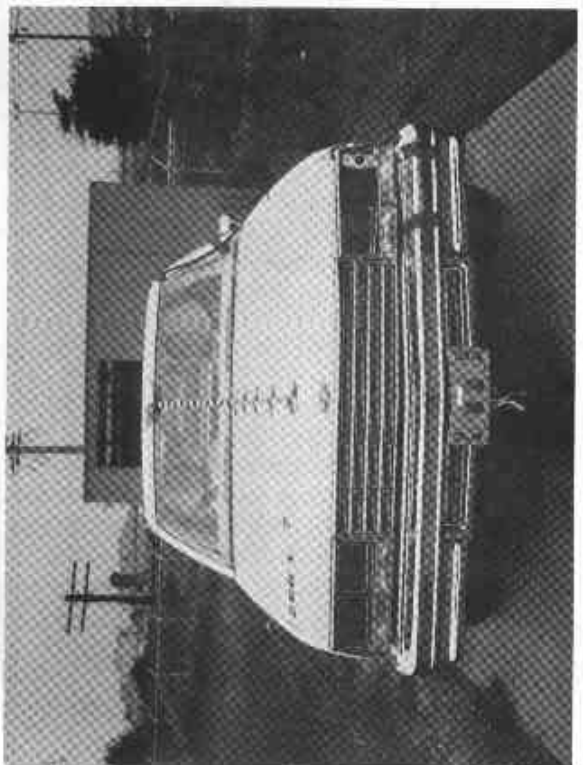
Figure 2 PRE-AND POST-TEST NO. 7 - CAR 1, 1978 CHEVROLET IMPALA

\*\*\*\*Vehicle No. 1 was used as the impacting vehicle for Test No. 6 and repaired for this test.

GLAZING Windshield was cracked; driver's door and rear side window were broken. Driver's door window was down for test.

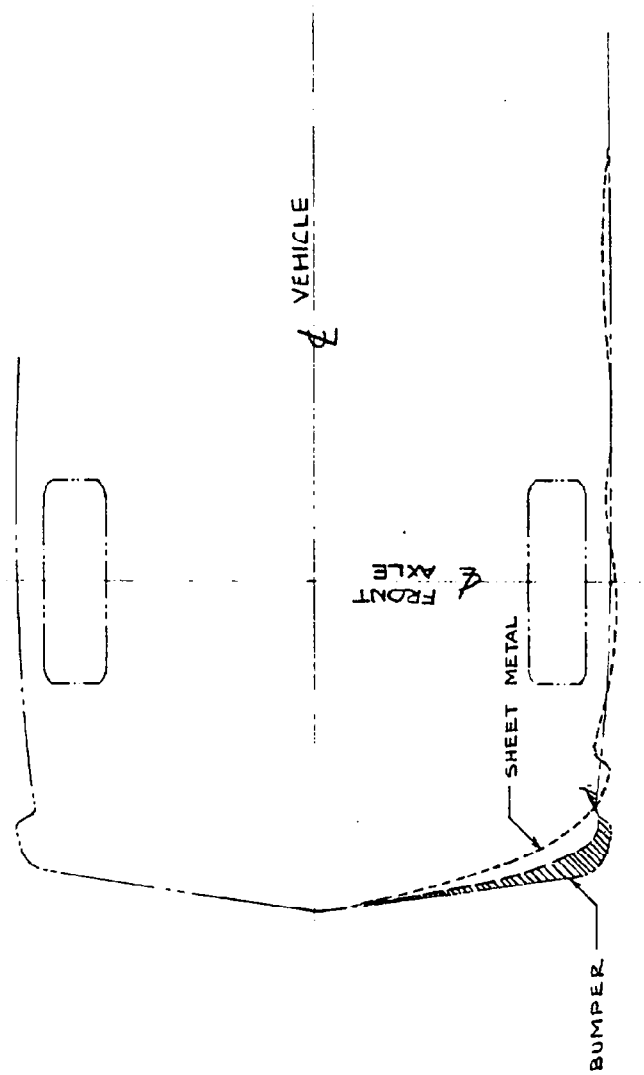
FIGURE 11 PRE- AND POST-TEST DEFORMATION - CAR 1, 1978 CHEVROLET IMPALA

| | VEH. NO. 1 | VEH. NO. 2 |
|---|---|---|
| MAX. CRUSH (in) | <u>See Figure 11</u> | <u>15.75</u> |
