**DYNAMIC IMPACT TEST OF
A SCHOOL BUS
WITH A 10,000 POUND MOVING BARRIER
WITH CONTOURED FRONT END**

1987 CARPENTER CONVENTIONAL SCHOOL BUS
65 PASSENGER

NHTSA NO. CH0902

FINAL REPORT

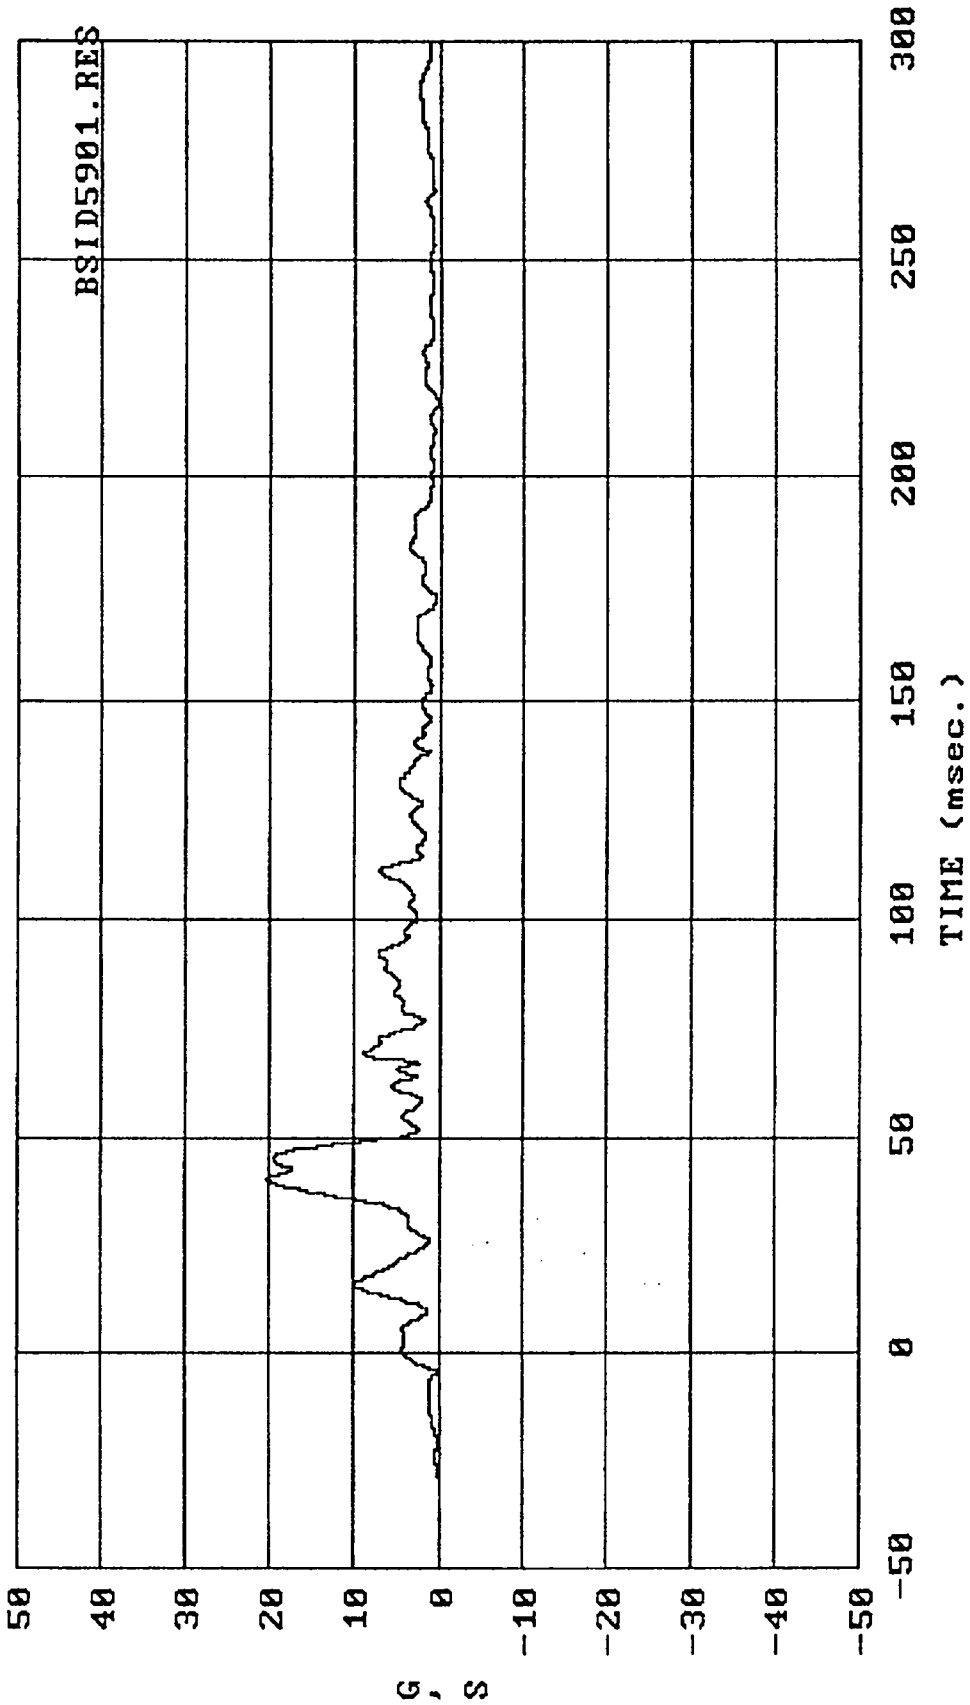
FIGURE 3-12

Filter: SAE CLASS 60 Max = 20.466 Min = .26009

MSE 02/07/89 -- Carpenter 65p Bus : Vehicle C/G resultant accel.
