# Insurance Institute for Highway Safety Crashworthiness Evaluation

## Crash Test Report 1998 Volkswagen Passat (CF98002)

**Vehicle identification number:** WVVMA63B8WE114404  
**Body style:** Four-door sedan  
**Engine/transmission:** Longitudinal 1.8-liter turbocharged 4-cylinder,  
5-speed automatic, front-wheel drive

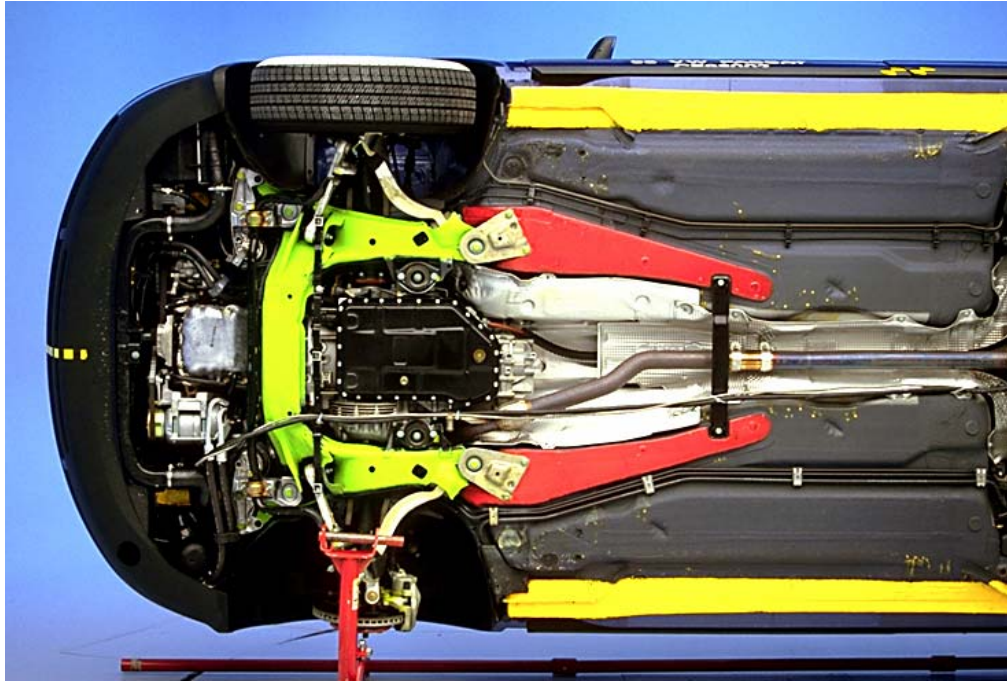
**Figure 3**  
**Preocrash View from Below — 1998 Volkswagen Passat**

Upper radiator support crossmember (made of plastic) at driver side was broken off during the crash. Indicated endpoint represents junction of crossmember with fender.
