# Insurance Institute for Highway Safety Crashworthiness Evaluation

## Crash Test Report 1998 Nissan Sentra (CF97021)

**Vehicle identification number:** 1N4AB41D2WC709761  
**Body style:** Four-door sedan  
**Engine/transmission:** Transverse 1.6-liter 4-cylinder, 4-speed automatic, front-wheel drive

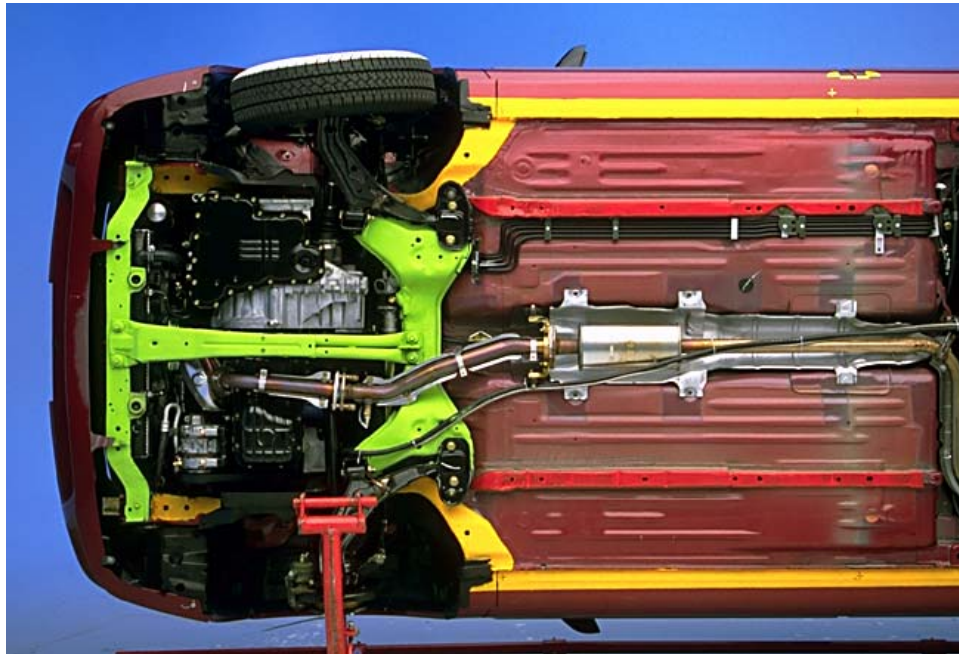
**Figure 3**  
**Preocrash View from Below — 1998 Nissan Sentra**

Figure 1 shows the overhead view of the crash deformation. Figure 2A illustrates the precrash and postcrash contour measures of the front bumper cover profile and the resulting permanent crush. Figure 2B illustrates the corresponding measures of both the front bumper reinforcement bar and the upper crossmember of the radiator support. Figure 3 shows the precrash and postcrash views from below. Figure 4 illustrates the deformation of the side rails, floor rails, and engine support members, which are visible in Figure 3.
