NHTSA - 98 - 3588 - 139

**Evaluation of Motor Vehicle Fire Initiation and Propagation
Part 8: Crash Tests on a Sport-Utility-Vehicle**

Jack L. Jensen, Jeffrey Santrock
General Motors Corporation

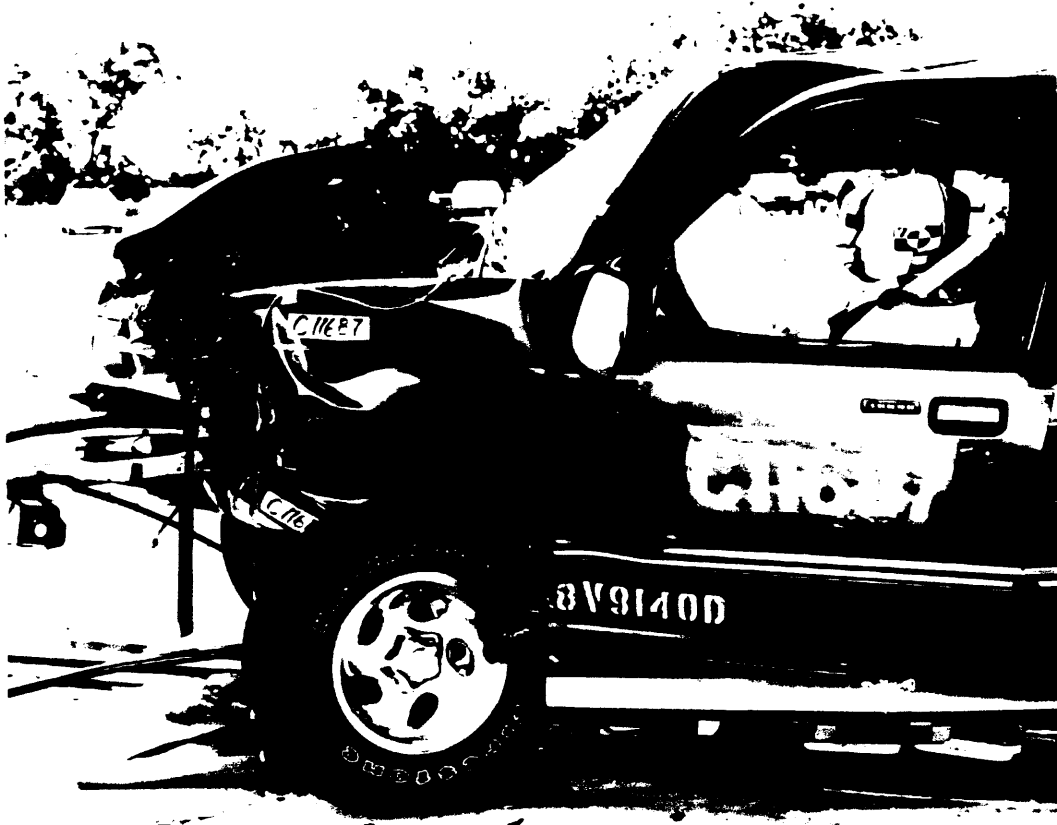
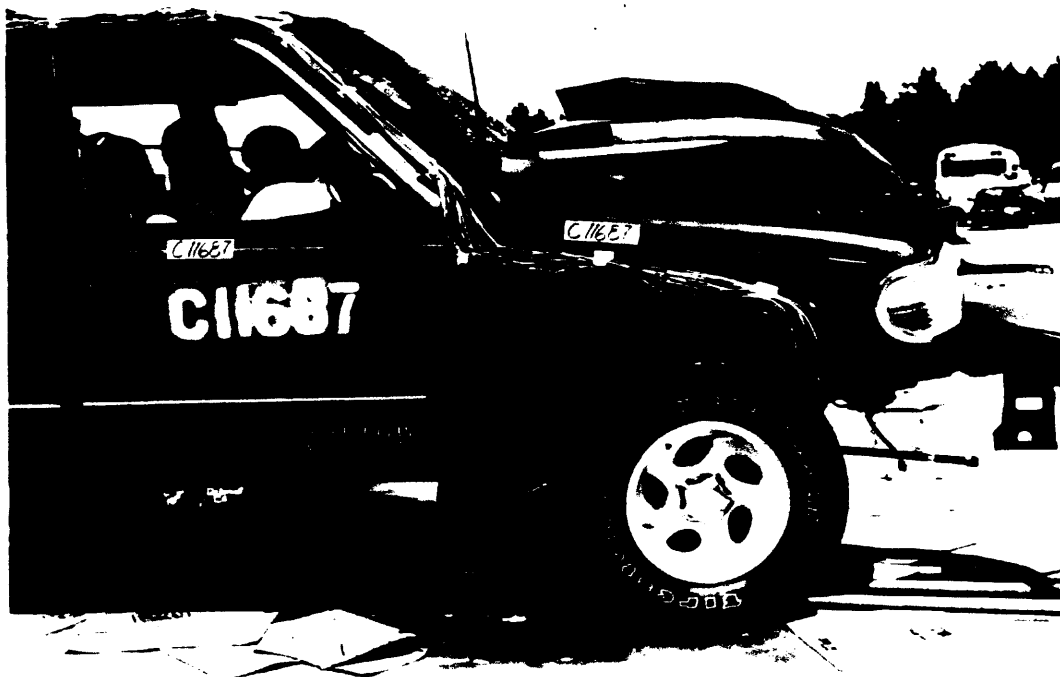
Figure 4
Post-Test Photograph of Test C11687, Front Left View

Figure 5
Post-Test Photograph of Test C11687, Front Right View

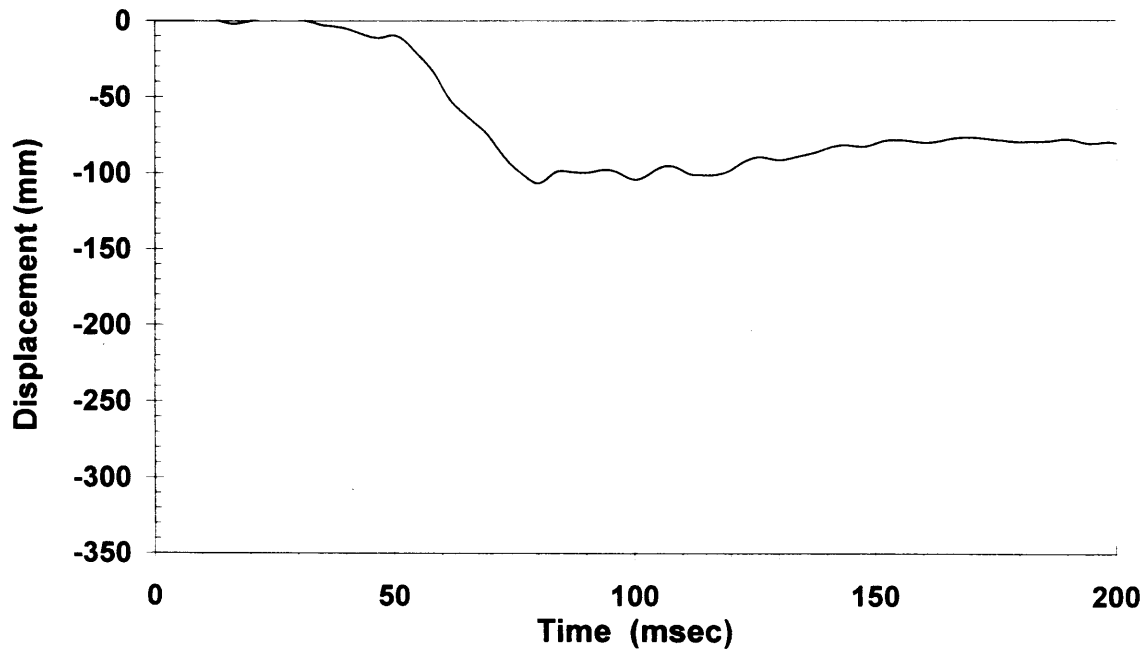
The displacement of the driver's side toe pan was approximately 107 mm as shown in Figure 11 and Plot 77 Appendix B.

Figure 11
 Left Toe pan Displacement, Relative to Floorpan
 Test C11687, filtered at SAE class 60 [8]

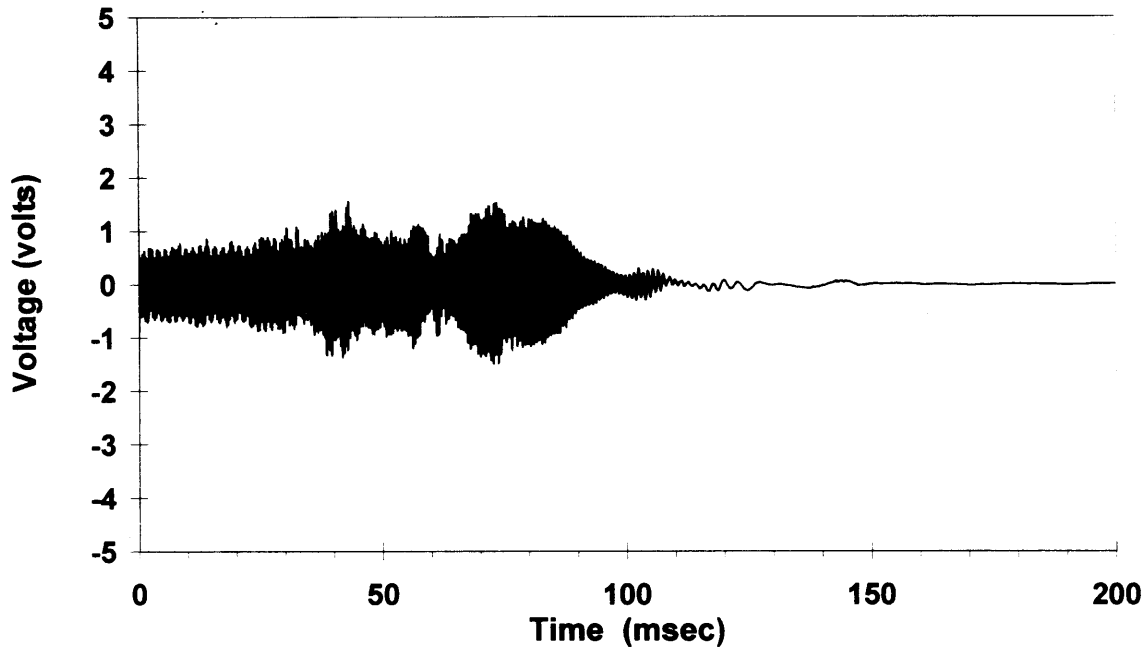
The engine motion measurement is shown in Appendix B, Plot 88 and recreated here as Figure 12. This measurement indicated that the engine was turning at normal speed through about 40 msec after which it began to slow. The engine motion stopped by about 110 msec after impact.

Figure 12
Engine Motion
Measured using Auxiliary Magnetic Pickup Transducer, Test C11687

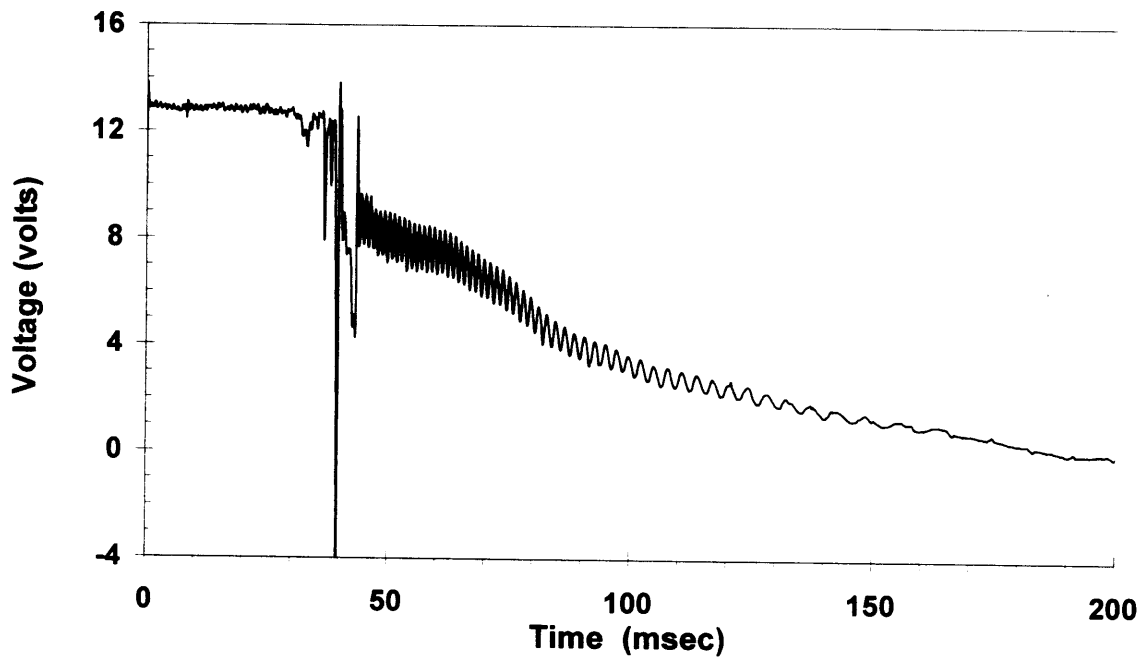
From 40 msec to 60 msec, the ignition voltage dropped from 13 volts to near zero in a stepwise manner (Figure 14 and Plot 85 in Appendix B). The fuel pump voltage decayed from 13 volts to near zero from about 40 msec to 180 msec as shown in Figure 15 and Plot 81 (Appendix B). Bench-tests on fuel pumps for other vehicles in the project [2], [3] indicated a gradual decay in voltage (lasting 40-150 msec) when current flow was stopped to the motor. This is likely due to the windings of the motor producing a voltage drop as the motor stops. The decay shown in Figure 15 is consistent with the observations from other tests.

Figure 15
Fuel Pump Voltage
Test C11687

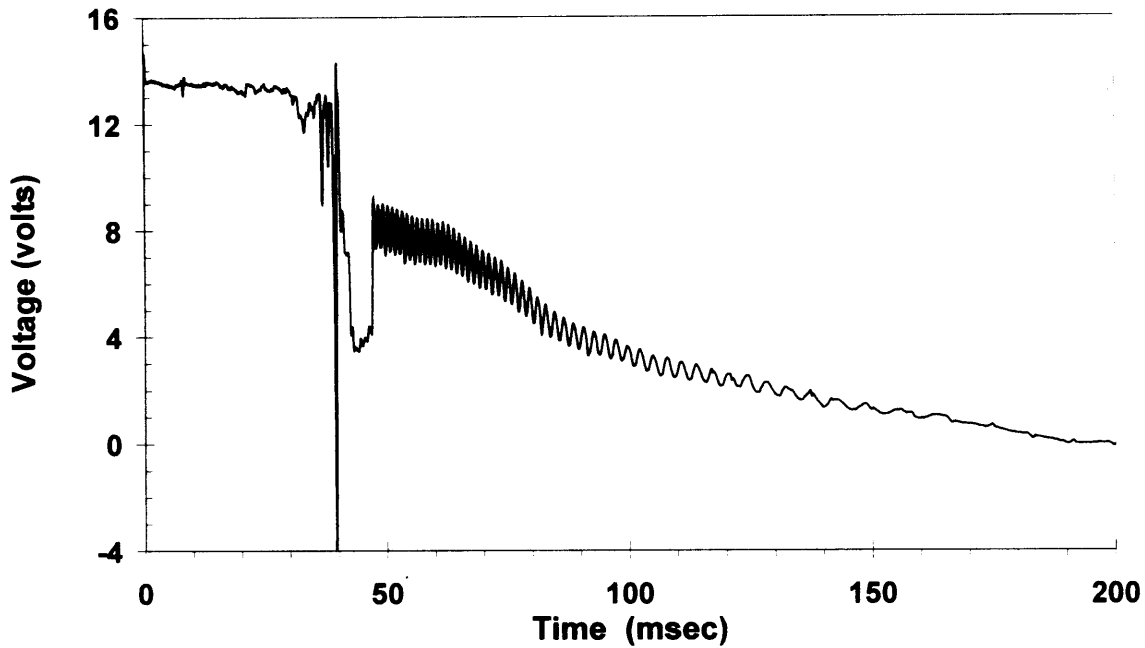
The fuel pump inertia switch did activate during the test at about 47 msec after impact. The switch was physically inspected following the test confirming its activation. The fuel pump inertia switch voltage measurement is shown in Figure 16 and Plot 82 in Appendix B. A schematic showing where this measurement was taken is shown in Figure 17. As indicated in the Figure 17, once the inertia switch is activated during the impact the fuel pump voltage (Figure 15) and the fuel pump switch voltage (Figure 16) should be the same. These two traces are nearly identical after about 47 msec, indicating that the switch likely activated at about 47 msec. The fuel pump was already shutting down at this point due to the loss of main vehicle power.

Figure 16
Fuel Pump Inertia Switch Voltage
Test C11687

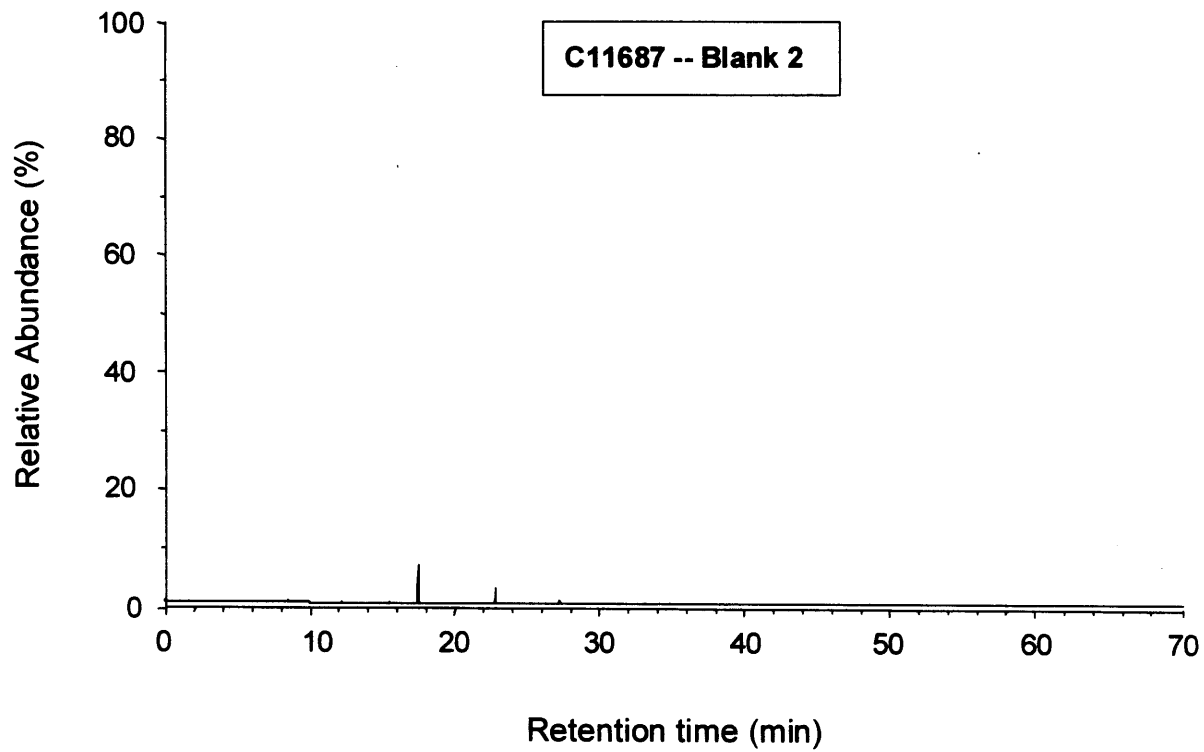
The vapor concentration at location #1 increased to slightly greater than 1% in the first 60 seconds following the impact, while the concentration at location #2 exceeded 3% during the first 60 seconds. The GCMS analysis was completed on the vapors collected from these same locations [1]. The results of the GCMS analysis for locations #1 and #2 were similar. The results of the GCMS analysis for location #2 is recreated here as Figure 21 and Figure 22. The GCMS analysis indicated the source of the vapors were gasoline, stoddard solvent and oils.

Figure 21
GCMS Analysis of Vapor Background Sample Collected near Left Exhaust Manifold (Location #2) Before the Test, Test C11687

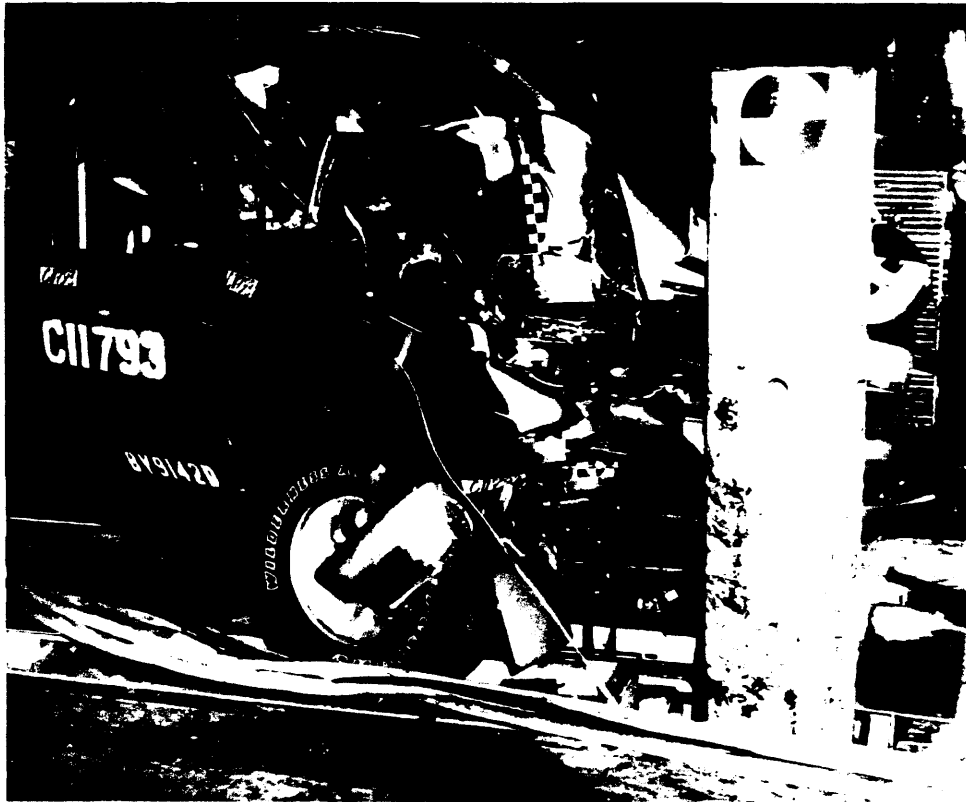
Figure 24
Post-Test Photograph of Test C11793, Front-Right View

Figure 25
Post-Test Photograph of Test C11793, Front-Left View

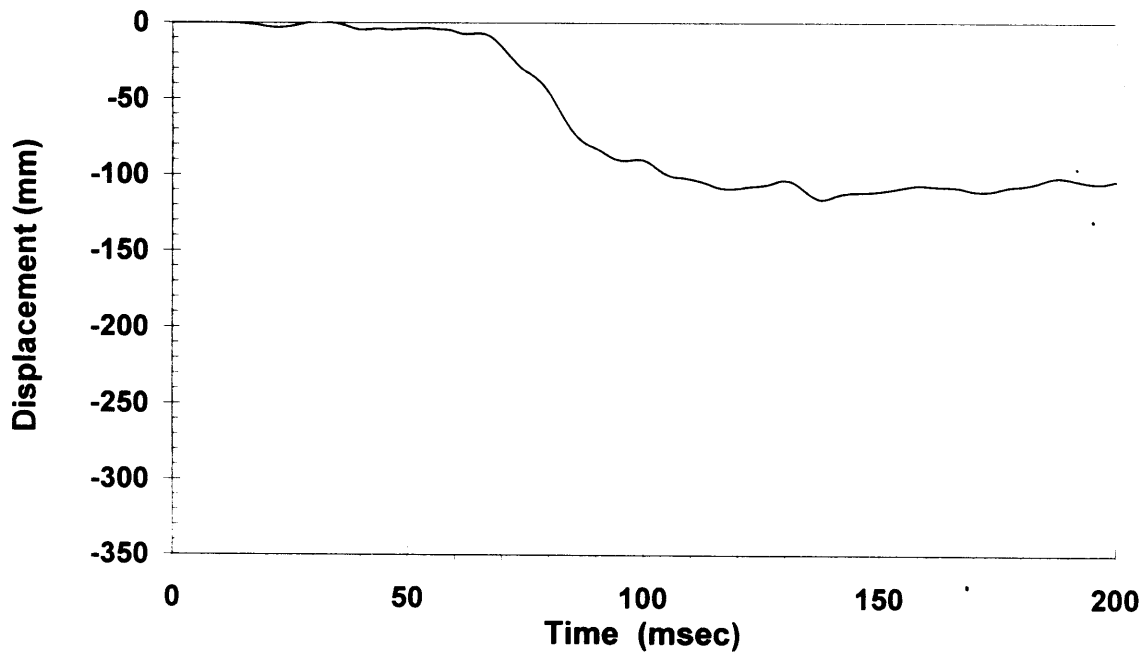
The displacement of the right toe pan, relative to the passenger compartment, was approximately 118 mm and is shown in Figure 28 and also Plot 77, Appendix D.

Figure 28
 Right Toe pan Displacement, Relative to Floorpan
 Test C11793, filtered at SAE class 60 [8]

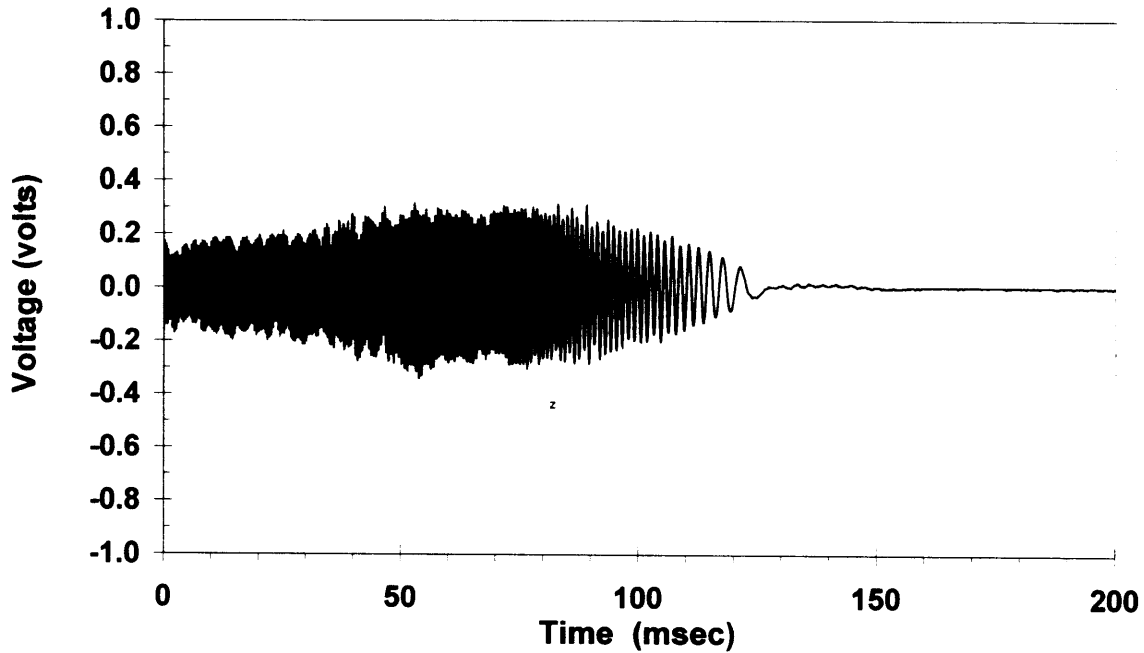
The engine motion began to slow at approximately 40 msec after time zero and stopped by 120 msec as shown in Figure 29 and Plot 88.

Figure 29
Engine Motion
Measured using Auxiliary Magnetic Pickup Transducer, Test C11793

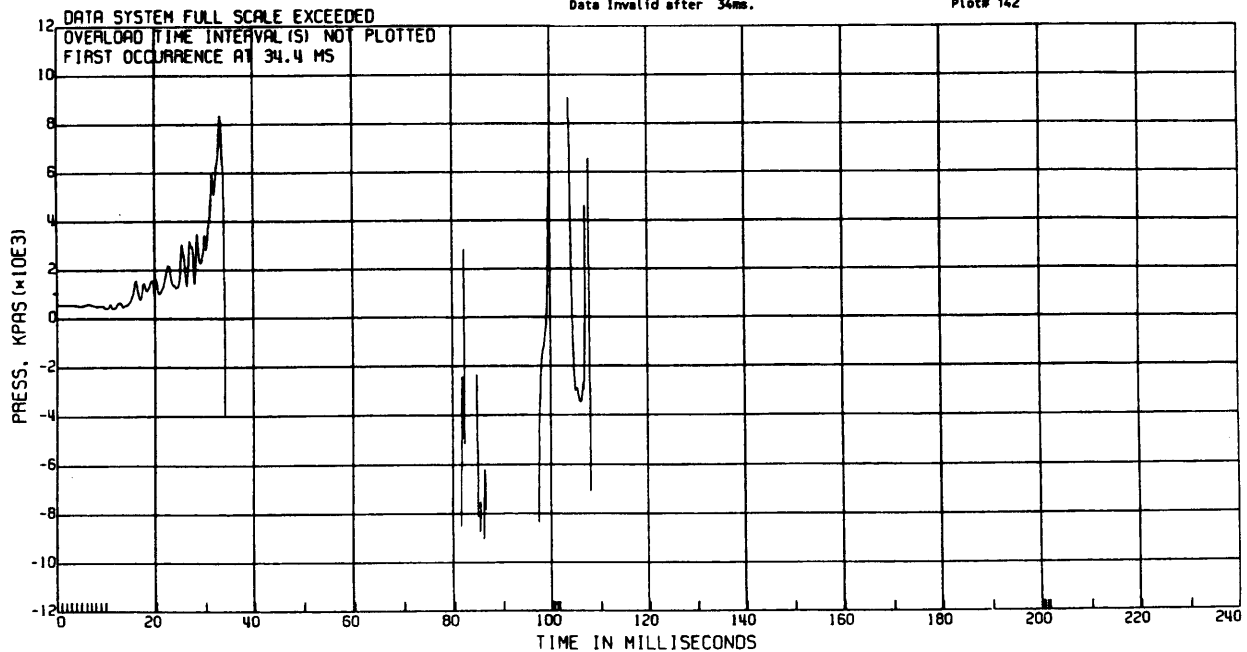
Appendix B, plot # 142

TRANSDUCER WIRES WERE DAMAGED/CUT

Data Invalid after 34ms.
