**REPORT NUMBER: NCAP305I-KAR-13-054**

**NEW CAR ASSESSMENT PROGRAM (NCAP)  
FMVSS NO. 305 INDICANT TEST**

**TESLA MOTORS, INC.  
2013 TESLA MODEL S 5-DOOR HATCHBACK**

**FINAL REPORT**

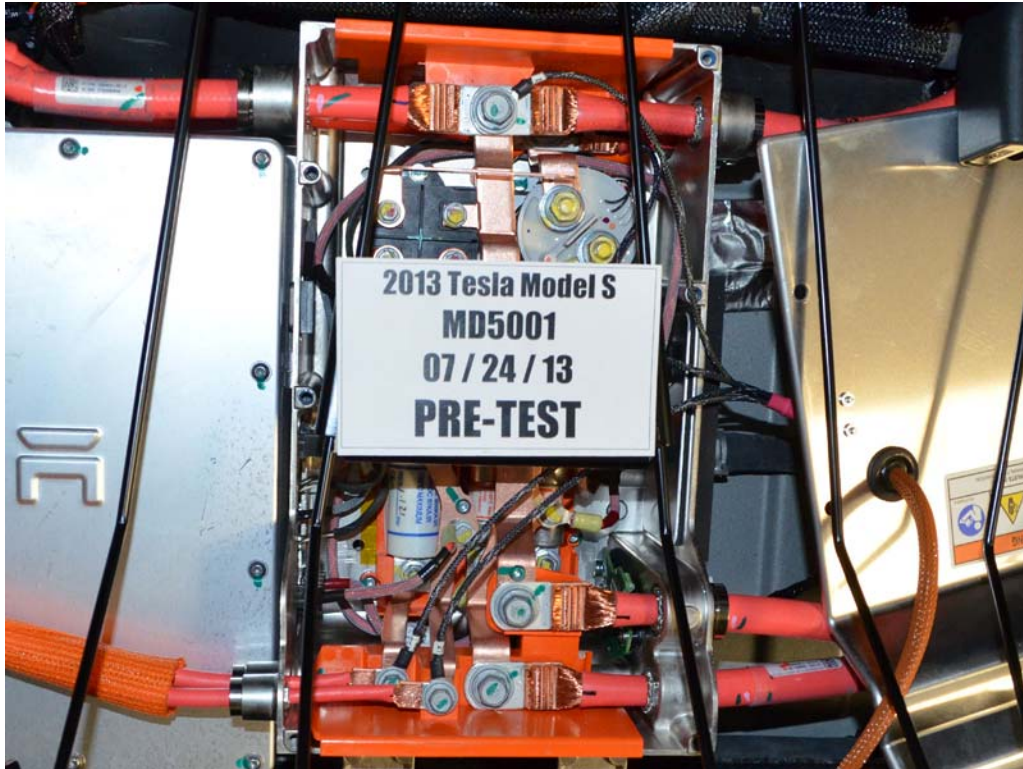
FIGURE 21. Pre-Impact View of Ground Lead Attached

The chassis ground used for the electrical isolation measurements was a pre-existing chassis ground point located in the rear trunk compartment near the right rear wheel well. A photograph of the location is included in Figure 21 of Appendix A.
