REPORT NUMBER: NCAP305I-KAR-14-007

**NEW CAR ASSESSMENT PROGRAM (NCAP)
FMVSS NO. 305 INDICANT TEST**

**VOLKSWAGEN DE MEXICO S.A. DE C.V.
2014 VOLKSWAGEN JETTA HYBRID SE 4-DOOR SEDAN**

FINAL REPORT

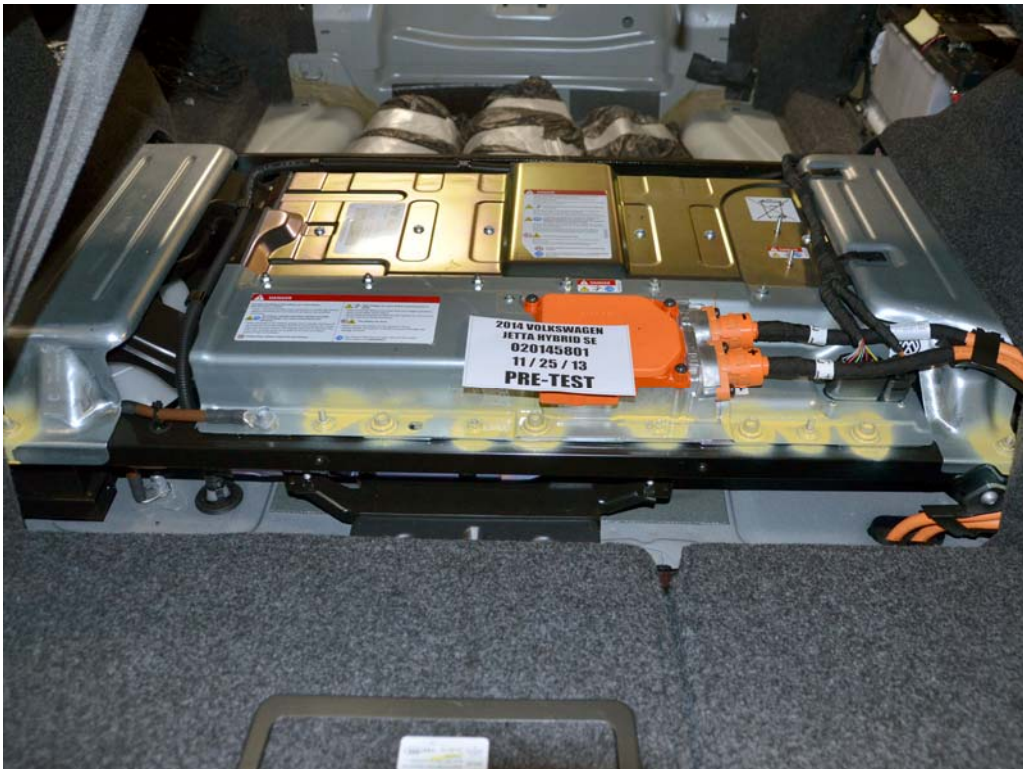
FIGURE 9. Pre-Impact View of Propulsion Battery

The electrical propulsion system utilized one Lithium-Ion (Li-Ion) Battery and a traction motor to propel the vehicle. The battery is located behind the rear passenger seat back. The propulsion battery service disconnect is located on the front top side of the battery, behind the rear passenger seat back. The propulsion battery's automatic disconnect is physically contained within the propulsion battery. A photograph of the location of the service disconnect is included in Figure 6 of Appendix A and is also visible in Figure 9 of Appendix A.

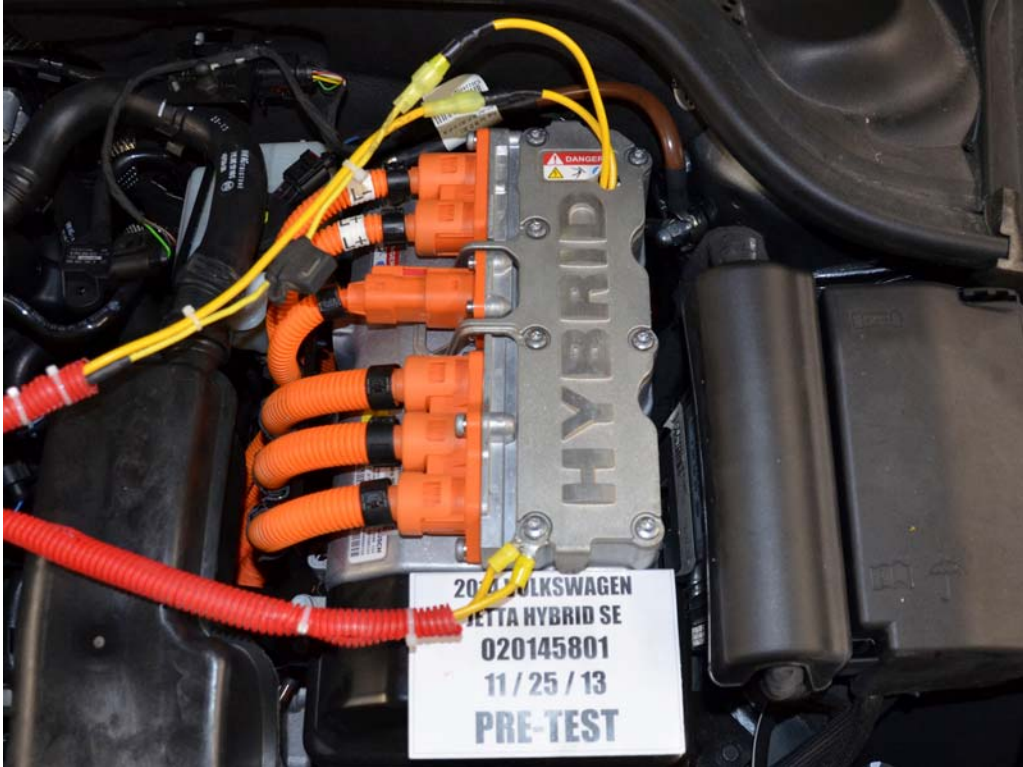
FIGURE 22. Pre-Impact View of High Voltage Leads Attached

The chassis ground used for the electrical isolation measurements was located on the top plate that covers the Electric Drive Power and Control Electronics compartment. The chassis ground connection was secured with one of the bolts used to seal the top plate that covers the Electric Drive Power and Control Electronics compartment. A photograph of the location is included in Figure 21 of Appendix A and is also visible in Figure 22 of Appendix A.
