REPORT NUMBER: TR-P32096-14-NC

**RESEARCH AND DEVELOPMENT
80 KM/H 70% OVERLAP REAR IMPACT**

**MITSUBISHI MOTOR MFG. OF AMERICA, INC.
1998 DODGE AVENGER 2-DOOR COUPE**

**REPORT DATE:
OCTOBER 2, 2012
FINAL REPORT**

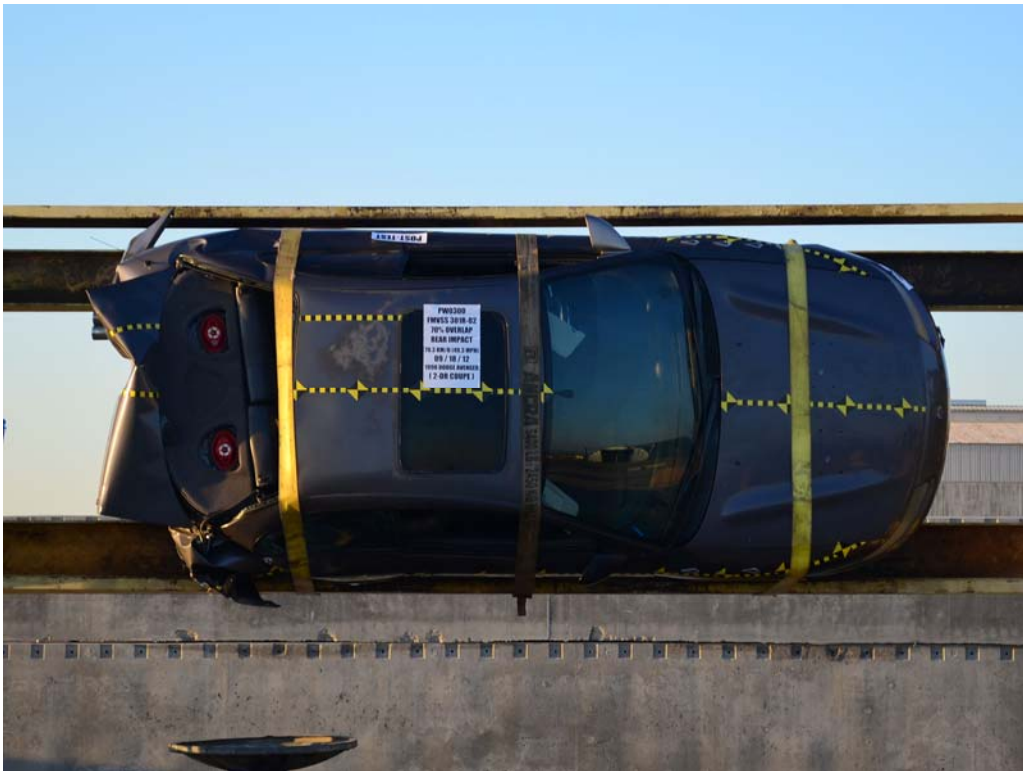
FIGURE 26. Vehicle at 90° on Static Rollover Device

Stoddard solvent leaked from the top front area of the fuel tank of the vehicle during portions of the static rollover. Leaks were visible while moving from 0° to 90°, while moving from 180° to 270°, while holding at the 270° position and while moving from 270° to 360°.
