**REPORT NUMBER: TR-P32096-02-NC**

**RESEARCH AND DEVELOPMENT  
80 KM/H 70% OVERLAP REAR IMPACT**

**HYUNDAI MOTOR COMPANY  
2000 HYUNDAI ELANTRA 4-DOOR SEDAN**

**NHTSA NUMBER: PY0500**

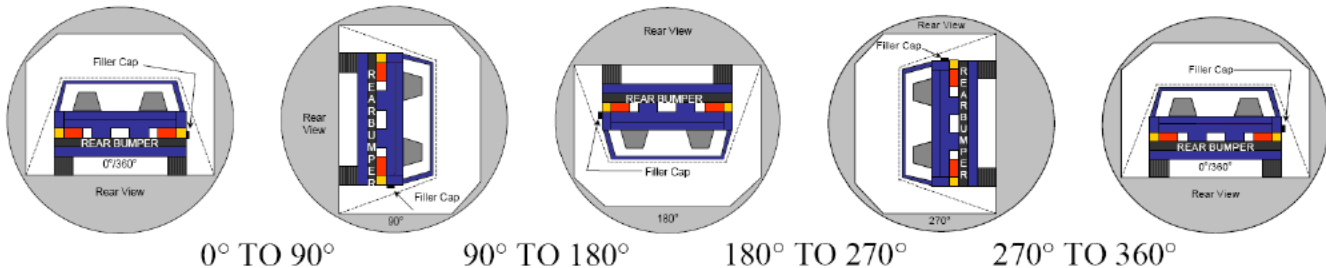
1. The specified fixture rollover rate for each 90° of rotation is 60 to 180 seconds.
2. The position hold time at each position is 300 seconds (minimum).
3. Details of Stoddard solvent spillage: Stoddard solvent leaked from the fuel filler neck area on the left rear of the vehicle.
