**NEW VEHICLE ASSESSMENT FOR  
SIDE IMPACT PROTECTION**

**CAR-TO-CAR SIDE IMPACT TESTING  
19° CRABBED SIDE IMPACTOR TO  
1982 VOLKSWAGEN RABBIT  
2-DOOR HATCHBACK  
AT 53.38 MPH**

**DYNAMIC SCIENCE, INC.  
An Exodyne Company  
1850 West Pinnacle Peak Road  
Phoenix, Arizona 85027**

**TEST REPORT  
JANUARY 1983**

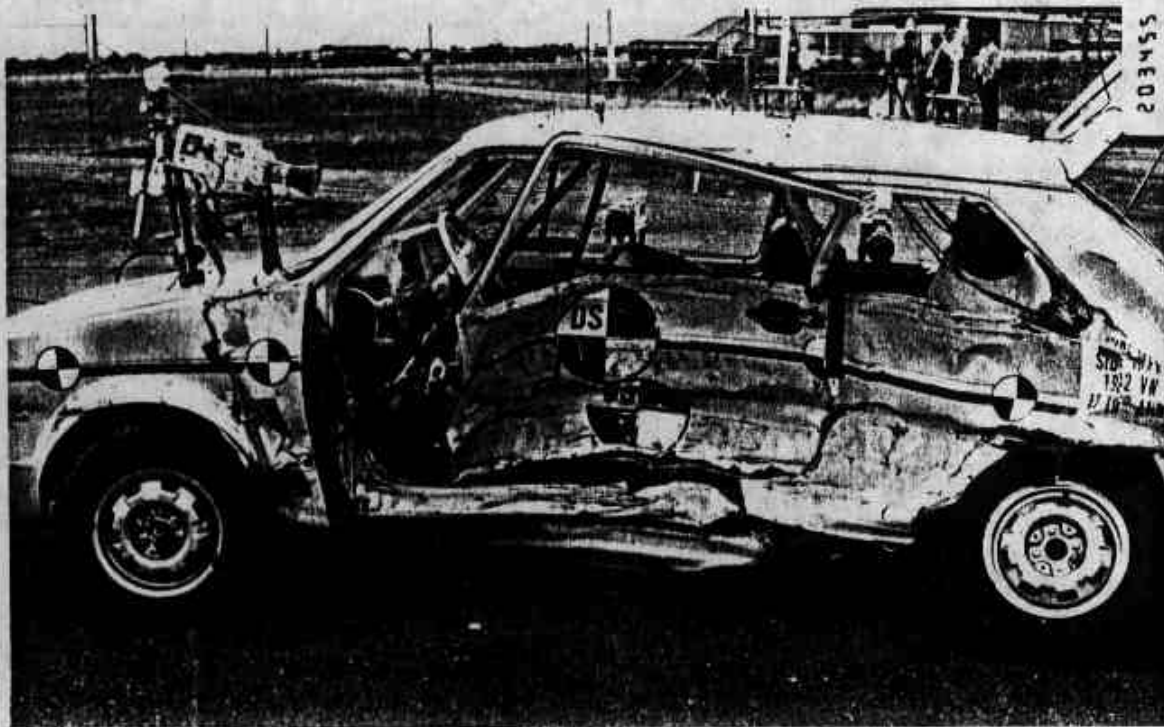
FIGURE A-4. POST-TEST LEFT SIDE VIEW OF VW RABBIT - 19° CRABBED SIDE IMPACTOR TO 1982 VW RABBIT - 53.38 MPH.

OTHER NOTABLE IMPACT EFFECTS: Vehicle crush to approximate vehicle centerline at B-pillar. Rear axle damaged. Door sill deformed upward and separated 42 inches aft of DOR. Door hinges separated from A-post. A-post split open at DOR. Roof buckled at B-pillar.

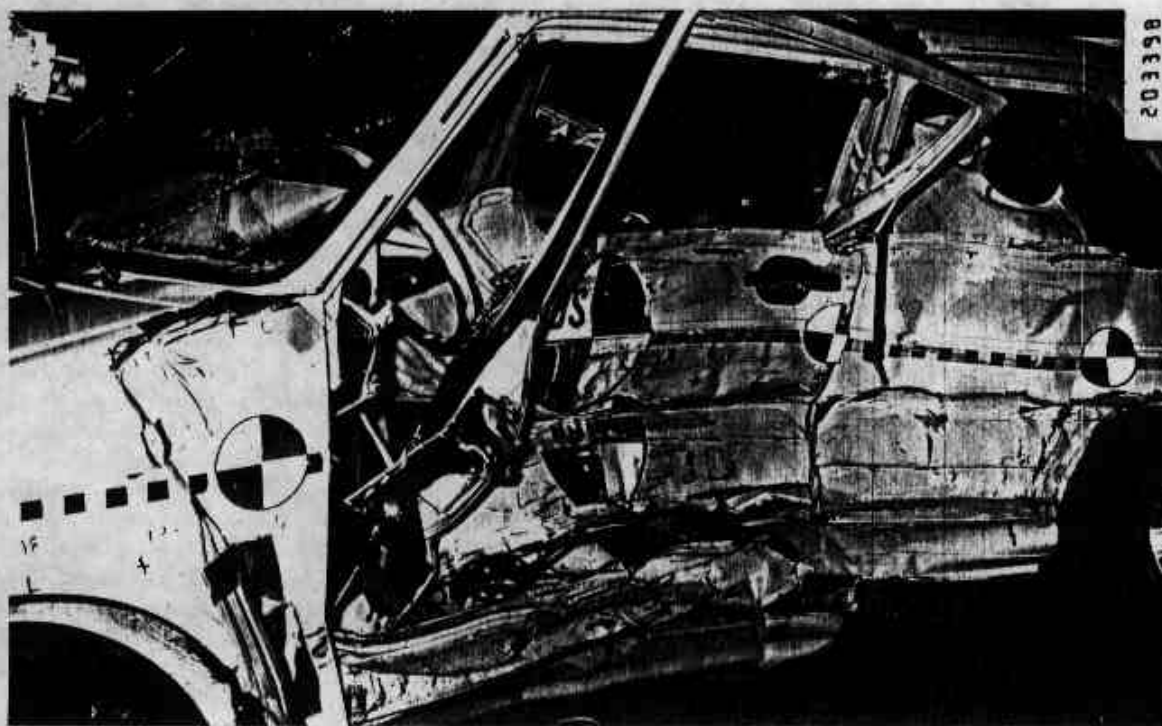
FIGURE A-6. POST-TEST LEFT SIDE FRONTAL OBLIQUE OF VW RABBIT.

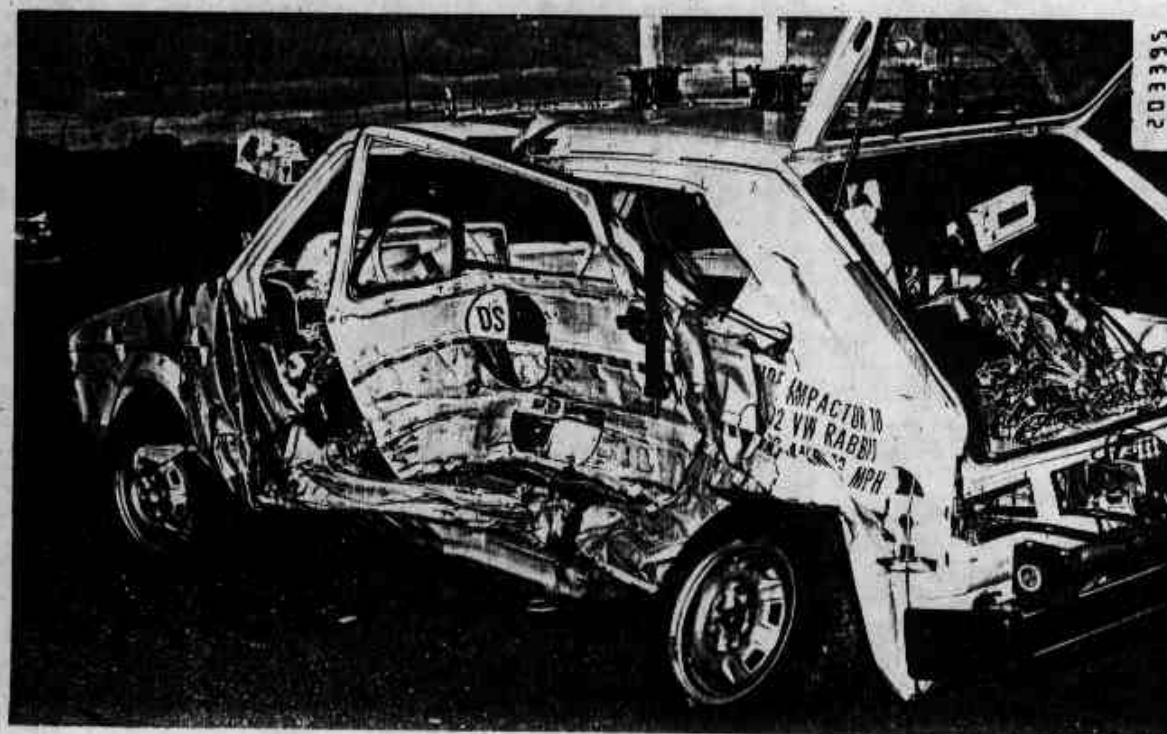
FIGURE A-8. POST-TEST LEFT SIDE OF REAR OBLIQUE OF VW RABBIT.

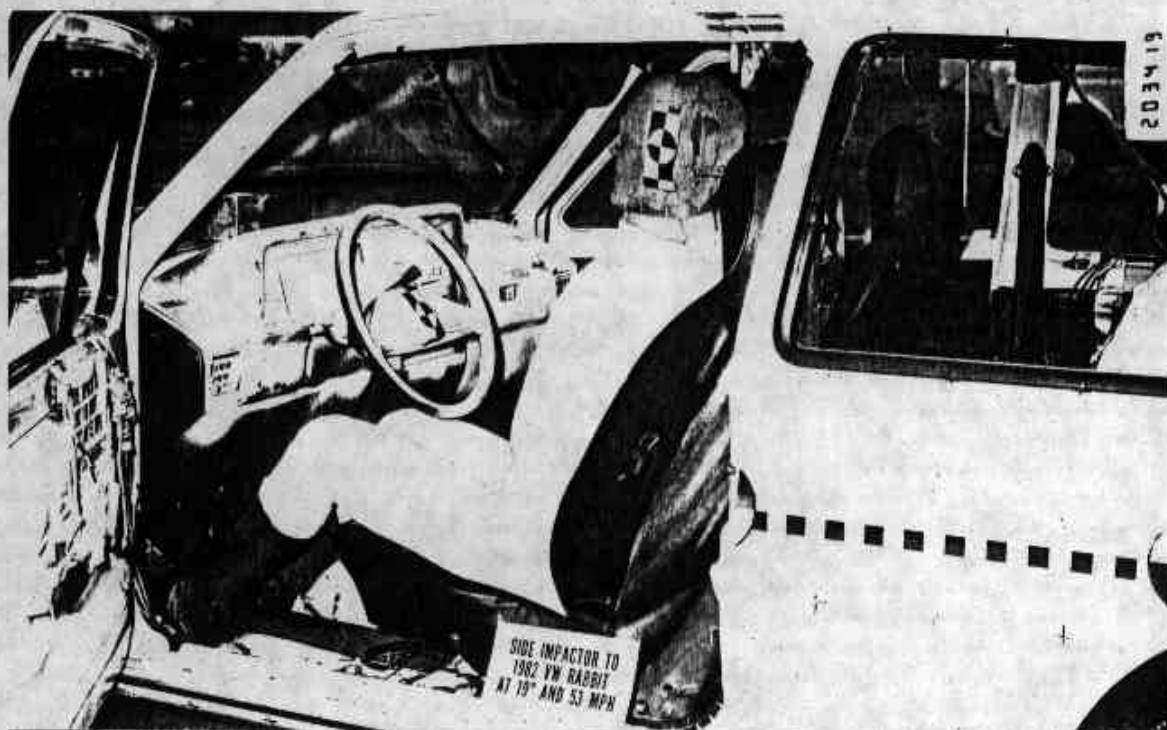
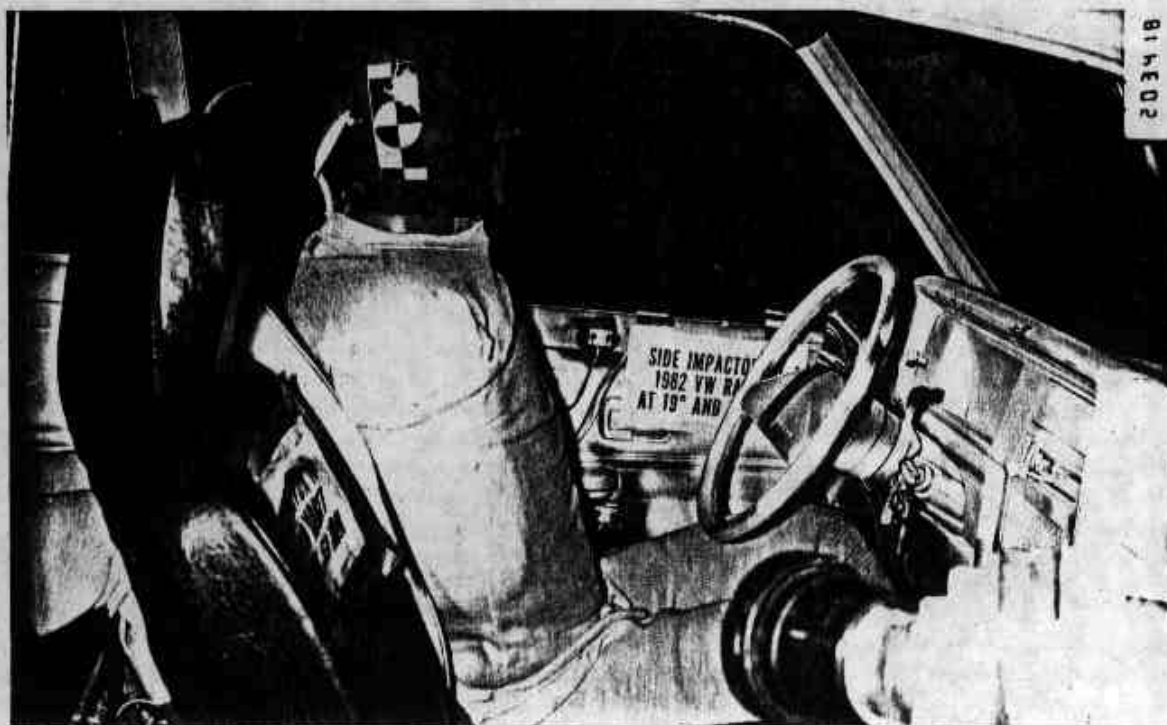
FIGURE A-17a. PRE-TEST DRIVER DUMMY POSITION.

FIGURE A-17b. PRE-TEST DRIVER DUMMY POSITION.

FIGURE A-17c. PRE-TEST DRIVER DUMMY POSITION.

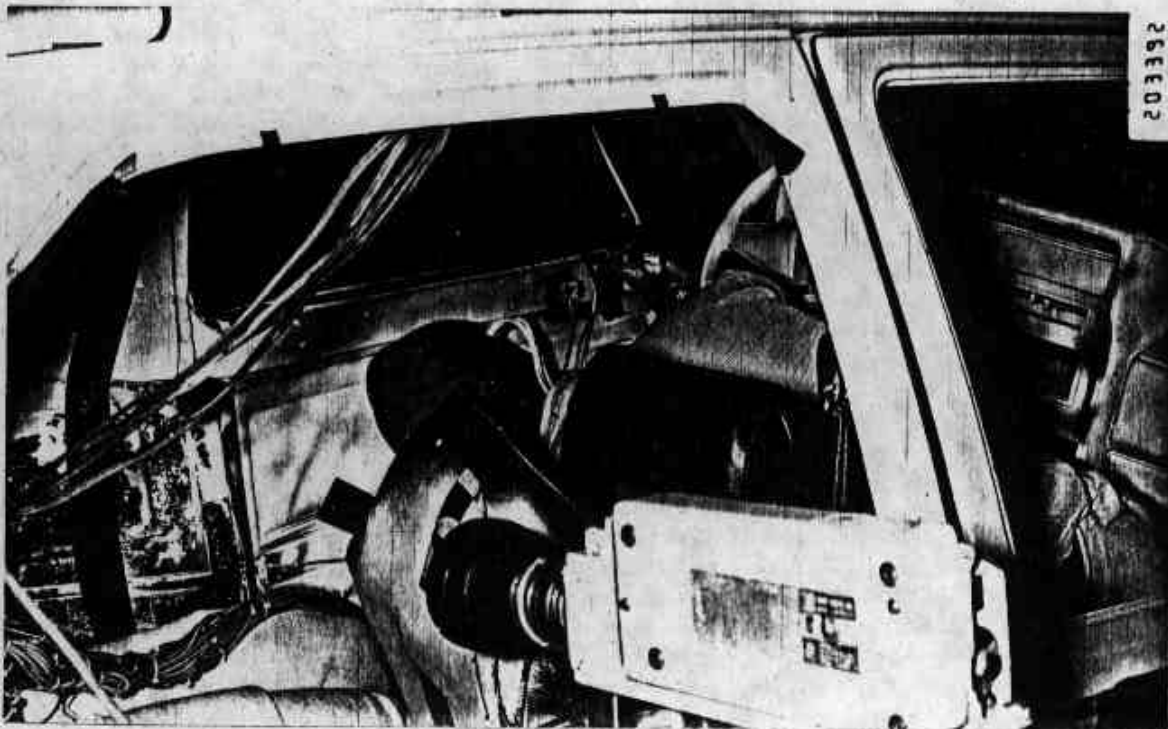
FIGURE A-18a. POST-TEST DRIVER DUMMY POSITION.

FIGURE A-18b. POST-TEST DRIVER DUMMY POSITION.

FIGURE A-18c. POST-TEST DRIVER DUMMY POSITION.

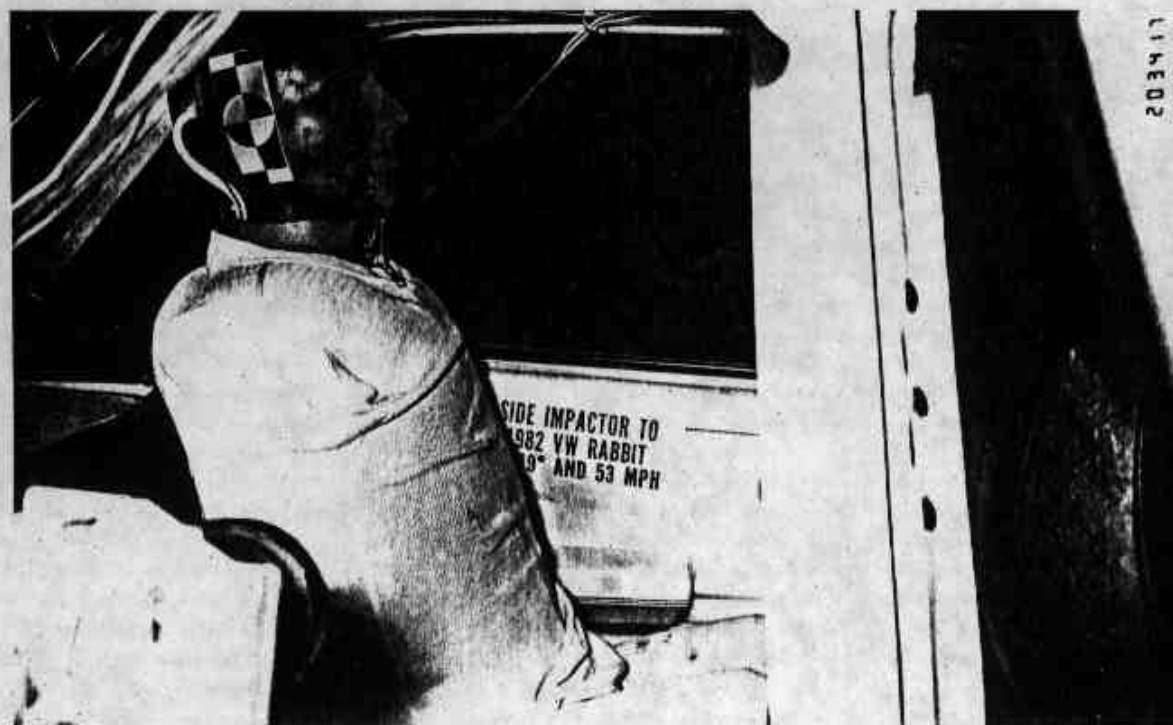
FIGURE A-19b. PRE-TEST LEFT REAR PASSENGER DUMMY POSITION.

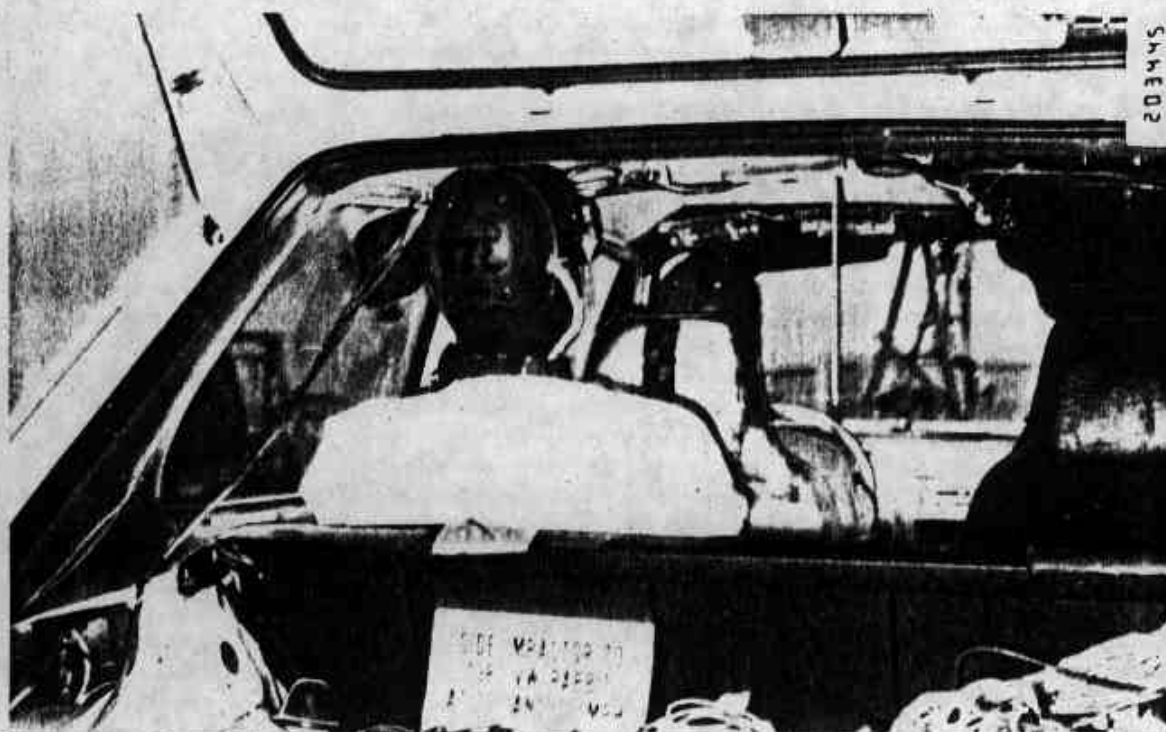
FIGURE A-19c. PRE-TEST LEFT REAR PASSENGER DUMMY POSITION.

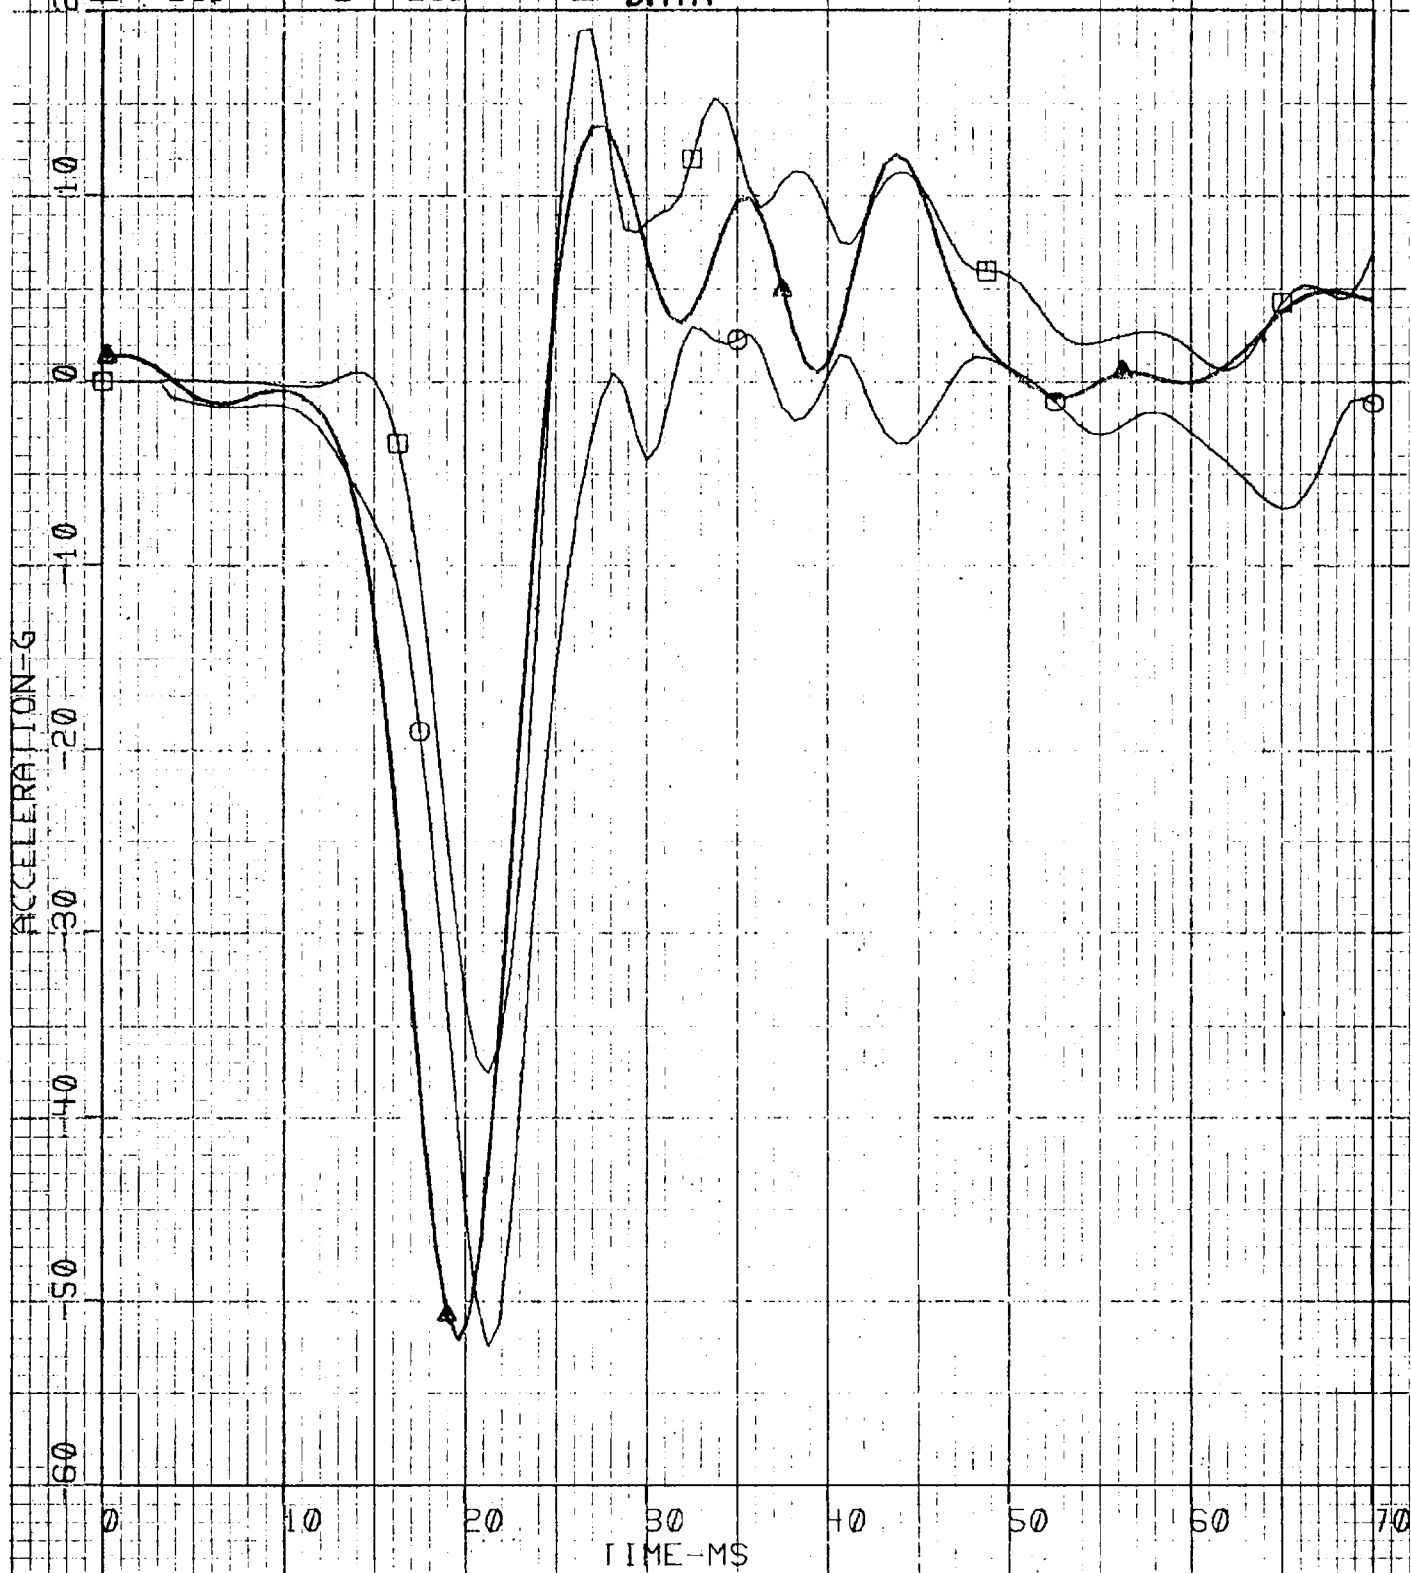
SID 175 CAL #2 LEFT LOWER RIB LAT P

$\square = +2SD$      $\circ = -2SD$      $\Delta = DATA$
