Vehicle Safety Compliance Testing  
for Occupant Crash Protection,  
Windshield Mounting, Windshield Zone Intrusion,  
and Fuel System Integrity

Explorer Van Division of  
Bodor Corporation  
1994 Explorer van  
NHTSA Number: CR1300  
TRC Test Number: 940317

Transportation Research Center Inc.  
10820 State Route 347  
East Liberty, Ohio 43319

Final Report

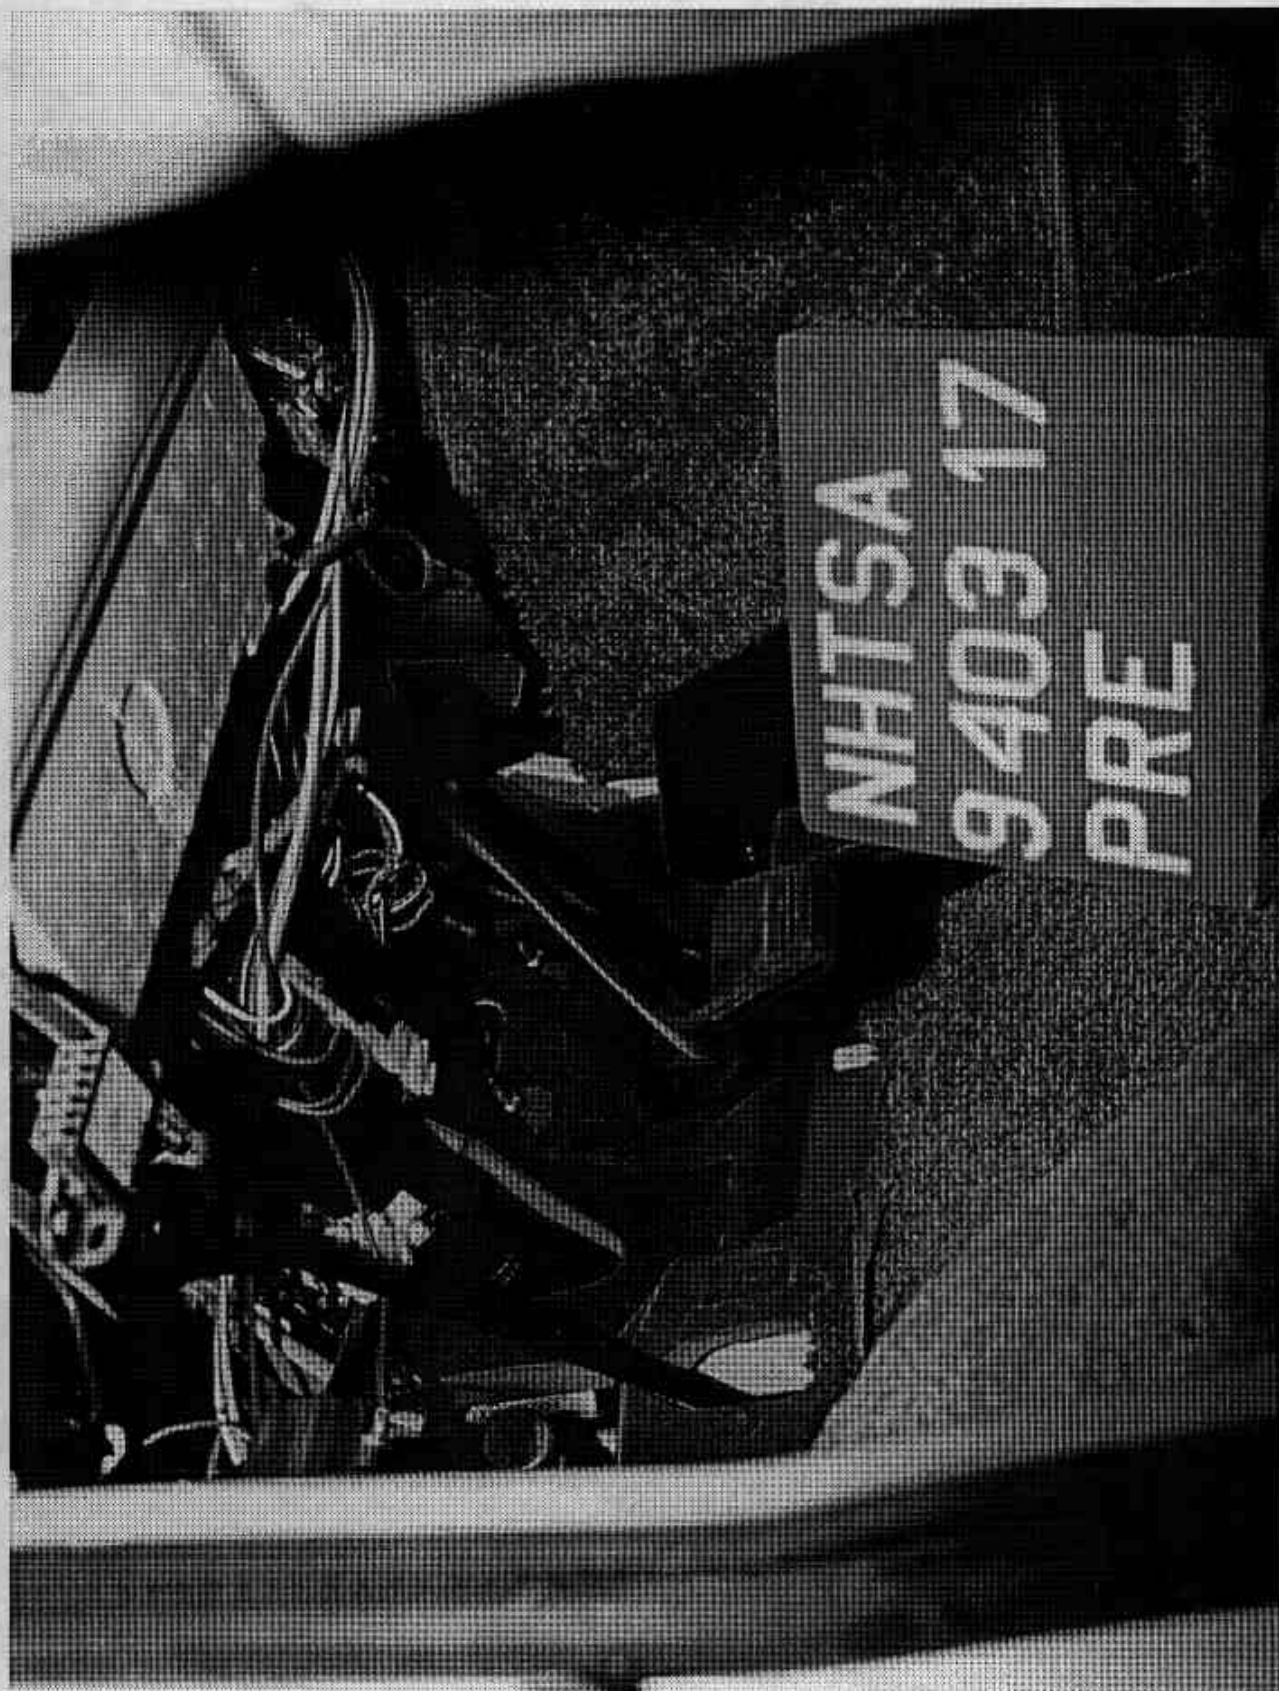
Figure A-31. Pre-test Steering Column at Firewall View - Interior

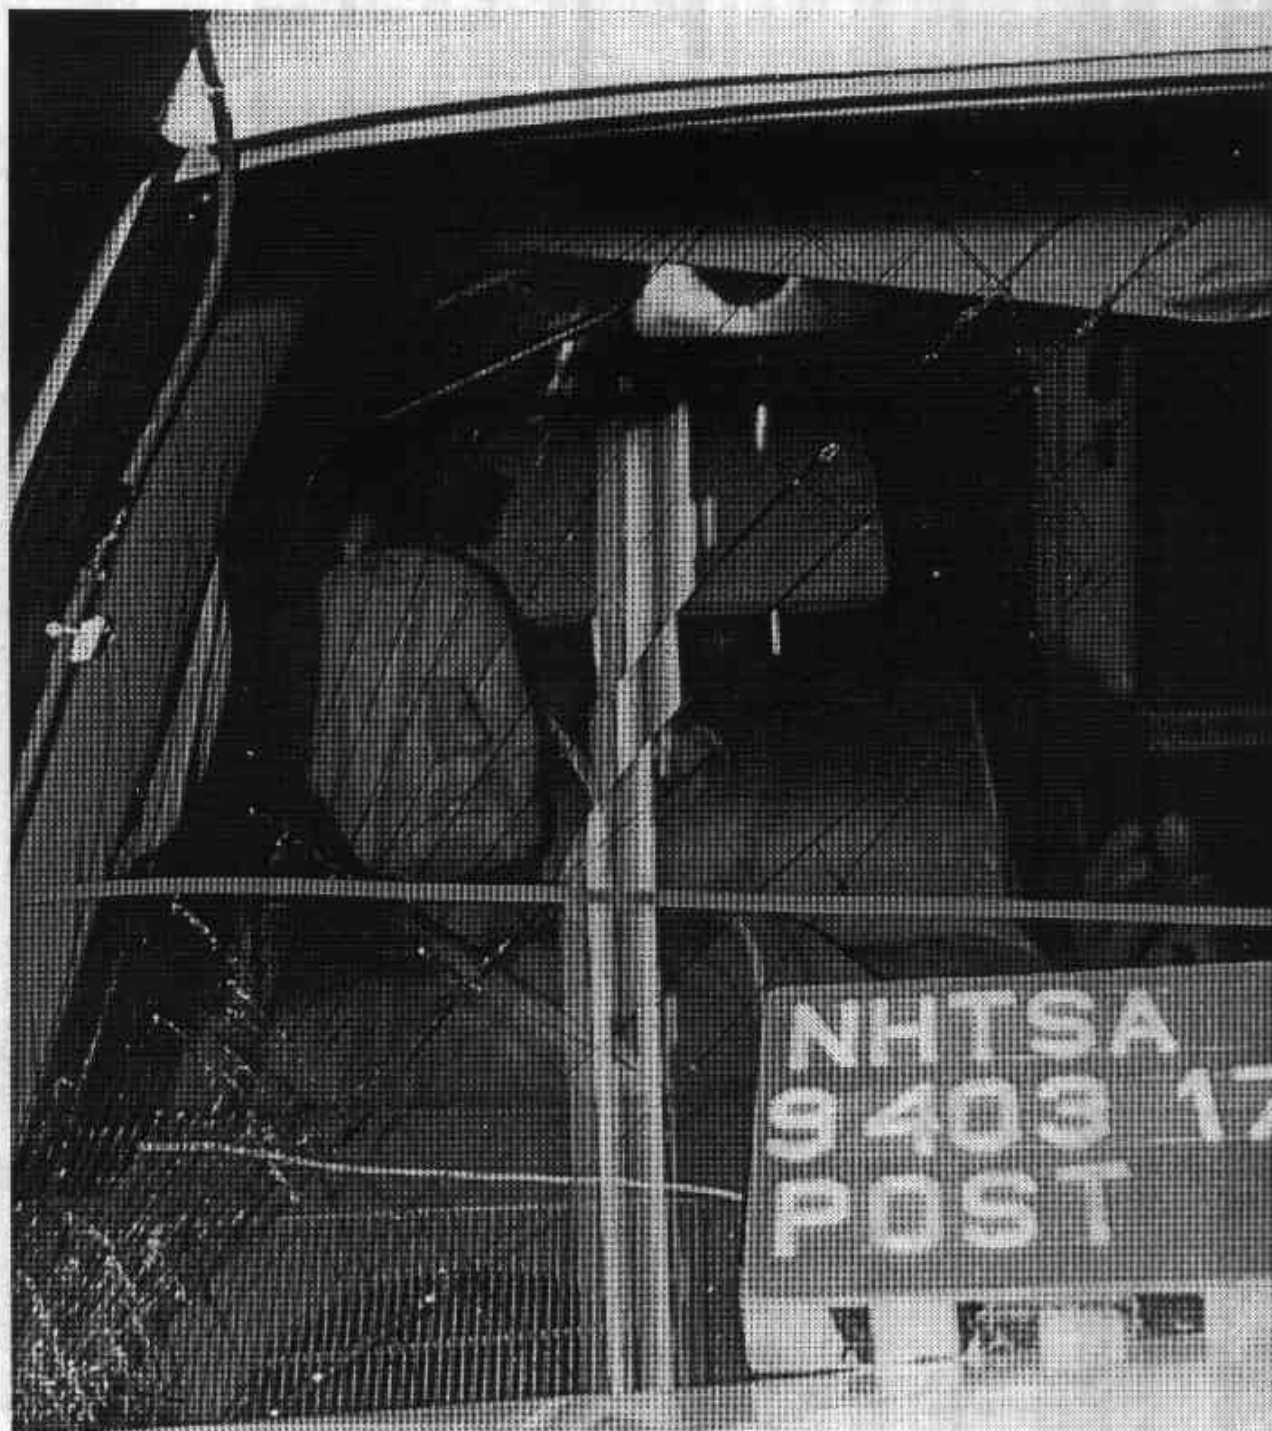
Figure A-38. Post-test Passenger Dummy Position - View 1  
A-39

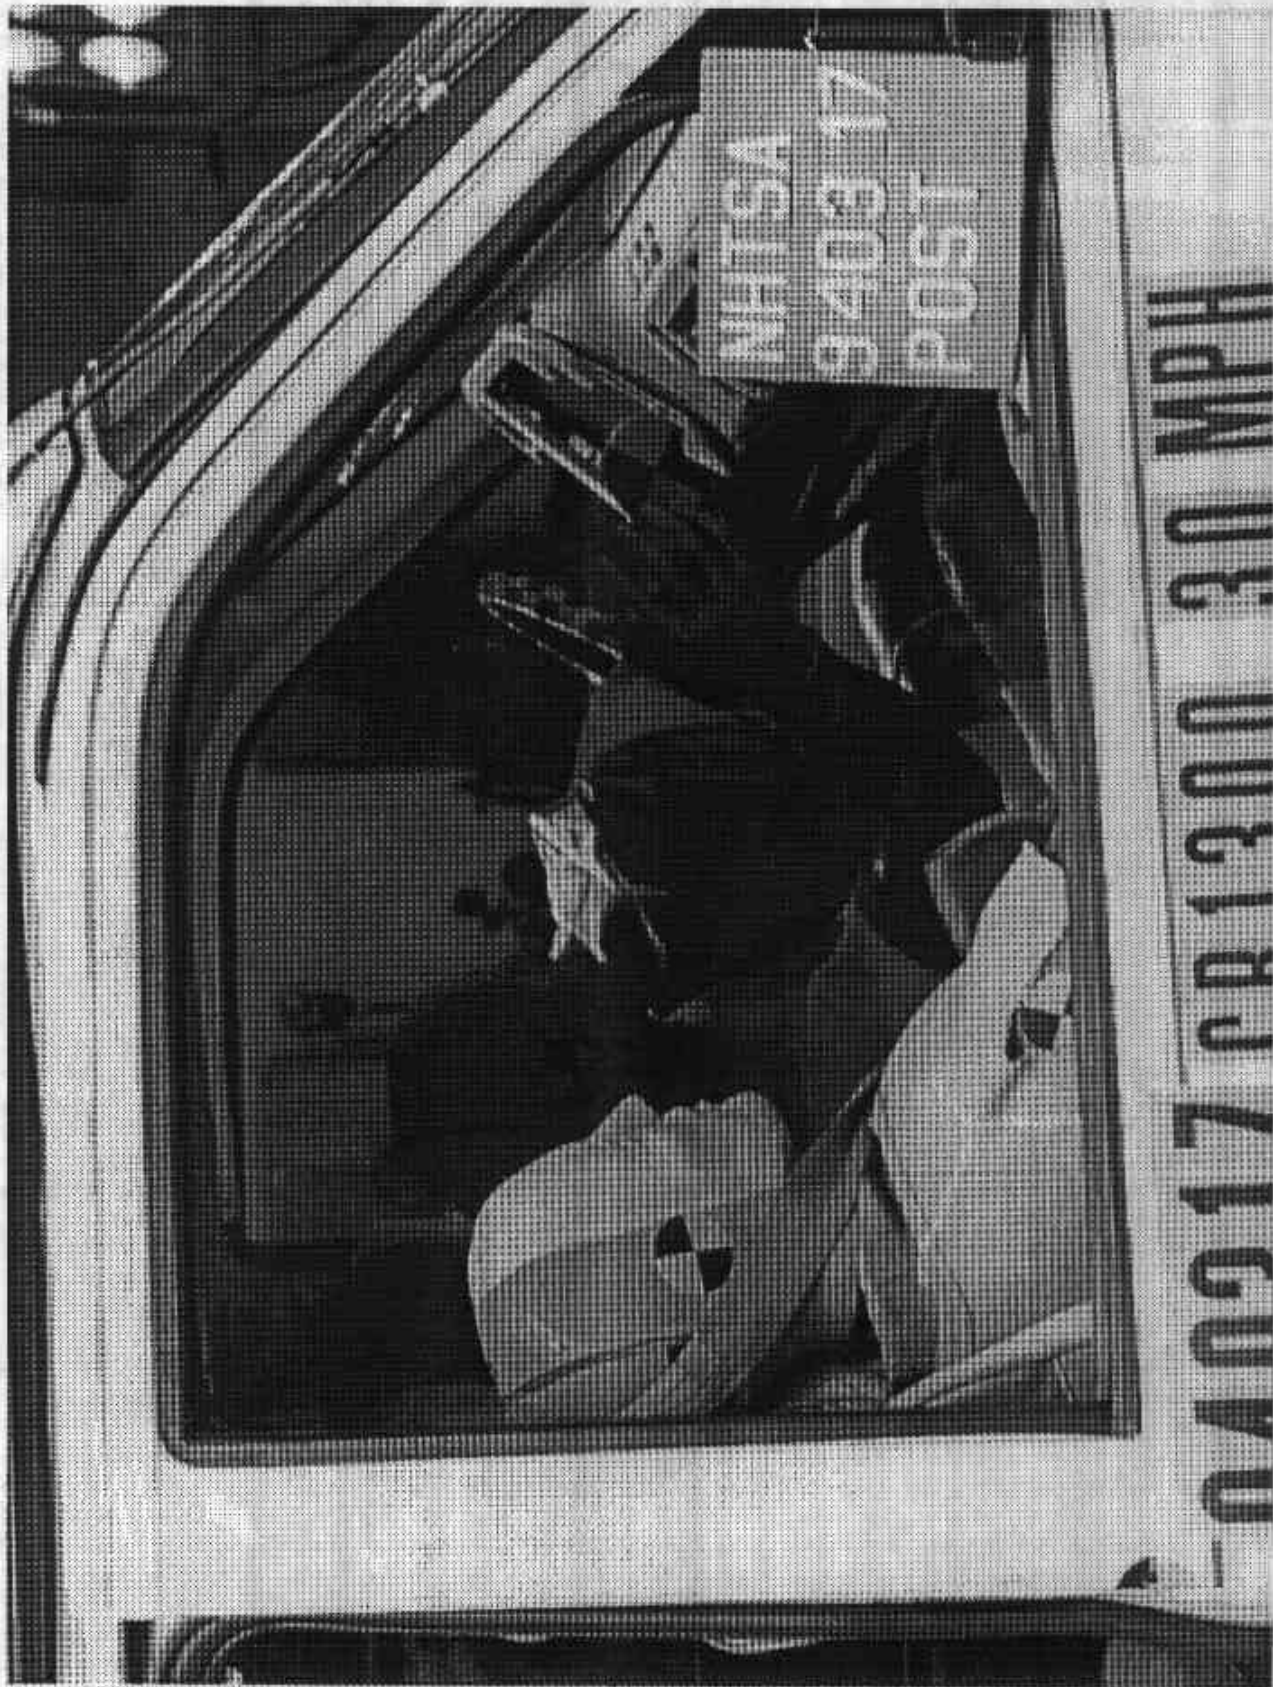
Figure A-40. Post-test Passenger Dummy Position - View 2  
A-41

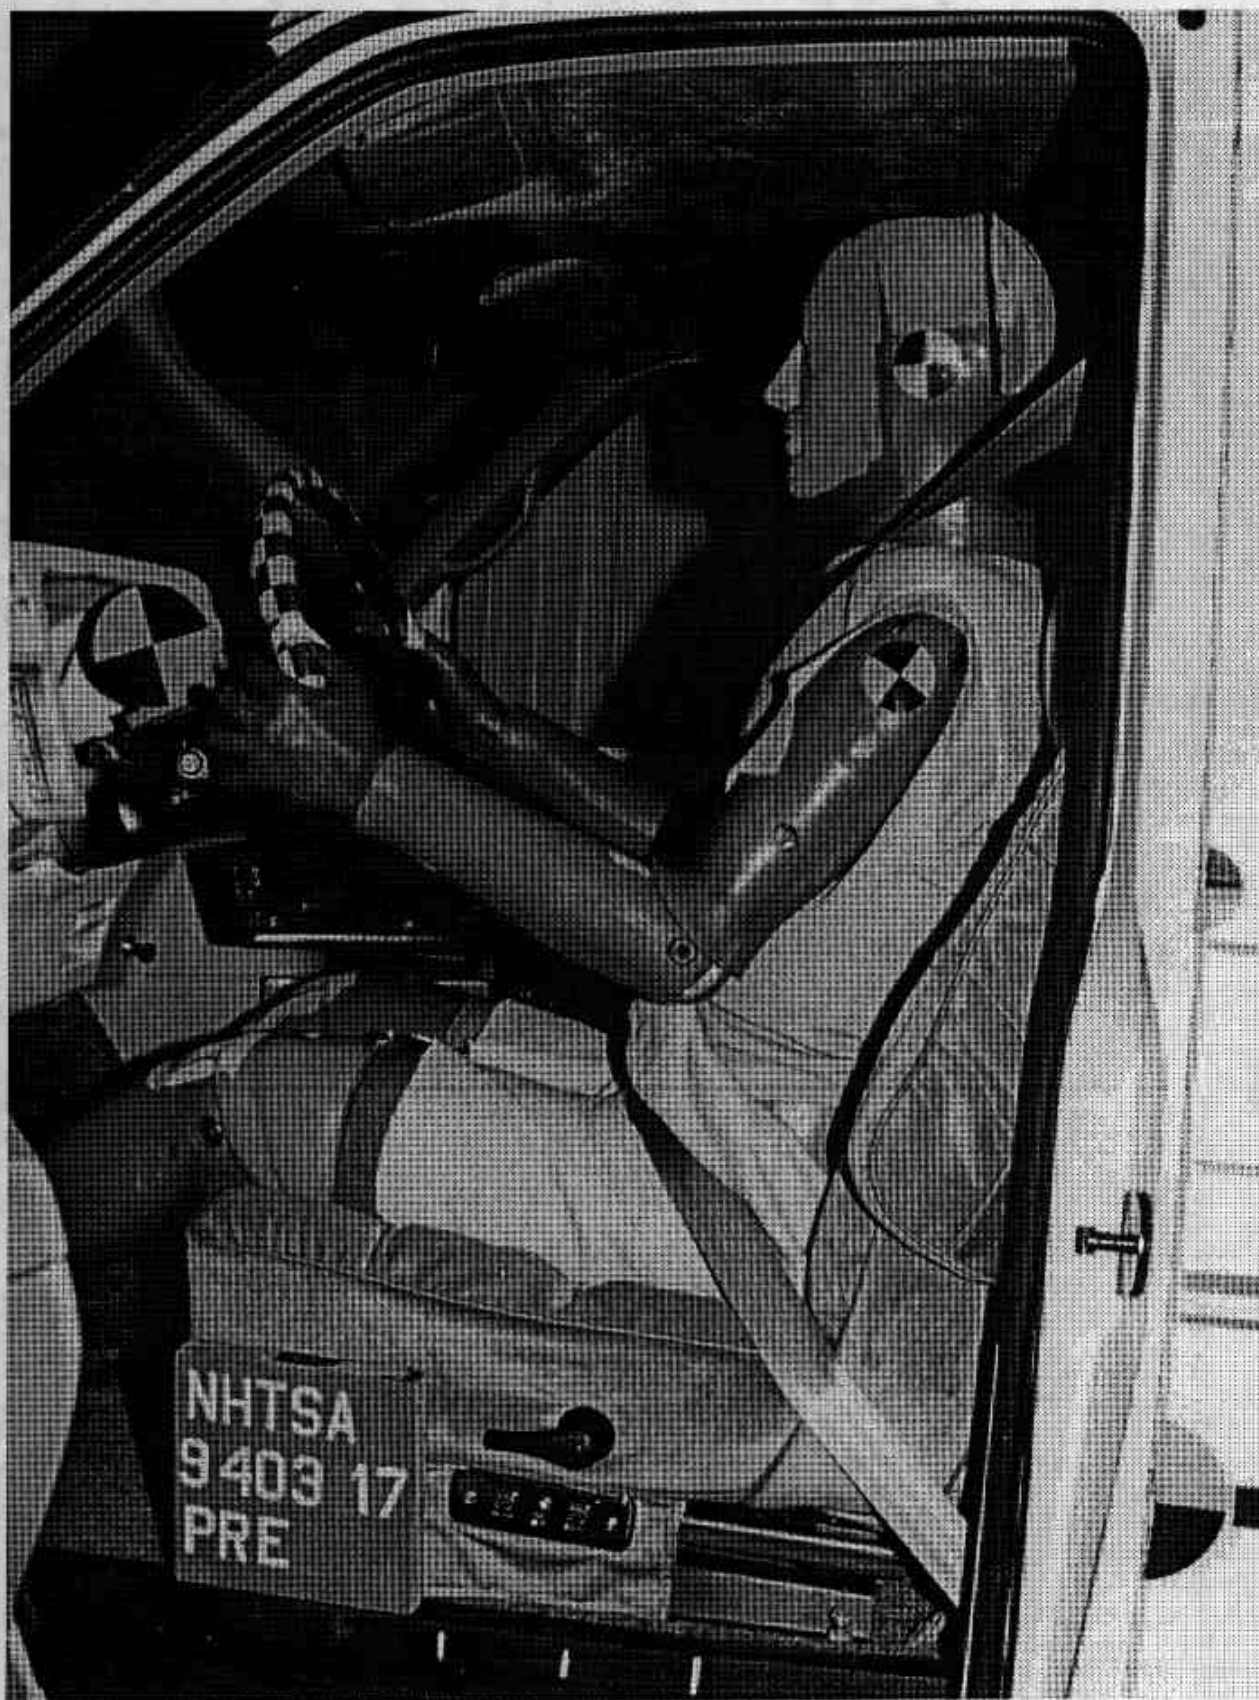
Figure A-41. Pre-test Driver Dummy & Vehicle Interior - View 1  
A-42

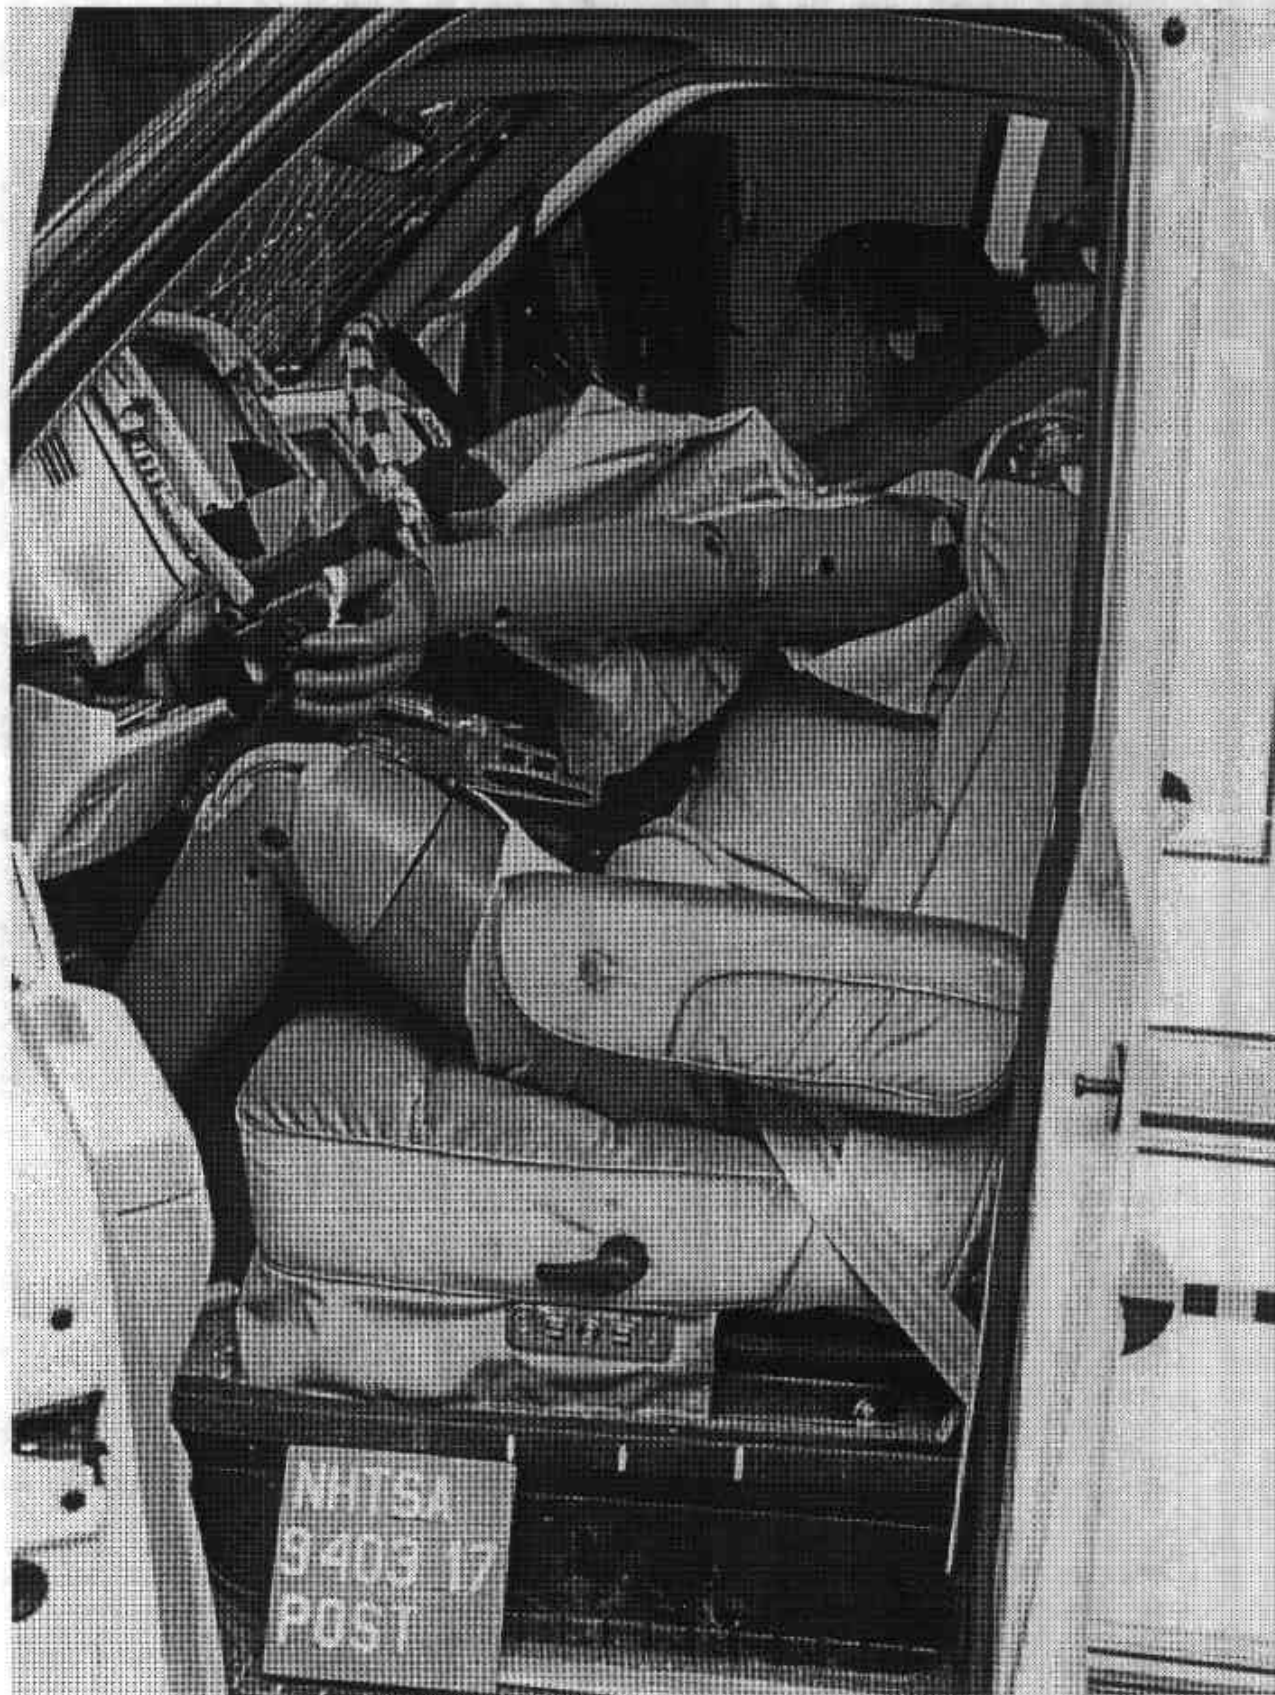
Figure A-42. Post-test Driver Dummy & Vehicle Interior - View 1  
A-43

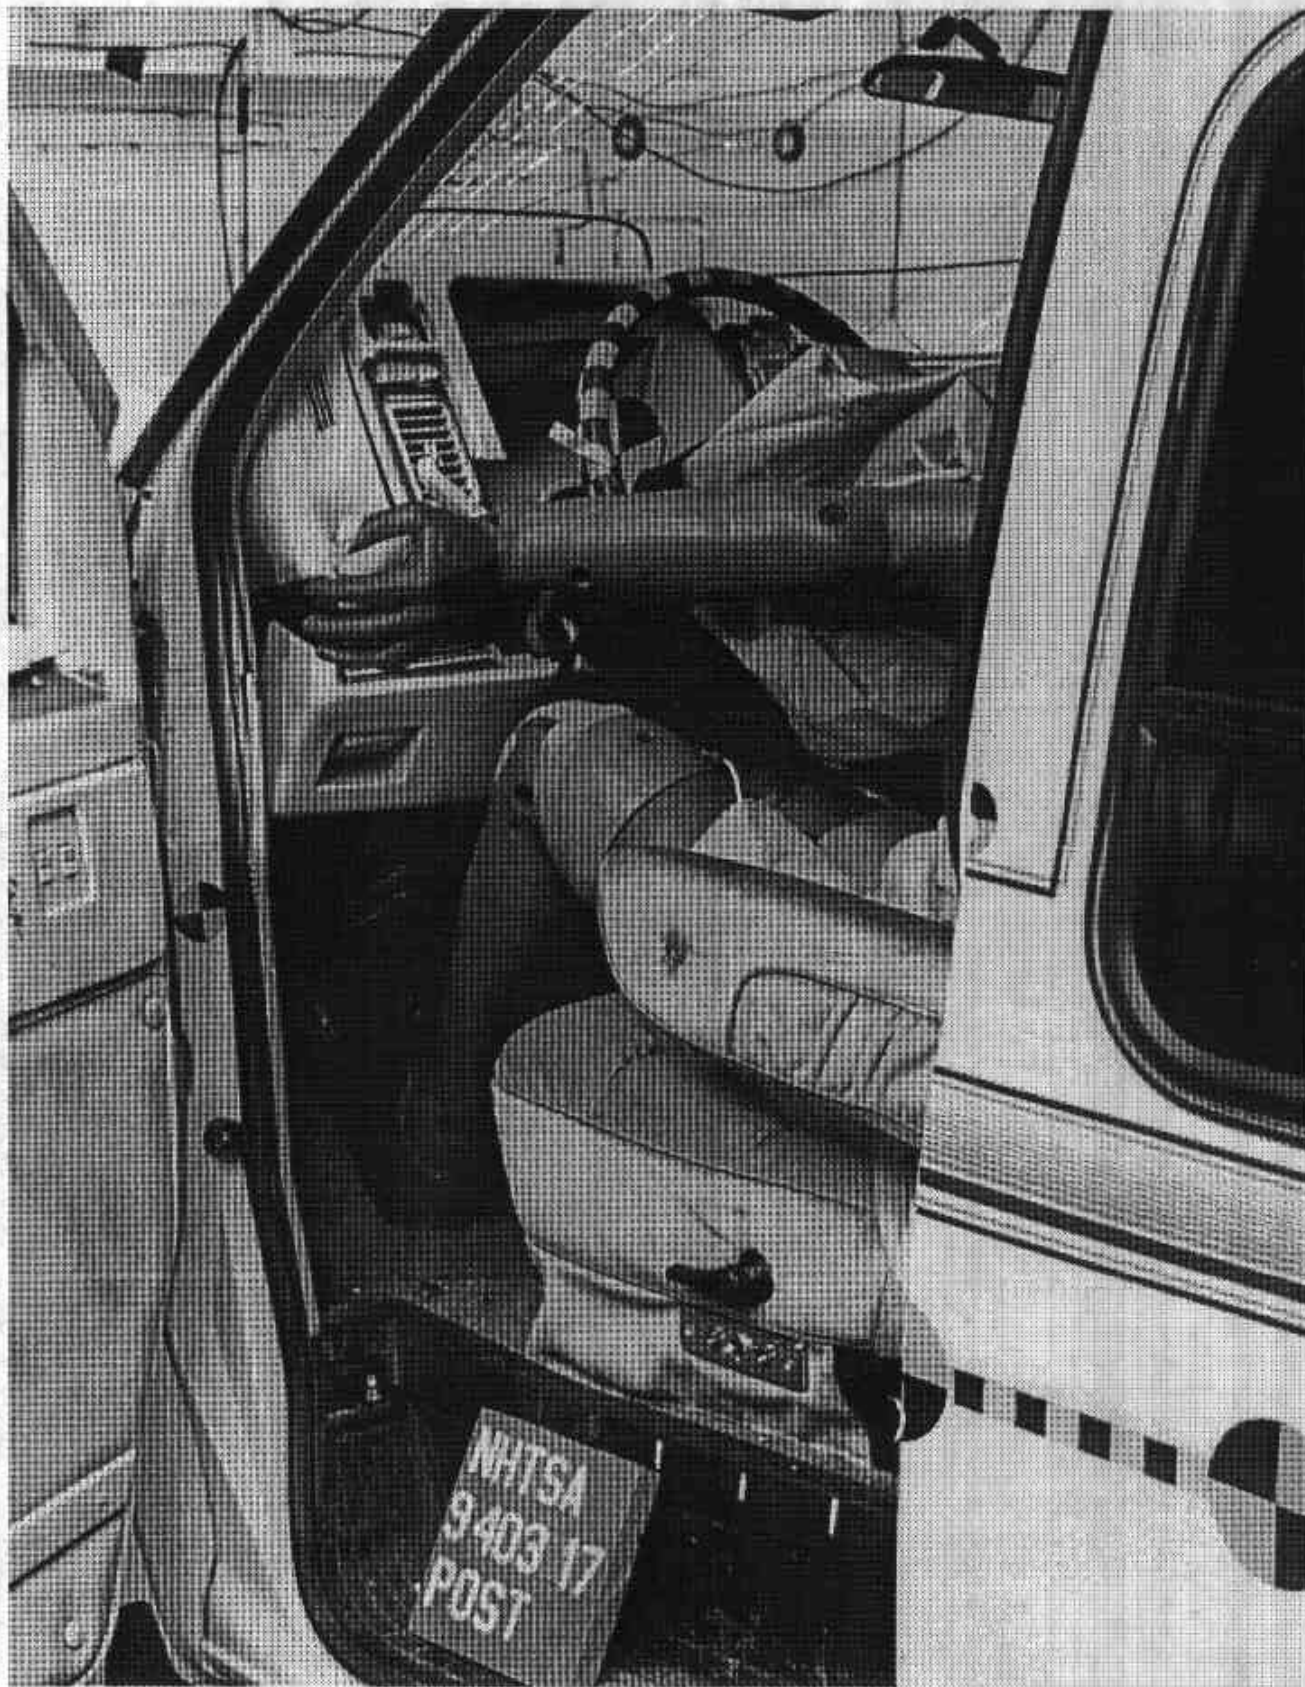
Figure A-44. Post-test Driver Dummy & Vehicle Interior - View 2

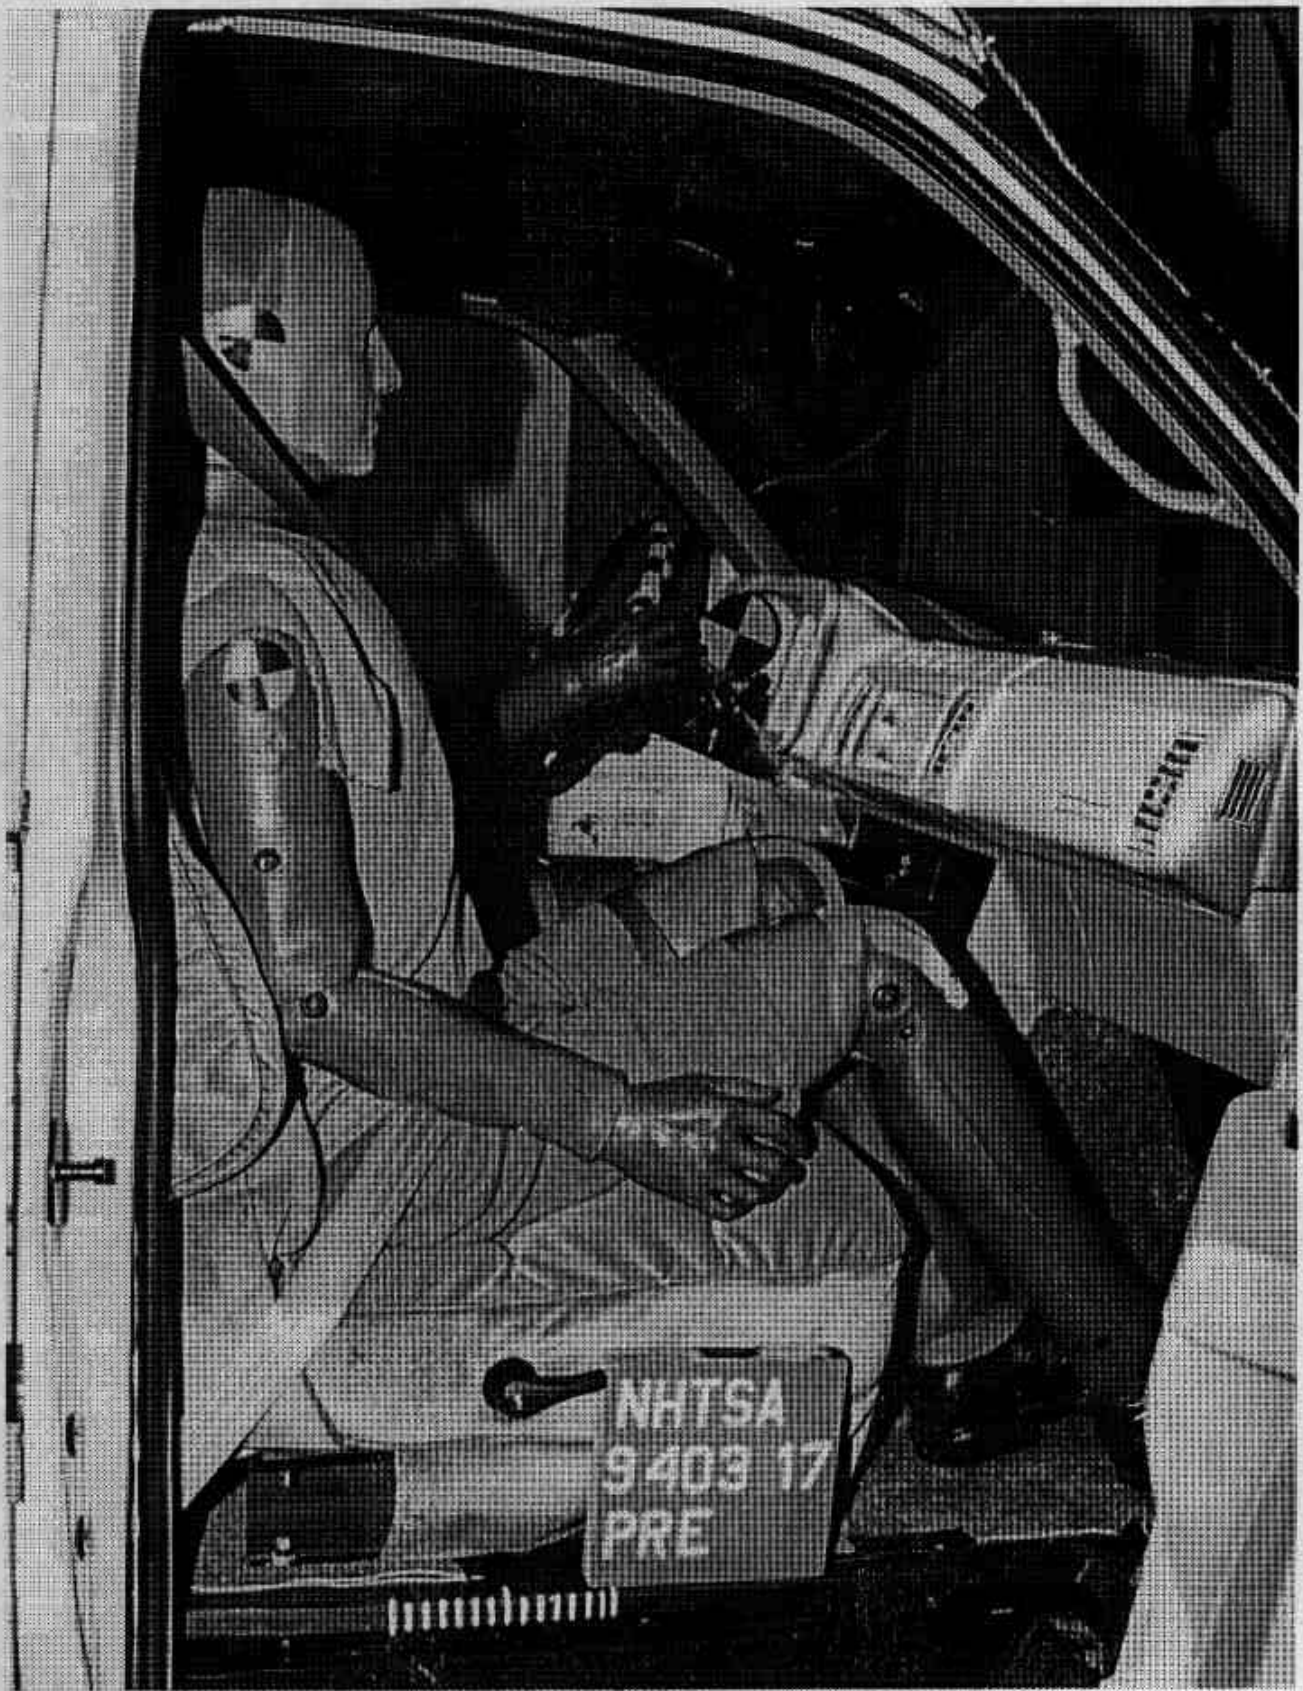
Figure A-45. Pre-test Passenger Dummy & Vehicle Interior - View 1

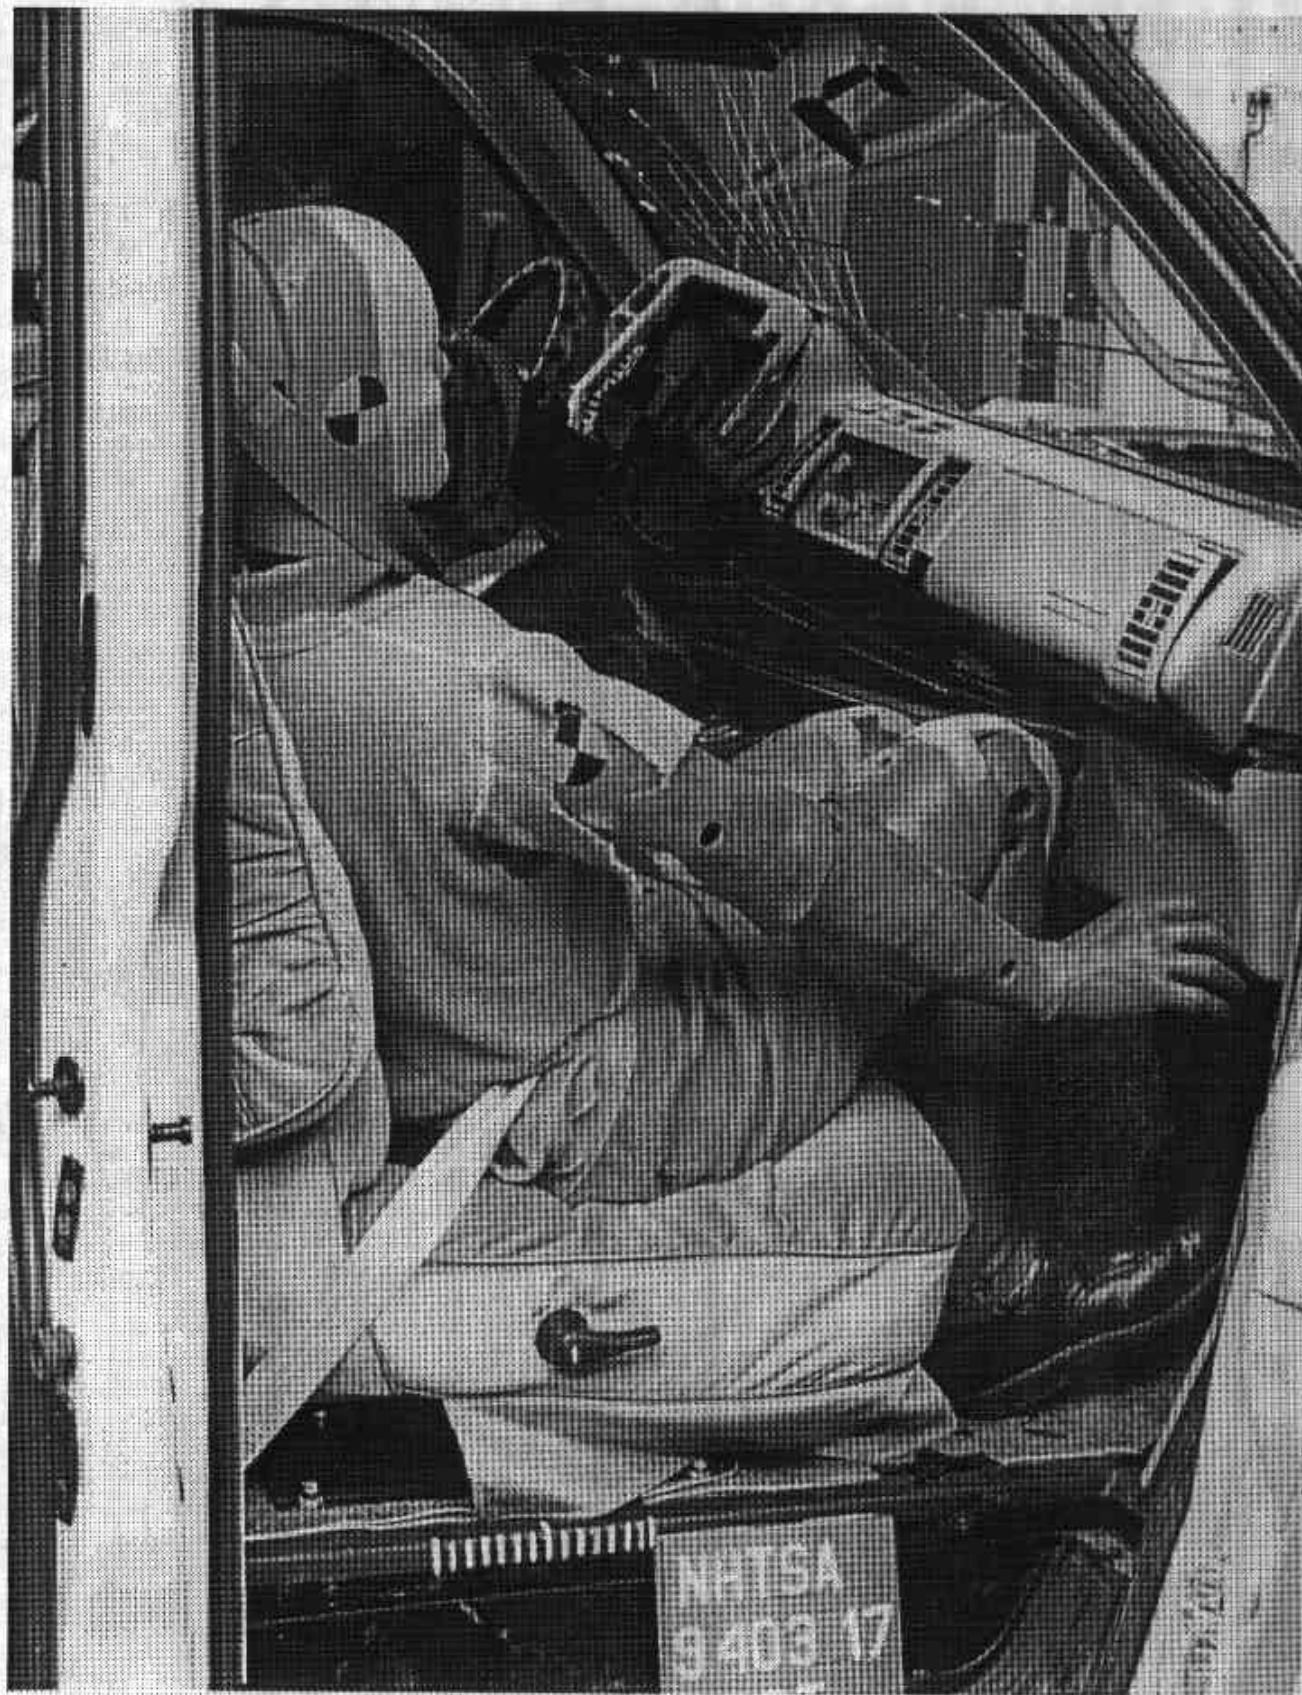
Figure A-46. Post-test Passenger Dummy & Vehicle Interior - View 1  
A-47

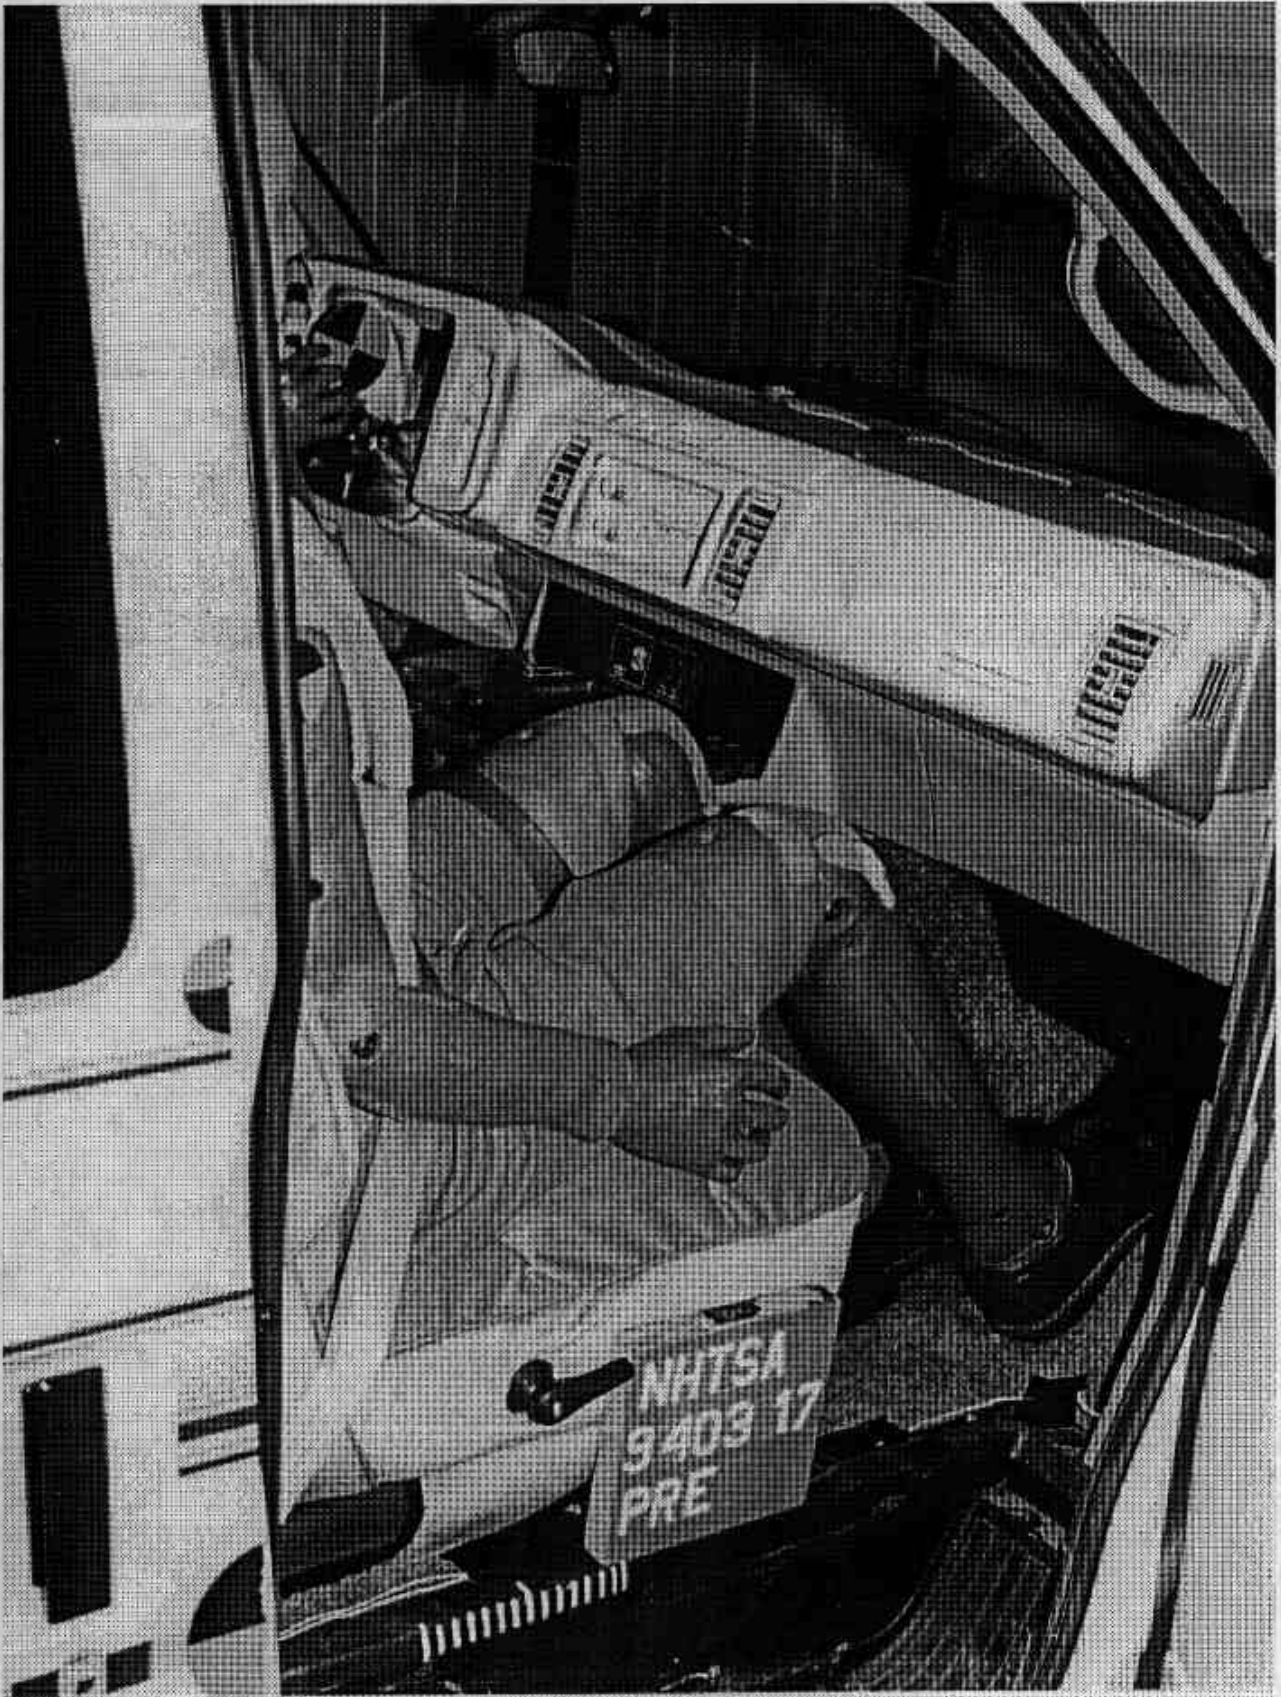
Figure A-47. Pre-test Passenger Dummy & Vehicle Interior - View 2

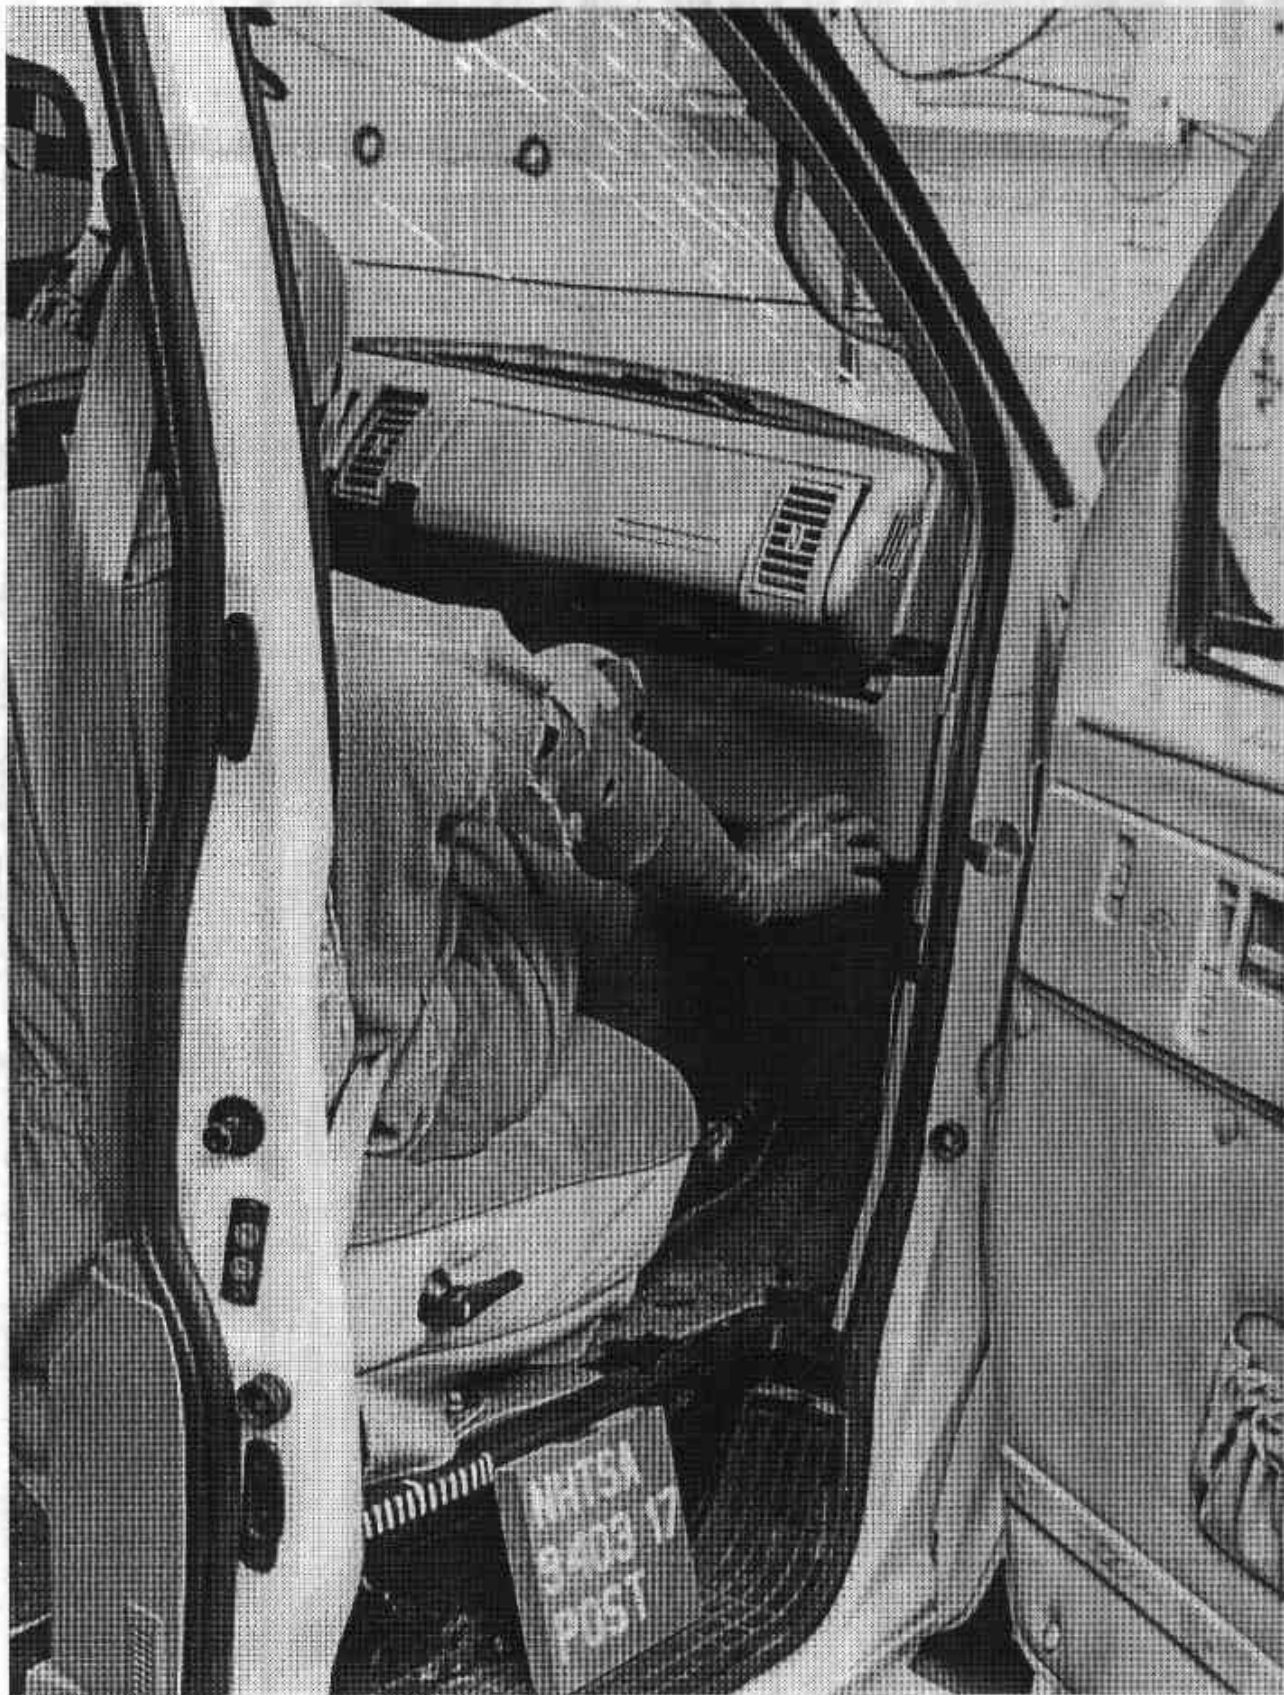
Figure A-48. Post-test Passenger Dummy & Vehicle Interior - View 2
