Vehicle Safety Compliance Testing  
for Occupant Crash Protection,  
Windshield Mounting, Windshield Zone Intrusion,  
and Fuel System Integrity

Explorer Van Division of  
Bodor Corporation  
1994 Explorer van  
NHTSA Number: CR1300  
TRC Test Number: 940317

Transportation Research Center Inc.  
10820 State Route 347  
East Liberty, Ohio 43319

Final Report

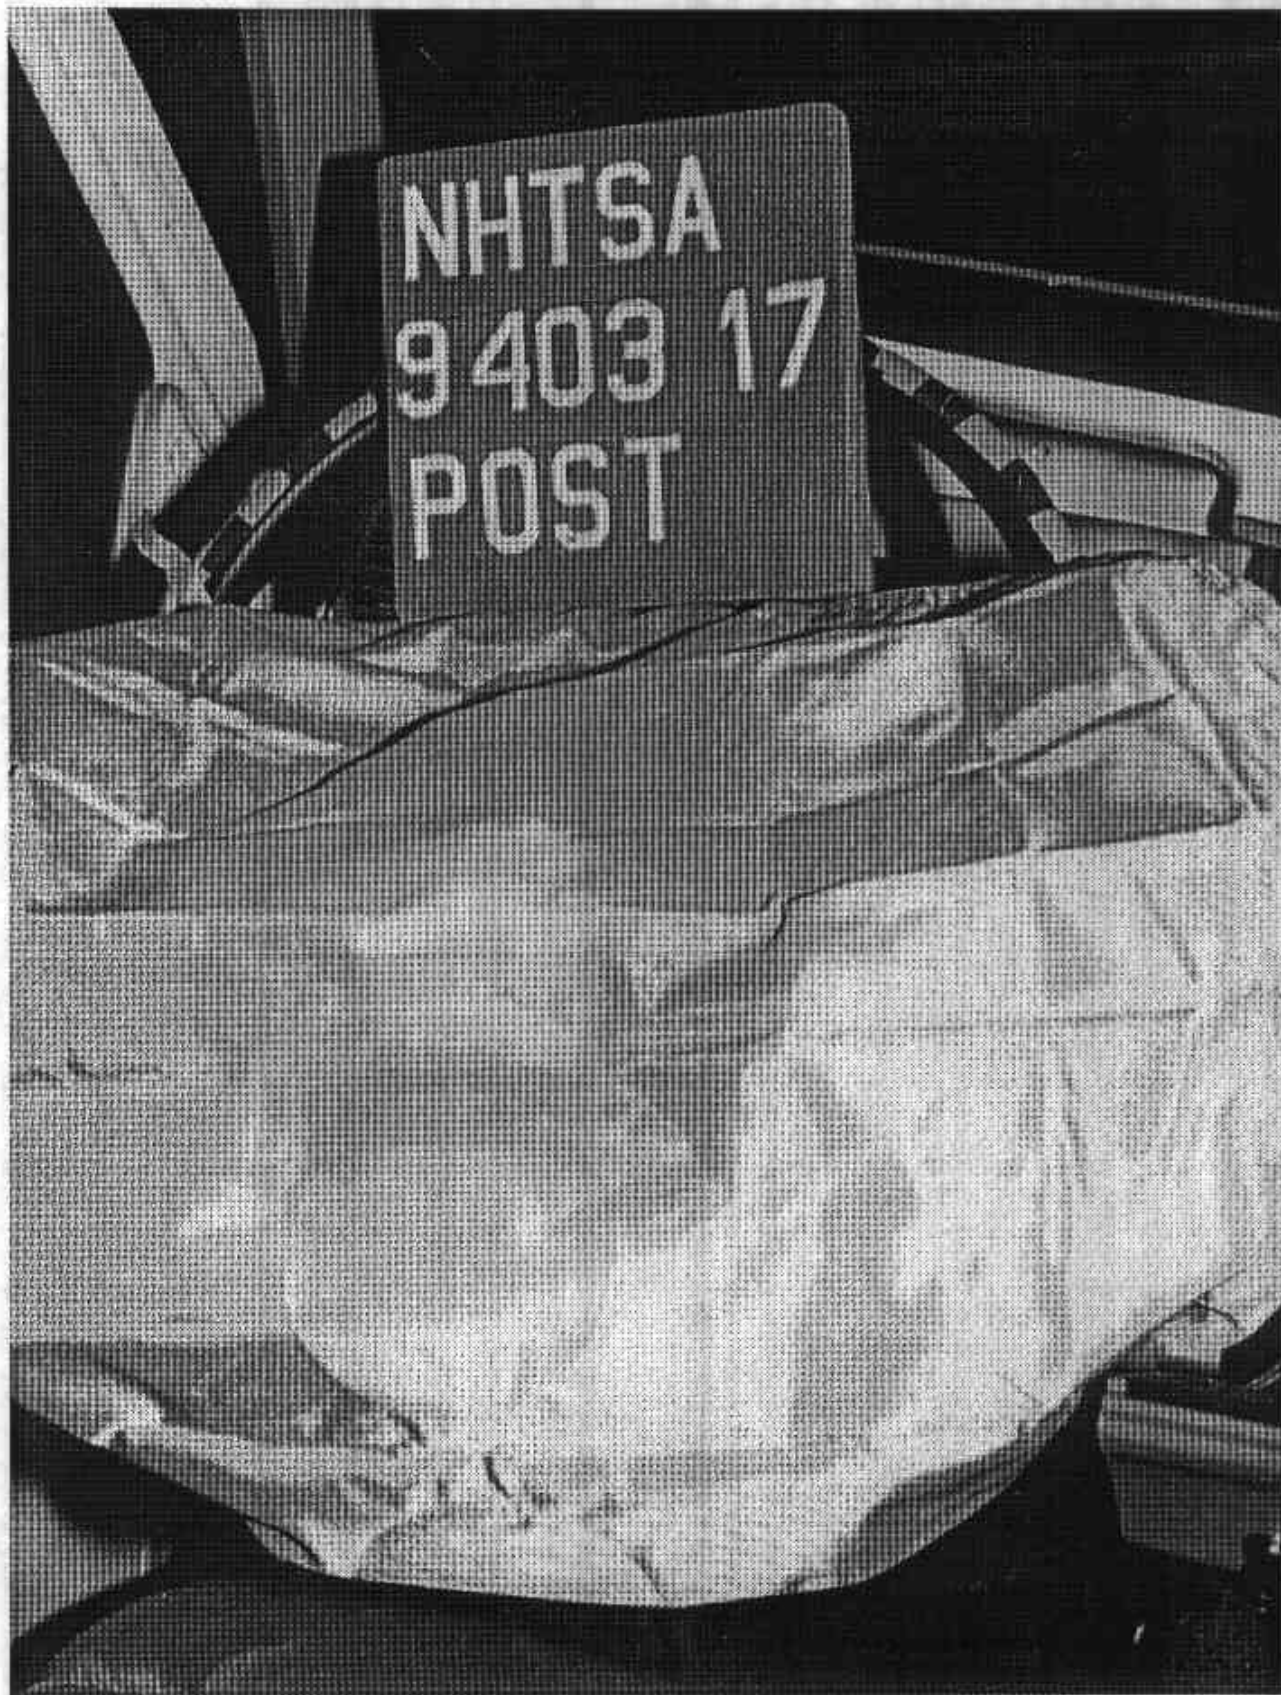
Figure A-50. Post-test Driver Dummy Head Contact - View 2  
A-51

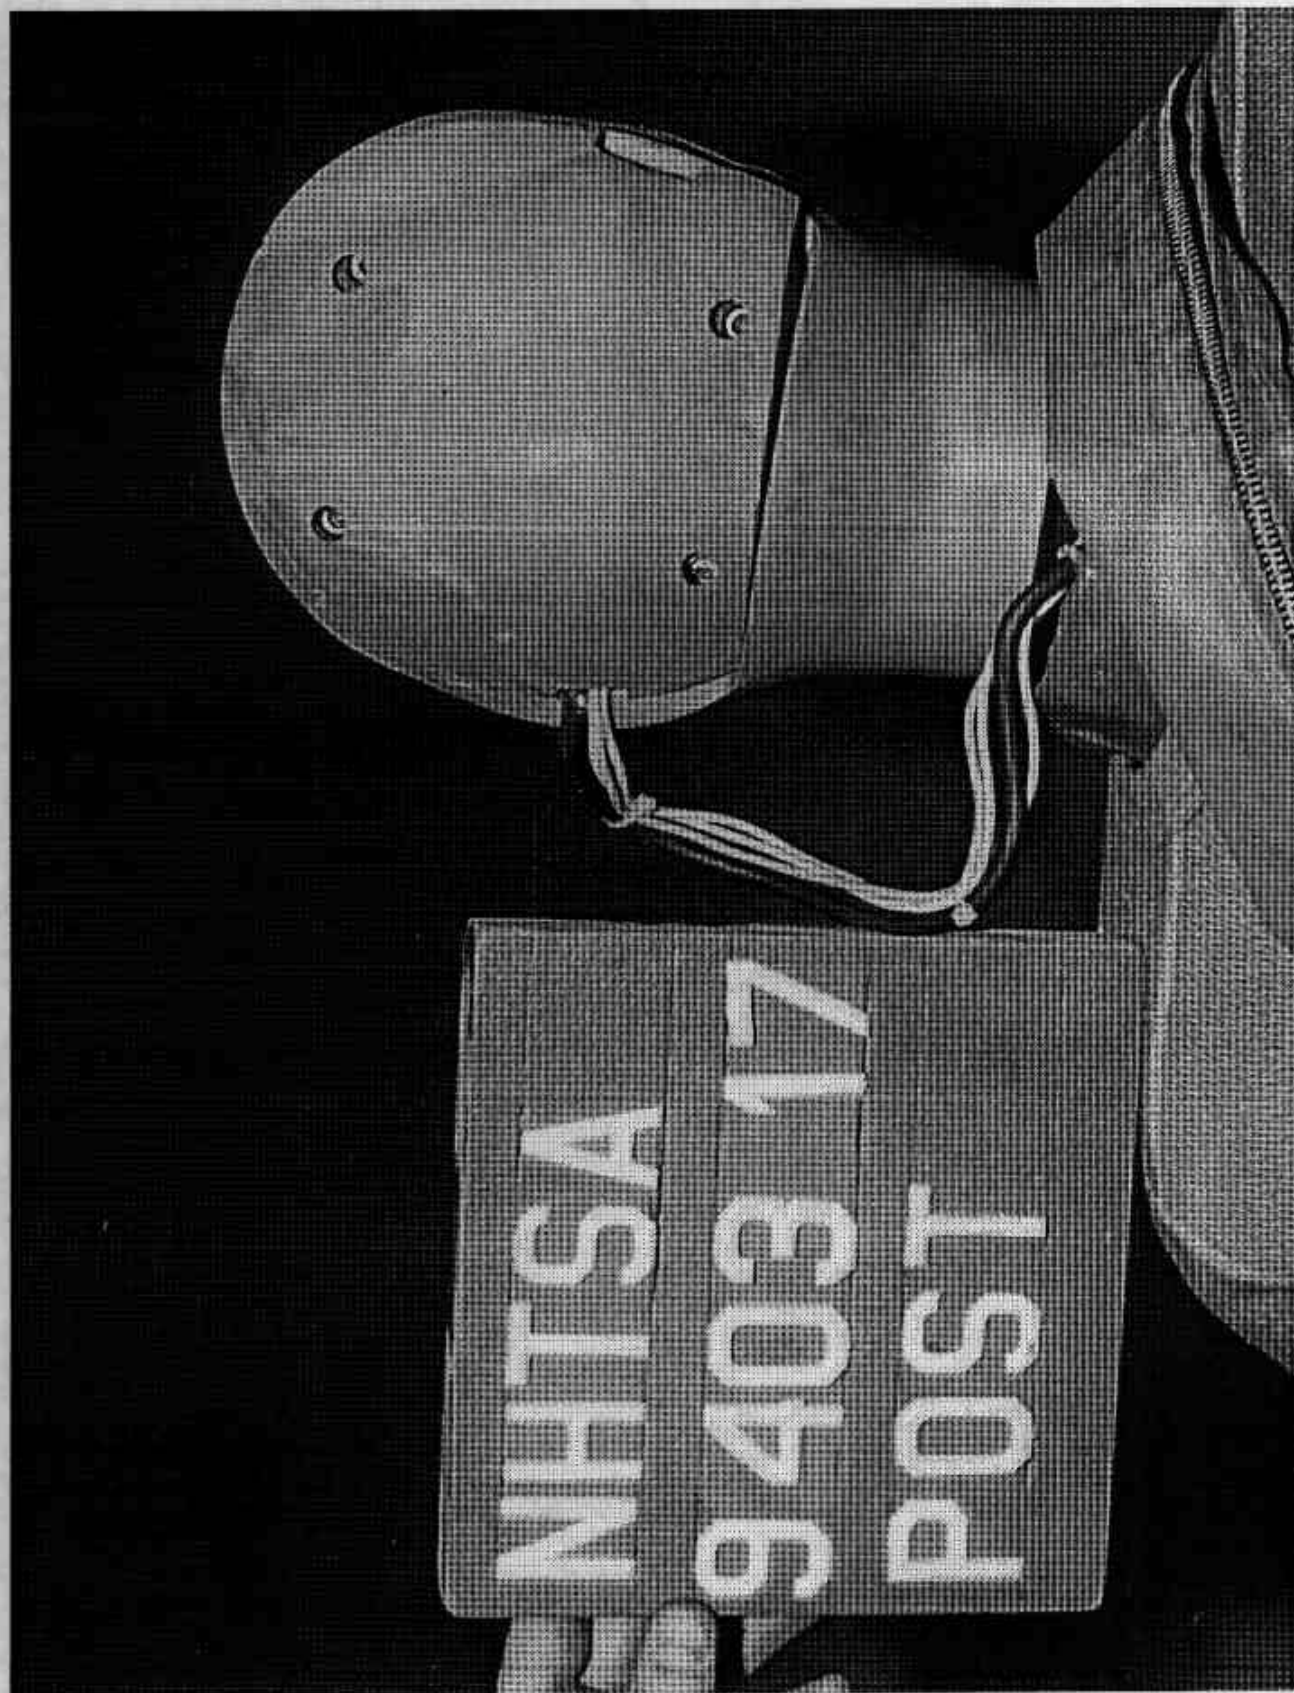
Figure A-55. Post-test Passenger Dummy Head Contact - View 2  
A-56

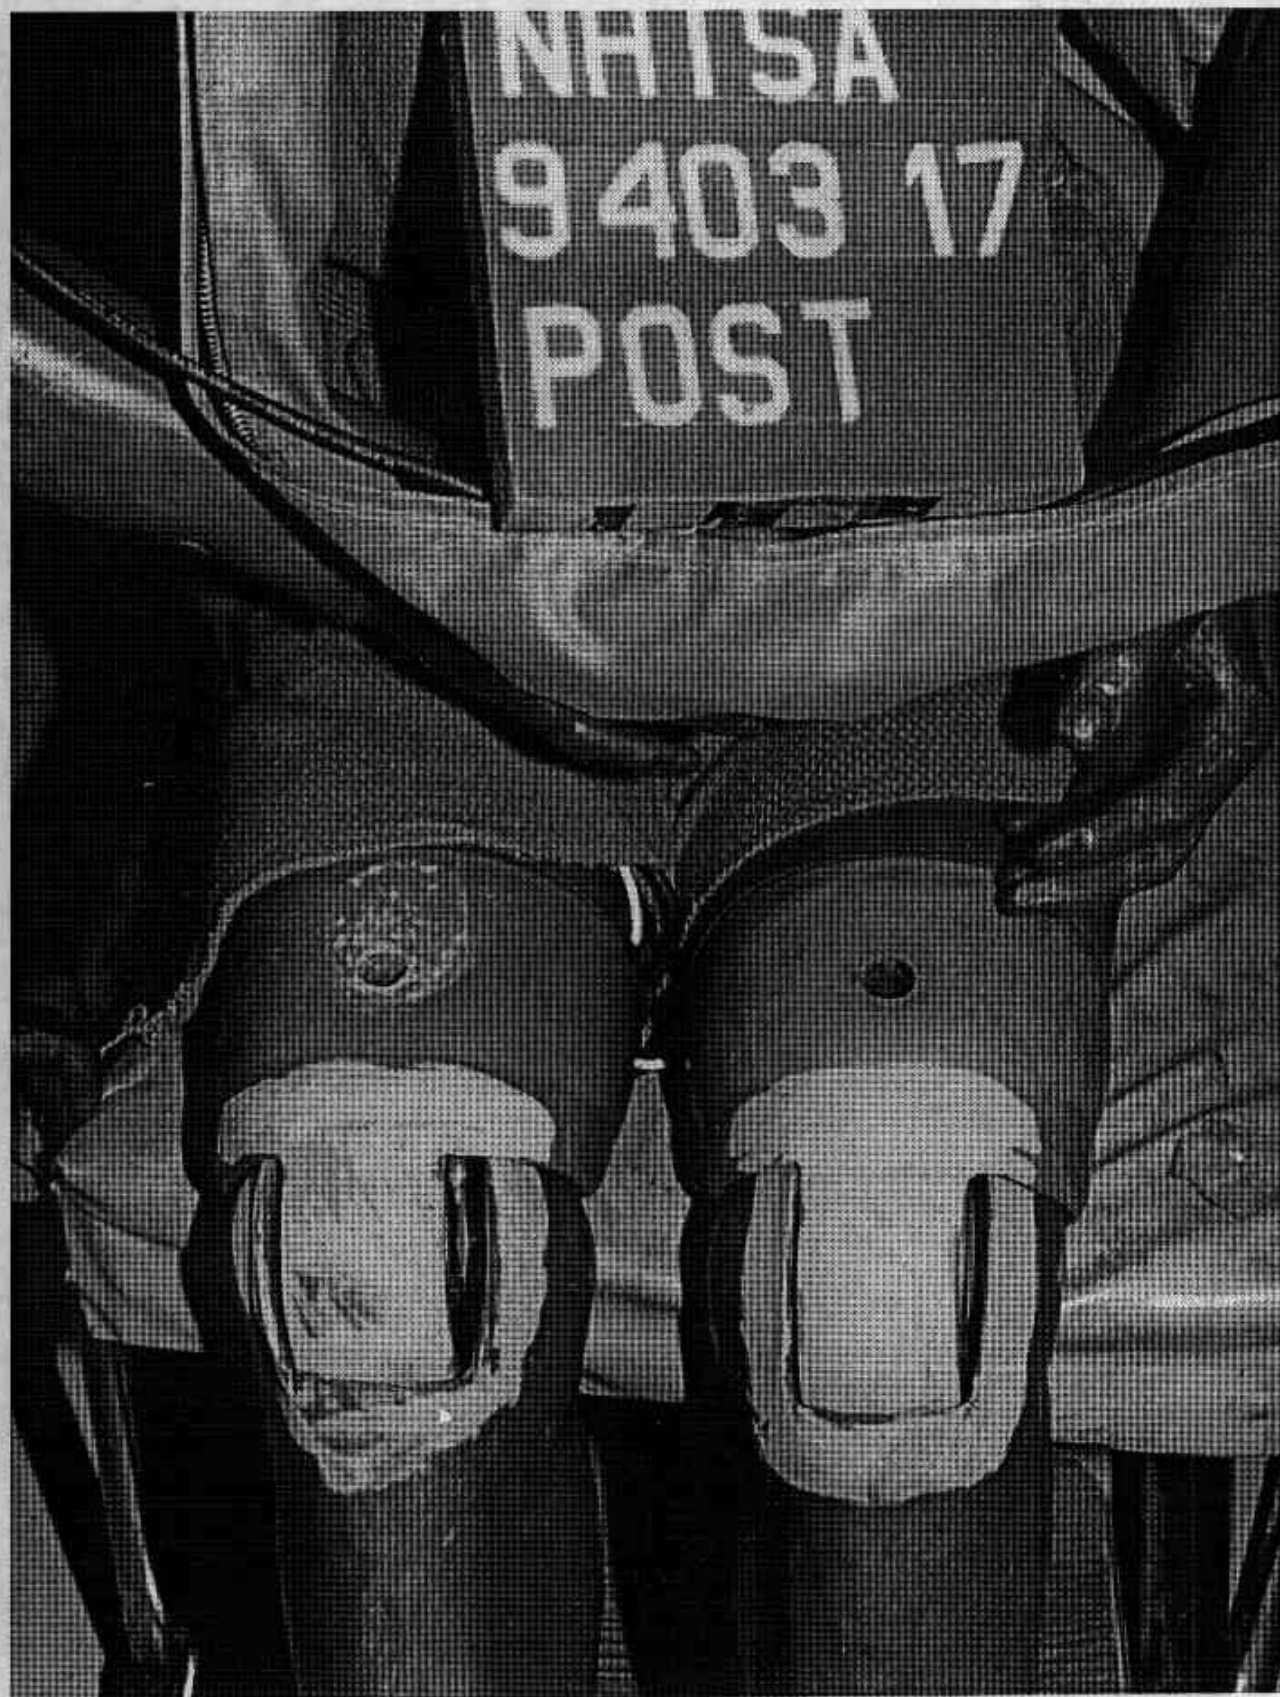
Figure A-57. Post-test Passenger Dummy Knee Contact - View 1  
A-58
