Vehicle Safety Compliance Testing
for Occupant Crash Protection,
Windshield Mounting, Windshield Zone Intrusion,
and Fuel System Integrity

Kentron, Inc.
1994 Kentron SS Sport Top Van
NHTSA Number: CR1301
TRC Test Number: 940322

Transportation Research Center Inc.
10820 State Route 347
East Liberty, Ohio 43319

Final Report

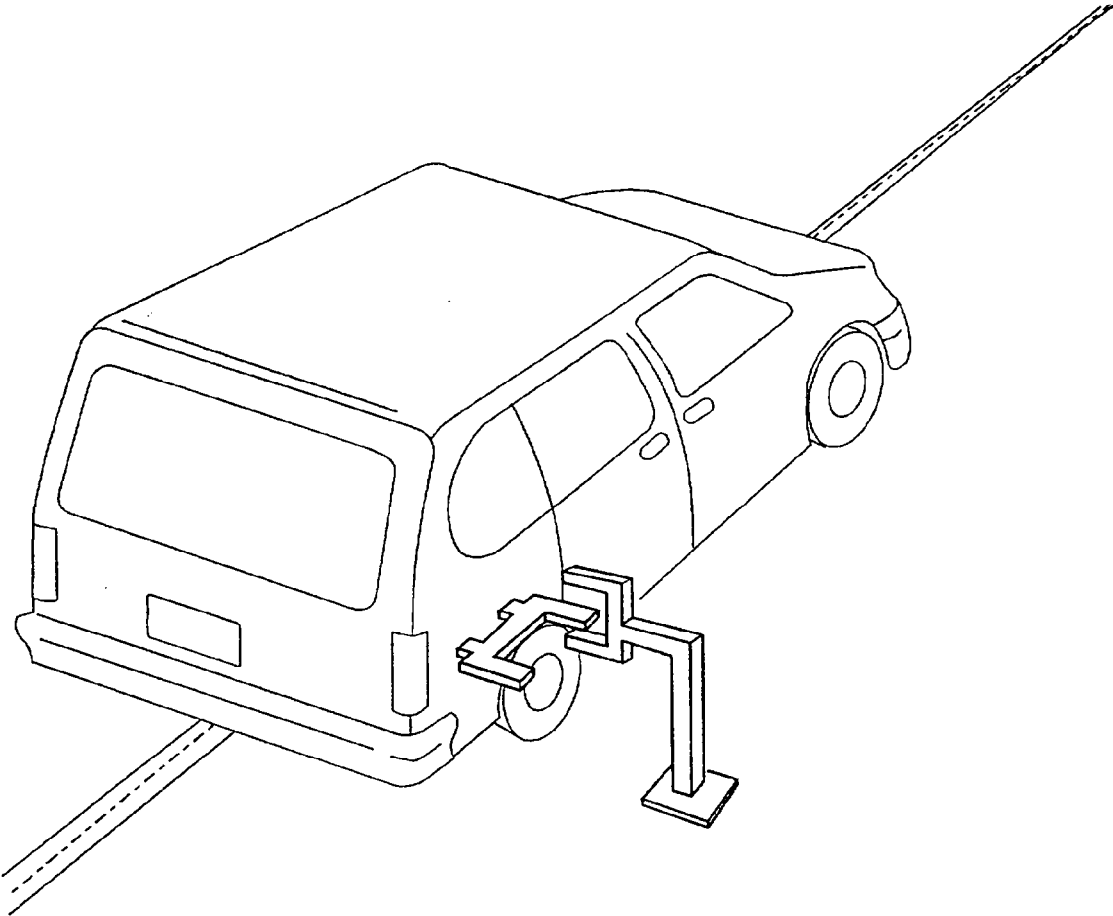
Figure 1 Impact Velocity Measurement System

The final vane clears emitter/receiver two inches before impact.
The vanes have a one-foot spacing.

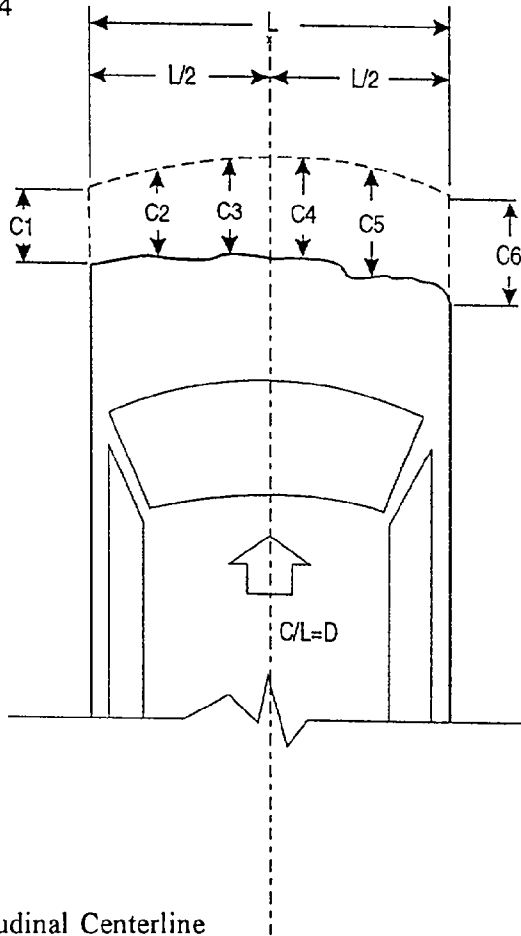
Figure 2 Accident Investigation Division Data for 30 mph Frontal Barrier Impact

Midpoint of damage: D: Vehicle Longitudinal Centerline

Length of damaged region: L: 64.4 in

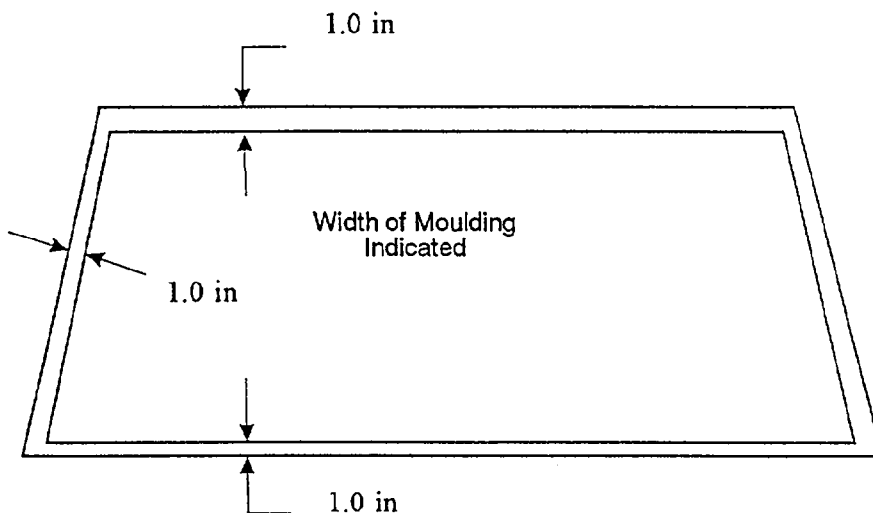
Front view of windshield¹

Pre-test	Post-test	Percent Retention
Right side	89.0 in	89.0 in	100.0
Left side	89.0 in	89.0 in	100.0
Total	178.0 in	178.0 in	100.0

Loss of windshield retention lengths: None

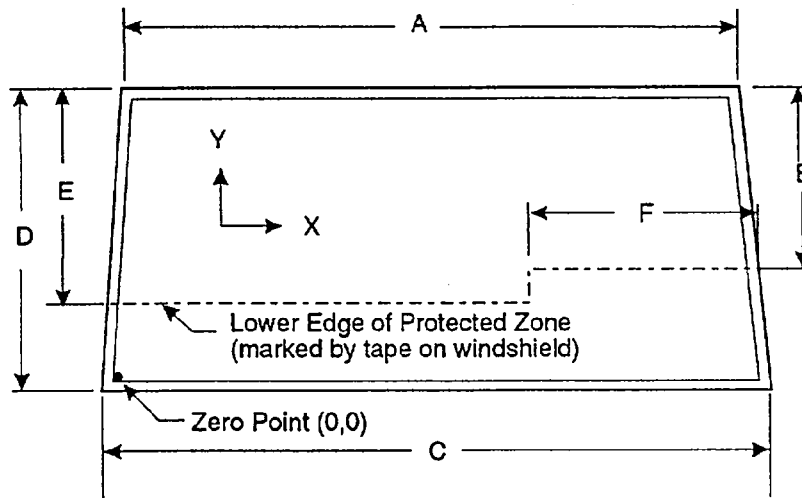
FRONT VIEW

- A: 64.0 in
- B: 14.1 in
- C: 73.0 in
- D: 25.0 in
- E: 16.6 in
- F: 48.8 in

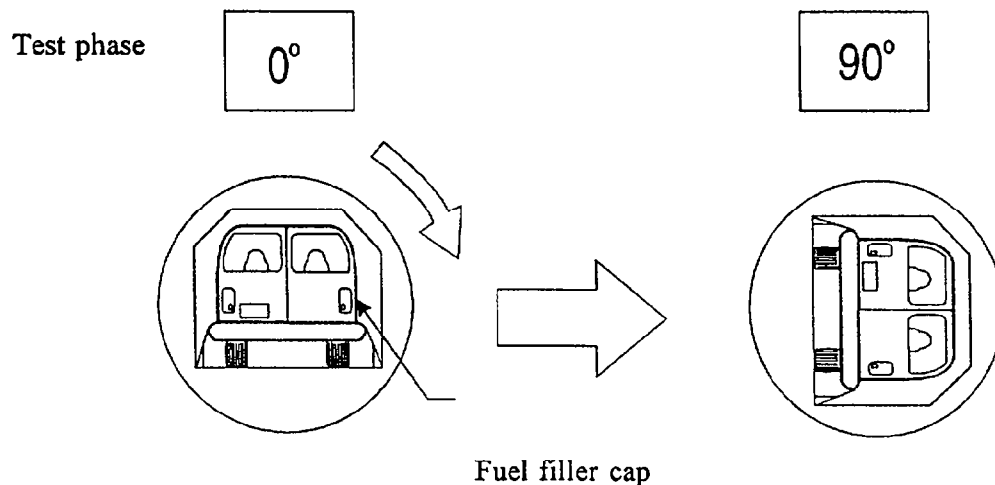
Figure 6 FMVSS 301 Static Rollover Test Data

Time required for machine to rotate 90° = 2 minutes, 0 seconds
 FMVSS 301 position hold time = 5 minutes, 0 seconds
 Total = 7 minutes, 0 seconds
 Next whole minute interval = 7 minutes

Fuel system fluid spillage location(s): None

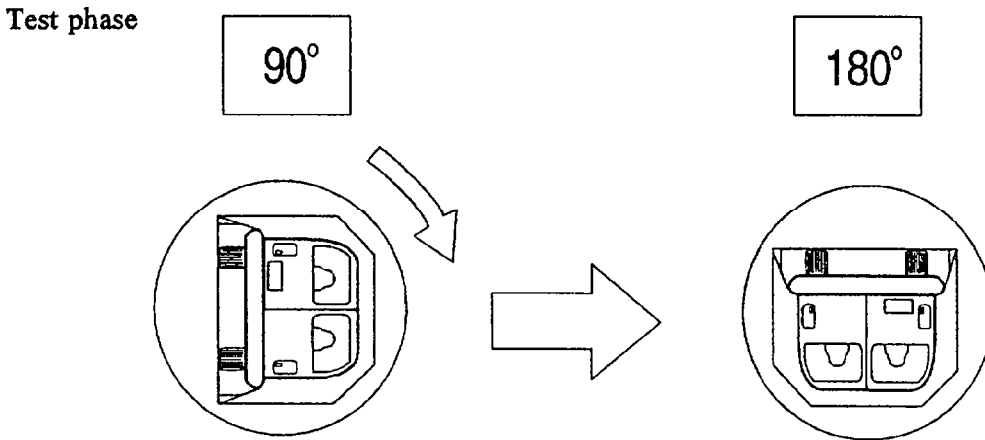
Figure 6 FMVSS 301 Static Rollover Test Data, Cont'd.

Time required for machine to rotate 90° = 2 minutes, 0 seconds
 FMVSS 301 position hold time = 5 minutes, 0 seconds
 Total = 7 minutes, 0 seconds
 Next whole minute interval = 14 minutes

Fuel system fluid spillage location(s): None

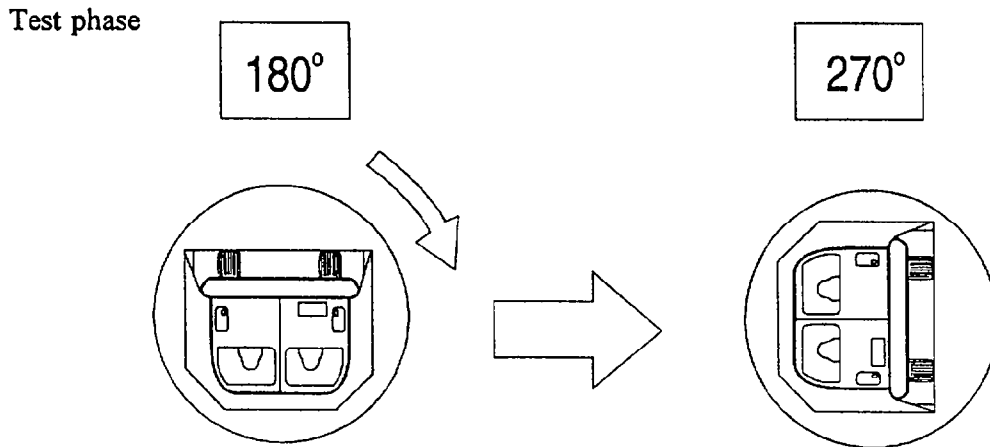
Figure 6 FMVSS 301 Static Rollover Test Data, Cont'd.

Time required for machine to rotate 90° = 2 minutes, 0 seconds
 FMVSS 301 position hold time = 5 minutes, 0 seconds
 Total = 7 minutes, 0 seconds
 Next whole minute interval = 21 minutes

Fuel system fluid spillage location(s): None

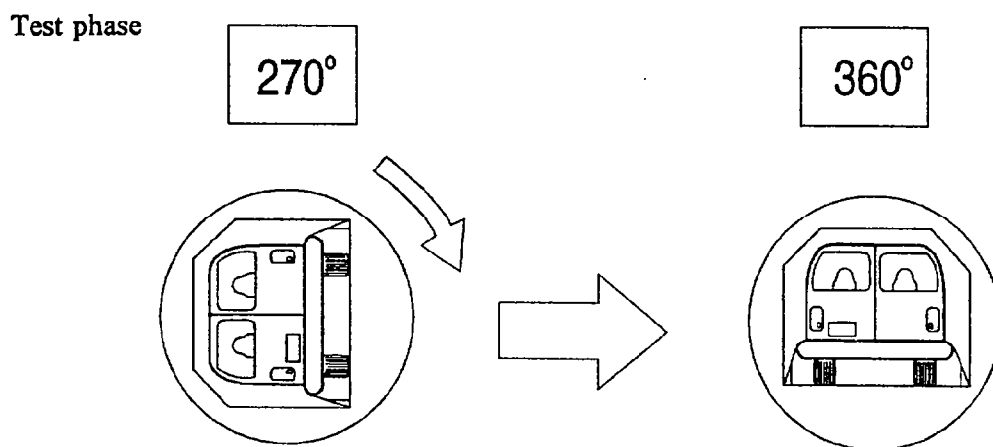
Figure 6 FMVSS 301 Static Rollover Test Data, Cont'd.

Time required for machine to rotate 90° = 2 minutes, 0 seconds
 FMVSS 301 position hold time = 5 minutes, 0 seconds
 Total = 7 minutes, 0 seconds
 Next whole minute interval = 28 minutes

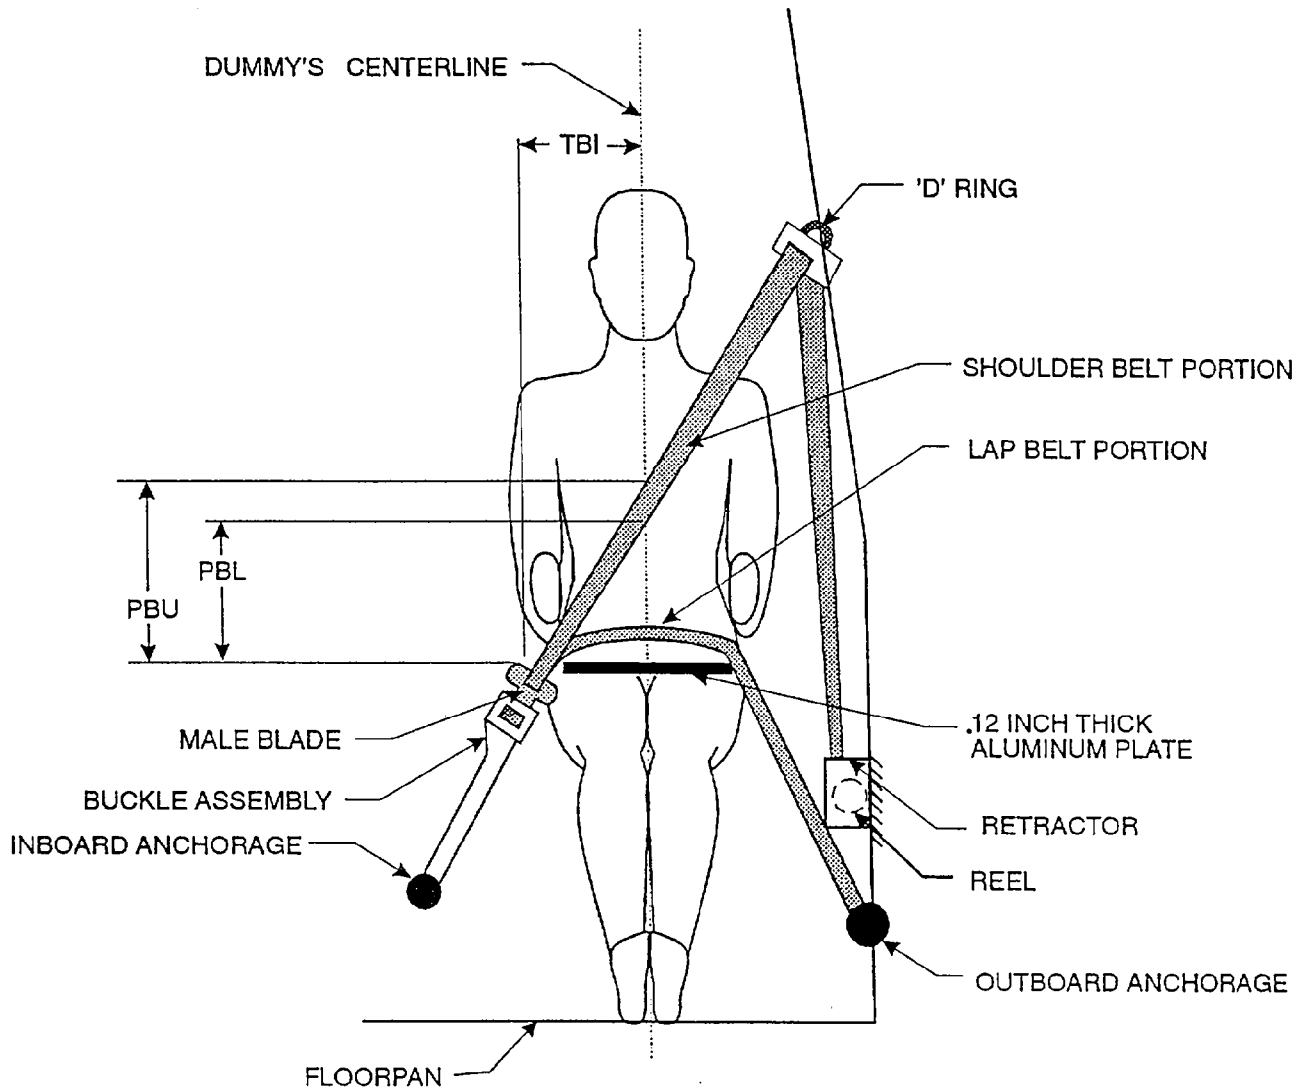
Figure 10 Seat Belt Positioning Data

Driver	Passenger
PBU - Top surface of aluminum plate to belt upper edge	14.1 in	14.1 in
PBU - Top surface of aluminum plate to belt upper edge	10.8 in	11.0 in
TBI - Dummy centerline to intersection of upper torso belt and lap belt	13.9 in	14.0 in

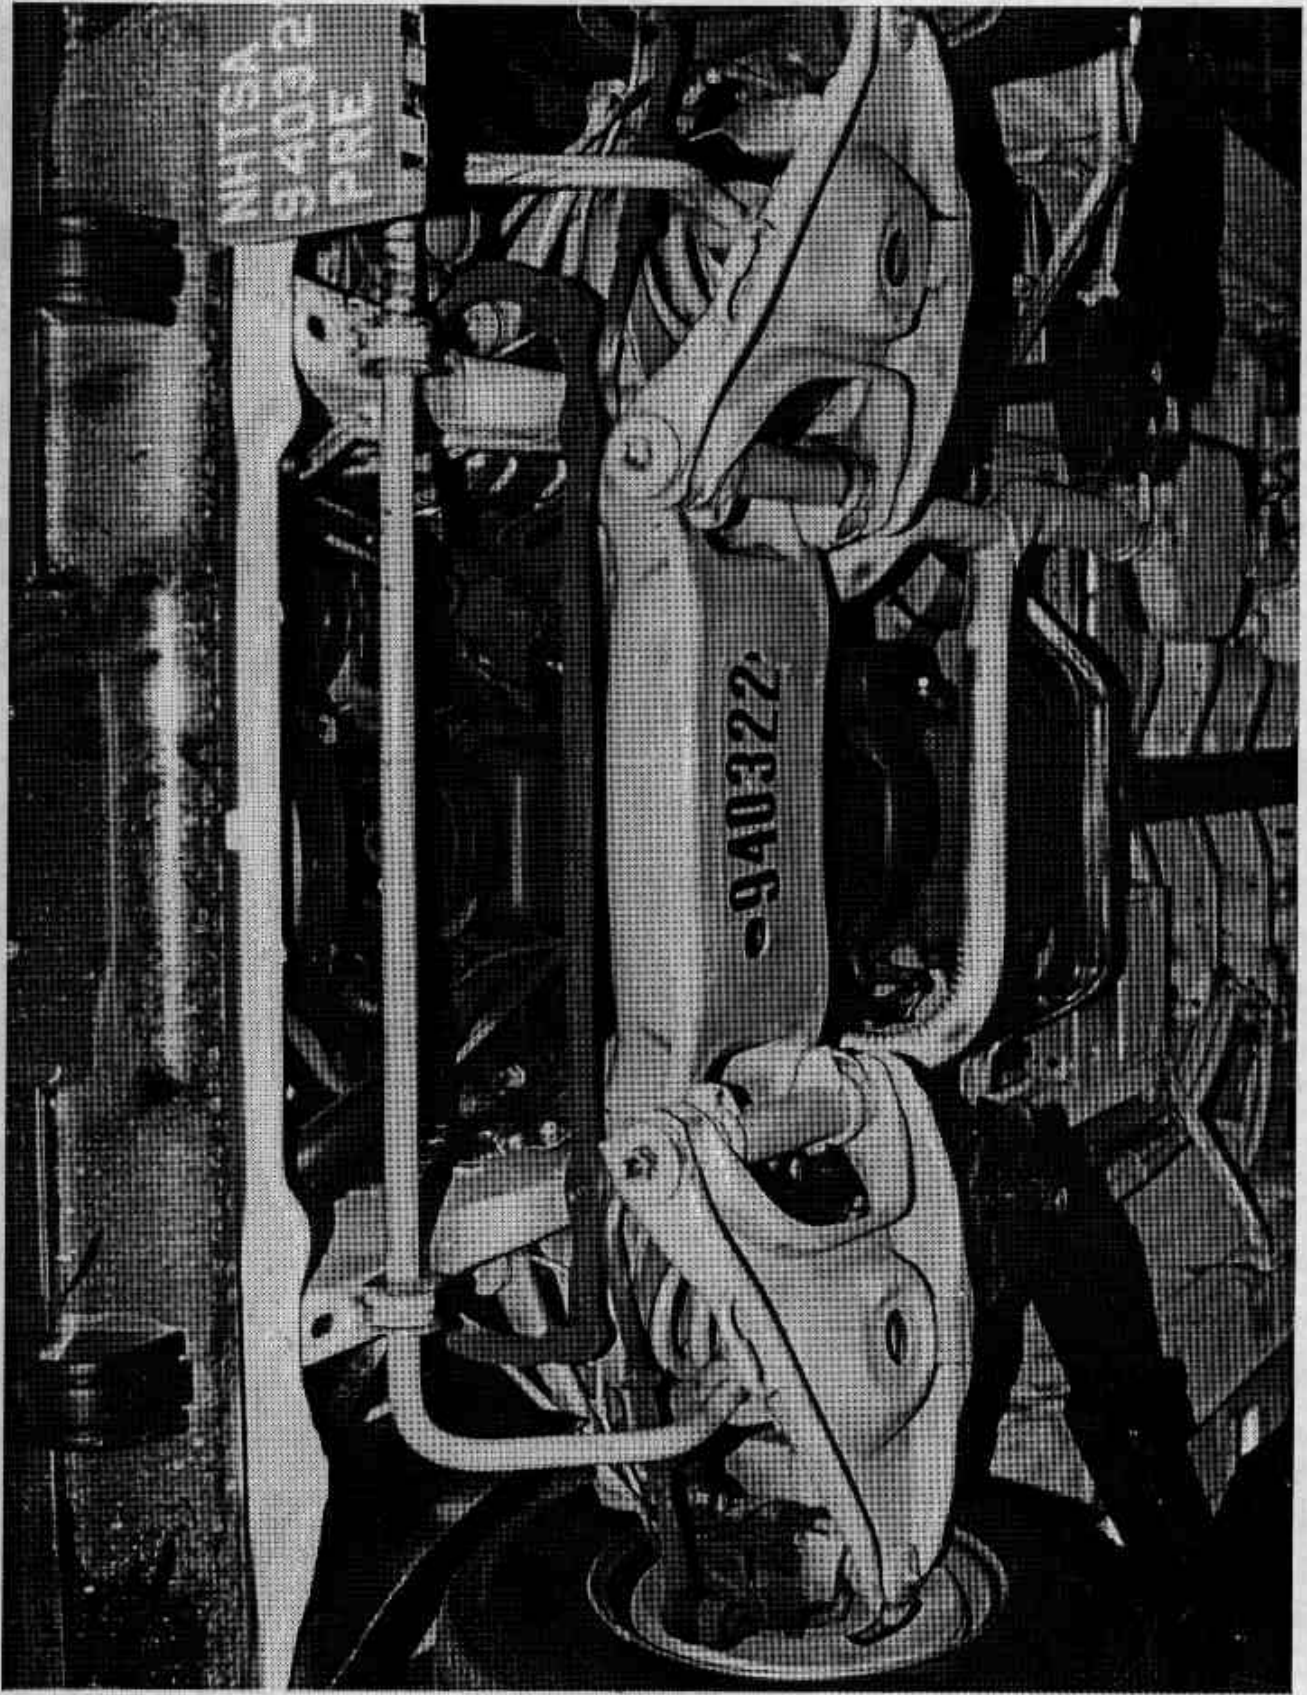
Figure A-23. Pre-test Front Underbody View

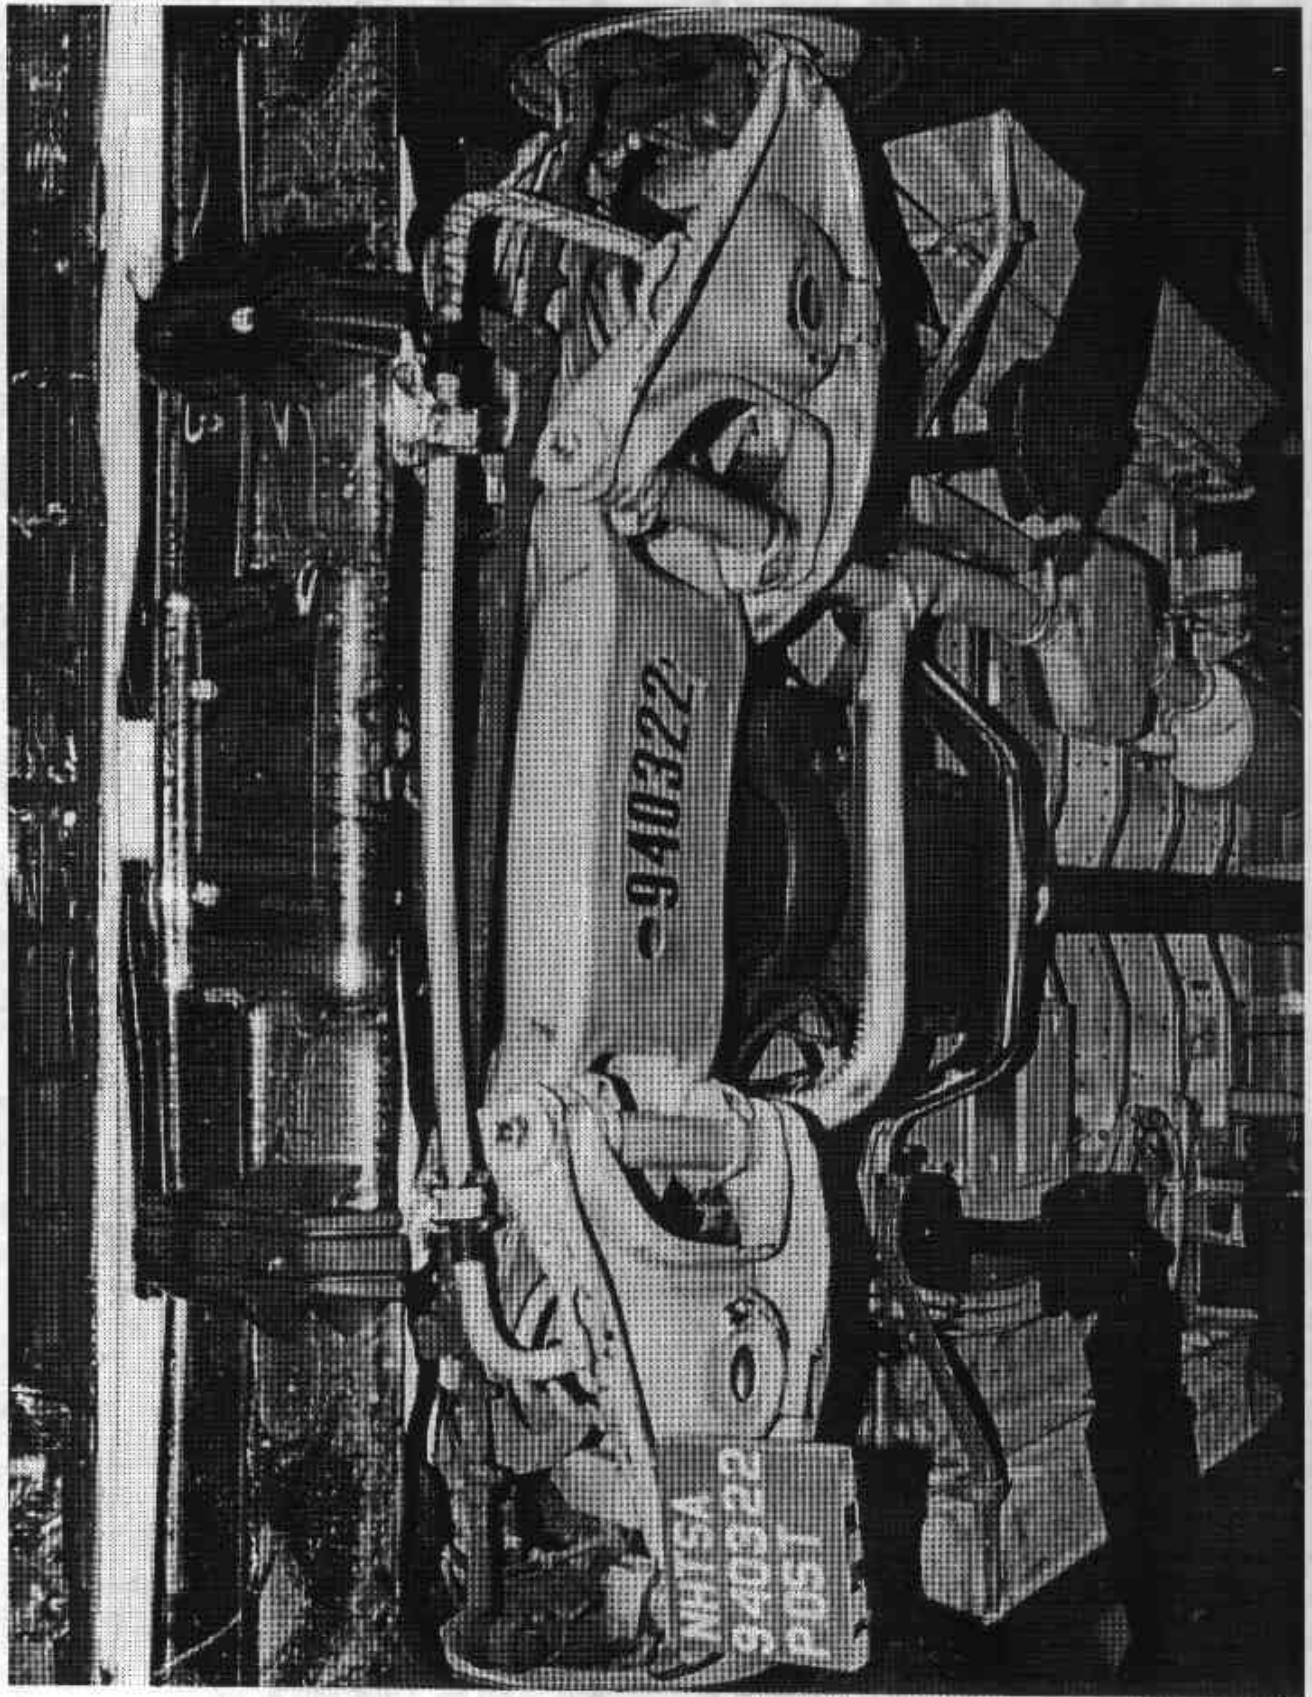
Figure A-24. Post-test Front Underbody View
A-25

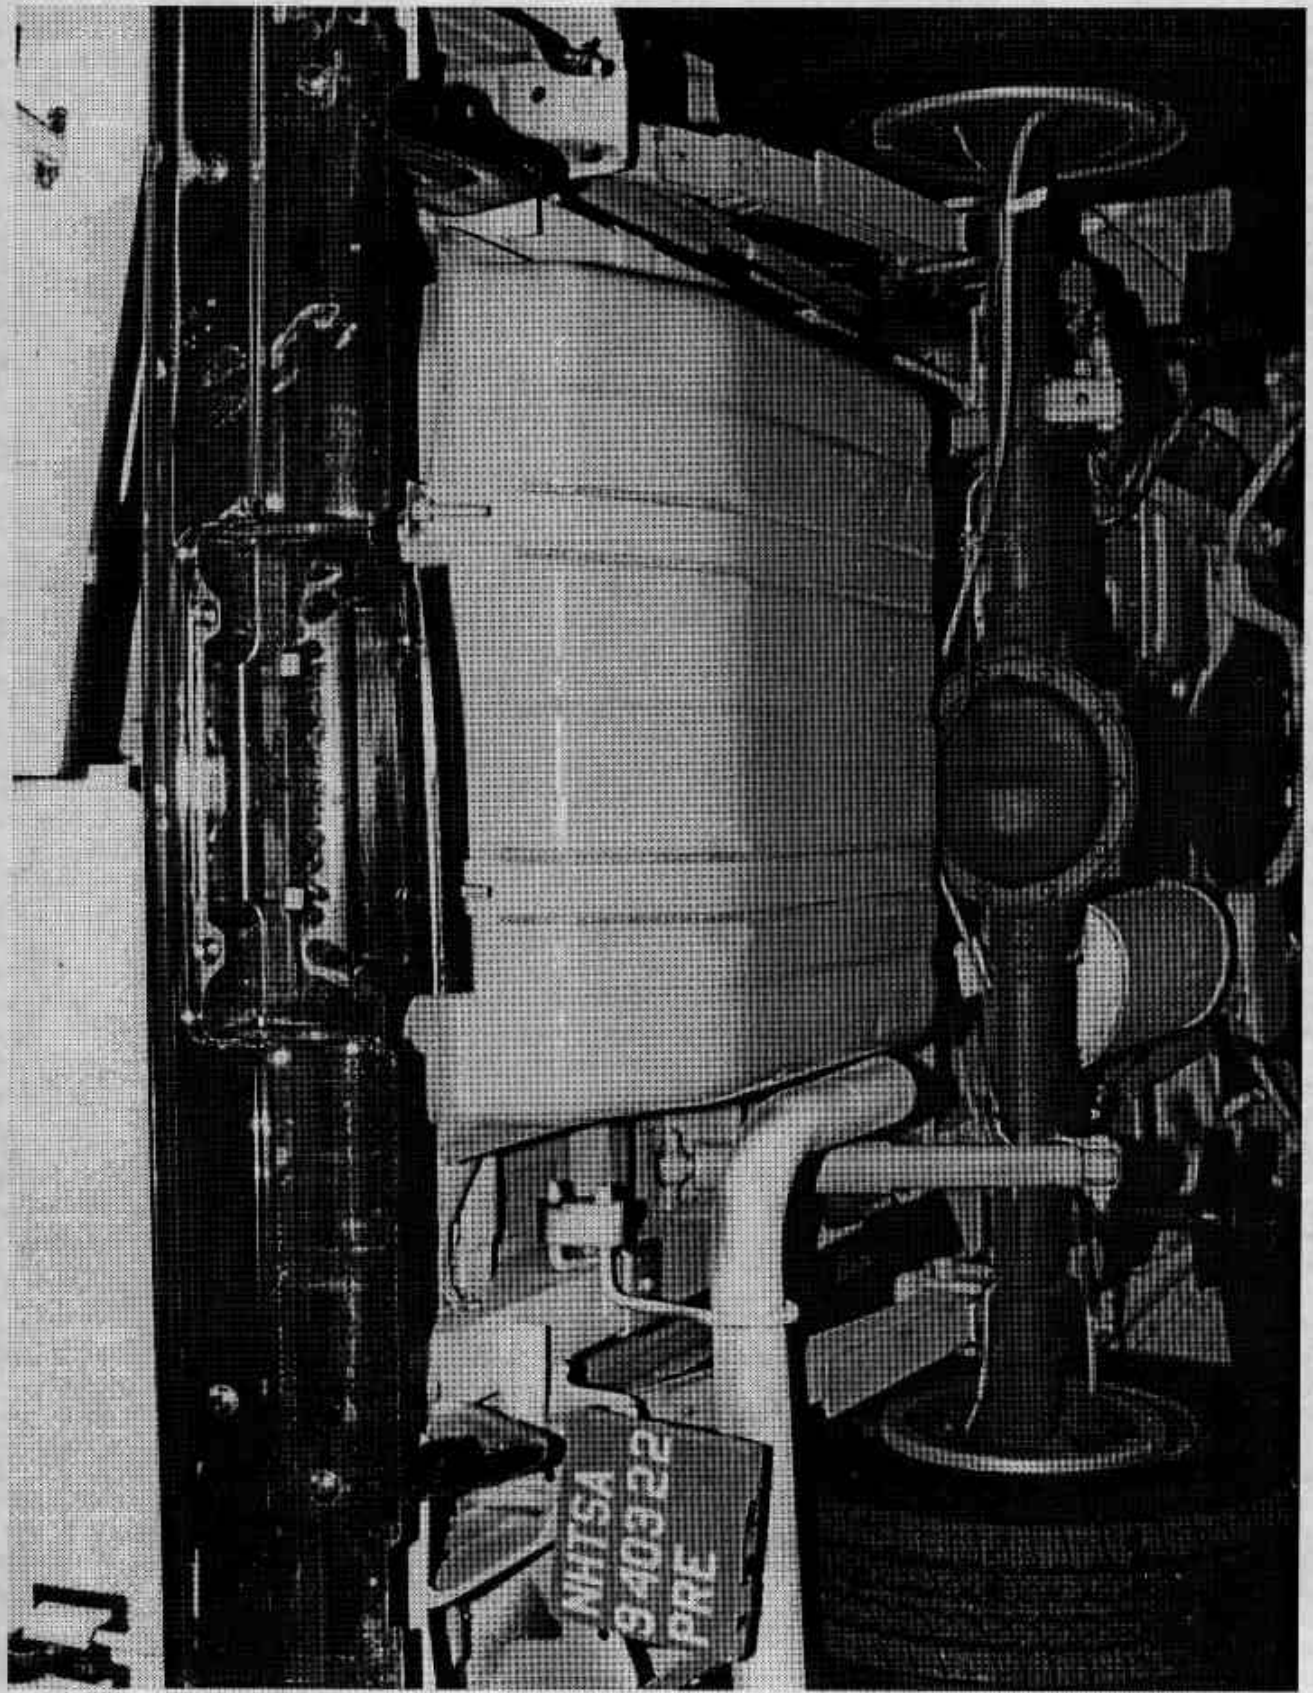
Figure A-25. Pre-test Rear Underbody View
A-26

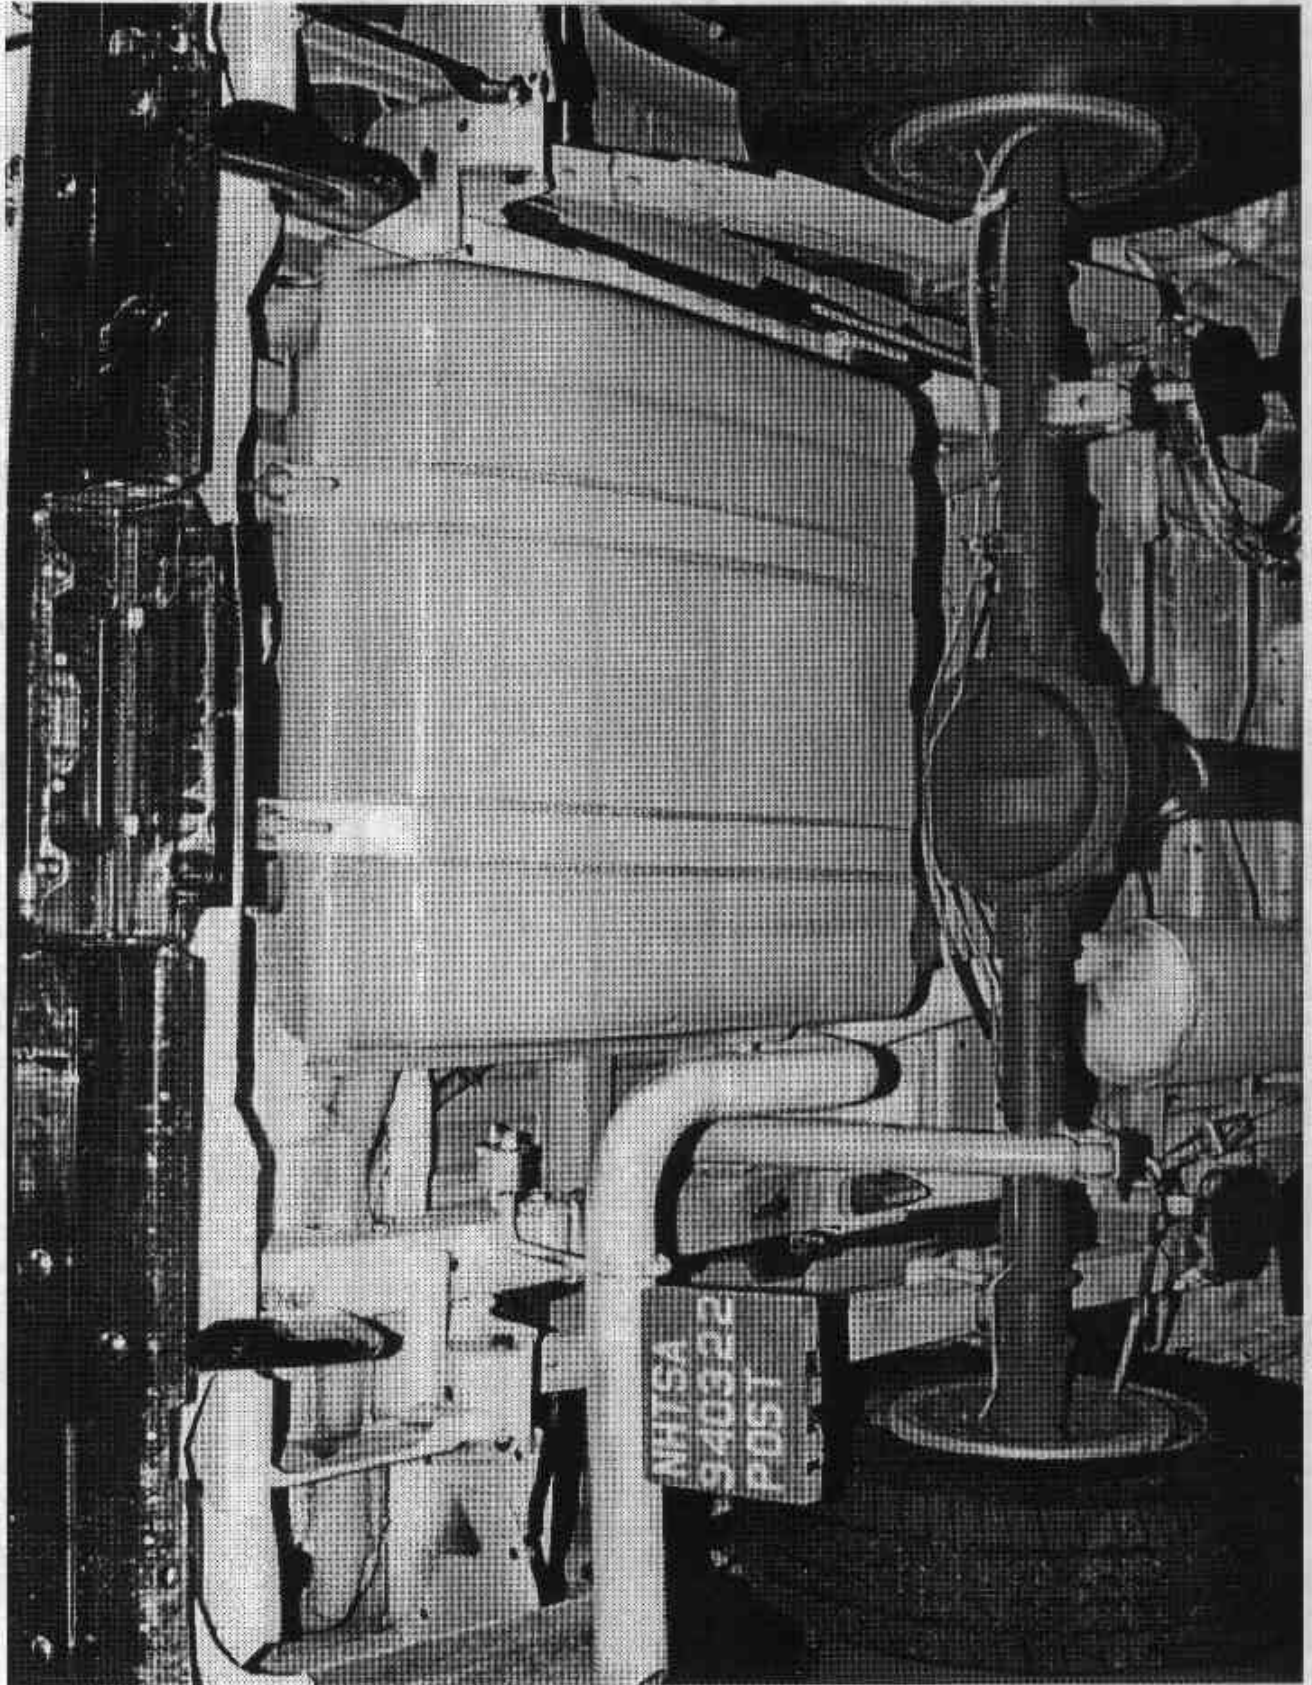
Figure A-26. Post-test Rear Underbody View
A-27

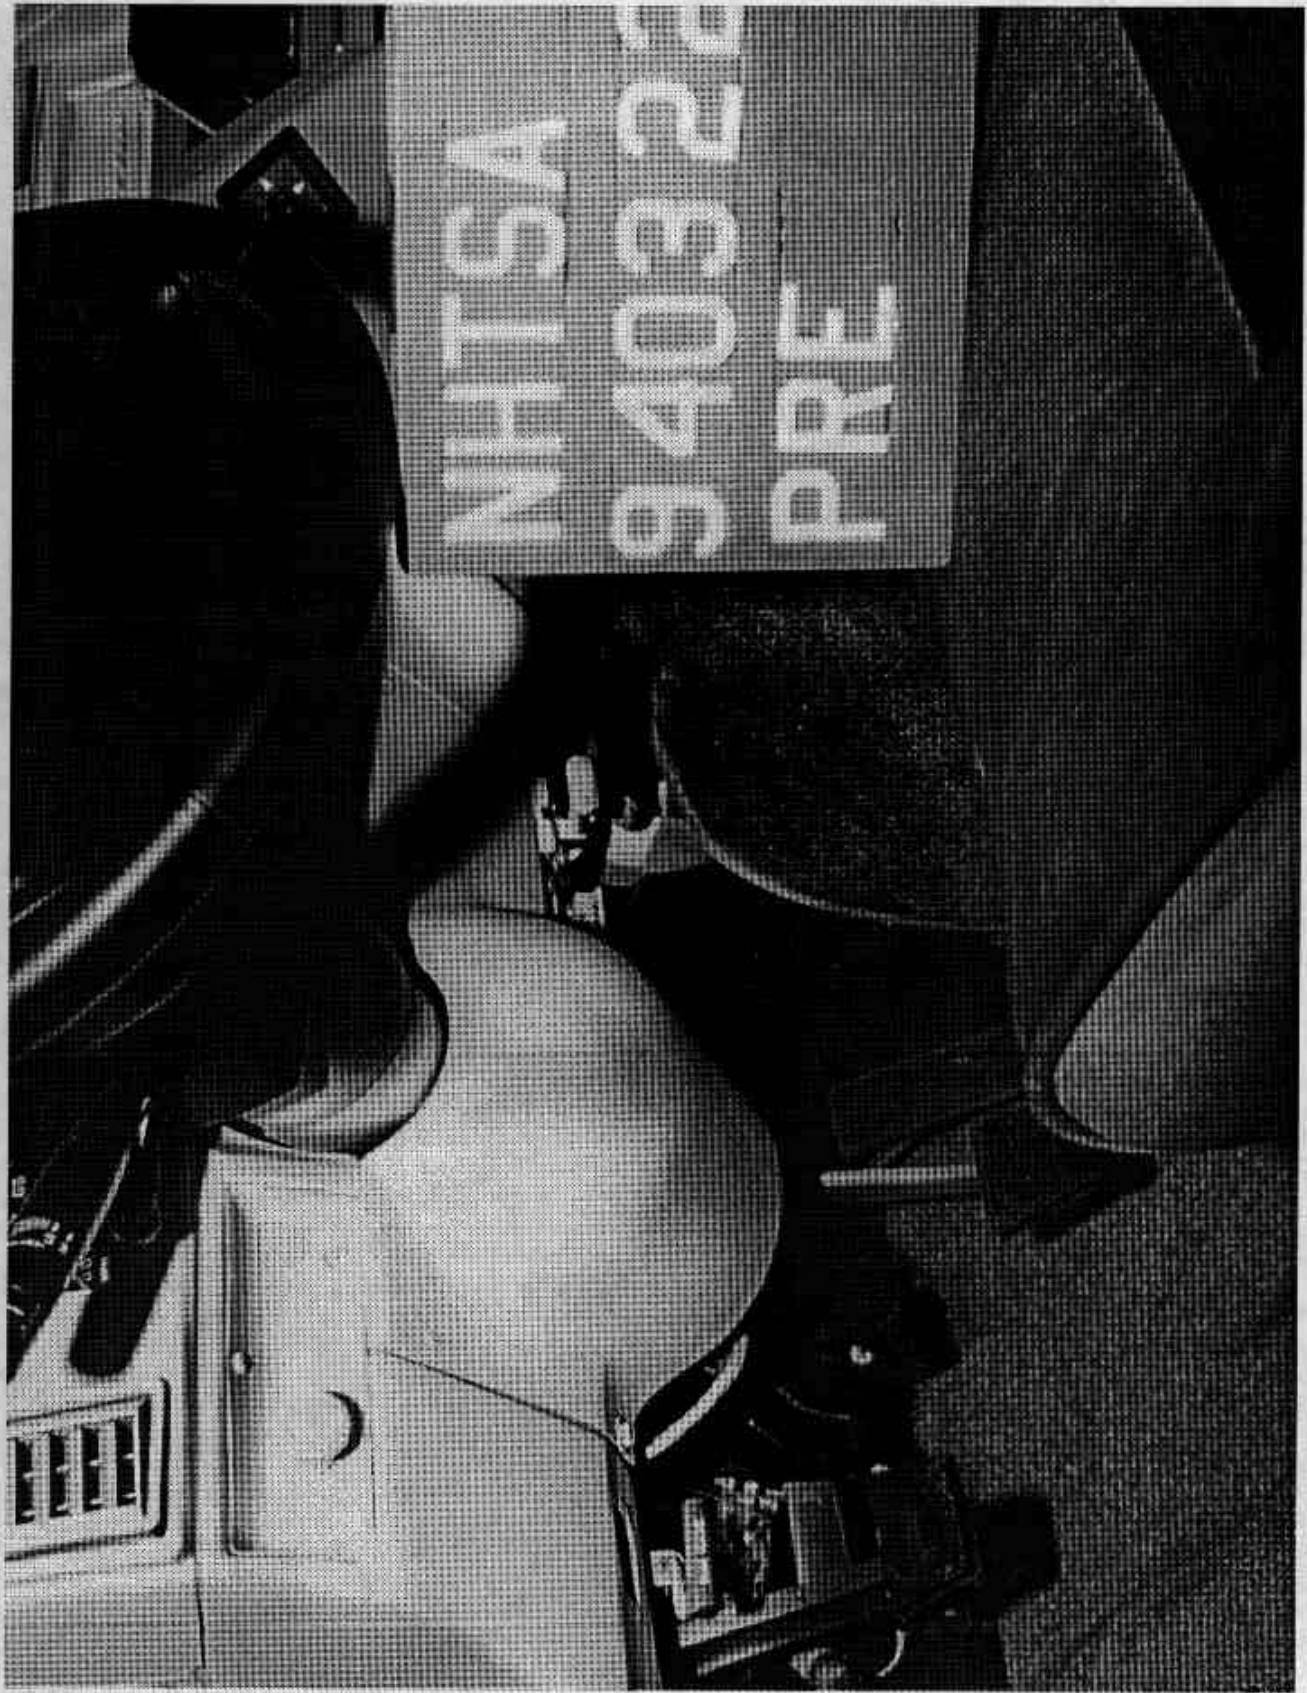
Figure A-27. Pre-test Driver's Knee Bolster View
A-28

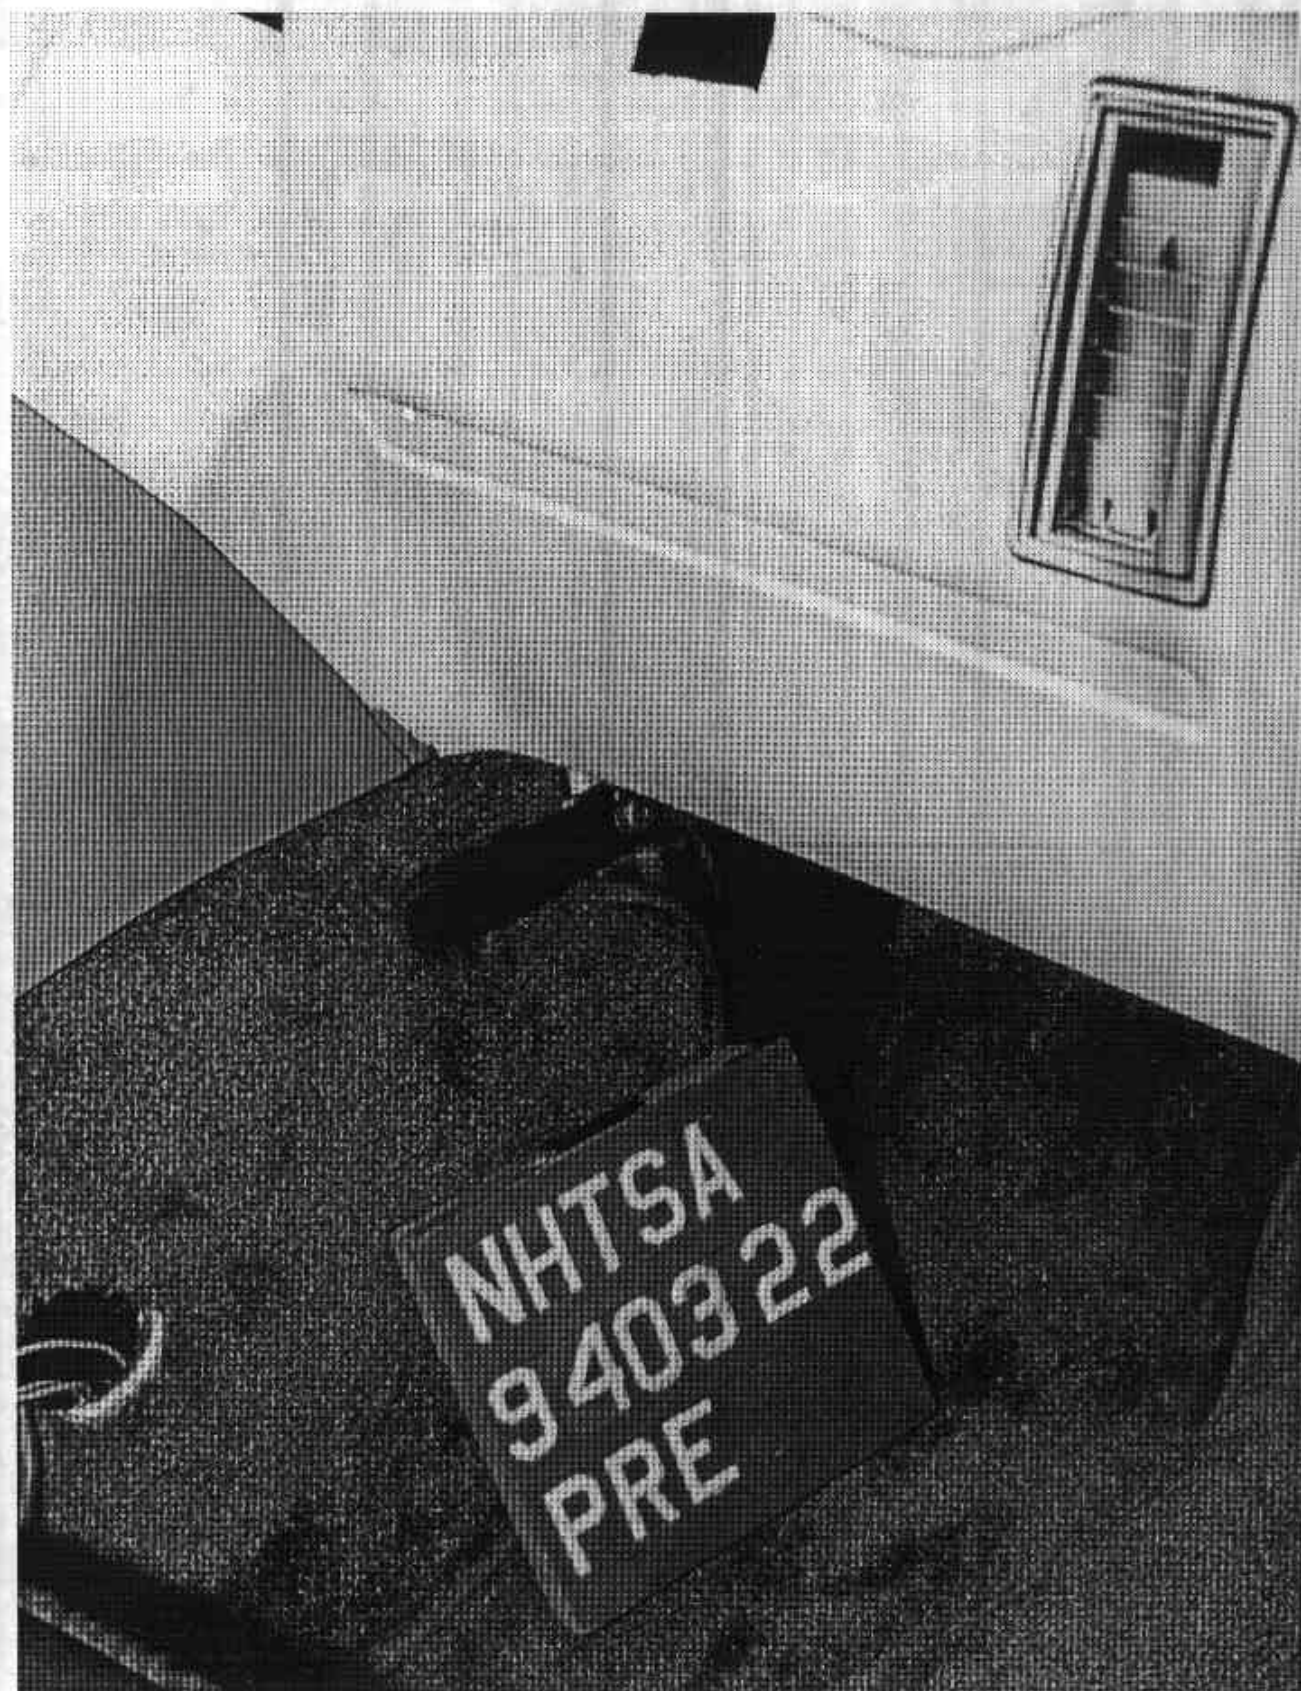
Figure A-28. Pre-test Passenger's Knee Bolster View
A-29

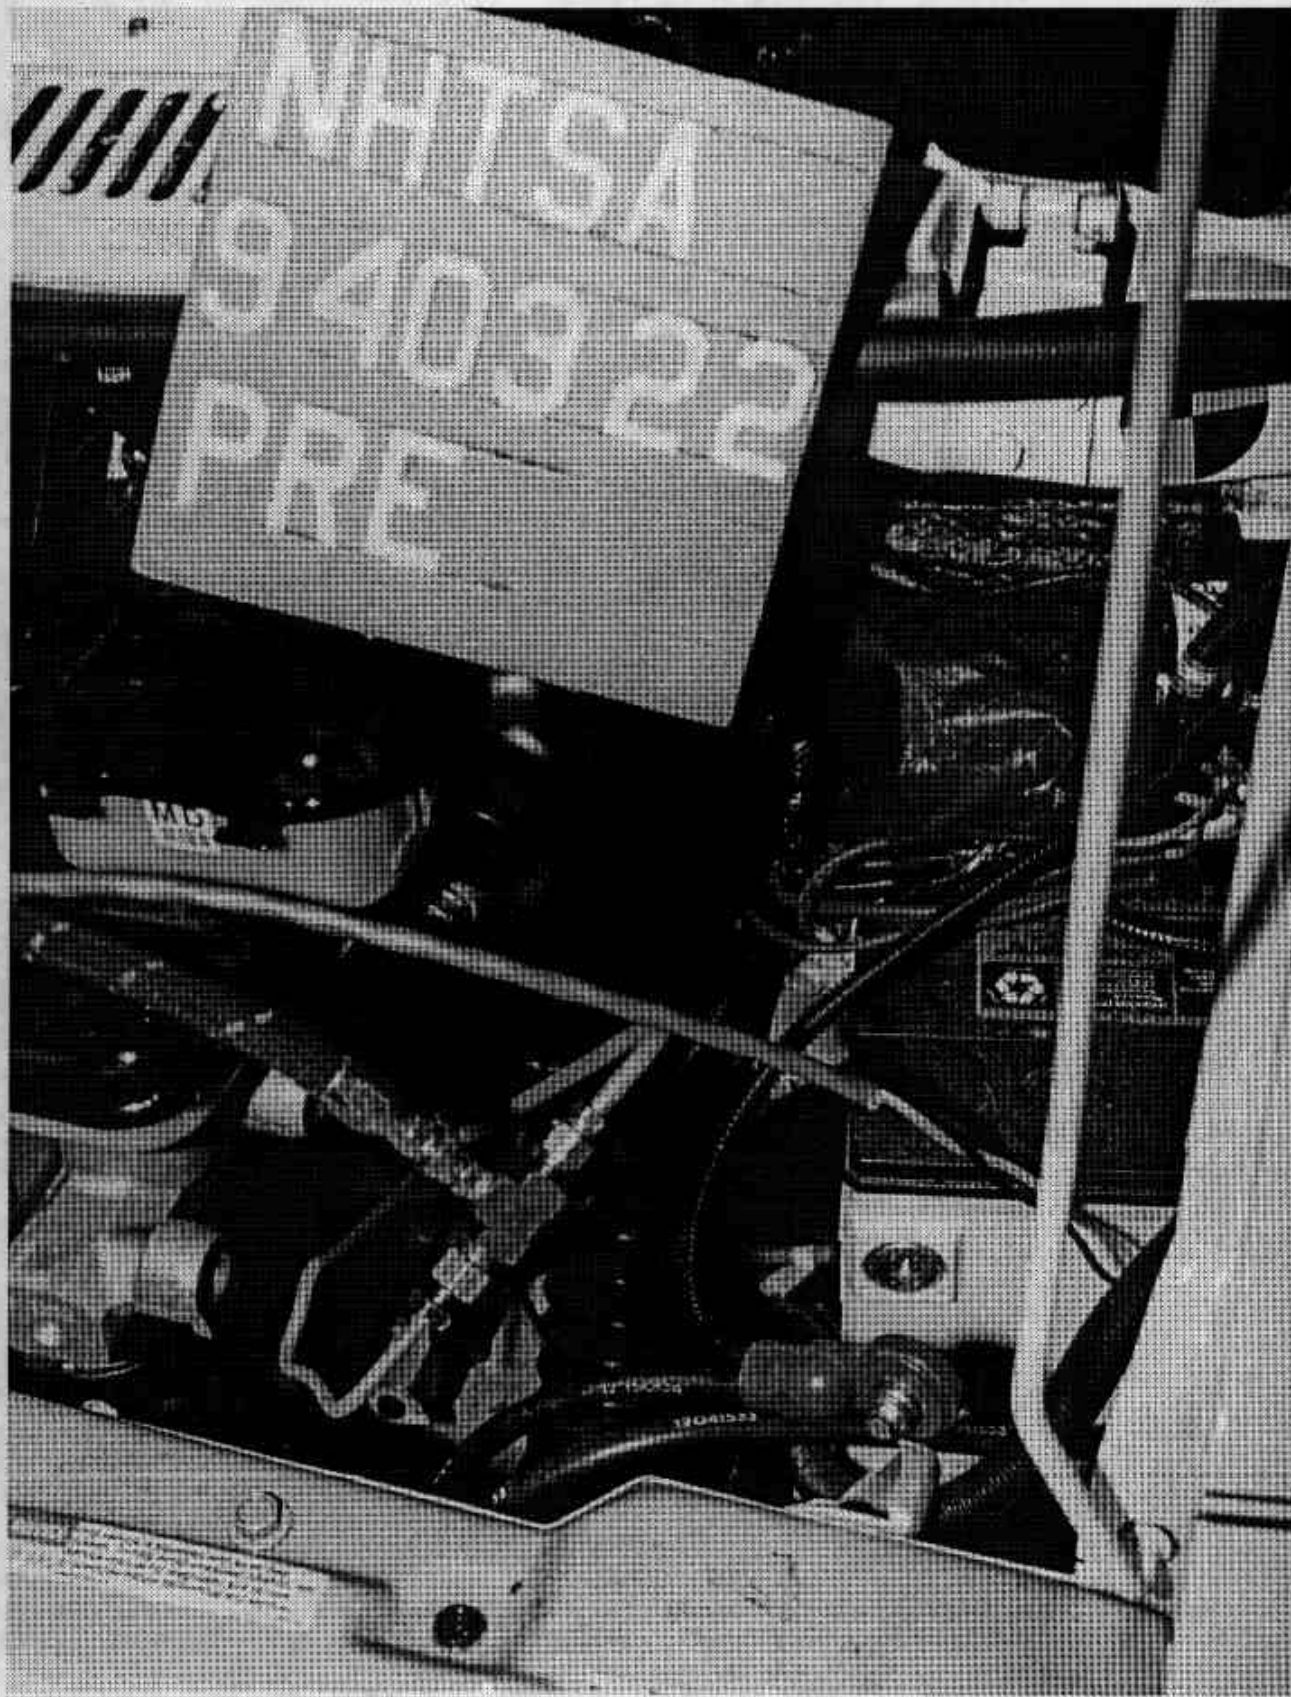
Figure A-29. Pre-test Steering Column at Firewall View
A-30
