Vehicle Safety Compliance Testing
for Occupant Crash Protection,
Windshield Mounting, Windshield Zone Intrusion,
and Fuel System Integrity

Kentron, Inc.
1994 Kentron SS Sport Top Van
NHTSA Number: CR1301
TRC Test Number: 940322

Transportation Research Center Inc.
10820 State Route 347
East Liberty, Ohio 43319

Final Report

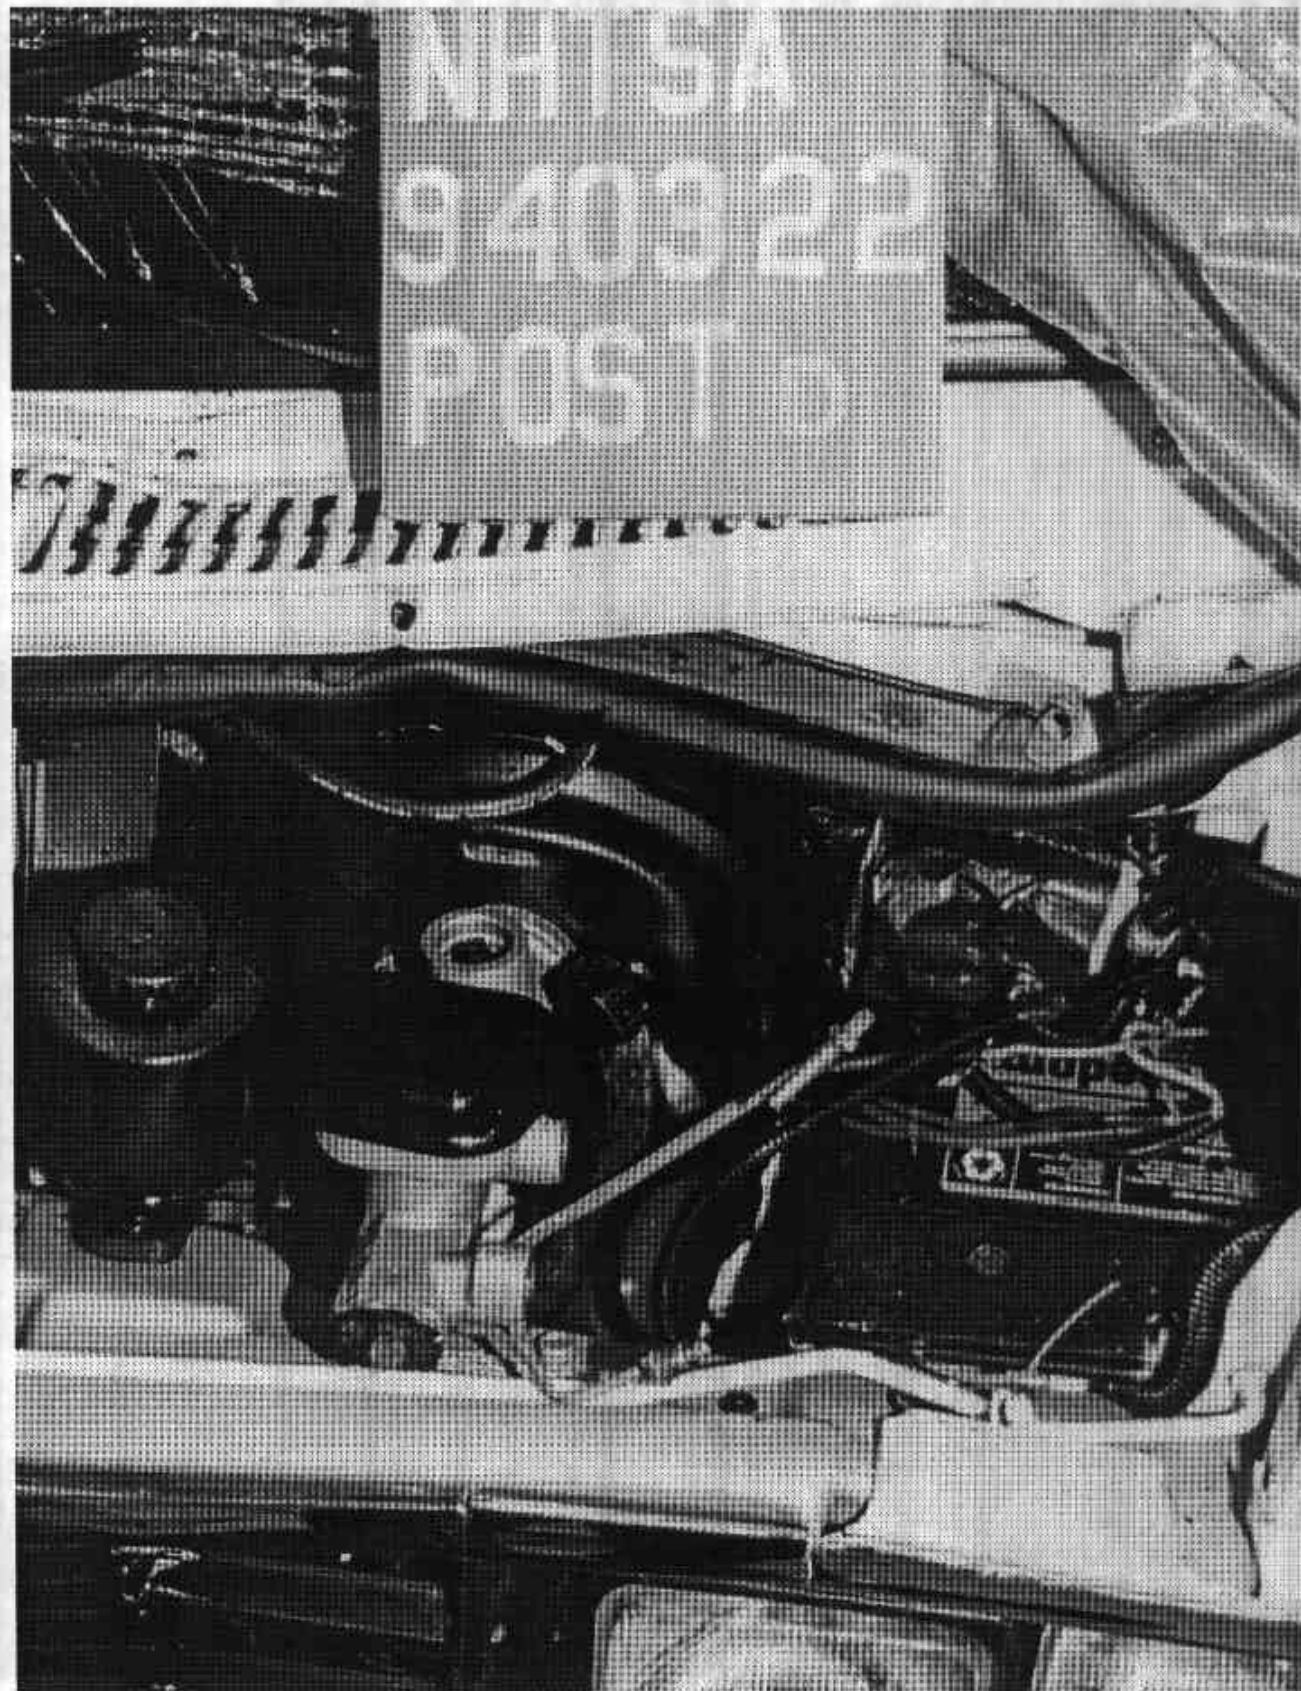
Figure A-30. Post-test Steering Column at Firewall View
A-31

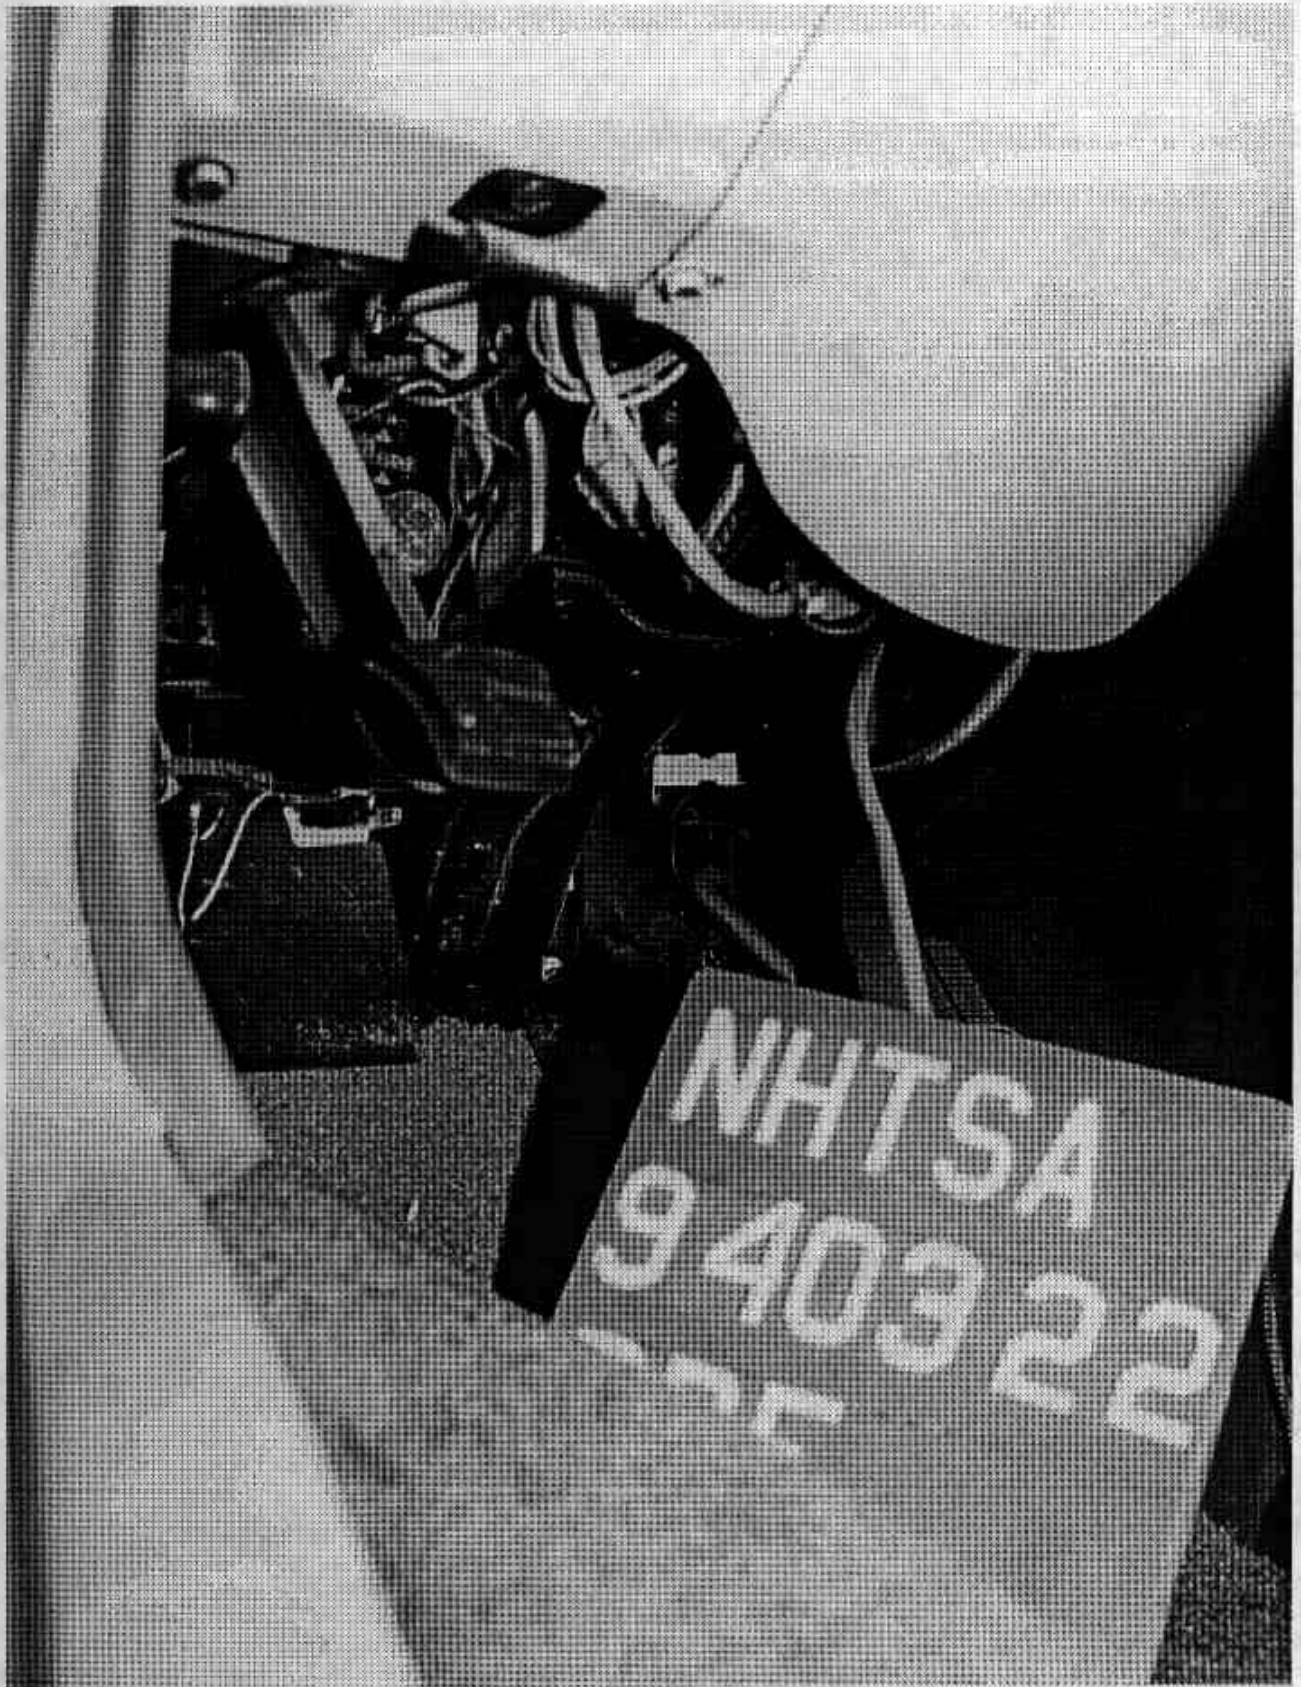
Figure A-31. Pre-test Steering Column at Firewall View - Interior
A-32

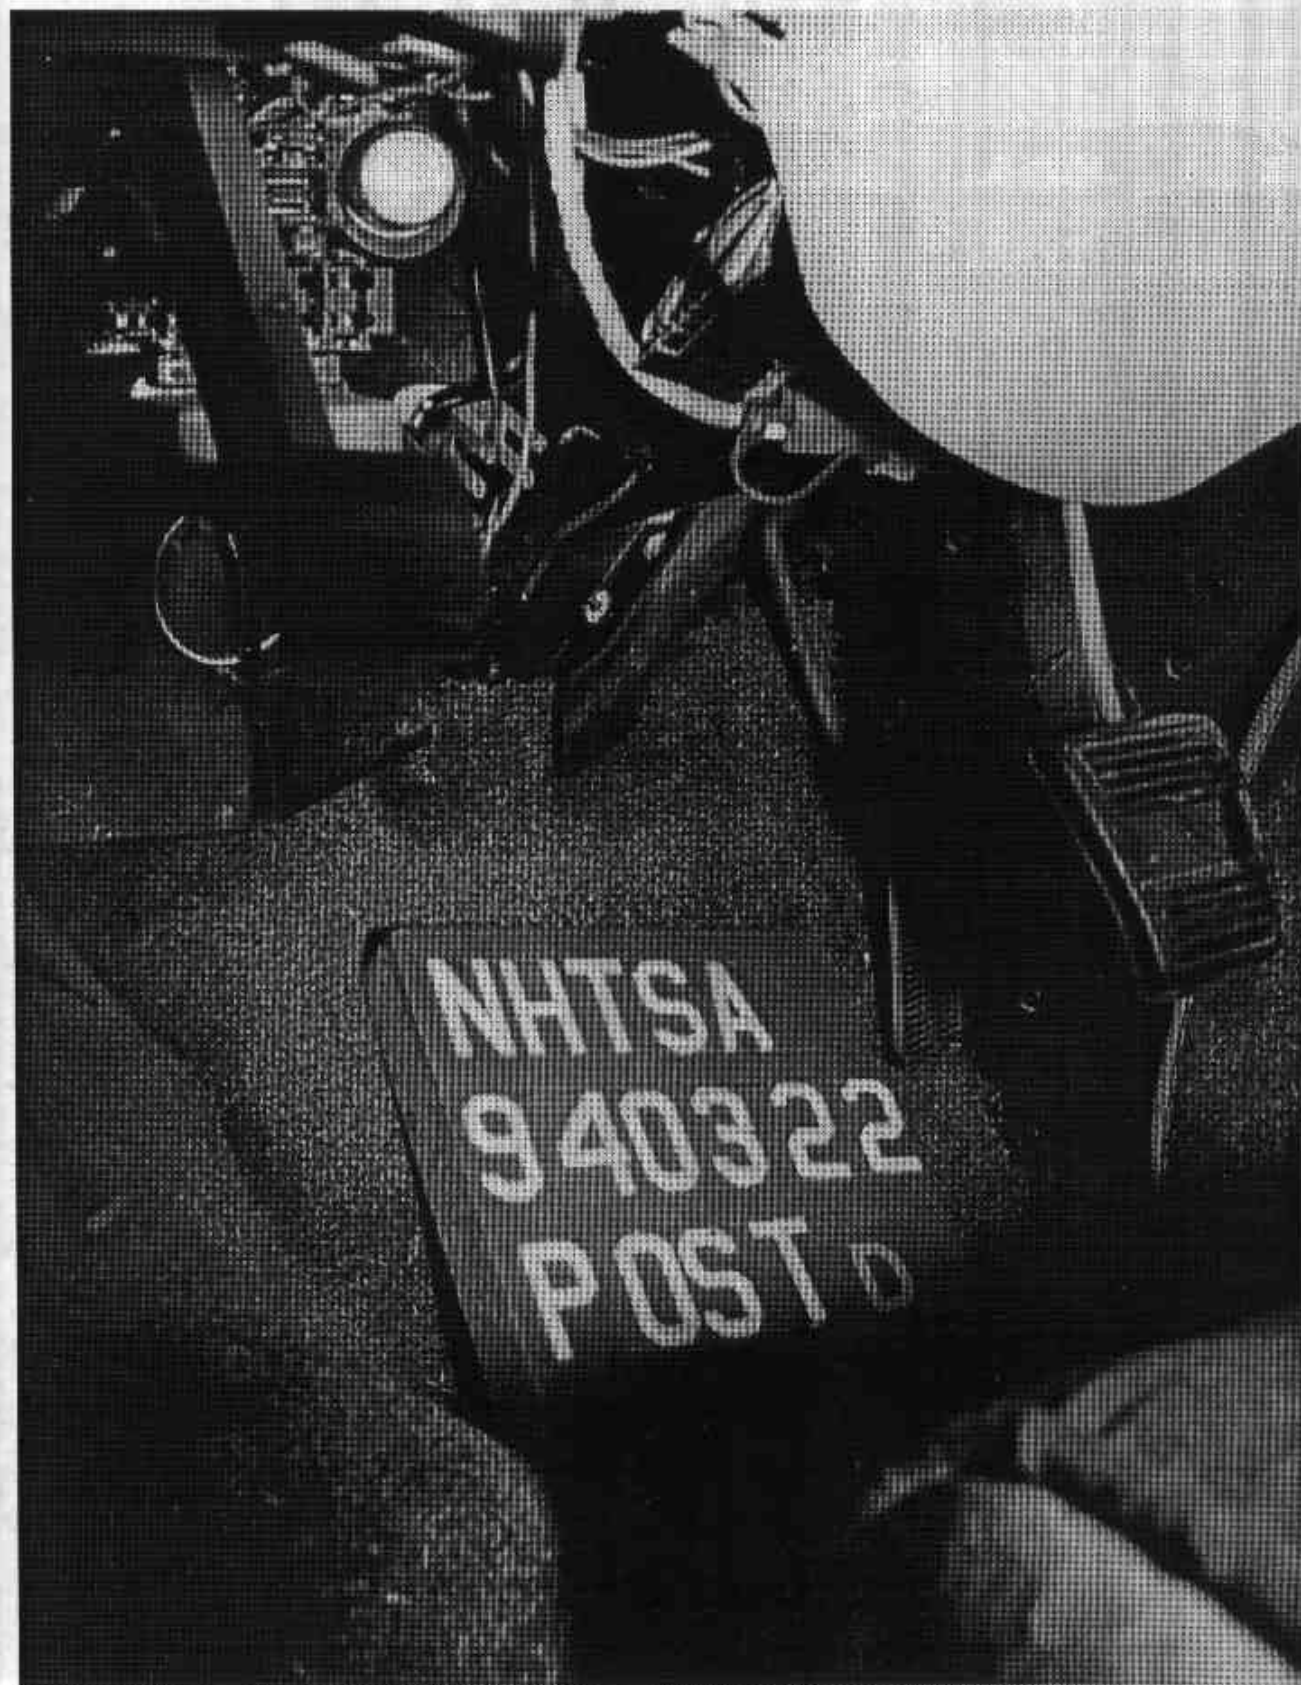
Figure A-32. Post-test Steering Column at Firewall View - Interior
A-33

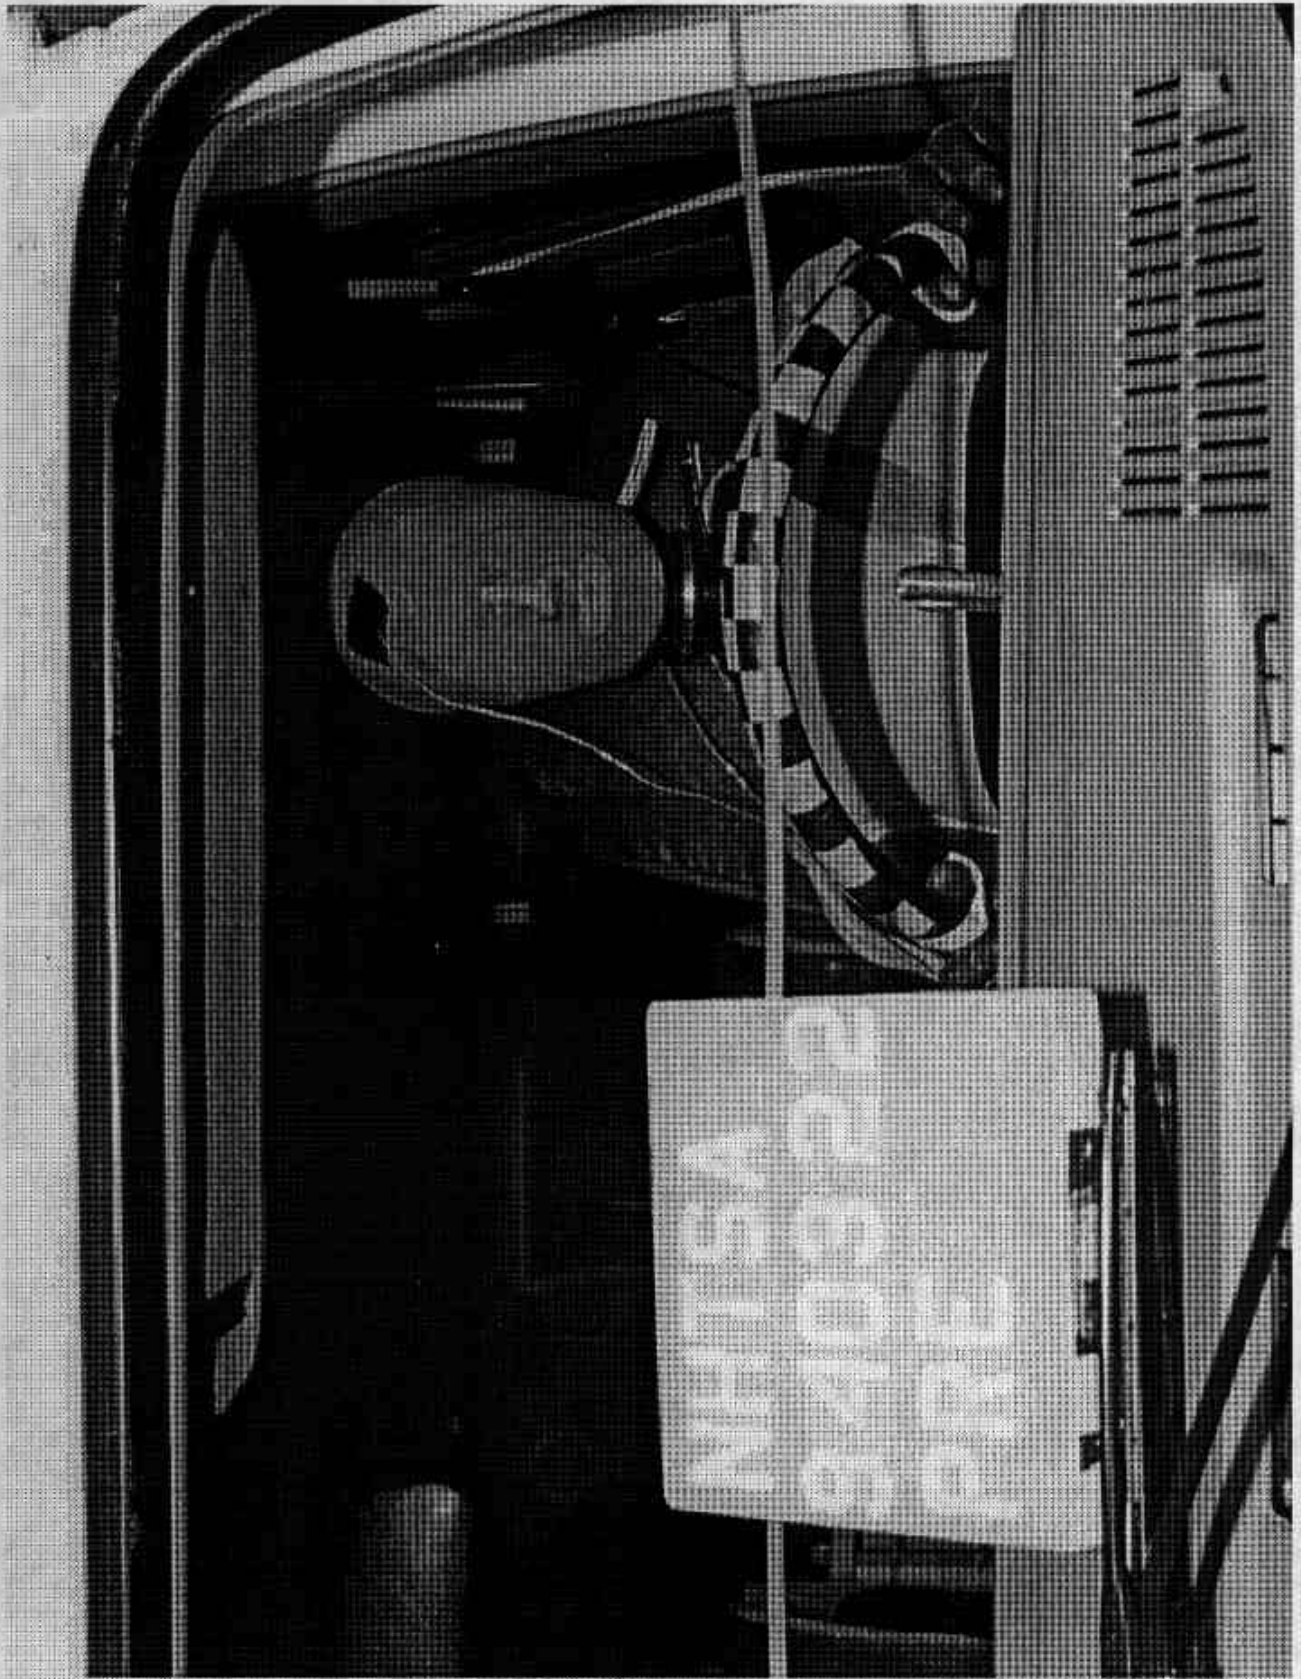
Figure A-33. Pre-test Driver Dummy Position - View 1

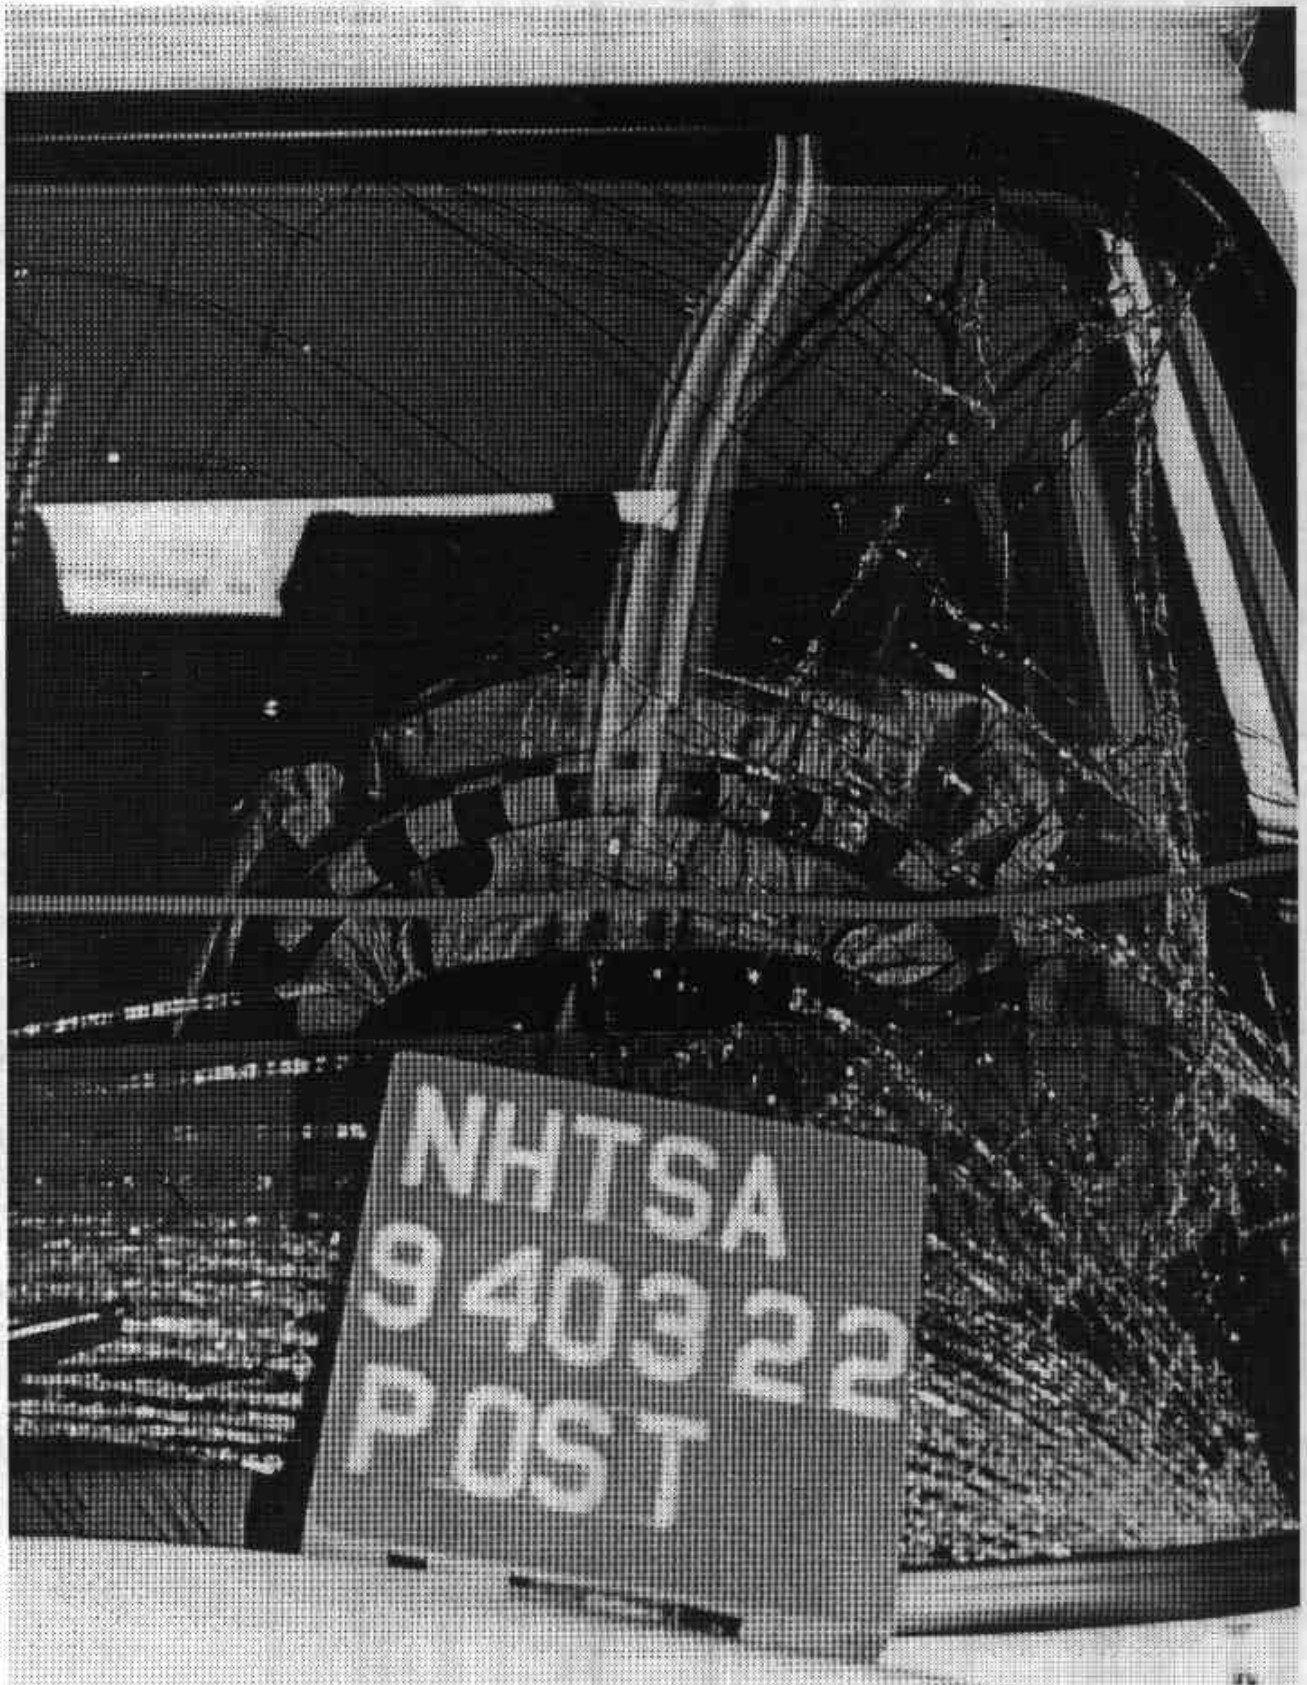
Figure A-34. Post-test Driver Dummy Position - View 1
A-35

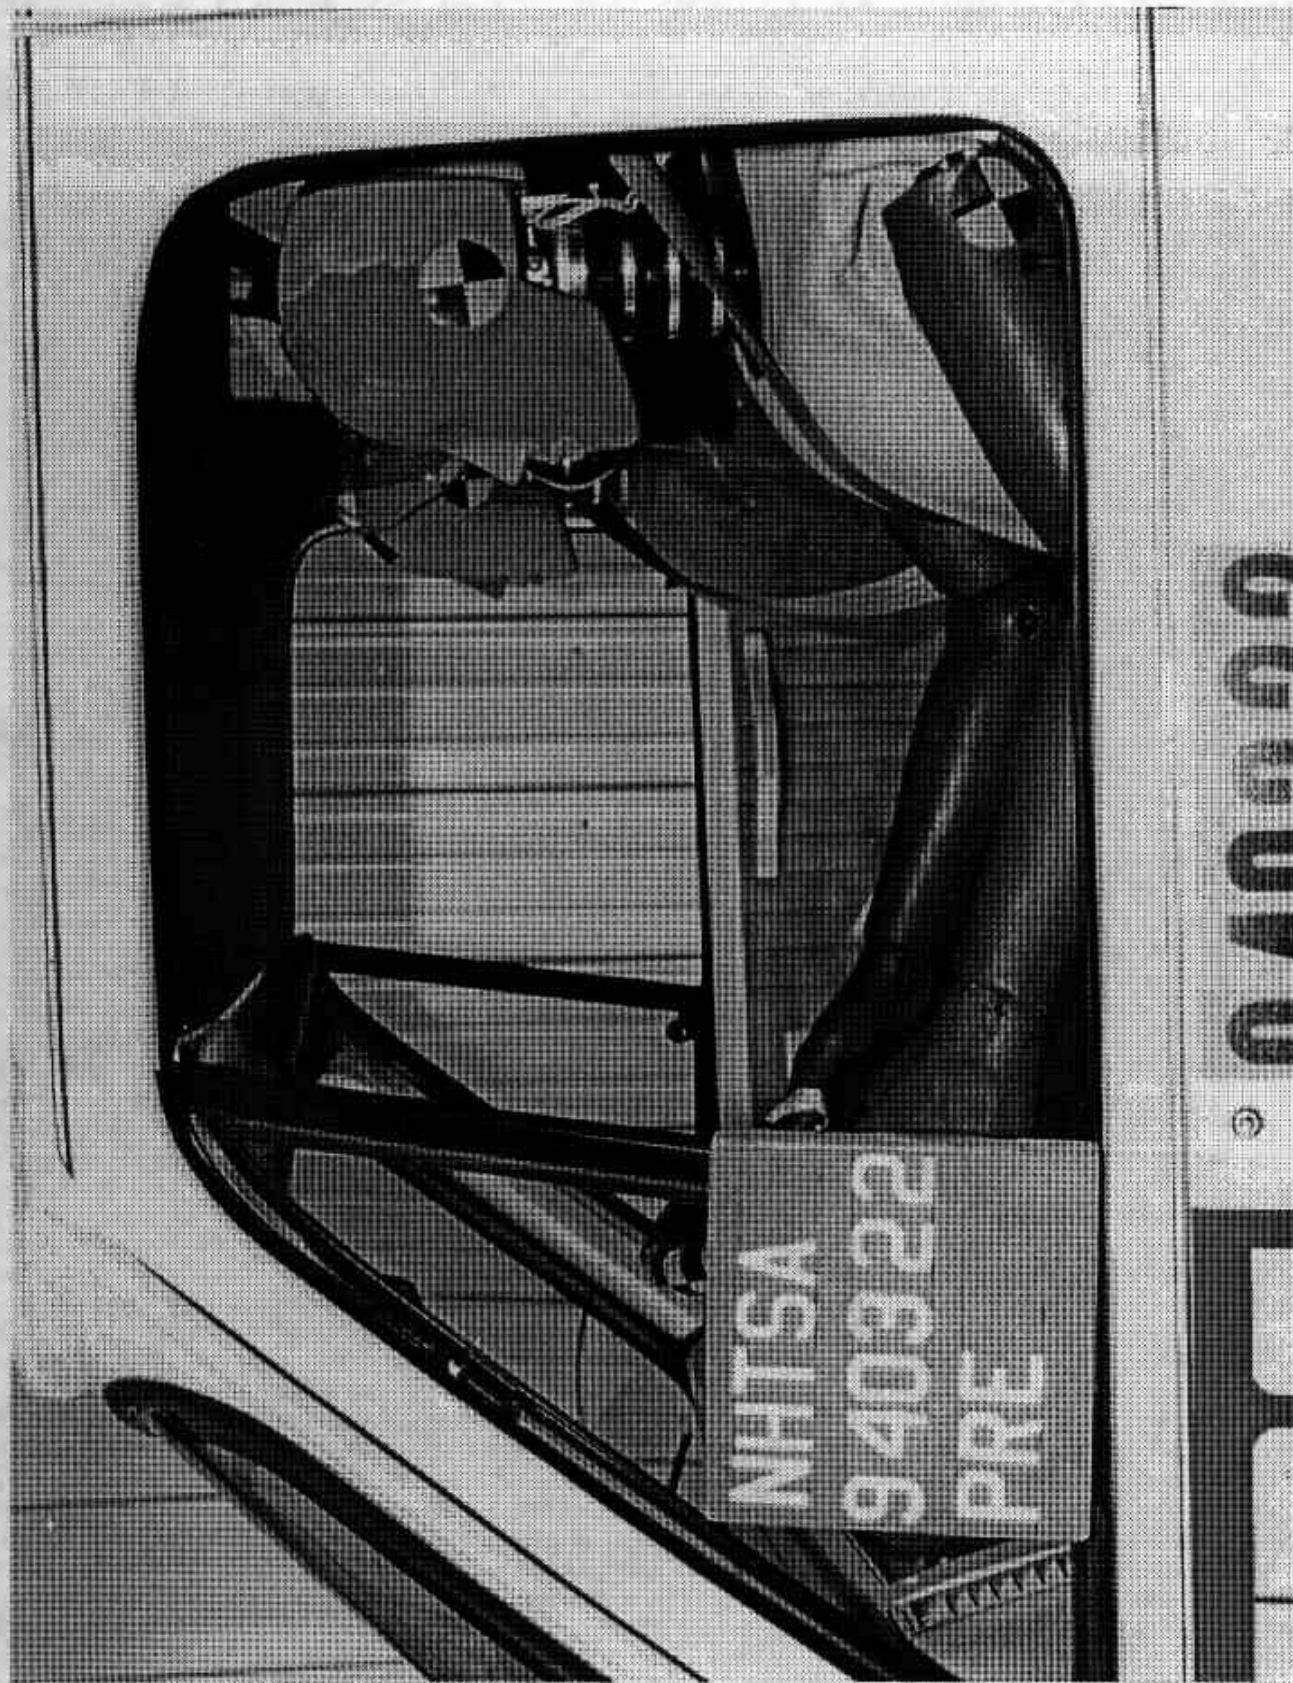
Figure A-35. Pre-test Driver Dummy Position - View 2

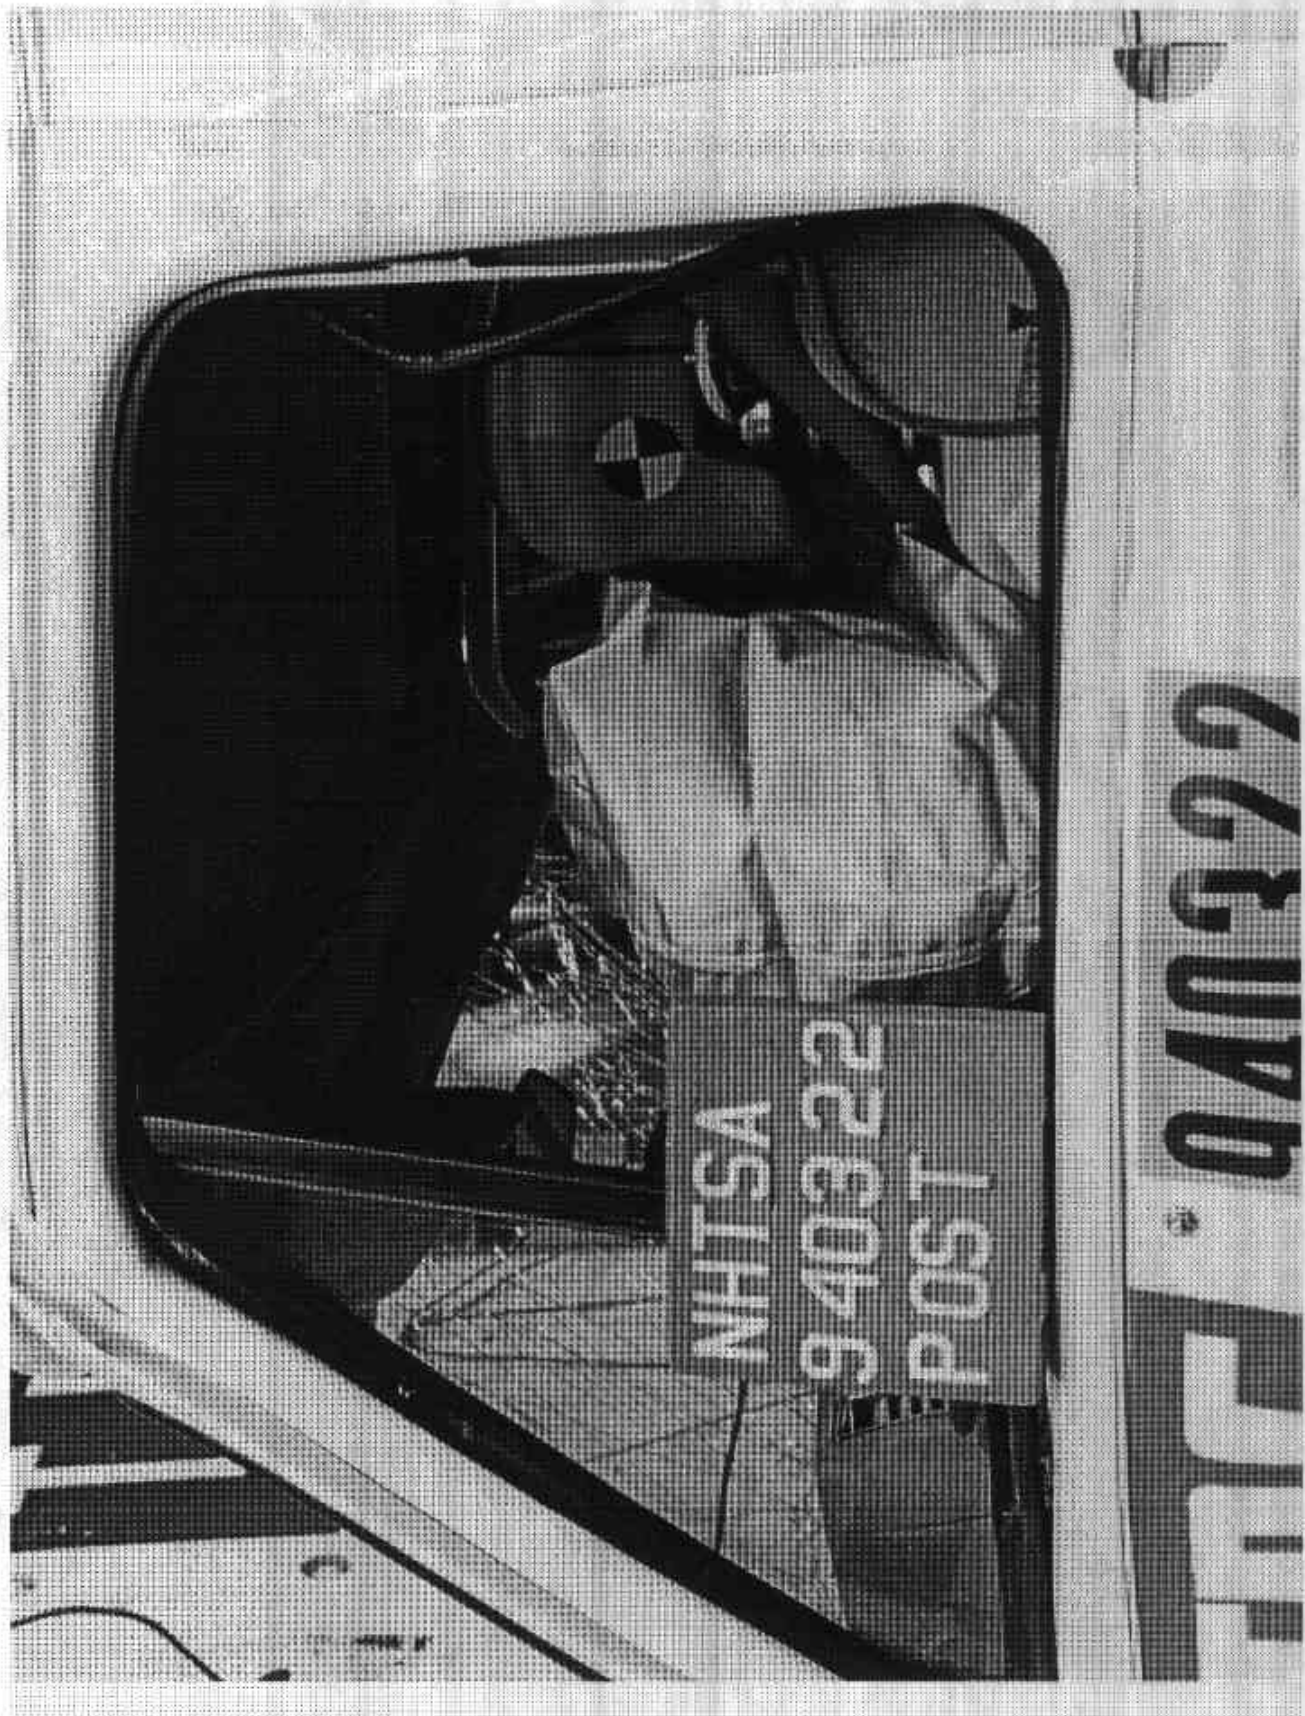
Figure A-36. Post-test Driver Dummy Position - View 2
A-37

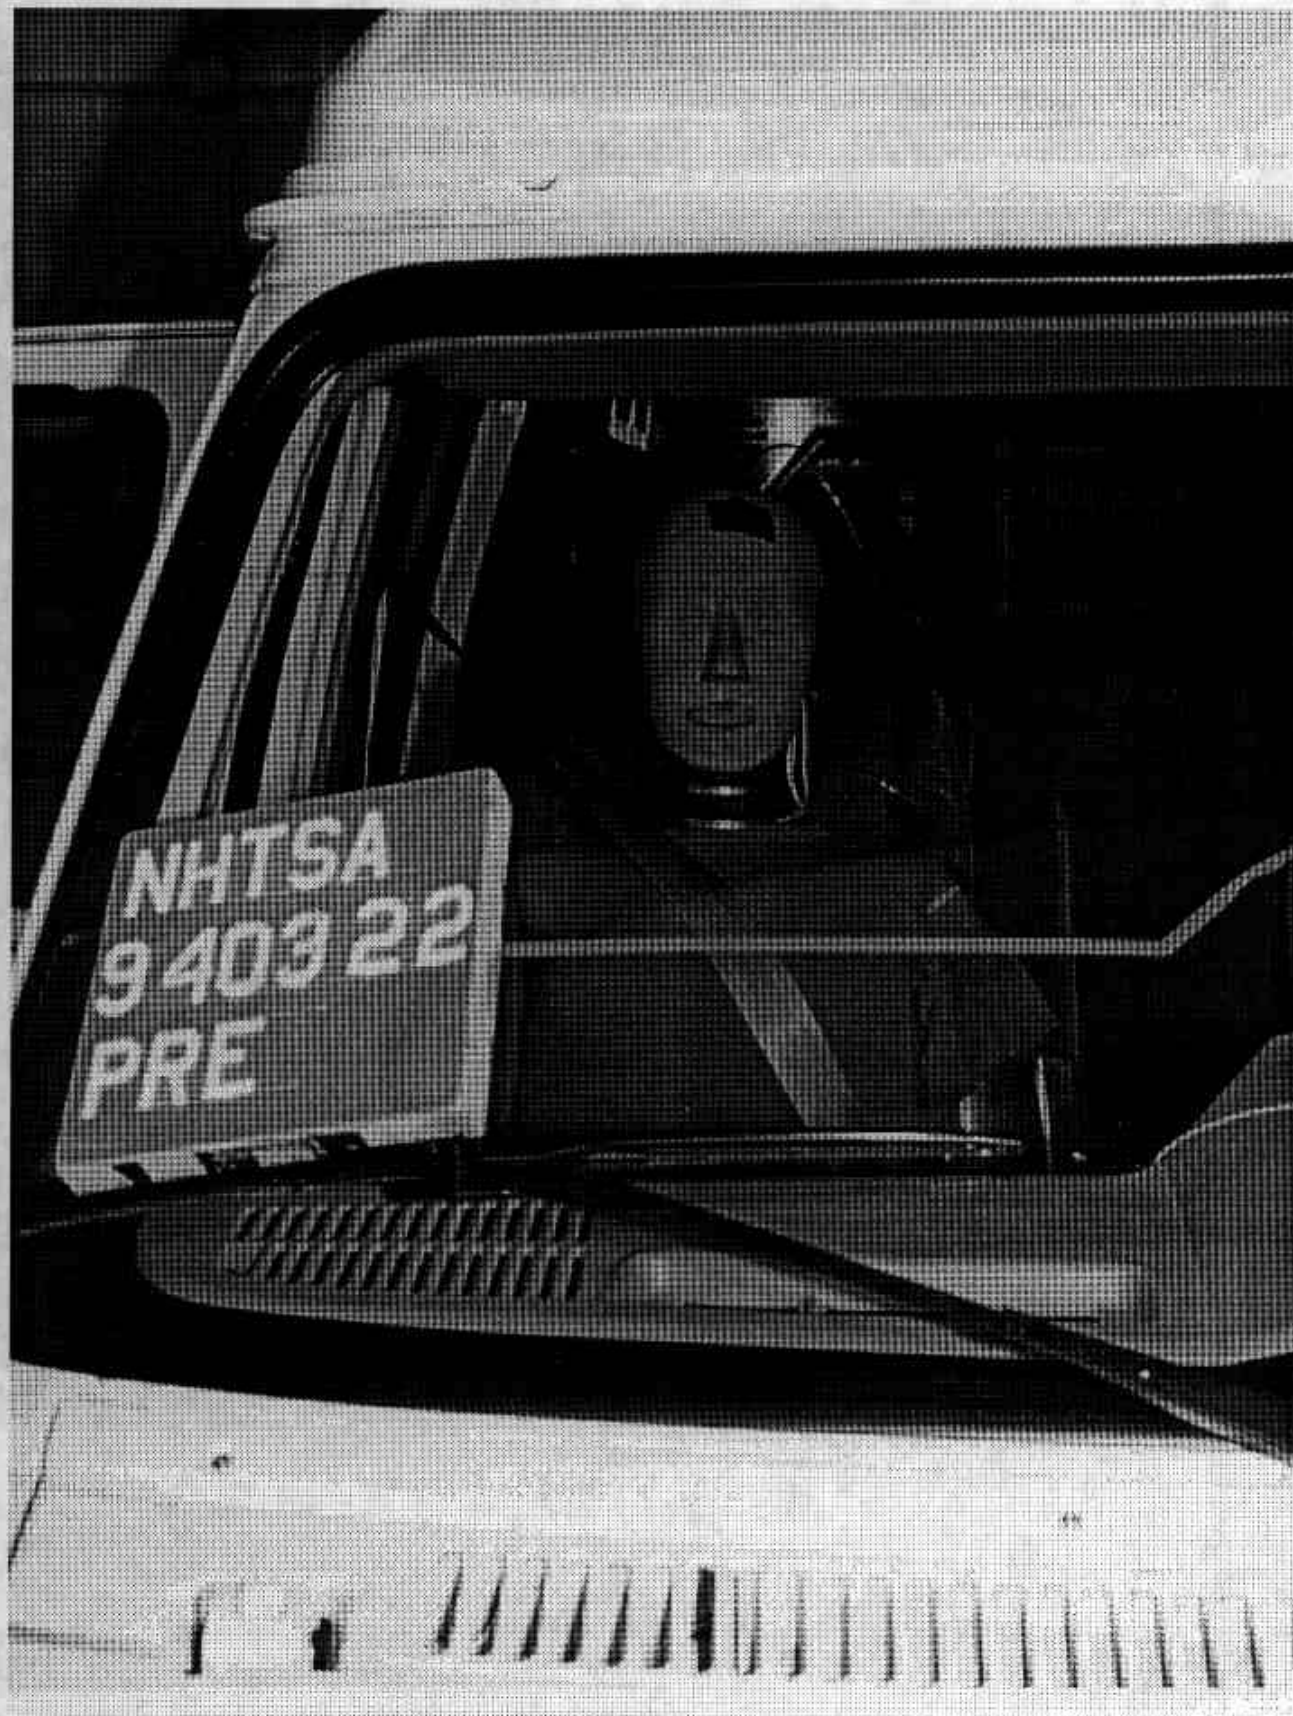
Figure A-37. Pre-test Passenger Dummy Position - View 1

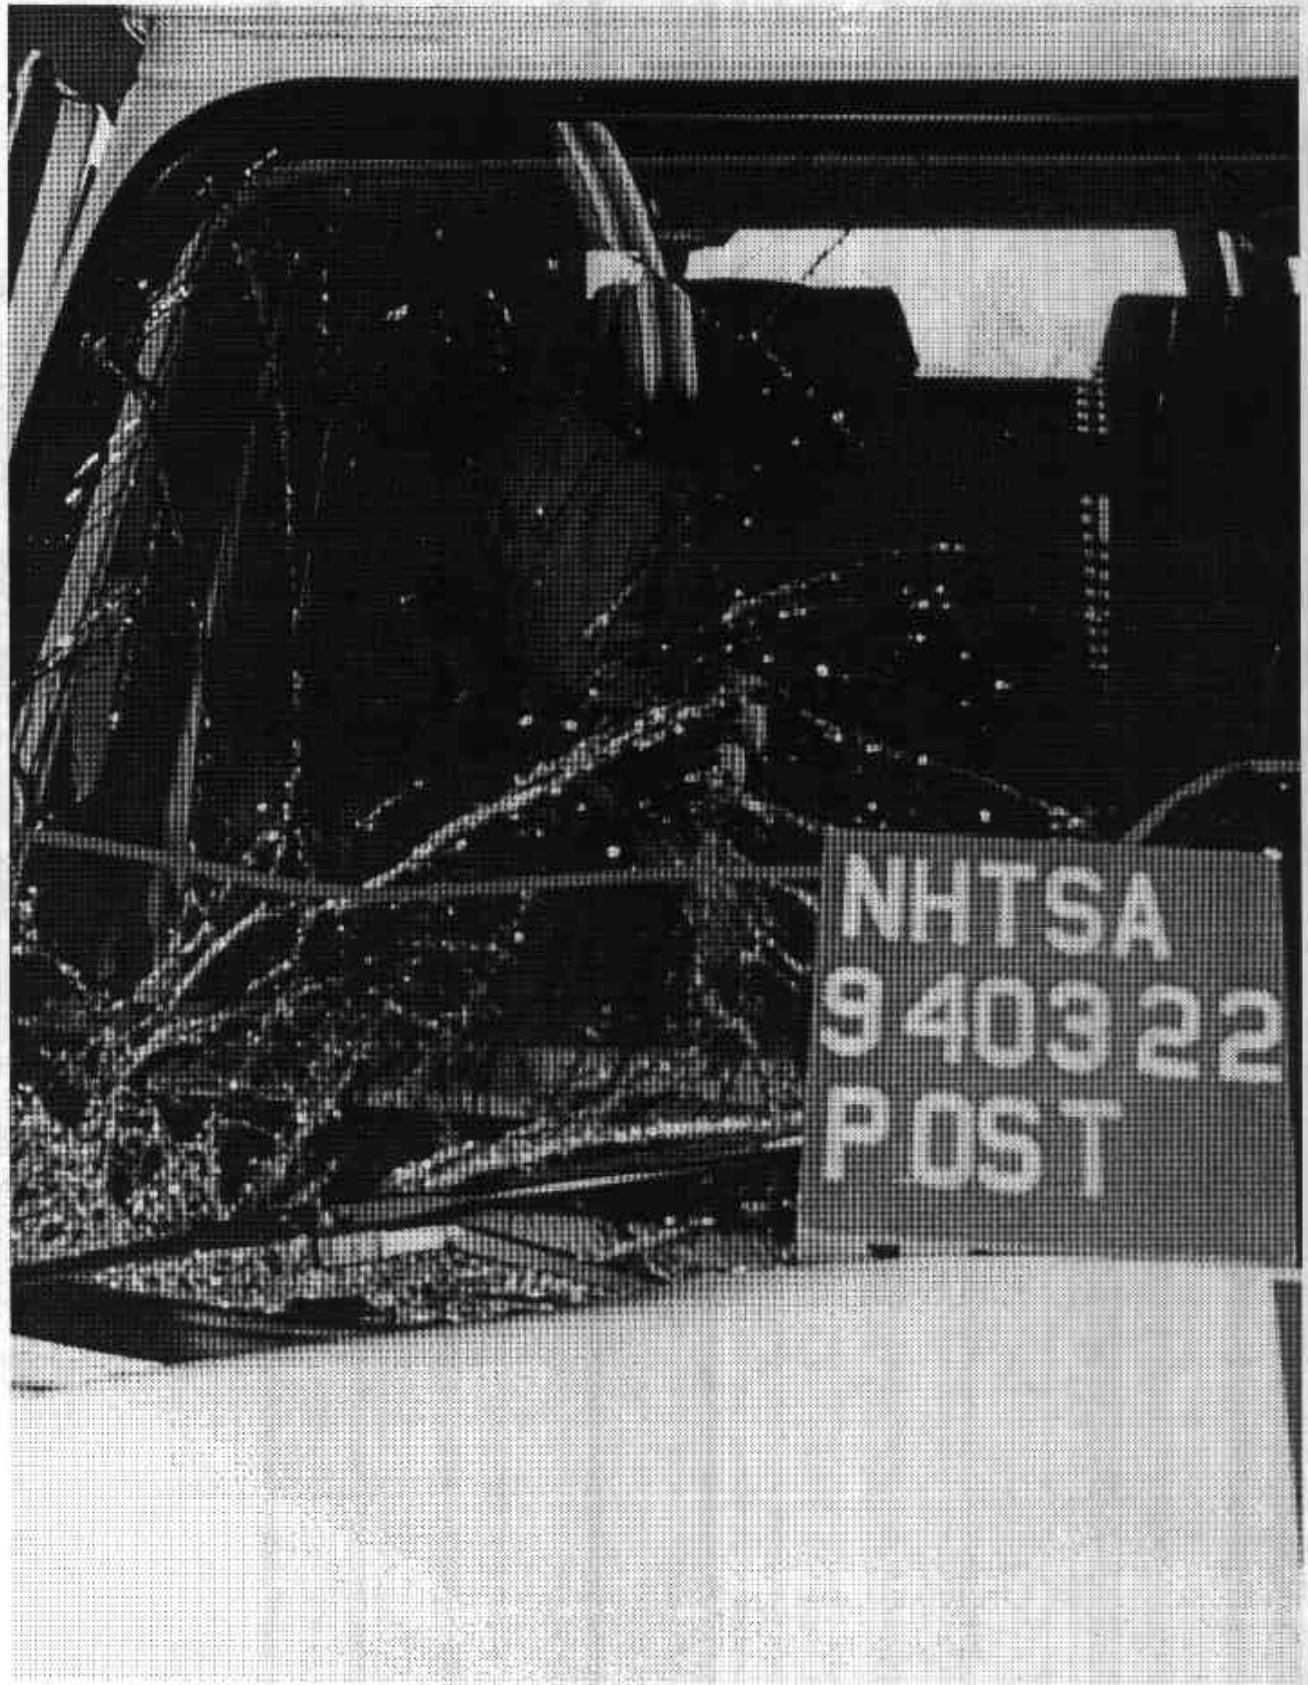
Figure A-38. Post-test Passenger Dummy Position - View 1
A-39

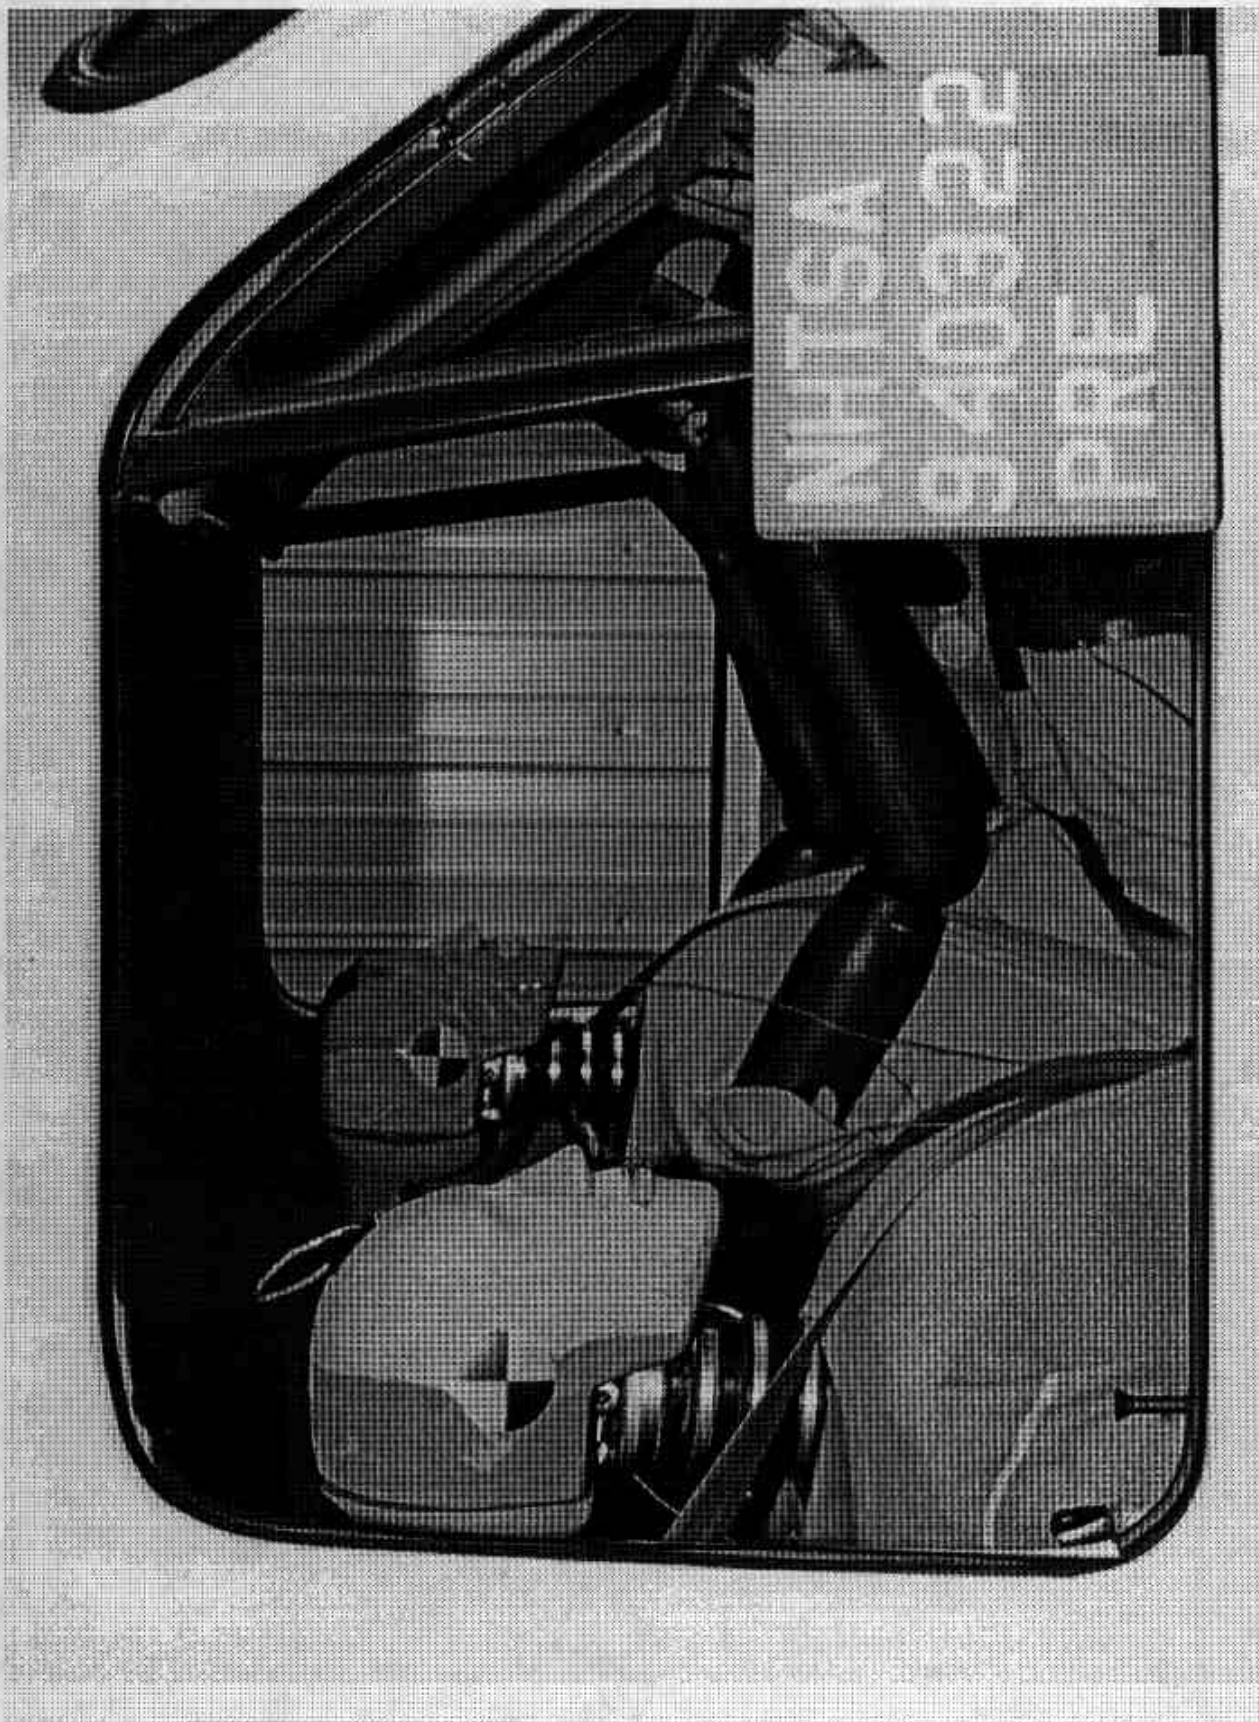
Figure A-39. Pre-test Passenger Dummy Position - View 2
