Vehicle Safety Compliance Testing
for Occupant Crash Protection,
Windshield Mounting, Windshield Zone Intrusion,
and Fuel System Integrity

Kentron, Inc.
1994 Kentron SS Sport Top Van
NHTSA Number: CR1301
TRC Test Number: 940322

Transportation Research Center Inc.
10820 State Route 347
East Liberty, Ohio 43319

Final Report

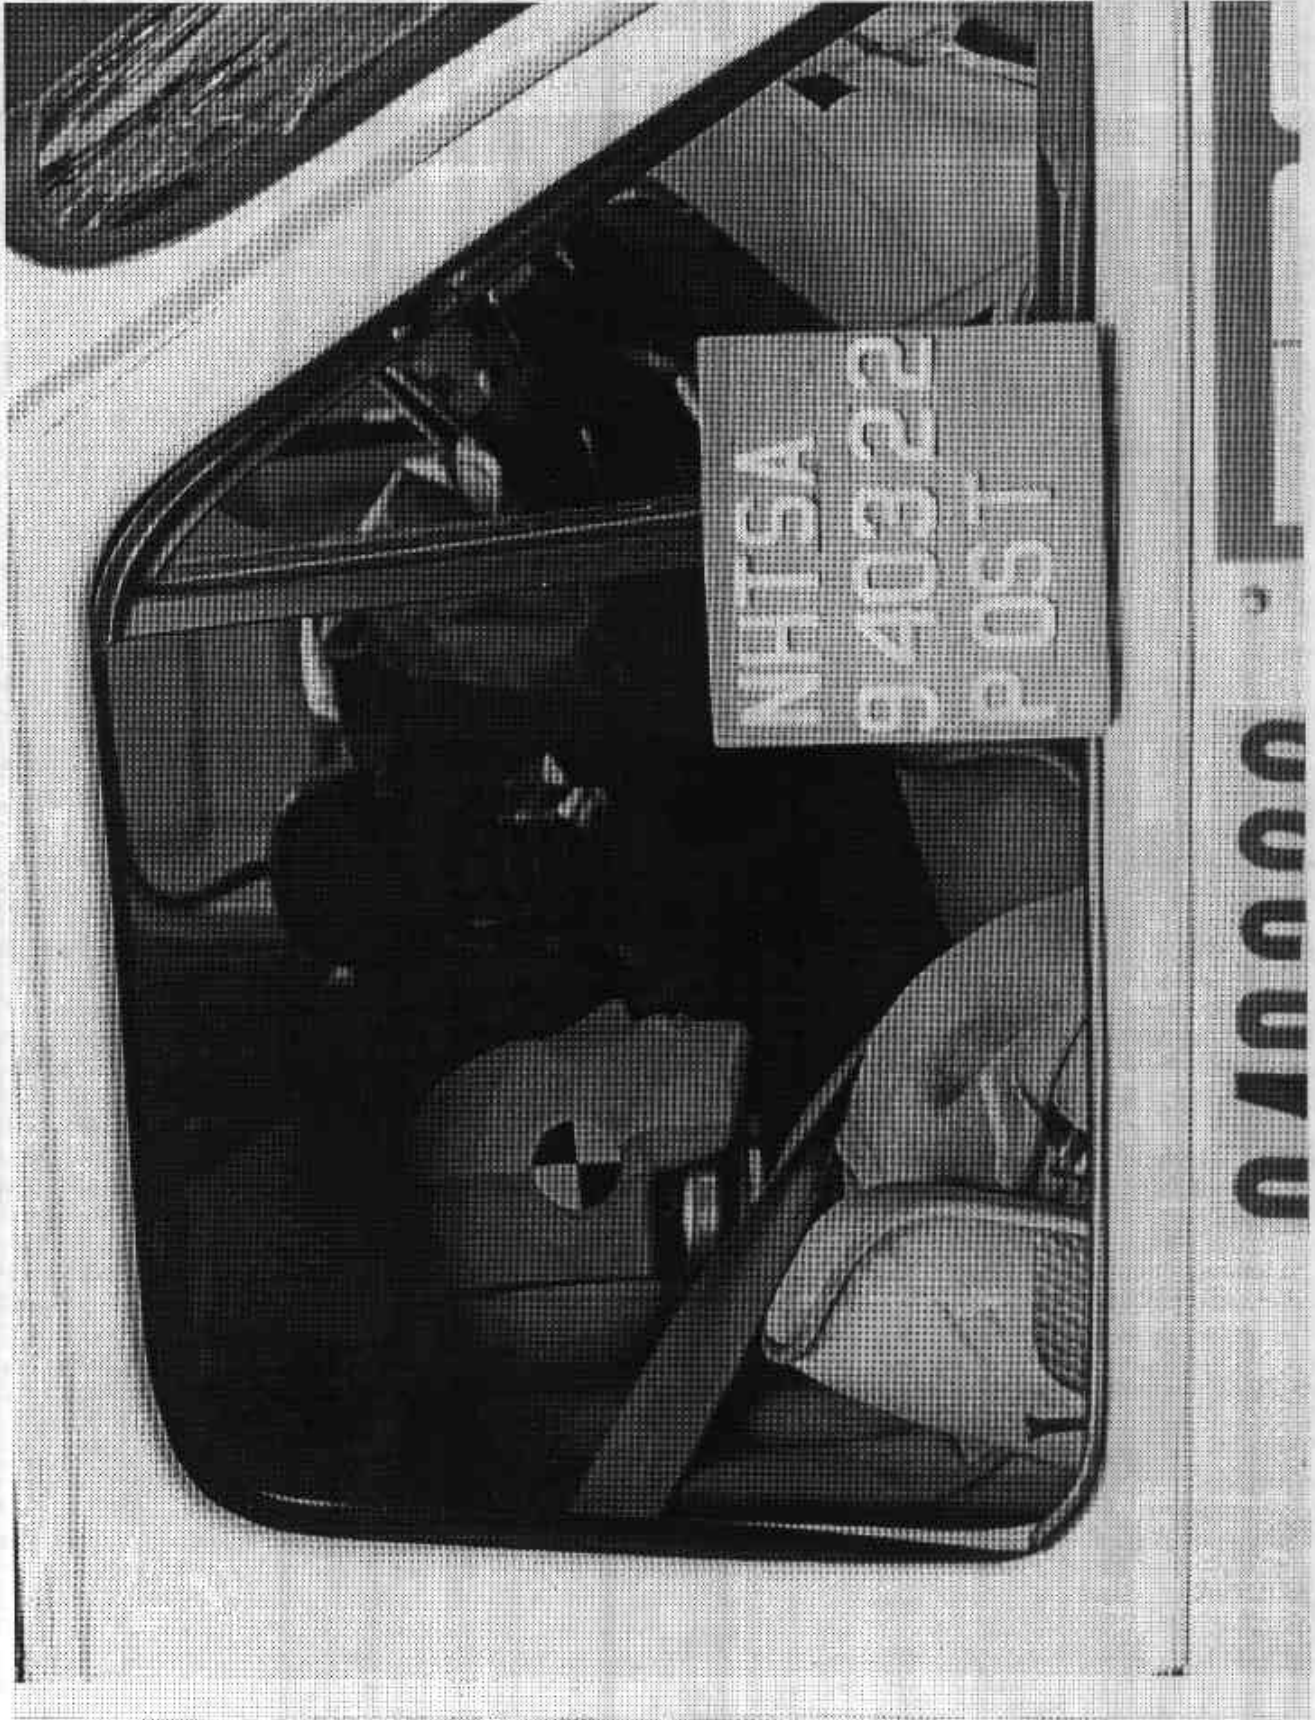
Figure A-40. Post-test Passenger Dummy Position - View 2
A-41

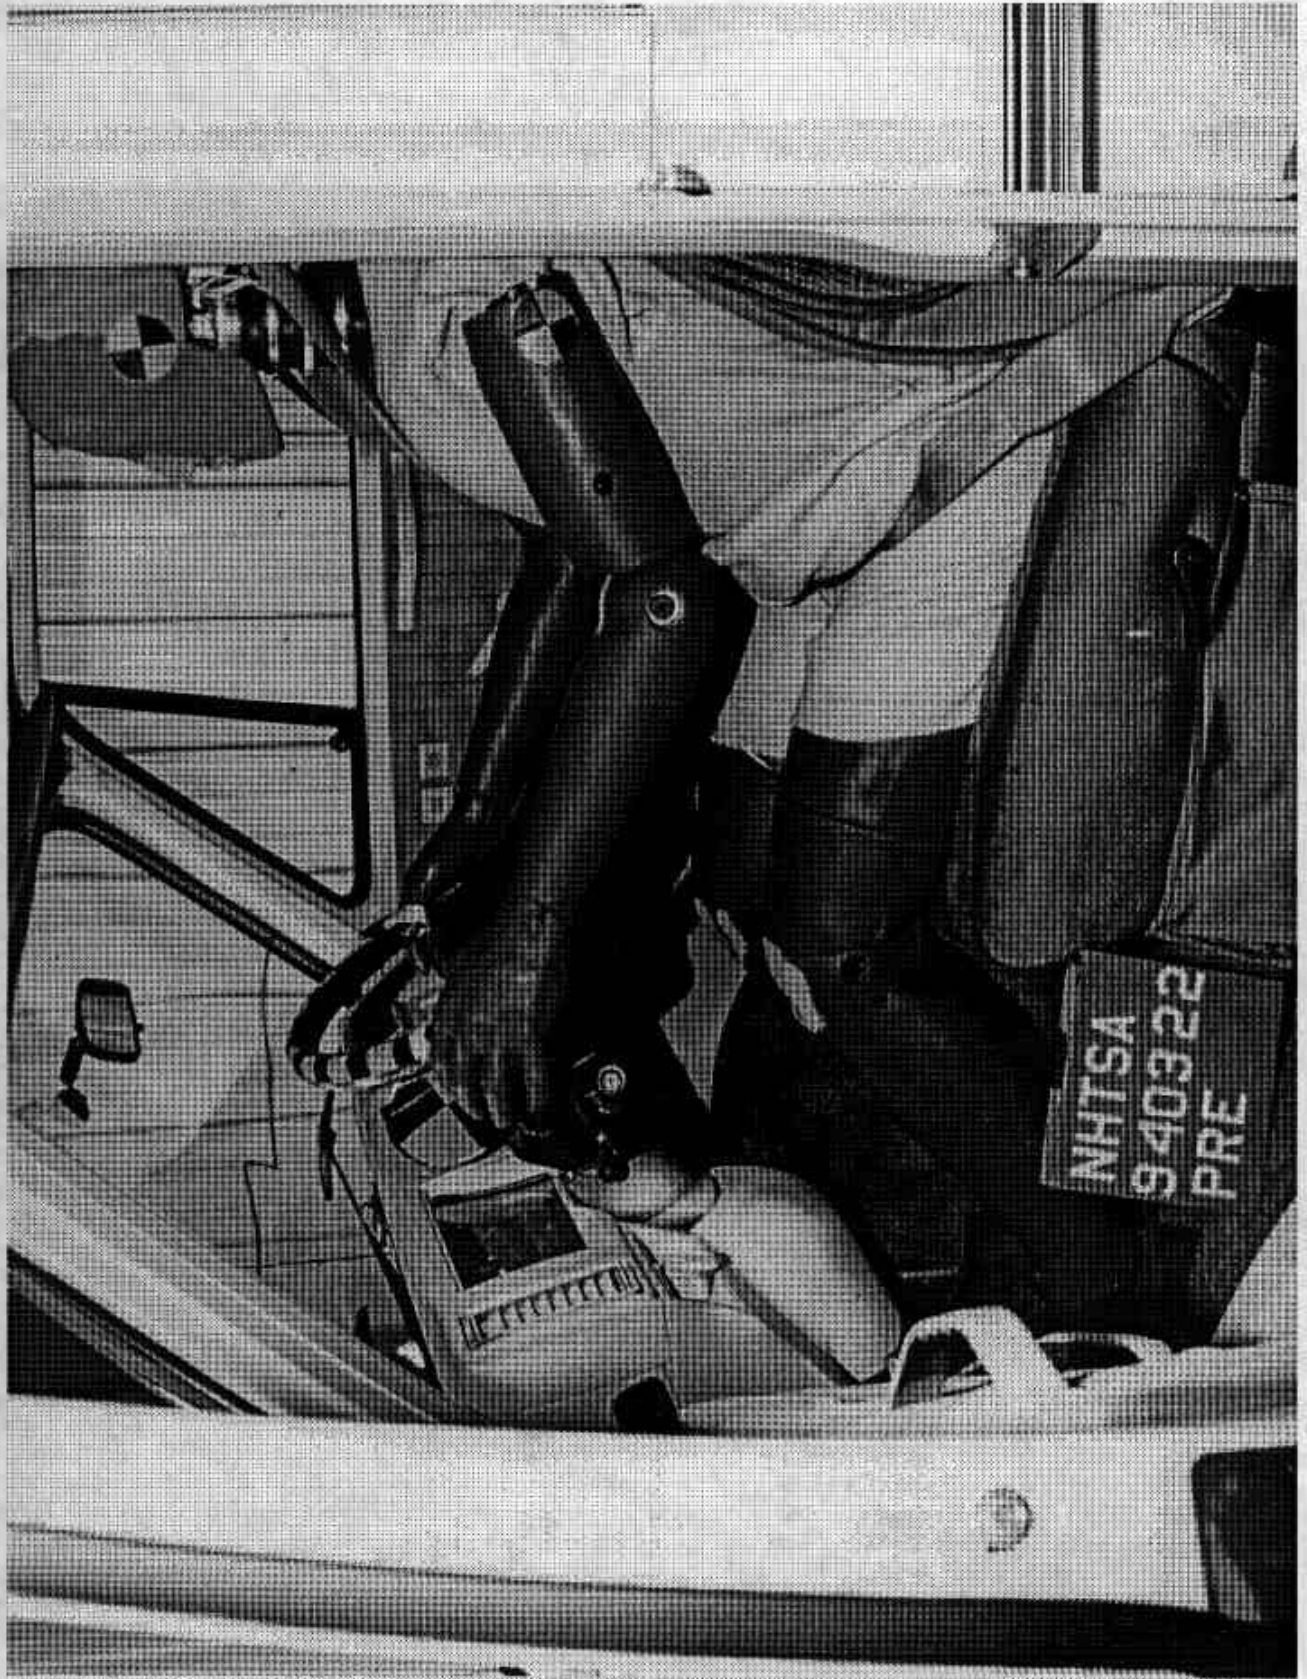
Figure A-41. Pre-test Driver Dummy & Vehicle Interior - View 1

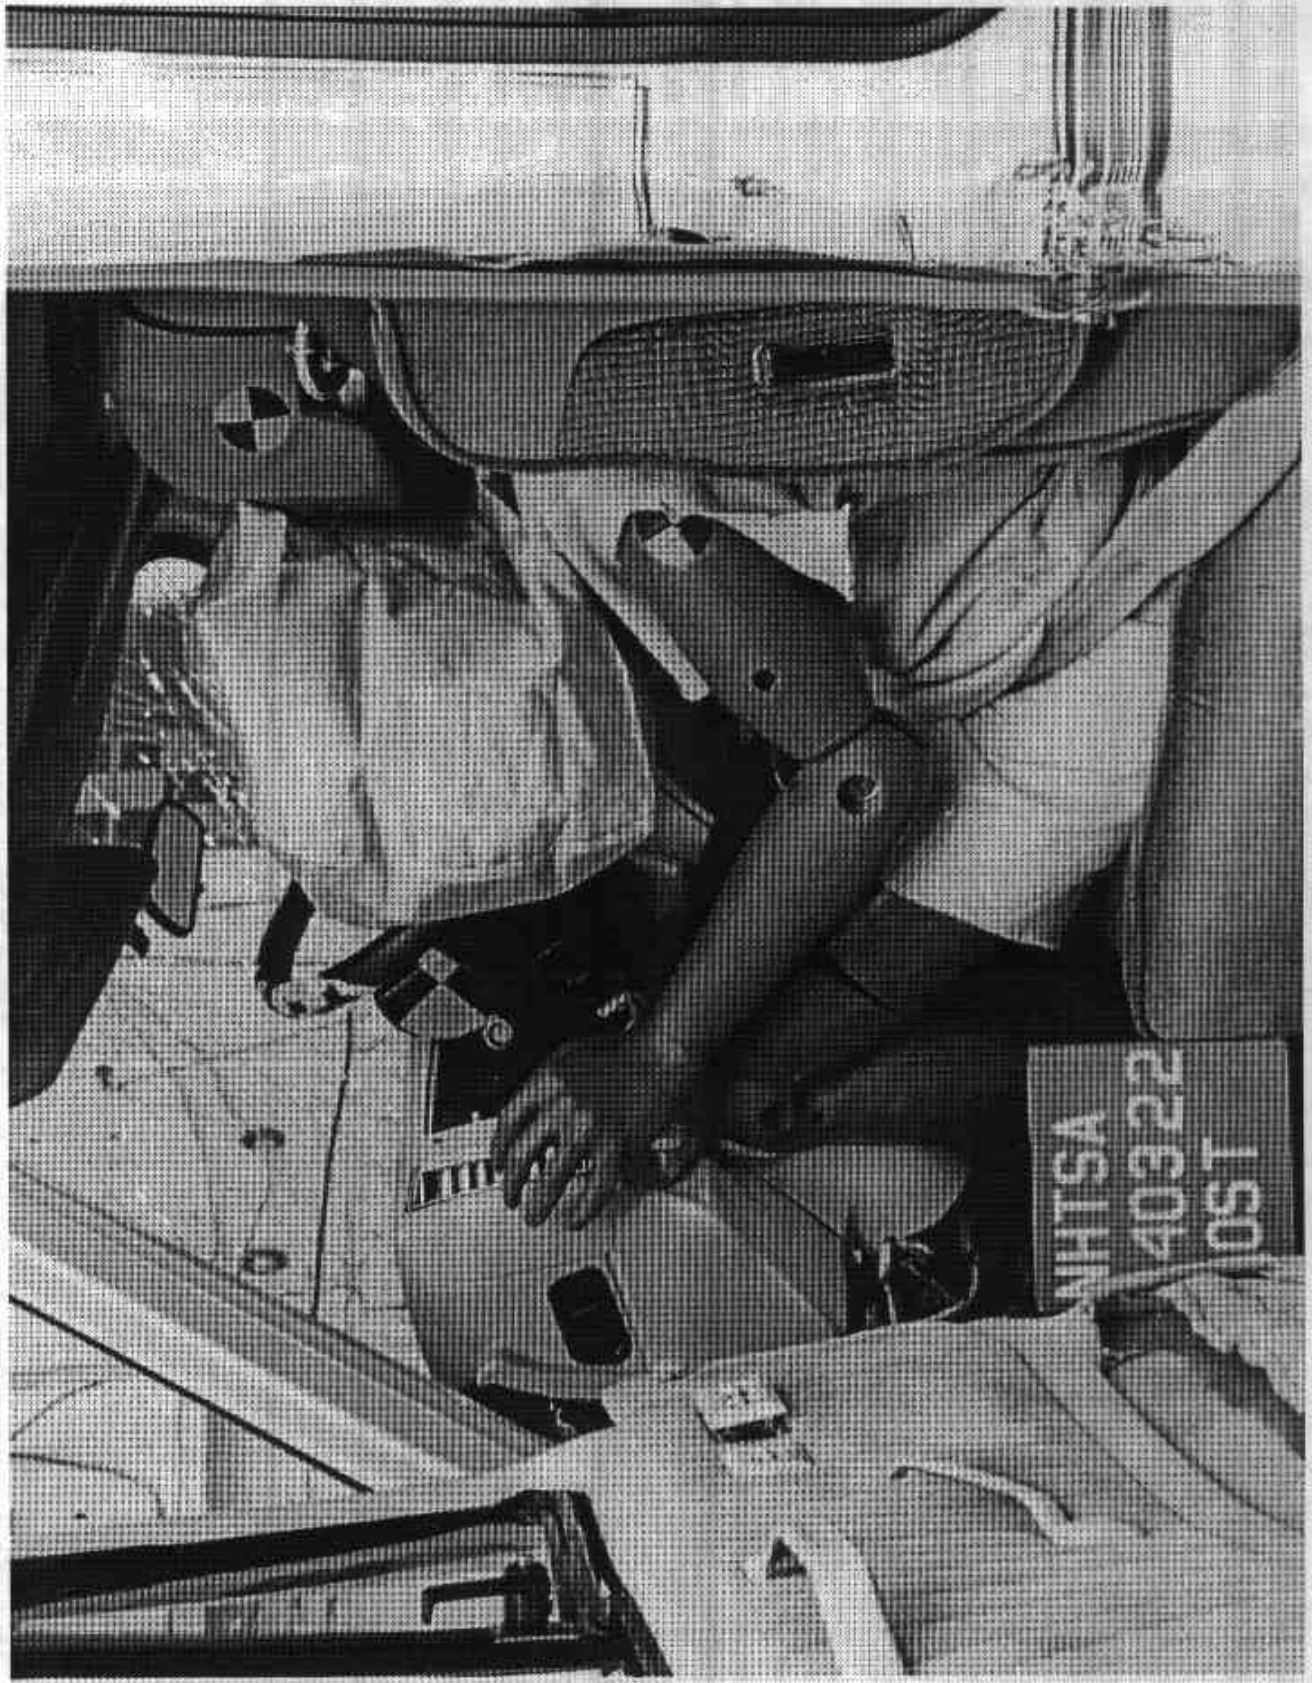
Figure A-42. Post-test Driver Dummy & Vehicle Interior - View 1

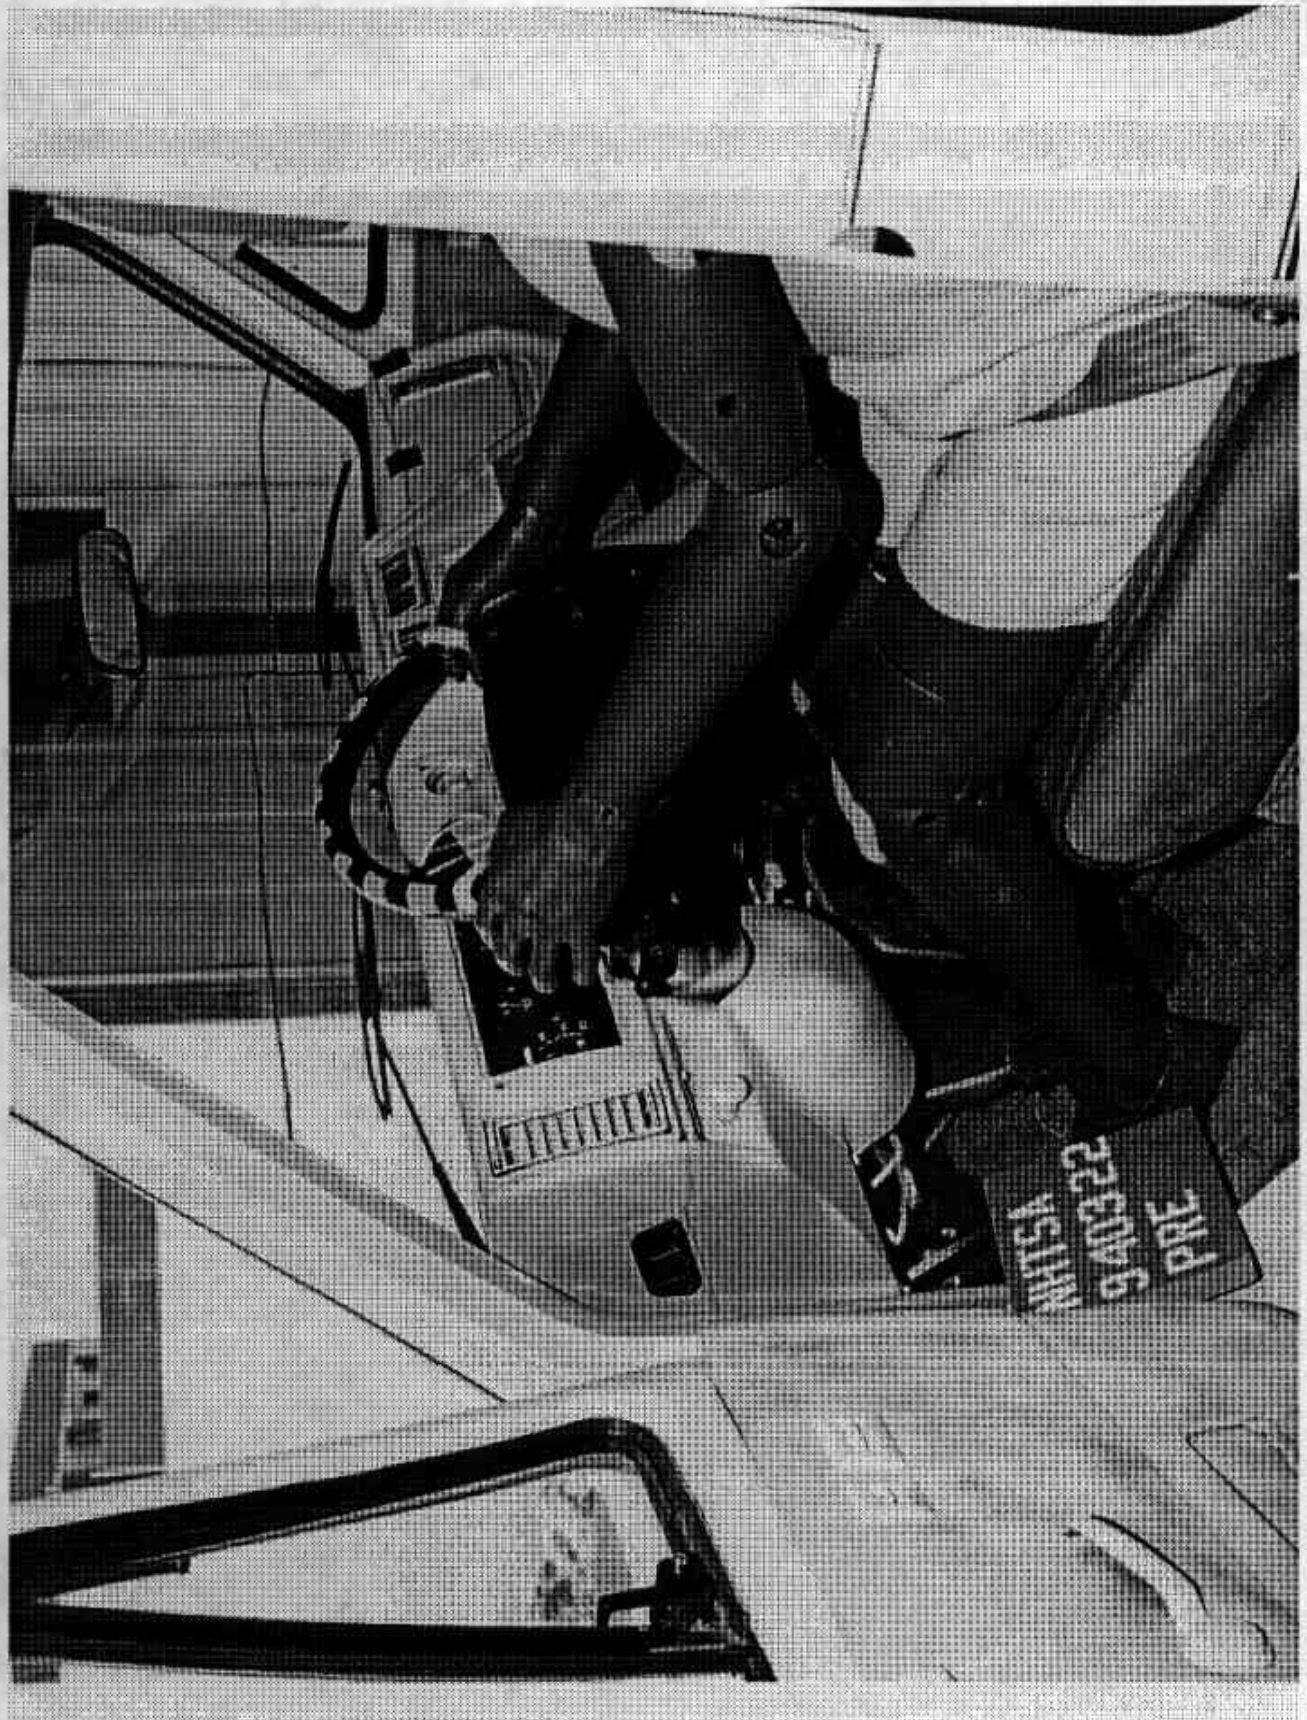
Figure A-43. Pre-test Driver Dummy & Vehicle Interior - View 2

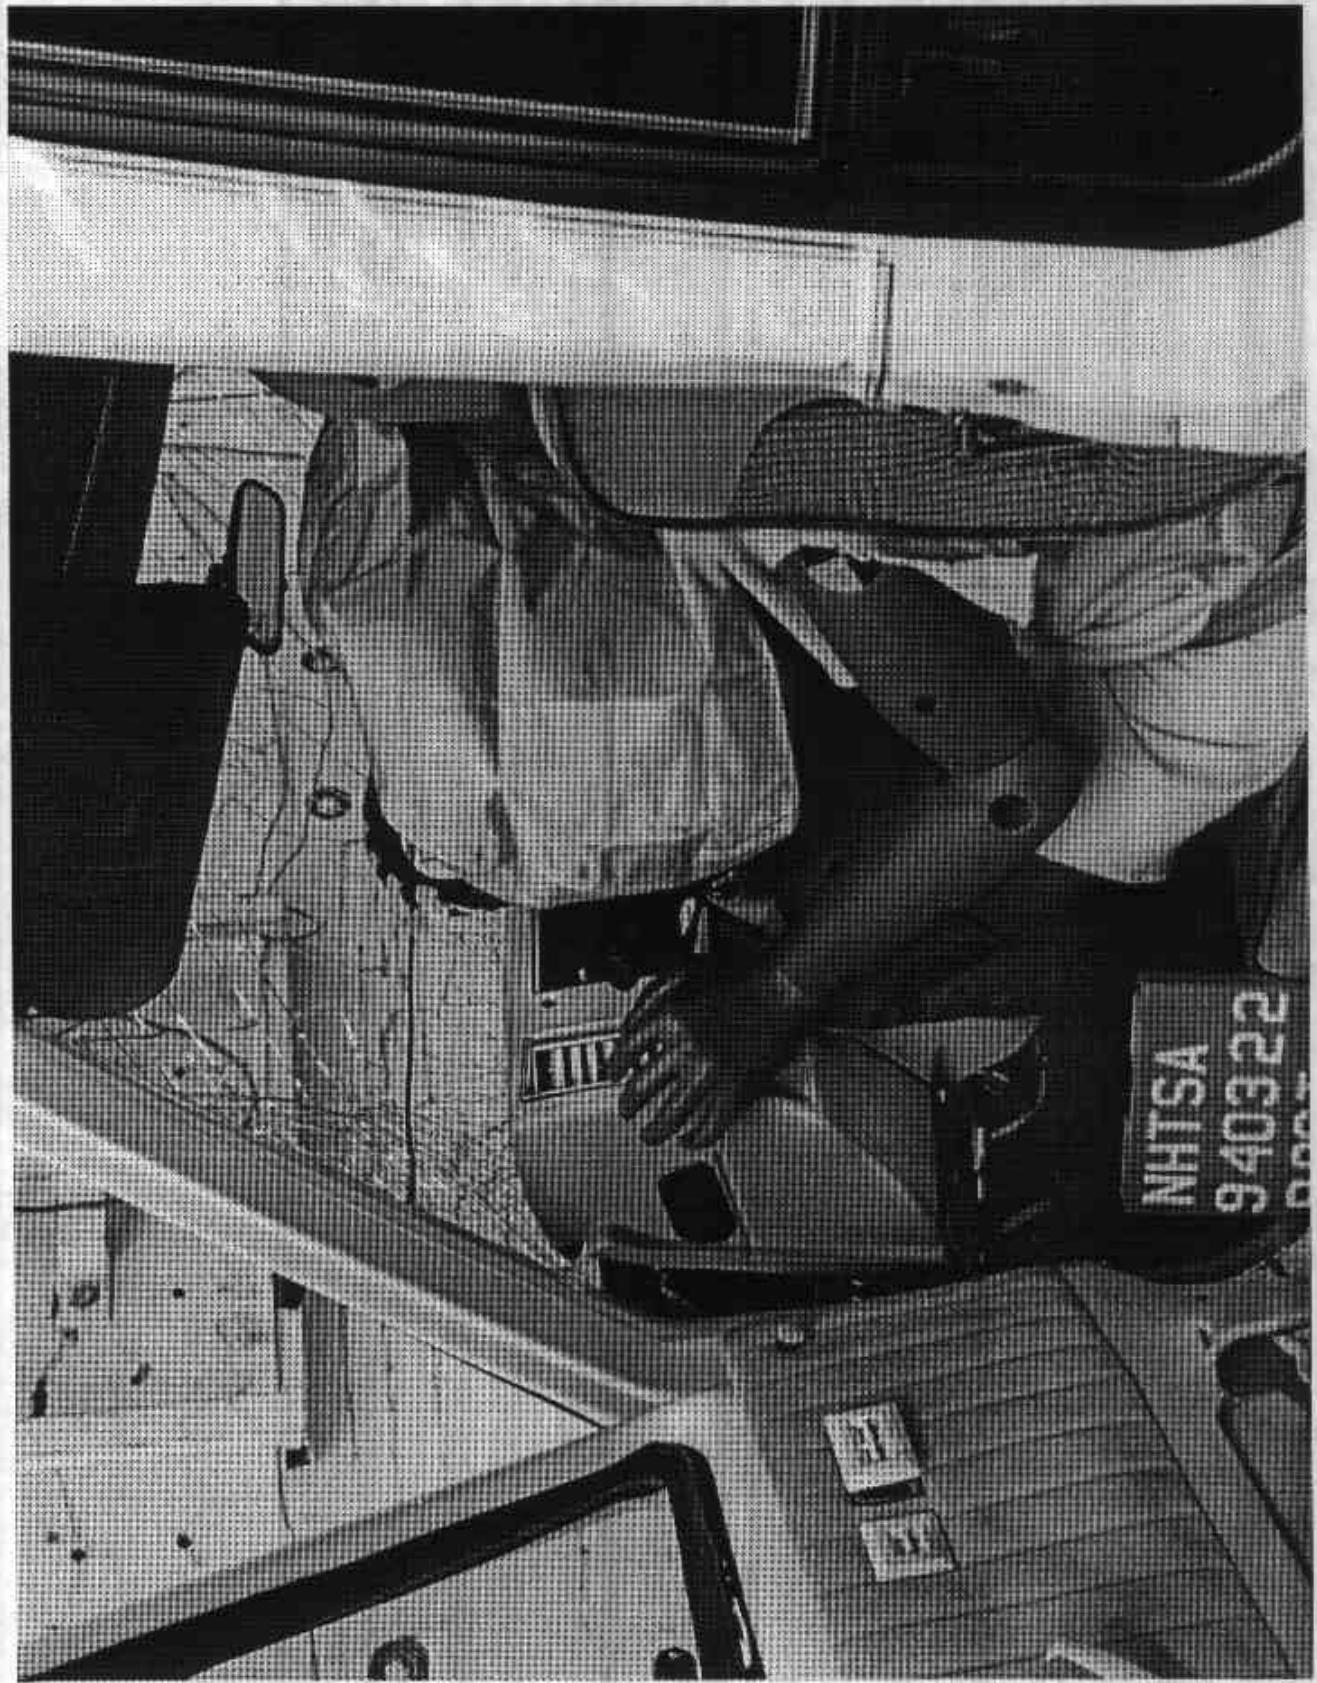
Figure A-44. Post-test Driver Dummy & Vehicle Interior - View 2

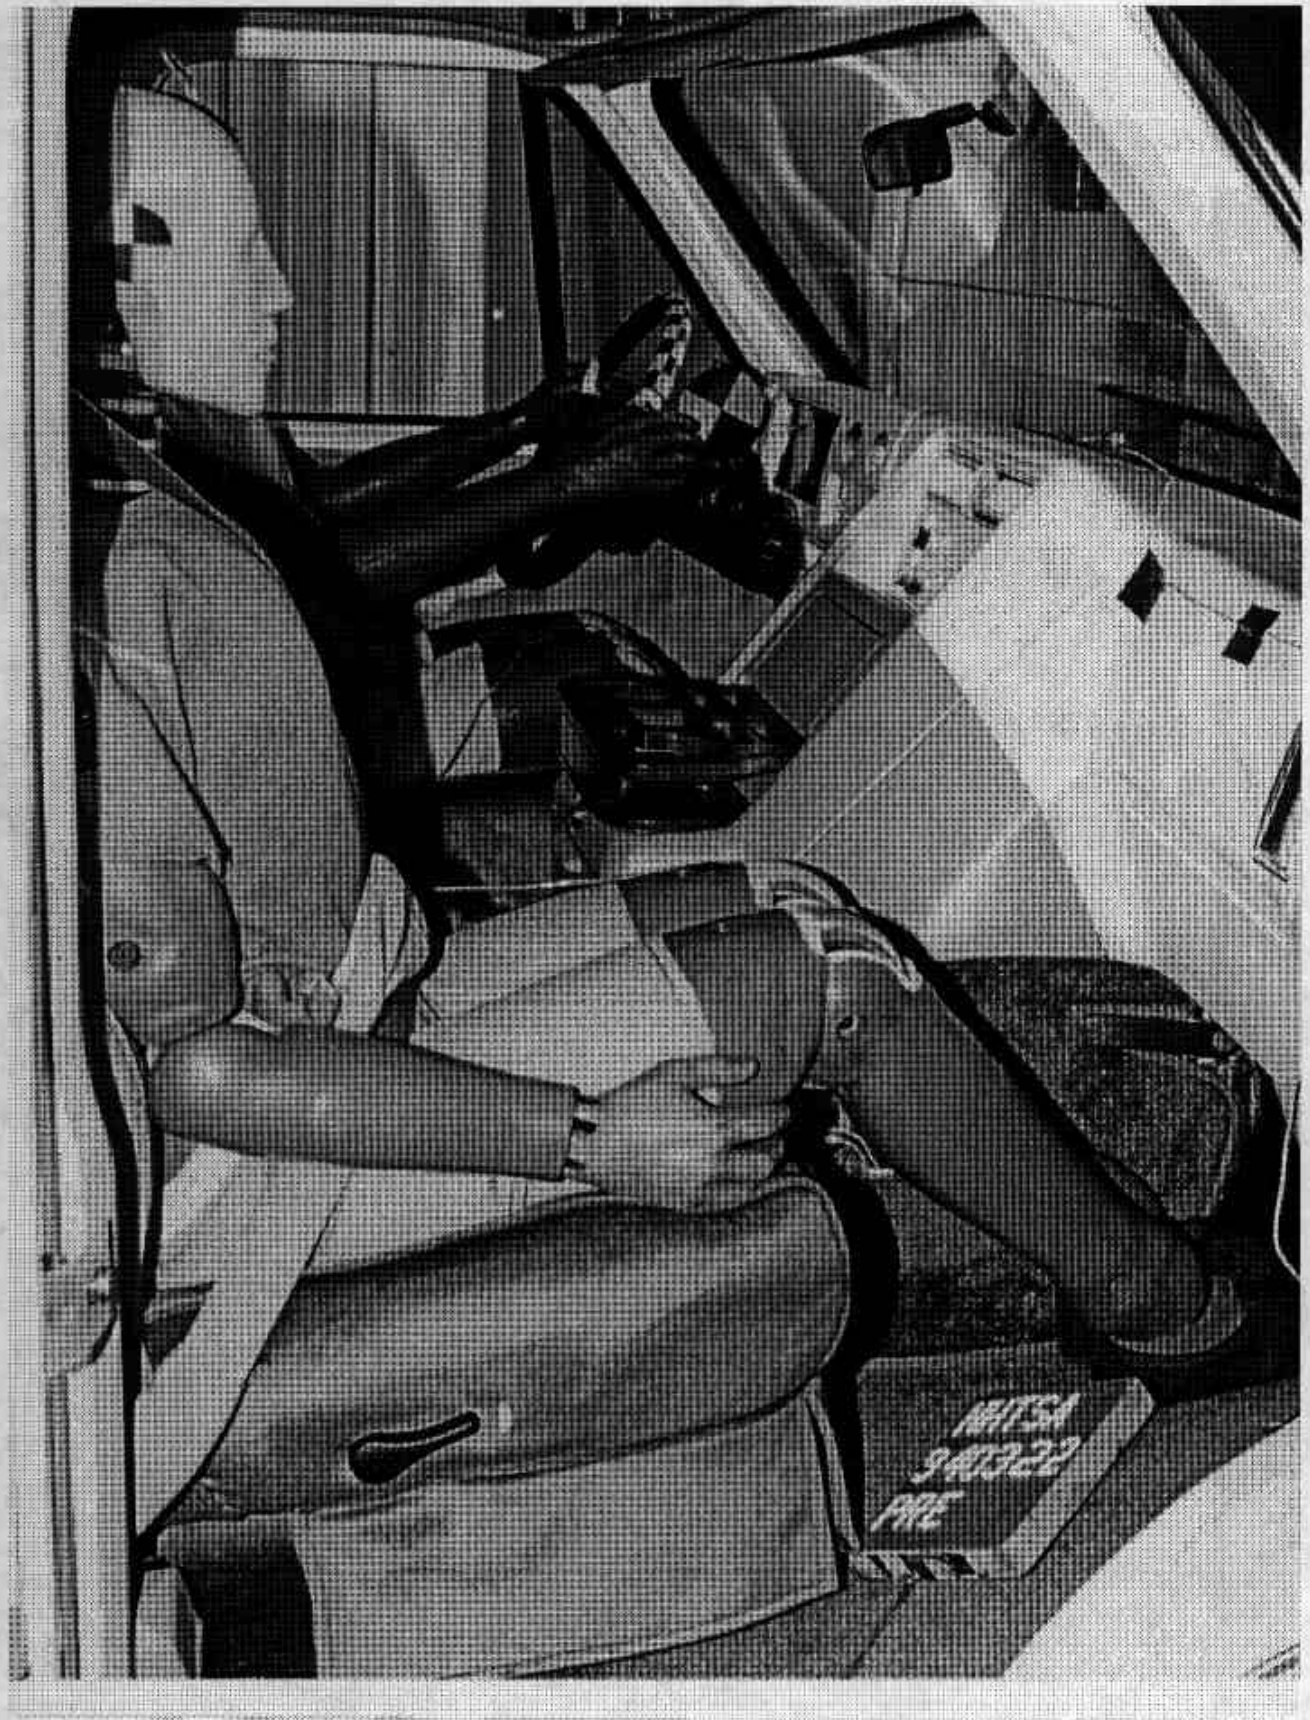
Figure A-45. Pre-test Passenger Dummy & Vehicle Interior - View 1

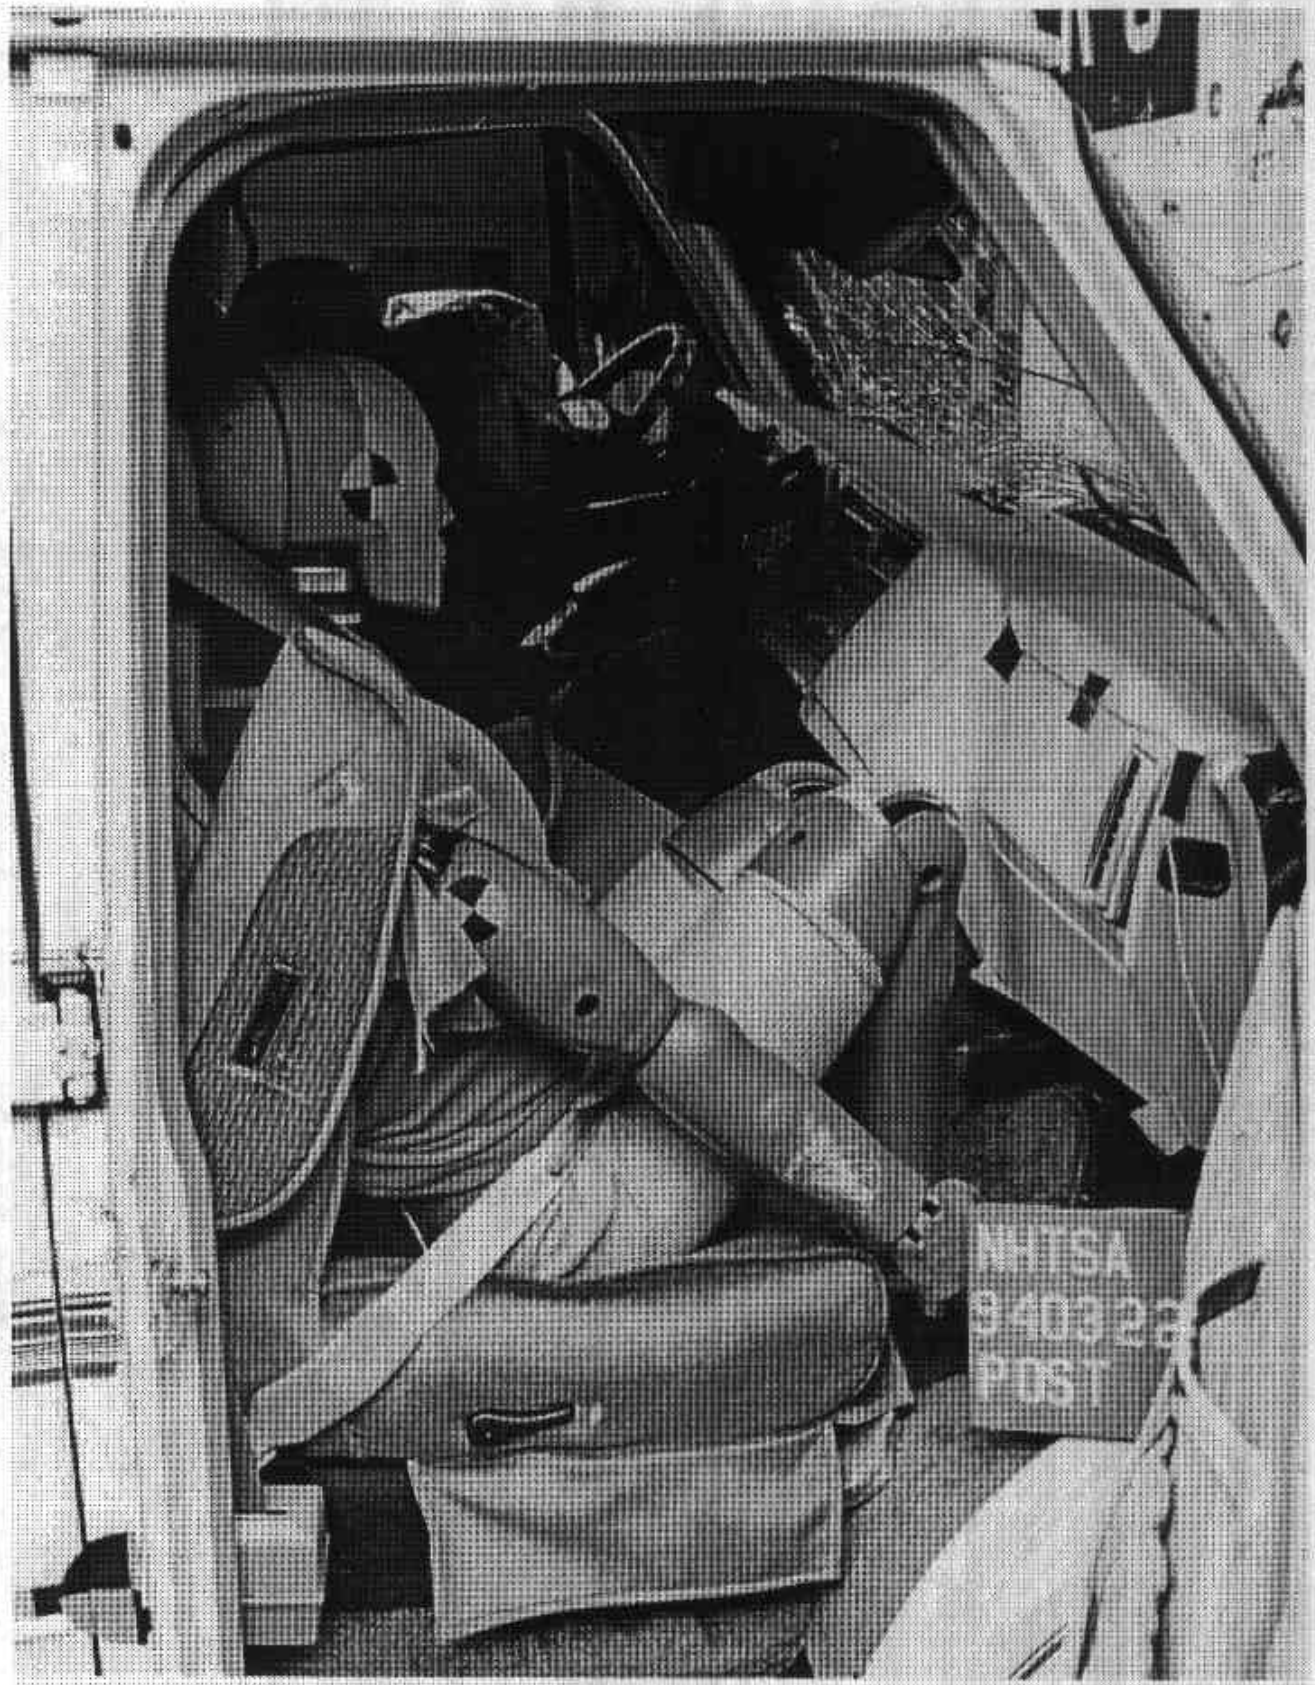
Figure A-46. Post-test Passenger Dummy & Vehicle Interior - View 1

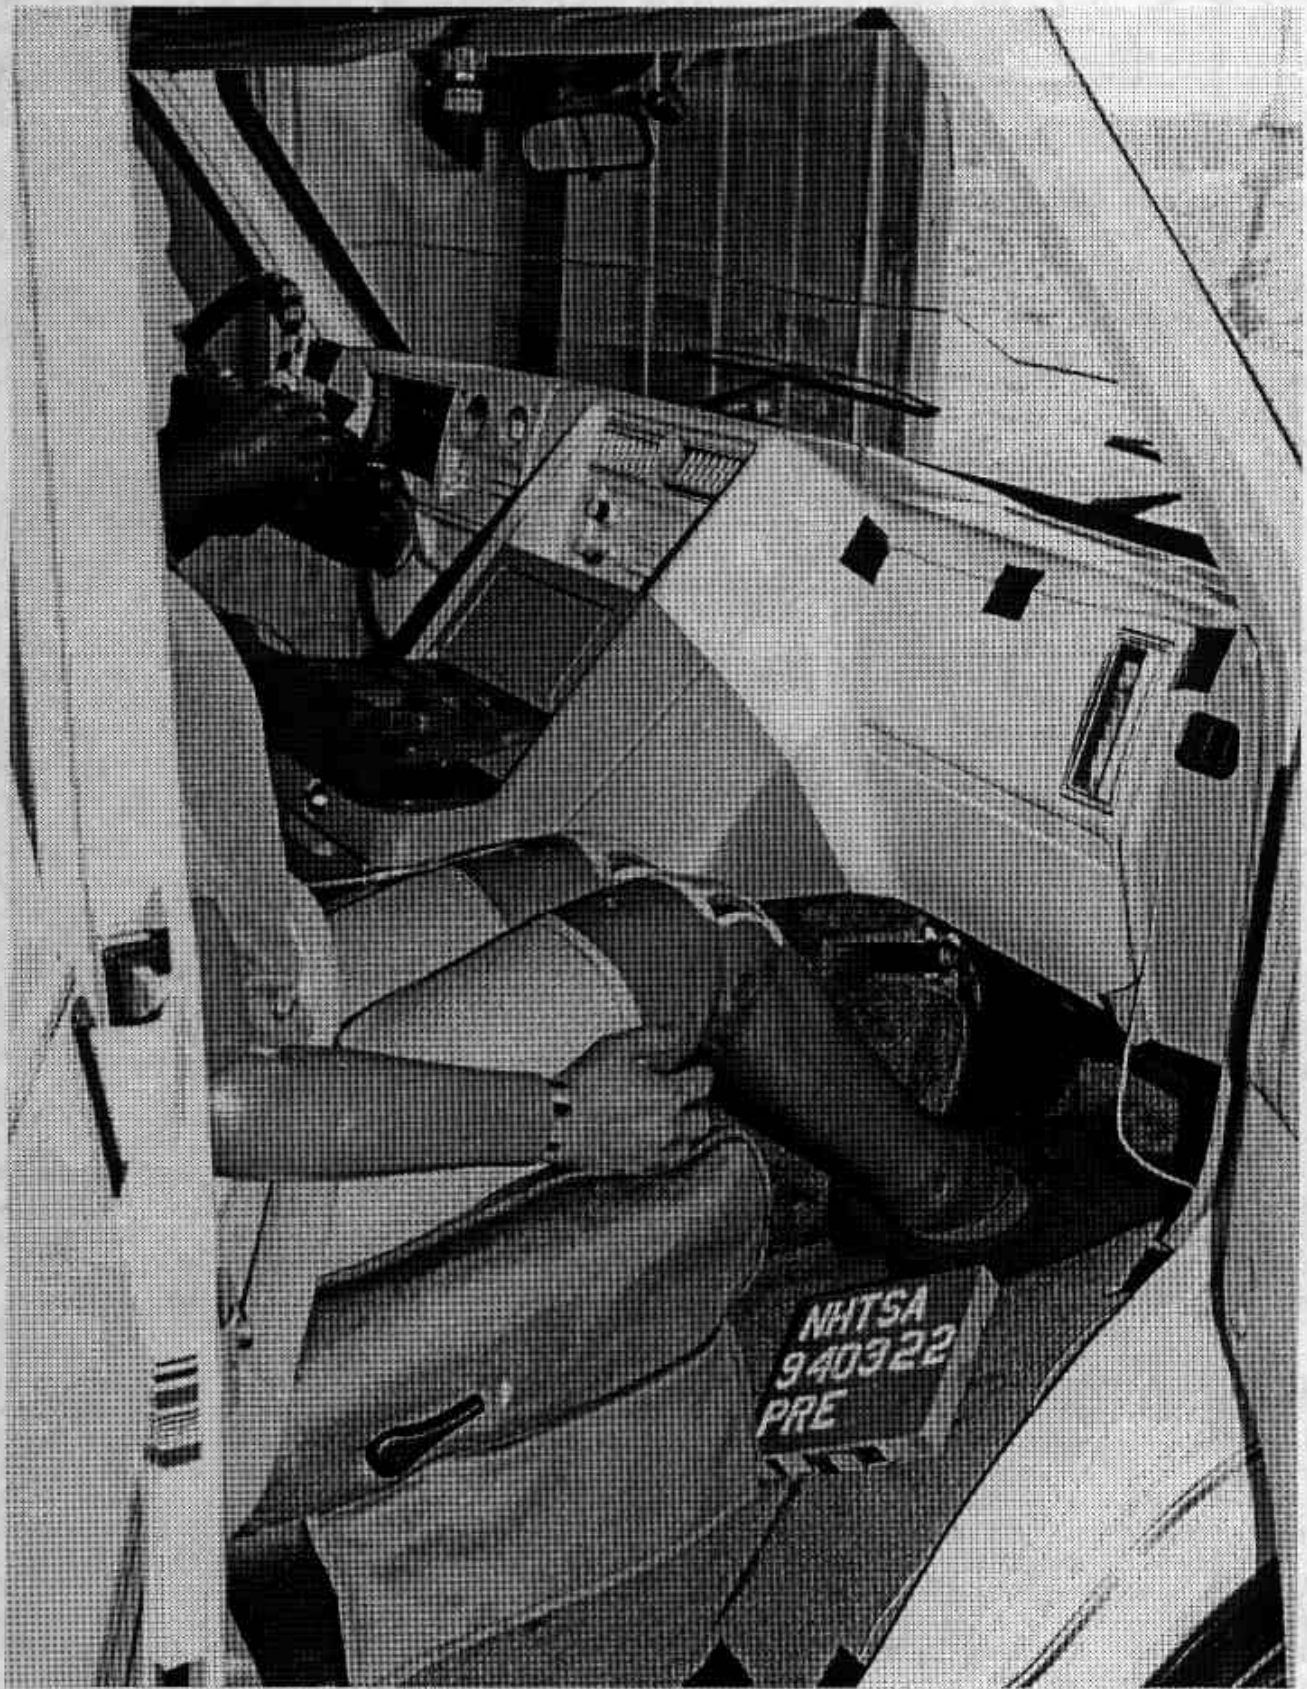
Figure A-47. Pre-test Passenger Dummy & Vehicle Interior - View 2

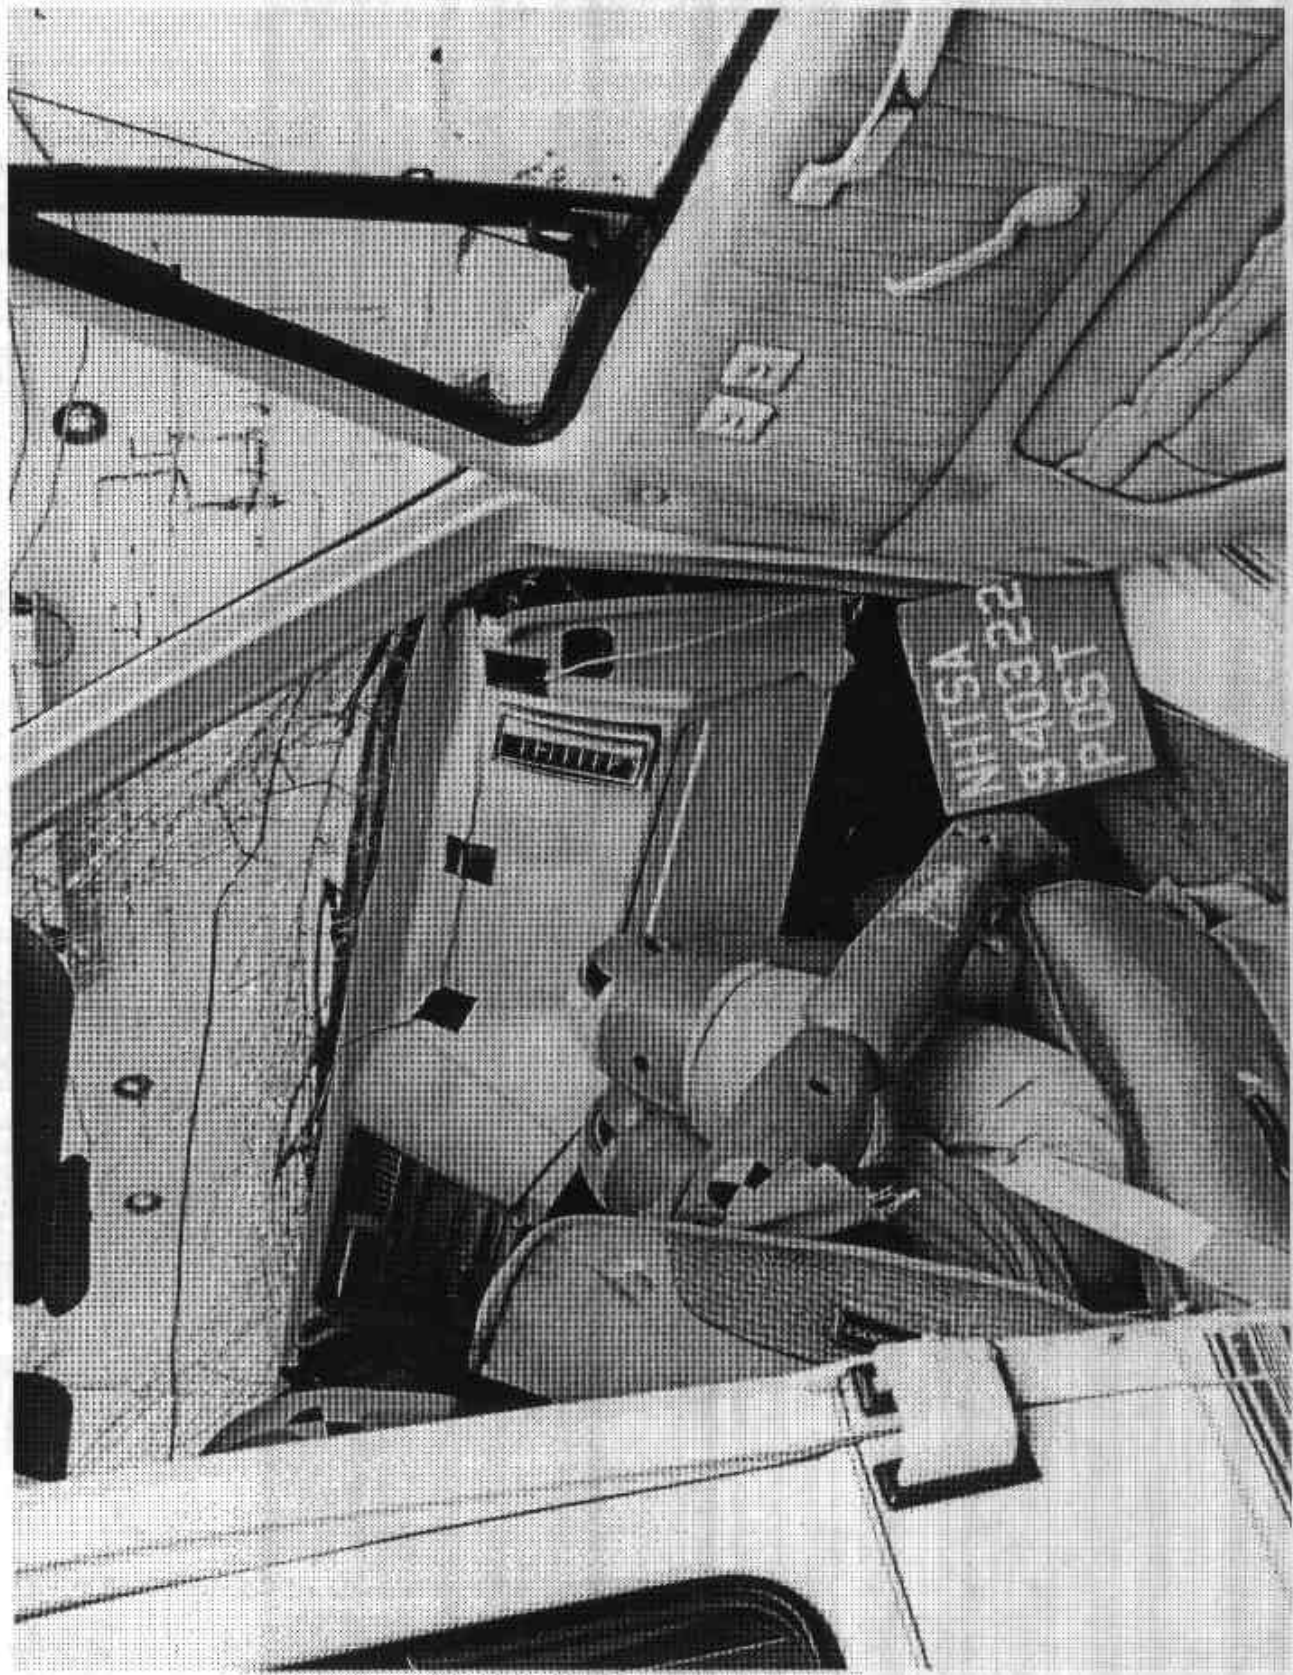
Figure A-48. Post-test Passenger Dummy & Vehicle Interior - View 2

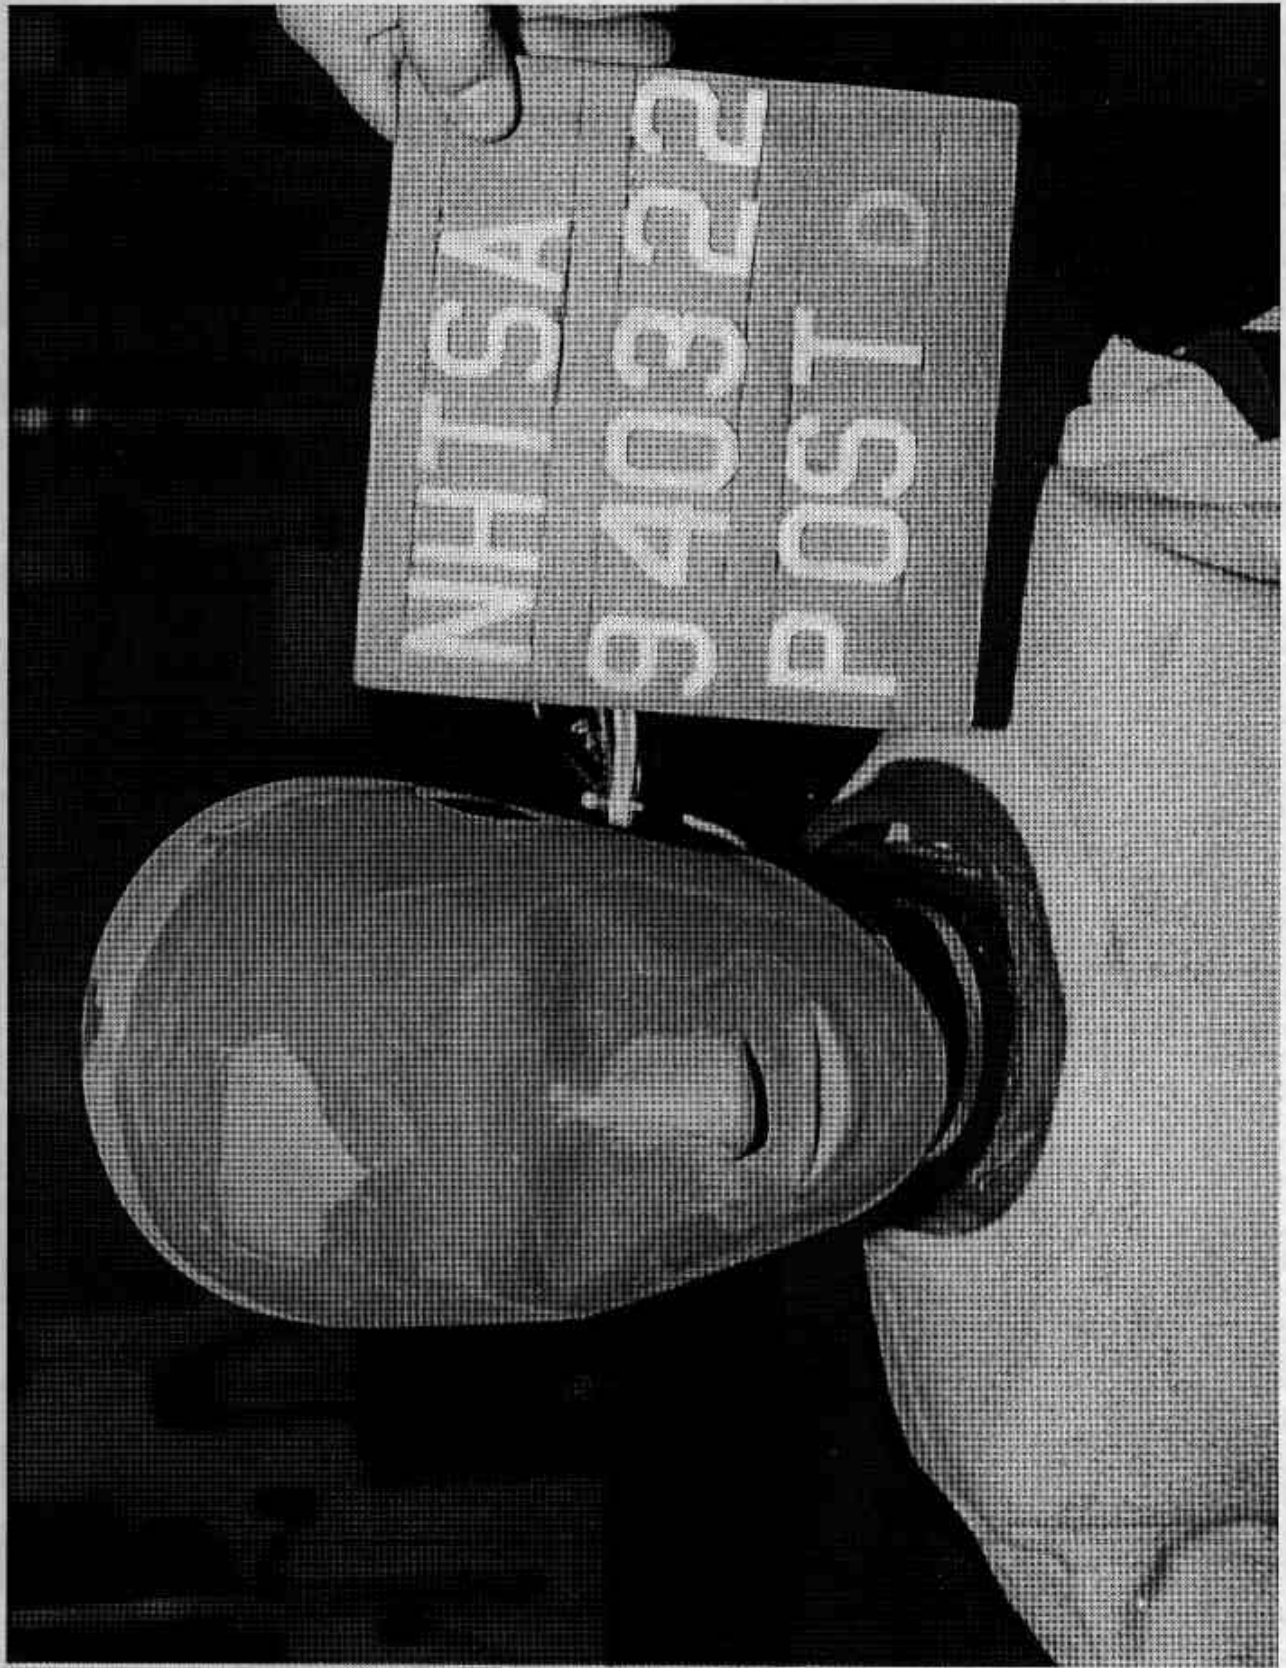
Figure A-49. Post-test Driver Dummy Head Contact - View 1
