Vehicle Safety Compliance Testing
for Occupant Crash Protection,
Windshield Mounting, Windshield Zone Intrusion,
and Fuel System Integrity

Kentron, Inc.
1994 Kentron SS Sport Top Van
NHTSA Number: CR1301
TRC Test Number: 940322

Transportation Research Center Inc.
10820 State Route 347
East Liberty, Ohio 43319

Final Report

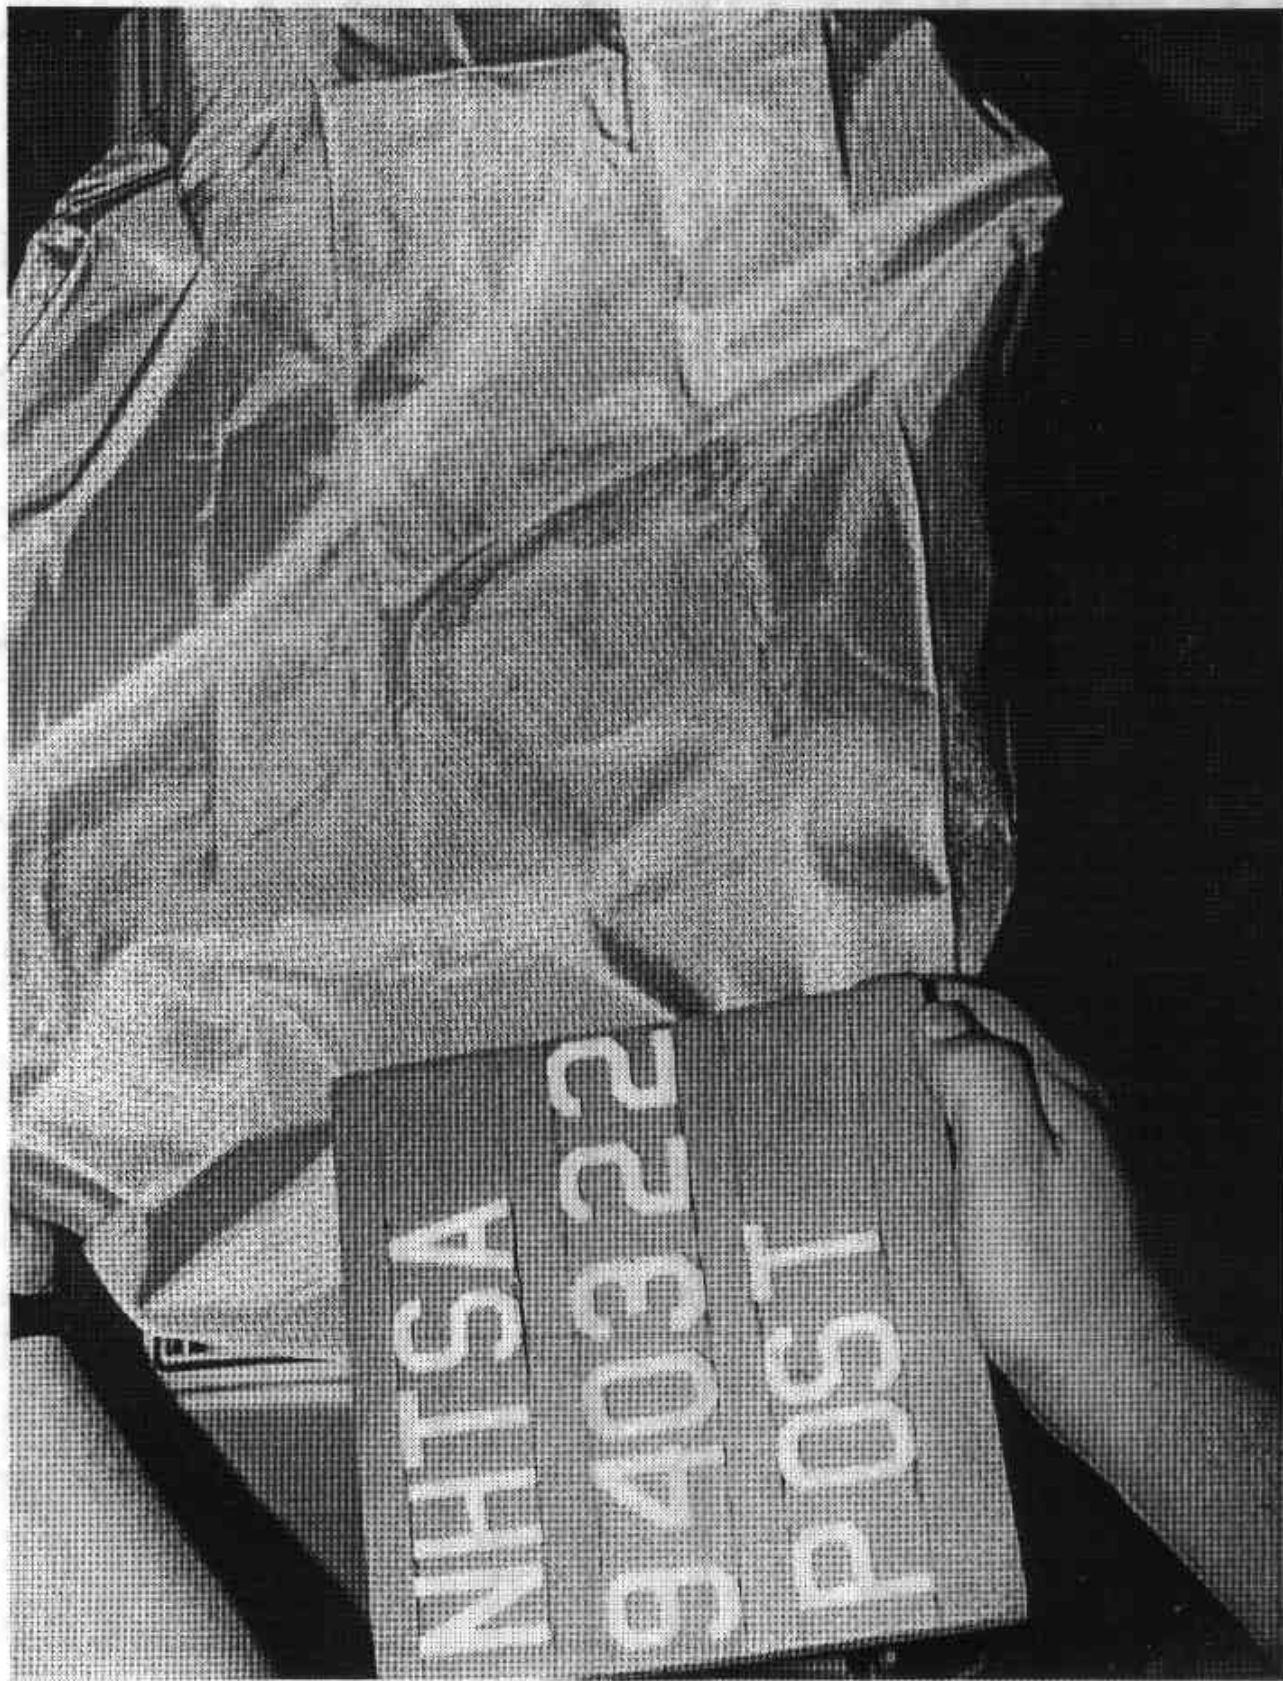
Figure A-50. Post-test Driver Dummy Head Contact - View 2
A-51

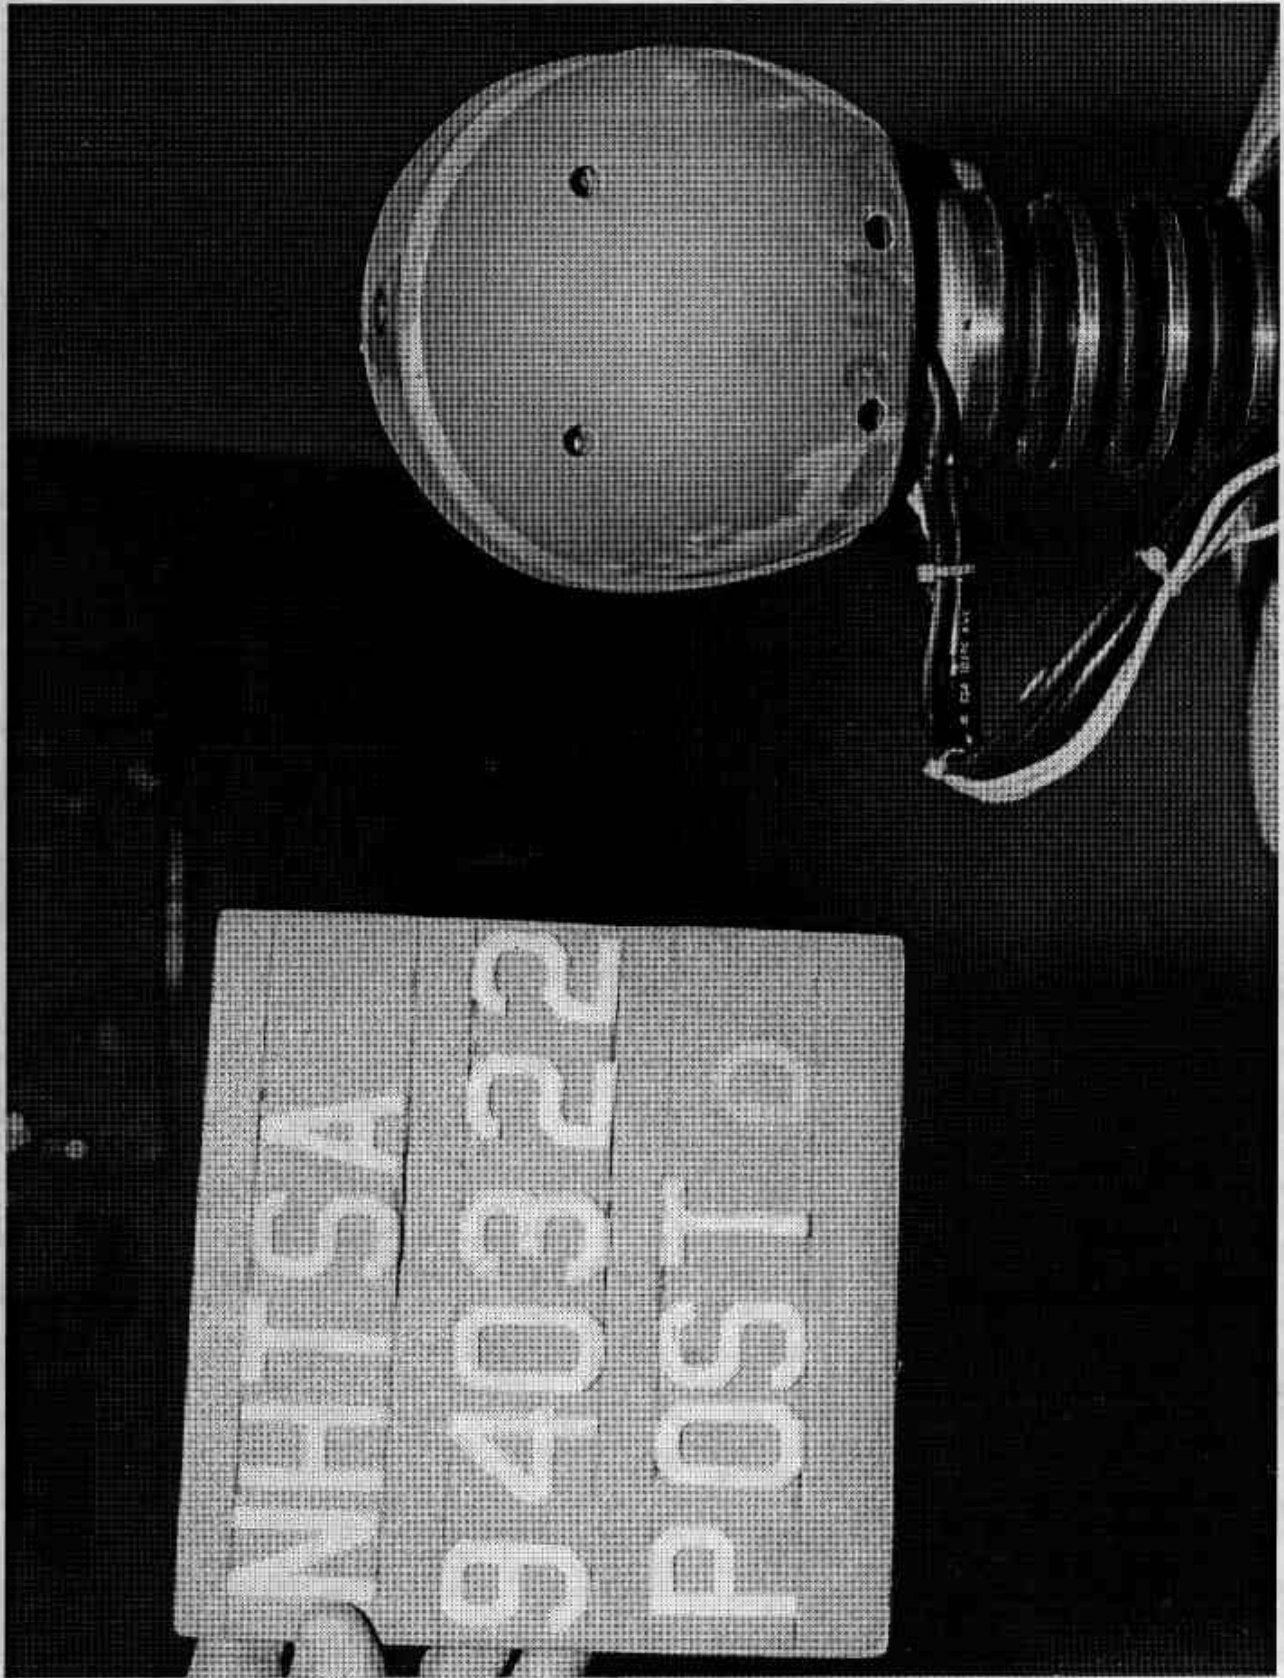
Figure A-51. Post-test Driver Dummy Head Contact - View 3

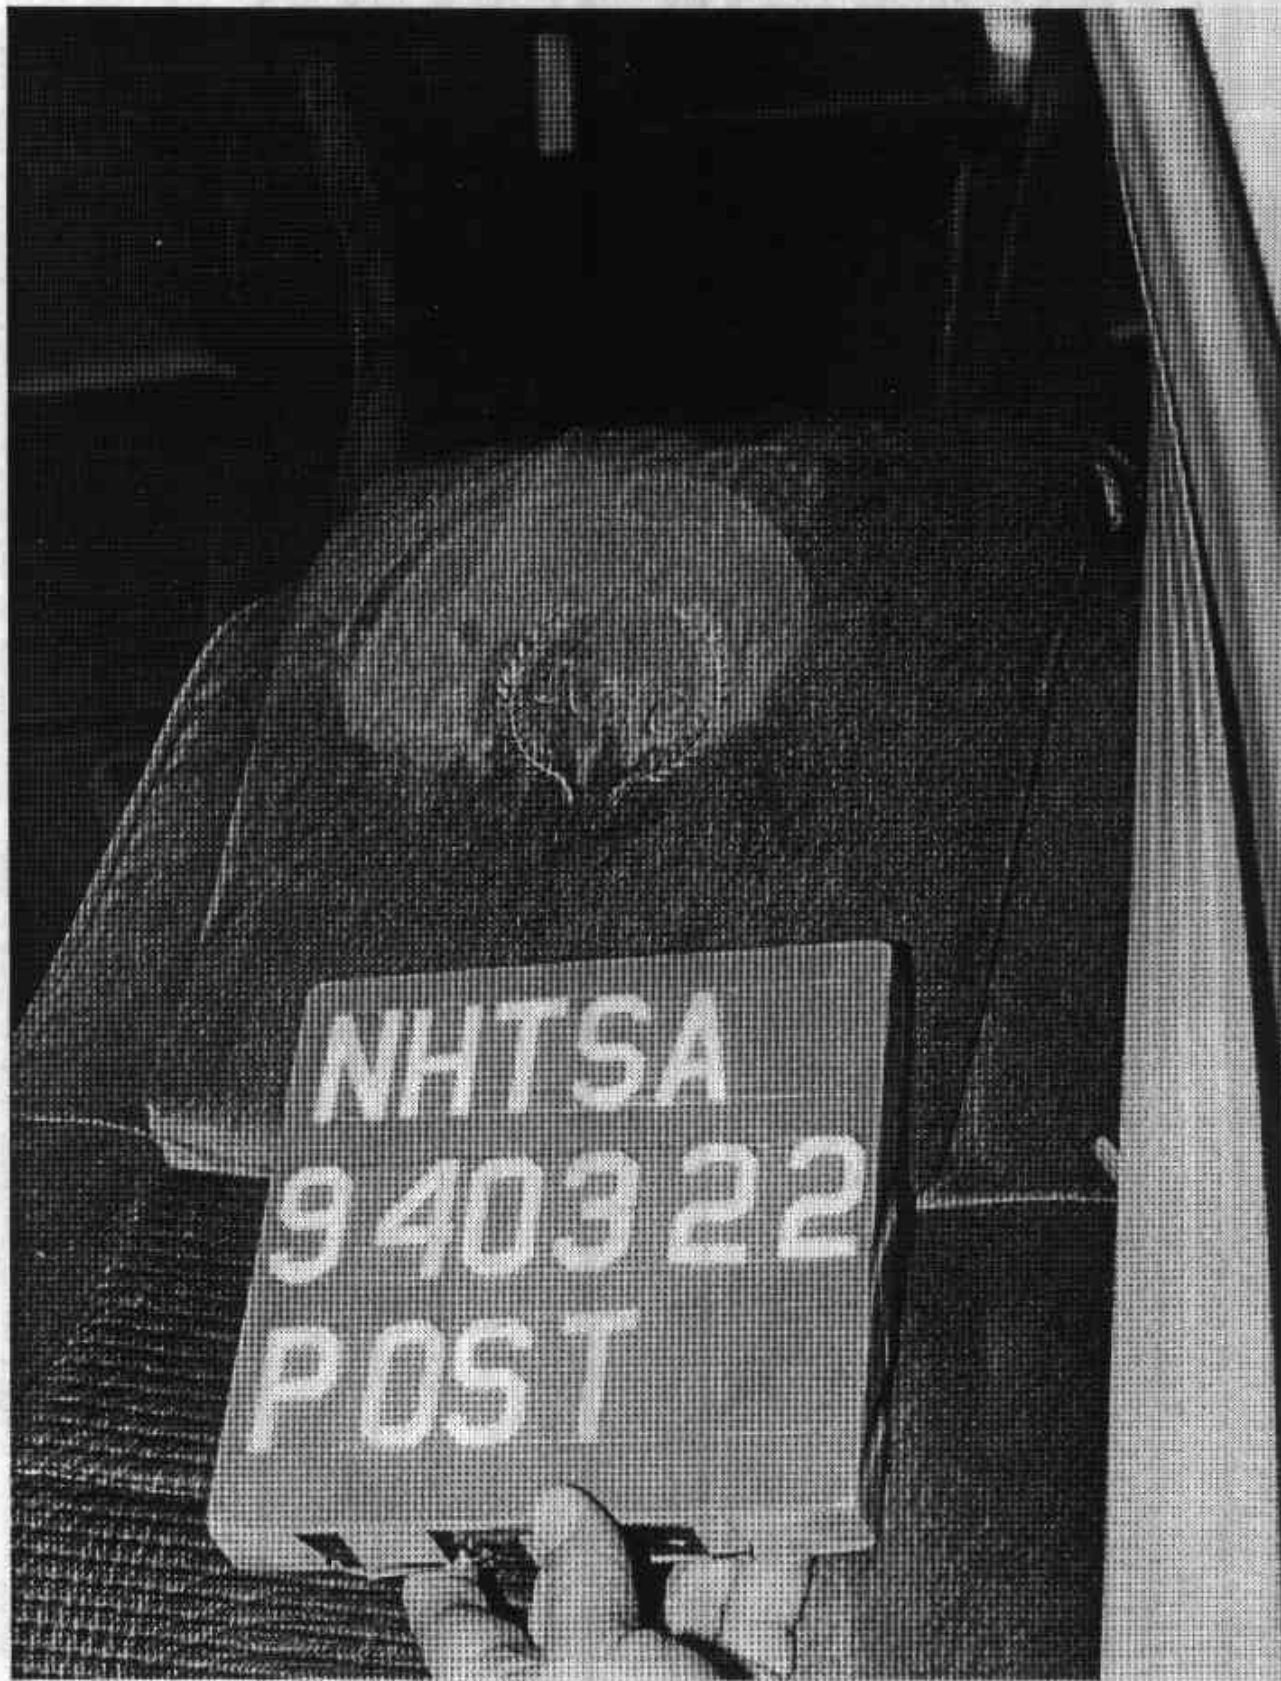
Figure A-52. Post-test Driver Dummy Head Contact - View 4
A-53

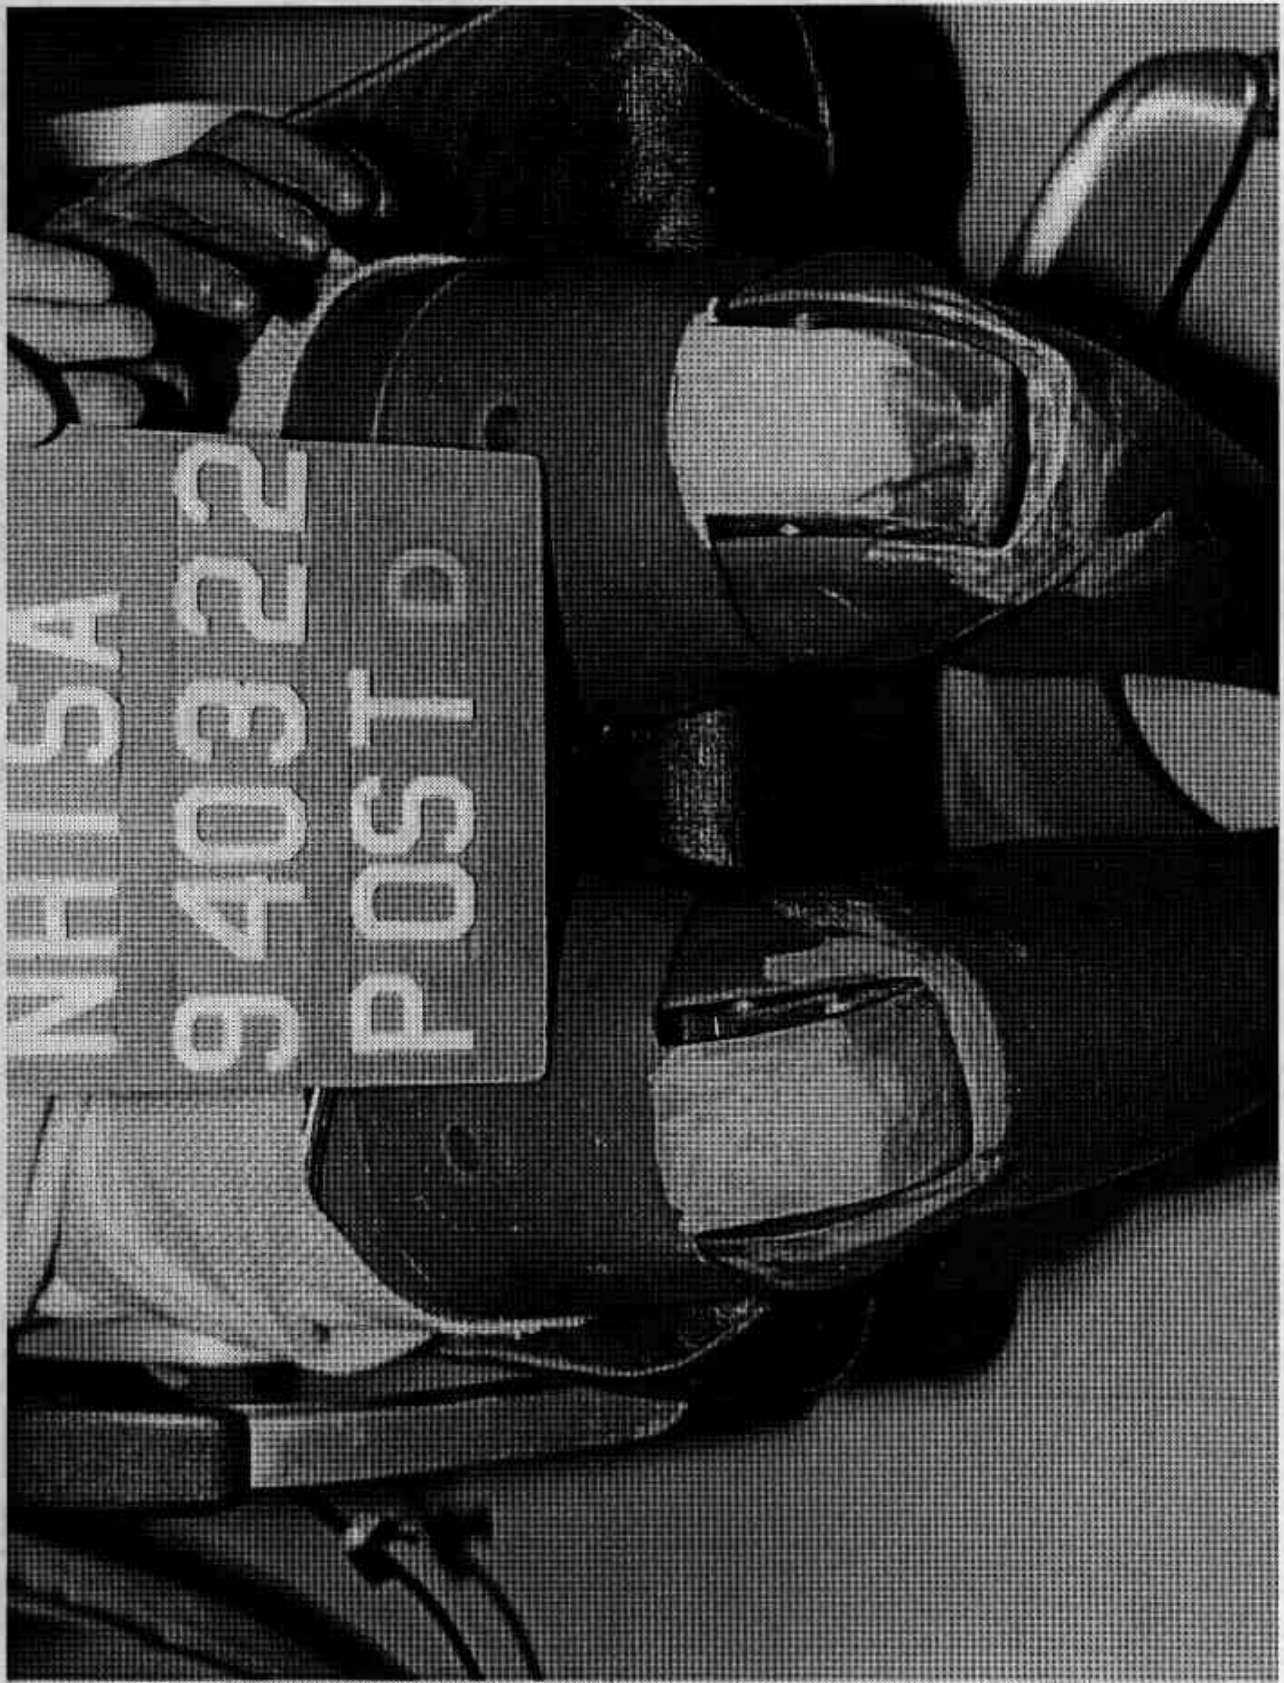
Figure A-53. Post-test Driver Dummy Knee Contact - View 1

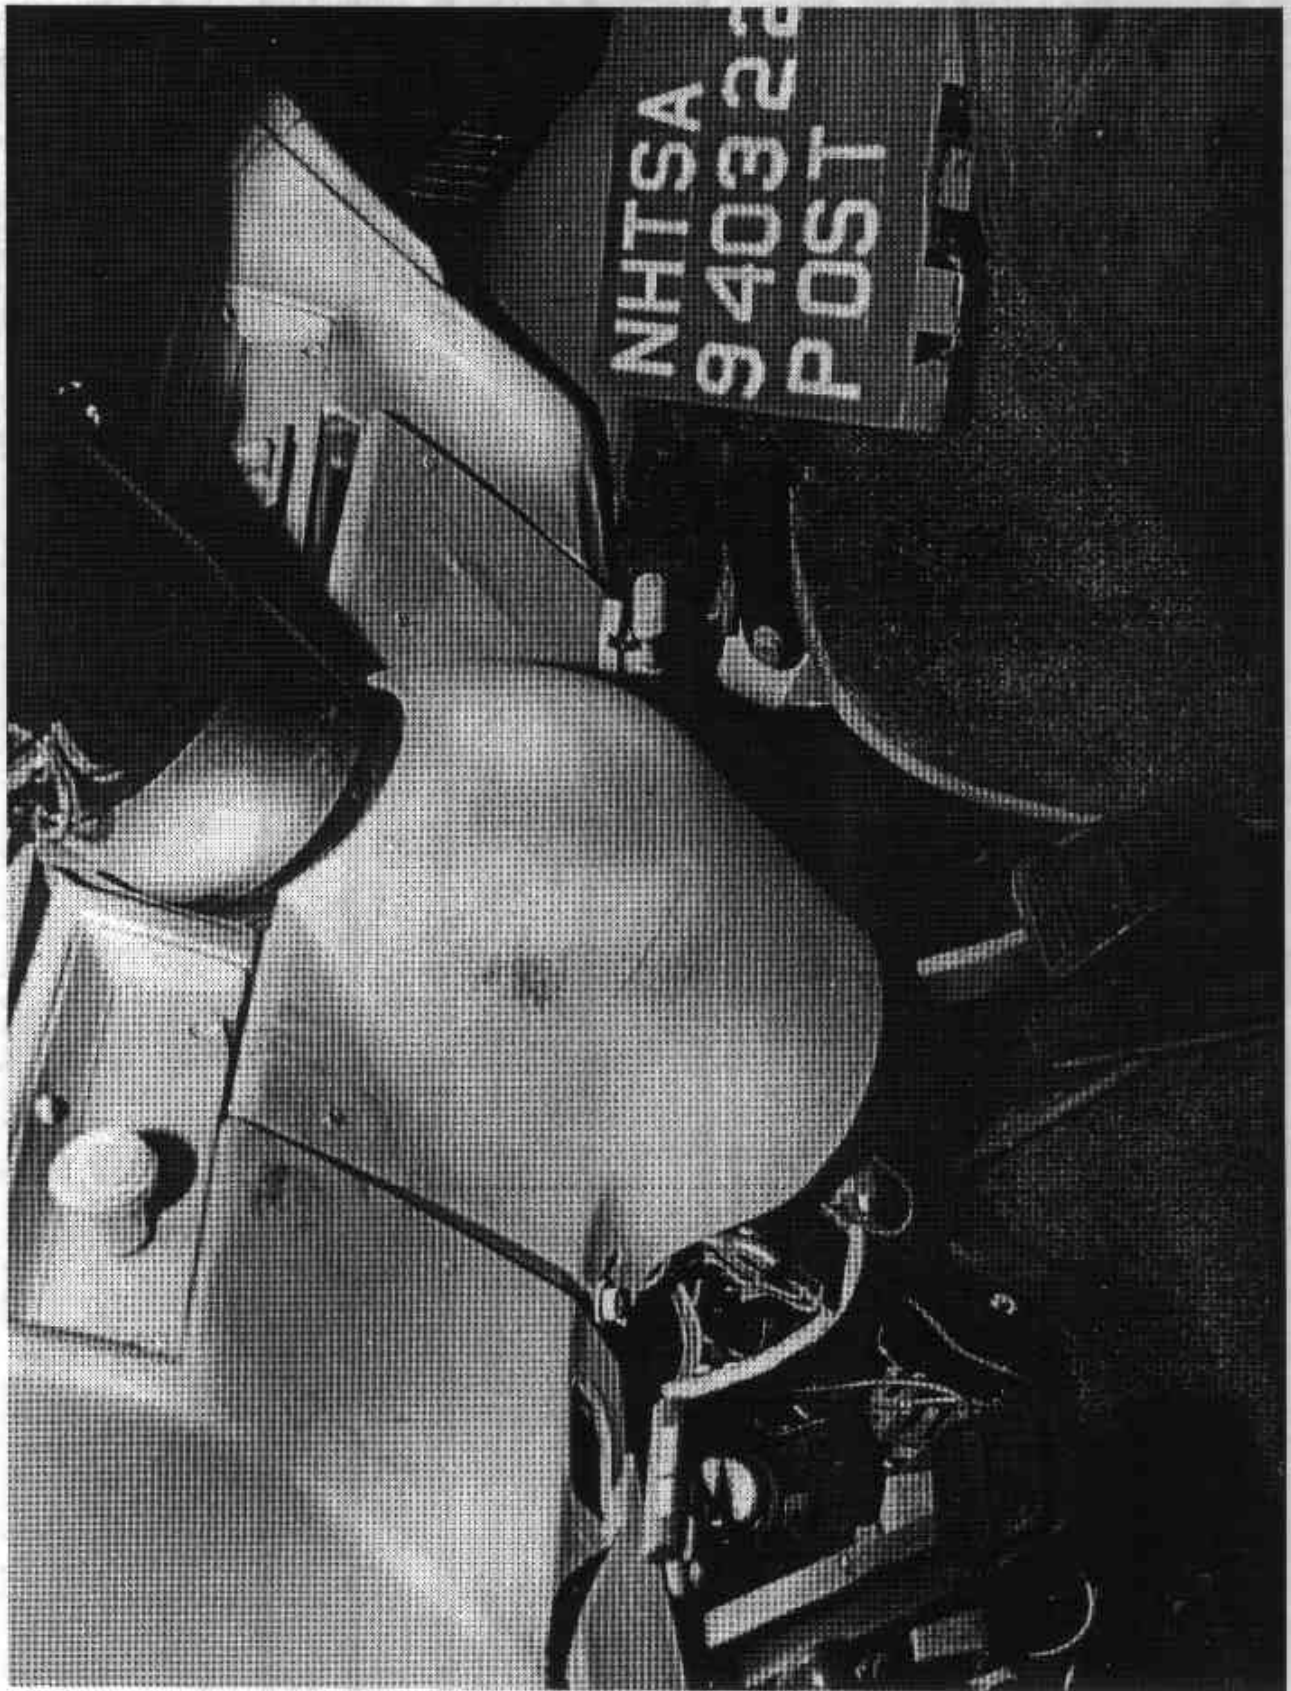
Figure A-54. Post-test Driver Dummy Knee Contact- View 2

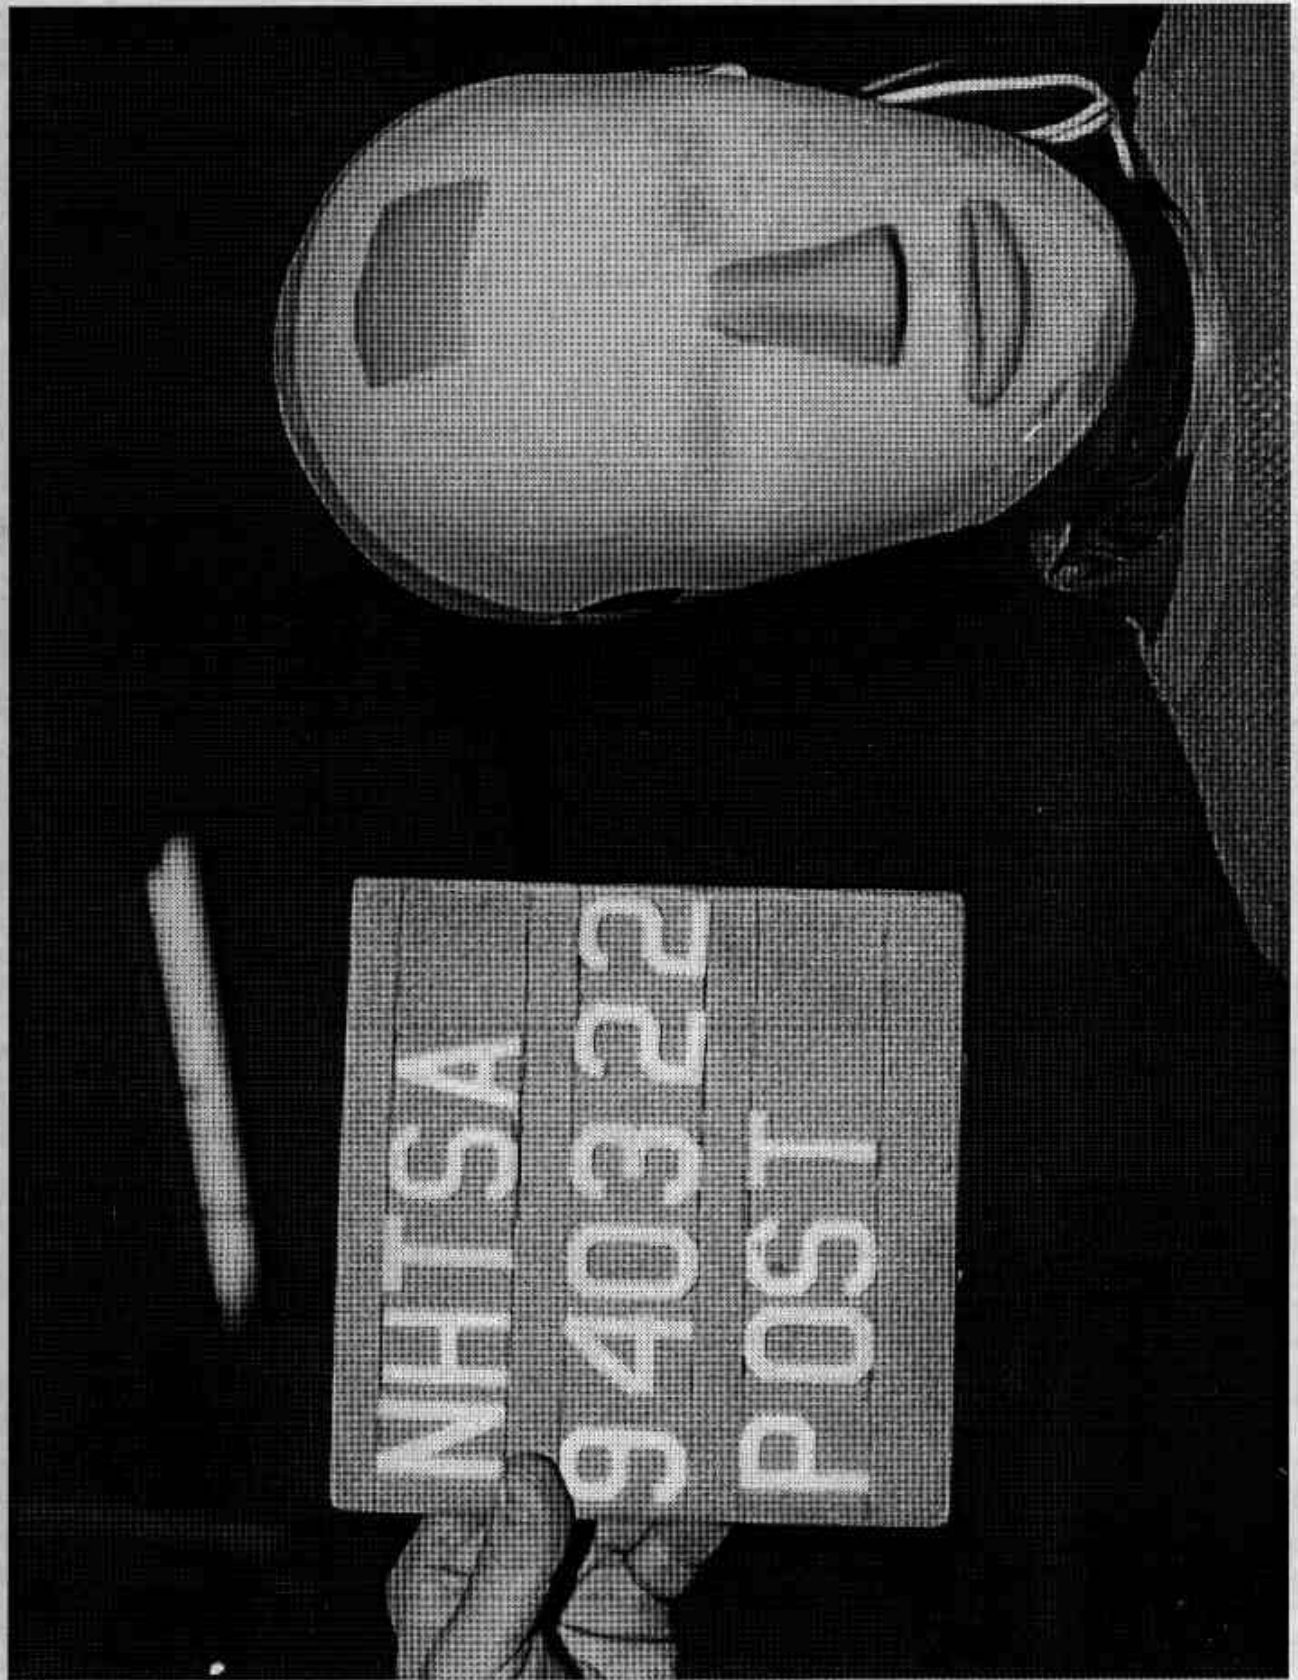
Figure A-55. Post-test Passenger Dummy Head Contact - View 1
A-56

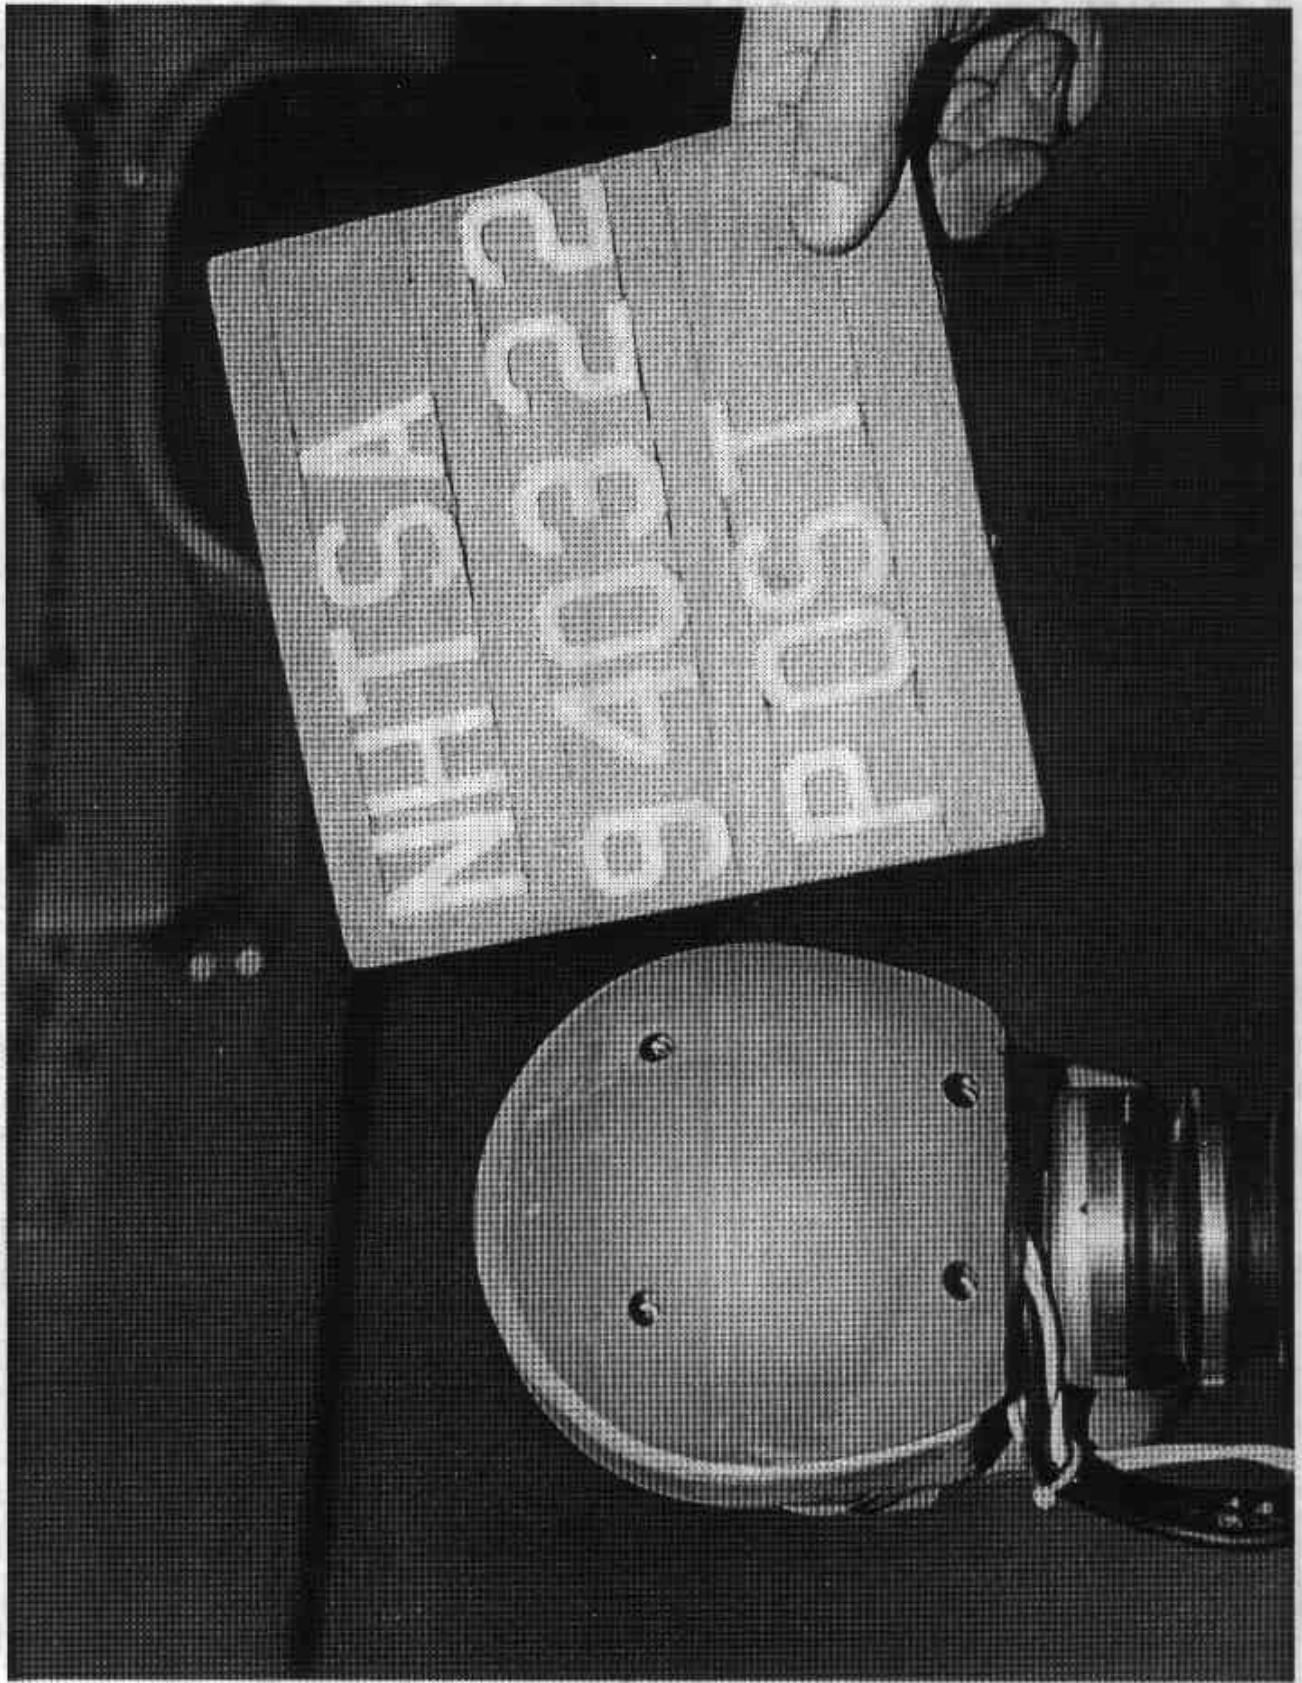
Figure A-56. Post-test Passenger Dummy Head Contact - View 2

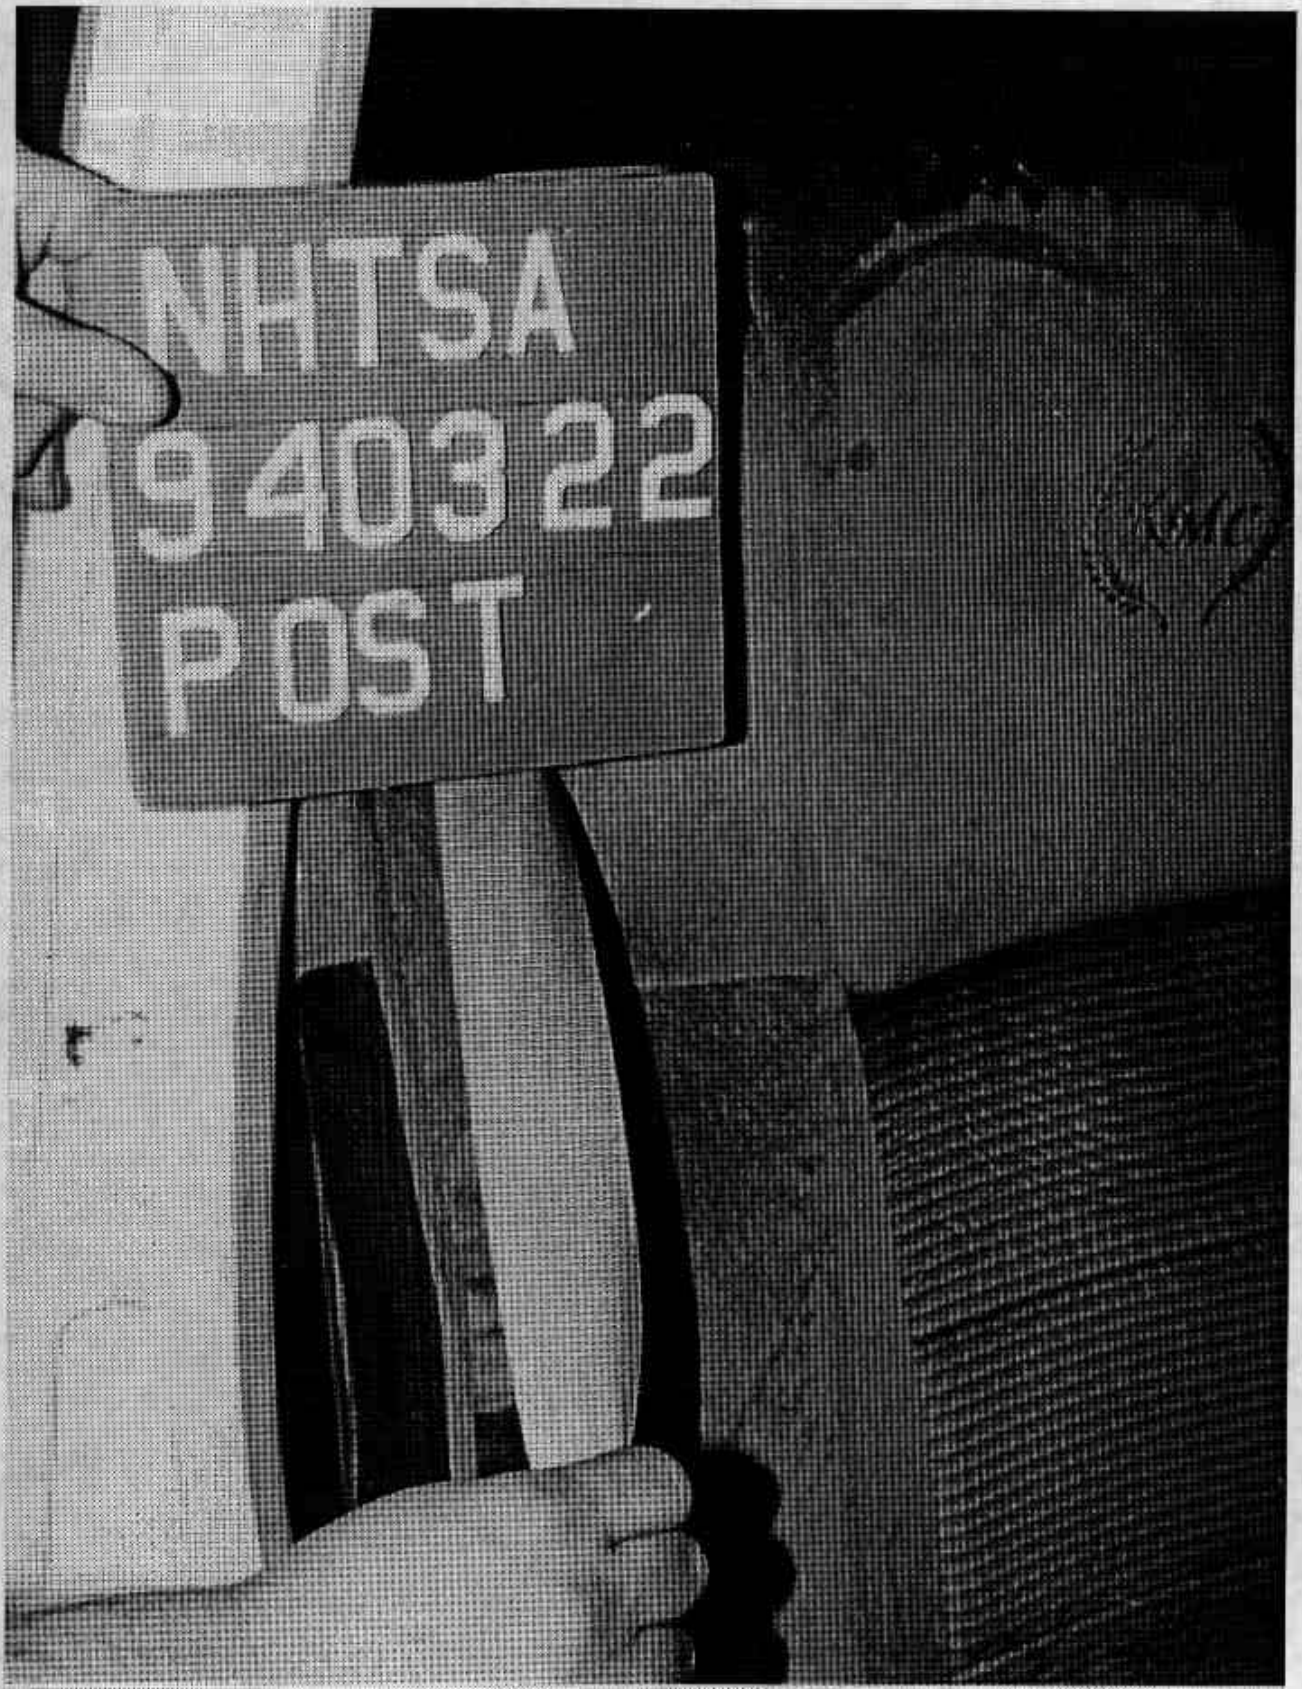
Figure A-57. Post-test Passenger Dummy Head Contact - View 3

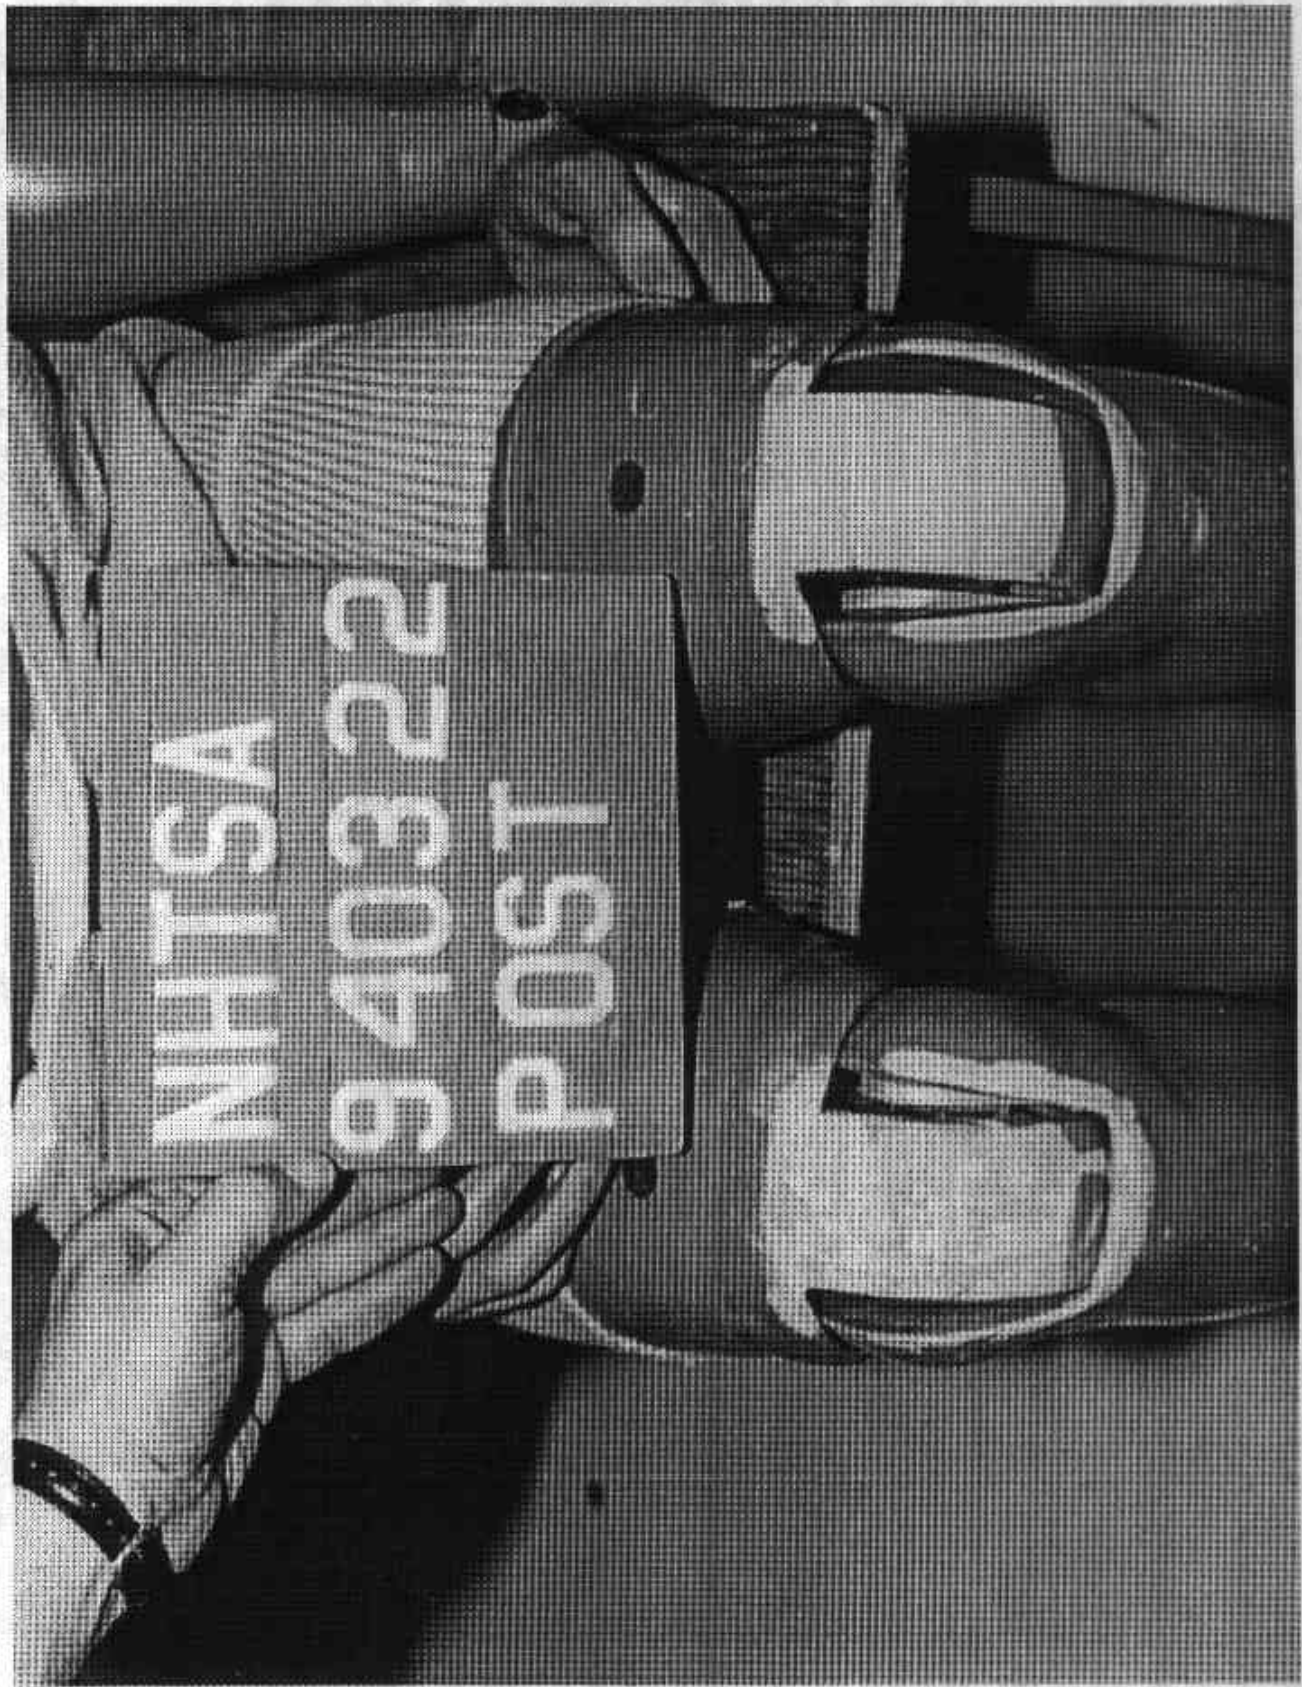
Figure A-58. Post-test Passenger Dummy Knee Contact - View 1
A-59

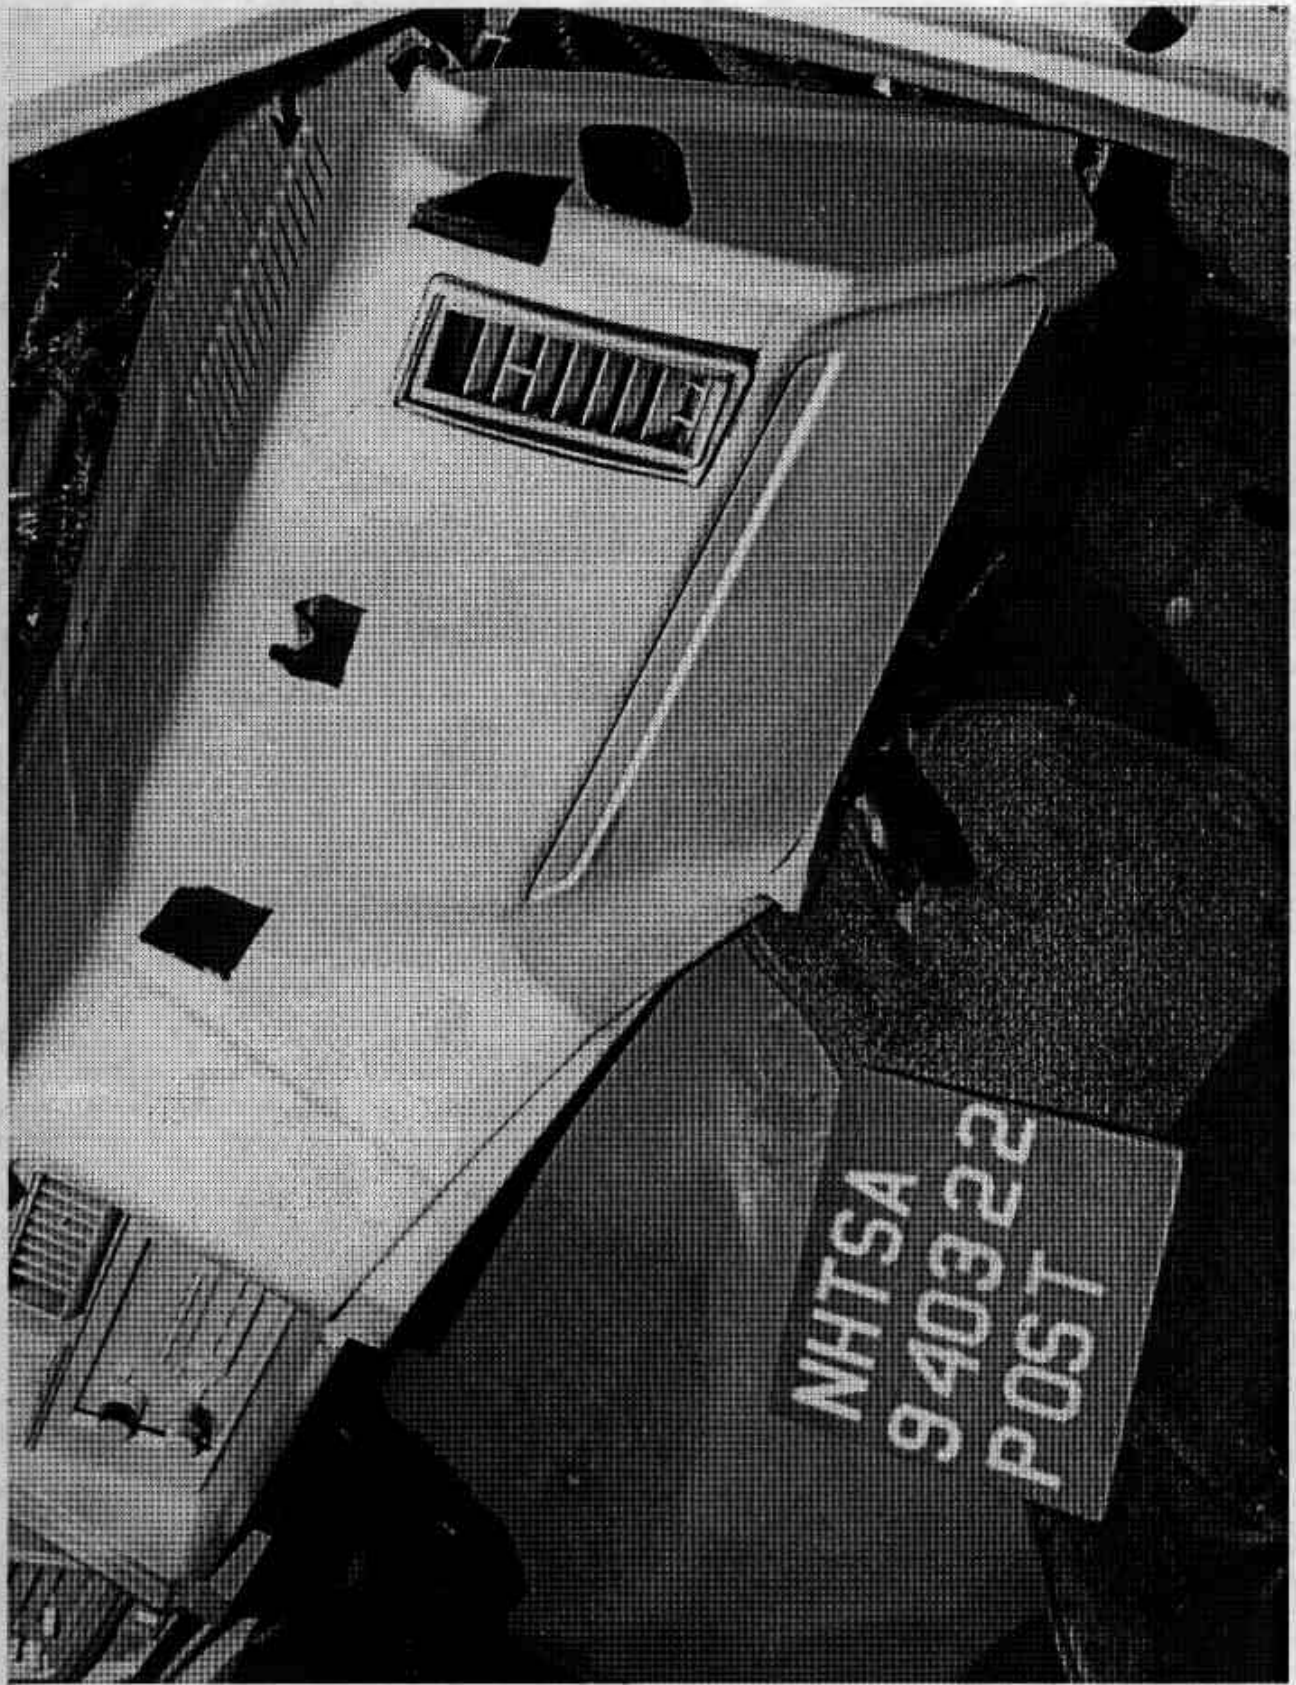
Figure A-59. Post-test Passenger Dummy Knee Contact - View 2
